Source Water Assessment

A Hydrogeologic Susceptibility and
Vulnerability Assessment for
North Face Lodge
Drinking Water System,
Denali National Park, Alaska
PWSID # 390324

By Ecology & Environment, Inc.

DRINKING WATER PROTECTION PROGRAM REPORT # 288

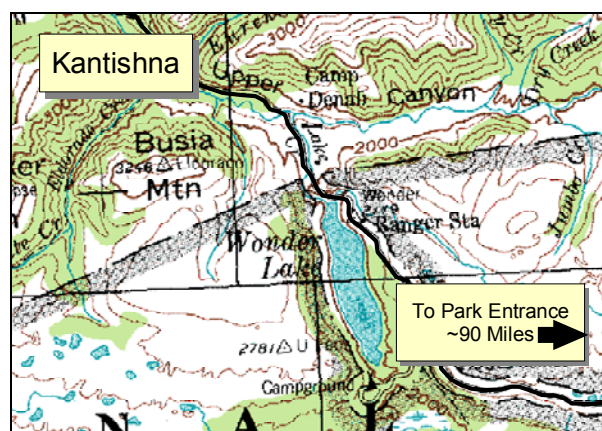
Figure 1

The entrance to Denali National Park is located 237 miles north of Anchorage and 120 miles south of Fairbanks, along the George Parks Highway. The park is accessed via the 89-mile Denali Park Road. Private vehicle access is restricted past mile 15. The road dead-ends in the Kantishna area. (Figure 1)
