# Hydrogeologic Susceptibility and Vulnerability Assessment for Matanuska Fitness Center Drinking Water Well, Palmer, Alaska

DRINKING WATER PROTECTION PROGRAM REPORT 116

September 2001

By Michael Baxter, B.E.S.T. Resource

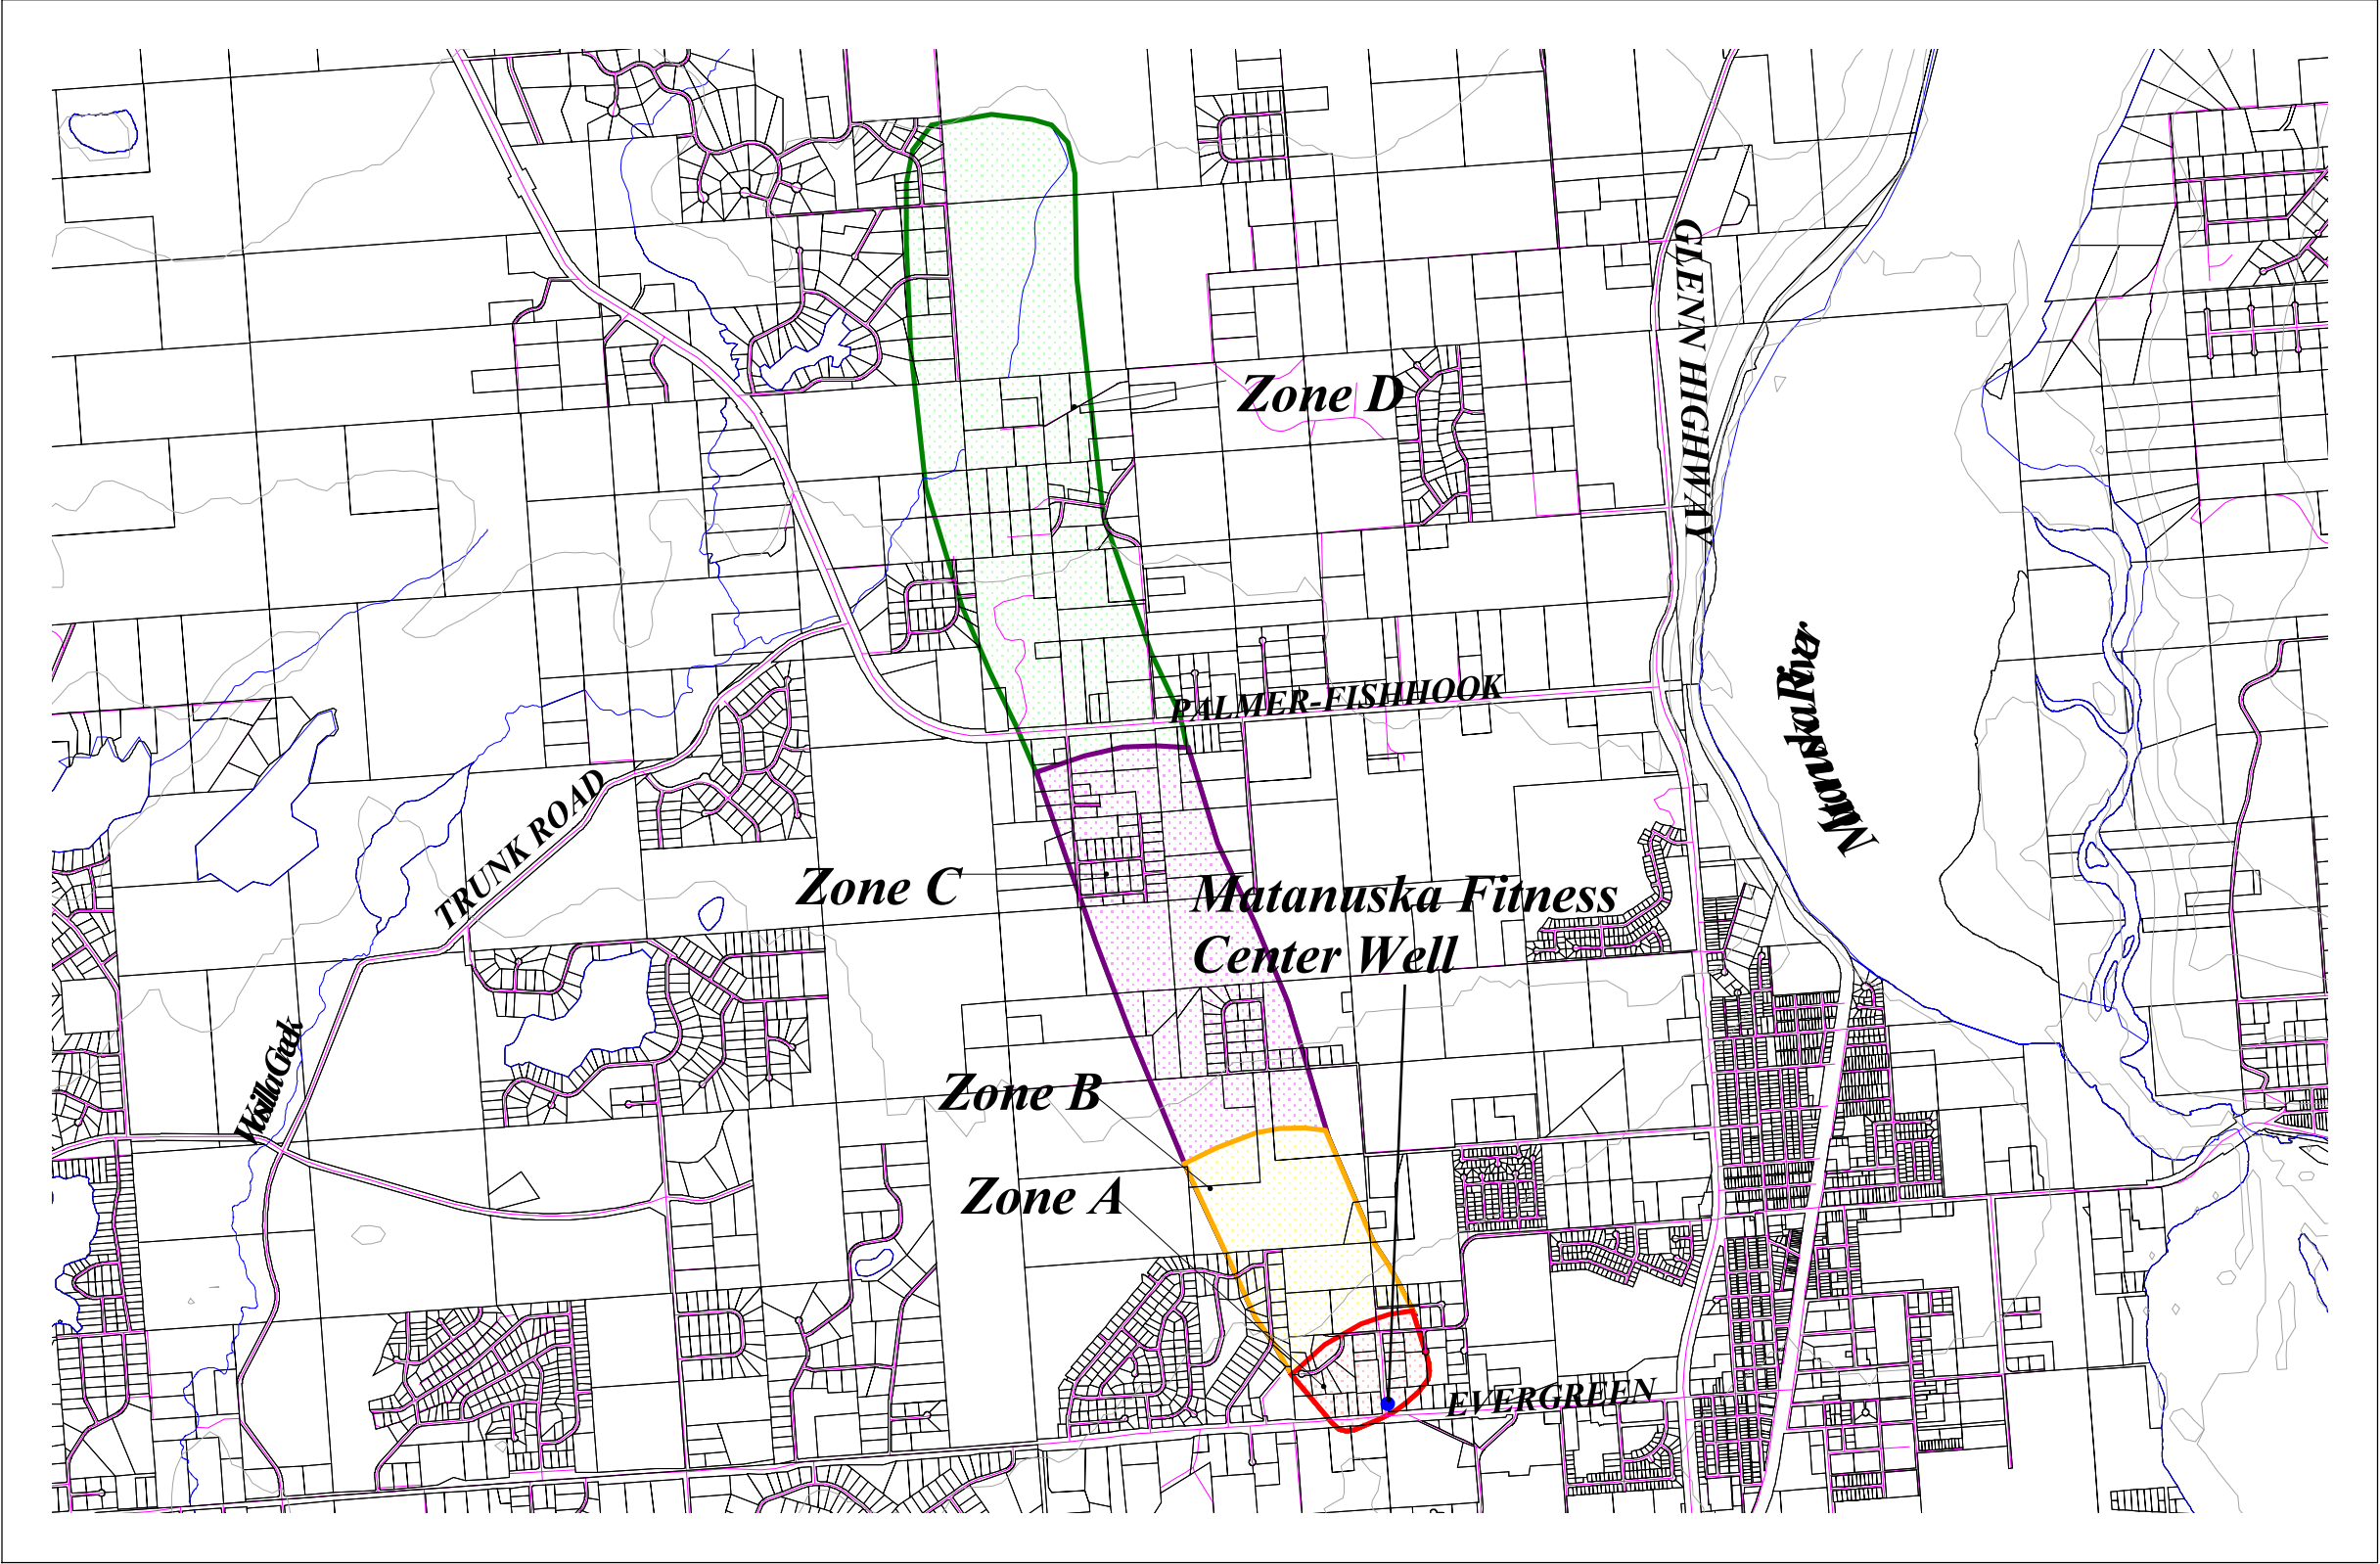
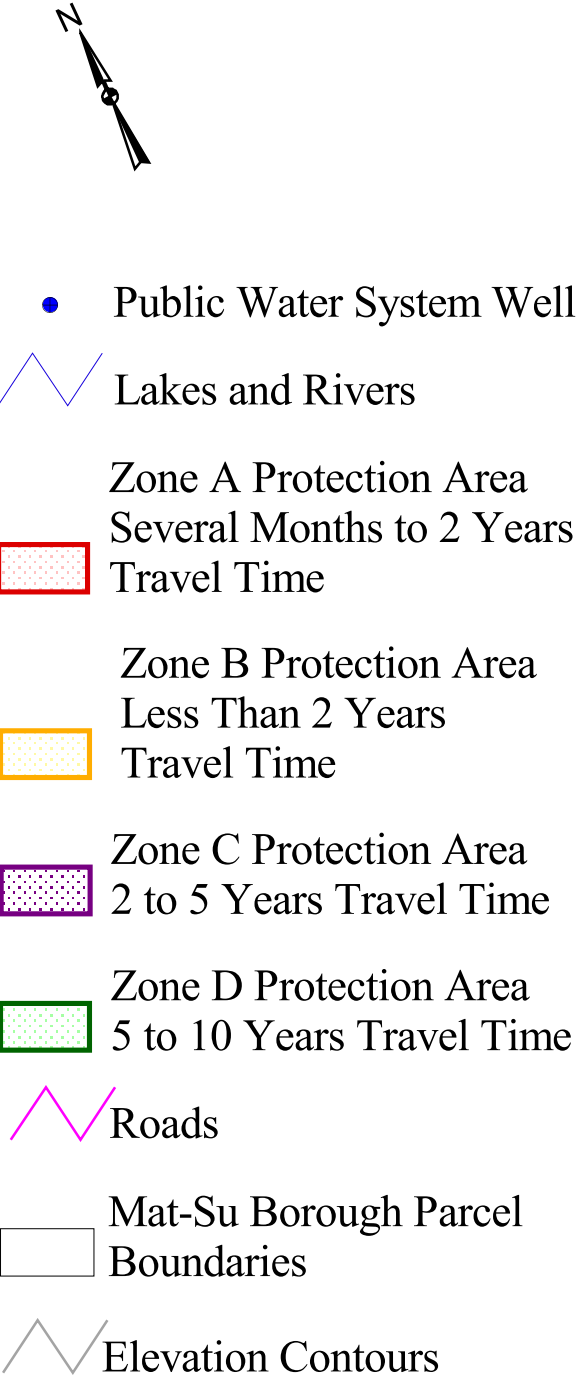
**Map 1**

### **Matanuska Fitness Center Drinking Water Protection Area**

## Drinking Water Protection Areas

The Drinking Water Protection Areas established for wells by the Alaska Department of Environmental Conservation (ADEC) are separated into zones. These zones correspond to a time-of-travel. Time-of-travel is the time required for water to move in the saturated zone of the ground from a specific point to the well. The Drinking Water Protection Areas for Matanuska Fitness Center contain four zones, Zone A, Zone B, Zone C and Zone D (See Map 1 in Appendix A). Zone A corresponds to the area between the well and the distance equal to  $\frac{1}{4}$  of the distance of the 2-year time-of-travel. Depending on where a contaminant source is located within Zone A, travel time for a contaminant to the well may be on the order of several days to several hours. Zone A also extends down gradient from the well to take into account the area of the aquifer that is influenced by pumping of the well.

The Zone B protection area for Matanuska Fitness Center corresponds to a time-of-travel of less than two years and extends toward to base of the Talkeetna Mountains. Zone C protection area extends from Zone B to Zone D, which extends north towards the Talkeetna Mountains.

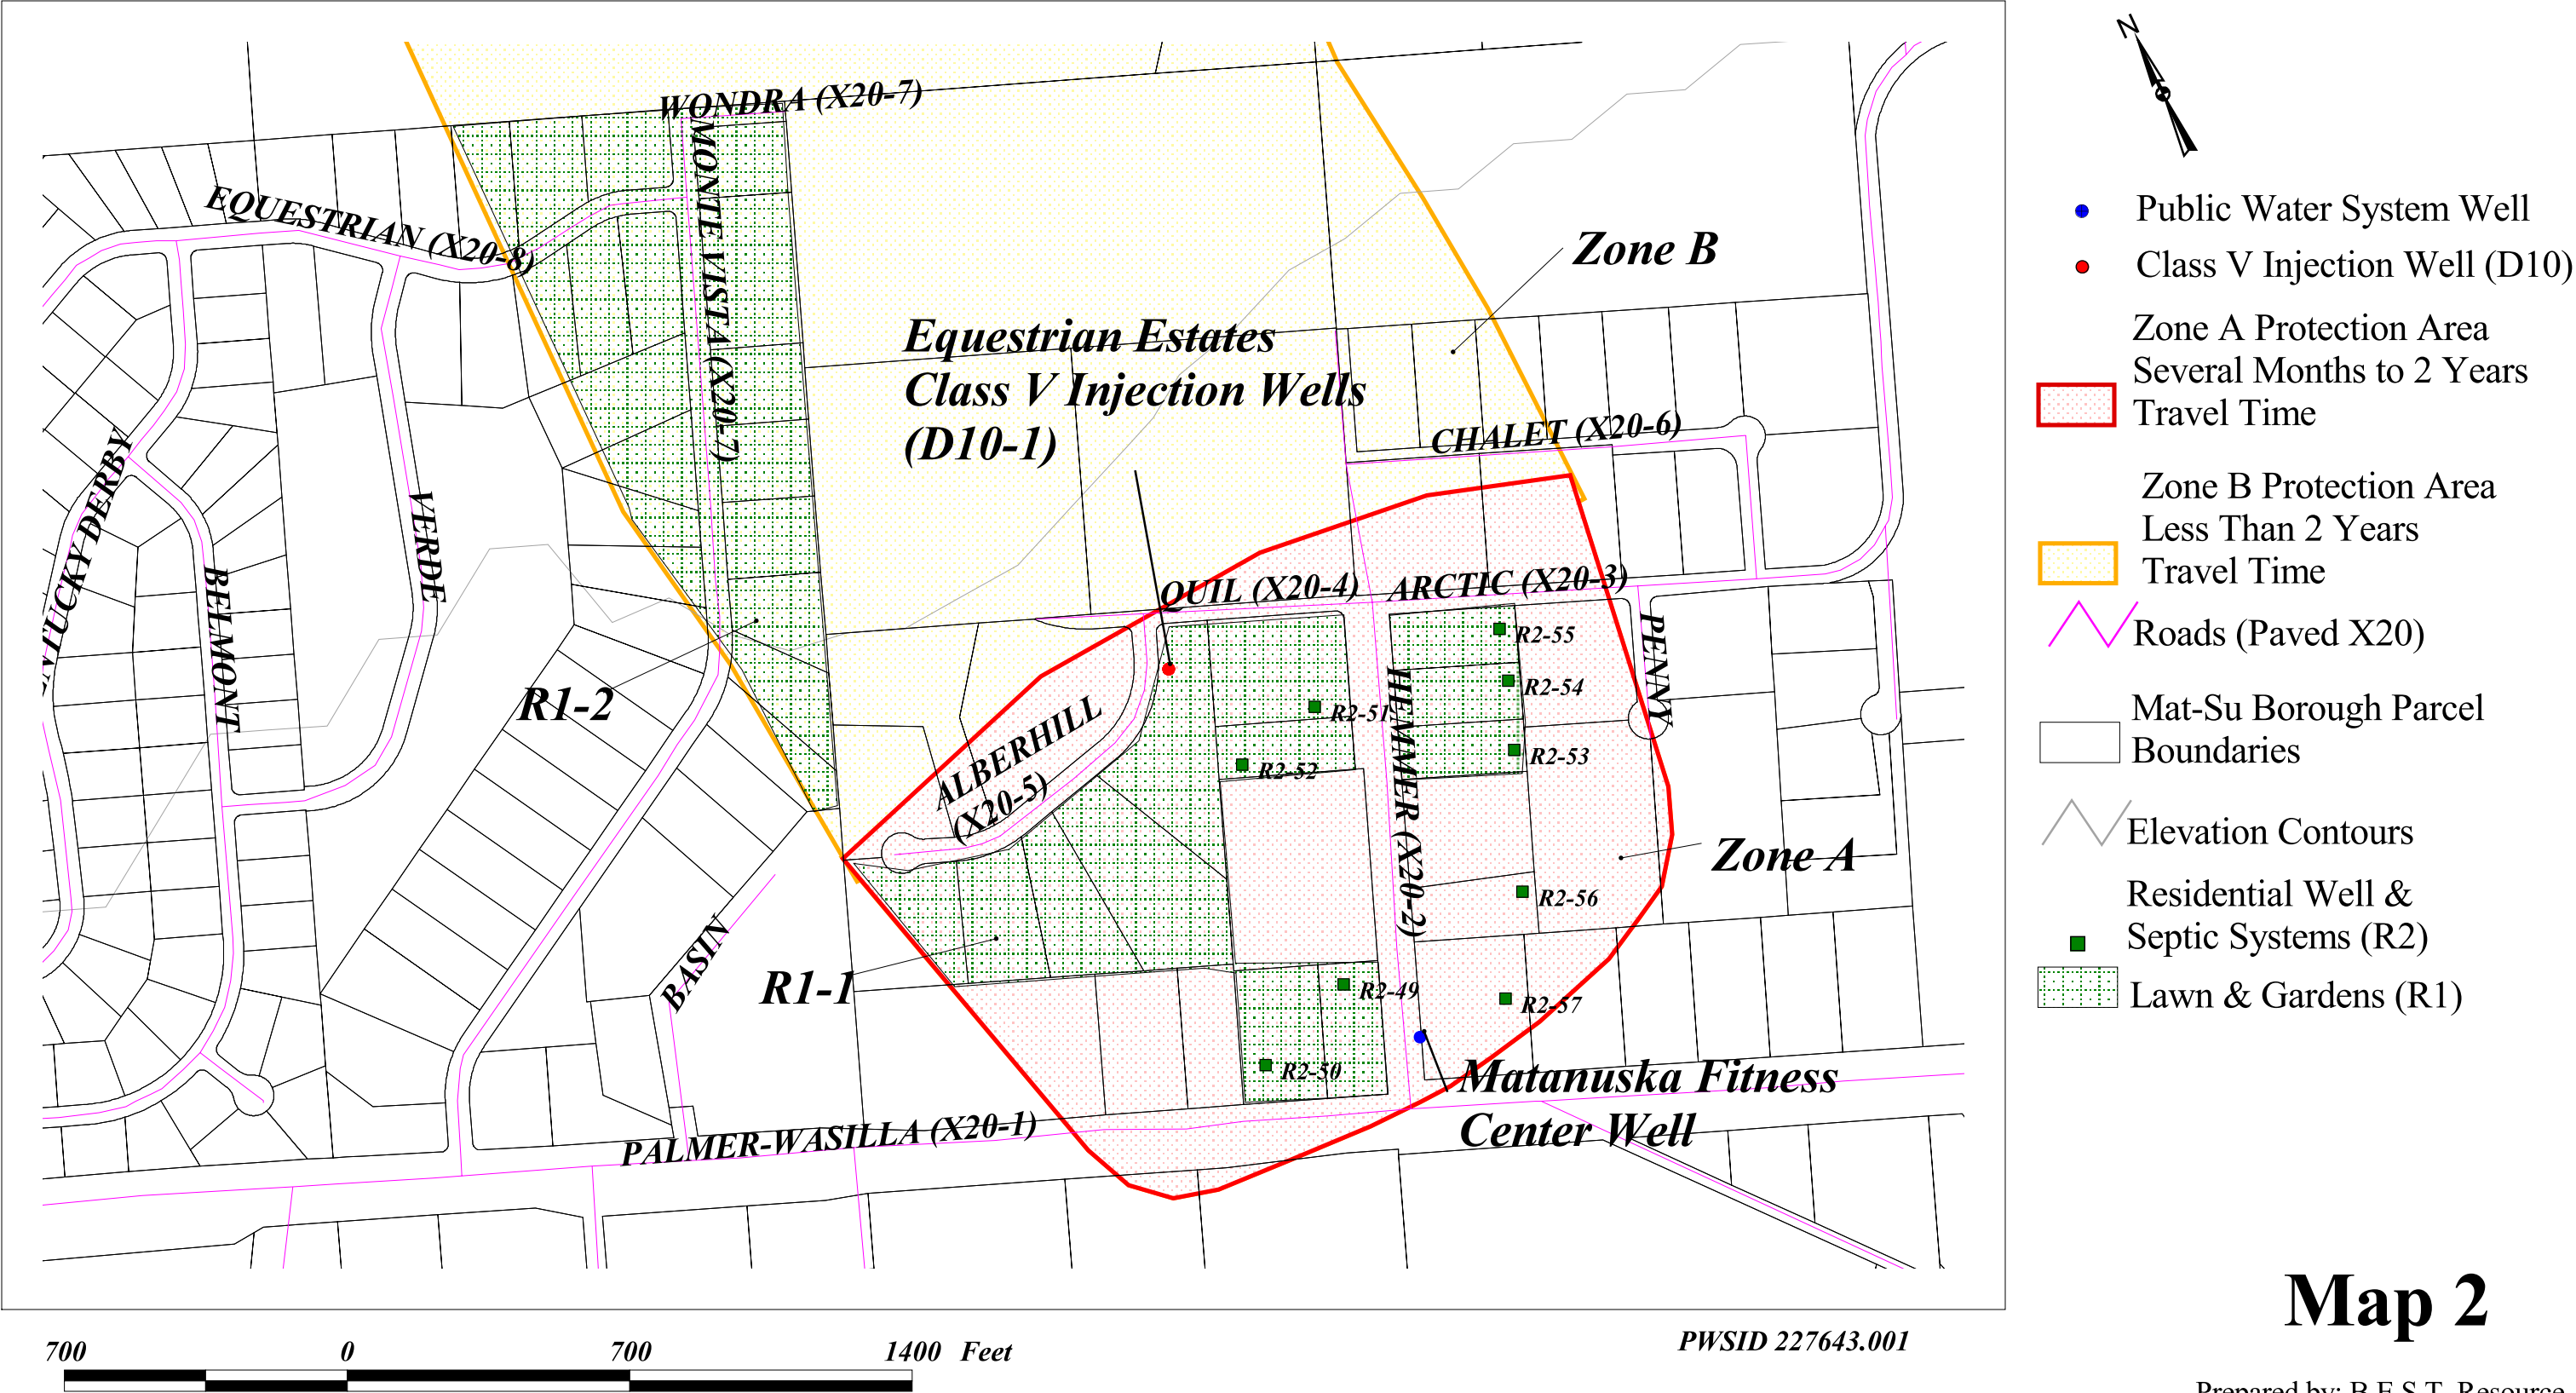
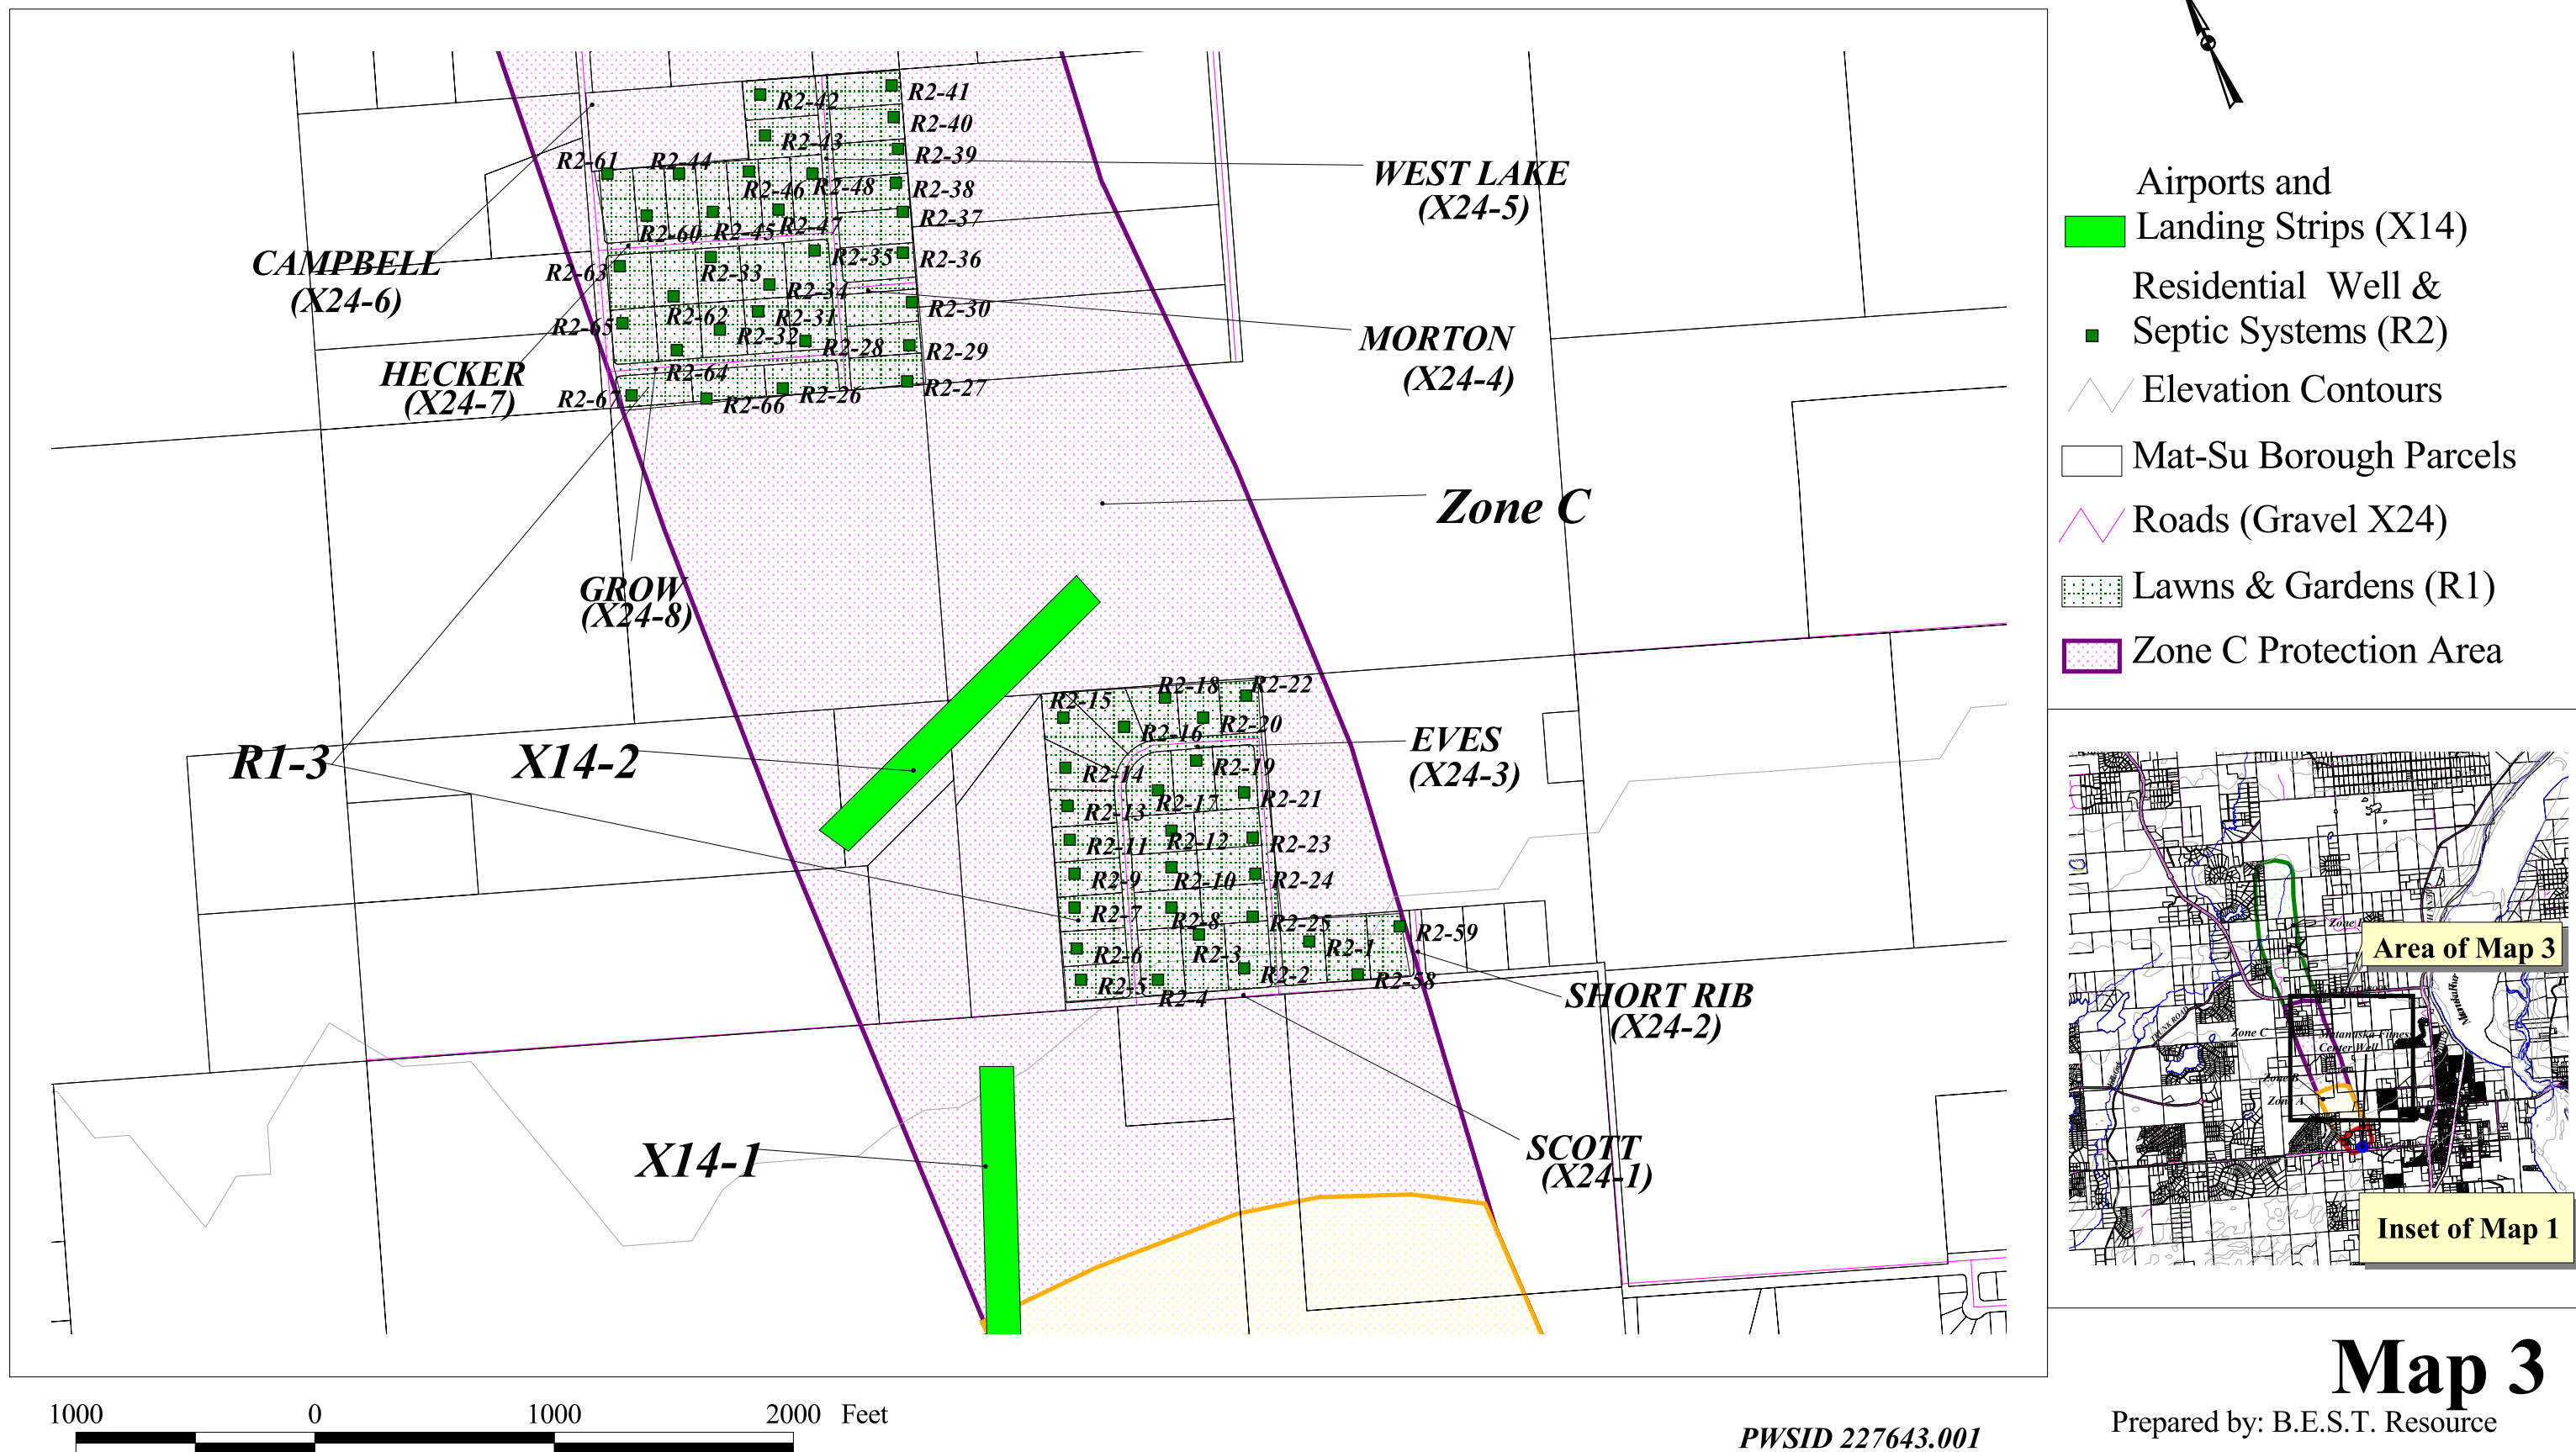
**Map 2**

### **Matanuska Fitness Center Drinking Water Protection Area and Potential & Existing Contaminant Sources**

# Drinking Water Protection Areas Potential & Existing Sources of Contamination for Matanuska Fitness Center

# Drinking Water Protection Area and Potential & Existing Sources of Contamination for Matanuska Fitness Center

Map 1 in Appendix C depicts the Contaminant Source Inventory for Matanuska Fitness Center. Inventoried potential sources of contamination within Zones A through Zone B were associated with residential activity. Below is a summary of the contaminant sources inventoried within the Matanuska Fitness Center protection area:

- Class V injection well
- Residential septic systems
- Airplane landing strip
- Roads
- Residential lawn and garden;

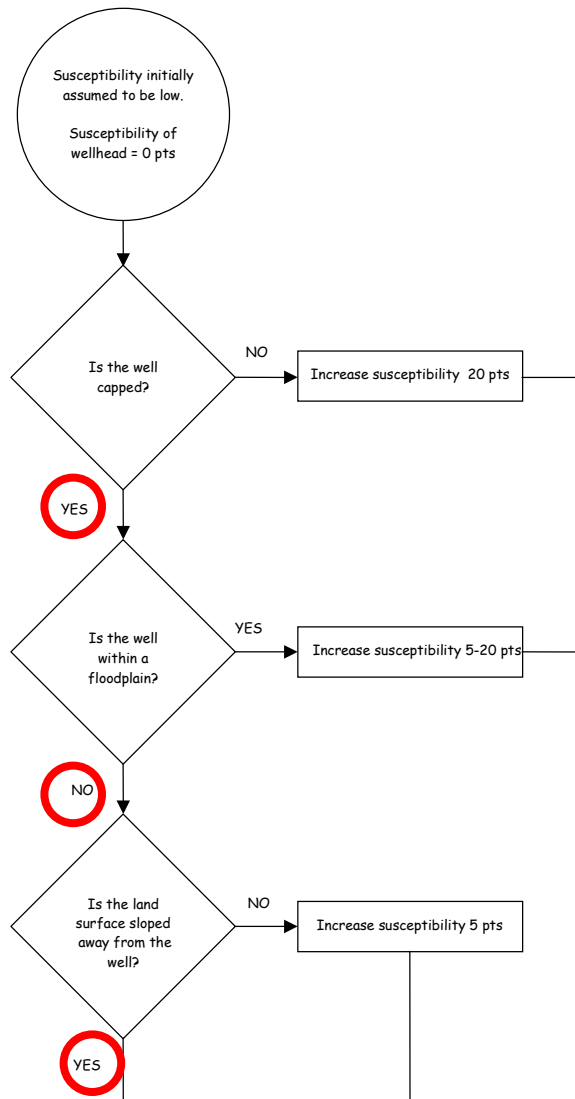
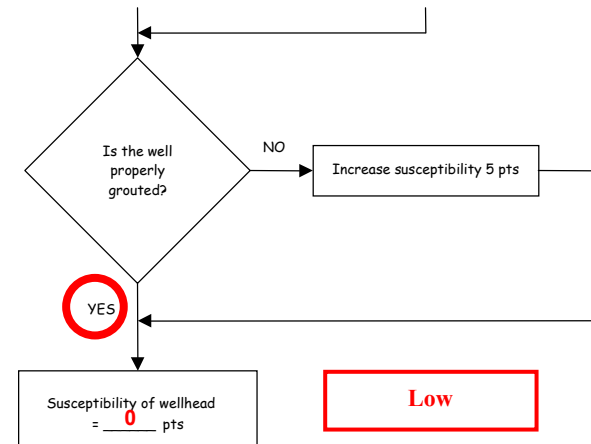
**Chart 1. Susceptibility of the wellhead – Matanuska Fitness Center**

**Wellhead Susceptibility Ratings**

20 to 25 pts	very high
15 to < 20 pts	high
10 to < 15 pts	medium
< 10	low

Appendix D contains eight charts, which together form the ‘Vulnerability Analysis’ for a source water assessment for a public drinking water source. Chart 1 analyzes the ‘Susceptibility of the Wellhead’ to contamination by looking at the construction of the well and its surrounding area. Chart 2 analyzes the ‘Susceptibility of the Aquifer’ to contamination by looking at the naturally occurring attributes of the water source and influences on the groundwater system that might lead to contamination. Chart 3 analyzes ‘Contaminant Risks’ for the drinking water source with respect to bacteria and viruses. The ‘Contaminant Risks’ portion of the analysis considers potential sources of contaminants as well as a review of contamination that has or may have occurred but has not arrived or been detected at the well. Lastly, Chart 4 contains the ‘Vulnerability Analysis for Bacteria and

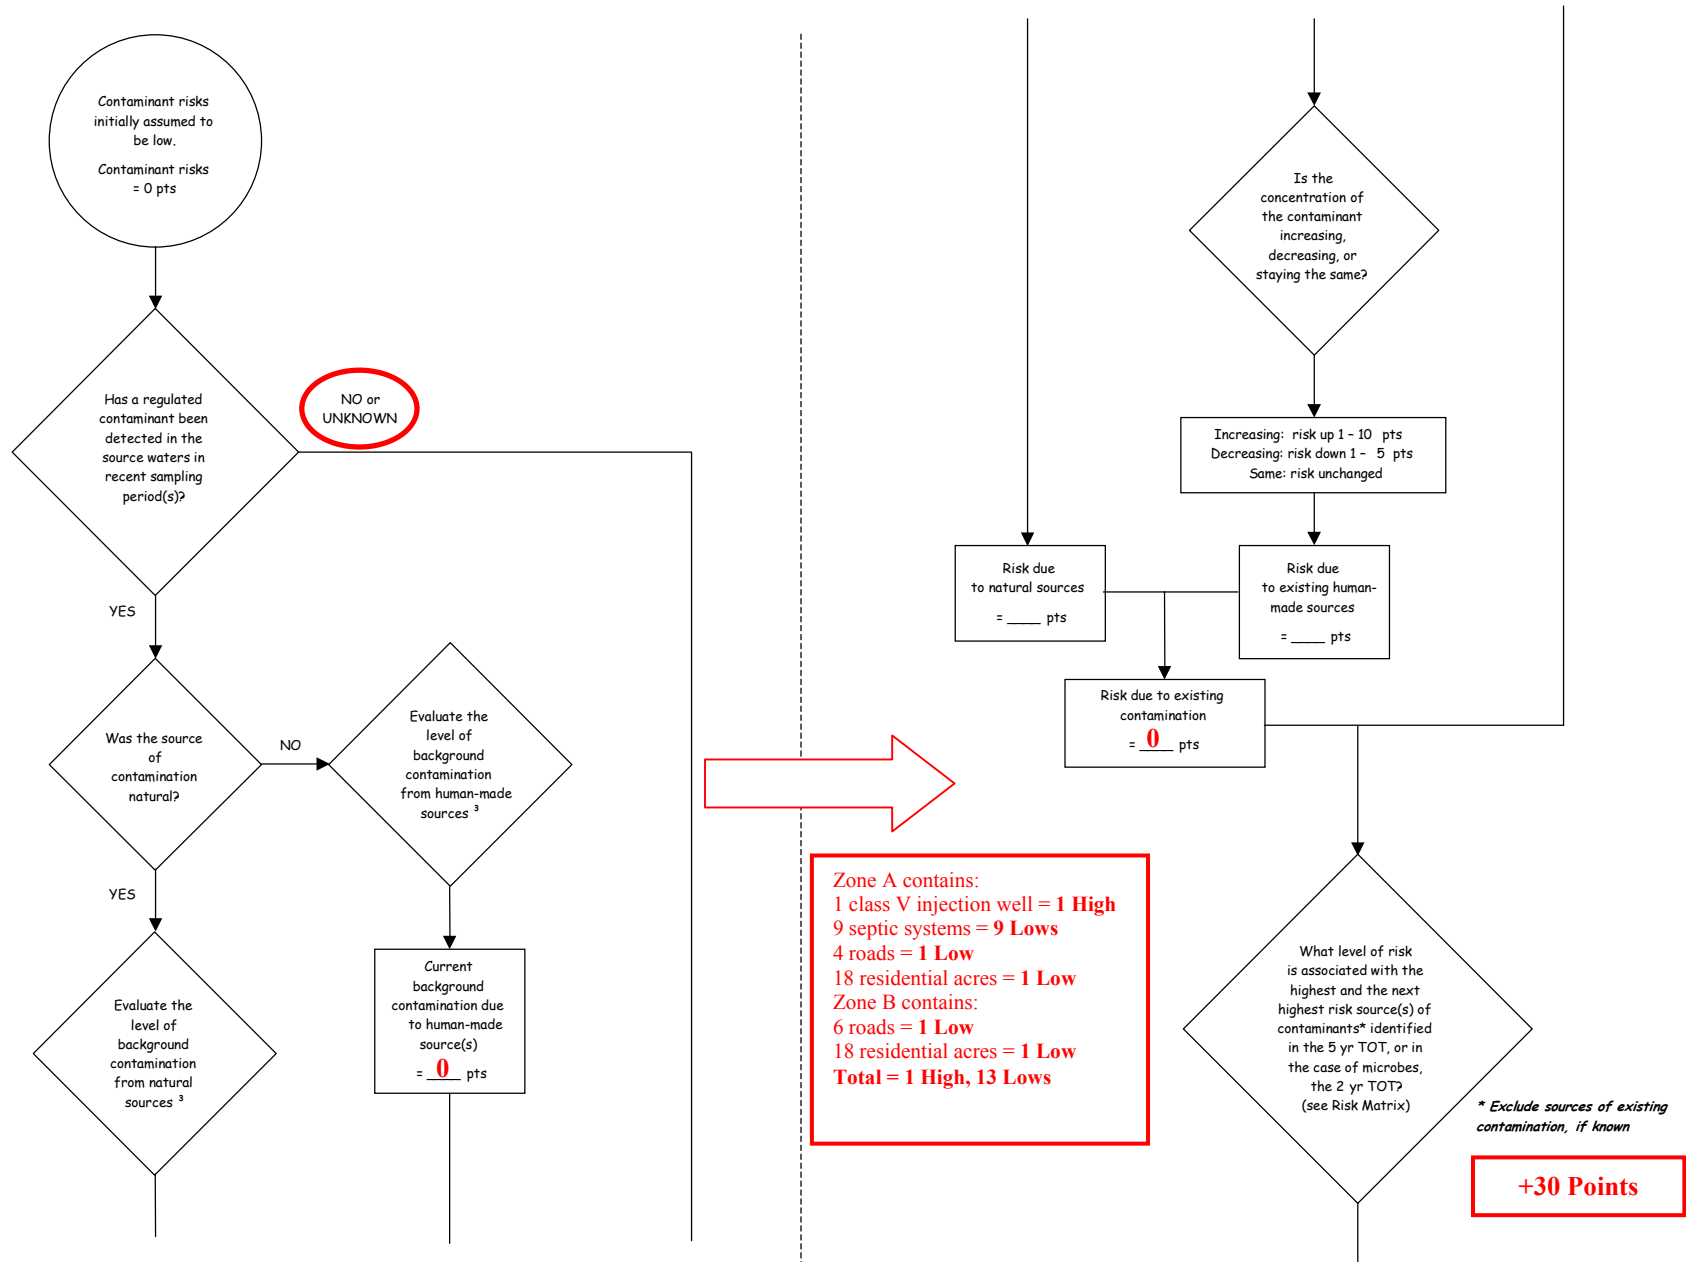
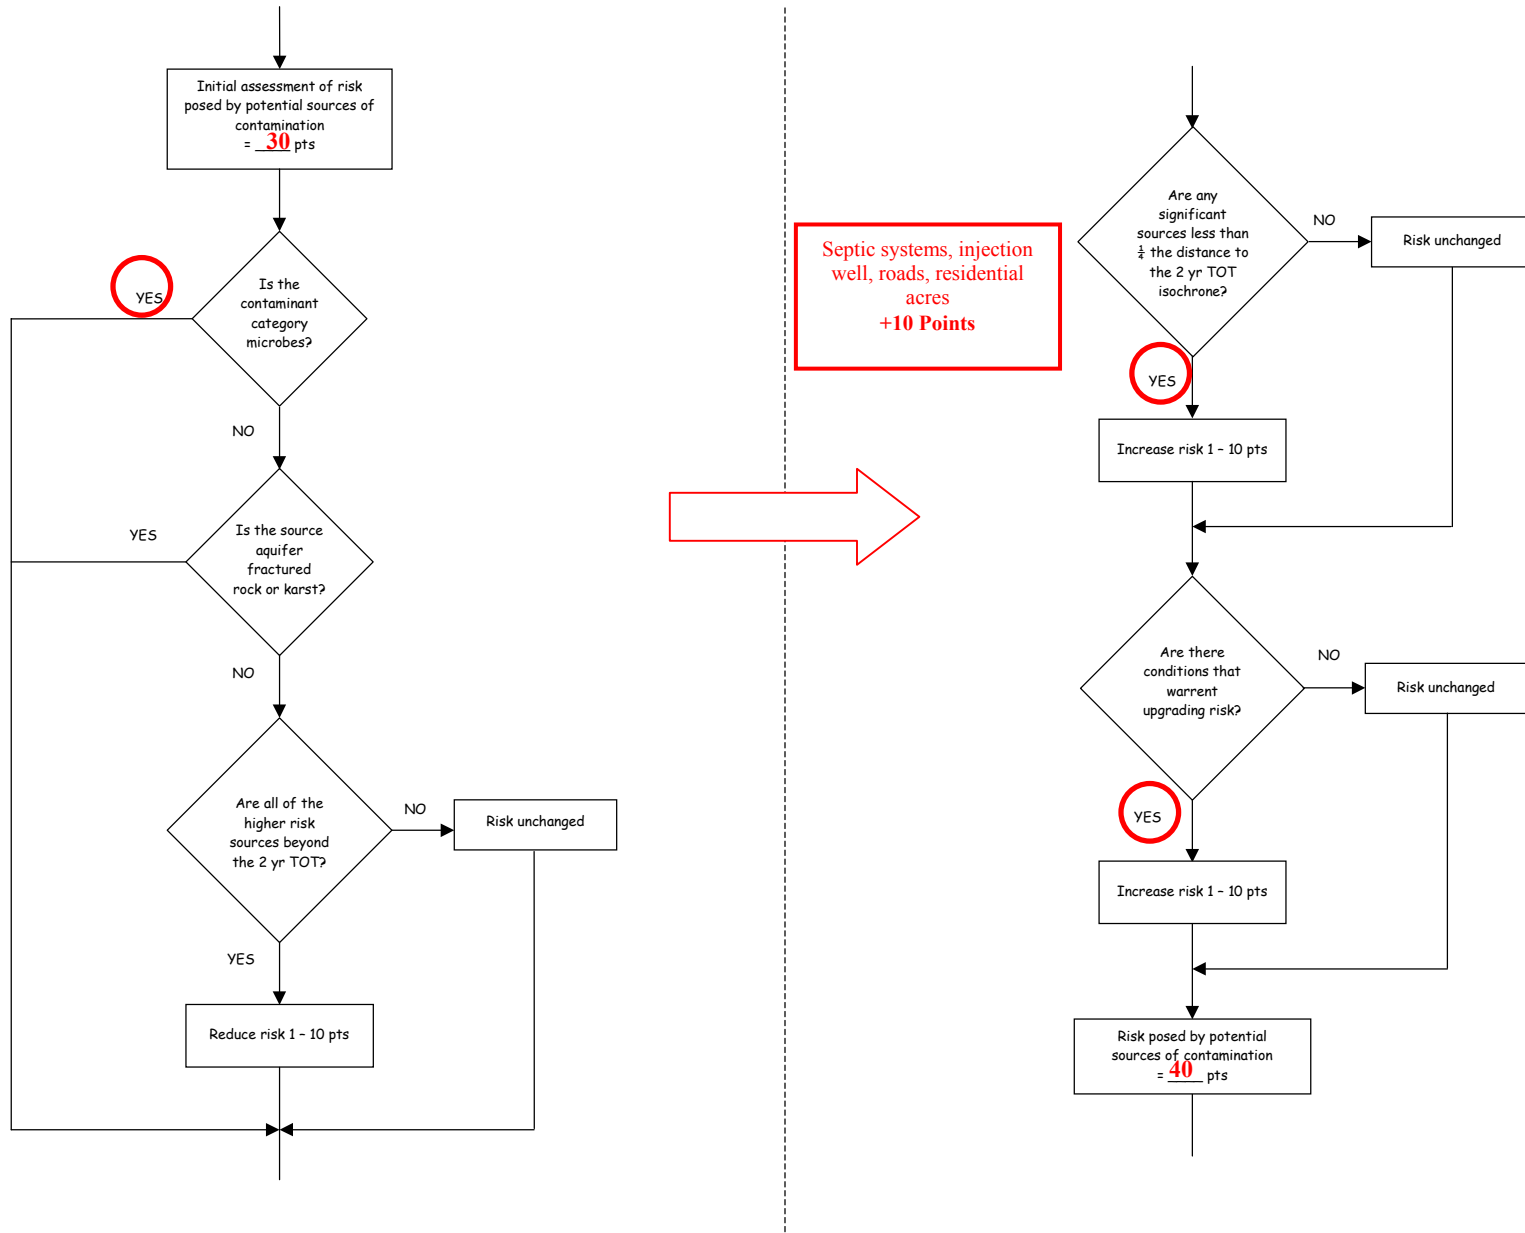
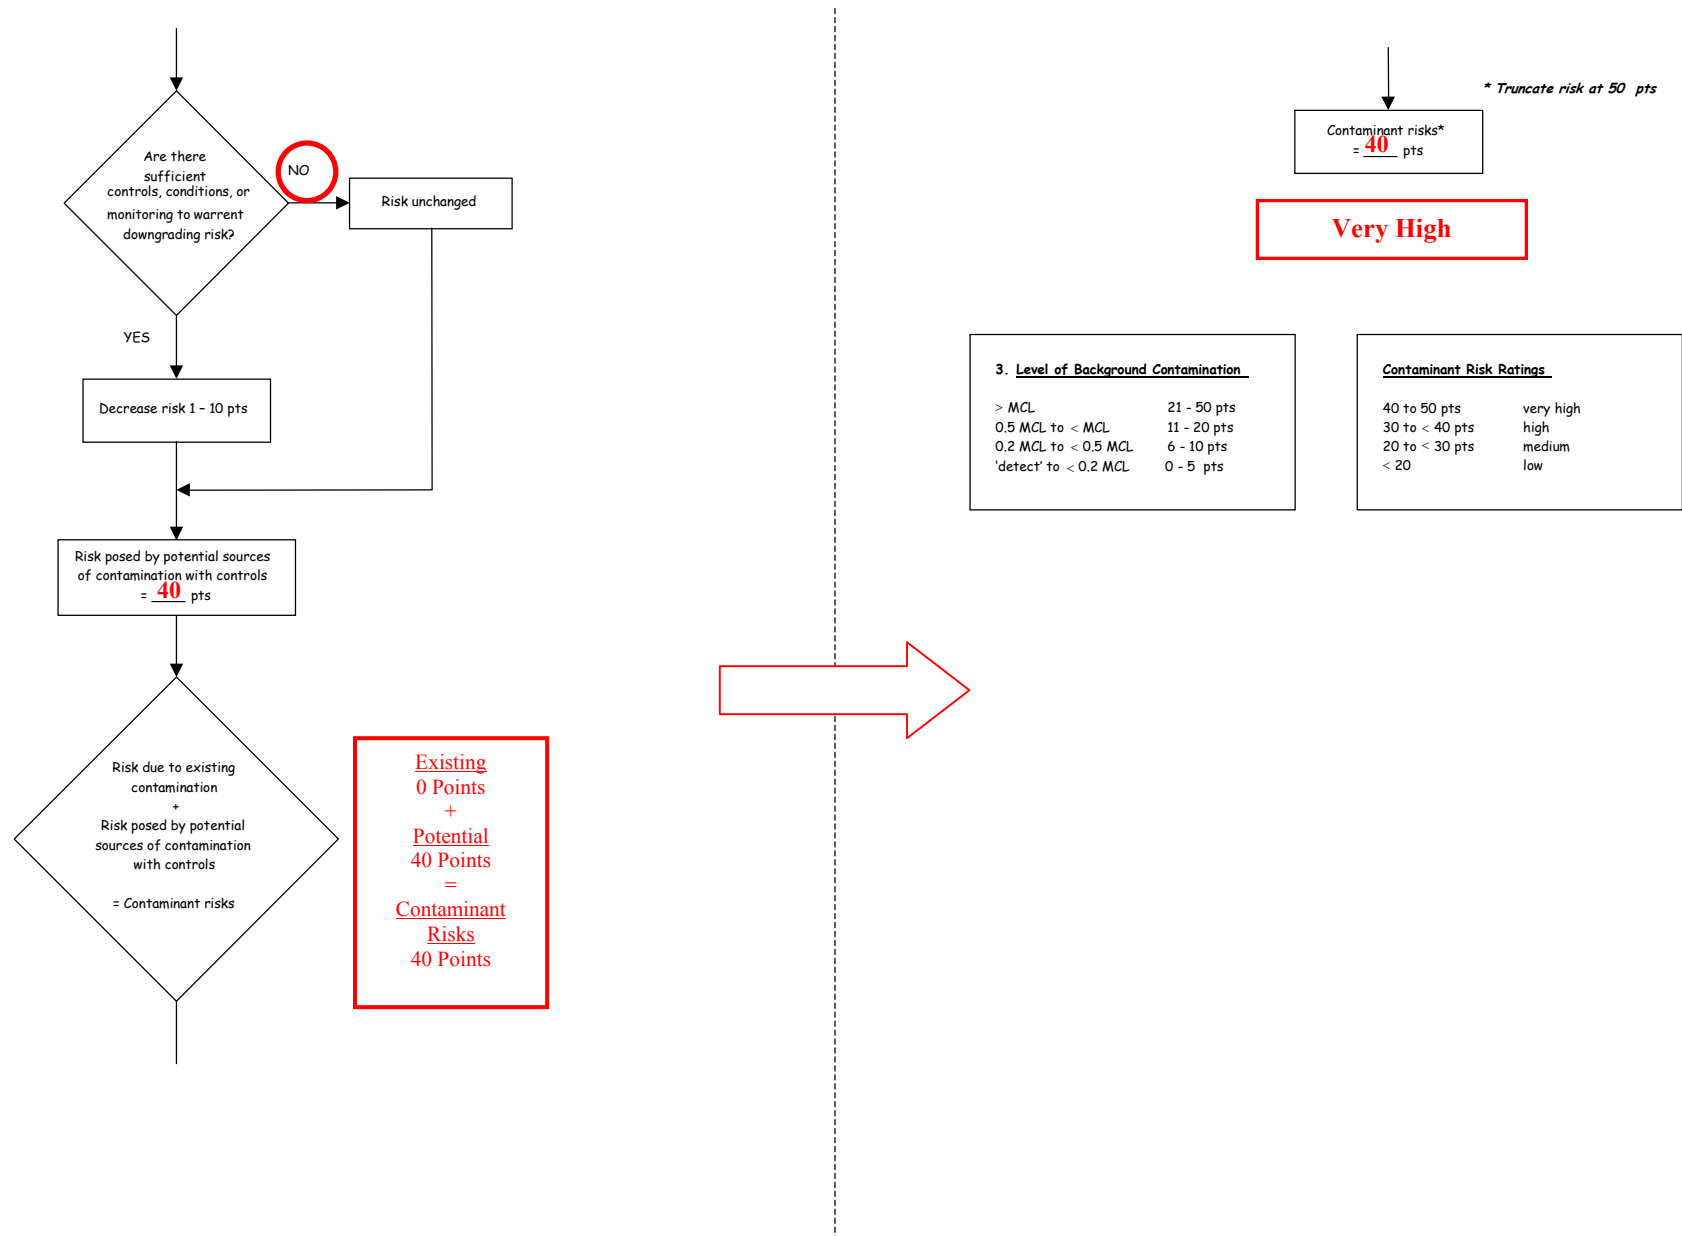
Chart 3. Contaminant risks for Matanuska Fitness Center – Bacteria & Viruses (Continued)

Bacteria and Viruses were not detected in the source waters of Matanuska Fitness Center. Overall, contaminant risk for the bacteria and viruses is very high due to the roads, residential acres, class V injection well a land strip and septic systems present up gradient from the well. This rating combined with the susceptibility of the well yields an overall rating of high for this category.
