# Hydrogeologic Susceptibility and Vulnerability Assessment for Matanuska Fitness Center Drinking Water Well, Palmer, Alaska

DRINKING WATER PROTECTION PROGRAM REPORT 116

September 2001

By Michael Baxter, B.E.S.T. Resource

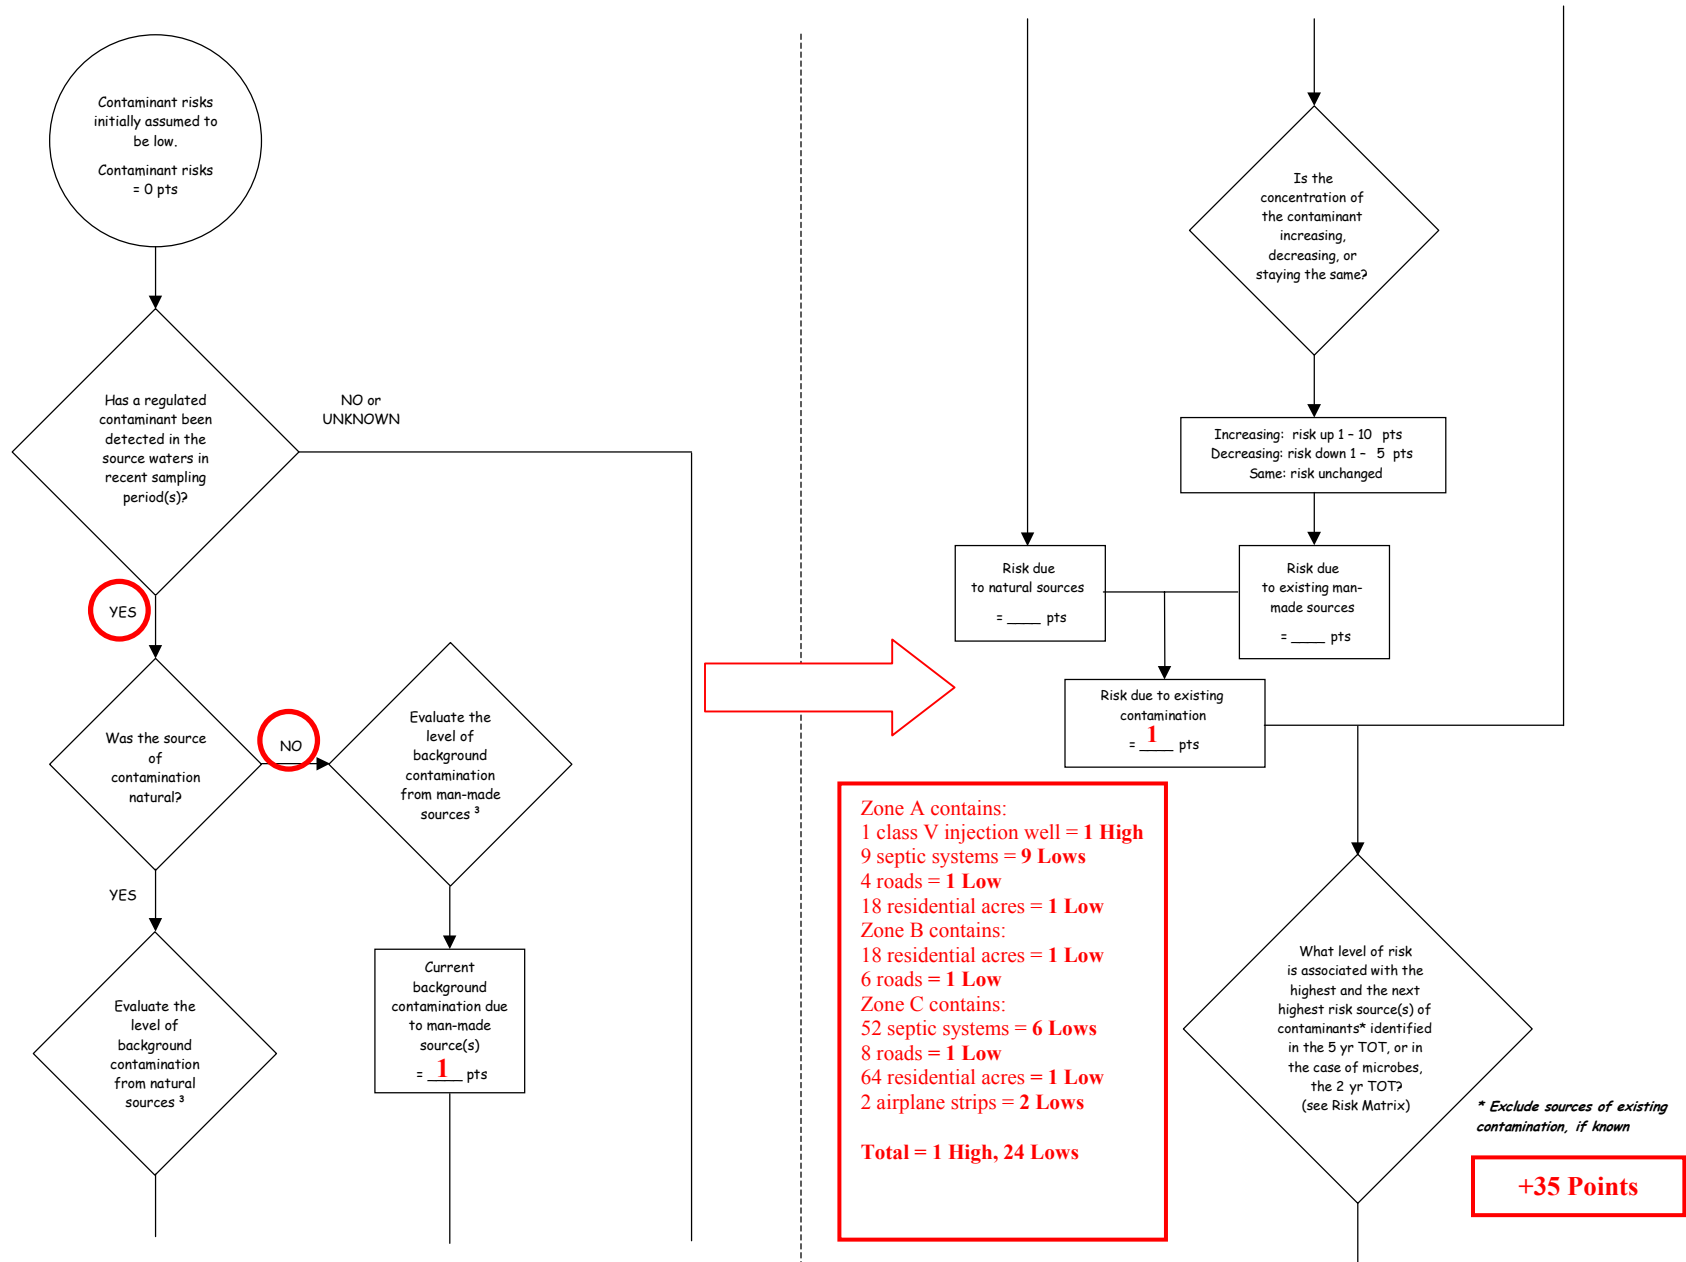
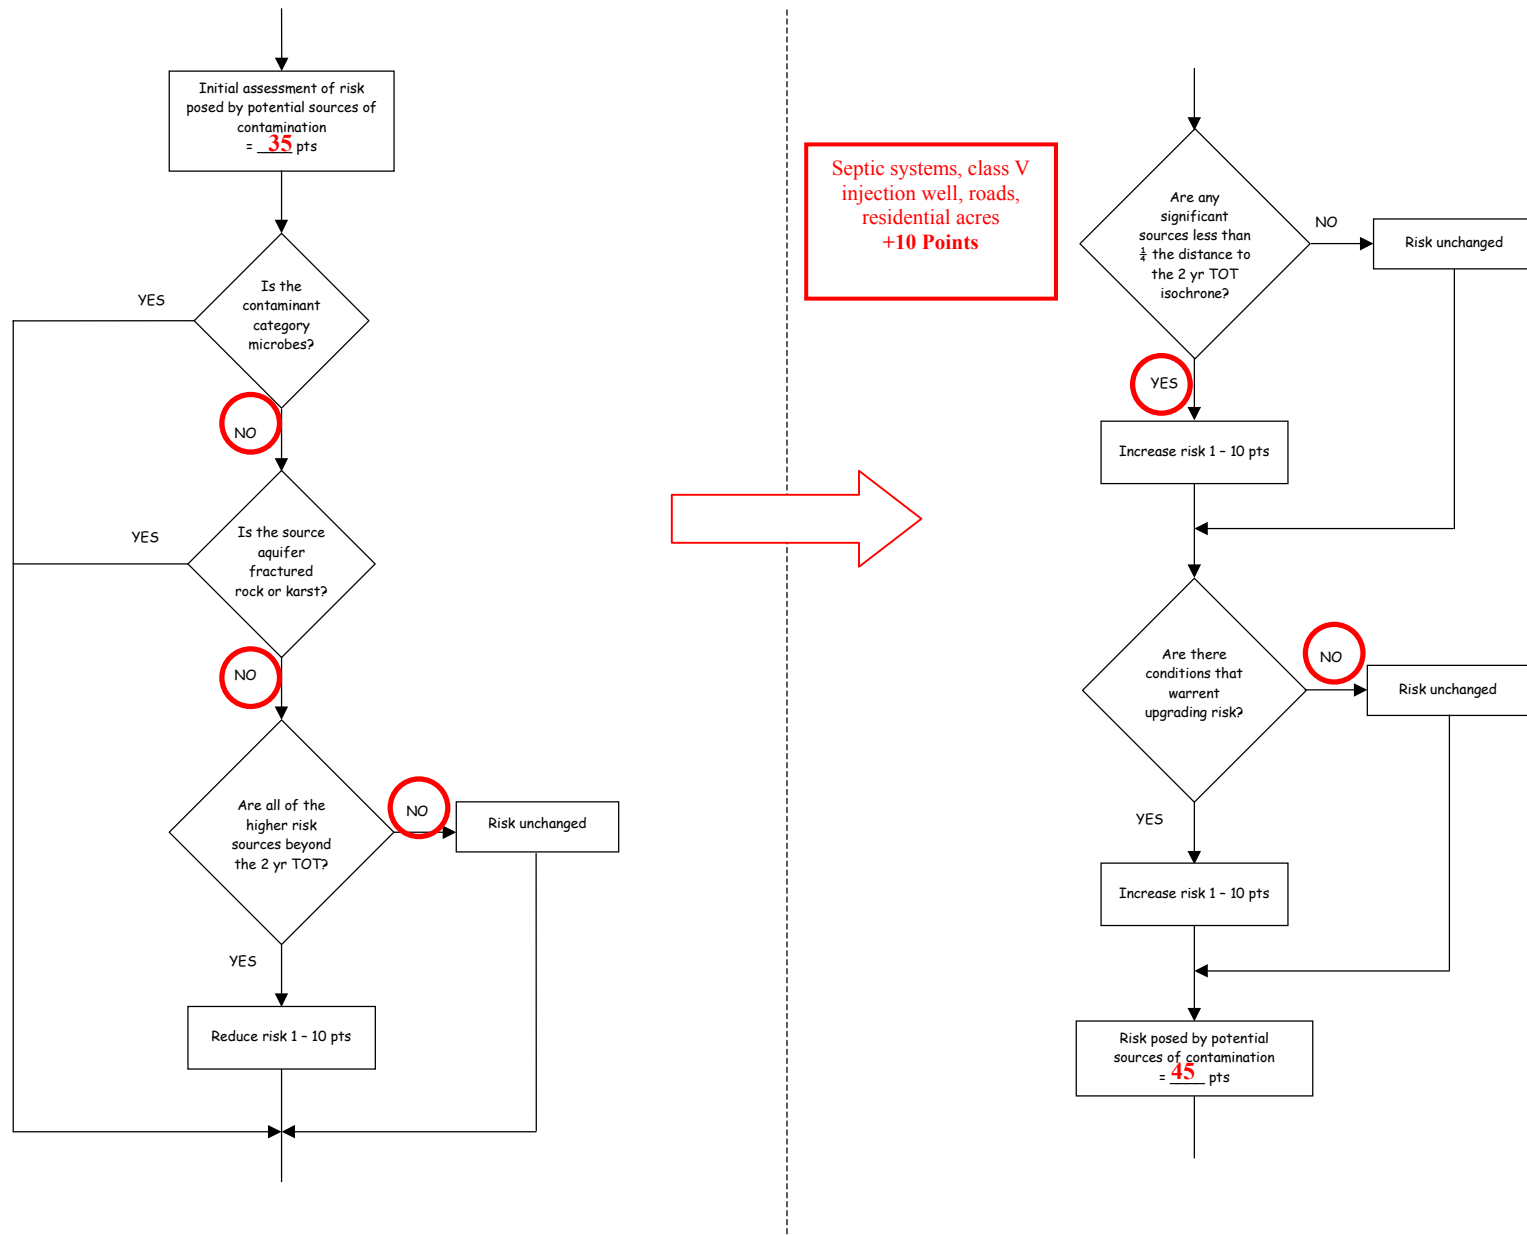
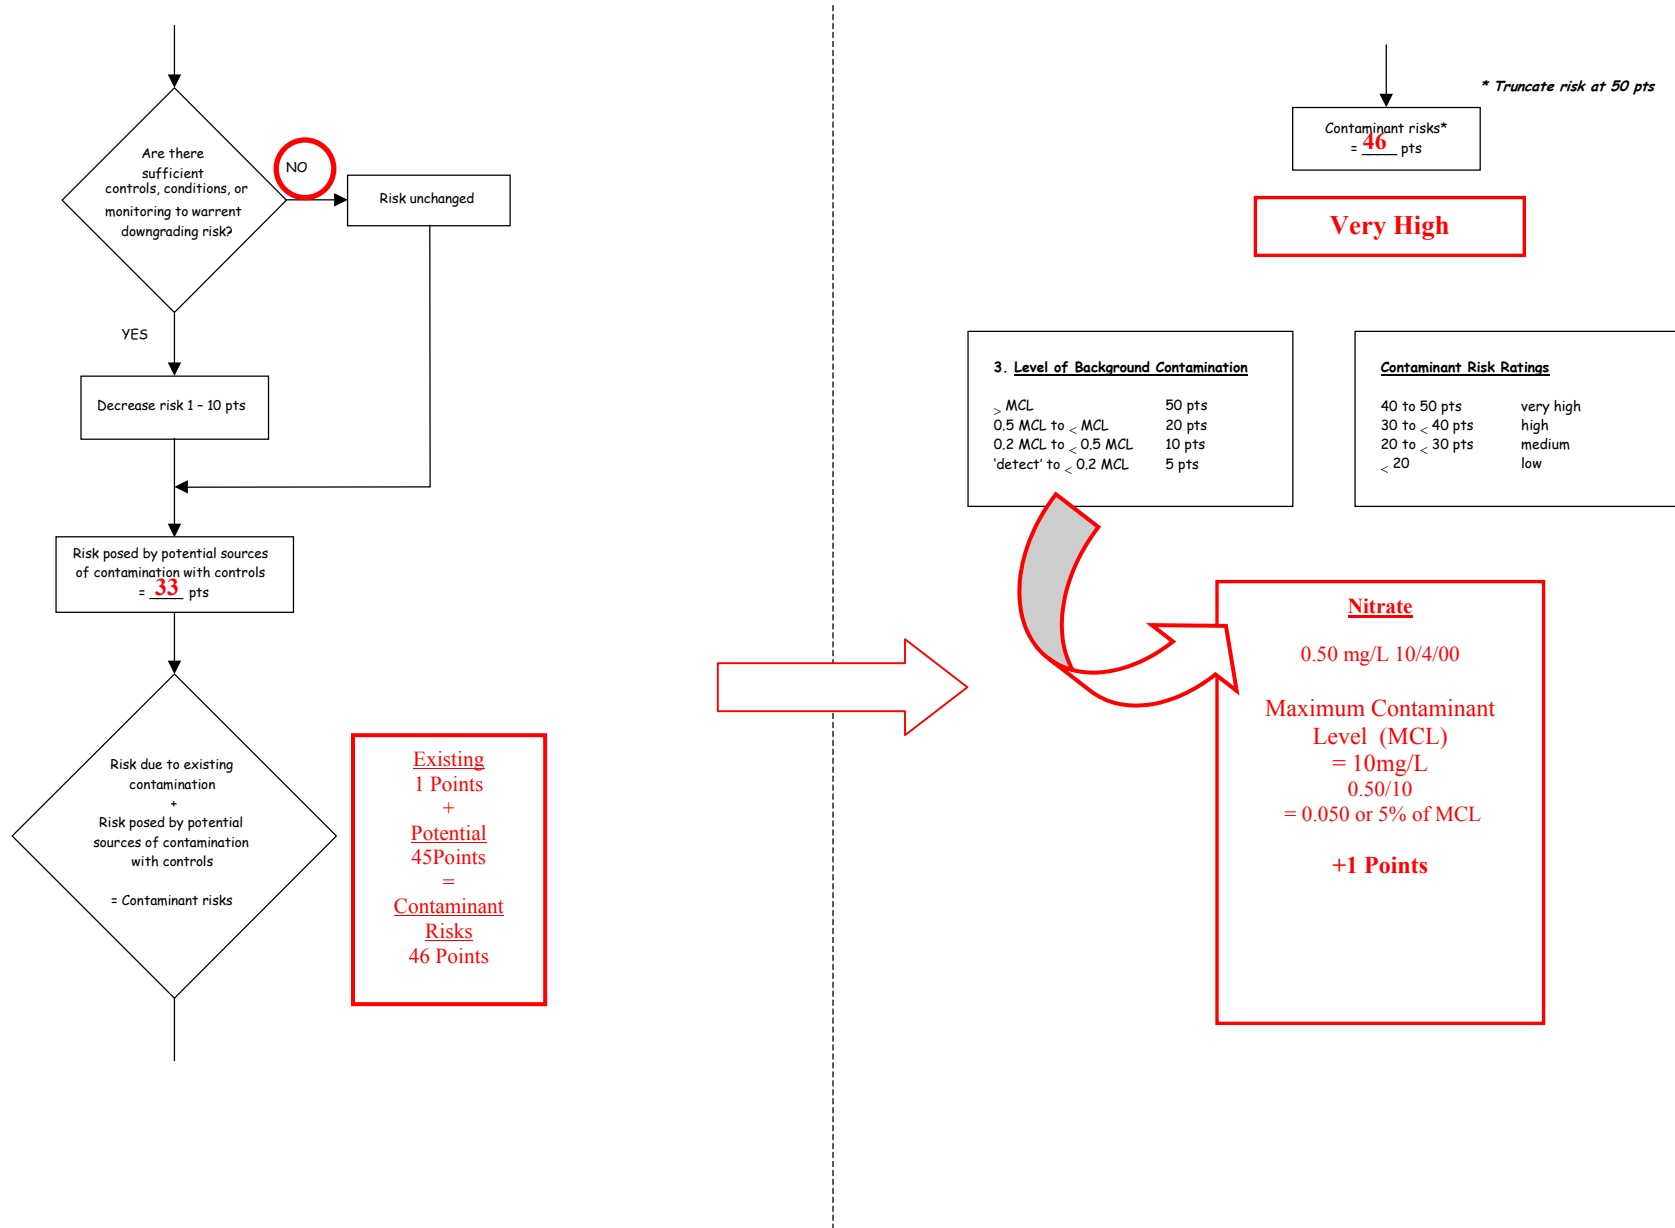
Chart 5. Contaminant risks for Matanuska Fitness Center– Nitrates and Nitrites (Continued)

Sampling history of Matanuska Fitness Center source waters indicate concentrations of nitrate (See Chart 6 – Contaminant Risks for Nitrates/Nitrites in Appendix D). Existing nitrate contamination is approximately 5% of the allowable limit (MCL) for this contaminant. Due to the high solubility and weak retention by soil, nitrates are very mobile in soil, moving at approximately the same rate as water. The current nitrate concentration in Matanuska Fitness Center remains at safe levels with respect to human health.

Overall, contaminant risk for the nitrate/nitrite category is high due to the roads, residential acres, class V injection well, a land strip and septic systems present up

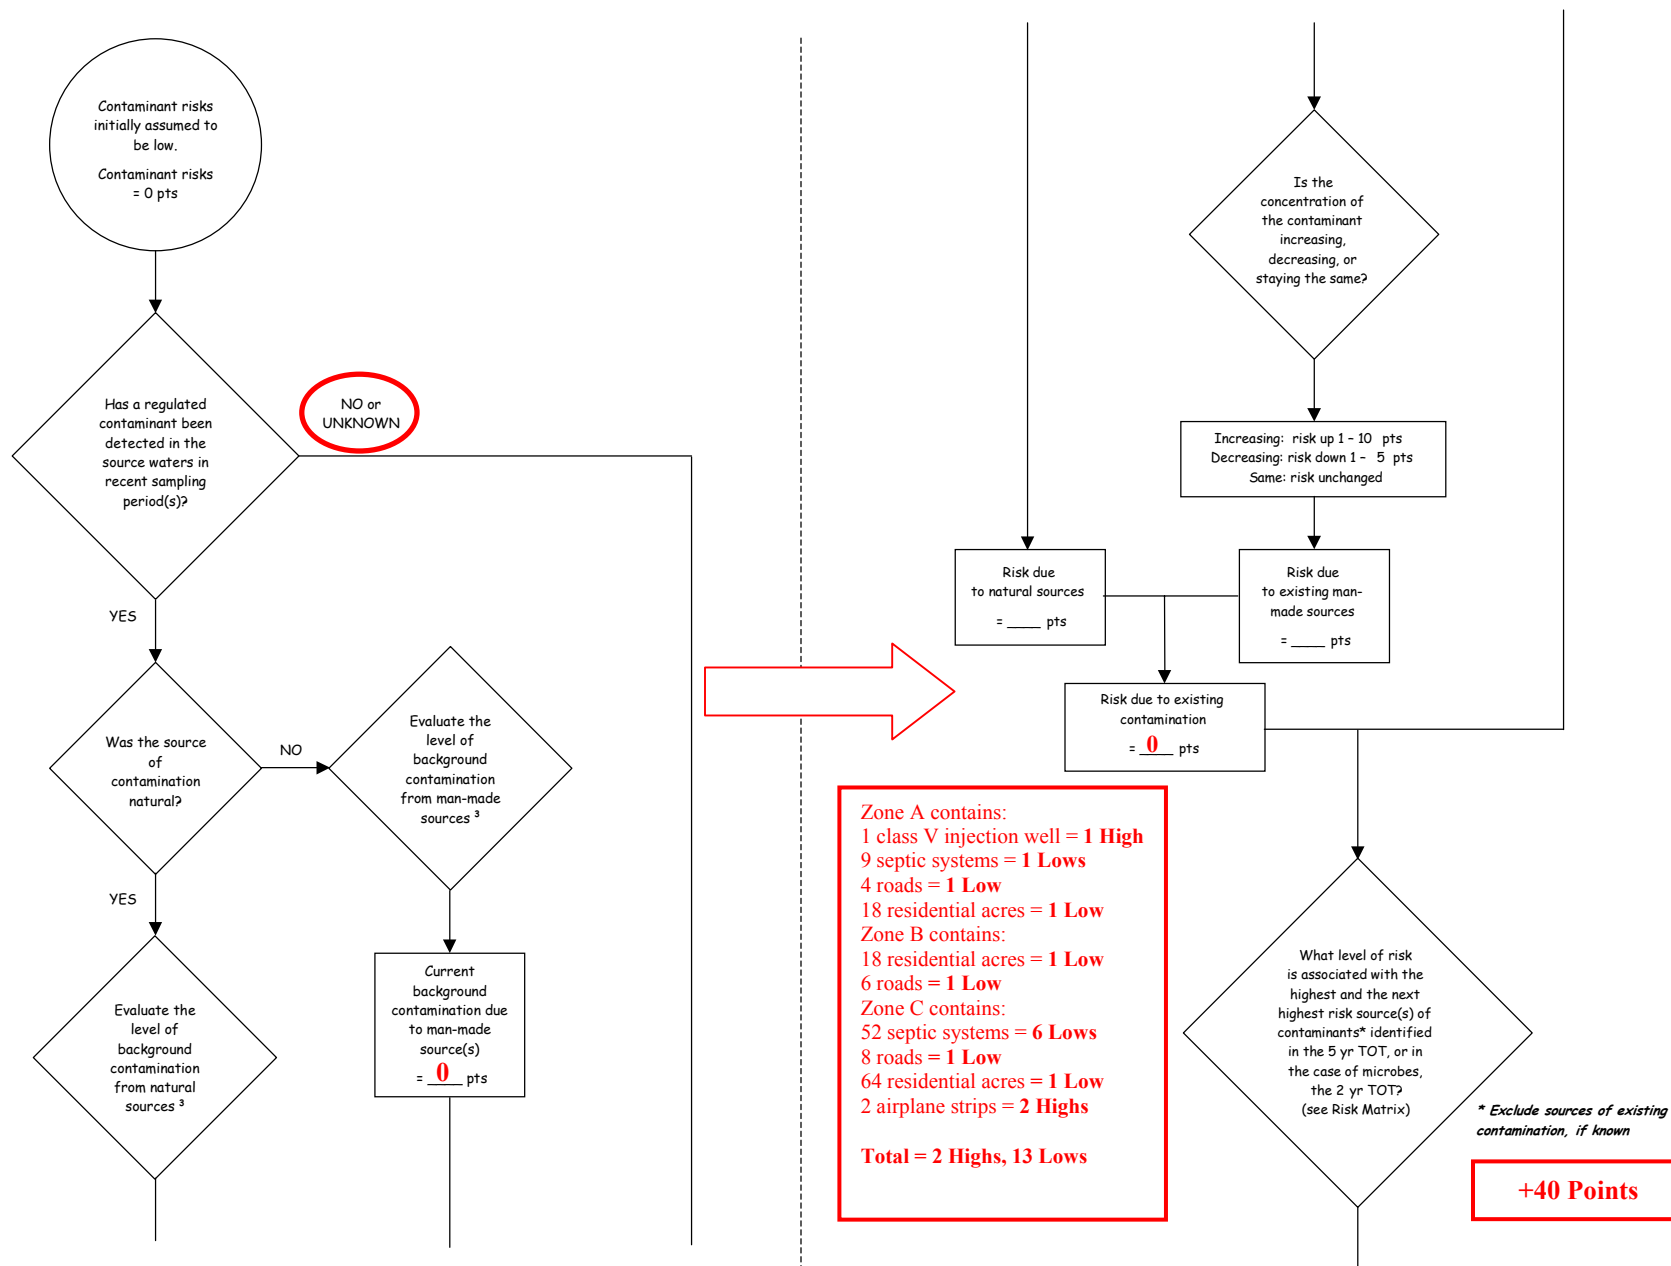
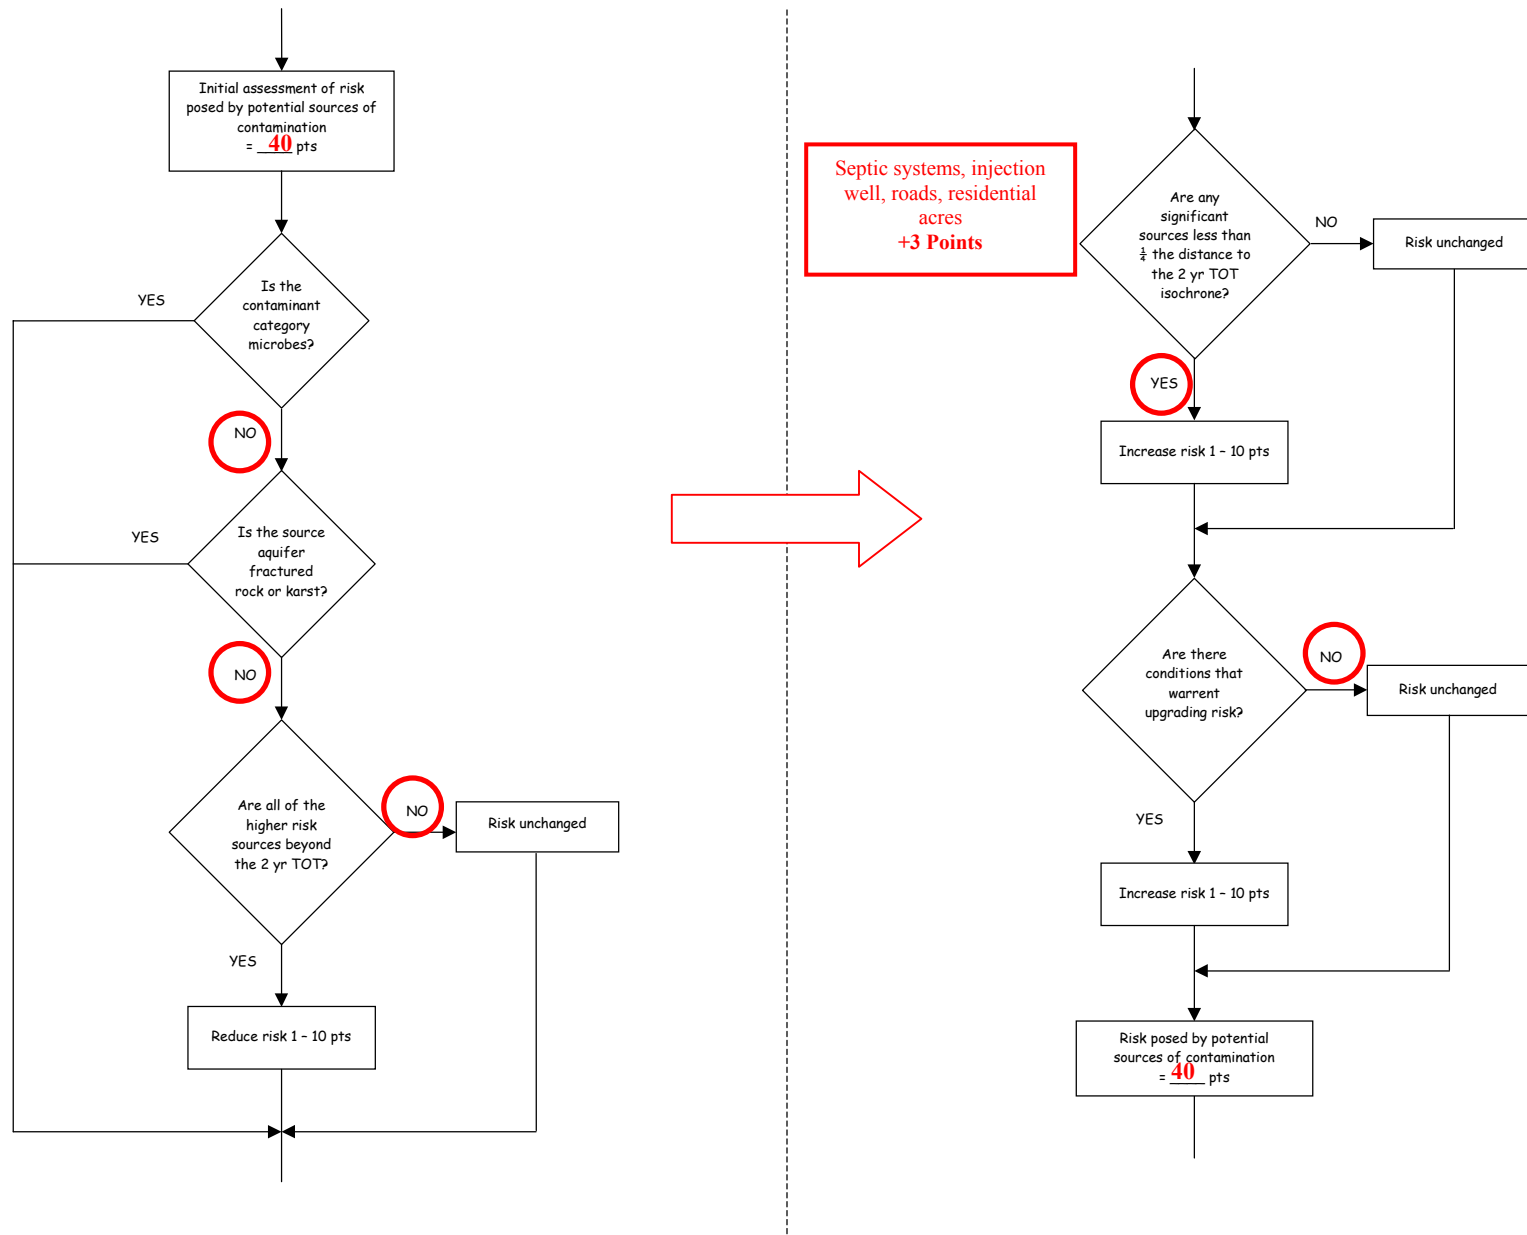
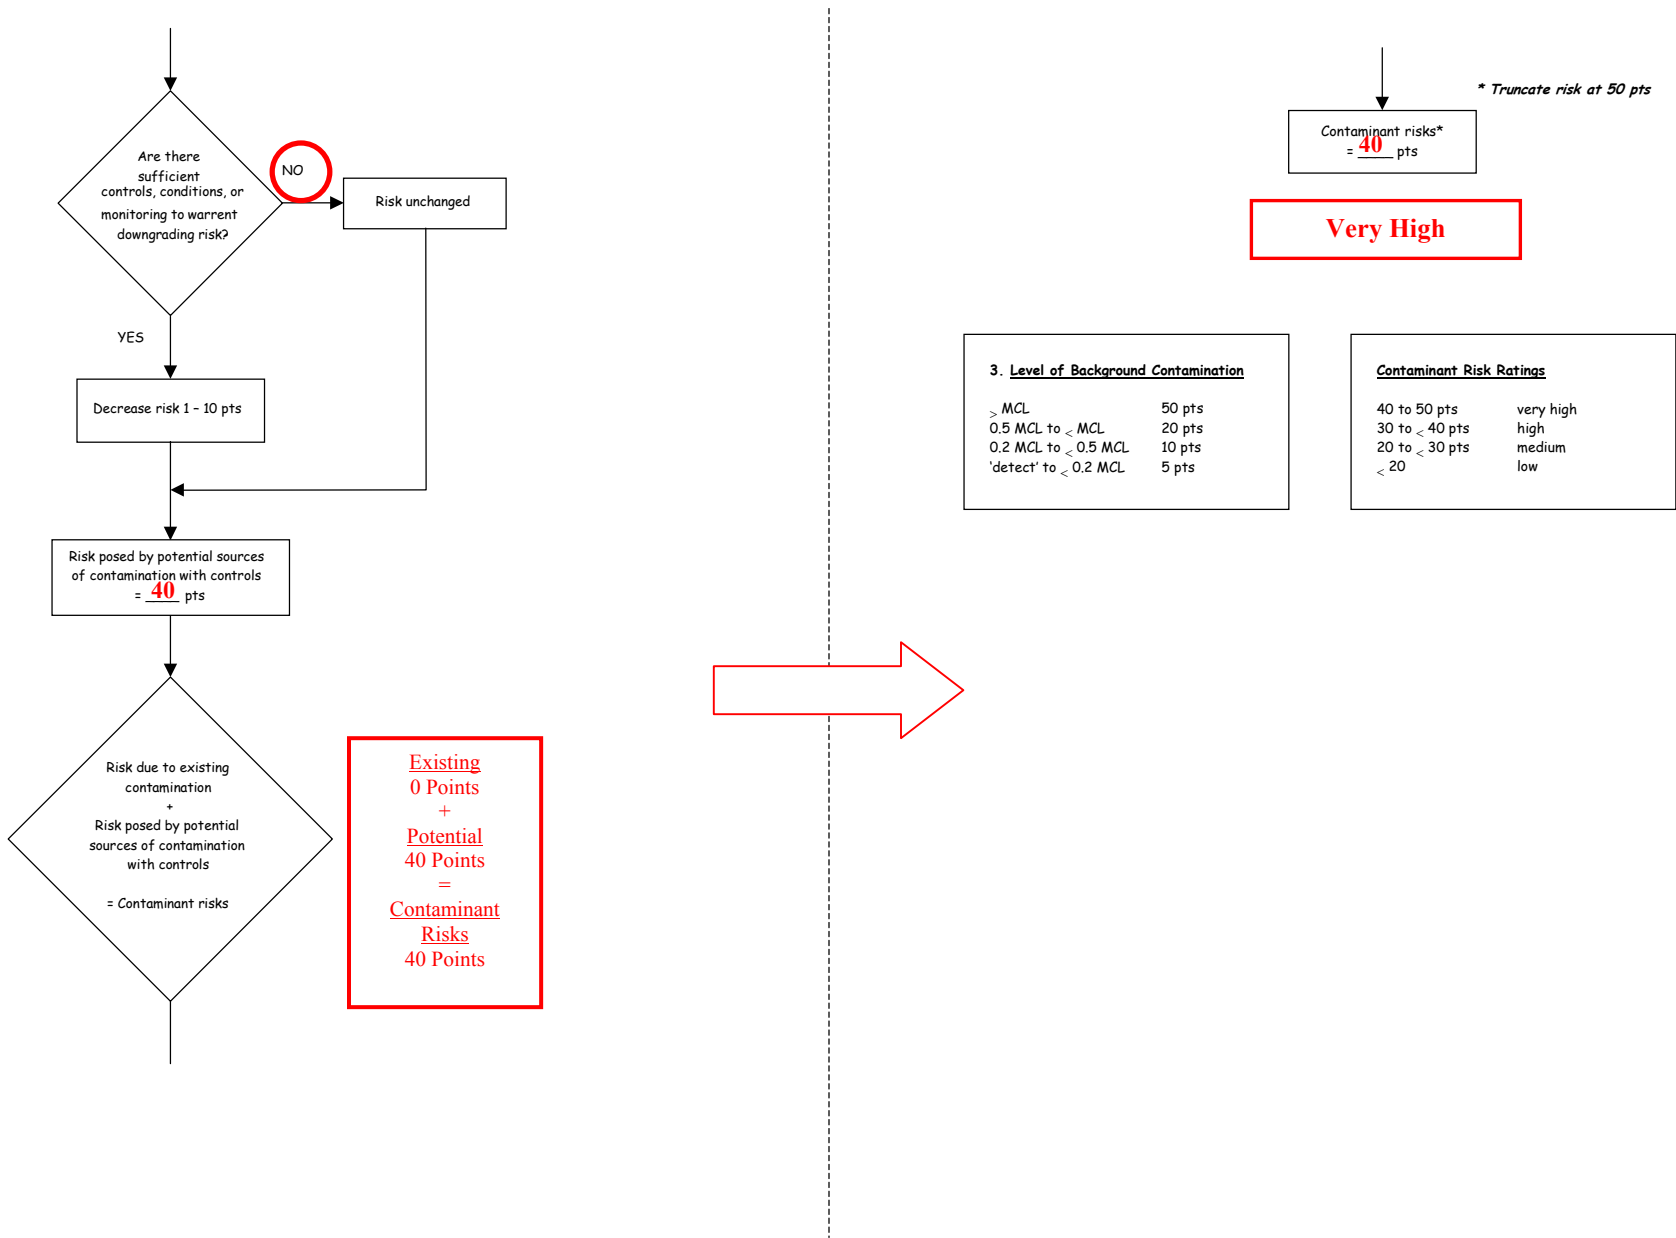
Chart 7. Contaminant risks for Matanuska Fitness Center – Volatile Organic Chemicals (Continued)

Volatile Organic Chemicals were not detected in the source waters of Matanuska Fitness Center. Overall, a contaminant risk for the volatile organic chemicals category is very high due to the roads, class V injection well, septic systems, class V injection well residential acres and an air strip present up gradient from the well. Combining the contaminate risk with the susceptibility of the well yields an overall high vulnerability to contamination for Volatile Organic Chemicals.
