Source Water Assessment

A Hydrogeologic Susceptibility and
Vulnerability Assessment for
Tundra Lodge RV Campground,
Tok, Alaska
PWSID #380997

DRINKING WATER PROTECTION PROGRAM REPORT NO. 912

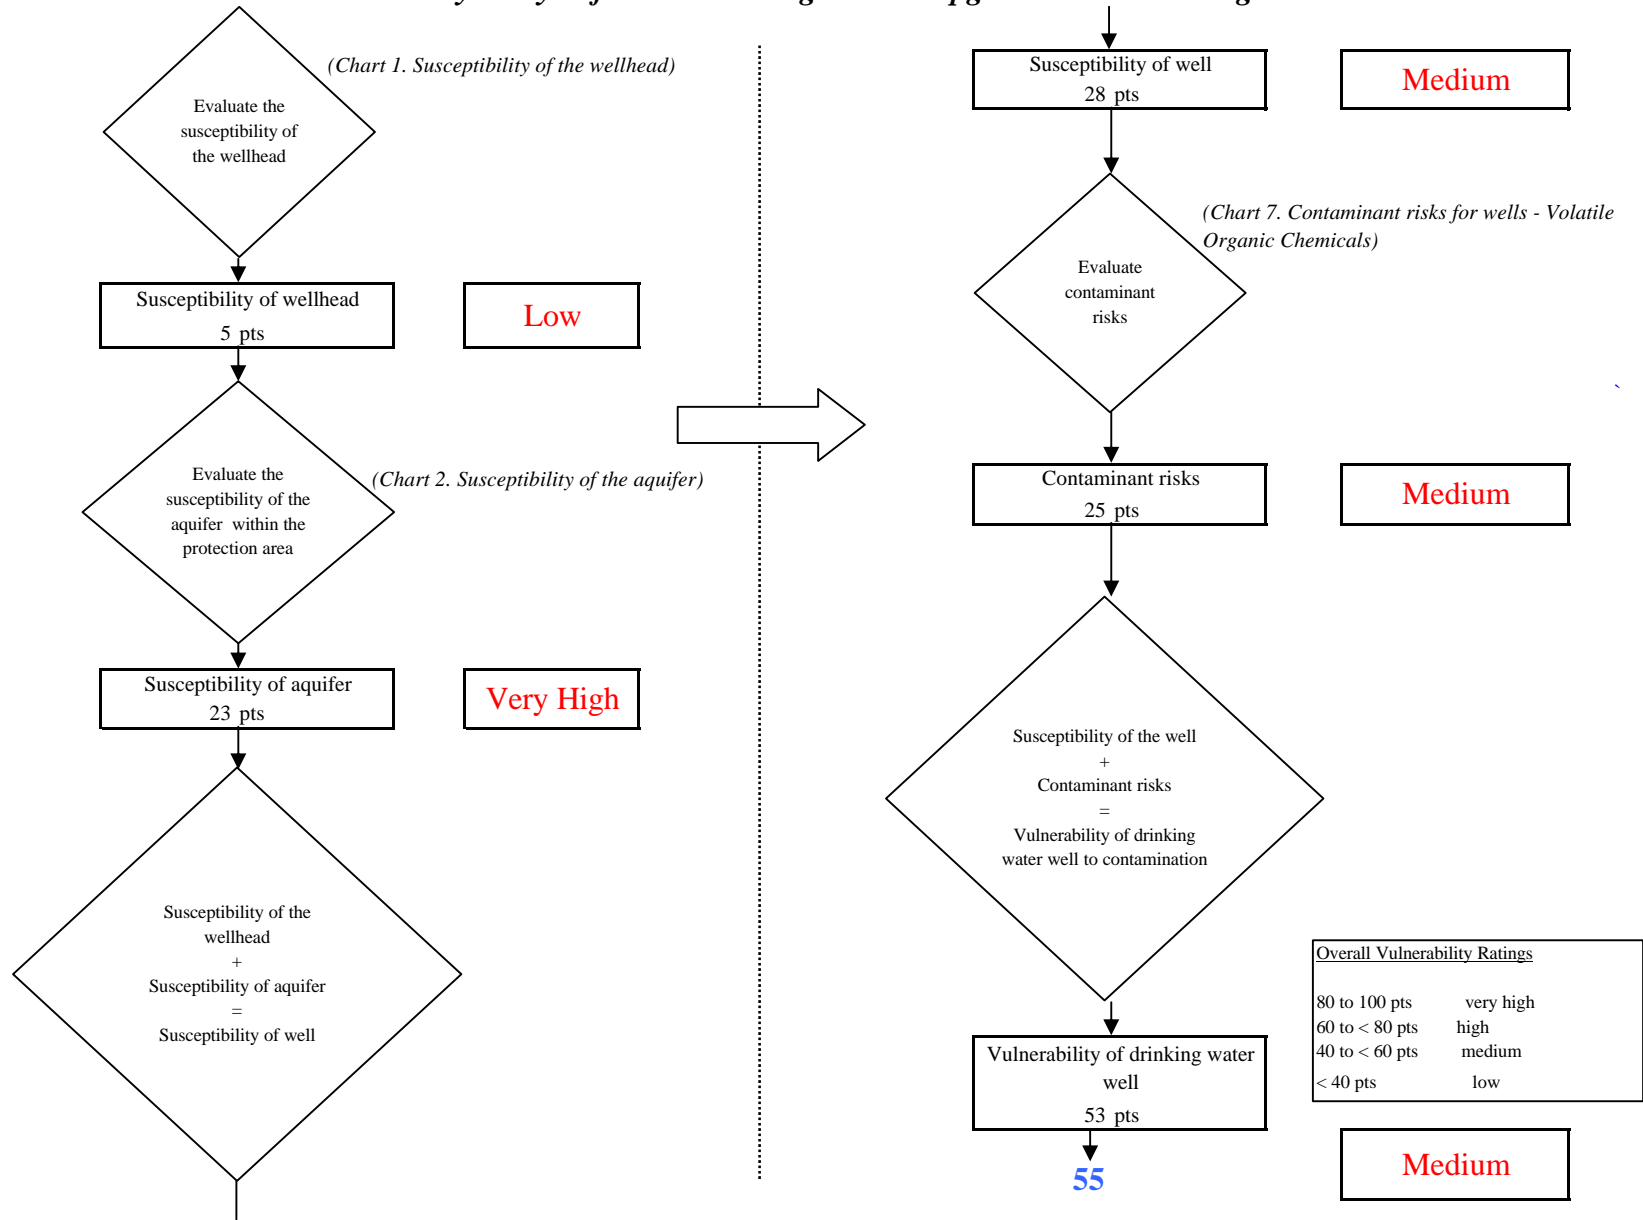
Chart 8. Vulnerability analysis for Tundra Lodge RV Campground - Volatile Organic Chemicals

Sample data for volatile organic chemicals was not available. However, after combining the contaminant risk for volatile organic chemicals with the natural susceptibility of the well, the overall vulnerability of the well to contamination by volatile organic chemicals is **Medium**.
