FALL 1980 FISHERIES SURVEY AND
PROVISIONAL LIST OF WATERBODIES
ALONG THE NORTHWEST ALASKAN
PIPELINE COMPANY ROUTE

FALL 1980 FISHERIES SURVEY AND PROVISIONAL LIST OF
WATERBODIES ALONG THE NORTHWEST ALASKAN PIPELINE COMPANY ROUTE:
PRUDHOE BAY TO THE YUKON TERRITORY

Final Report

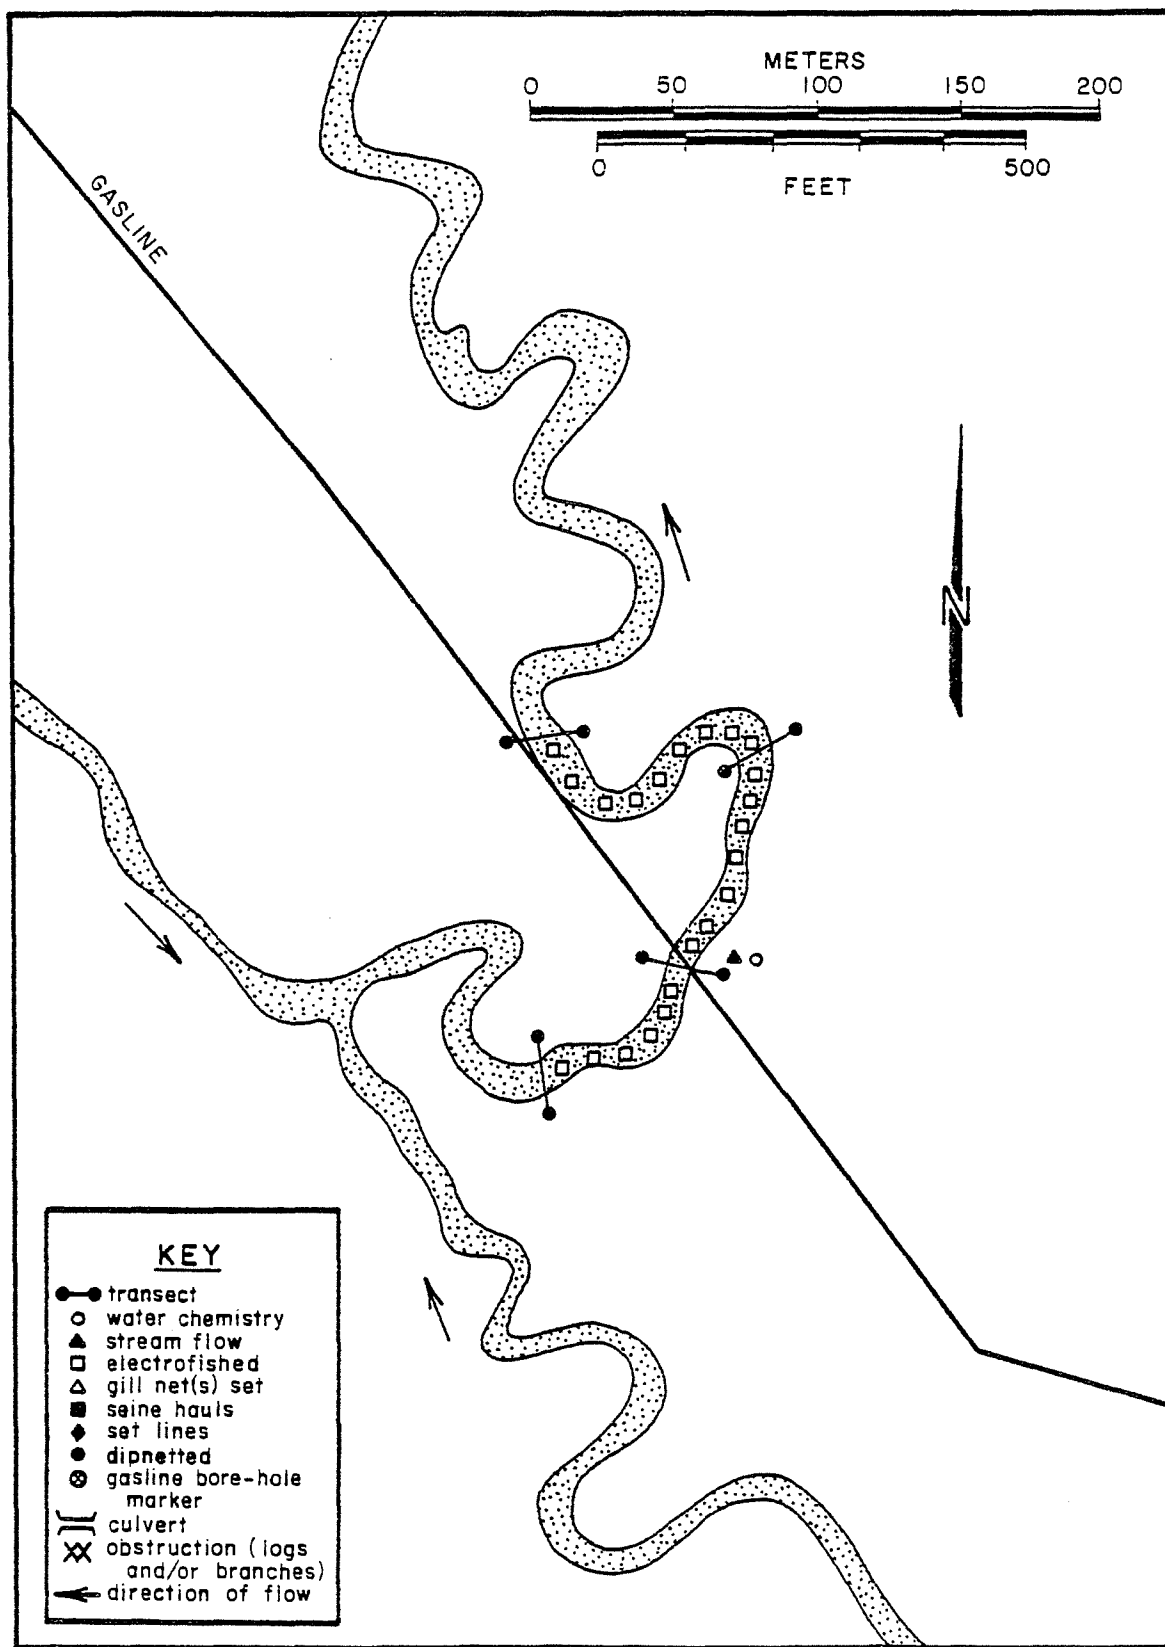
Fig. 31. Fall survey. West Fork Erickson Creek, 15 September 1980.

Date 15 September 1980Wetted Width (m) 1.3-10Depth (cm) 14-200Discharge (m^3/s) 0.14Dissolved Oxygen (mg/l) 12Temperature ($^{\circ}\text{C}$) 2.0Conductivity ($\mu\text{mhos}/\text{cm}$) 25pH (pH units) 6.4Color (color units) 150Turbidity (NTU) 6.5T. Hardness ($\text{mg CaCO}_3/\text{l}$) 63Nitrate ($\text{mg}/\text{l N}$) <0.1Phosphate ($\text{mg}/\text{l P}$) <0.1Bottom Type (%) 50 gravel, 30 pebble, 20 sandBank Stability (%) 75Aquatic Vegetation (P/A) ARiparian Vegetation (%) 60 willow/alder, 30 spruce, 10 grassesCover (%) 10Fish Block(s) None observed

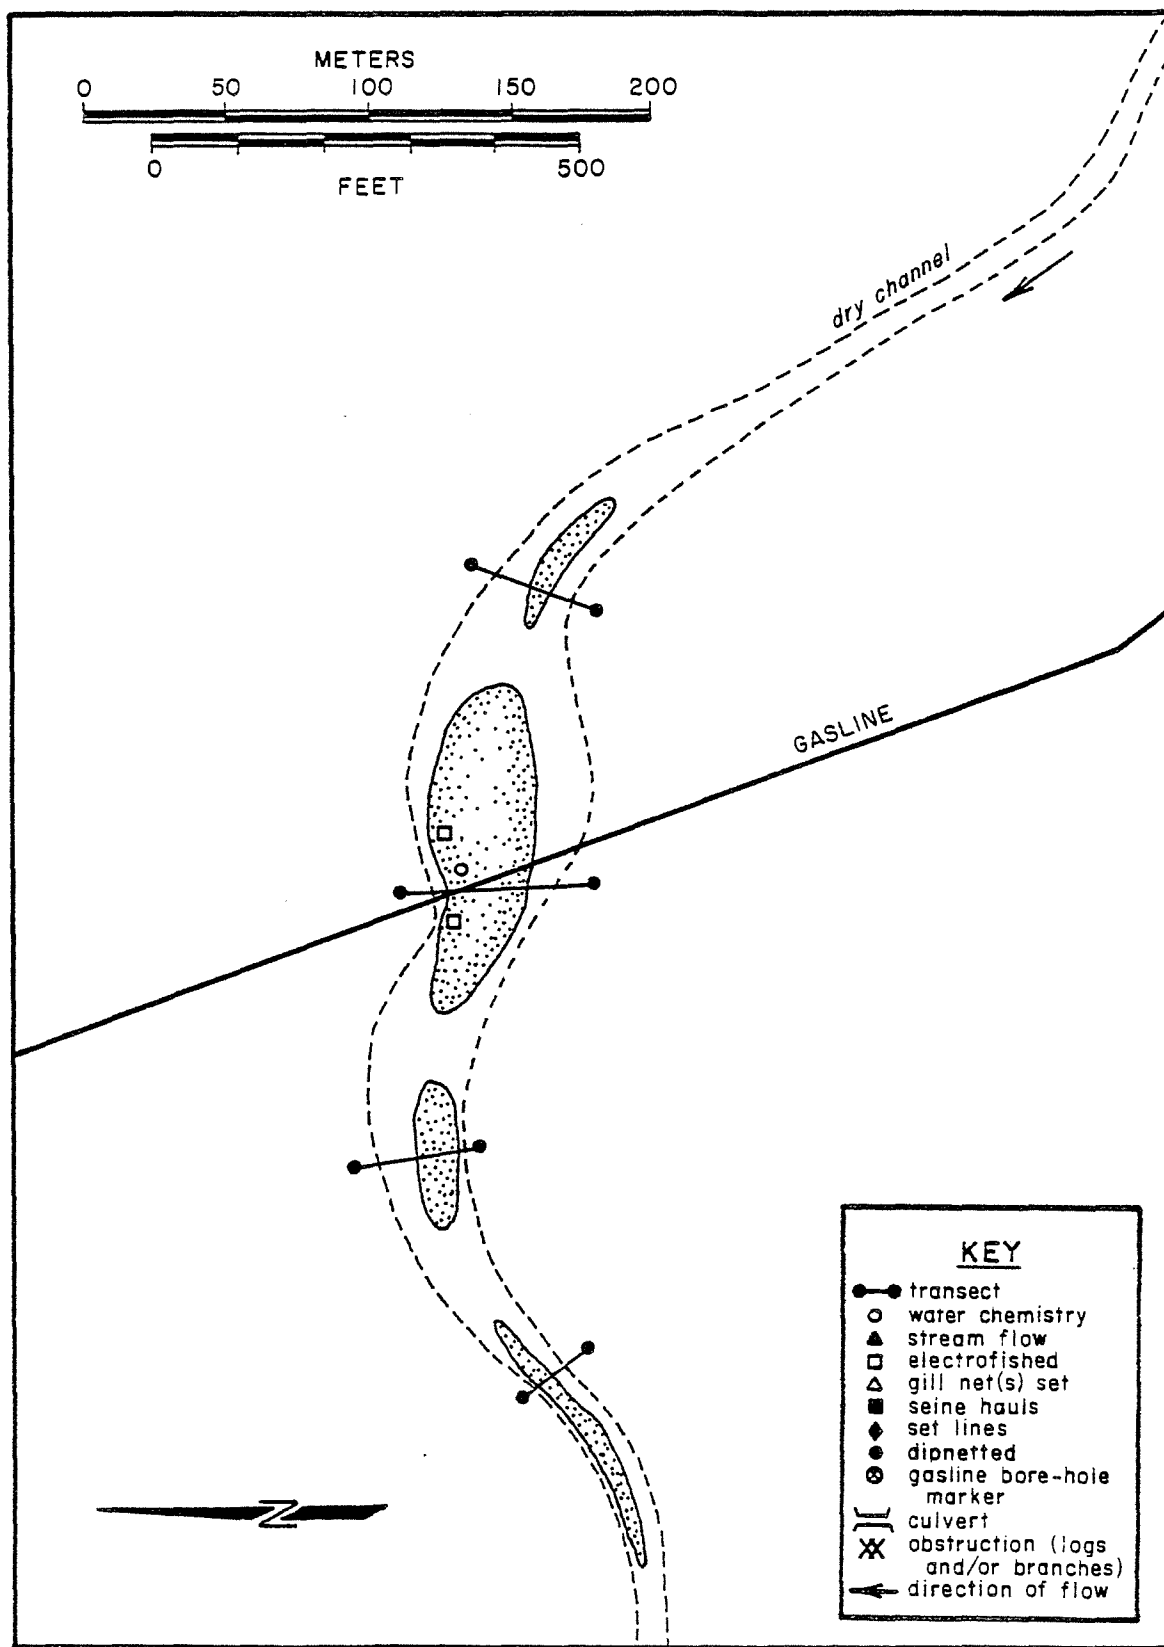
Fig. 32. Fall survey. Hess Creek Tributary (NPMP 387.0), 14 September 1980.

Date 14 September 1980Wetted Width (m) 0-15Depth (cm) 0-10Discharge (m³/s) Unable to detectDissolved Oxygen (mg/l) 2.6Temperature (°C) 4.5Conductivity (umhos/cm) 90pH (pH units) 5.8Color (color units) 120Turbidity (NTU) 15T. Hardness (mg CaCO₃/l) 69Nitrate (mg/l N) <0.1Phosphate (mg/l P) <0.1Bottom Type (%) 100 gravelBank Stability (%) 100Aquatic Vegetation (P/A) PRiparian Vegetation (%) 100 willowCover (%) 5Fish Block(s) Isolated pools, no inlet or outlet at this time.
