Willow Master Development Plan

Appendix D.3A Ice Bridge Plan

WILLOW DEVELOPMENT

OCEAN POINT ICE BRIDGE REVISION

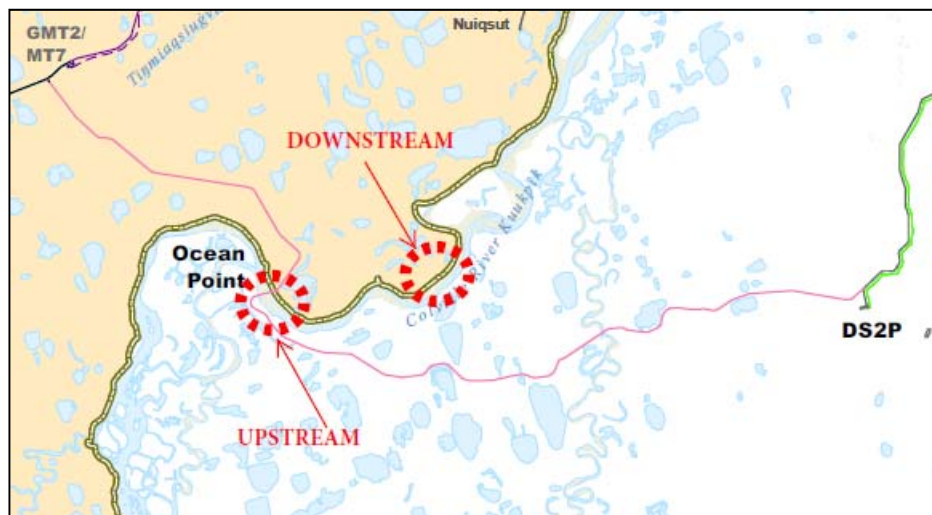
FIGURE 2.1: PROPOSED OCEAN POINT ICE BRIDGE CROSSINGS

Figure 2.1 shows the approximate positions of the two locations overlaid on the ‘Willow Optimization Option 3’ that is presented in Appendix A. A follow-on study was planned for the winter of 2019-2020. The Upstream Site was selected for study because of its location on existing permitted routes and its ease of access.

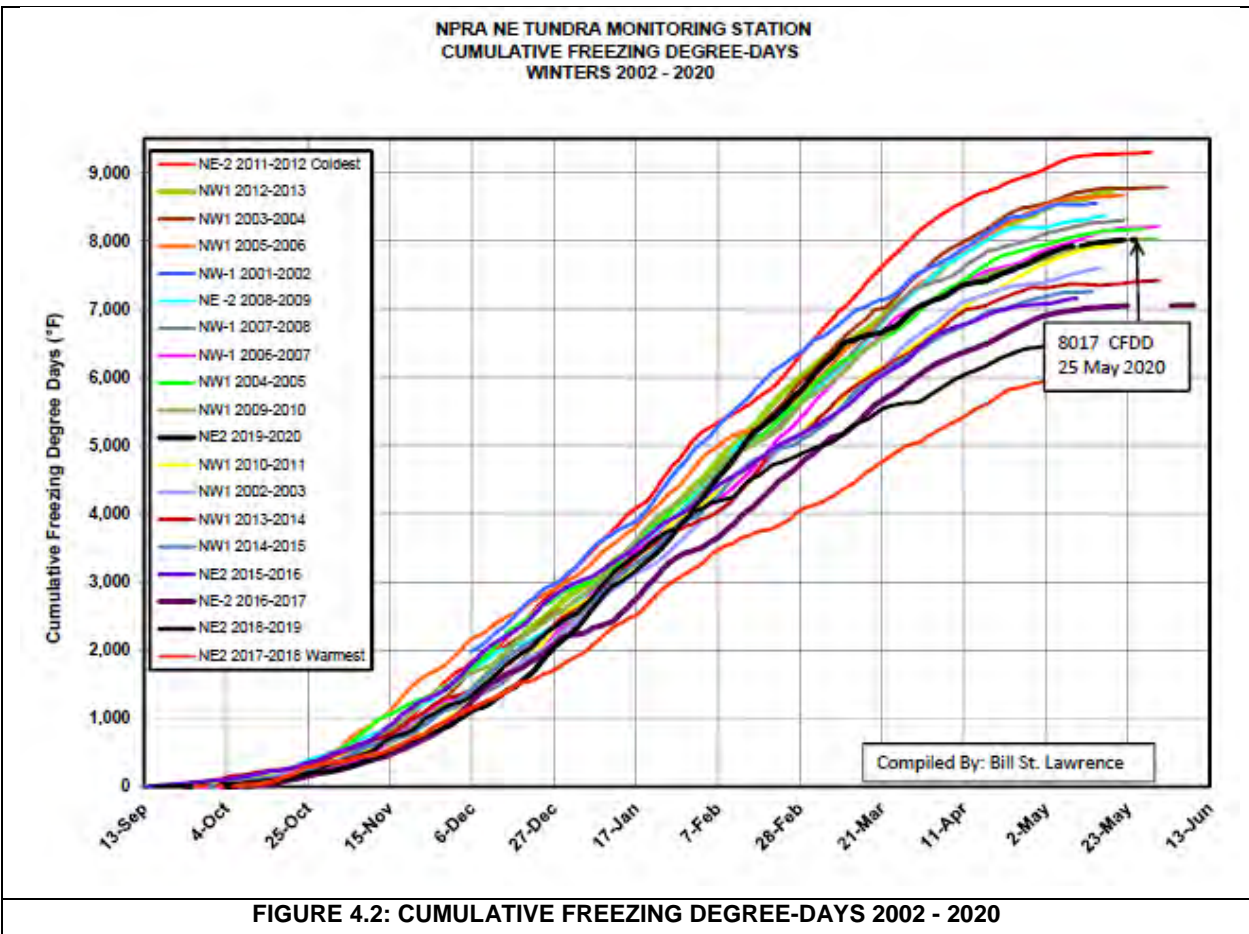
Cumulative Freezing Degree-Days (CFDD) are calculated as a sum of average daily degrees below freezing for a specified time period and are frequently used to measure and compare the coldness of winter from year to year. The annual CFDD has ranged from a high of 9,300°F (2011-2012 winter season) to a low of 6,200°F (2017-2018 winter season). Generally speaking, the higher the CFDD then the colder a winter was. However, a higher CFDD doesn't necessarily equate to a longer winter. Figure 4.2 presents the historical CFDD from 2002 to 2020.

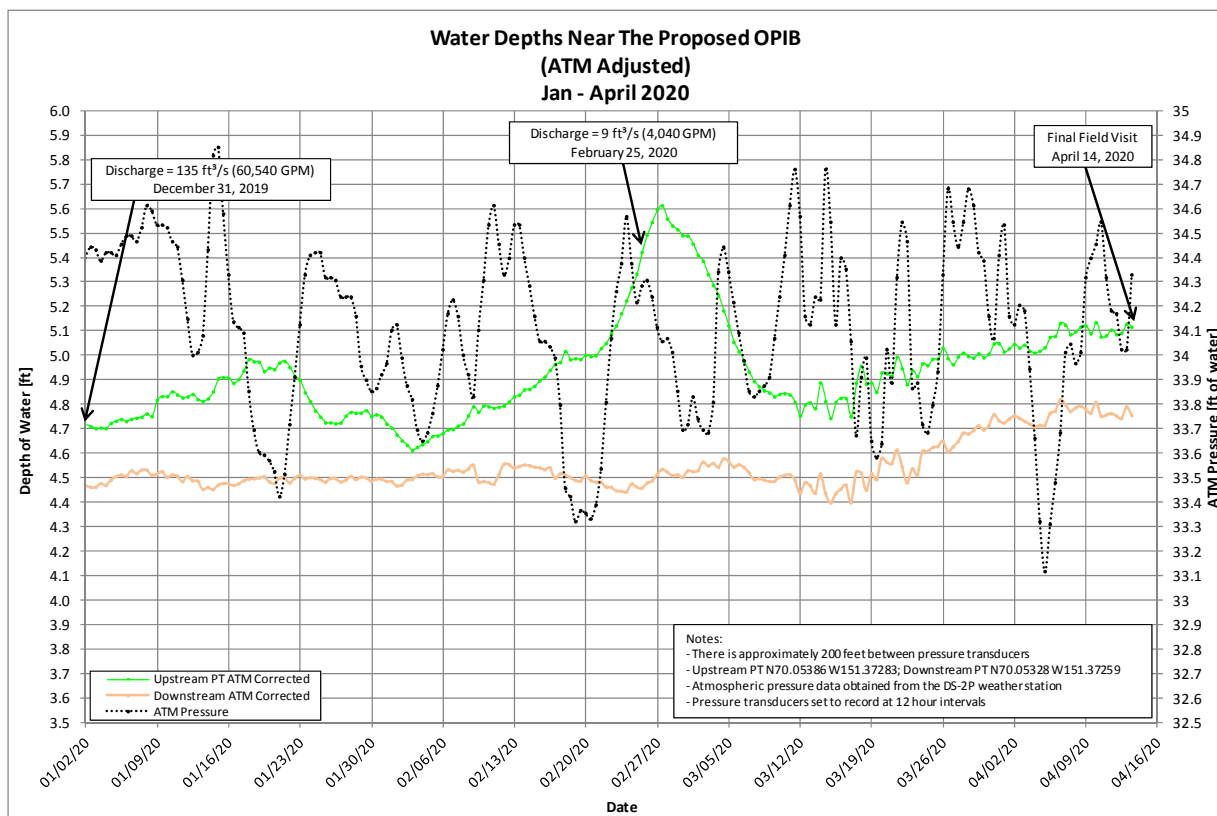
**FIGURE 4.4: PT WATER DEPTHS NEAR THE PROPOSED OPIB****TABLE 4.4: MAXIMUM WATER DEPTHS**

Figure 4.4 illustrates the PT water levels and the atmospheric pressure. Potential overflow events were likely recorded by the pressure increases during February and early March (Section 4.8). The water levels increased by late March at a rate of about 0.2 ft in 30 days. Overall water depths were less than 5.0 ft with the maximum 5.6 ft in February.

Possible explanations of the water depths whether rising or falling are a complex system of many unknown variables. A study of all the possible variations is beyond this report. Increasing ice thickness can constrict the flow and cause an increase in recorded pressure. During the coldest weeks of the winter, ground waters are emitted in larger volumes, but the waters freeze before moving far from the effluent. This makes the casual observations see what appears to be low flow.

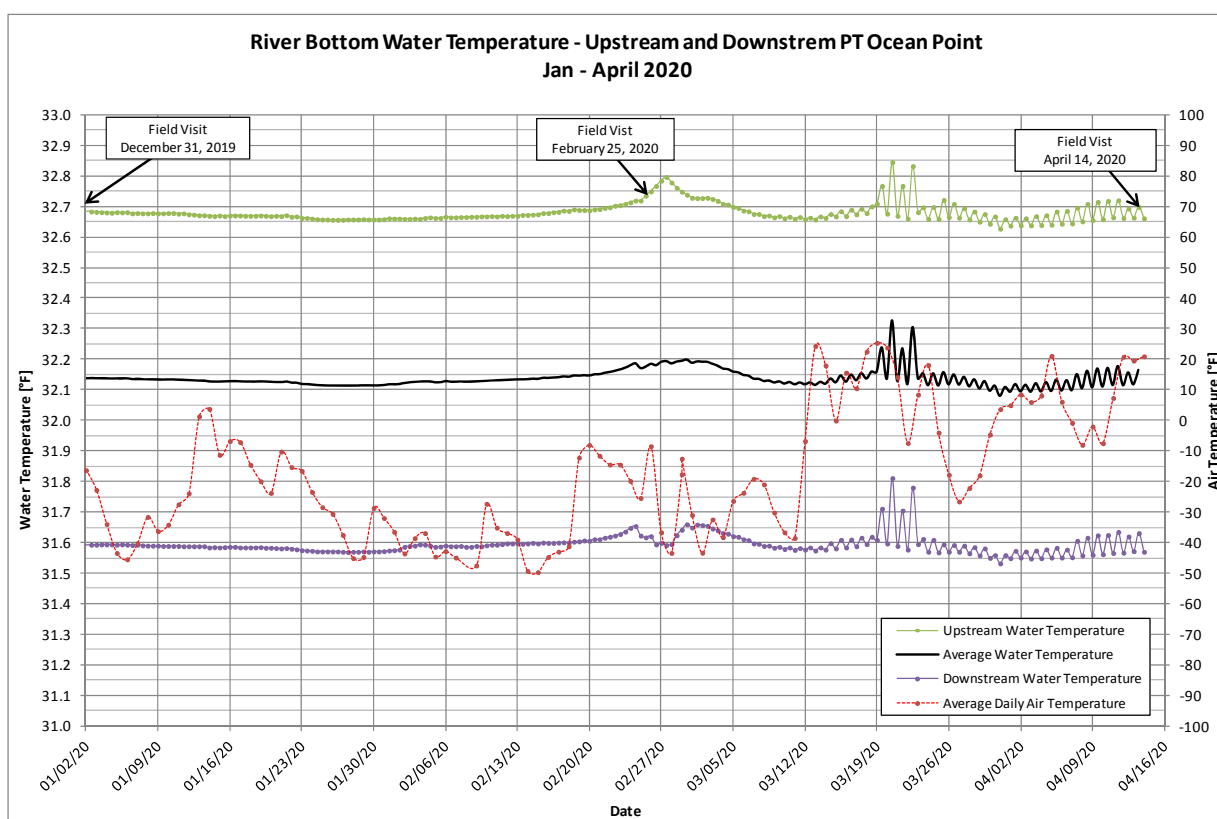
FIGURE 4.5: RIVER WATER TEMPERATURE – OCEAN POINT JANUARY TO APRIL 2020

In addition to pressure, water temperatures were recorded. Figure 4.5 presents the river bottom water temperatures and the average daily air temperature as recorded by the Drill Site 2P weather station (plotted on the right vertical axis). What is noteworthy in the data are the following:

1. There are spike-increases in the river bottom temperatures on February 28th and March 24th. These are likely related to overflow events and are discussed in further detail in Section 4.8.
2. For about 5 days starting on March 19th there was an event that caused the temperature to rise and fall $\pm 0.2^{\circ}\text{F}$ at both PT locations. This is also likely related to an overflow event (Section 4.8) in addition to a potential phenomenon that is explained below in Section 4.7.3.
3. Daily temperature oscillations are visible in the data beginning on March 19th. These undulations are likely due to solar diurnal rhythms. The first annual sunrise at the OPIB latitude began on January 17th and by March 17th the daily sun exposure exceeded 12 hours per day.

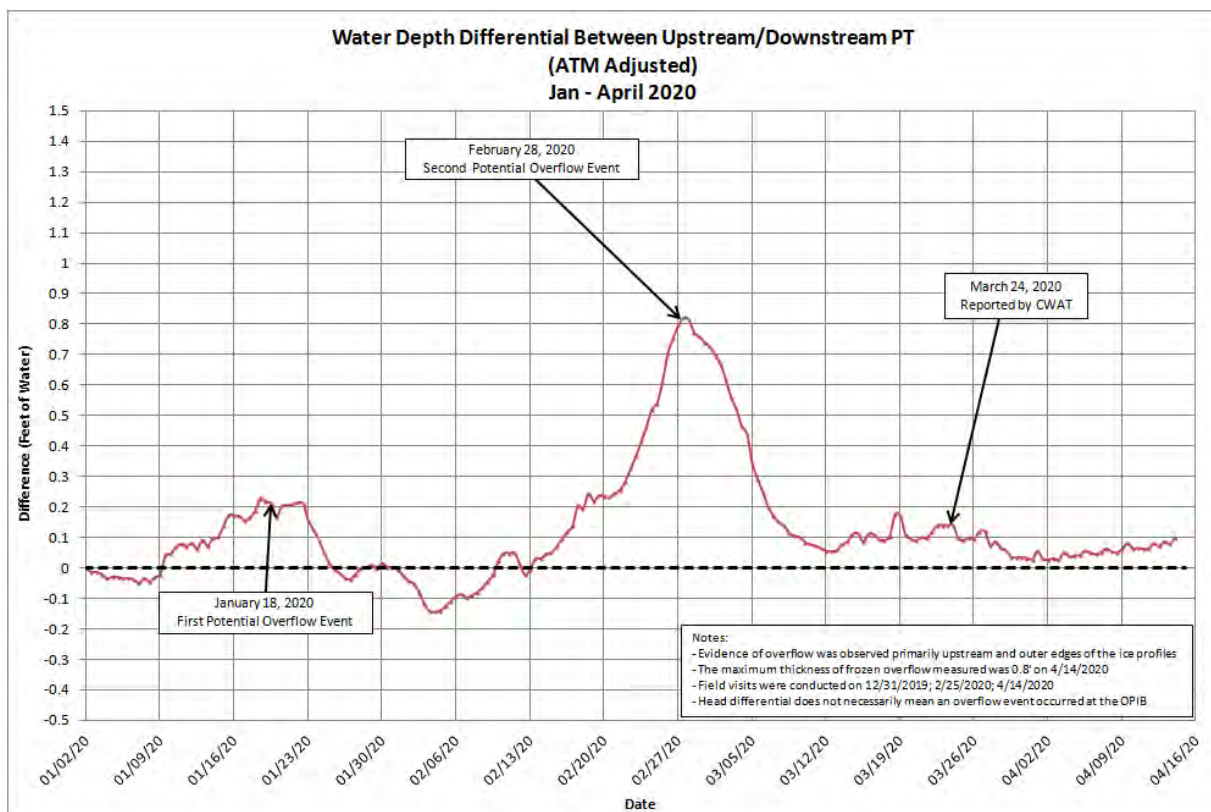
**FIGURE 4.6: WATER DEPTH DIFFERENTIAL BETWEEN UPSTREAM AND DOWNSTREAM PTS**

Once the potential February overflow event ended the water temperatures at the US and DS PTs returned to their typical differentials. It is likely that flow resumed under the ice. The overflow likely flowed toward the banks of the river and froze.

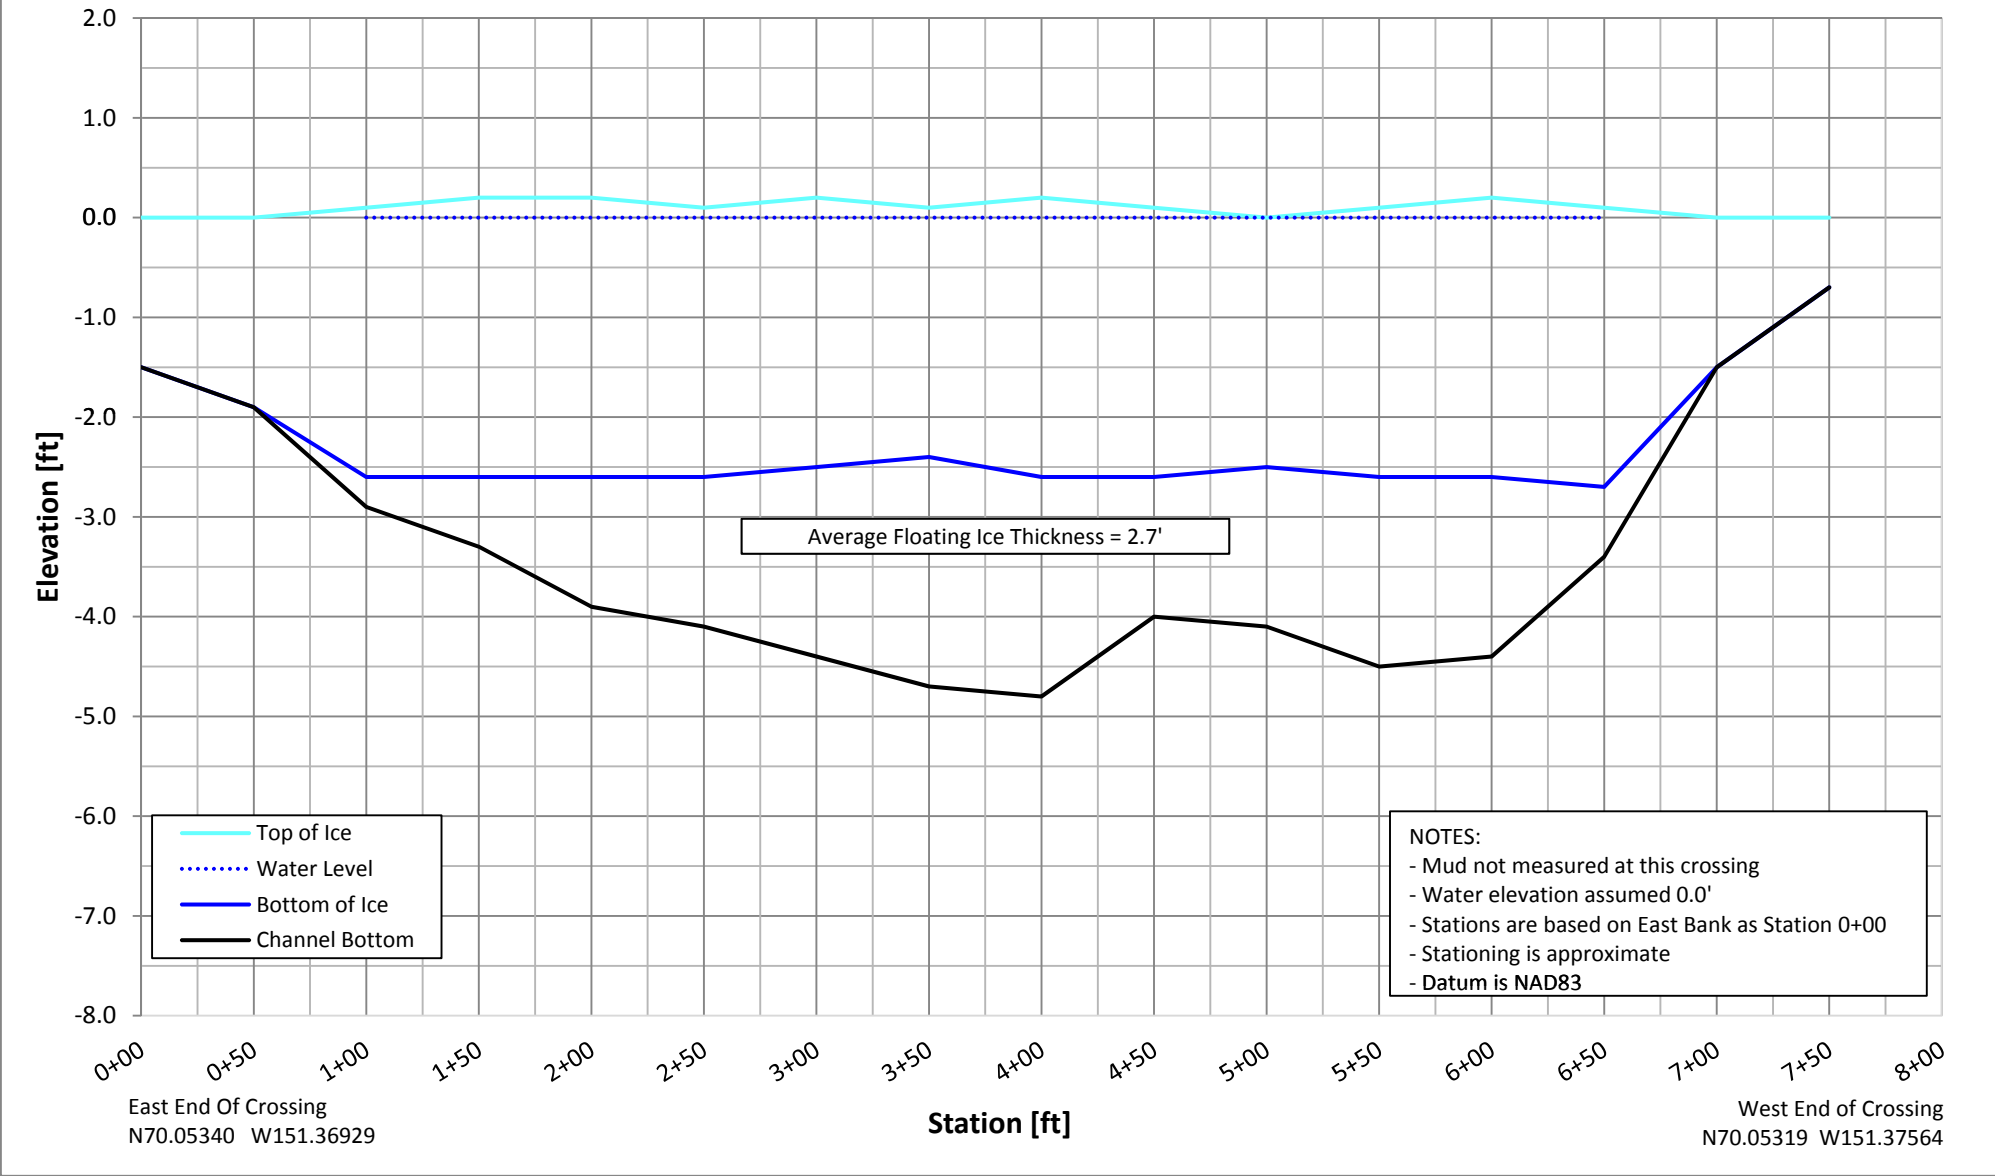
Ocean Point Crossing Profile

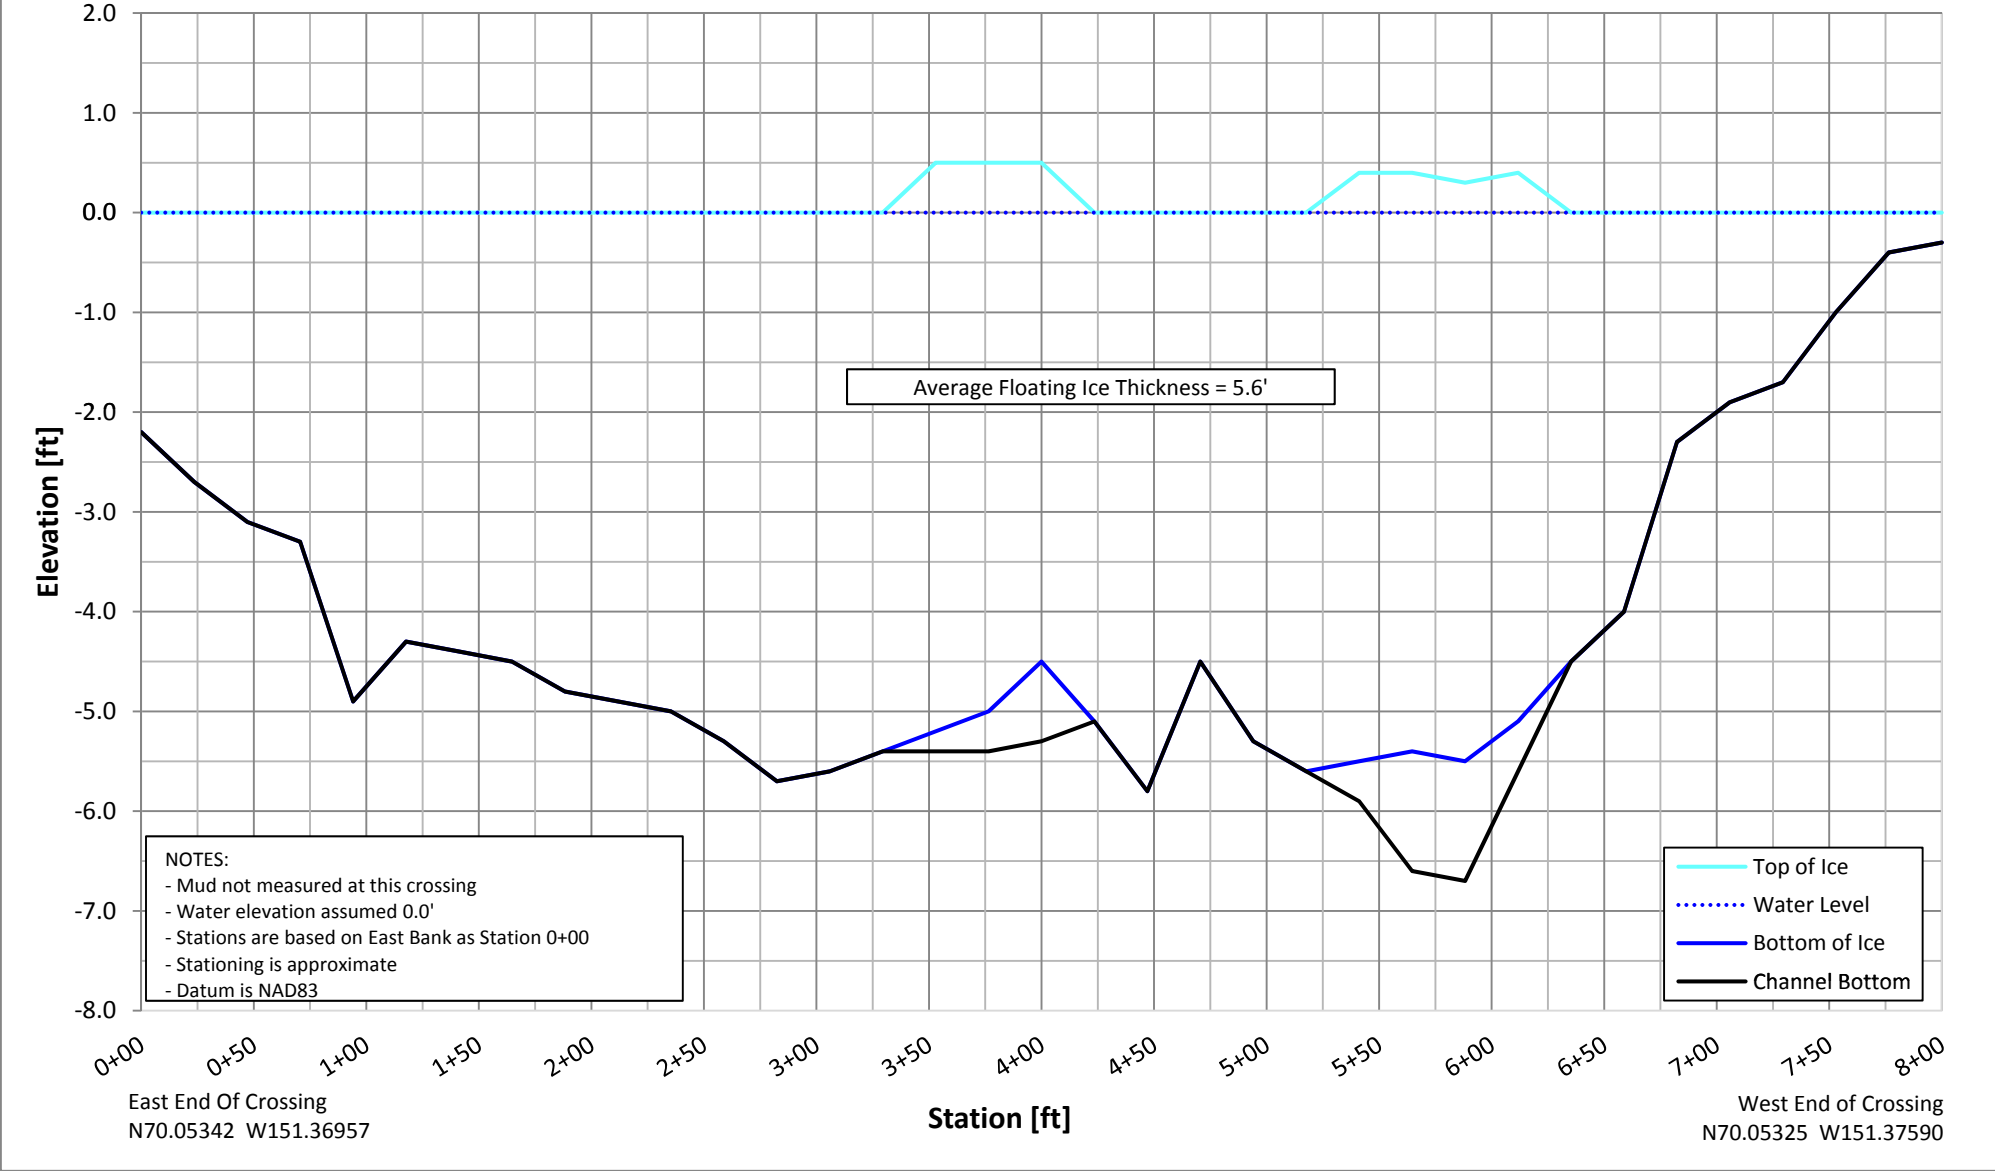
Ocean Point Crossing Profile (Looking Downstream) April 14, 2020

During the April 14th field visit, the natural ice had come into contact with the river bottom about mid-way across the channel. This created two independent spans of free water measuring 117 ft and 94 ft wide (Appendix B – April 14, 2020 Ocean Point Crossing Profile).

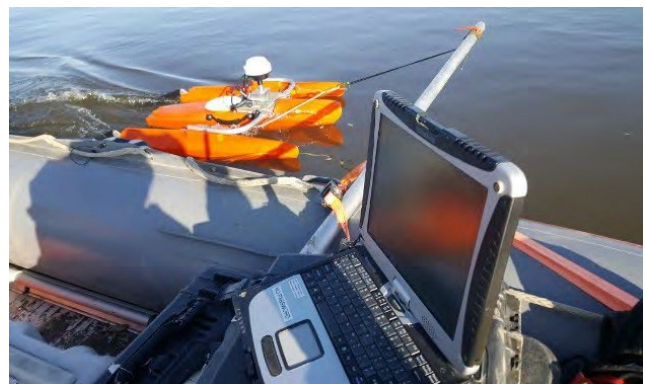
Photo 3.1: Discharge measurement at Ocean Point Upstream Transect; 9/5/19

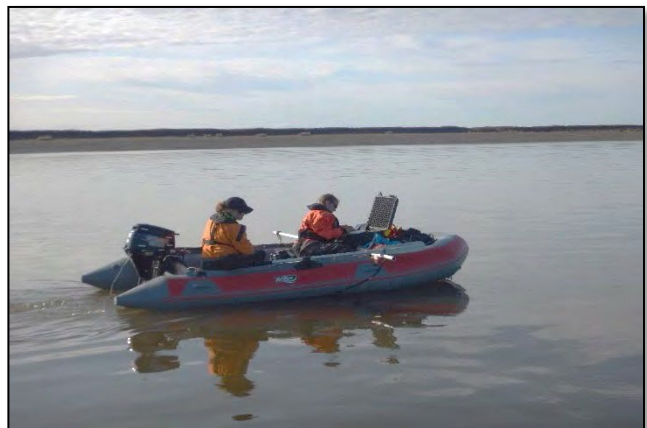
Photo 3.2: In-situ water quality sampling at Ocean Point Downstream Transect; 9/5/19

In-situ water quality parameters including temperature, conductivity (C), and salinity were recorded using the YSI ProPlus meter; dissolved oxygen (DO) was measured using the YSI ProODO meter. Specific conductance (SC) referenced to 25 degrees Celsius was calculated based on temperature, conductivity, and a conversion coefficient of 0.0196 based on empirical data. Measurements were collected at the deepest portion of each cross-section; two depths were investigated at each to confirm that parameters were consistent throughout the water column.

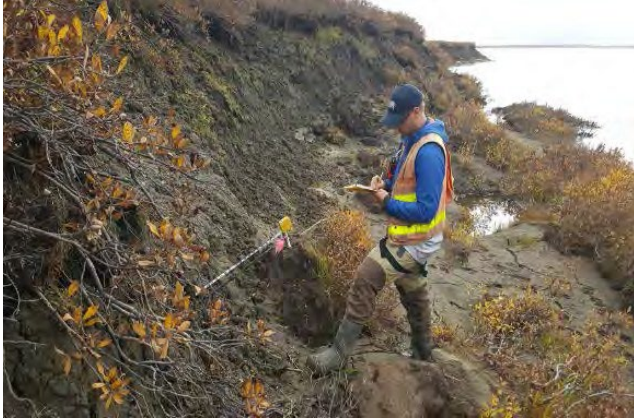
Photo 3.3: Investigating soil active layer at Ocean Point Downstream Transect; right/east bank; 9/14/19

The soil active layer was investigated to characterize the depth of permafrost below the surface in the transition zones adjacent to the river. This investigation was performed on the right and left banks of each transect, perpendicular to the channel. Probing was performed using a 5-foot long T-bar probe driven by hand (Photo 3.3). Spacing was approximately 5-foot increments and at major grade breaks, between water's edge and the top of the riverbank. Results were provided directly to Golder as a separate deliverable and included in this report along with discharge and water quality in Attachment A.

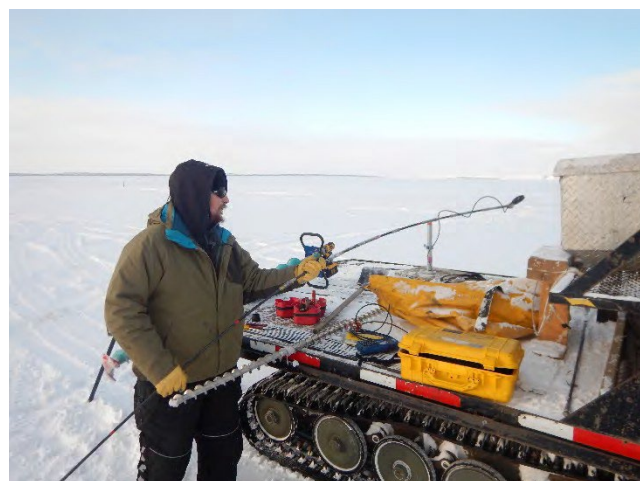
Photo 3.4: Attaching Hach flow meter to fixed rod at Ocean Point Upstream; 2/25/20

Water measurements were facilitated by mechanically drilling through the river surface ice cover. Thermal drill probing was performed by ICE to identify the extents of under-ice water bounded at the left and right by ice grounded against the channel bed. Investigation of soils or groundwater within the channel bed was not performed. Discharge was determined using USGS mid-section techniques. Velocity was measured using a handheld Hach flow meter (Photo 3.4) and a handheld Sontek flow meter. These were attached to a fixed rod and lowered to 0.6 the water depth below the ice. In-situ water quality parameters investigated were the same as those in the fall. Measurements were collected at multiple depths from one location in the deepest portion of the cross-section.

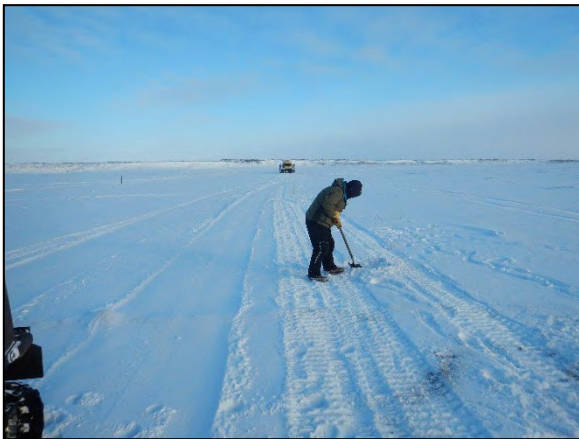
Photo 4.1: Field investigation at Ocean Point Upstream, looking toward the left/east bank; 2/25/20

Ice-cover investigation was performed only at Ocean Point Upstream (Photo 4.1). This was determined considering: the comparison of open water discharge quantity and water quality values, the better suitability of the Upstream transect to the Downstream transect based on the potential for undesirable geomorphological and hydraulic influences (i.e. actively eroding and sloughing bank and a tributary at Ocean Point Downstream), the remoteness of Ocean Point relative to facilities and the challenges of winter accessibility, the time available for investigation, and the historical use of the upstream transect.

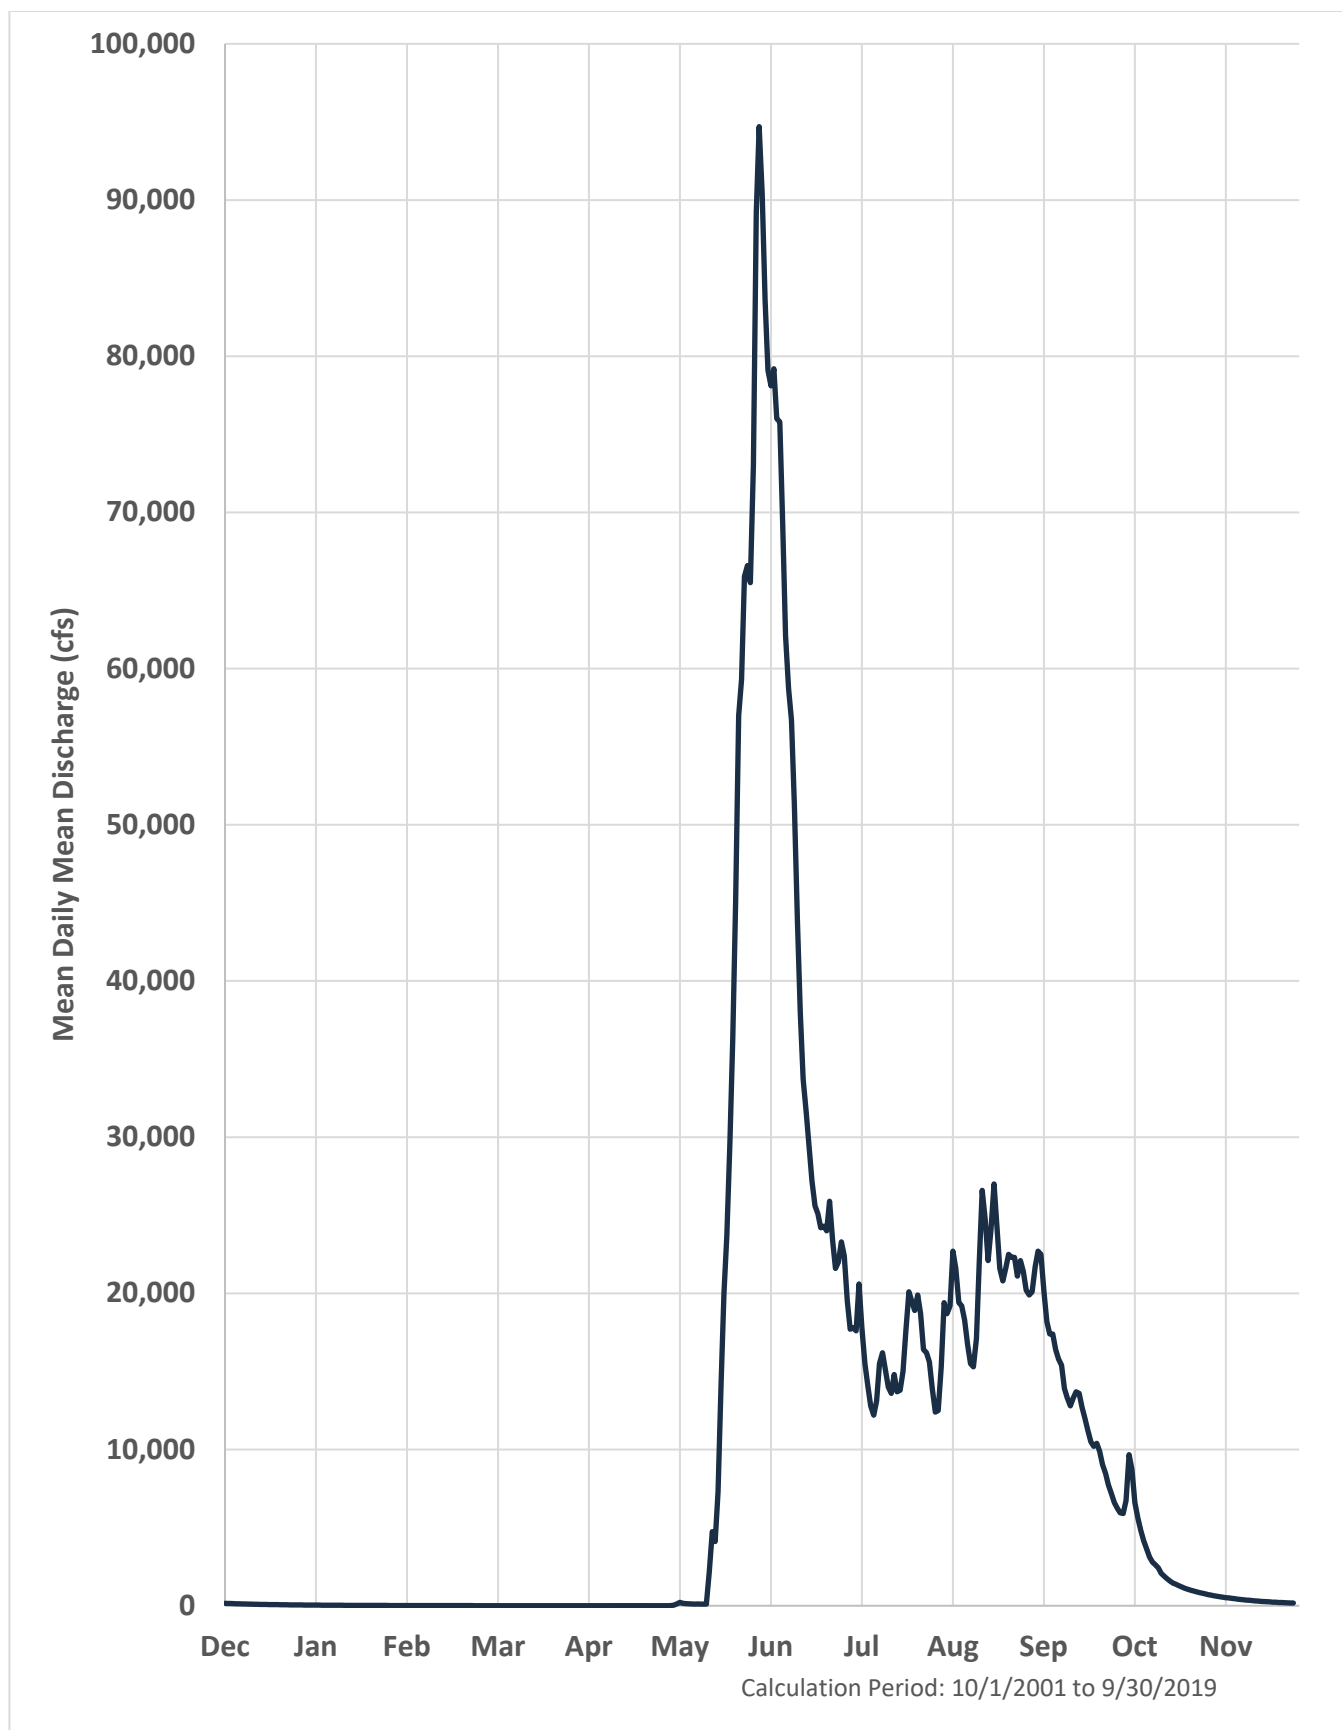
Chart 1: USGS Mean of Daily Mean Discharge Values for Colville River at Umiat - Annual

It is reasonable to assume that Colville River seasonal discharge trends at Ocean Point are similar to those at Umiat. Direct measurements at Ocean Point support this conclusion. Lacking evidence suggesting otherwise, it is further reasonable to assume that mid-April discharge at Ocean Point, had it been measured, would have been lower than the 9 cfs measured in February.

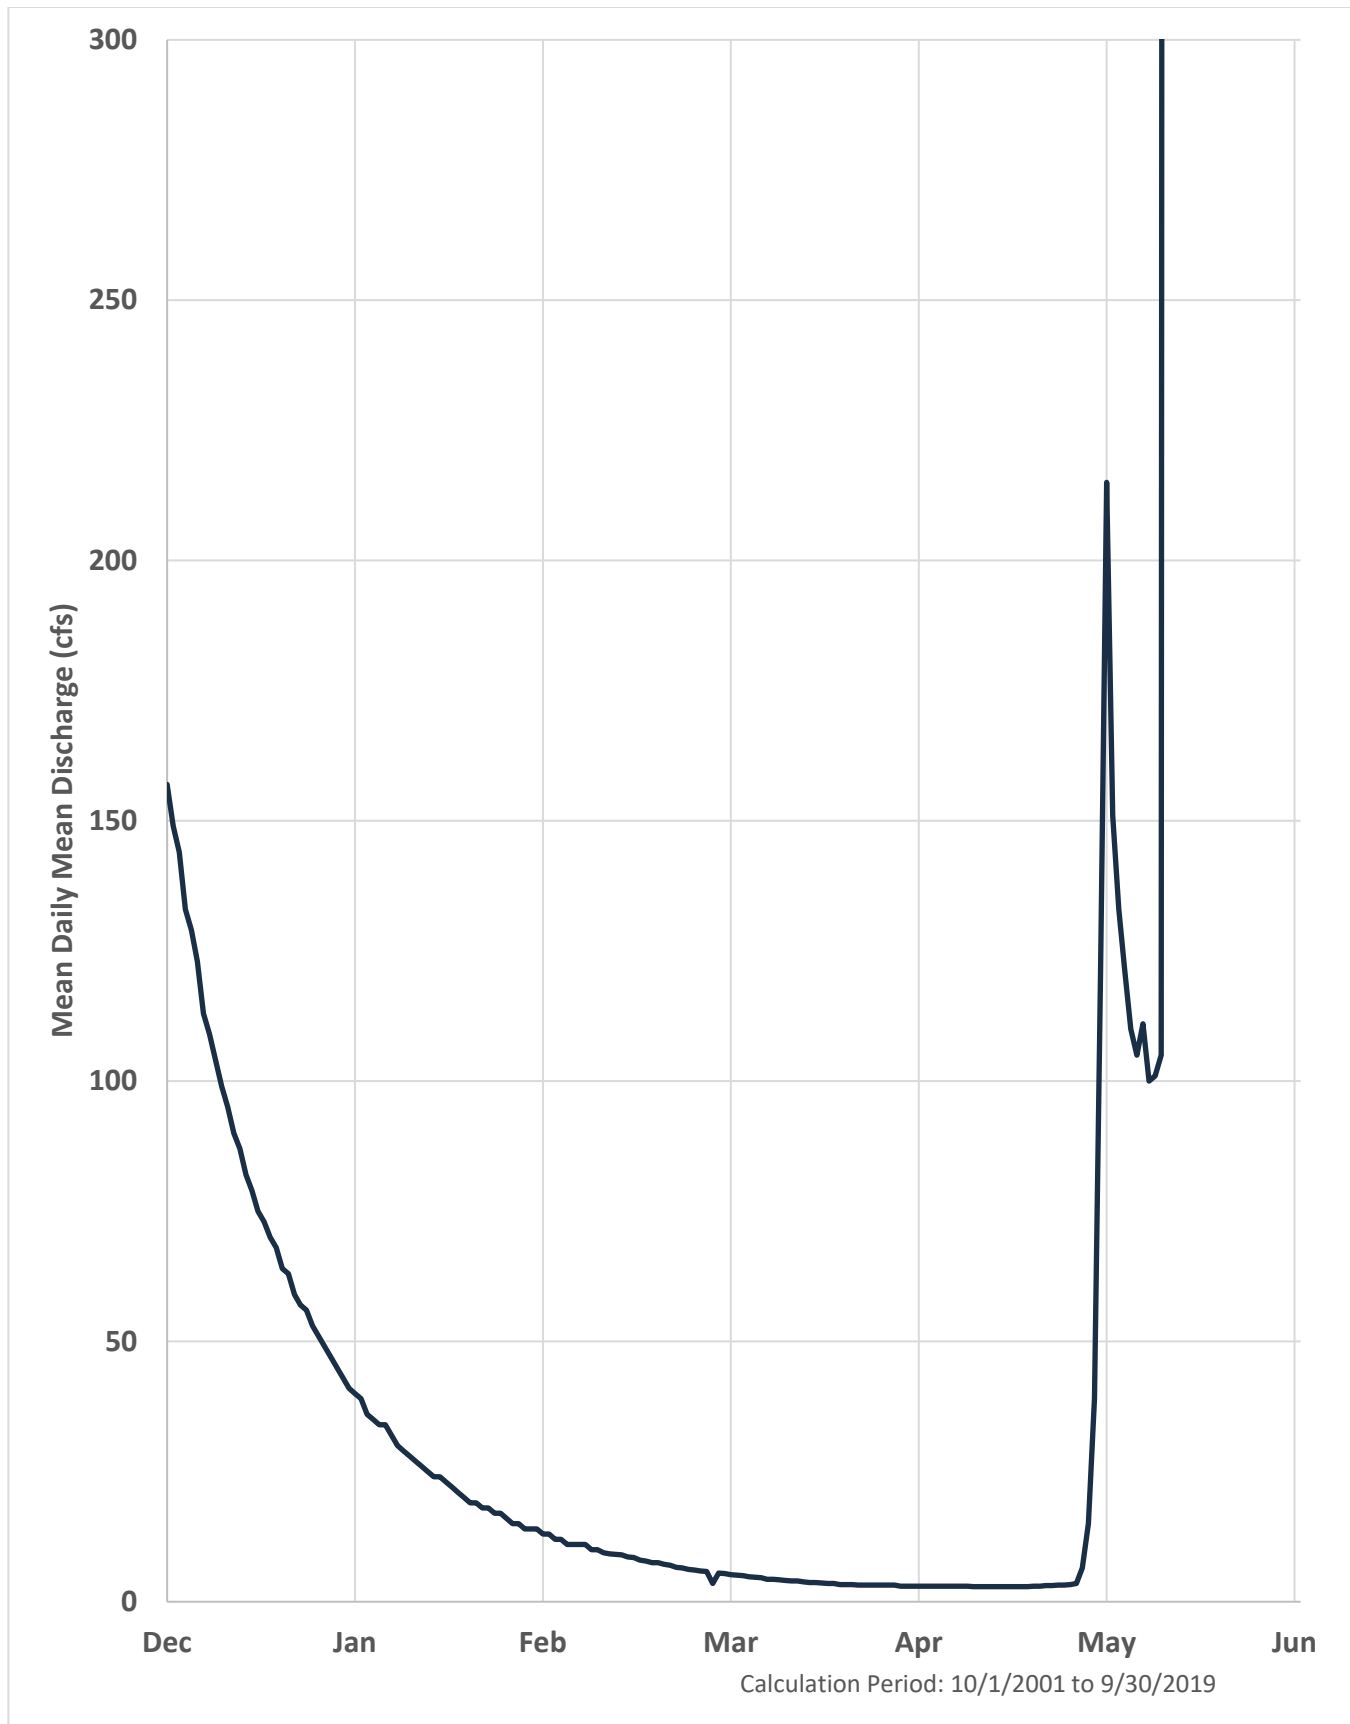
Chart 2: USGS Mean of Daily Mean Discharge Values for Colville River at Umiat – December through May

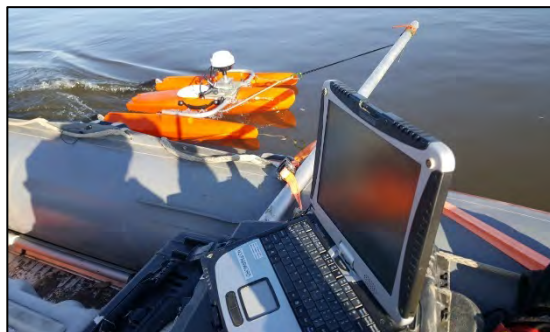
Photo 1. Discharge measurement in progress at Transect #1; Sept 5, 2019

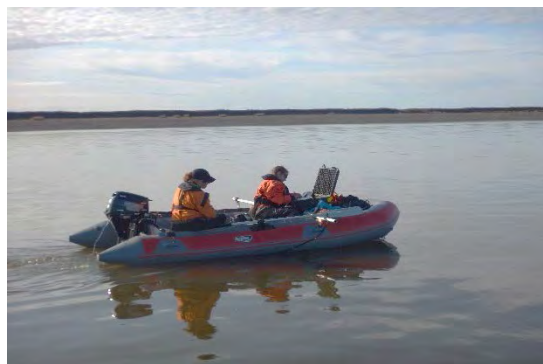
Photo 2. In-situ water quality sampling at Transect #6; Sept 5, 2019

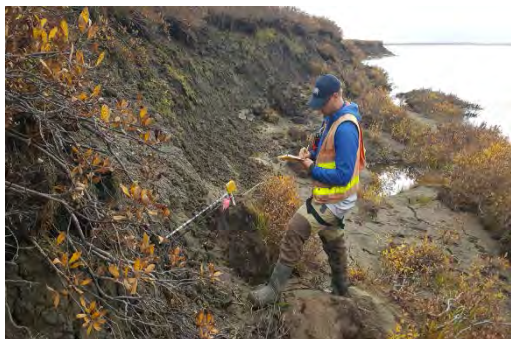
Photo 3. Investigating soil active layer at Transect #6; left bank. Sept 4, 2019

The soil active layer was investigated to characterize the depth of permafrost below the surface in the transition zones adjacent to the river. This investigation was performed on the right and left banks of each transect, perpendicular to the channel. Probing was performed using a 5-foot long T-bar probe driven by hand (Photo 3). Spacing was approximately 5-foot increments and at major grade breaks, between water's edge and the top of the riverbank. Results were provided directly to Golder as a separate deliverable and included in this report as Appendix A.

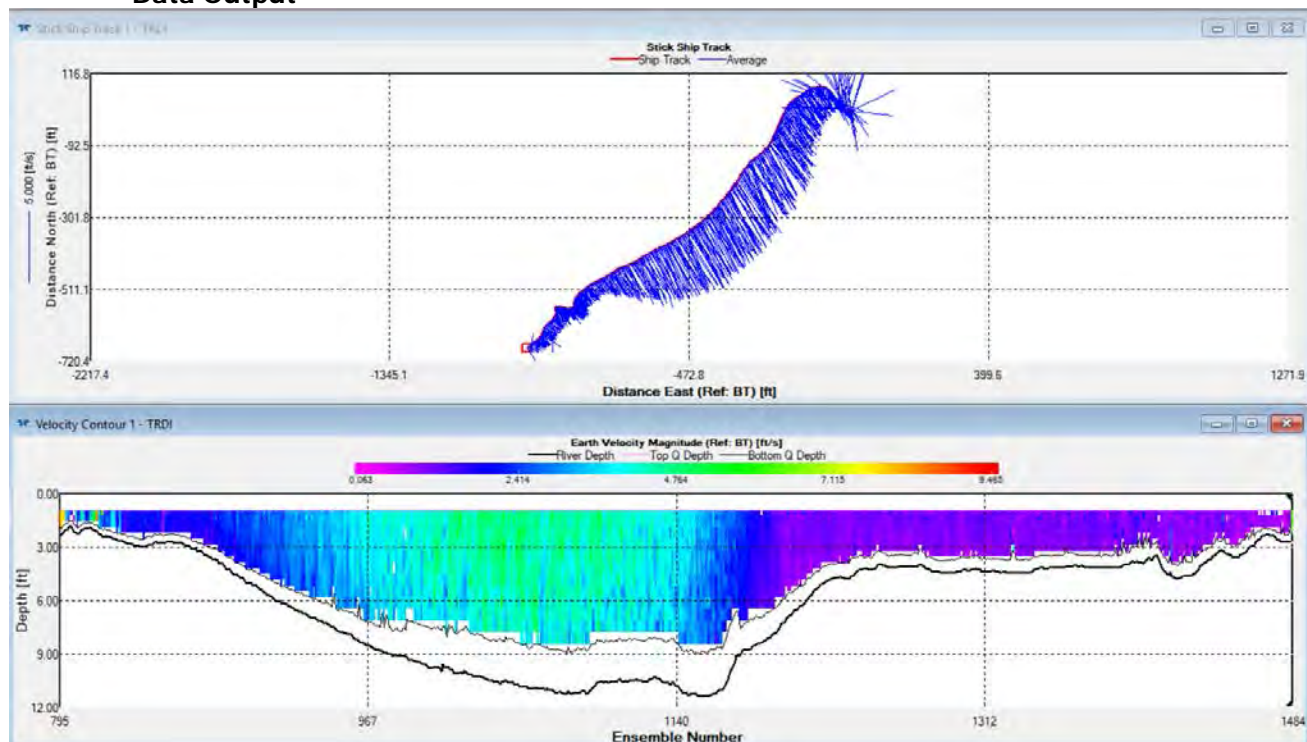
A. Colville River Ocean Point Transect#1/Rolligon Route: Measurement Transect 001 Raw Data Output

Location:	Transect #1/Rolligon Route
Date & Time:	September 5, 2019 2:50 PM
Equipment:	RiverRay ADCP attached to the side of an inflatable raft with outboard motor
WSE (ft NAVD88):	11.67
Discharge ([Q] cfs):	29,000
Velocity ([v] fps):	2.7
Measurement Rating:	Good
Measurement Notes	At the time of the measurement, open-channel conditions were present. Wind was negligible and surface waves were not present. Prior to deployment, diagnostic tests were performed, and the internal compass calibrated.

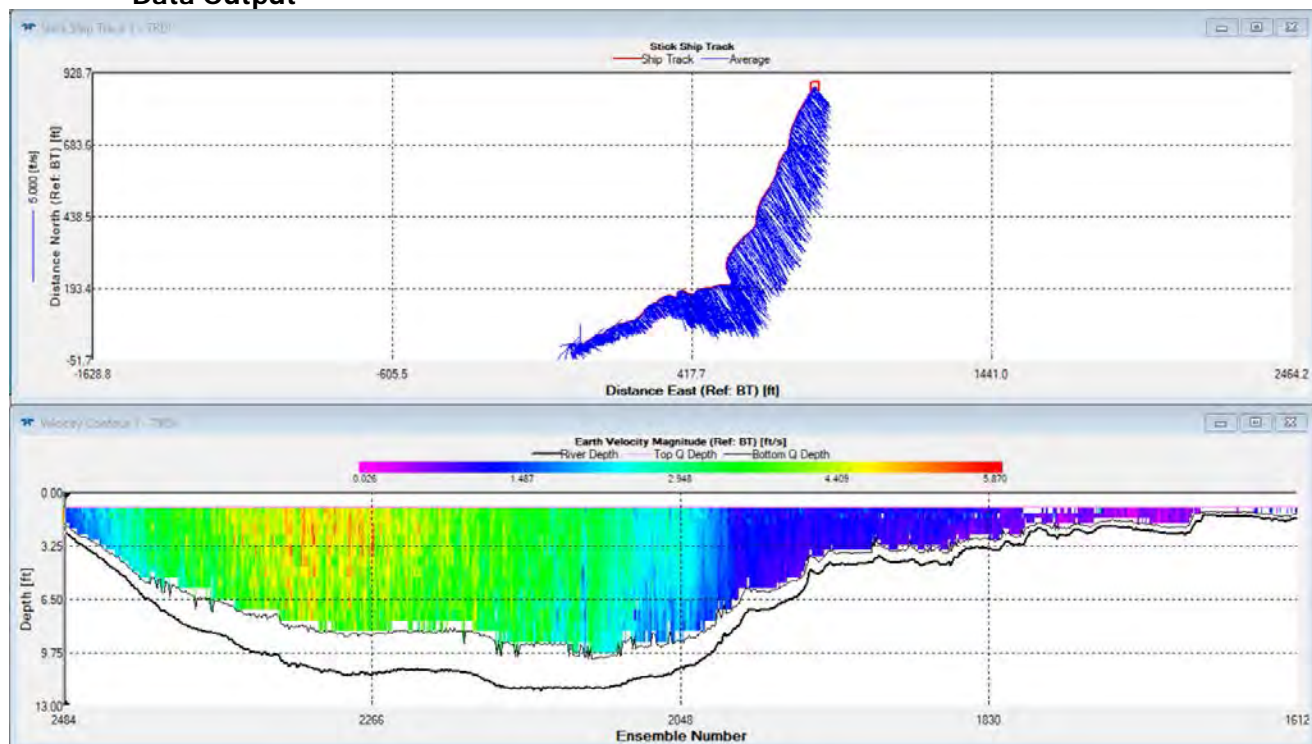
B. Colville River Ocean Point Transect#1/Rolligon Route: Measurement Transect 002 Raw Data Output

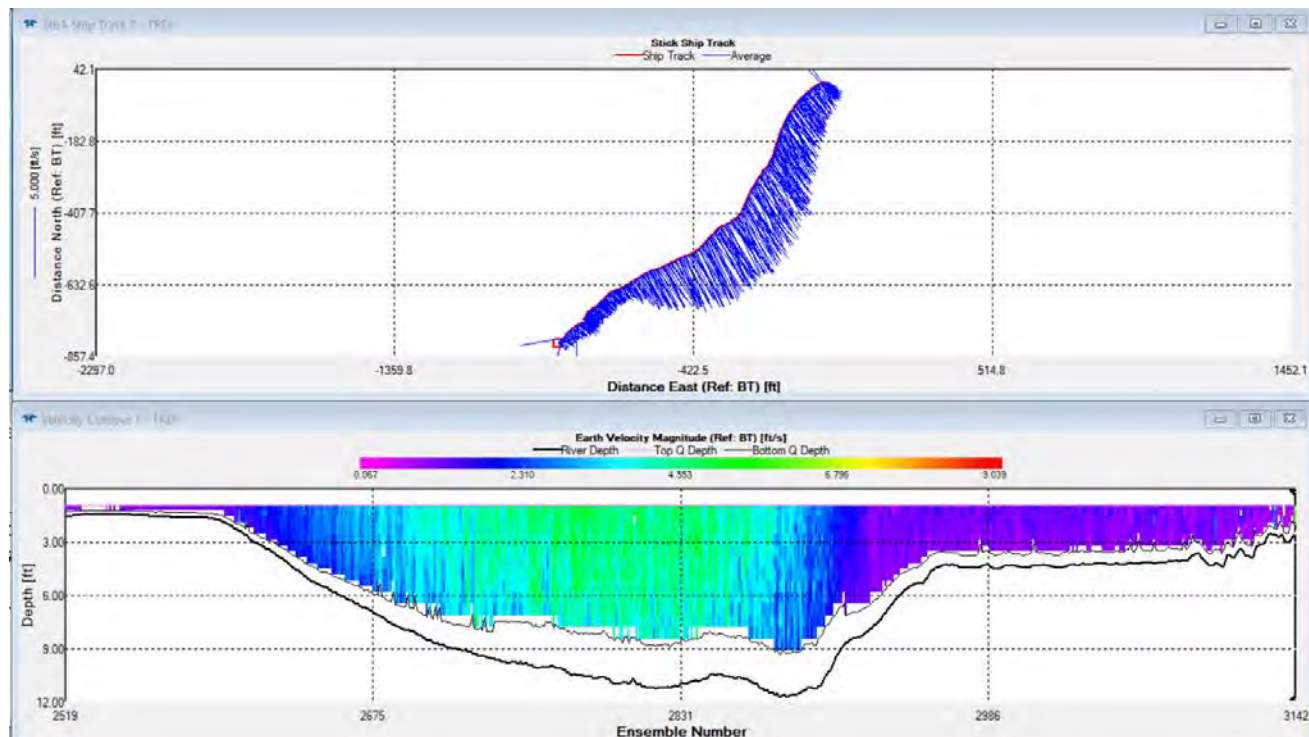
C. Colville River Ocean Point Transect#1/Rolligon Route: Measurement Transect 003 Raw Data Output

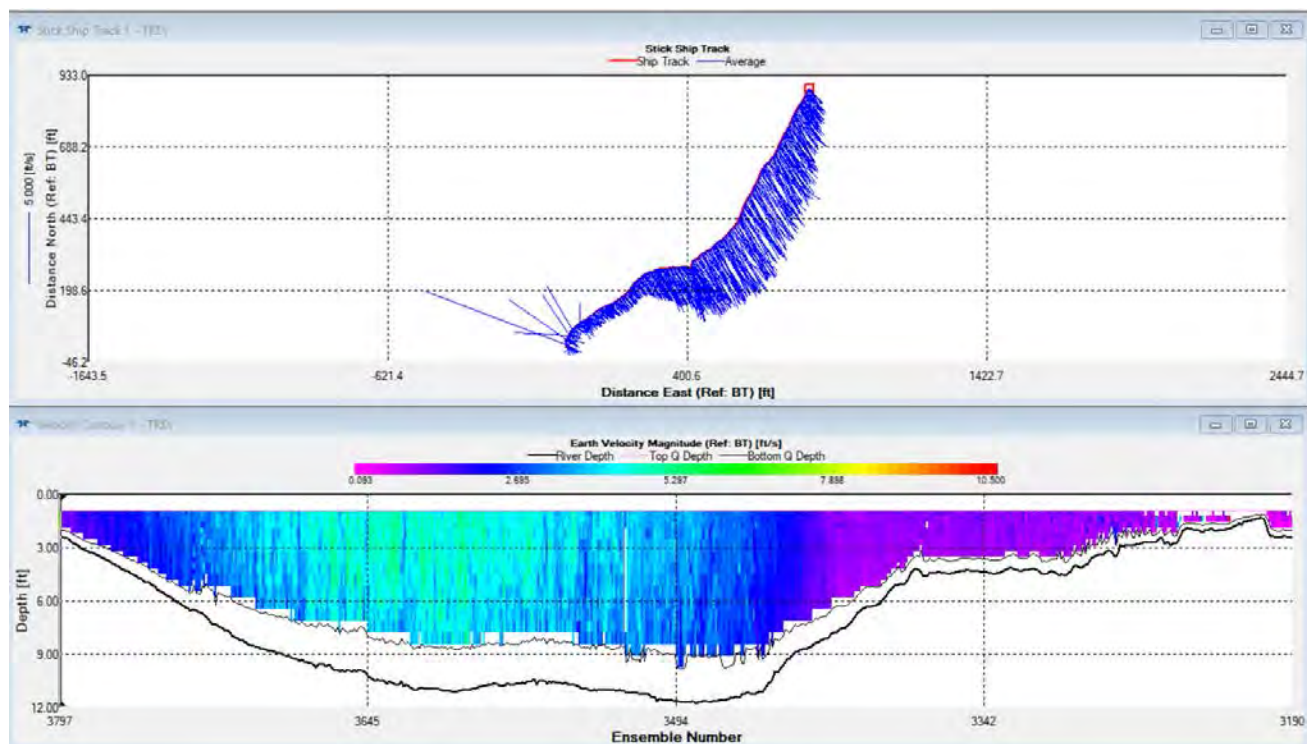
D. Colville River Ocean Point Transect#1/Rolligon Route: Measurement Transect 004 Raw Data Output
