Willow Master Development Plan

Appendix D.3A Ice Bridge Plan

WILLOW DEVELOPMENT

OCEAN POINT ICE BRIDGE REVISION

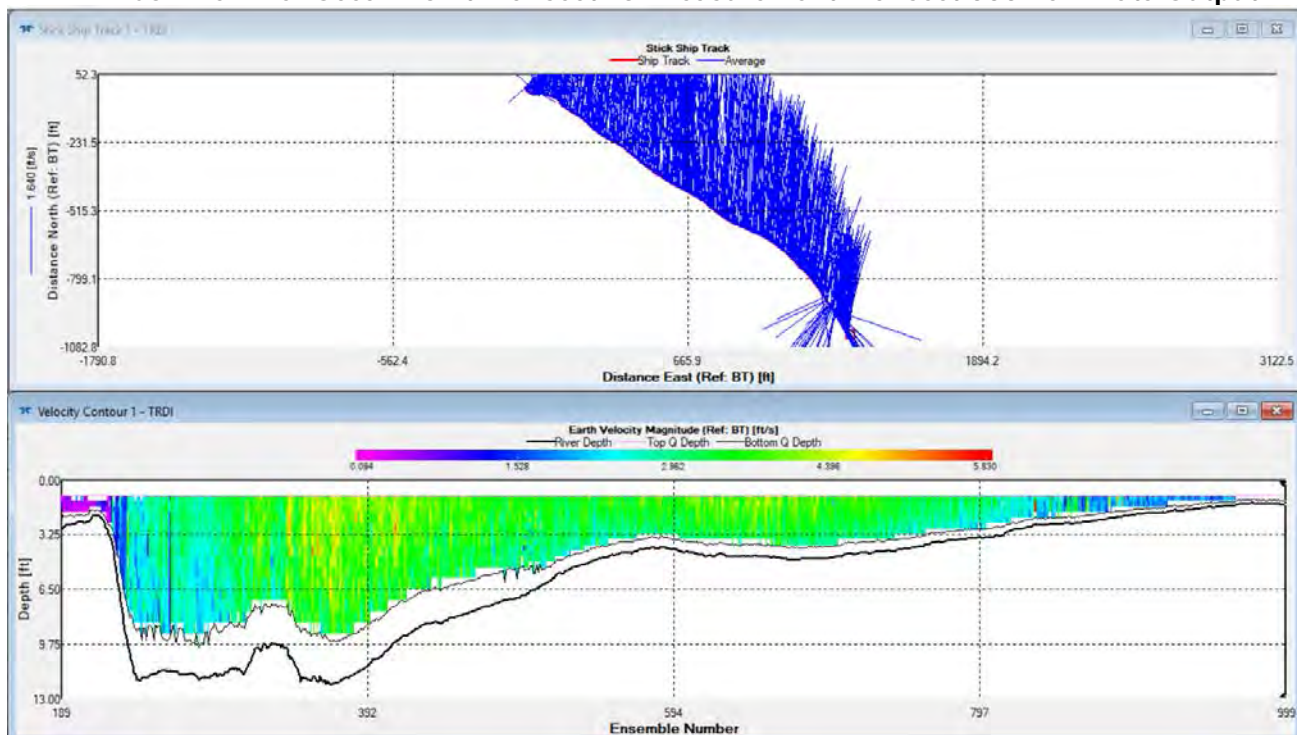
A. Colville River Ocean Point Transect#6: Measurement Transect 000 Raw Data Output

Measurement Notes: At the time of the measurement, open-channel conditions were present. Wind was negligible and surface waves were not present. Prior to deployment, diagnostic tests were performed, and the internal compass calibrated.

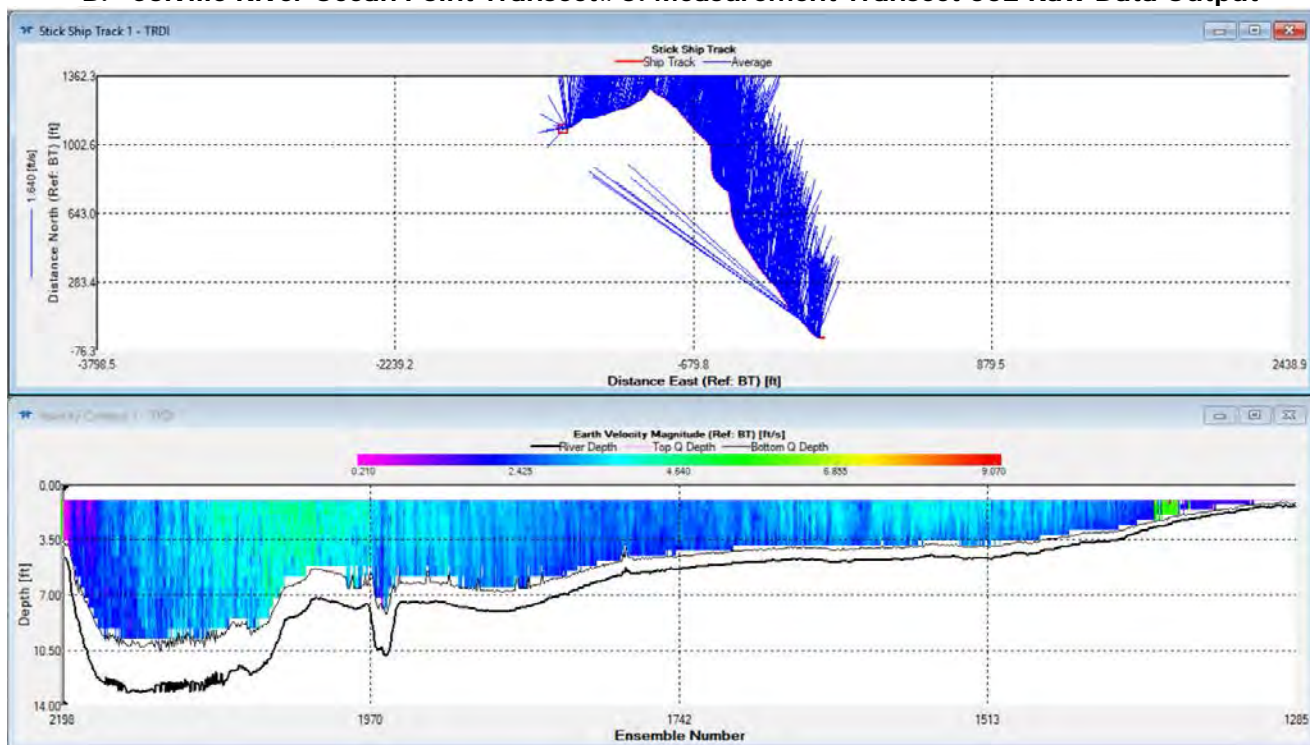
B. Colville River Ocean Point Transect#6: Measurement Transect 002 Raw Data Output

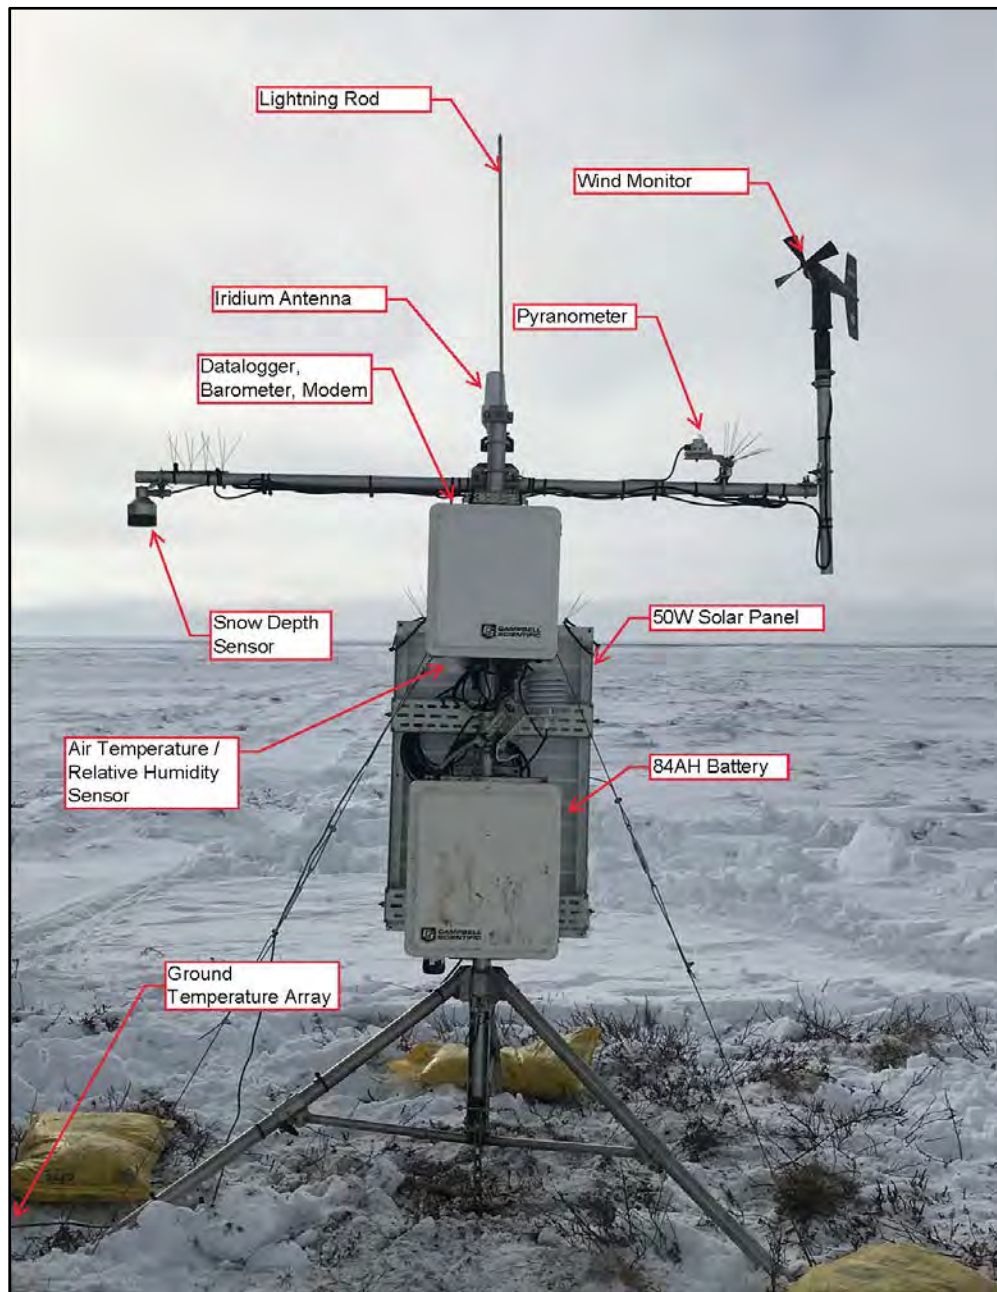
Figure 3 – Ocean Point Weather Station Configuration

The Ocean Point weather station is configured with the following instruments that are depicted in Figure 3:

1. Wind monitor (wind speed and direction)
2. Pyranometer (solar radiation)
3. Air temperature sensor
4. Relative humidity sensor
5. Snow depth sensor
6. Barometric pressure sensor
7. Ground temperature sensor array

The sensor information is processed by a CR1000X data processor and transmitted to a remote server via satellite modem. Power is supplied by a single 12-volt deep cycle battery that is recharged by a 50-watt solar panel.
