Willow Master Development Plan

Appendix D.3B Ice Bridge Plan

**2021 Willow Development Ocean Point Ice Bridge Crossing
Update**

2021 WILLOW DEVELOPMENT OCEAN POINT ICE BRIDGE CROSSING UPDATE

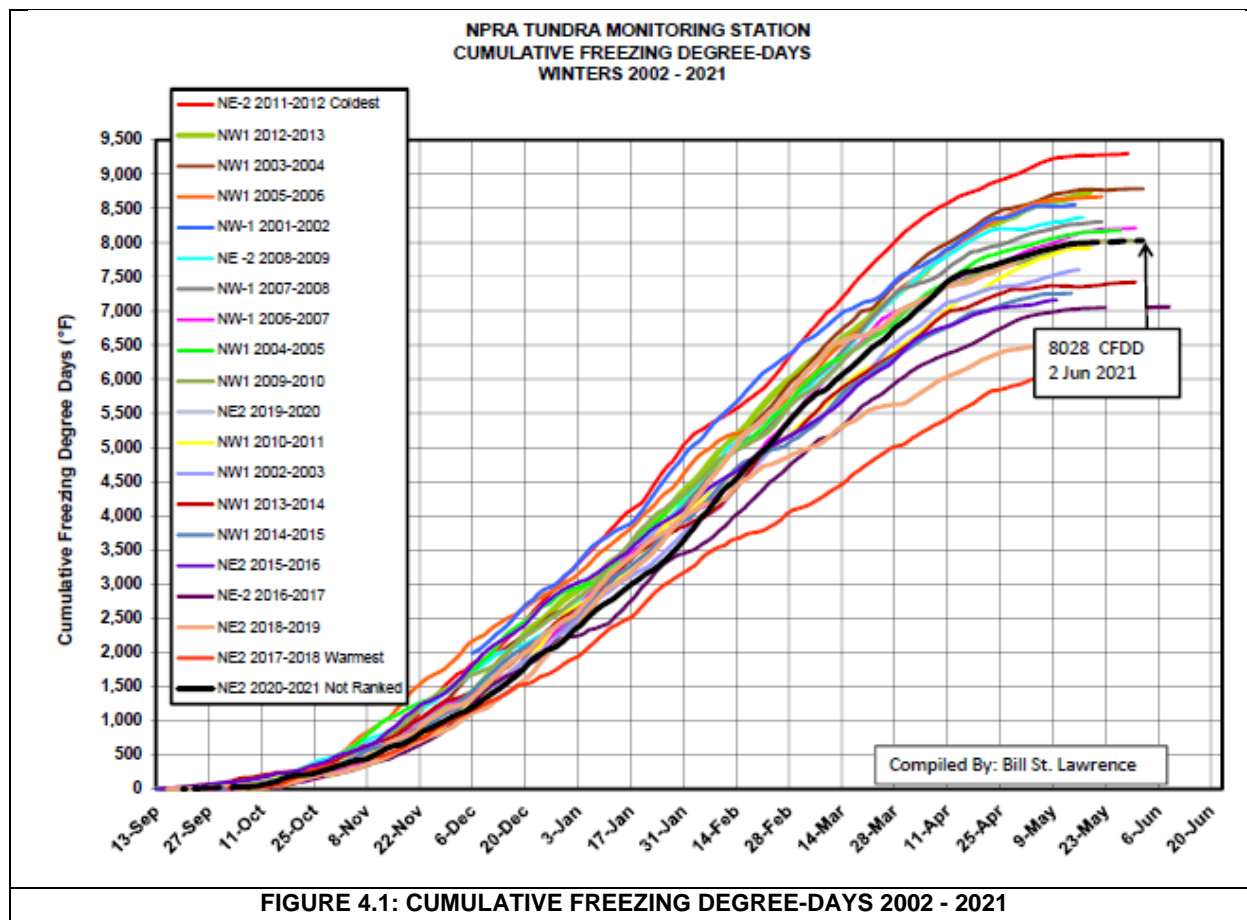
Cumulative Freezing Degree-Days (CFDD) are calculated as a sum of average daily degrees below freezing for a specified time period and are frequently used to measure and compare the coldness of winter from year to year. The annual CFDD (referenced to Fahrenheit degrees) has ranged from a high of 9,300 (2011-2012 winter season) to a low of 6,200 (2017-2018 winter season). The higher the CFDD the colder the winter. However, a higher CFDD doesn't necessarily equate to a longer winter. Figure 4.1 presents the historical CFDD from 2002 to 2021. The 2020-2021 winter was on the colder end of the data set spectrum.

FIGURE 4.1: CUMULATIVE FREEZING DEGREE-DAYS 2002 - 2021

The air temperature CFDD index correlates with:

1. Natural ice growth
2. Ice construction rates
3. Refreezing of seasonal thawed tundra

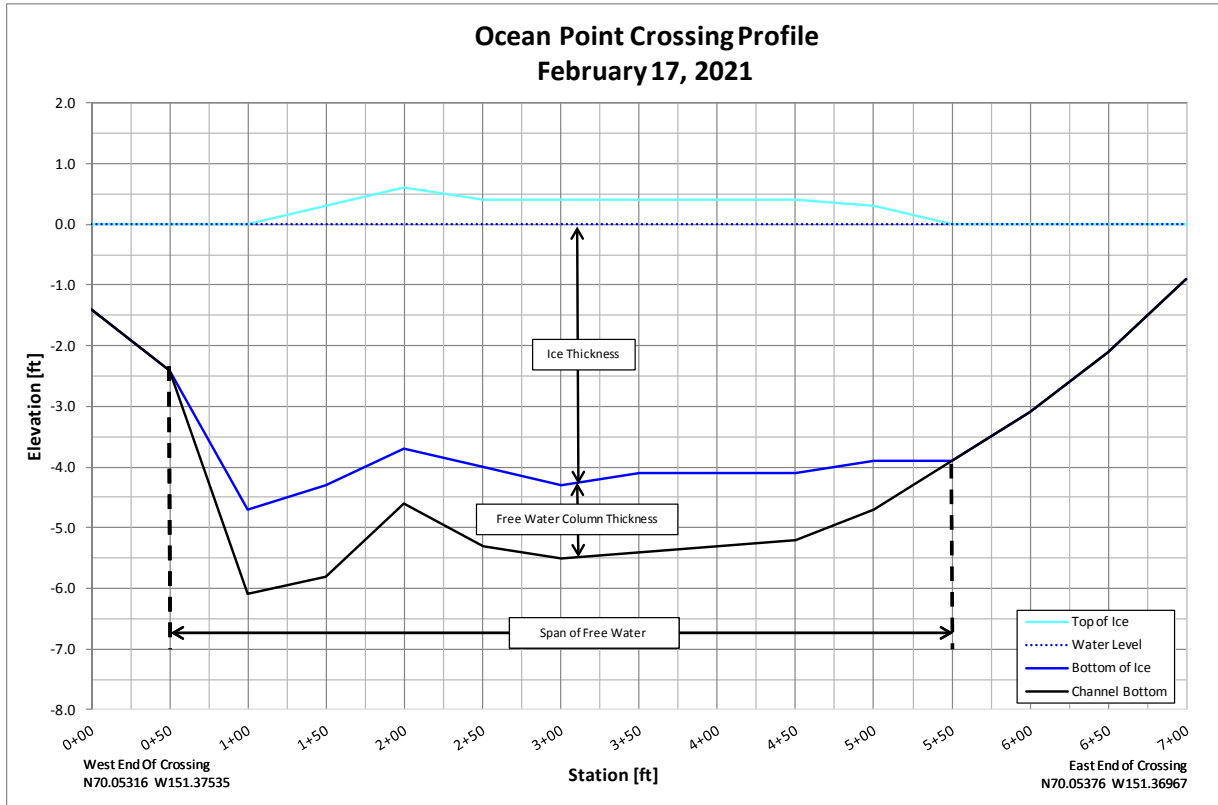
The span of free water is the distance between the edges of water below the ice. Figure 4.2 provides an illustration of the span of free water.

**FIGURE 4.2: ICE PROFILE AND SPAN OF FREE WATER AREA****TABLE 4.2: SPAN OF FREE WATER**

Table 4.2 presents the length of the free water span during each of the five field visits. As the ice thickness increases the span of free water length and column thickness decreases.

By the time of the April 7th field visit, the natural ice had grounded across the alignment. It is possible that small pockets of flow were present under the ice but were not detected with the 50-foot ice profile intervals.

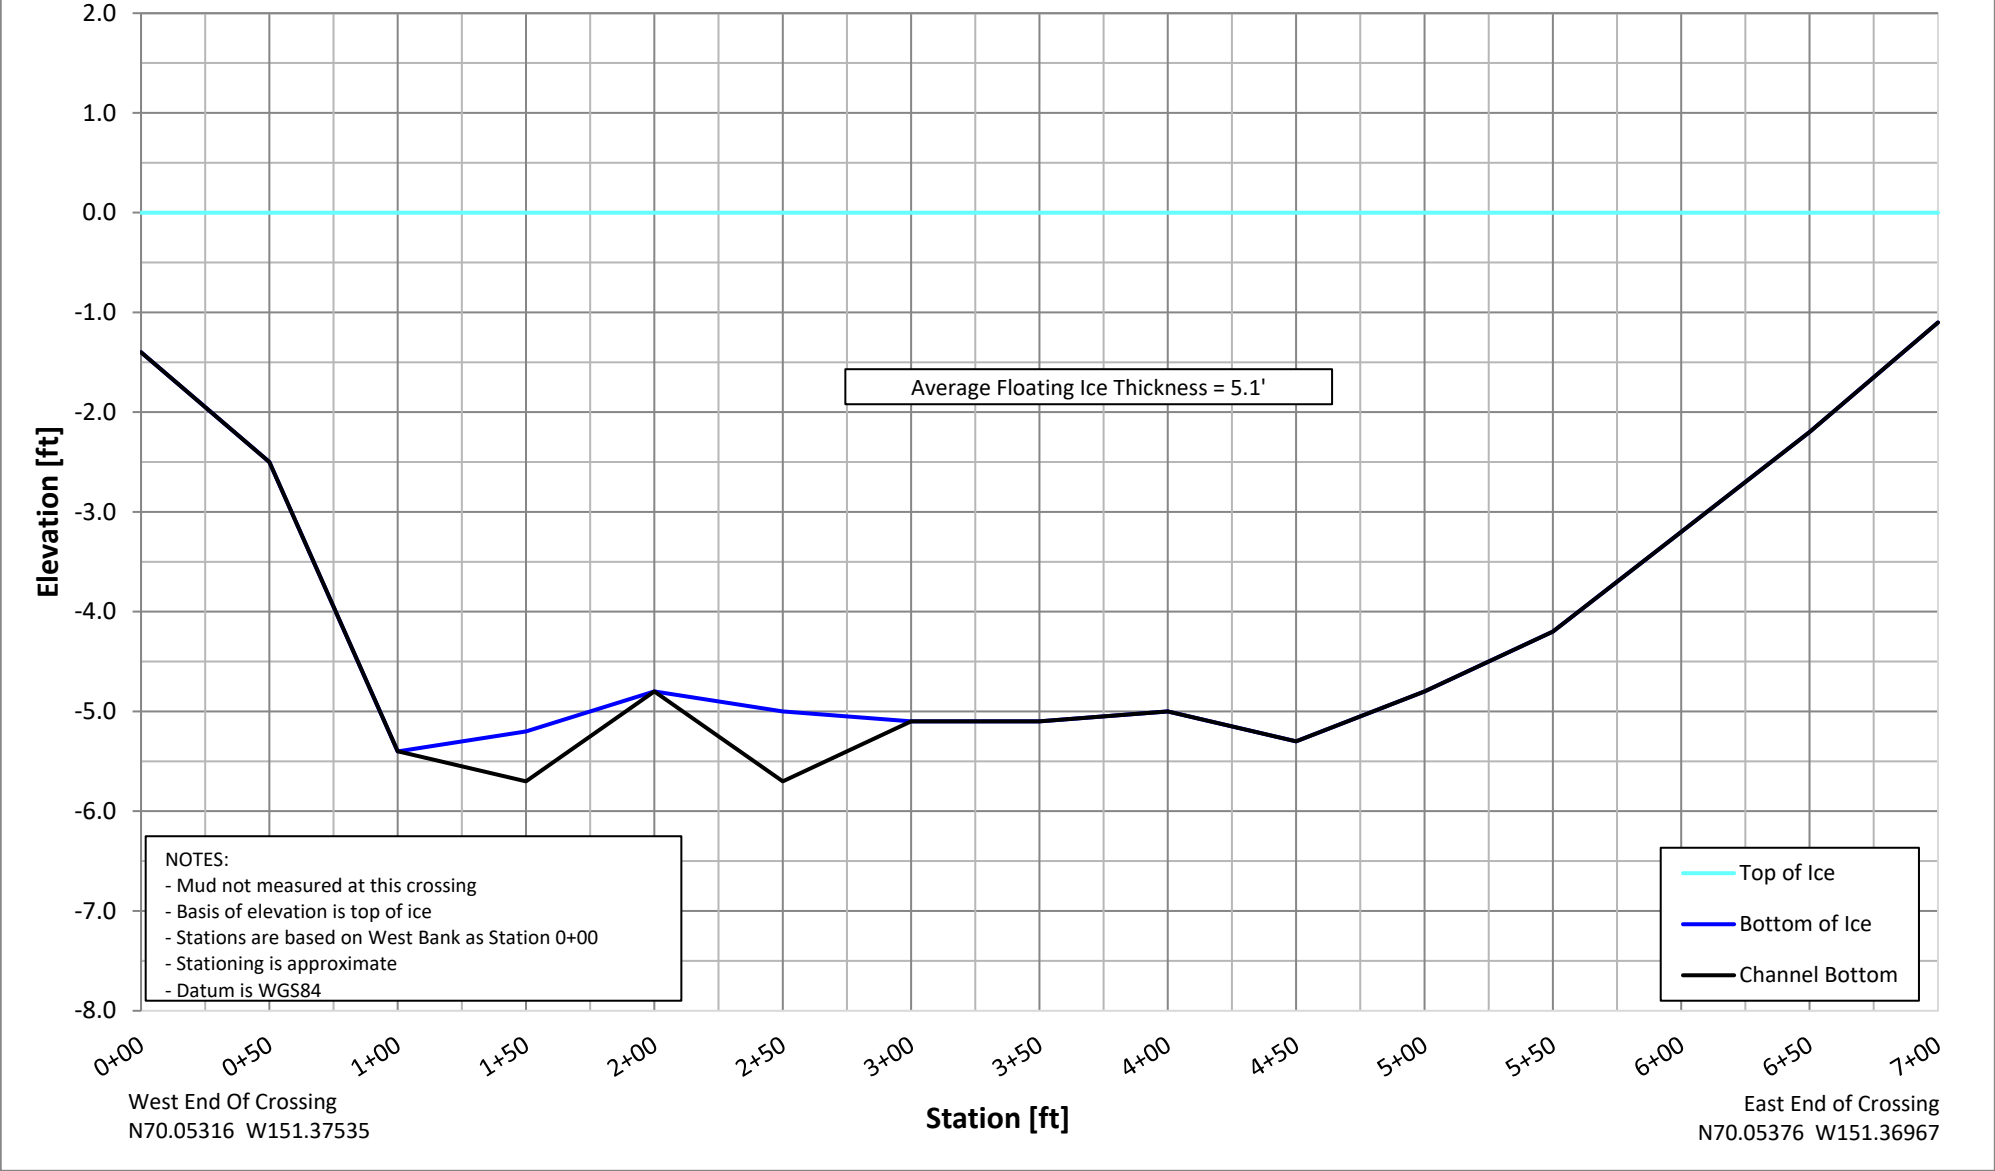
March 10, 2021

Ocean Point Crossing Profile

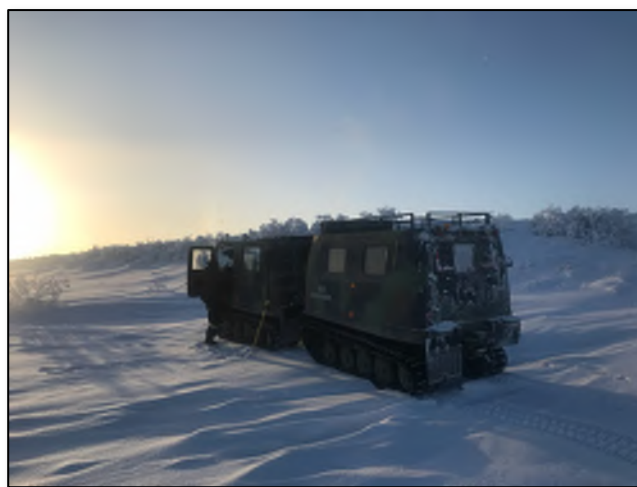
**Photo 3.1: Crew setting up GPS at Ocean Point;
2/17/21**

Photo 3.1: Crew setting up GPS at Ocean Point; 2/17/21	4
--	---

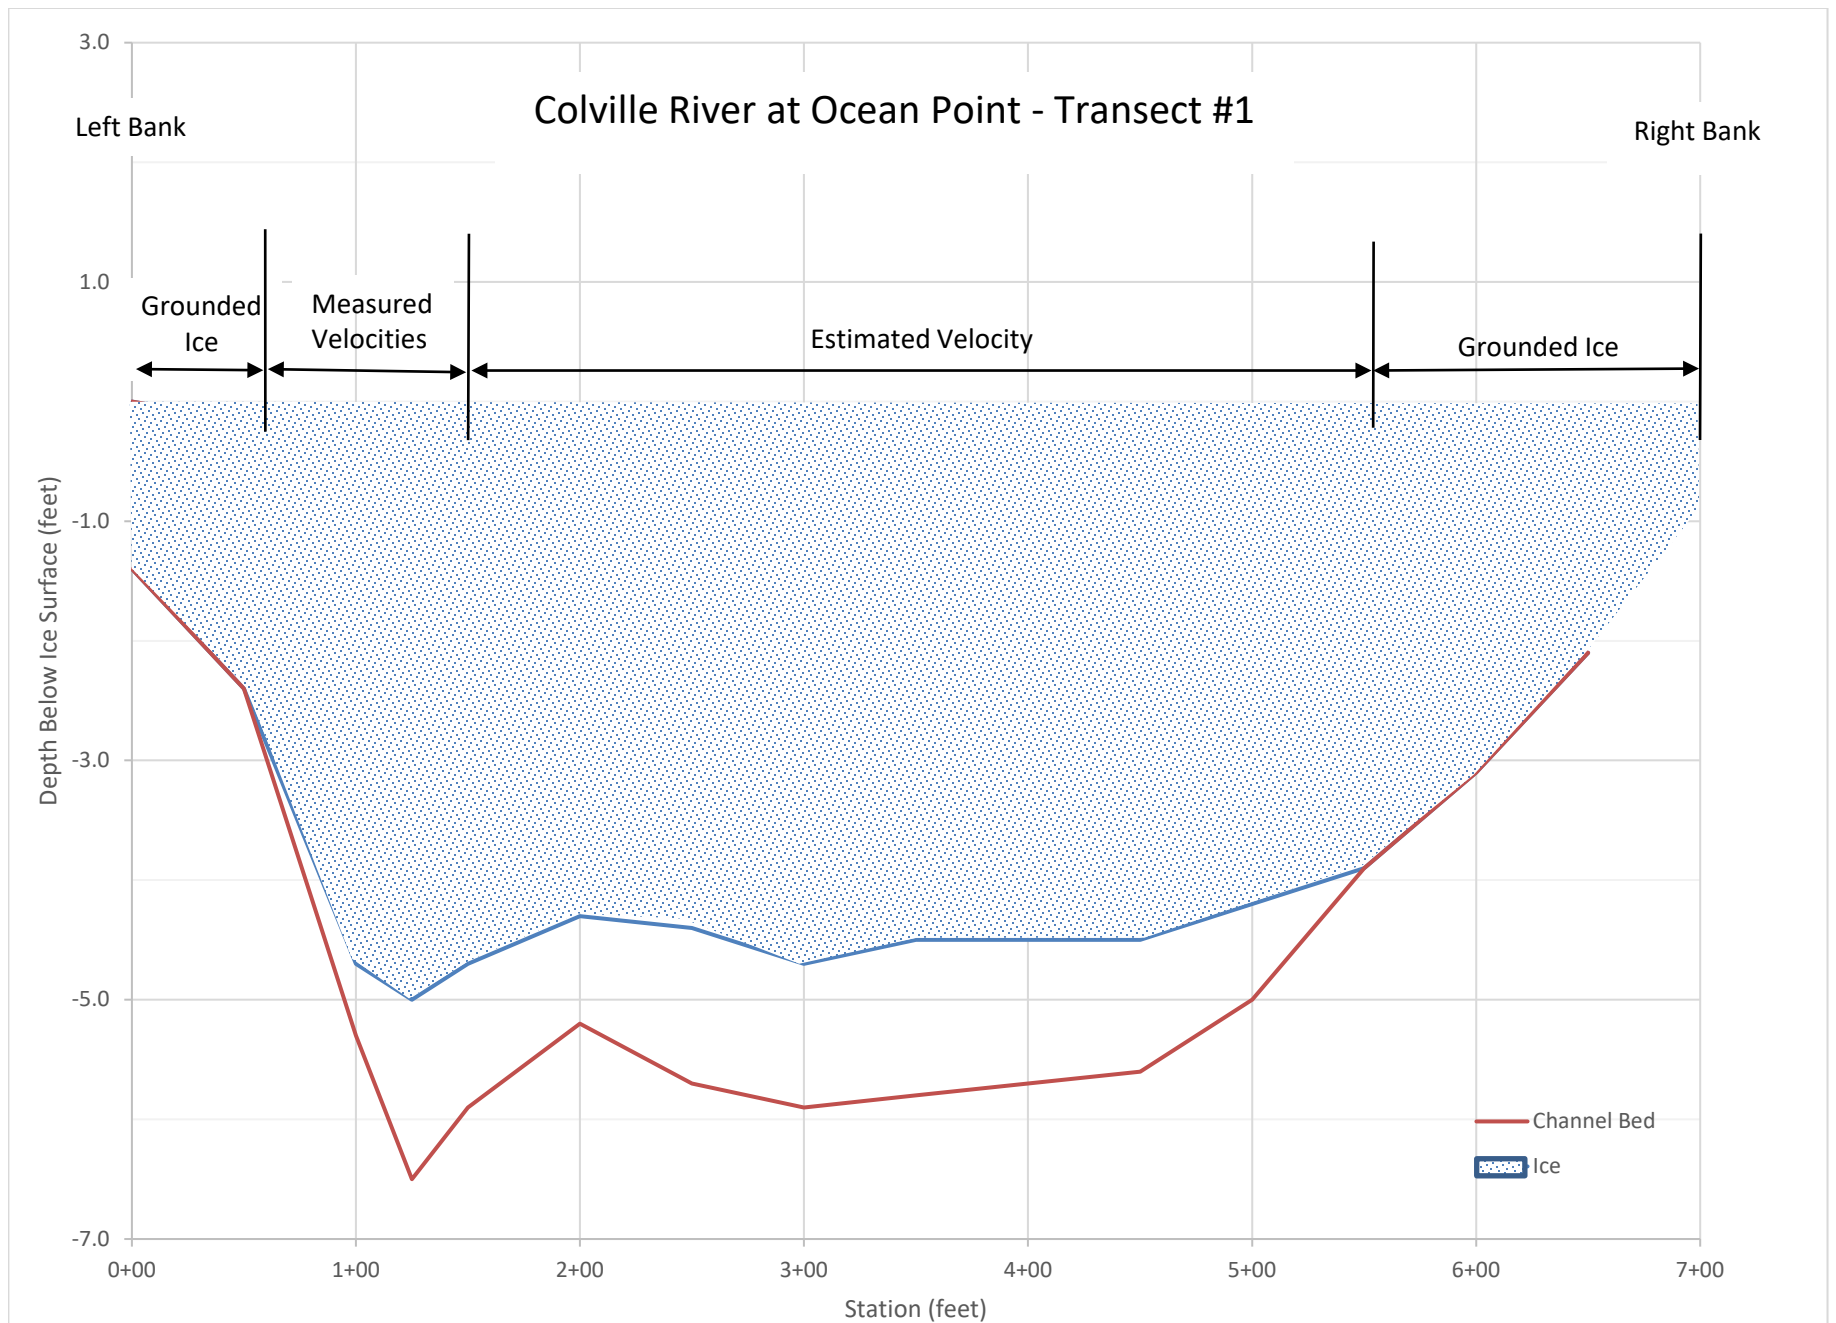
Notes: Velocities were taken at station 1+00, 1+25 and 1+50. The average velocity was 0.03 ft/sec in that section and was applied to the other stations to estimate the discharge.

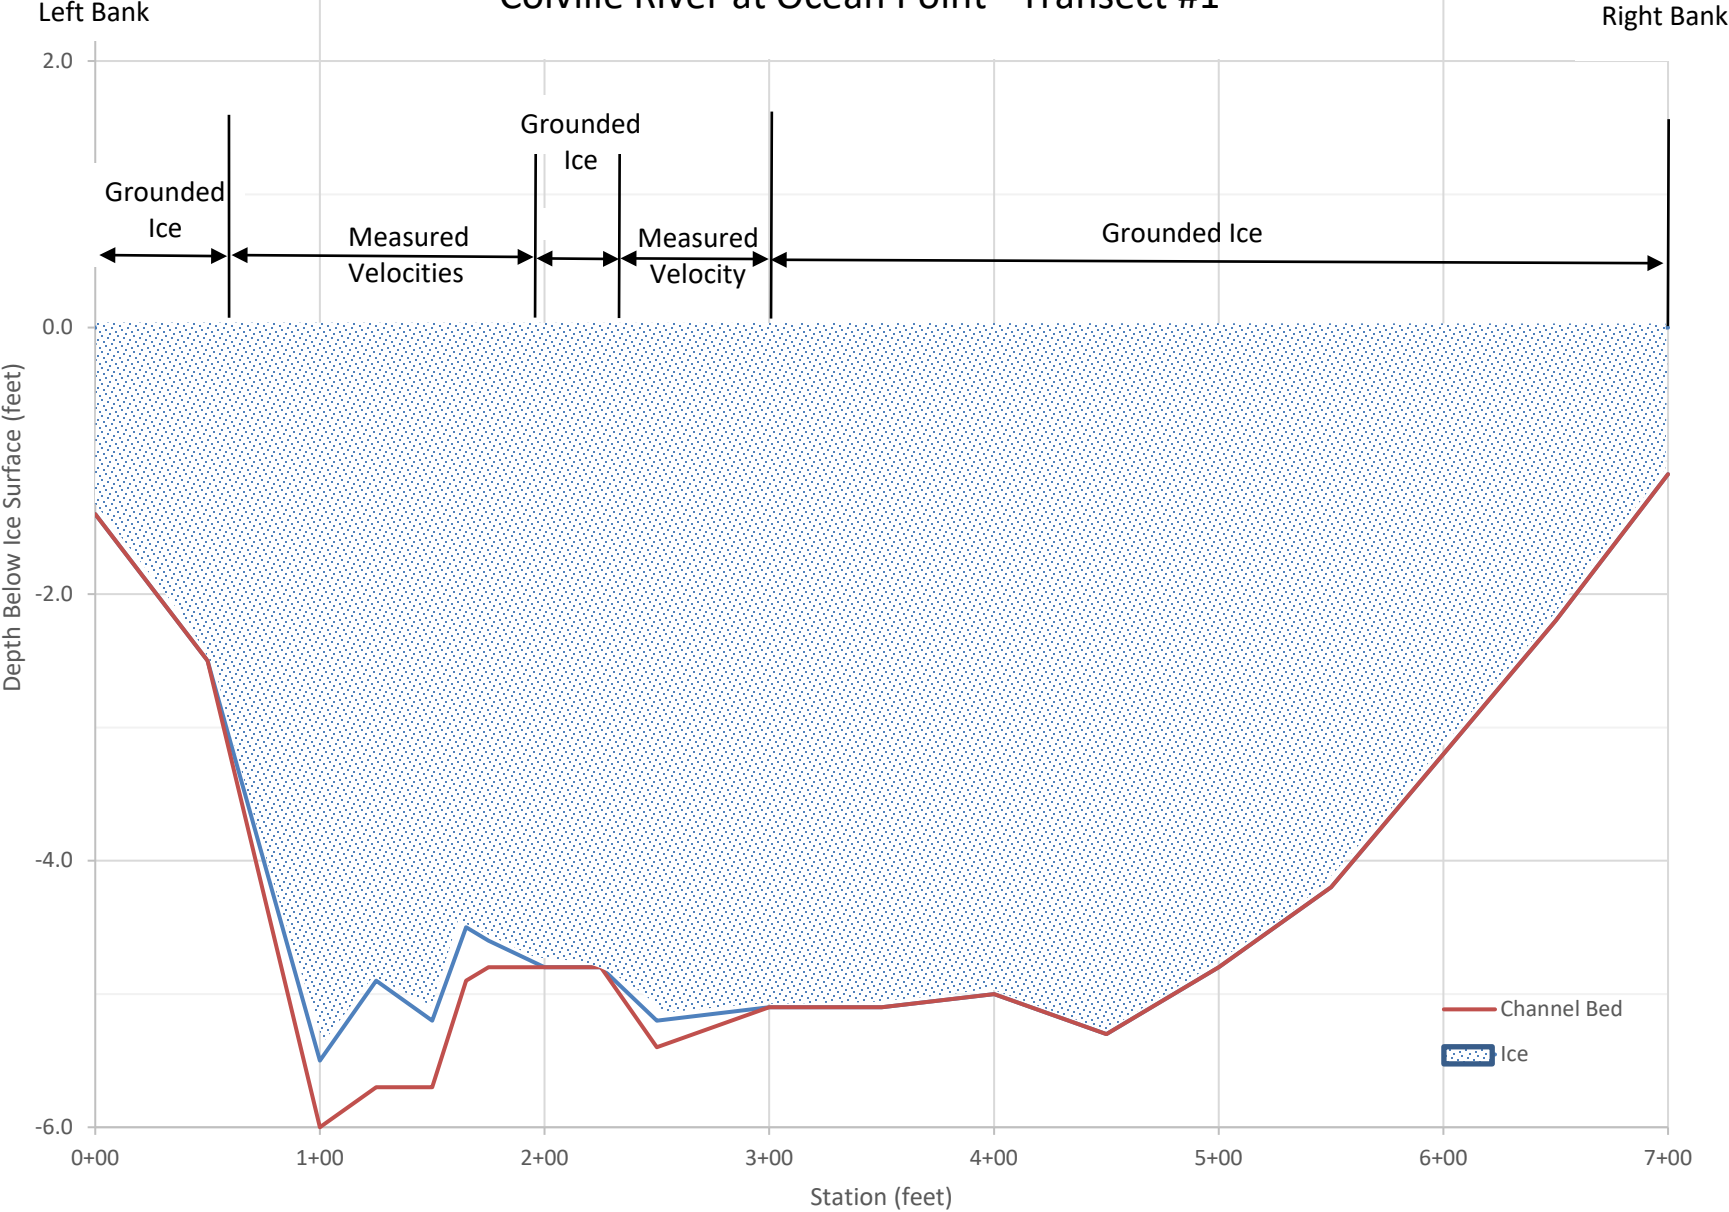
Notes: All water columns were less than 0.8 feet deep. Velocity measurements were collected with a Hach electromagnetic velocity meter. Postive freeboard occurred between stations 1+00 through 1+75 and at 2+50, averaging 1.3' below the ice surface. Water quality parameters were taken at Sta 1+00.

Colville River at Ocean Point- Transect #1
Water Quality
