APPENDIX E
AQUATIC SITE ASSESSMENT AND CREDIT-DEBIT CALCULATION

***Willow Master Development Plan
Wetlands Compensatory Mitigation Plan***

WILLOW MASTER DEVELOPMENT PLAN
POA-2018-00190 HARRISON BAY
AQUATIC SITE ASSESSMENT
AND
CREDIT-DEBIT CALCULATION

October 2020

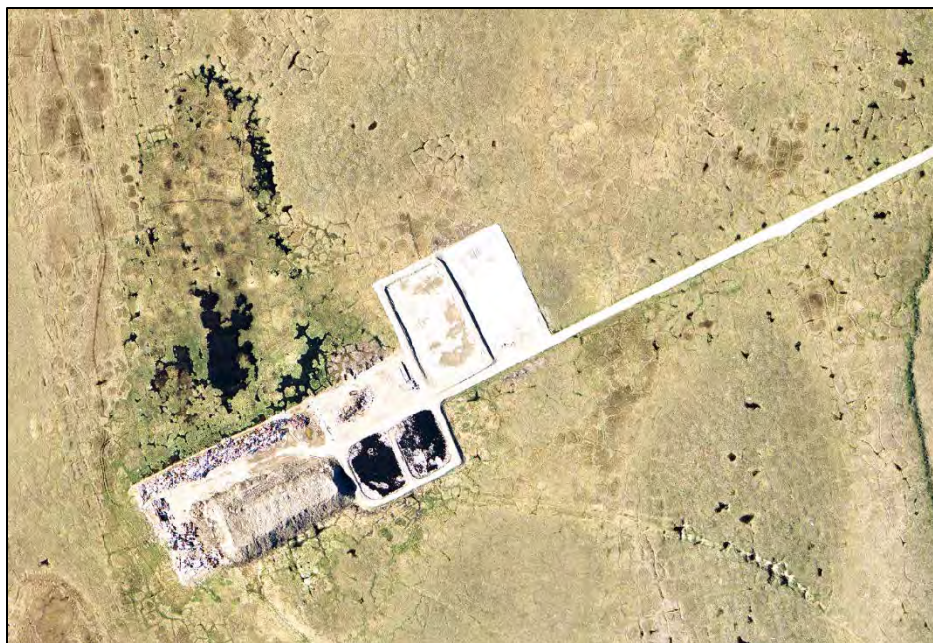
Photo 1: Nuiqsut trail area showing no discernable areas of textural changes or discoloration (2001)

Currently, CMWAA6 contains 4.1 acres of existing local landscape disturbance in the 80-meter-radius plot (82 percent of the plot area) related to a web of rutted trail sections caused by the repeated use of all-terrain vehicles (ATVs). These trail ruts are evident on aerial imagery as texture and discoloration differences from the surrounding un-impacted wetlands, and from historical imagery where no discernible disturbance is evident (Photos 1 and 2).

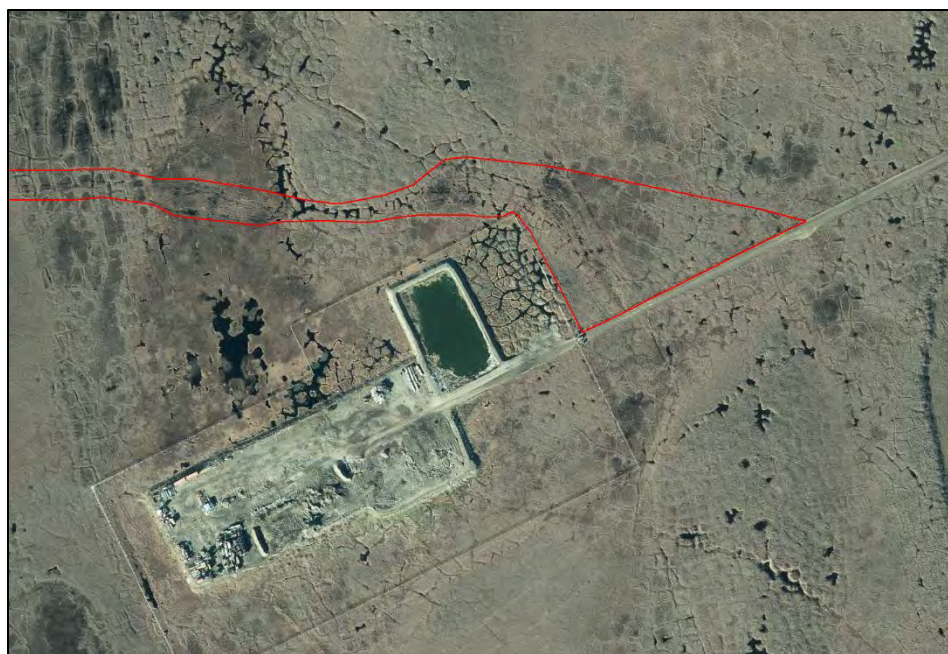
Photo 2: Nuiqsut trail anthropogenic disturbance showing areas of textural and discoloration (2018)

Dust (V_{DD}) is assumed to be present adjacent to gravel fill and the landfill. Thermokarst (V_{TK}) is visible in the aerial imagery, particularly near the landfill (Photo 2). The plot also includes impediments to wildlife movement (V_{IW}) in three quadrants. The current trail rutting could act in some degree to impede wildlife movement; however, because the definition in the method appears to restrict this metric to larger gravel roads and above ground pipelines, the rutting was not accounted for in either the pre or post condition assessment. The site is 96 meters from the nearest road (V_{DR}).

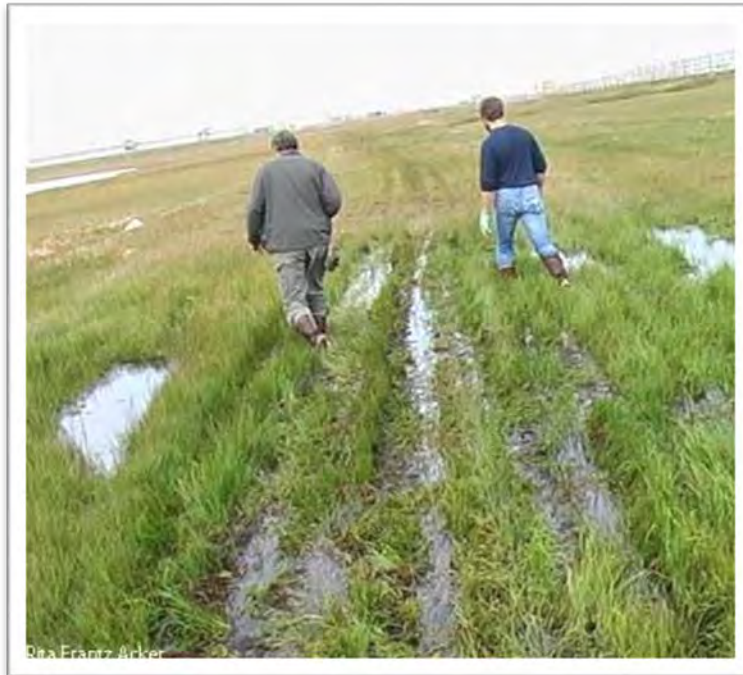
Photo 3: Example of anthropogenic disturbance caused by rutting along a similar trail in Utqiaġvik

A similar level and type of disturbance has occurred in Utqiagvik along an ATV trail near the community's fresh water supply lake. Geogrid was placed successfully along that trail and resulted in a noticeable improvement in 2 years (Photos 3 and 4). The disturbance appears to have been mitigated by the geogrid trail allowing natural revegetation to take place, and the rutting was eliminated by residents limiting travel to the new trail surface.

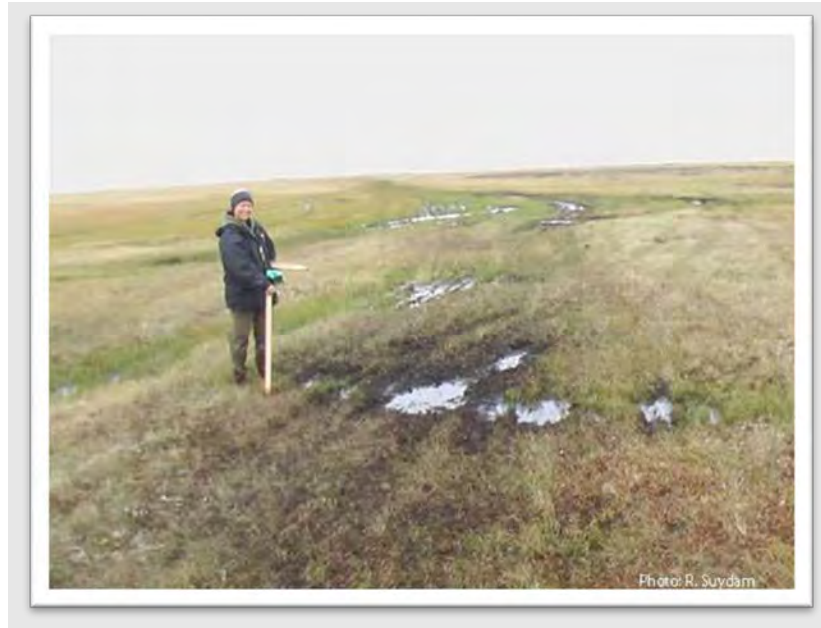
Photo 5: Example of anthropogenically-derived surface water along similar trail in Utqiagvik. Photo Credit: NSB Website- Robert Suydam.

As with the local anthropogenic disturbance example presented above, a similar level and type of disturbance previously existed in Utqiagvik near the community's fresh water supply lake. Geogrid was placed successfully along that trail and resulted in a noticeable improvement in reduction in anthropogenically-derived surface water in 2 years (see photos 5 and 6). The disturbance appears to have been mitigated by the geogrid allowing natural revegetation to take place, and the rutting and ponding was eliminated by residents limiting travel to the new trail surface.

Based on the Utqiagvik trail recovery example, CPAI anticipates that anthropogenically-derived water related to the subsistence trail damage would decrease to zero in the post-mitigation project condition as natural vegetation recovers and residents use the geogrid trail instead of the tundra surface. In addition, the geogrid trail would float on the natural surface water, which would avoid creation of ruts and prevent compaction of the soil that could inhibit percolation and natural water movement. However, as with anthropogenic disturbance, recovery of the Nuiqsut trail may take longer than in the Utqiagvik example due to the deeper ruts related to the Nuiqsut trail ruts. Therefore, CPAI estimates reduction of all anthropogenic surface water along the Nuiqsut trail within 6 to 10 years.

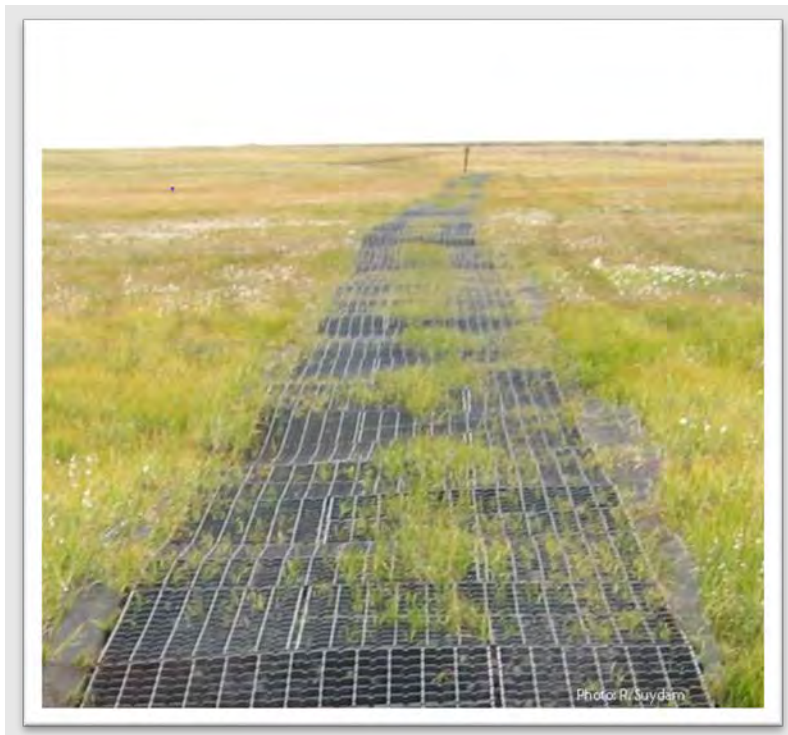
Photo 6: Example of geogrid application mitigating anthropogenically-derived surface water in Utqiagvik. Photo Credit: NSB Website- Robert Suydam

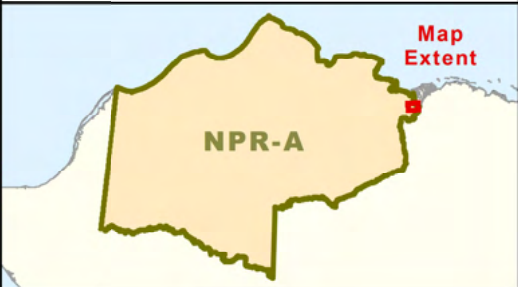
Willow and CM Projects
North Slope Rapid
Assessment Method
 Figure 12
 Overview - Credits

- Wetland Assessment Area (WAA)
Locations
 ● WAA Credit Point
- Compensatory Mitigation Proposed Projects
 ~ Subsistence Trail Rehabilitation
 □ Nuiqsut Culvert Repair
- Infrastructure
 ~ Pipeline ▢ Pad
 ■ Road
- Boundaries
 □ Oil and Gas Unit
 ▢ NPR-A (BLM)

Compensatory mitigation project sites were also evaluated using the NS Assessment Method (Figure 12). As described above, functional gains for compensatory mitigation projects were evaluated based on changes in the FCI prior to and following implementation of the mitigation project based on professional judgment regarding how the mitigation project would affect existing conditions in each WAA.

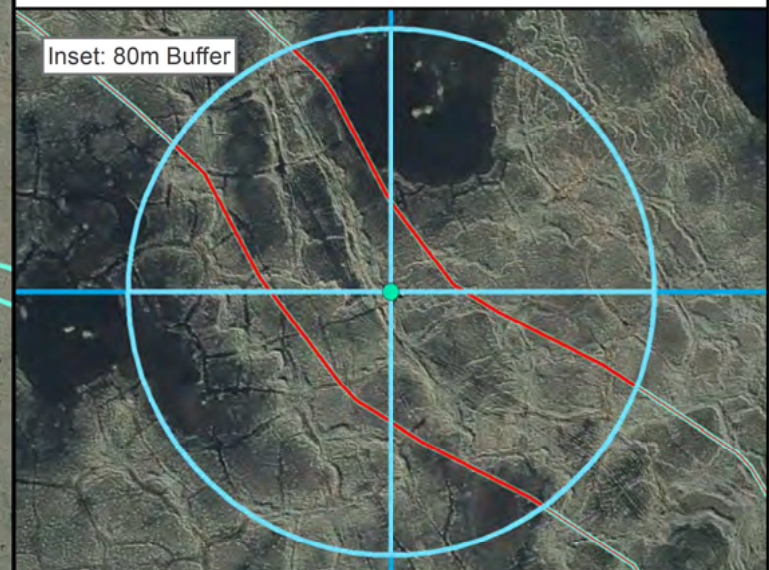
Figure 17

CMWAA1: Nuiqsut Culvert Repair

Representative point CMWAA1 is in a riverine-HGM class area immediately west of one of the culverts that would be repaired by the Culvert Repair mitigation project (Figure 17). The area has existing gravel fill and other anthropogenic disturbance both upstream, downstream, and to either side. Table 3-14 provides the NS Assessment Method variables, subindex scores, and assessment scores for CMWAA1.

At present, CMWAA1 contains 1.4 acres of anthropogenically-derived surface water in the 80-meter-radius plot. In post-condition, anthropogenically-derived surface water would decrease to zero as the culverts would be replaced and brought up to current and appropriate hydraulic design.

In post-condition, repair of the existing culverts would substantially reduce the degree to which existing infrastructure serve as impediments to hydrology. However, because those impediments would still exist, although the degree to which they would impede hydrology would be reduced, there would be no change in the number of impediments to hydrology identified on the NS Assessment Method data forms. No change would occur to local landscape disturbance, evidence of dust, evidence of thermokarst, landscape disturbance, impediments to wildlife, or distance to roadway.
