**APPENDIX F**  
**ANAKTUVUK PASS TRAIL REHABILITATION AQUATIC SITE**  
**ASSESSMENT AND CREDIT-DEBIT CALCULATION**

**WILLOW MASTER DEVELOPMENT PLAN  
POA-2018-00190 HARRISON BAY**

**ANAKTUVUK PASS SUBSISTENCE TRAIL  
REHABILITATION AQUATIC SITE ASSESSMENT  
AND  
CREDIT DEBIT CALCULATION**

**October 2020**

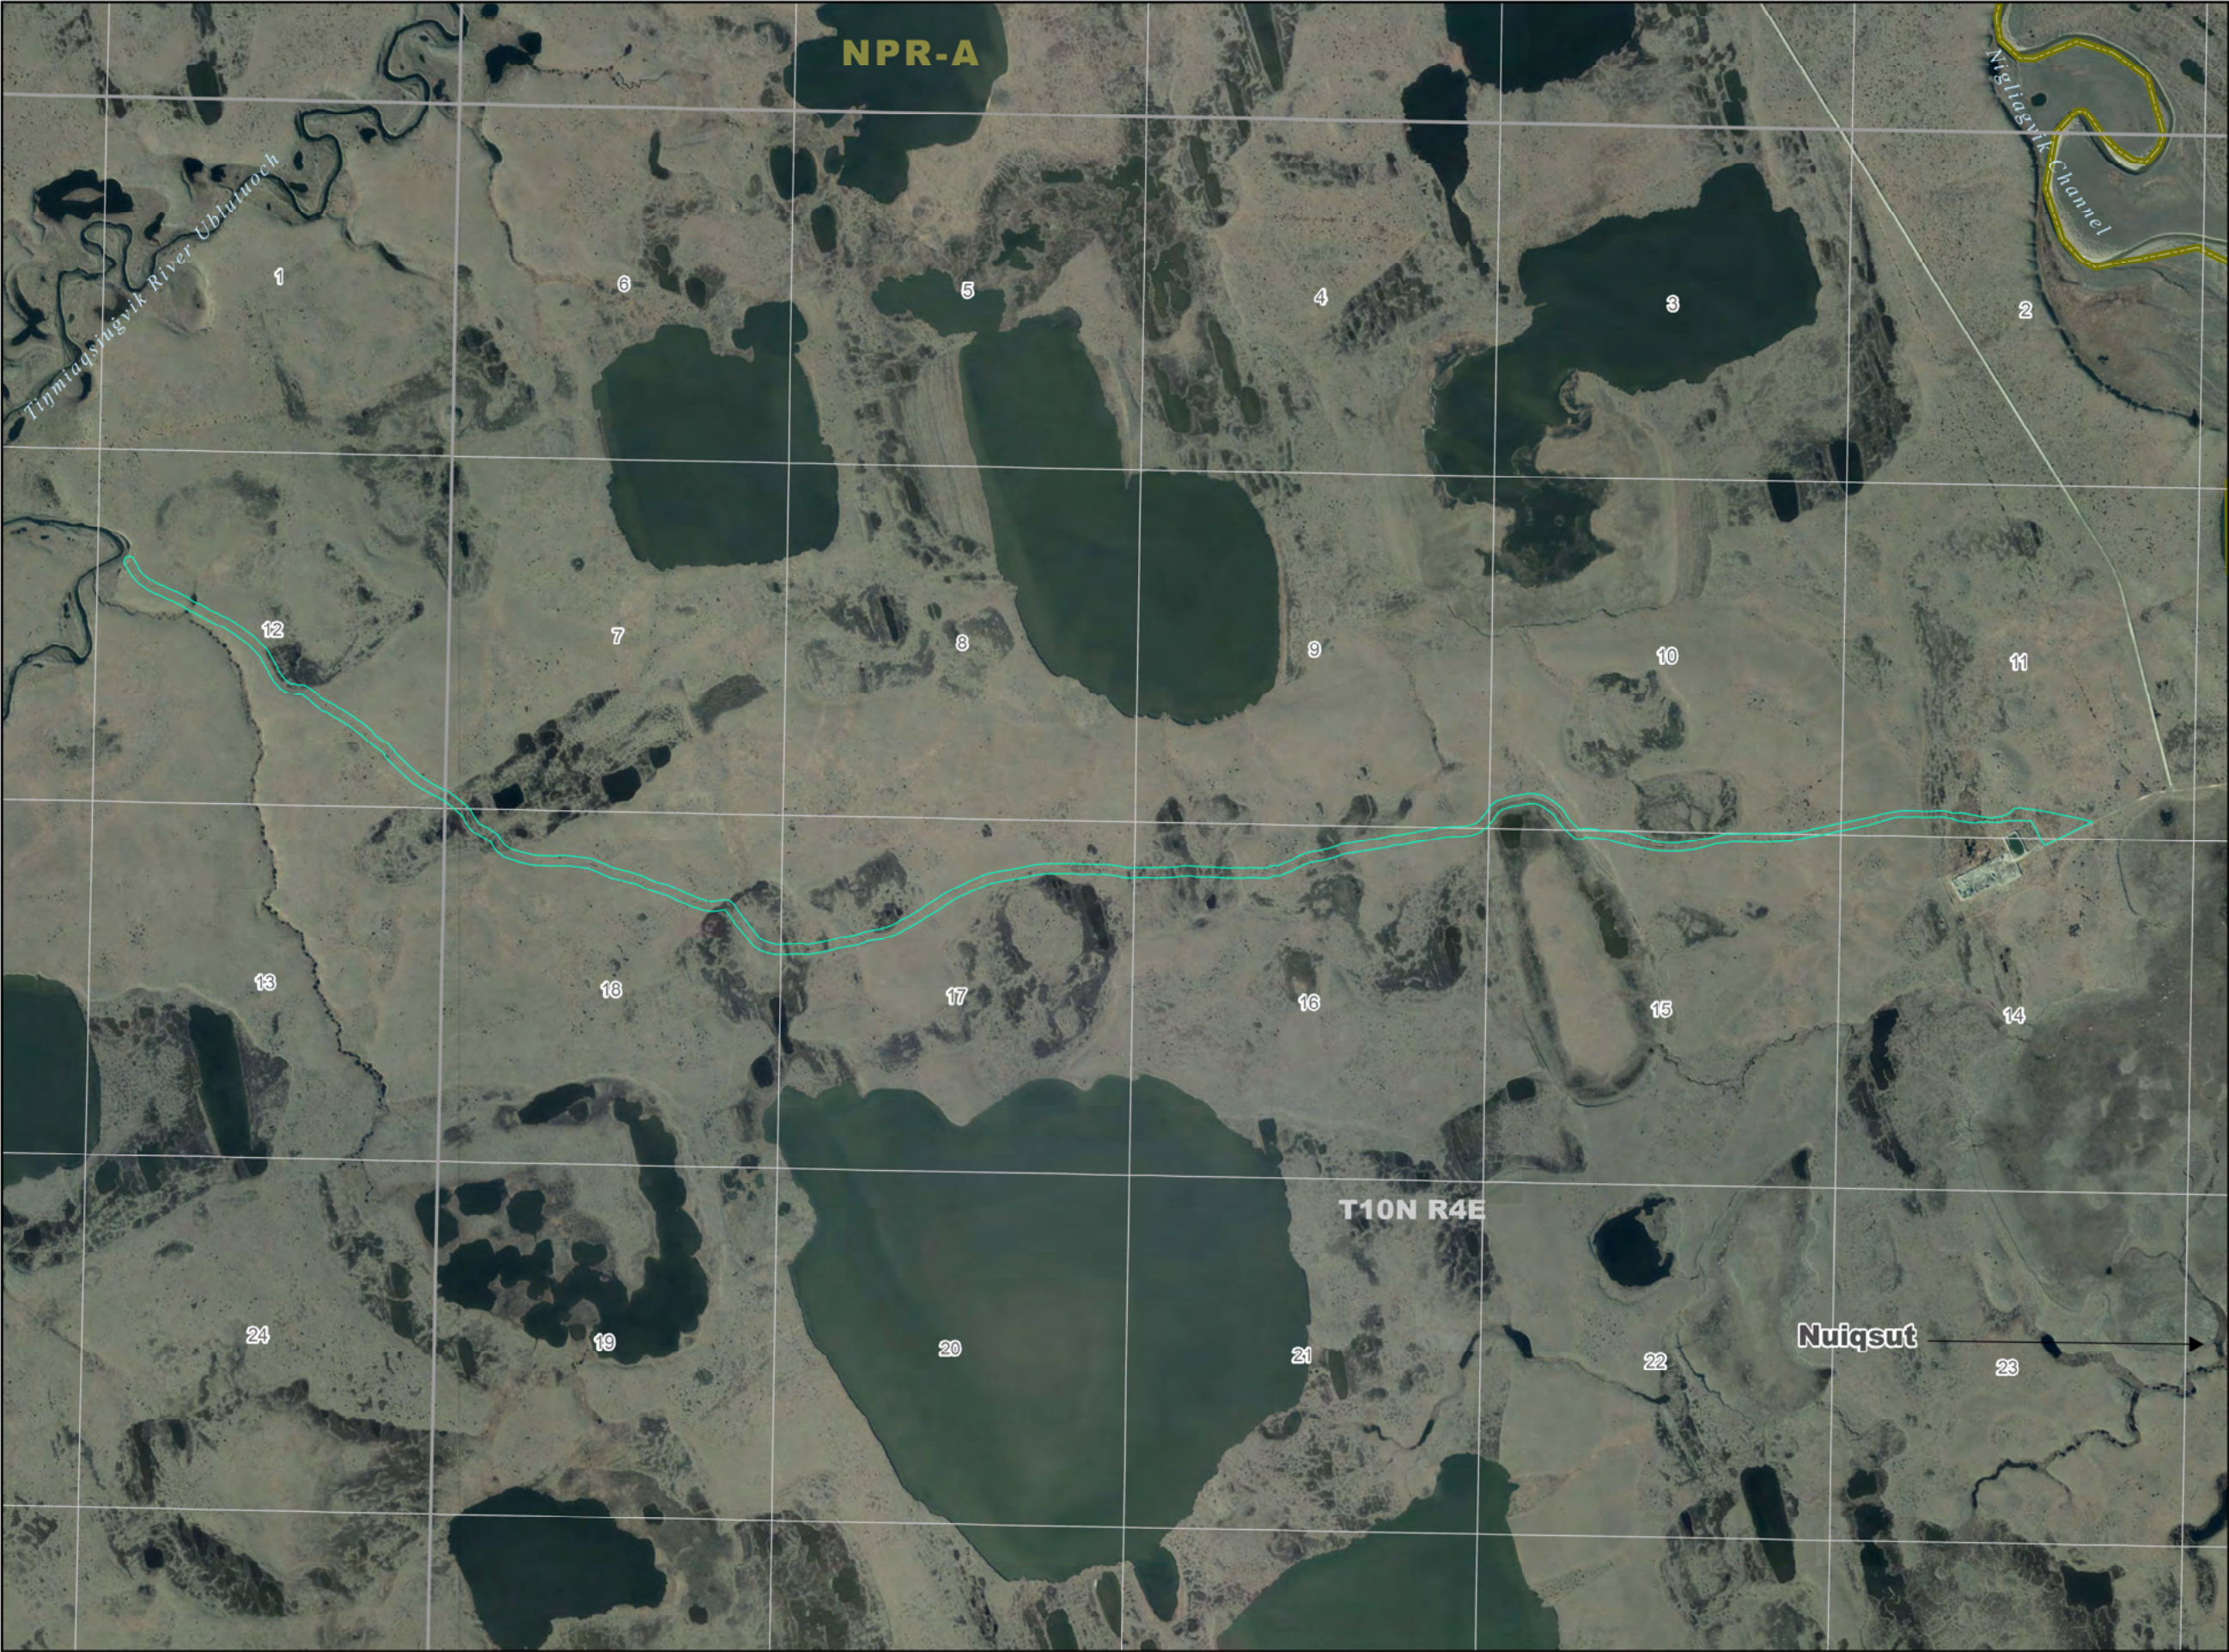
Figure 1  
Site Vicinity

ConocoPhillips Alaska, Inc. (CPAI) is submitting this permittee responsible preservation mitigation monitoring plan (Monitoring Plan) to the United States Army Corps of Engineers (USACE) that describes the monitoring methods, frequency, and reporting format to support the Willow Project (POA-2018-00190 Harrison Bay) Wetlands Compensatory Mitigation Plan (Mitigation Plan) dated October 2020. CPAI plans to enhance wetlands near Nuiqsut and Anaktuvuk Pass, Alaska by upgrading two subsistence trails that have become damaged due to all-terrain vehicle (ATV) use in order to access subsistence areas. The trail upgrades will involve placement of a geogrid trail over the damaged tundra in order to provide a stable surface to access subsistence locations. The projects are referred to as the Nuiqsut Subsistence Trail Tundra Rehabilitation (Nuiqsut Trail) and Anaktuvuk Pass Subsistence Trail Tundra Rehabilitation (Anaktuvuk Pass Trail) projects. The two projects will enhance 109.0 acres near Nuiqsut and 100.1 acres in Anaktuvuk Pass. Both compensatory mitigation projects will partially offset debits incurred by constructing the Willow Project. A project site and vicinity map for the Nuiqsut Trail project and Anaktuvuk Pass Trail project are shown on Figures 1 and 2, respectively, in Appendix A.

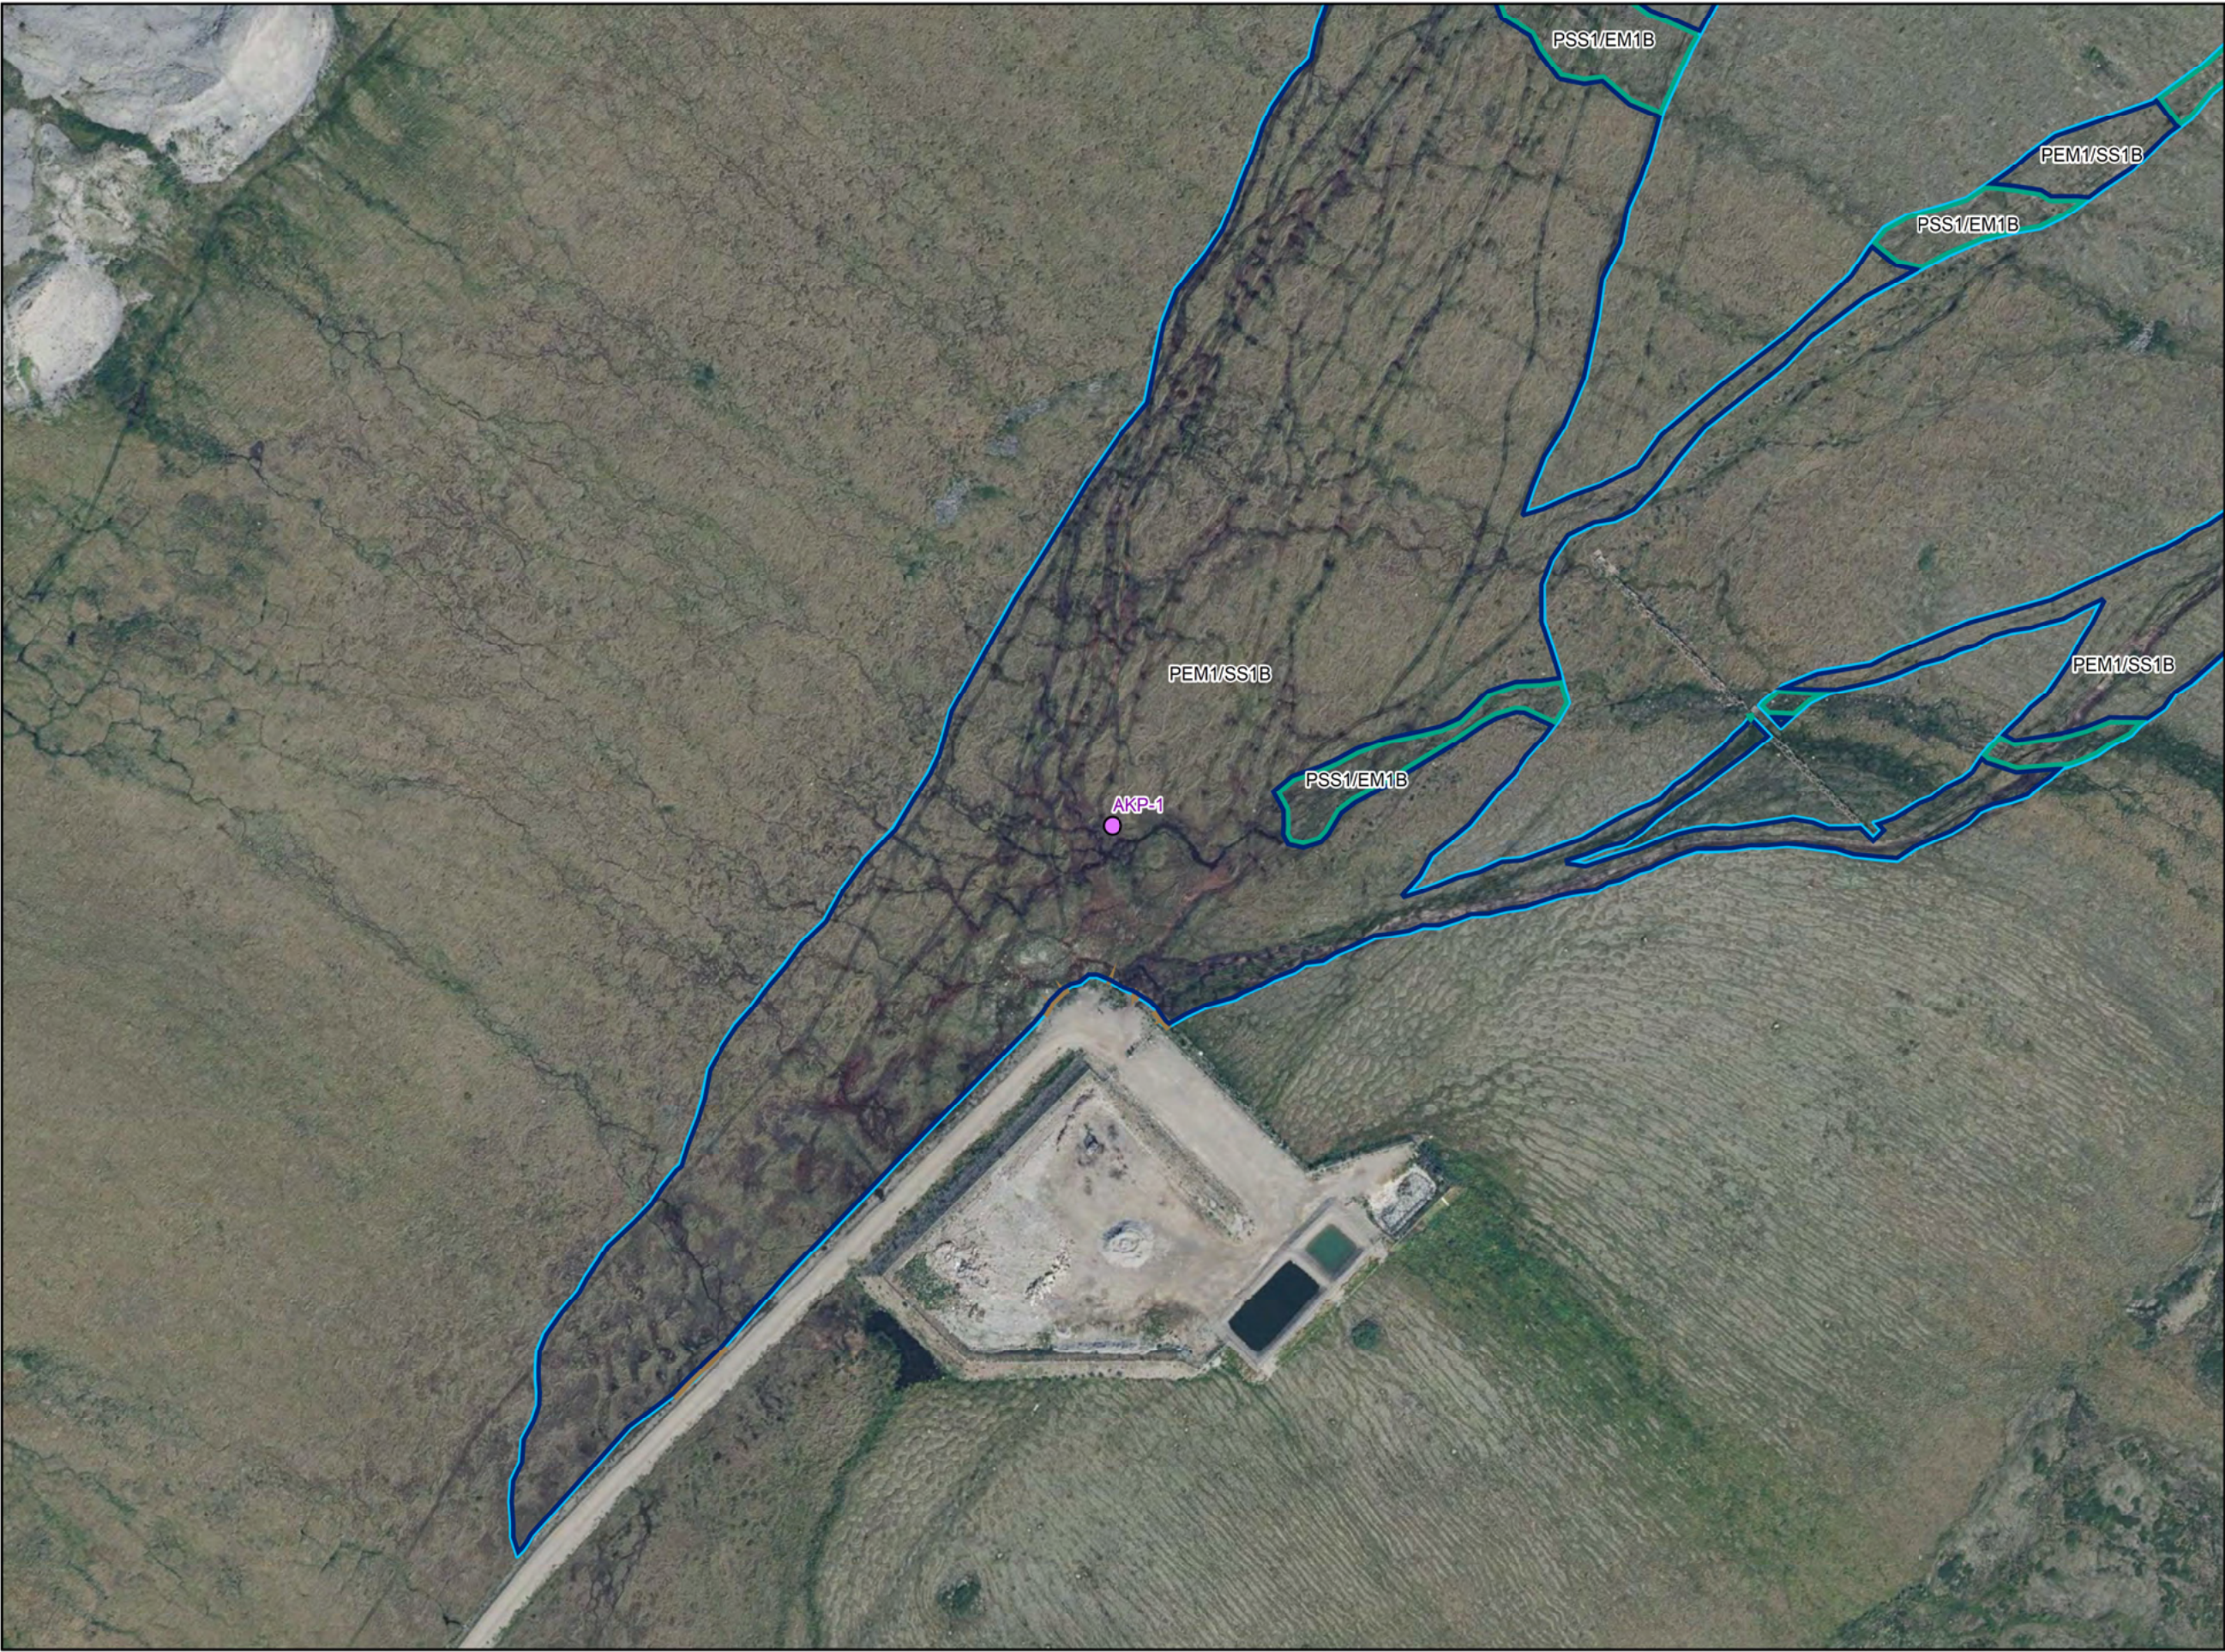
Figure 10  
Field Target: AKP-1

- Confirm wetlands desktop mapping is accurate by performing a wetlands delineation at each field target according to the USACE 1987 Manual and 2007 Regional Supplement.
- Document general trail condition and vegetation damage.
- Record the dominant vegetation species present.
- Document soil and surface hydrology conditions.
- Document adjacent tundra use and condition.
