**BLM-Alaska Open File Report 96**  
BLM/AK/ST-009+7200+930  
December 2003

## **Water Resources of the Colville River Special Area, National Petroleum Reserve-Alaska**

By Jon Kostohrys, Kristine Kosnik, and Ethan Scott

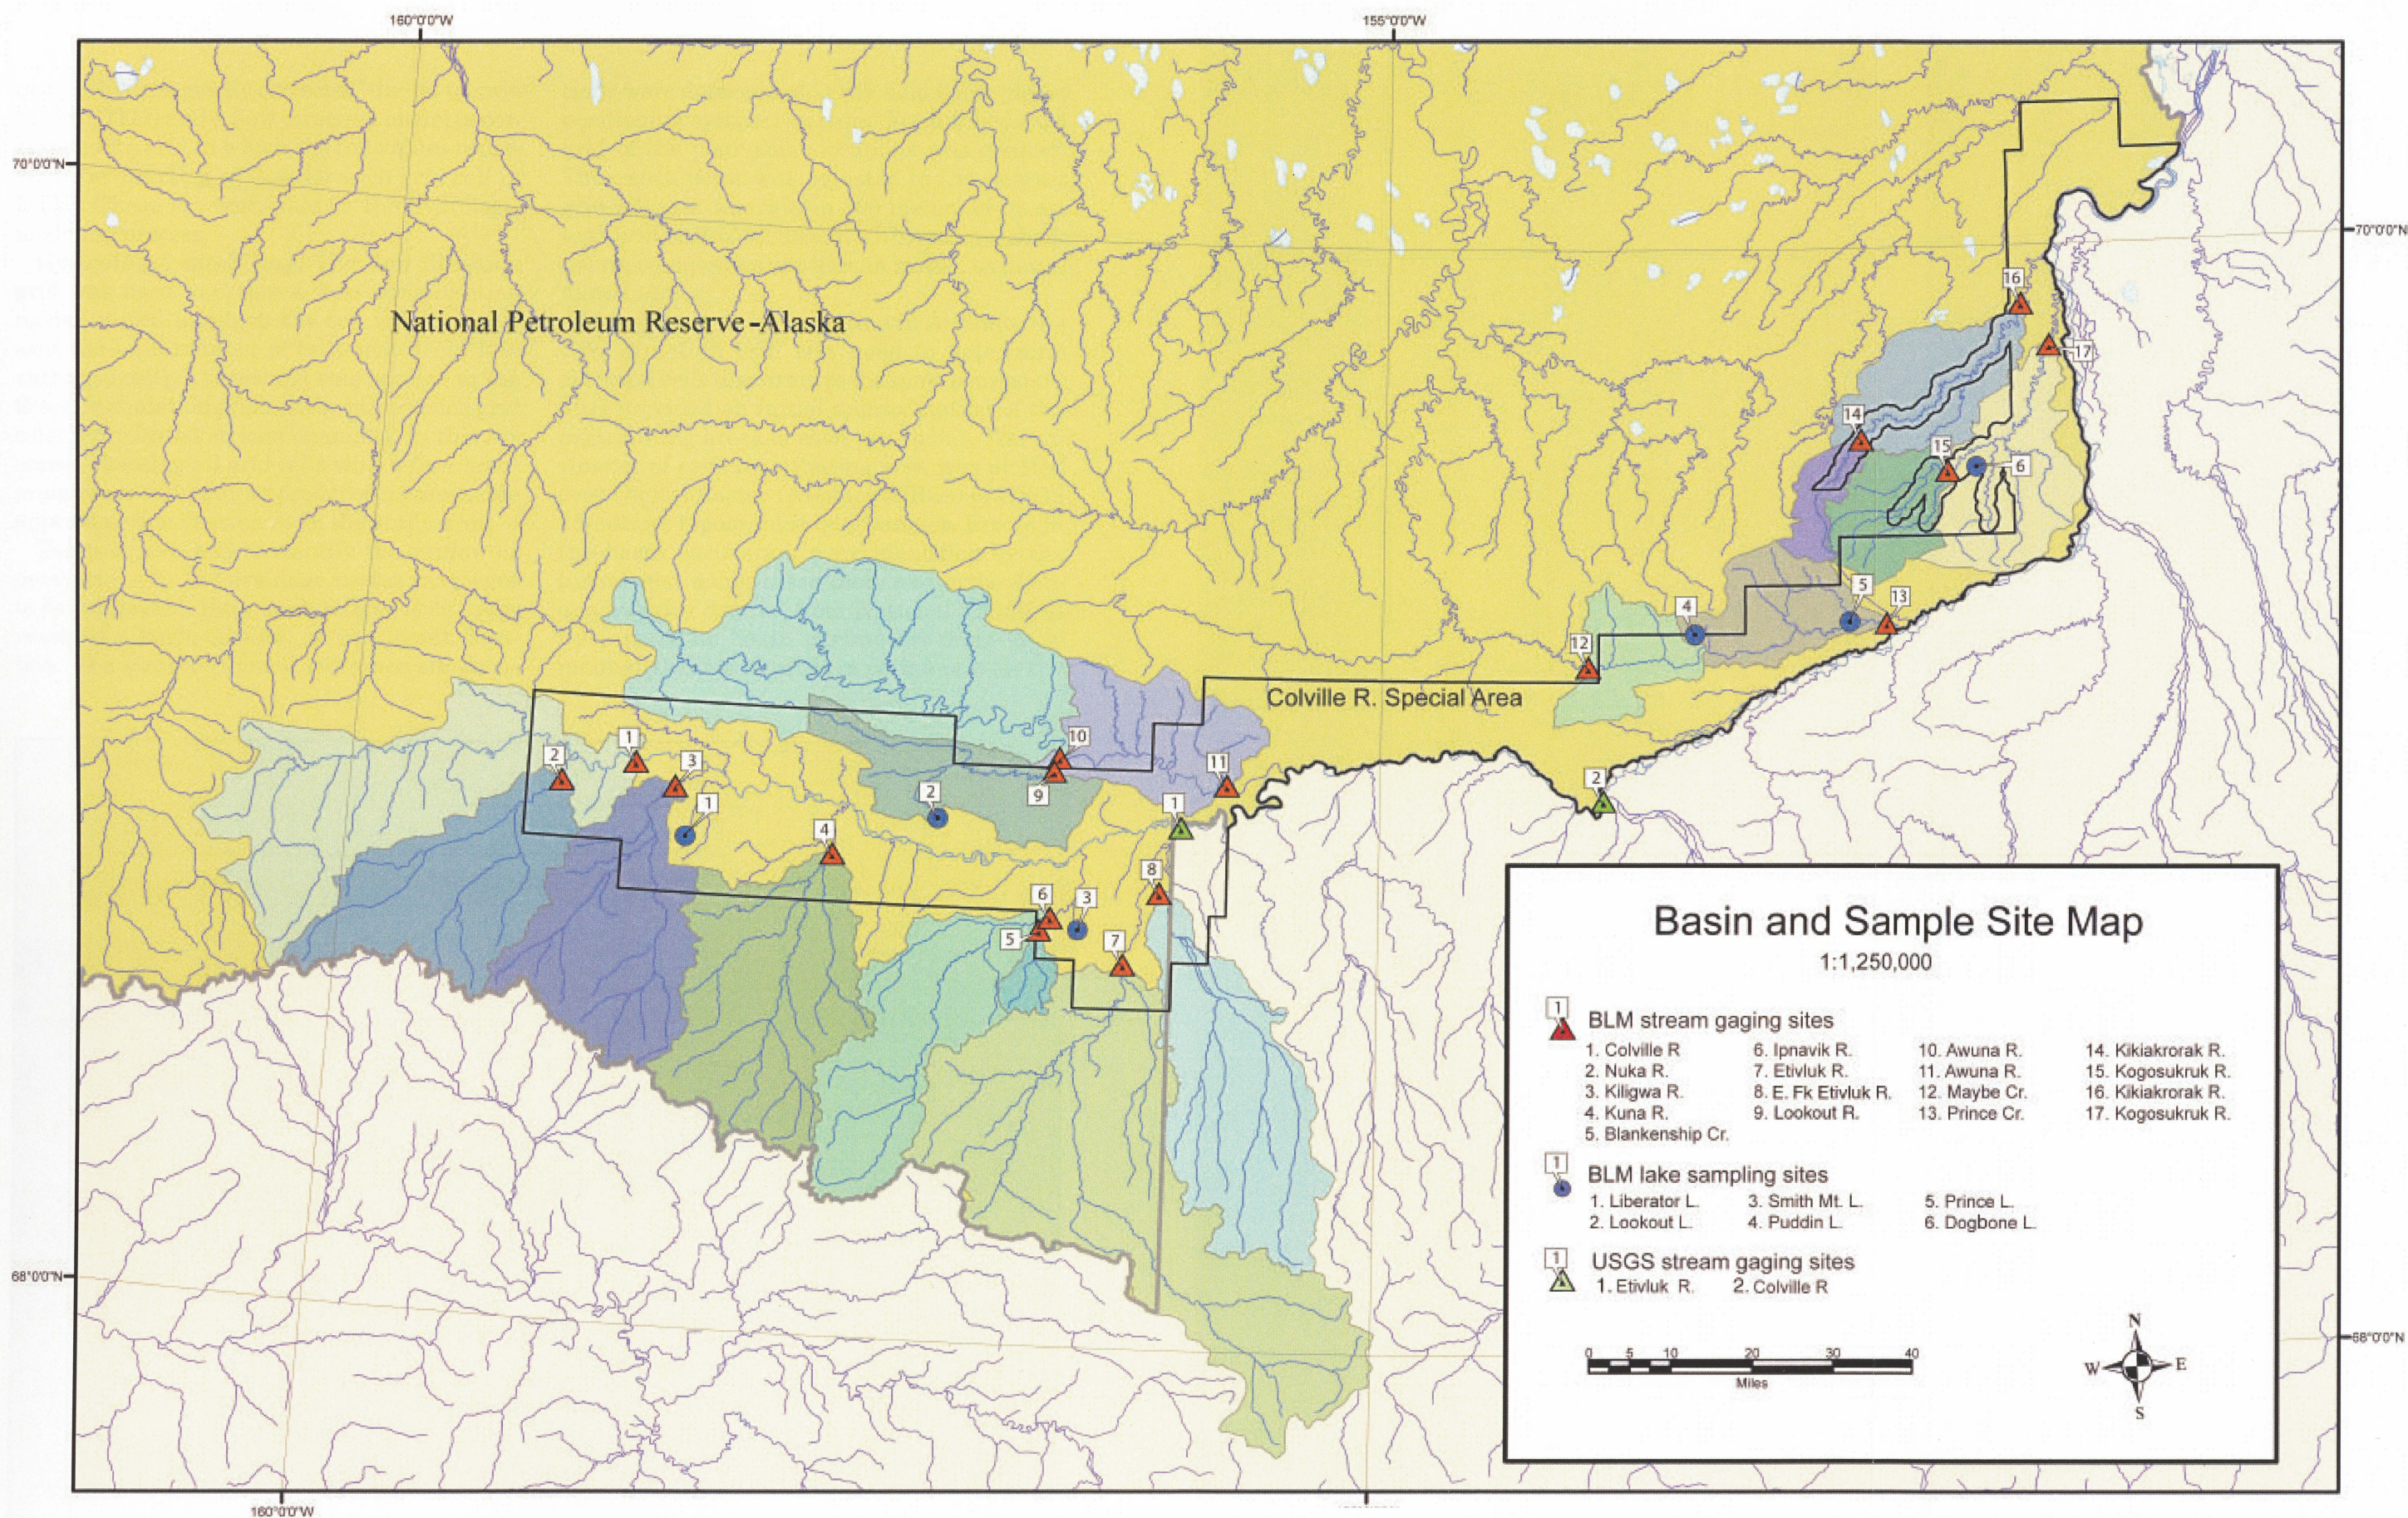
Figure 2. A hydrologic basin map showing sampling sites in the Colville River Special Area generated from GIS analysis.

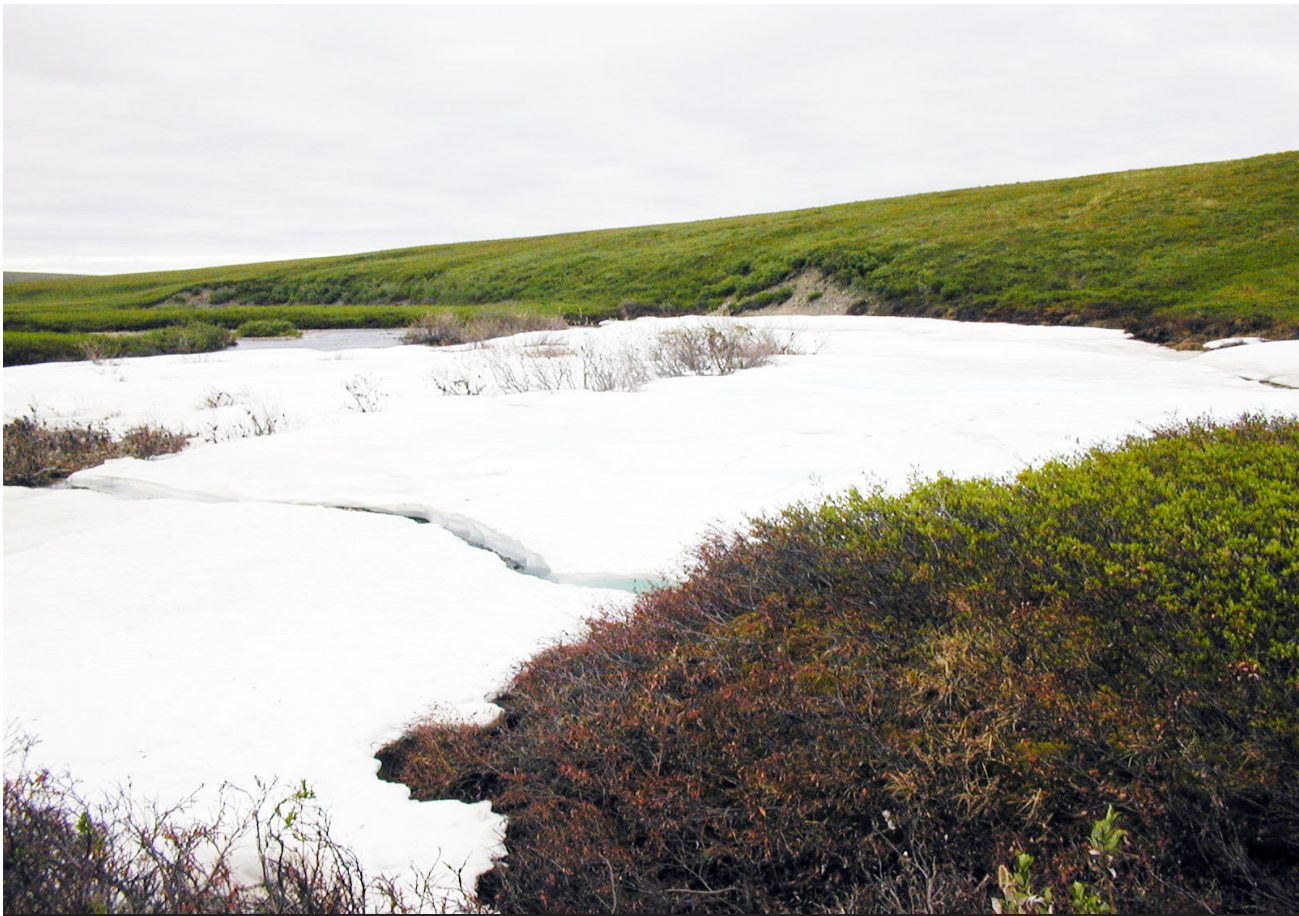
*Figure 6. Blankenship Creek, with the presence of a large overflow icing (aufeis), indicates a ground water source.*

limits ground water infiltration, so that the waters are almost totally derived from snowmelt runoff (Sloan 1987). The notable exception is Blankenship Creek (Figure 6) where the presence of a large overflow icing (aufeis) in July, low water temperature, and relatively high specific conductance indicates a year-round, continuously flowing groundwater spring. Sloan (1987) noted that icings invariably form downstream from springs due to the extremely low winter temperatures on the North Slope. A similar aufeis field was observed on a tributary stream in the headwaters of the East Fork of the Etivluk River, just outside of the NPR-A.

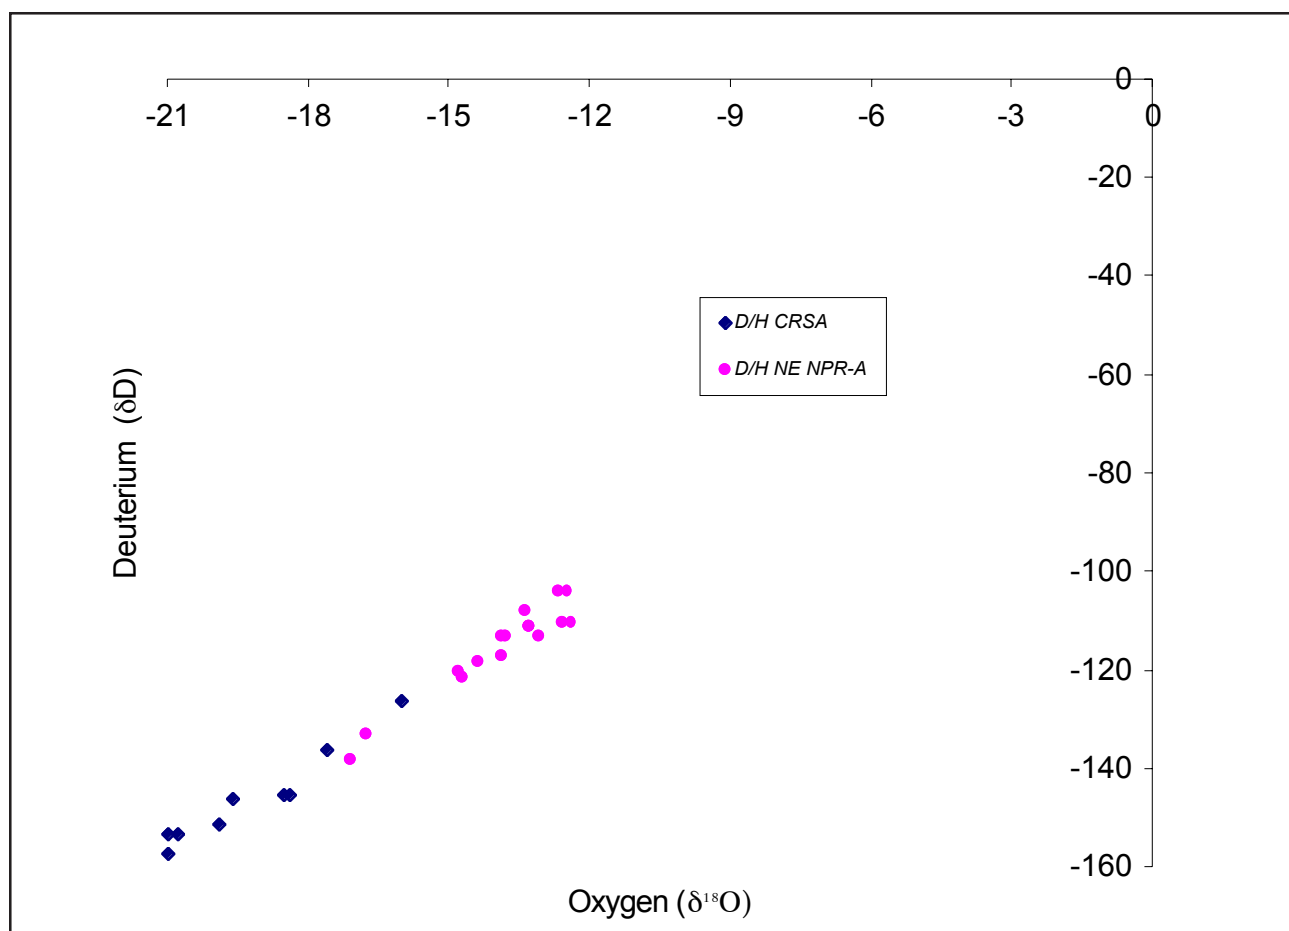
**Figure 7.** Plot of Colville River Special Area and NE NPR-A water samples analyzed for oxygen and hydrogen isotopes.

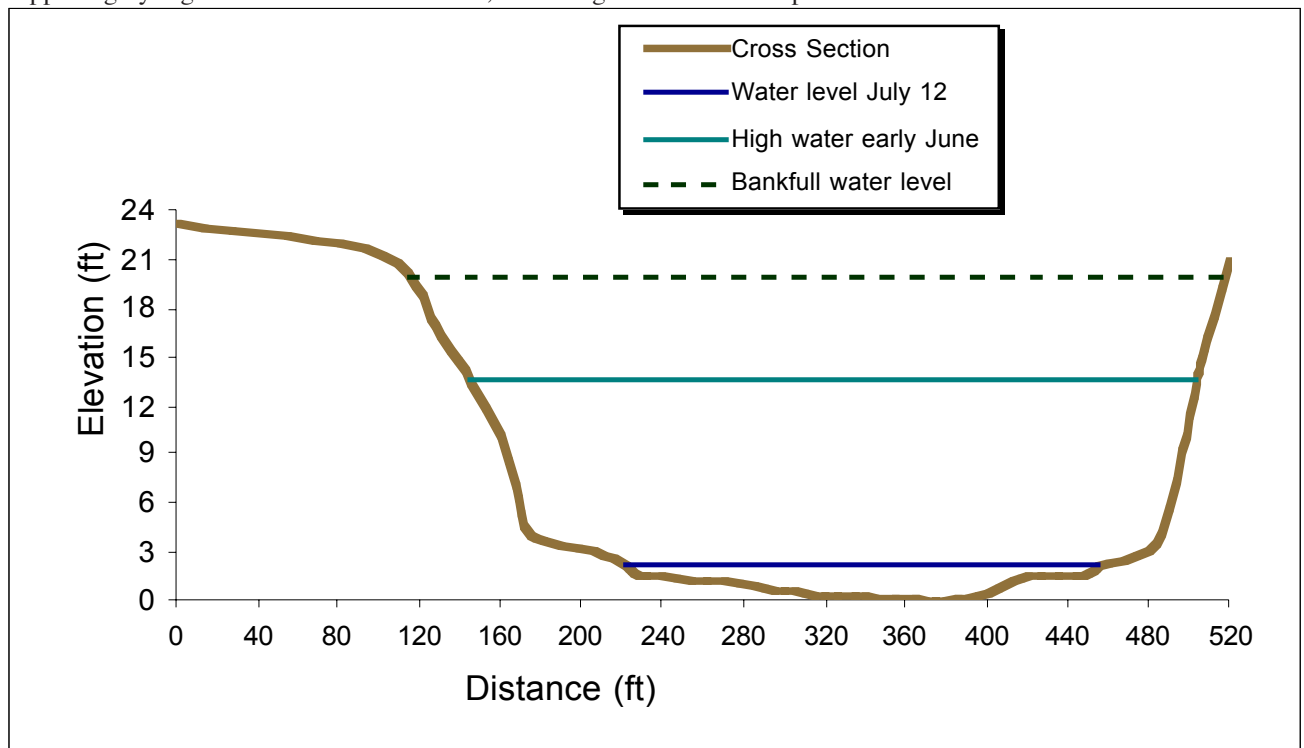
**Figure A-9.** Channel cross section for the Colville River above the Kiligwa River.

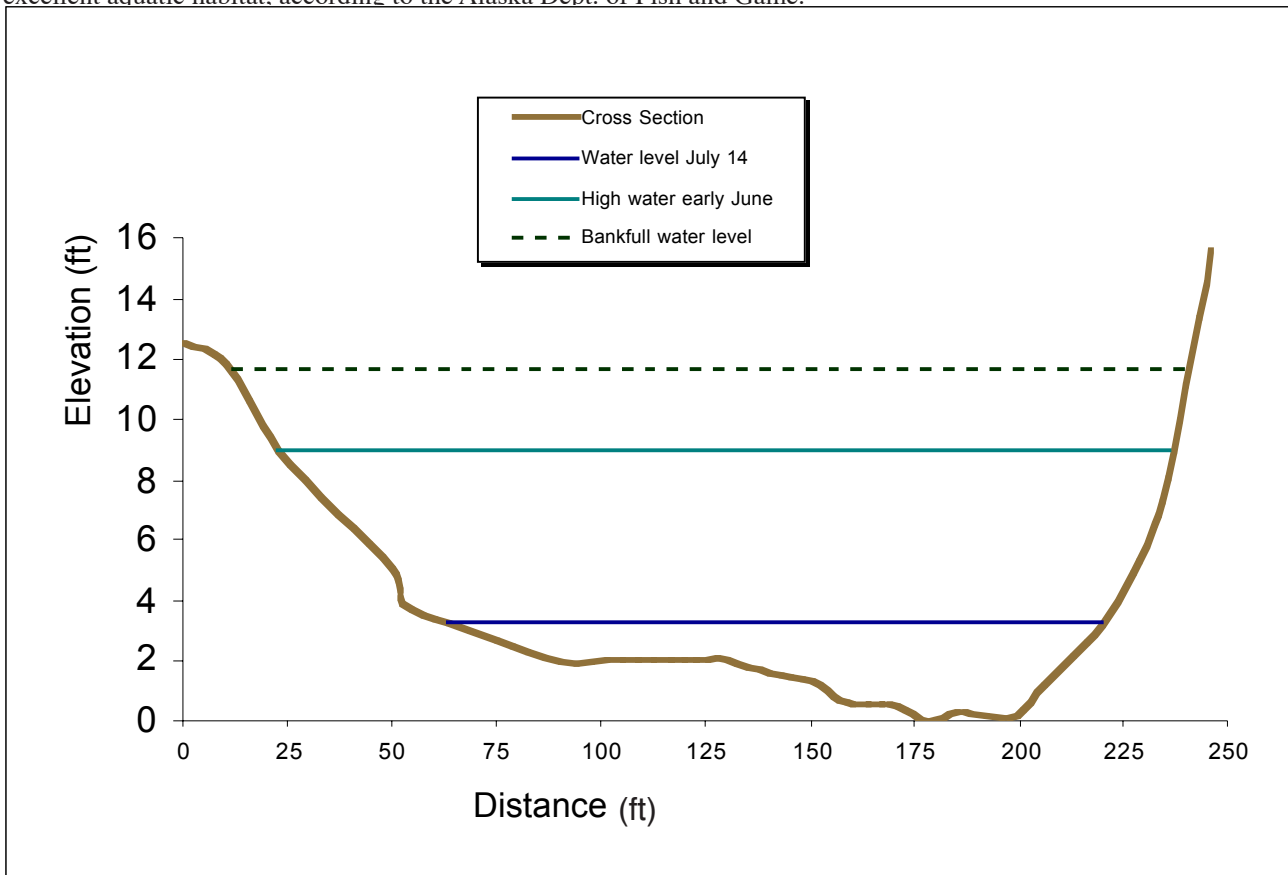
**Figure A-11.** Channel cross section for the Nuka River.

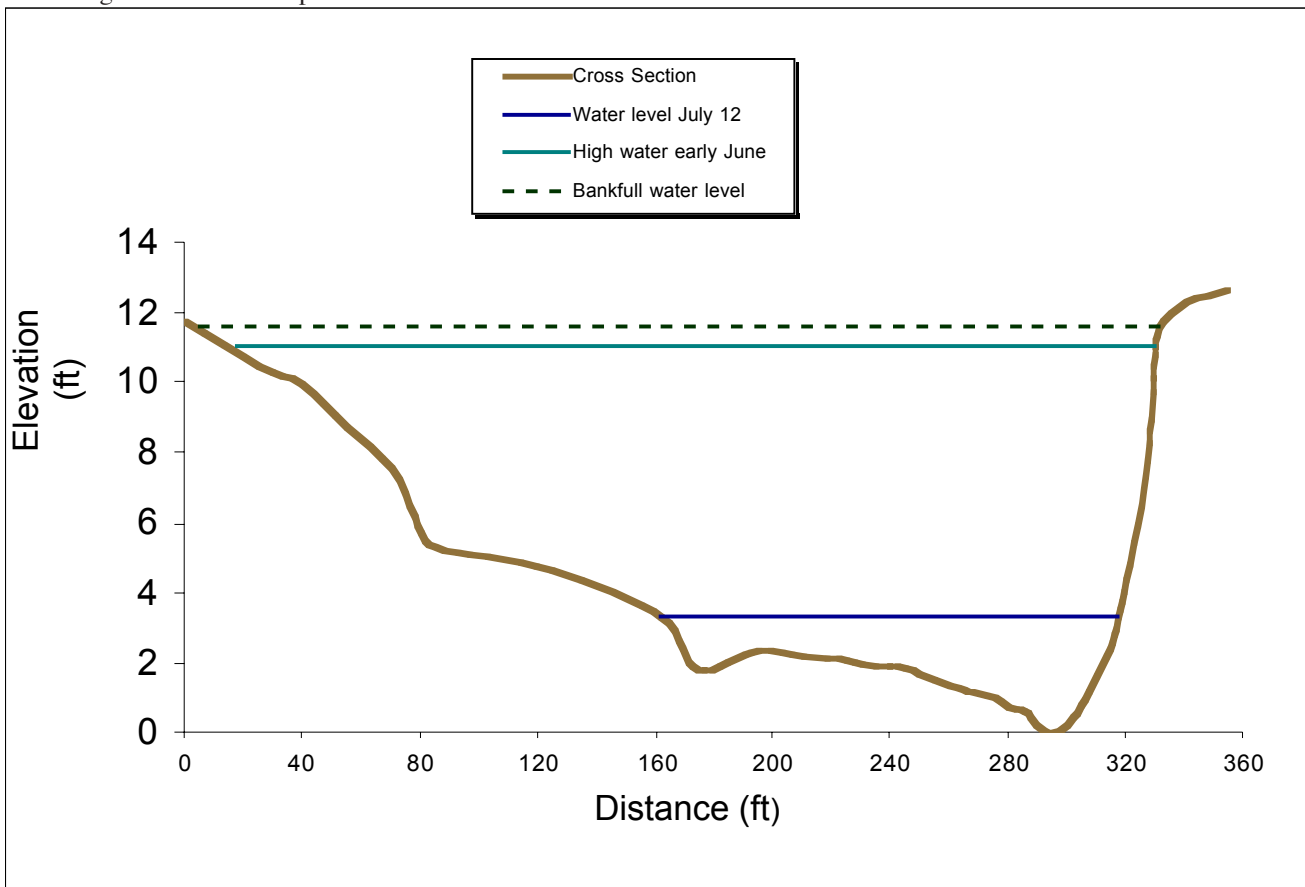
**Figure A-13.** Channel cross section for the Kiligwa River.

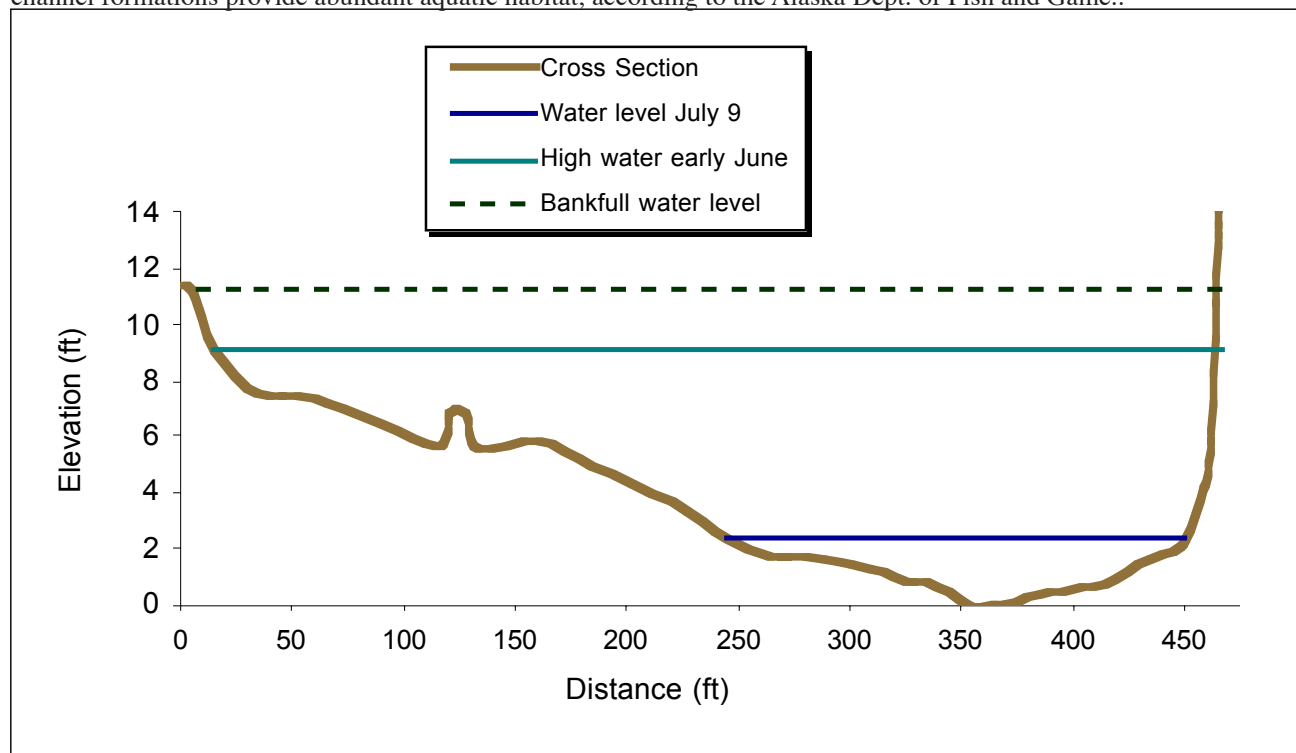
**Figure A-15.** Channel cross section for the Kuna River.

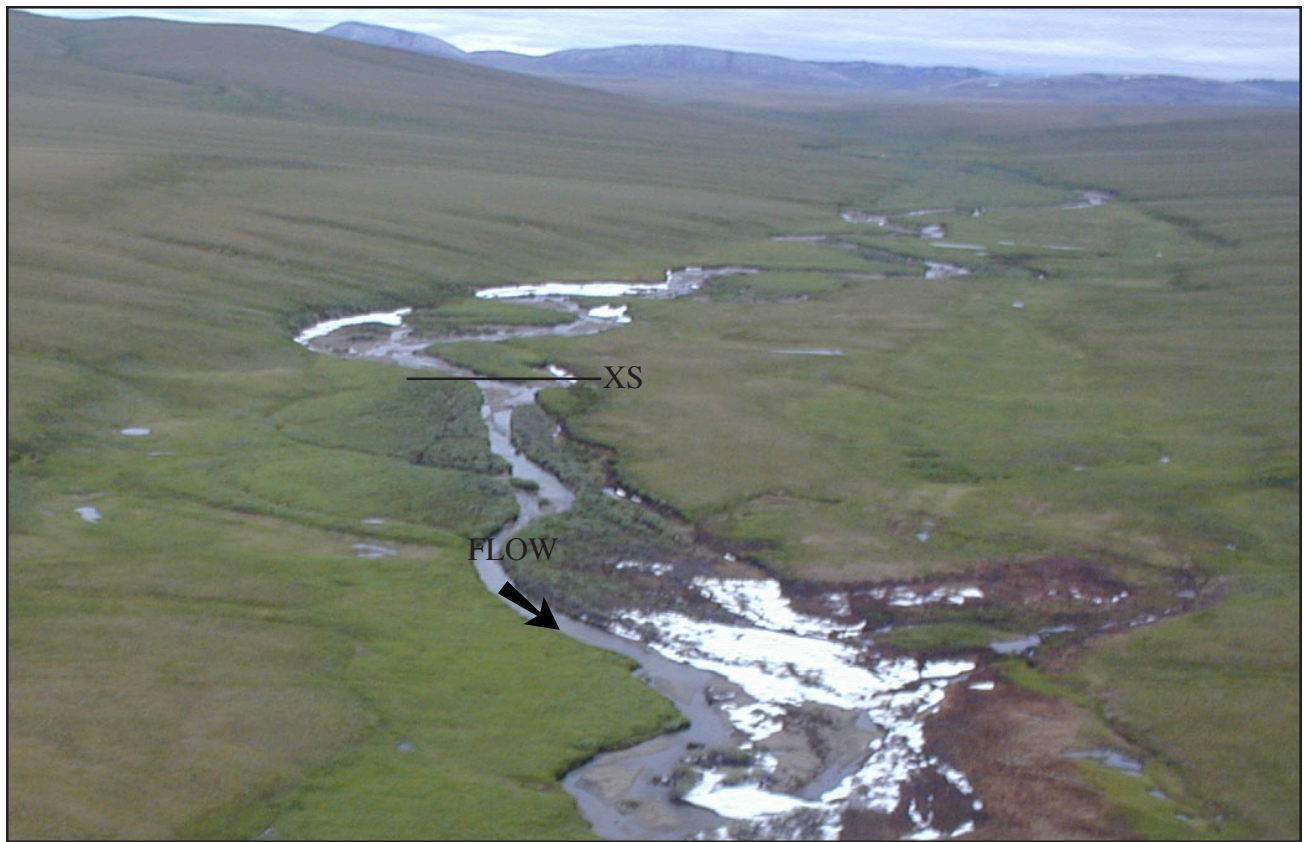
**Figure A-16.** Channel cross section for Blankenship Creek. The remnant ice fields indicate a groundwater spring system in the basin.

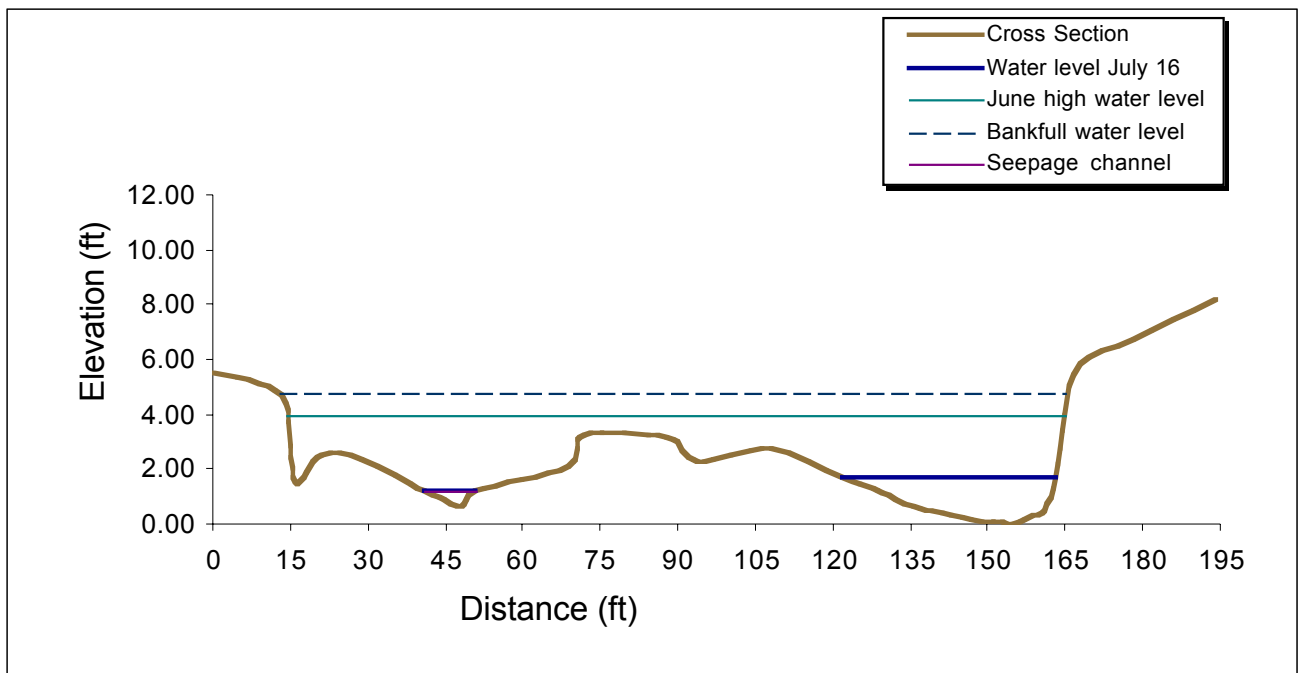
**Figure A-17.** Cross section of Blankenship Creek.

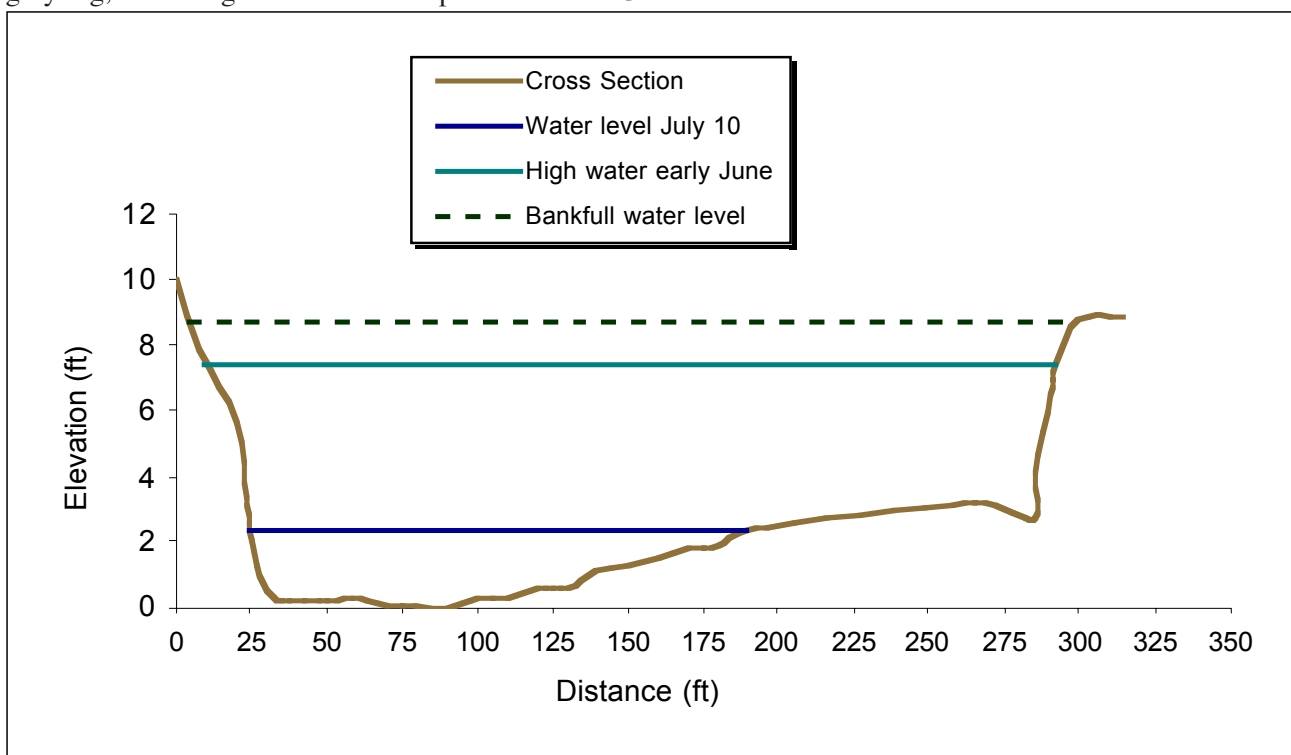
**Figure A-19.** Channel cross section for the Ipnarik River.

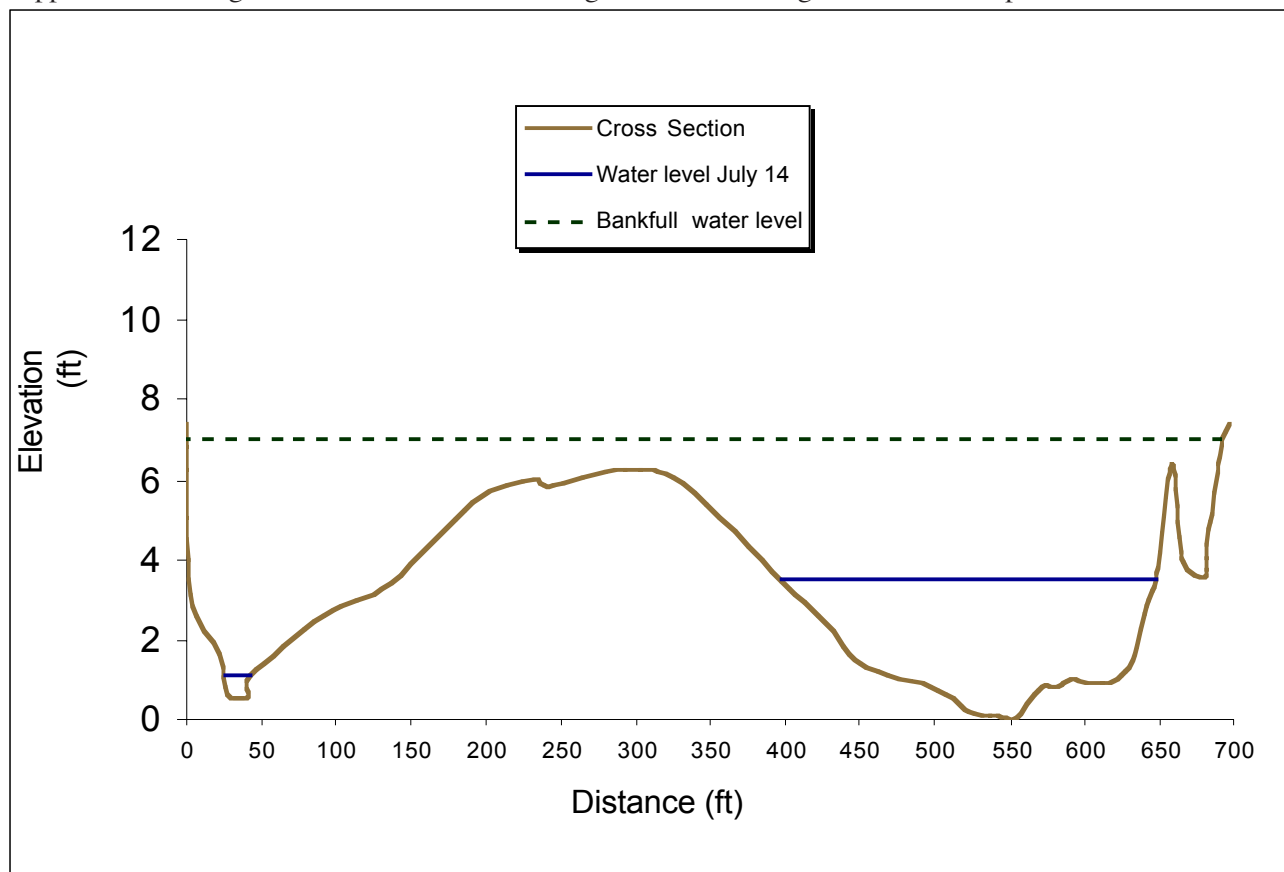
**Figure A-21.** Channel cross section for the East Fork Etivluk River.

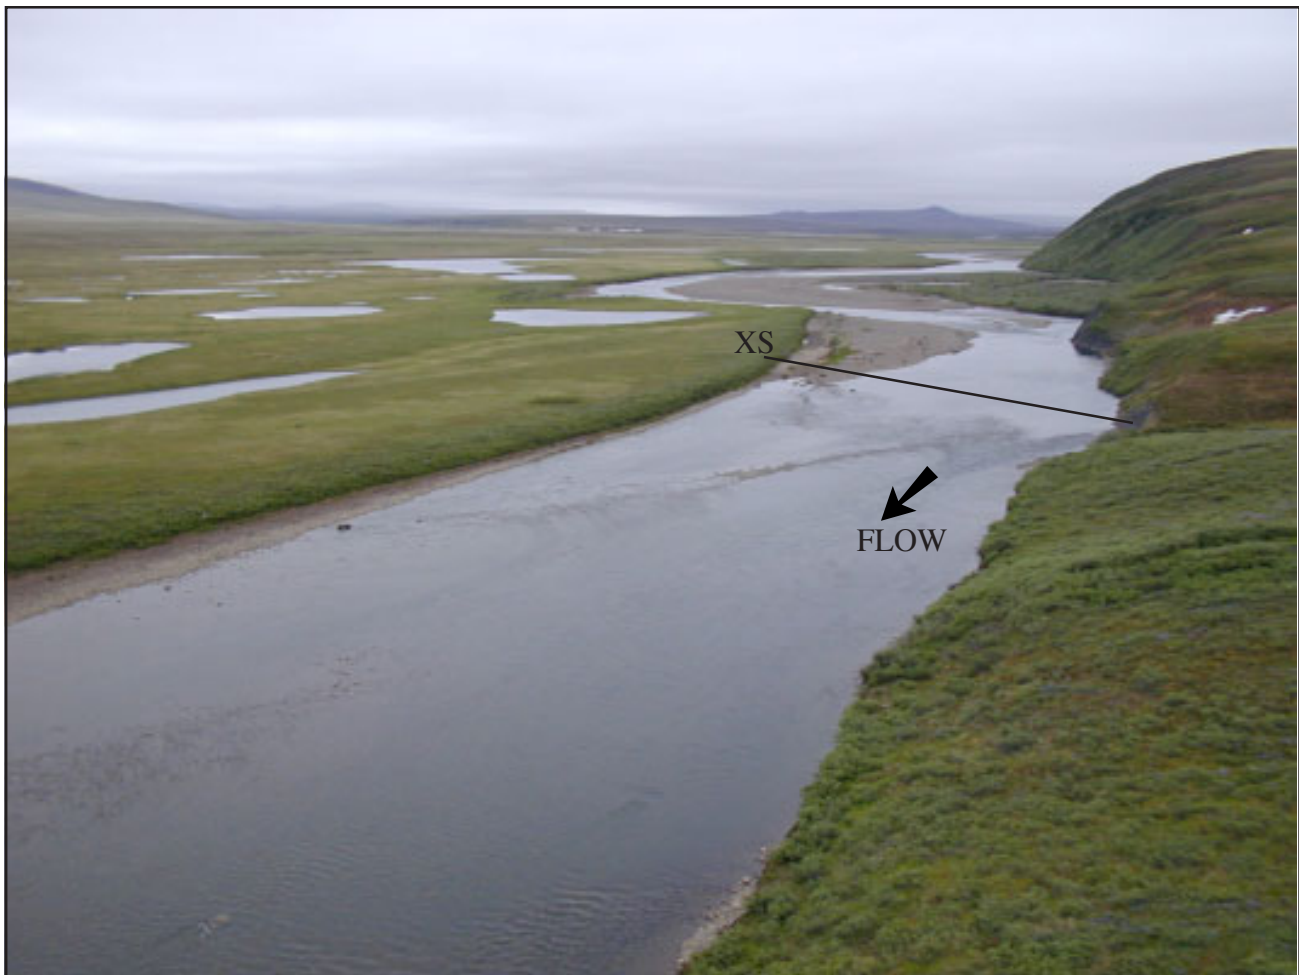
**Figure A-22.** Looking upstream at the survey site on the Etivluk River. The Etivluk is a braided stream for most of its course.

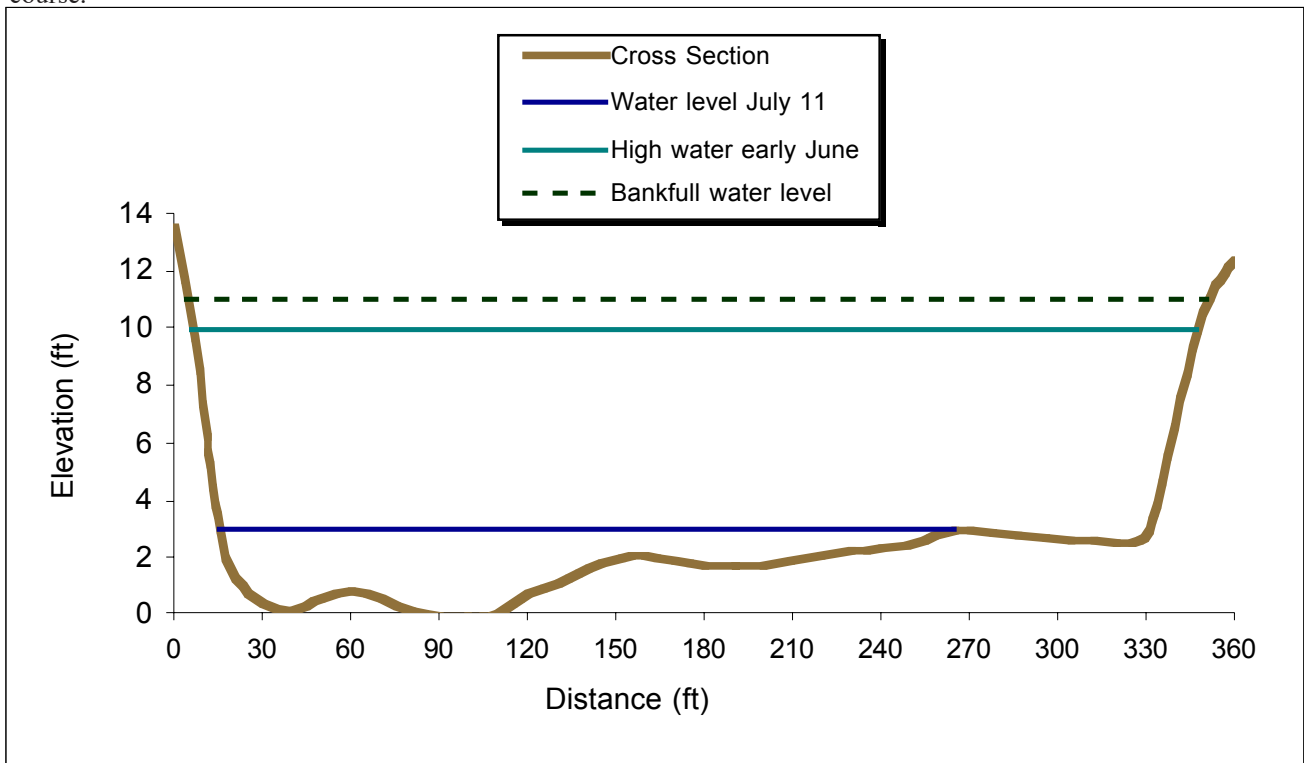
**Figure A-23.** Channel cross section for the Etivluk River above East Fork.

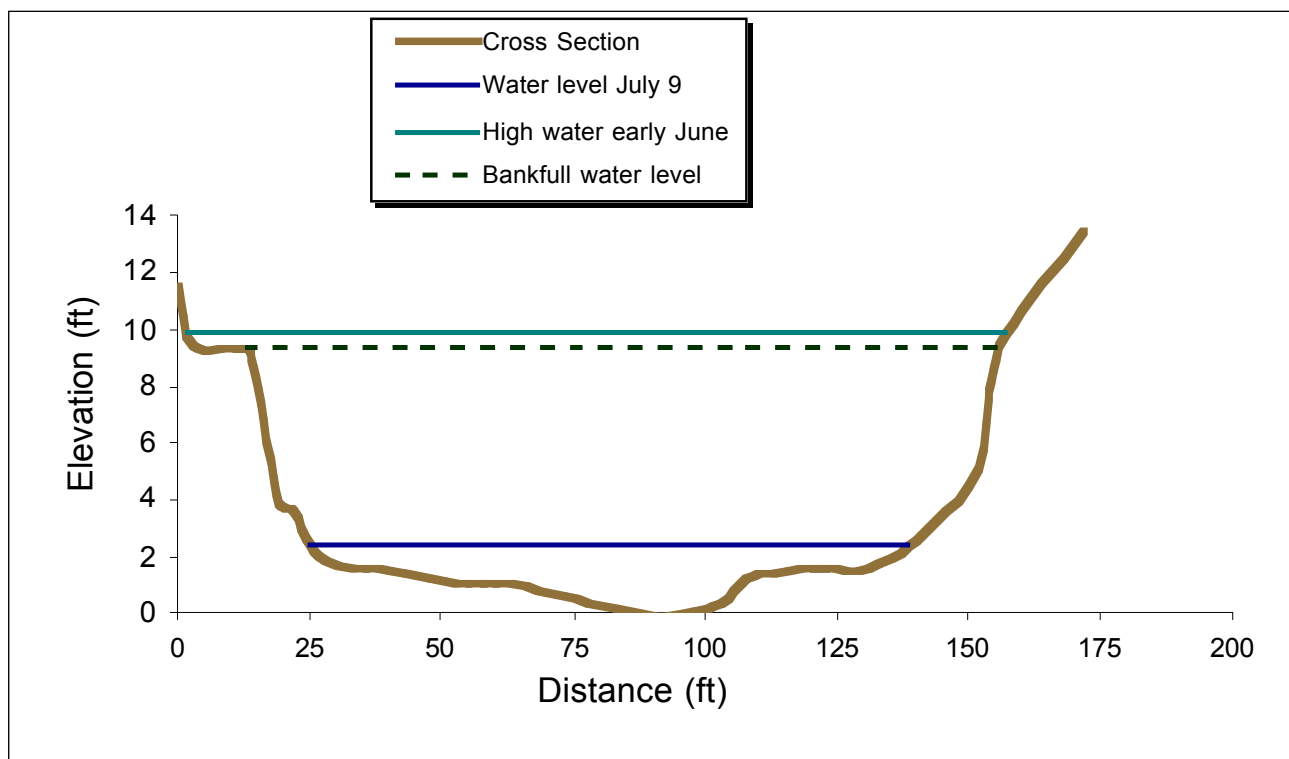
**Figure A-25.** Channel cross section for the Lookout River.

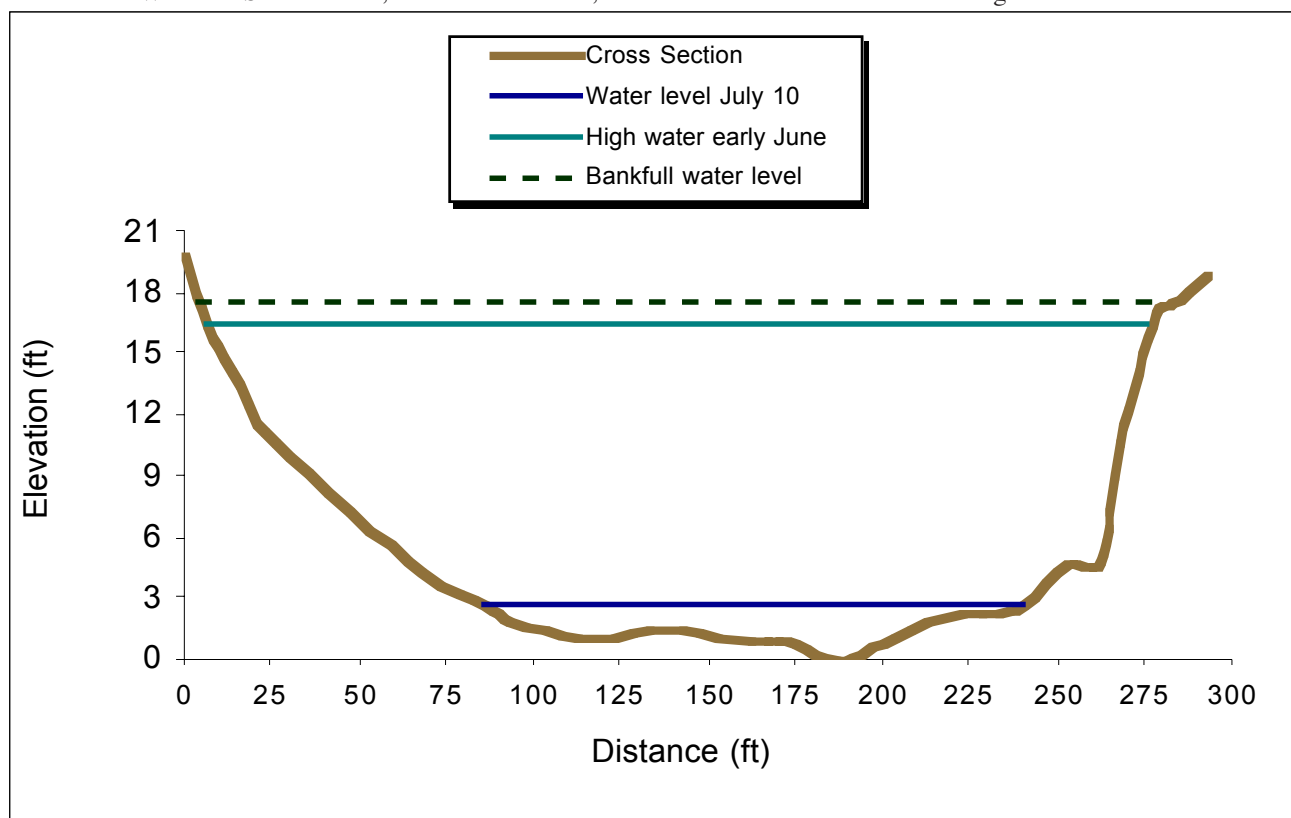
**Figure A-27.** Channel cross section for the Awuna River above the Lookout River.

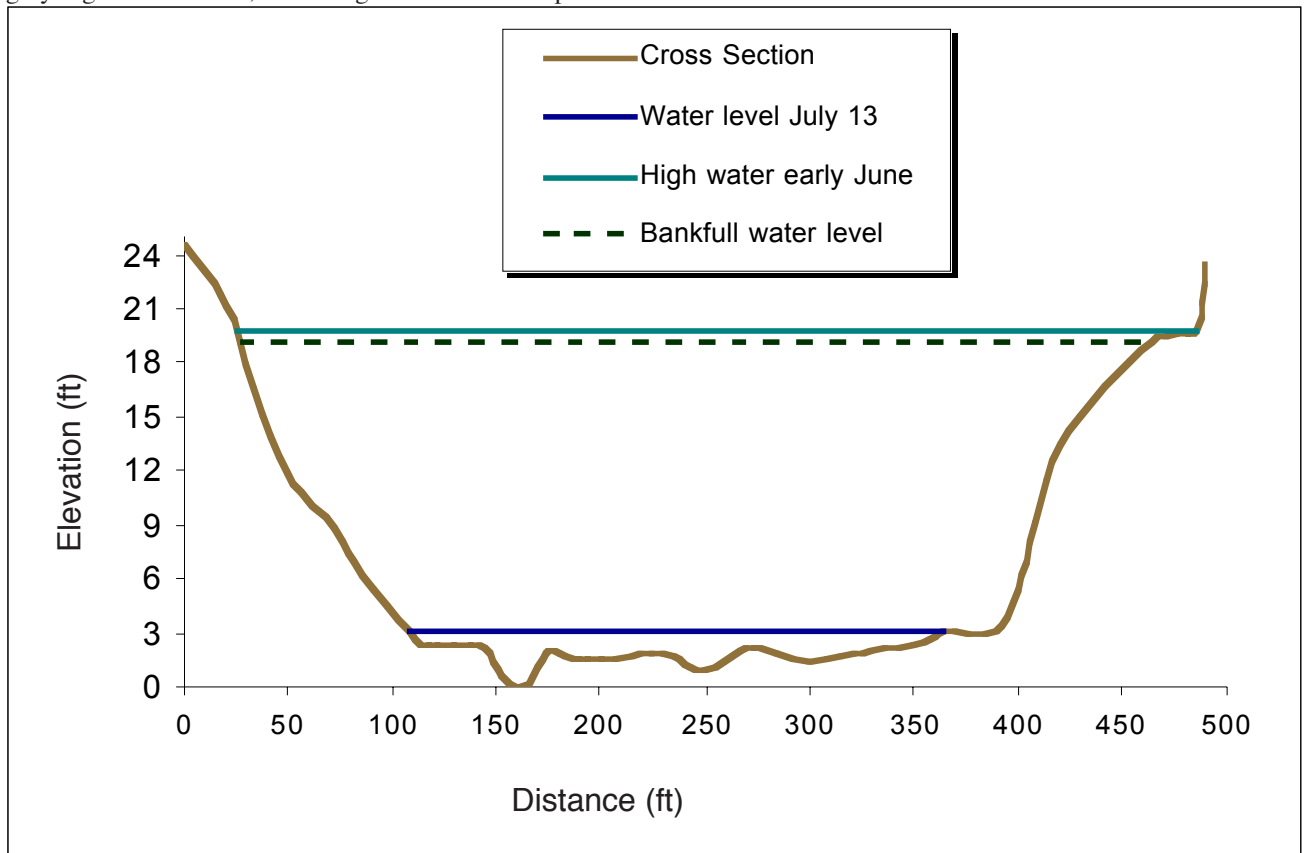
**Figure A-29.** Channel cross section for the Awuna River near the mouth.

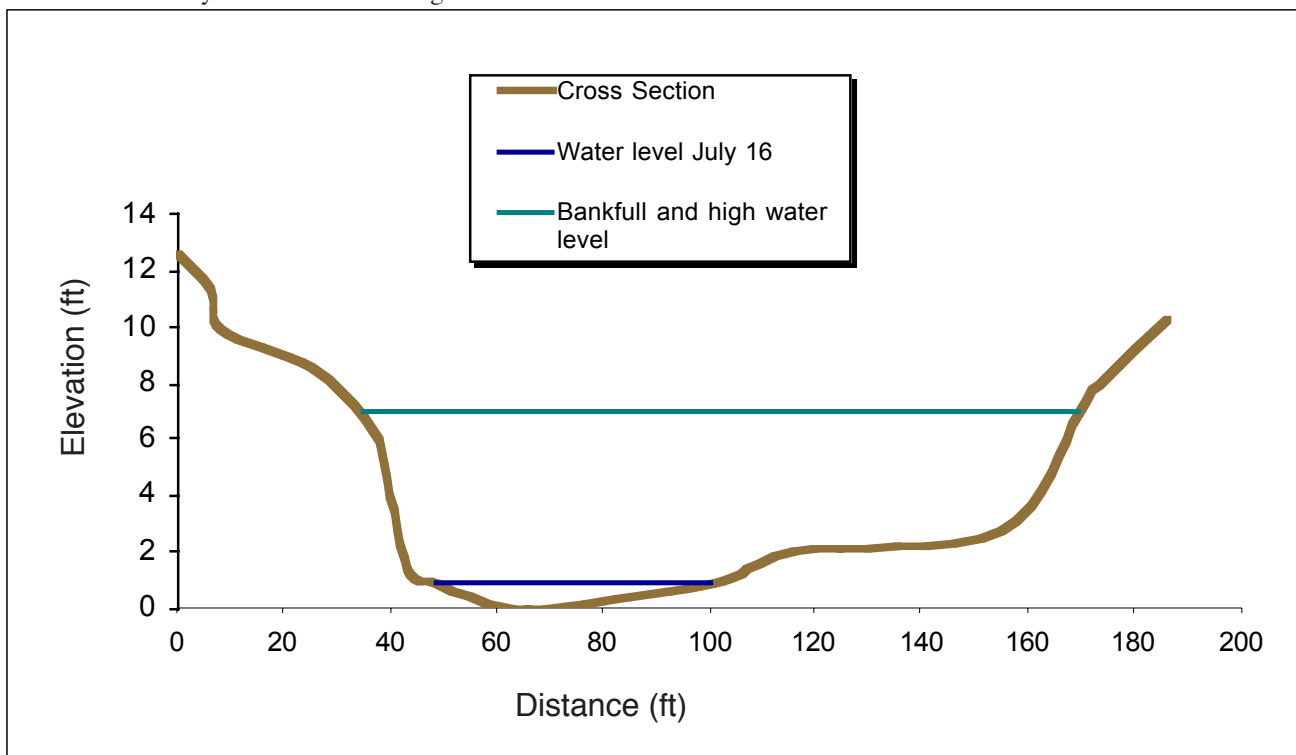
**Figure A-31.** Channel cross section for Maybe Creek.

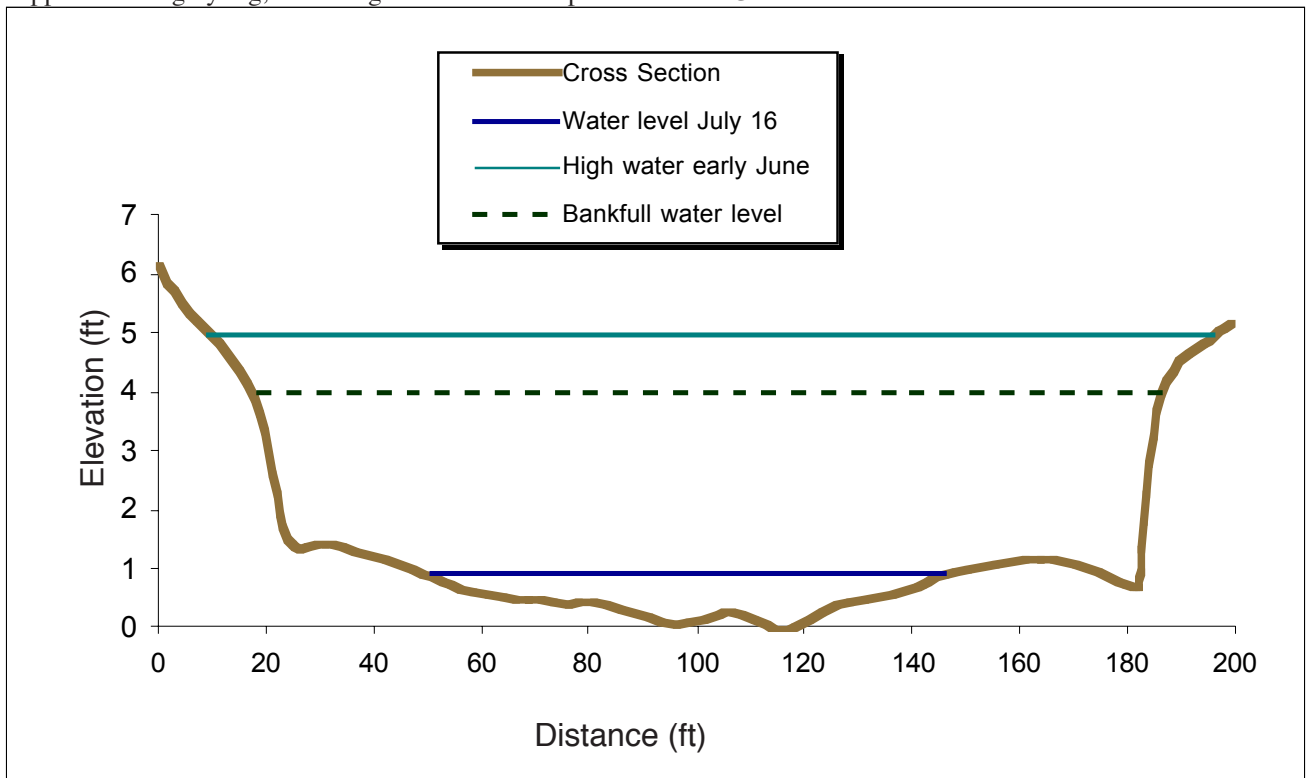
**Figure A-33.** Channel cross section for Prince Creek.
