**BLM-Alaska Open File Report 96**  
BLM/AK/ST-009+7200+930  
December 2003

## **Water Resources of the Colville River Special Area, National Petroleum Reserve-Alaska**

By Jon Kostohrys, Kristine Kosnik, and Ethan Scott

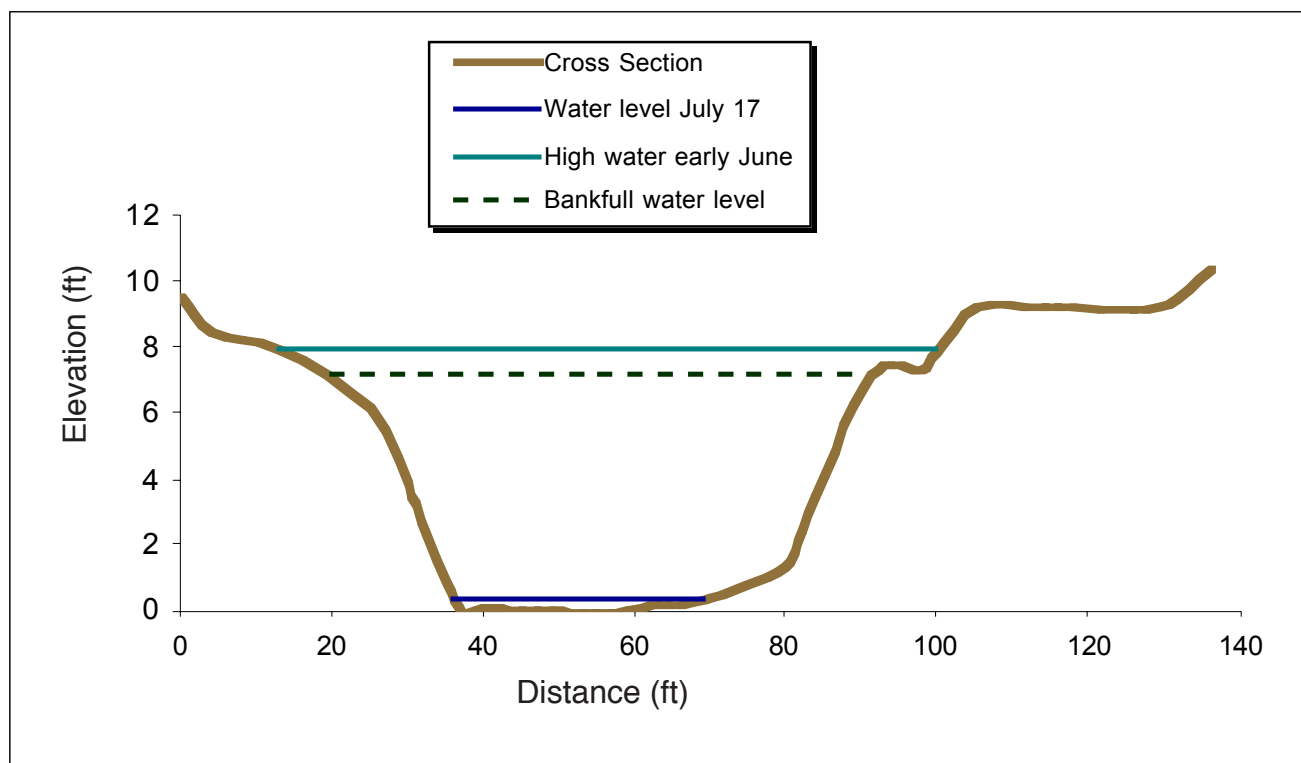
**Figure A-35.** Channel cross section for the upper Kikiakrorak River.

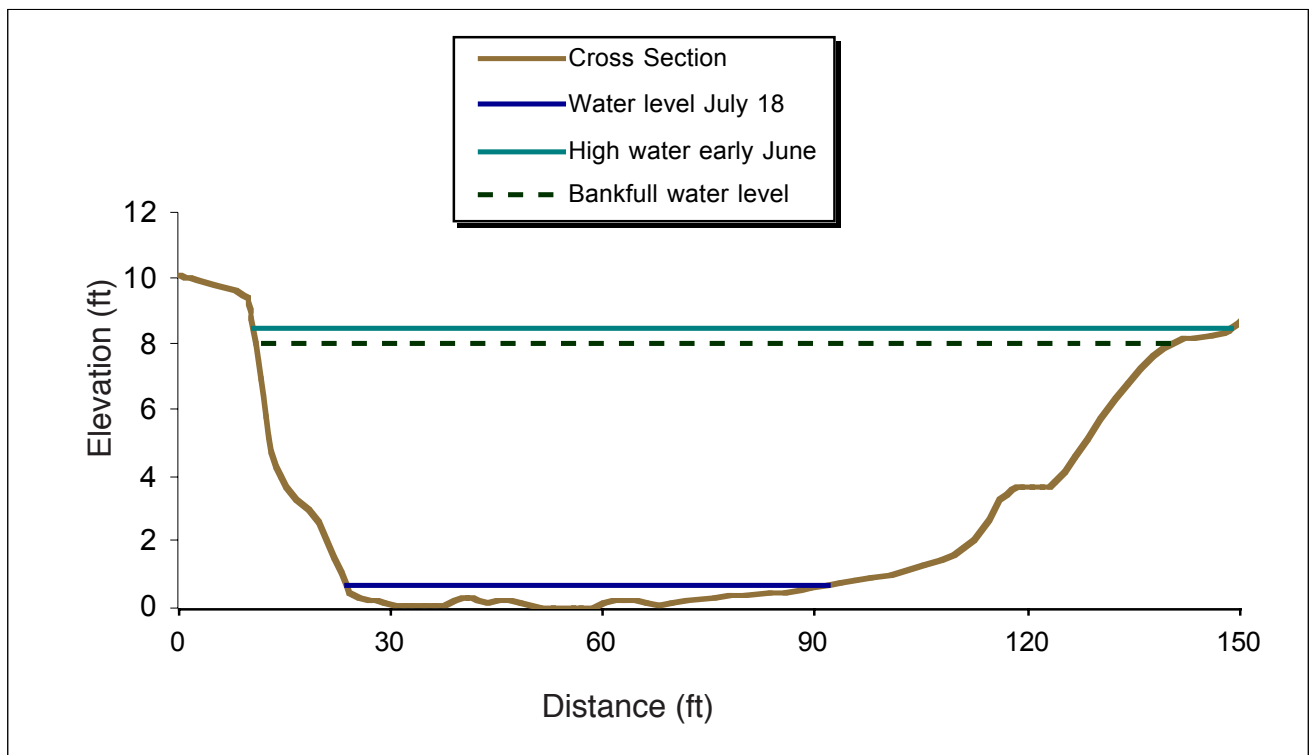
**Figure A-37.** Channel cross section for the upper Kogosukruk River.

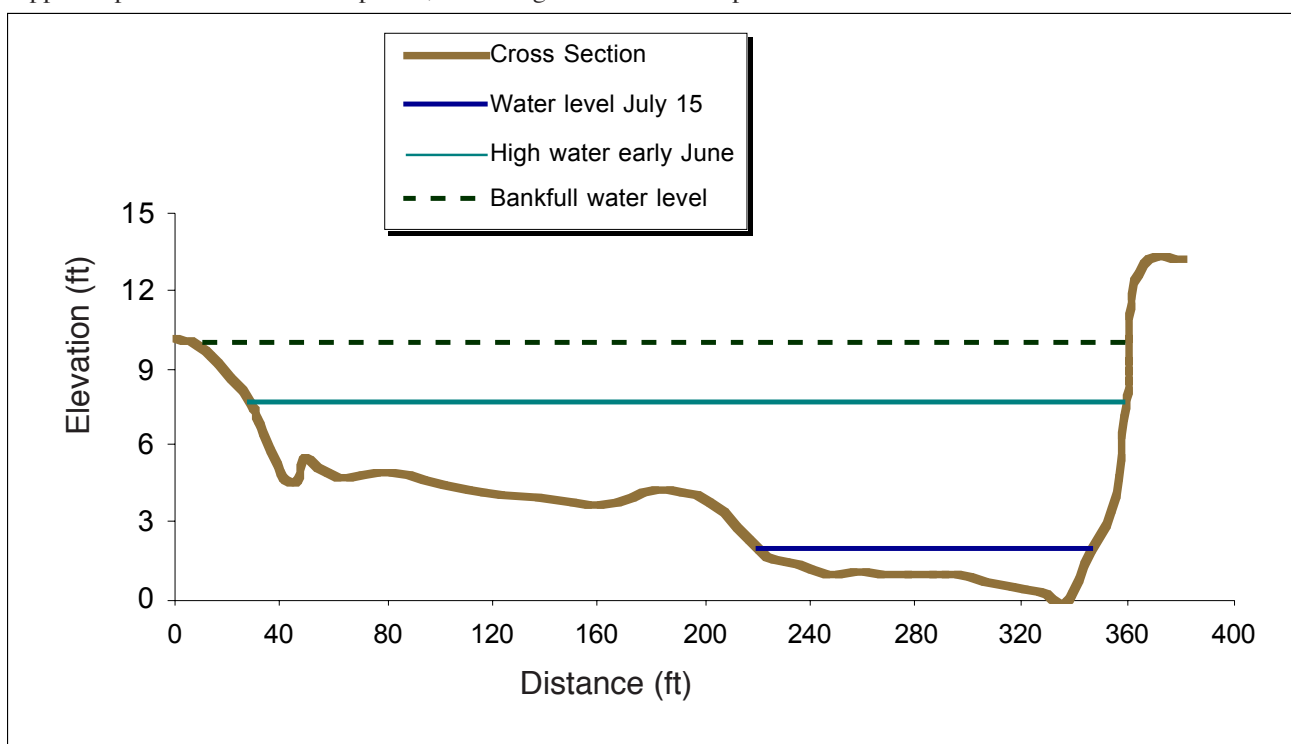
**Figure A-39.** Channel cross section for the lower Kikiakrorak River.

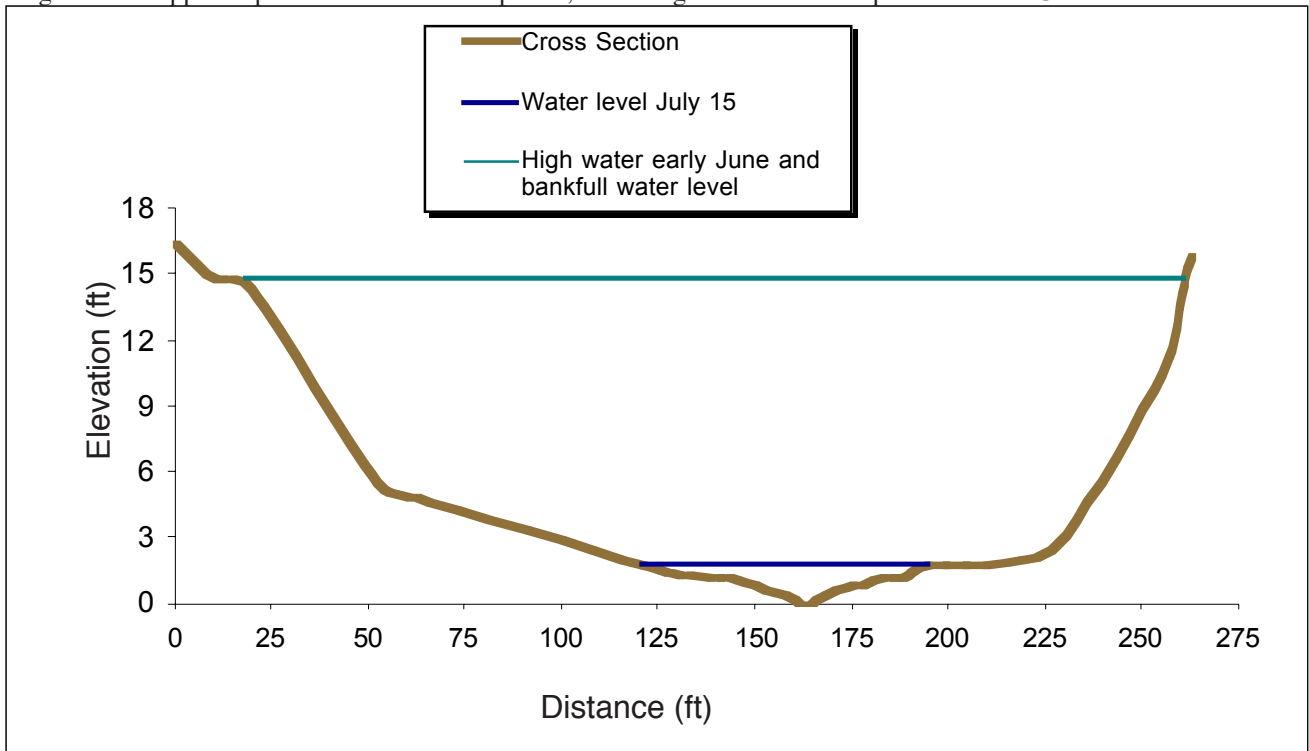
**Figure A-41.** Channel cross section for the lower Kogosukruk River.
