# **The Impact of Ice Roads and Ice Pads on Tundra Ecosystems, National Petroleum Reserve-Alaska**

**The Impact of Ice Roads and Ice Pads  
on Tundra Ecosystems,  
National Petroleum Reserve-Alaska (NPR-A)**

BLM Open File Report 98  
April 2005

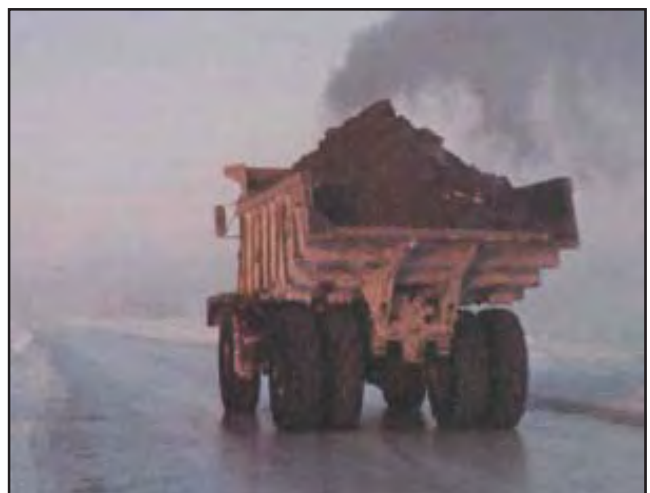
**Figure 6.** Gravel was hauled each day in two 10-hour shifts.

The ice road building period started on February 1, 1978, on a steep bluff overlooking the Kikiakrorak River barrow pit. On February 13, 1978, a second crew mobilized at the east end of the road and worked toward the mid-point of the 37.5-mile long ice road.<sup>8</sup> The ice road was estimated to be 75 percent complete by the end of February and the gravel haul was started on March 9, 1978.<sup>2</sup> Thirty-five million gallons of water were spread along the road alignment.<sup>2</sup> In addition, between 400,000 and 600,000 gallons of additional water were placed each day until early April to repair tension cracks and surface sapling so a smooth running surface could be maintained.<sup>2</sup> The gravel haul included 20- and 25-cubic yard trucks pulling 10-yard pony trailers. Roughly 2,500-3,000 cubic yards of gravel were moved per day for the construction of a C-130 airstrip and the Inigok drill pad. On April 15, 1978, the gravel haul from the Kikiakrorak River barrow pit to the well site was complete.<sup>2</sup> During the 38-day haul period approximately 88,000 trips were made with dump truck and trailer loads exceeding 65 metric tons (mt). Peak two-way daily metric tonnage exceeded 10,000 mt for the gravel haul (Figure 6). Replenishment and

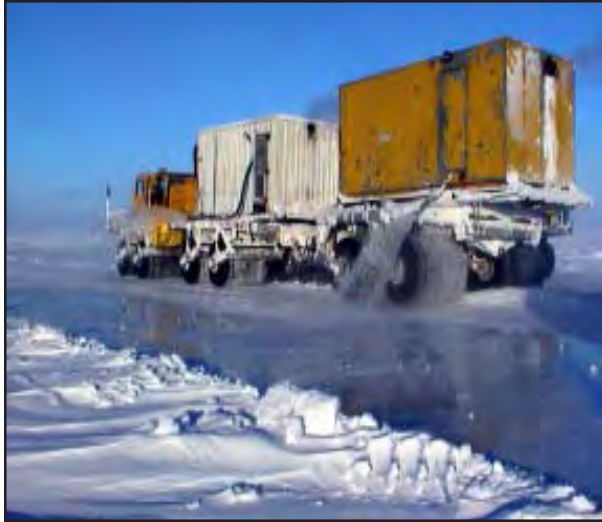
**Figure 7.** Water added to ice road layer.

maintenance of the ice required the daily transport of  $\pm 1,800$  mt of water along the 37.5 miles of ice road (Figure 7).

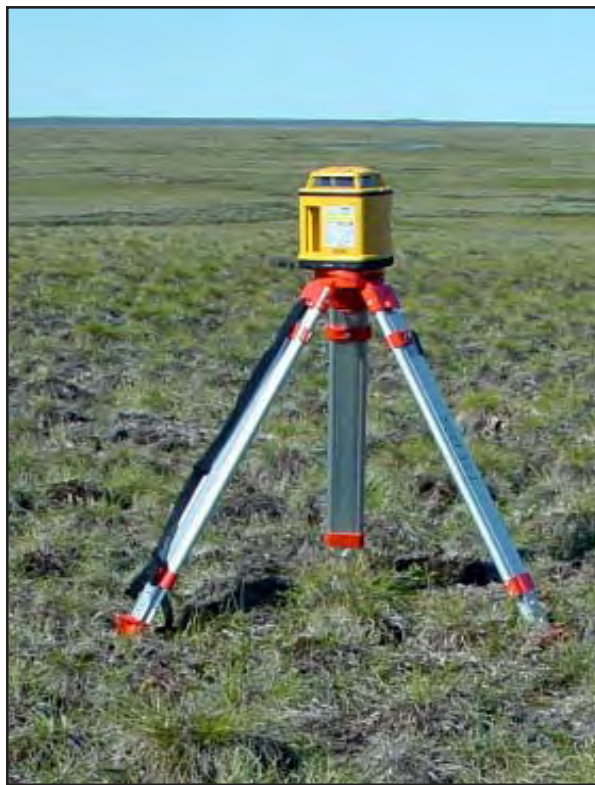
**Figure 12.** Depth to permafrost measurements using the Laser Alignment LB-9 Laser Beacon.

recorded every 2 meters across each transect. A “T” shaped steel rod was driven into the tundra to measure depth to permafrost.

The relative surface elevation provided a terrain profile and a sub-surface measurement profile of the active permafrost layer. The laser level technique removed some of the micro-terrain bias caused by the local tundra relief, which can make local permafrost trends difficult to analyze. Measurements made on the 2001 and 2002 ice road traces were identical to those made on the 1978 ice road trace (Appendices A-1 and A-2).

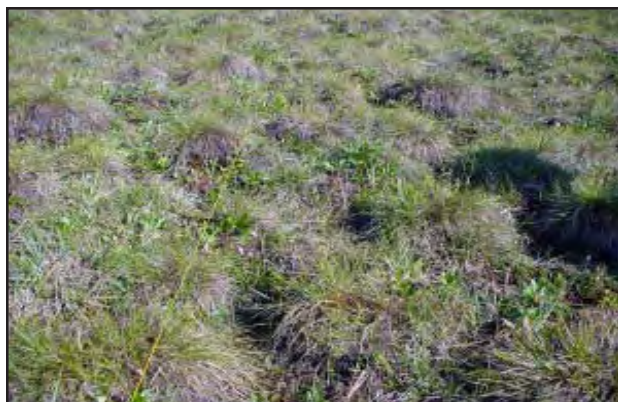
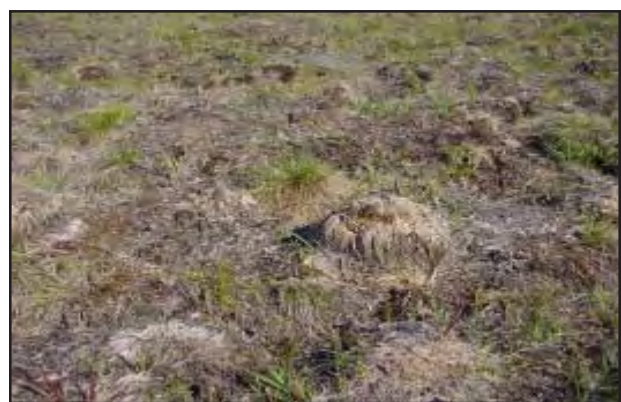
**Figures 14 and 15.** Tussocks outside ice road (left). Tussocks impacted by ice road (right).

Vegetation data collected on the 2001 and 2002 ice road traces showed significant impacts from physical and thermal (freezing) damage to grasses, shrubs, forbs, and bryophytes, with the most significant impacts occurring to cotton grass (*Eriophorum vaginatum*), the most abundant plant on each transect location (Figures 14 and 15). The dominant shrubs found on these sites were *Salix planifolia*, *Cassiope tetragona*, and *Vaccinium vitis-idea*, all of which displayed significant stress and decrease in plant size.

While the upland cotton grass tussock tundra areas showed a high degree of impact, adjacent low lying wetland areas displayed little or no impact from ice road construction (Figure 16). These wetlands are seasonally inundated with water and the plants are already frozen and encased in ice before ice road construction begins. Plants in these wetland areas (ex. *Carex aquatilis*, *Eriophorum angustifolium*) are naturally accustomed to surviving ice conditions, while drier upland sites not accustomed to being frozen in ice showed the greatest degree of impact from ice roads.

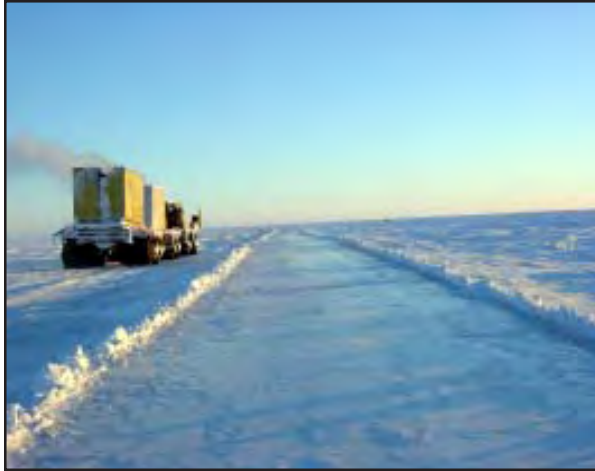
**Figure 19.** Rolligon with water tanks preparing to spray road.

the Puviaq ice pad. Each hauled a double trailer with two large water tanks that were used to siphon water from a nearby lake. Once the tanks were filled, the rolligons traveled adjacent to the ice road and sprayed water on the road to fill cracks and increase the ice thickness (Figure 19). Under the conditions on the day of the visit (temperatures were minus 12 degrees Fahrenheit), the water on the ice road froze solid in about 15 minutes. The ice road and ice airstrip were used extensively by trucks equipped with regular tires to transport personnel and equipment.

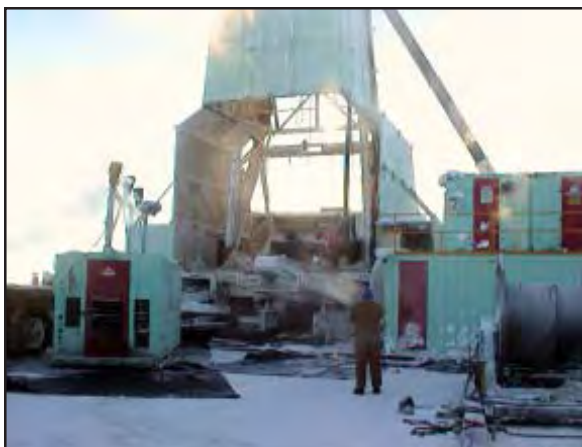
**Figure 20.** Oil drill rig under construction.

The 500 by 500 square foot Puviaq ice pad, which was approximately two feet thick, provided the base for drilling operations. The pad housed personnel in modular buildings that included offices, bunk rooms, and a kitchen, as well as exploratory equipment, high powered generators, and an oil derrick that was being constructed at the time of the visit (Figure 20).

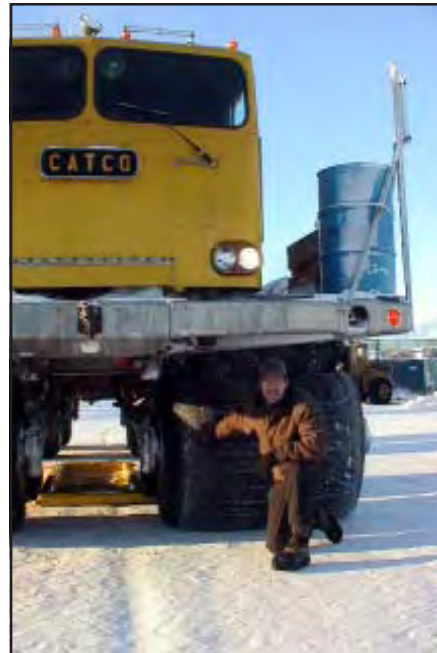
**Figure 21.** Rolligon parked on the ice pad with oil catchment.

Catchments were placed under rolligons and trucks when they were parked on the ice pad to insure that no oil leaked from the vehicles onto the pad (Figure 21). In the spring after the equipment was removed from the ice pad, the top four inches of the pad were shaved off and filtered to insure no oil or debris were left to melt into the tundra.

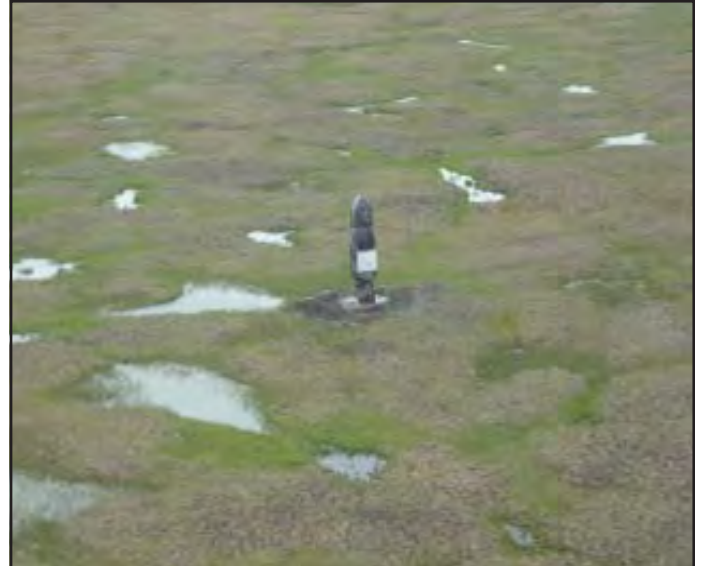
**Figures 22 and 23.** Puviaq test well and ice drill pad in March 2003 (left) and in July 2003 with only well head remaining (right).

vegetation transects across the ice pad and ice road; however, the initial examination of the site showed limited impacts to the tundra from the ice pad and ice road construction similar to the limited impacts of the 2001 and 2002 ice roads (Figures 22 and 23). No evidence of physical damage to tussocks, such as clipping or knocking over of tussocks, was found. The reason these types of physical impacts did not occur could be attributed to the relative flatness of the terrain around Puviaq or could have been a result of improved ice road construction techniques.

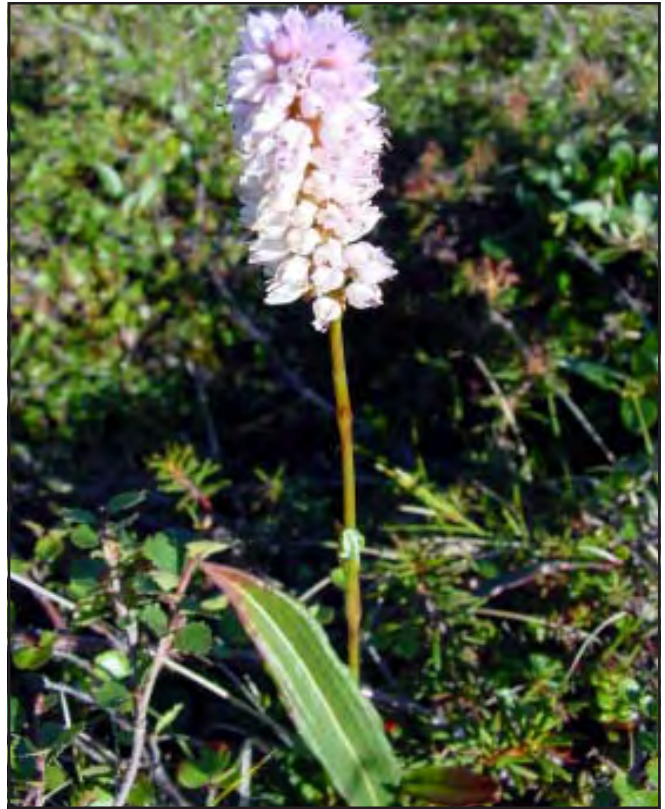
**Figure 24.** Pink plume (*Polygnum bistorta*).

**2. Build ice roads in the wettest locations.** Field analysis and observation revealed that there was little to no damage resulting from ice roads constructed in standing water and wetland sites (Figure 24).

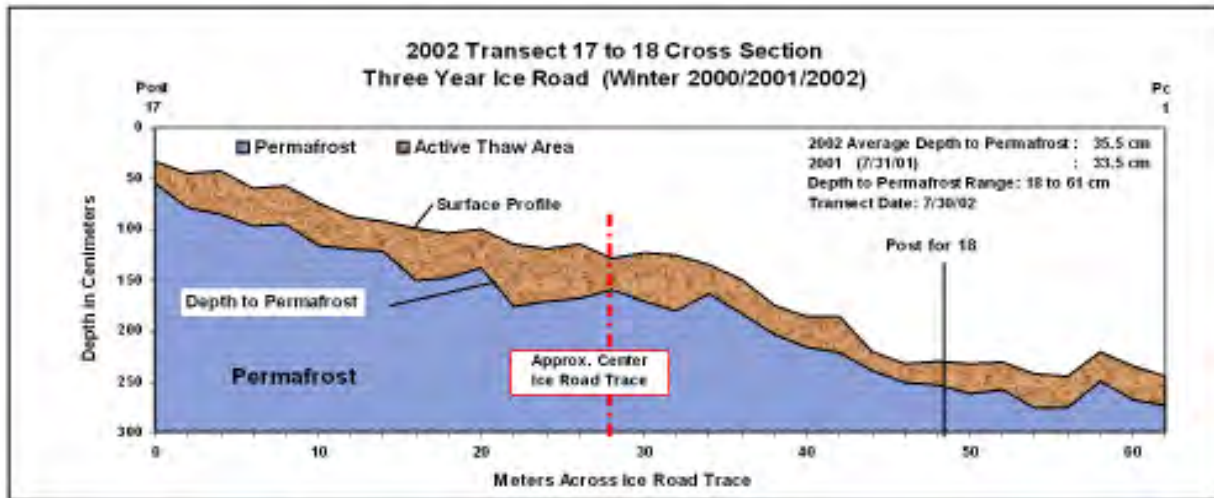
# Transect T17-18

## Depth to Permafrost Profile
