# Water Resources and Riparian Reclamation of Nome Creek, White Mountains National Recreation Area, Alaska

**BLM-Alaska Open File Report 113**  
July 2007

**U. S. Department of the Interior  
Bureau of Land Management**

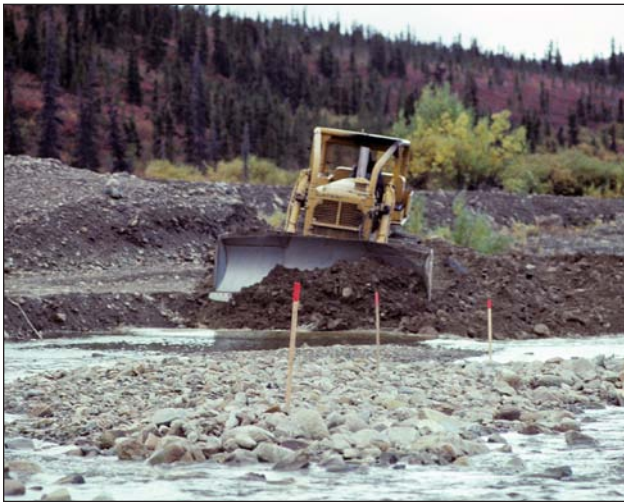
**Figure 5.** The initial step in reclamation was to fill the settling ponds with the dozer, using the material from the surrounding tailings piles.

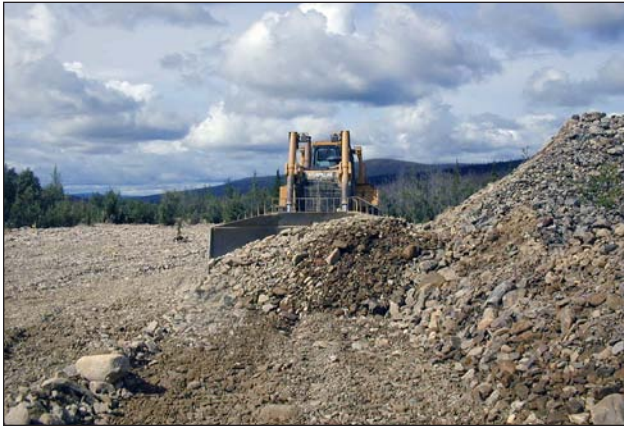
**Figure 6.** After filling the ponds, the bulldozer then graded the floodplain as flat as possible.

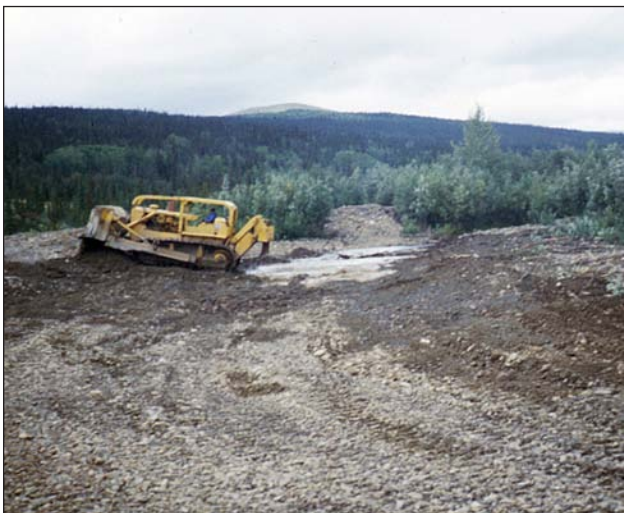
**Figure 7.** The bulldozer constructed the channel using short, almost level grading to deepen the pilot channel.

down the lowest portion of the valley at as uniform a grade as possible (Figure 7). Two years of reclamation (1996 and 1997) were completed in conjunction with road and campground construction, during which some of the largest and most accessible mined areas were stripped of tailings. This road project was a cooperative effort under the direction of Alaska Department of Transportation & Public Facilities (AKDOT), whose contractors completed only limited channel realignment and floodplain reclamation in these locations. The BLM subsequently regraded some of these areas, as needed, to the standards noted above.

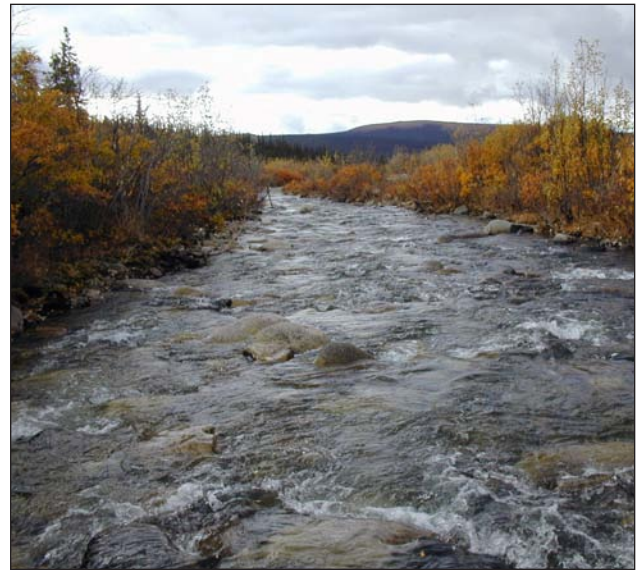
**Figure 8.** Upper Nome Creek's stable channel provided the most accurate streamflow information.

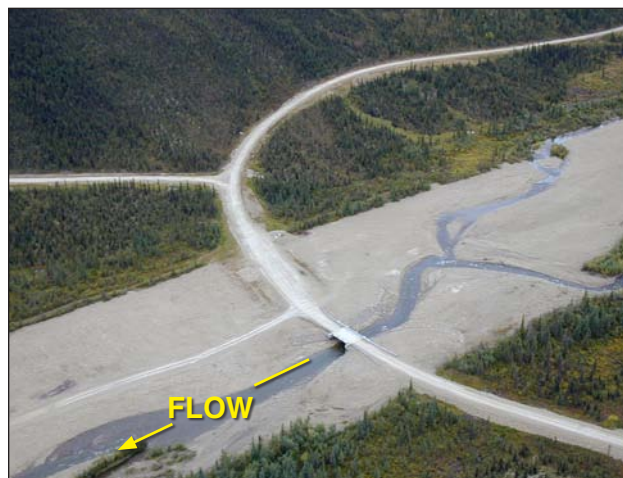
**Figure 9.** Aerial view of the channel upstream of the bridge, where the gabions are being eroded by the unstable channel.

bridge abutment (Figure 9). An estimate of the highest peak discharge, based on limited surveys completed at that time, was calculated primarily to aid in the design and reconstruction of the bridge armoring. However, no flood-frequency data was computed for this site due to the channel instability. Because of its proximity to the bridge and its relatively more stable channel, the flood-frequency data from the site at the Maze could be used to estimate the channel redesign at the bridge, if needed. Summaries of the instantaneous peak-flow data and log-Pearson flood-frequency calculations are shown in Tables 2 and 3. A comparison of the log-Pearson gaged data and the USGS regression estimates for the site above Sumner Creek is shown in Table 4. It is interesting to note that all these regression equations underestimate the field-determined discharges at the lower-interval, higher-recurrence values.

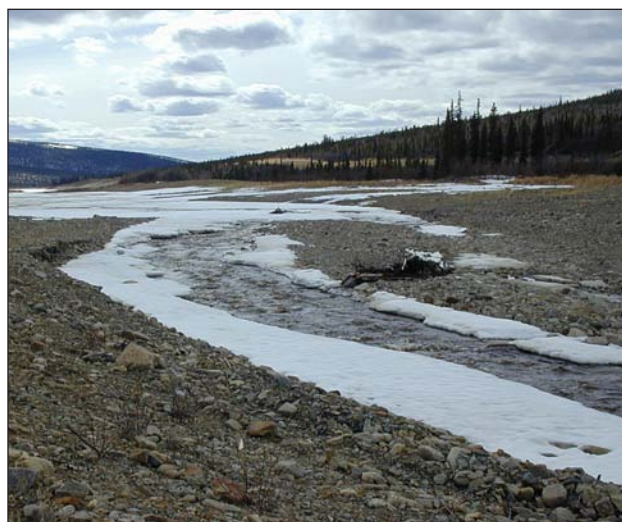
**Figure 11.** Overflow icing (aufeis) forms during most winters and can persist well into summer.

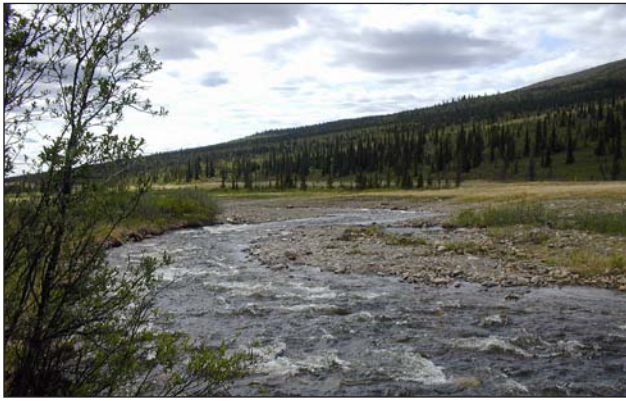
**Figure 12.** In the upper reclamation area, the meanders had to be increased and the point bars leveled to stabilize the channel. Note the grass in the background, a result of hydroseeding during road construction.

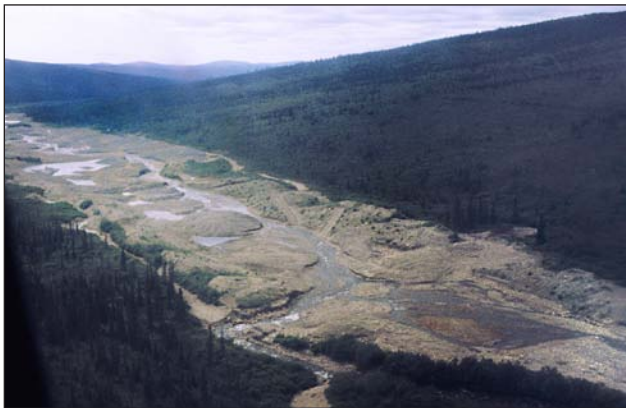
**Figure 13.** Aerial photo of Nome Creek before the reclamation project began.

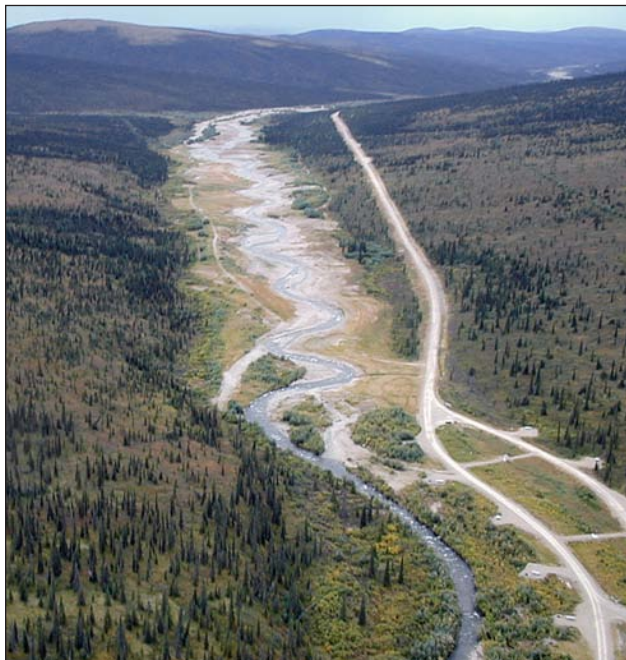
**Figure 14.** Aerial photo of the upper reclamation area, road, and campground after reclamation.

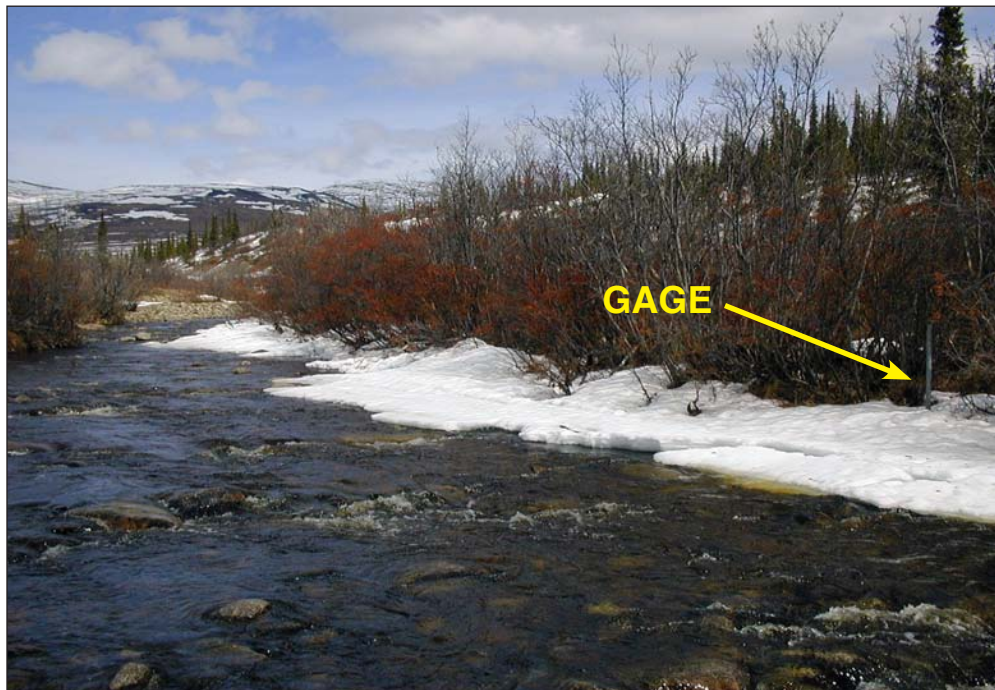
**Figure A-1.** Looking upstream at the crest-stage gage reach for Nome Creek above Sumner Creek during late spring. The remnant ice shelves can persist well into summer and confound peak discharge determinations.

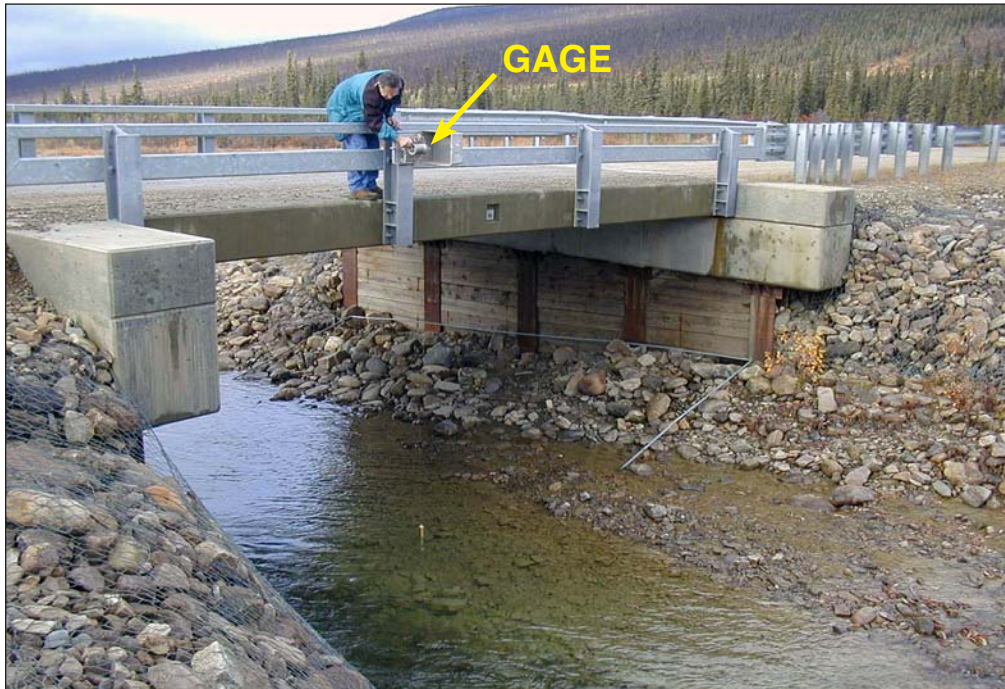
**Figure A-3.** Looking downstream at the wire-weight gage reach for Nome Creek at the bridge. The gage was installed in 1998 on the downstream side and relocated to the upstream side of the bridge in 1999. Gaging continues to the present.

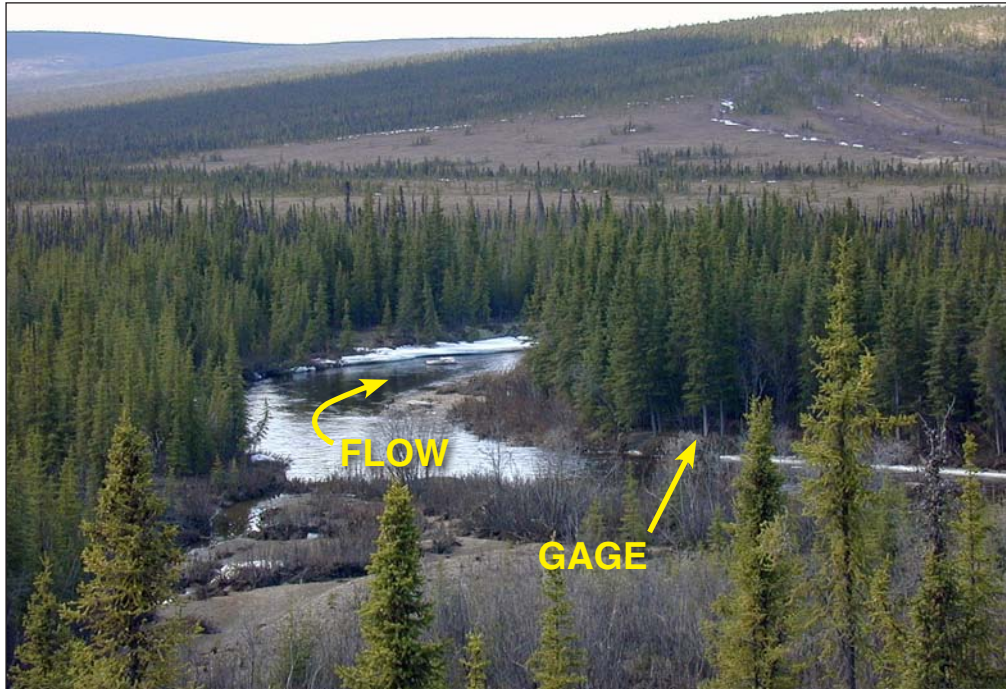
**Figure A-7.** Looking downstream at the data-logger gage reach for Nome Creek above Ophir Creek in late spring. The gage was installed in 1999 and gaging continues to the present.

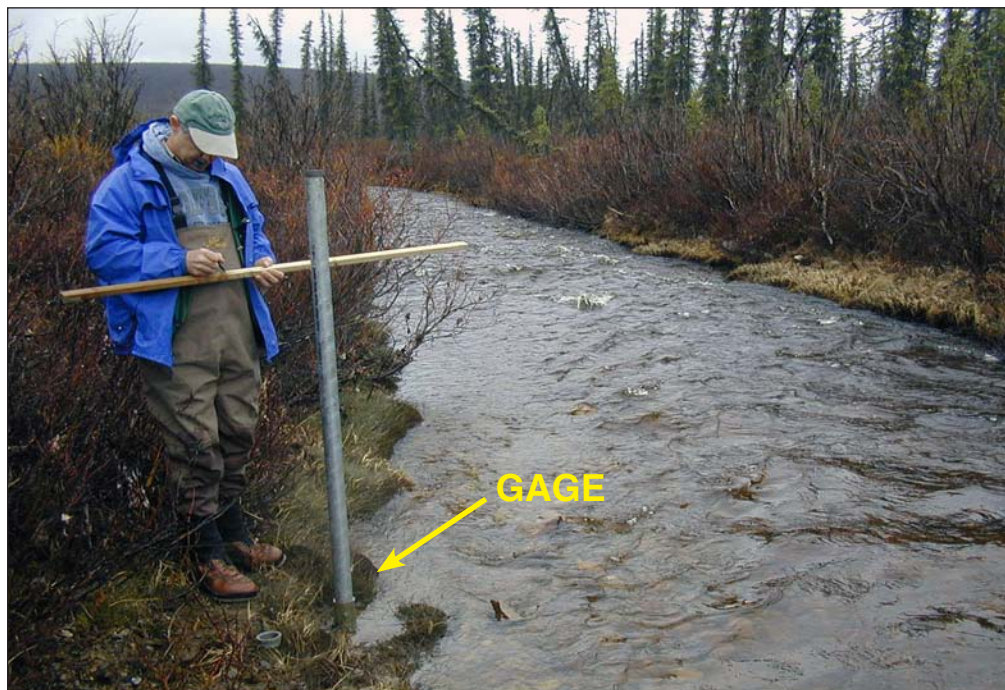
**Figure A-9.** Looking downstream at the crest-stage gage reach for Moose Creek above the Nome Creek Road. The gage reach was selected and surveys were begun in 1996. Gaging continues to the present. The hydrologist is marking the cork line for measurement on the gage stick.

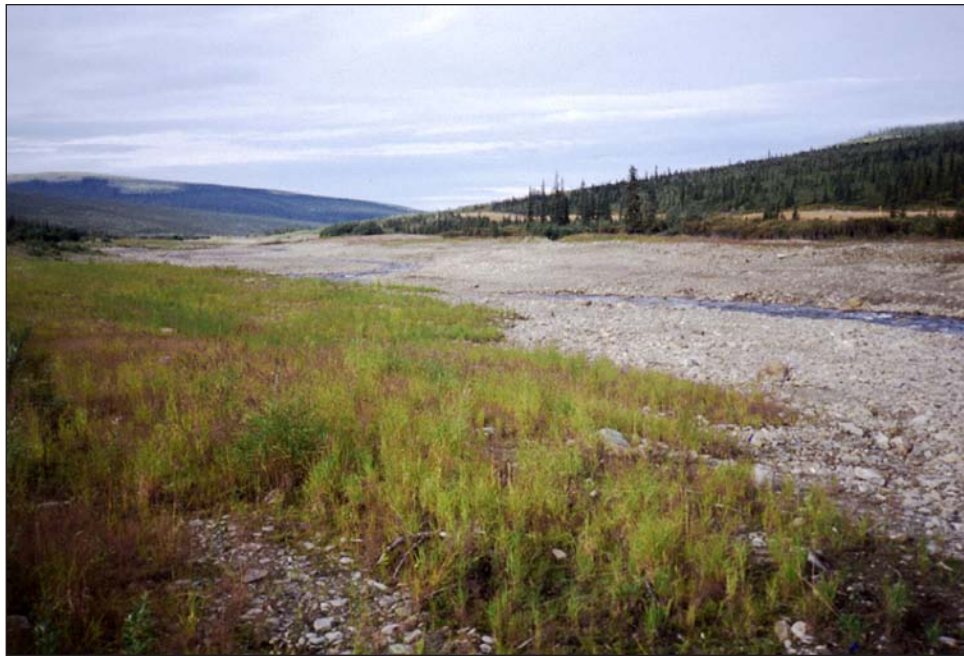
**Figure C-1.** Upstream portion of the reclaimed area, showing extensive establishment of grass in 1993 on what became known as the “field of dreams.” Most of this grass was dead or dying by 1996.

Jim Sisk assisted in a quick assessment of plant cover in the seeded area. Seeded grasses had created a dense, tough sod. However, much of the grass was dead or dying. Live grass cover (predominantly red fescue and Bering hair grass, with small amounts of native *Calamagrostis* (bluejoint) averaged only 15%, while dead grass litter averaged 69%. Number and vigor of native species was low—there was never more than a trace of forb species and willow cover was more than 1% in only one of 17 plots. It appeared that few plants in the planting area had not already been present at the time of seeding.
