FORT EGBERT AND THE EAGLE HISTORIC DISTRICT

summer-1977

Results of Archeological and Historic Research

Anne D. Shinkwin, Elizabeth F. Andrews, Russell H. Sackett, and Mary V. Kroul
University of Alaska Anthropology Program—Fairbanks, Alaska

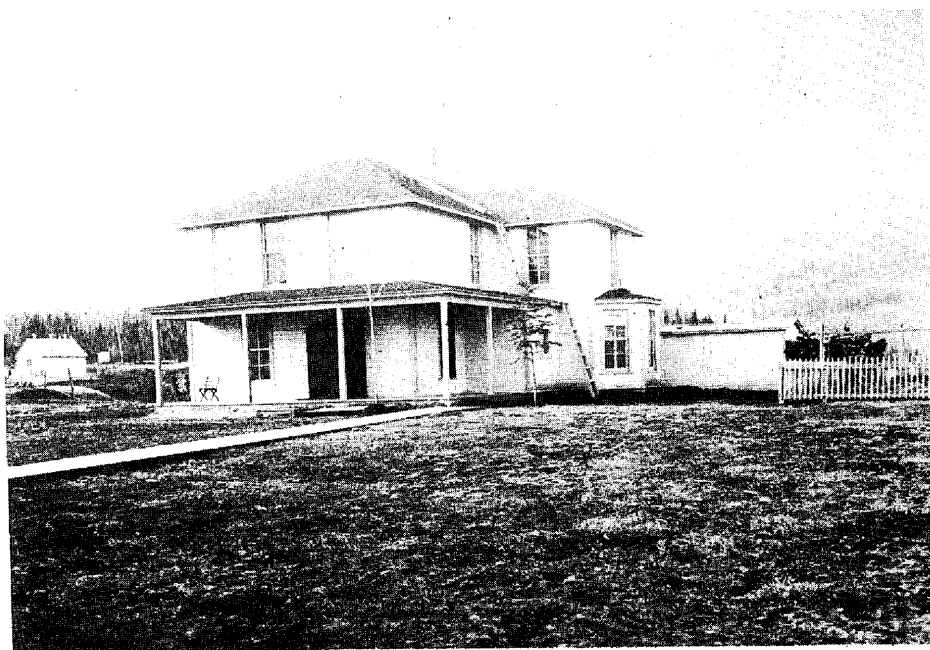
Fig. 10. Commanding Officer's Quarters (Building 1), 1905 (C. L. Andrews Collection, University of Oregon Archives).

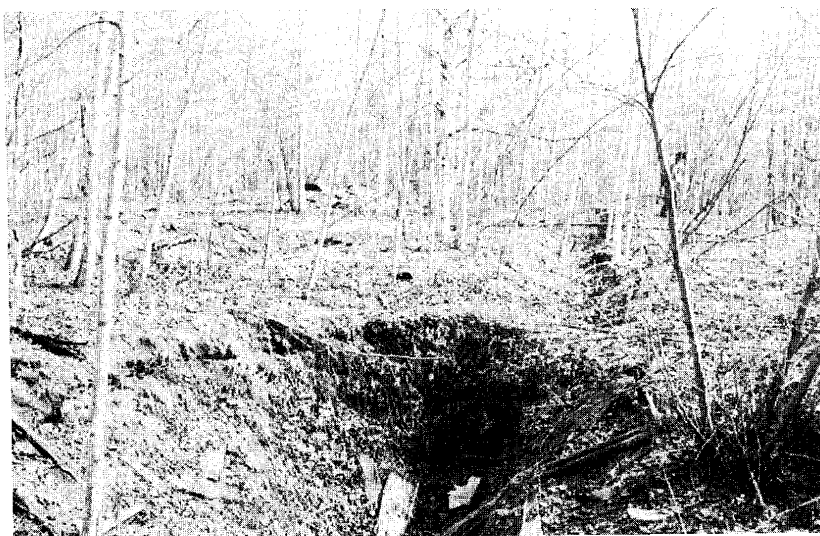
Fig. 11. Site of Building 20
(Old Hospital, Laundry)--1977.

The site of Building 20 (Old Hospital, Laundry) is similarly characterized by wooden structural debris from the foundation and floor system and a probable cellar, but remains are not nearly as extensive as those found at Building 1. Material remains are limited to a predominance of shingles and corrugated iron (Fig. 11). Several features such as ditches along with the presence of some lead pipe (presumably drainpipe) and a possible boiler probably relate to the later use of the site as a laundry rather than its earlier function as the hospital. There are no historic data indicating the hospital had laundry rooms. A picket fence found nearby apparently enclosed an undefined area of a yet unidentified activity just beyond the limits of the structure (Fig. 12). A modified five-gallon can similar to those used as feeding dishes found at the dog kennels at Building 14 was in the same locality (Fig. 12). The history of this site, along with the unidentified activity areas found during our survey and possibly associated with the use of Building 20, points to the potential for archeologically documenting the multiple use of the

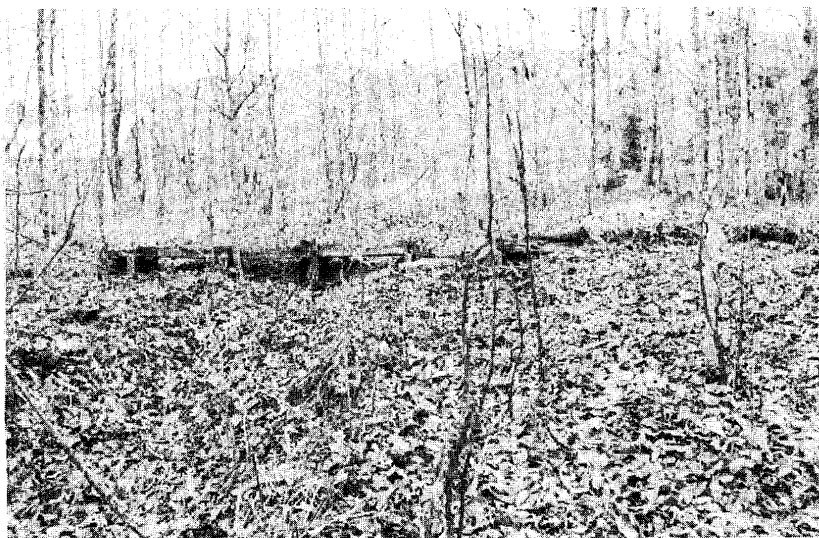
Fig. 13. Structural remains of the site of Building 24 (Civilian Employees' Quarters) --1977.

The remains at the site of Building 24 (Civilian Employees' Quarters) consist almost entirely of structure from the floor and foundation system (Fig. 13). Piers, sills, and joists are clearly visible above and in the ground surface. Stove pipe, flashing, and terra cotta chimney fragments were observed on the ground adjacent to the actual building site of the structure. This relatively modest structure served as quarters for up to 16 civilian "teamsters and packers." The Alaska Road Commission received authorization to dismantle in 1929 (Record Group 49). It is likely that archeological remains might shed comparative light on the behavior of civilian employees at this military outpost. Well-planned and systematic limited test excavations should reveal whether or not there is any potential for this contribution.

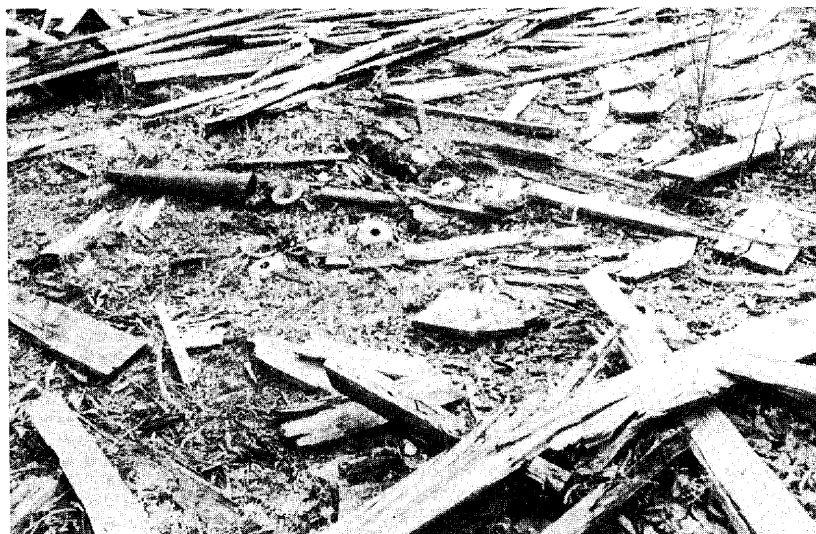
Fig. 15. Structural and material debris at the site of Building 32--1977.

much of the structural debris deposited around the margins of the structure probably has disguised and preserved the cultural remains beneath.

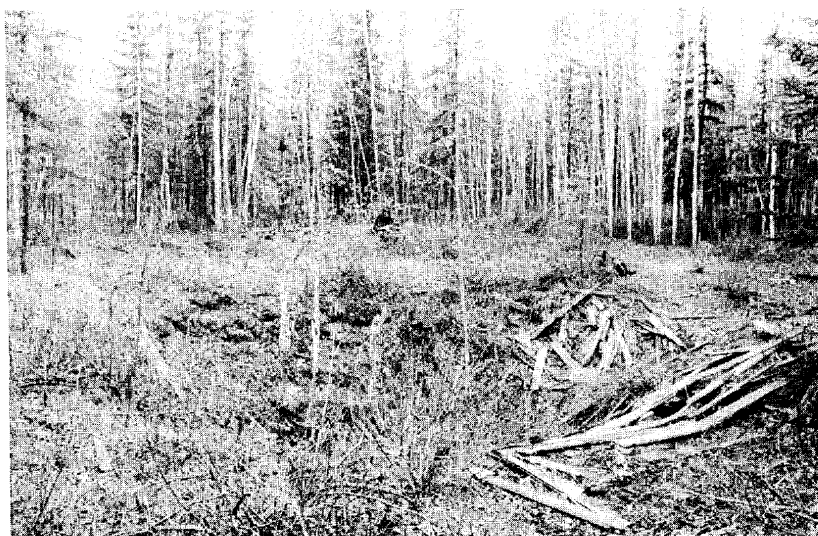
At the site of the Hospital Corps' Quarters (Building 35), relatively extensive structural debris was found, and a variety of material items observed nearby (Fig. 16). The site is well-delineated, complete with an apparent cellar and the outline of a probable wood shed at the rear. This building was one of the later structures built at Fort Egbert in 1908, and thus was occupied for only three years prior to the abandonment of the fort. Although a map drafted in 1925 by the Alaska Road Commission noted that it was sold at that time, the historic record also shows the Road Commission was granted authority "to dismantle" it in 1927. It is clear, however, from the remains at the site that the structure was removed, although some subsurface pieces remain. The relatively short-term occupation of the building by only one or two medical personnel does not seem to suggest that archeological investigations might make any major contribution.

Fig. 16. Site of Hospital Corps' Quarters (Building 35)--1977.

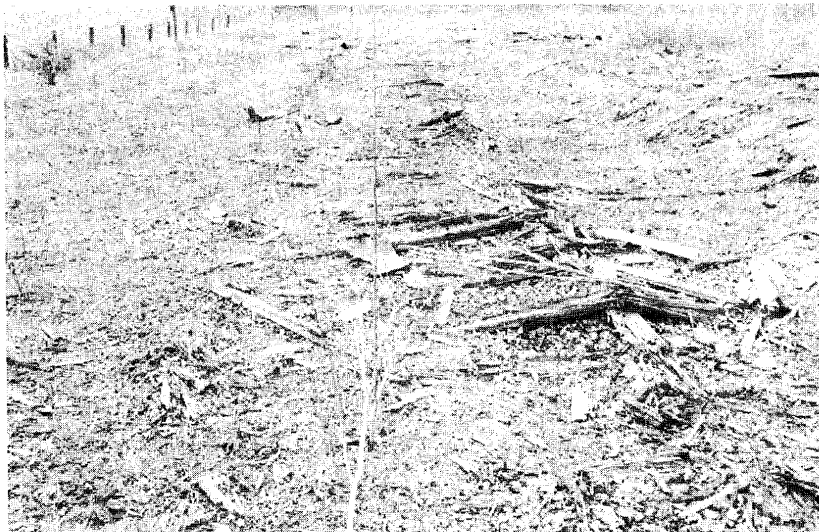
Fig. 17. Structural remains of the south wing of Building 21 (Barracks) --1977.

Structural debris from the floor and subfloor systems for the Barracks is present where the south wing was located (Fig. 17) and along the east wing only where a porch addition was built. At these two localities the vast amount of wooden remains represent construction materials and techniques employed in building the two additions to the Barracks (Fig. 18). A variety of material items, almost all associated with the structure rather than its occupants, were observed. These, which were prominent on the sandy ground surface at the building site, included nails, shingle fragments, sash weights, siding, and corrugated sheet-metal fragments. While the outlines of the east and west wings are distinct, little structural debris was present. A wood-lined pit, possibly a cellar of some sort, was located within the limits of the west wing. At the rear of the structure, the site was ill-defined and is presumably the area where the latrine additions were made. Several subsurface probes with a soil auger revealed that the structure, like most others tested, was constructed directly on the bar sand present throughout the area and in most areas has not been stained by human activity or organic decomposition. At one locality a gravel horizon was present beneath a two-inch sand level just below the ground surface but was underlain with bar sand. Our tests were not extensive enough to determine whether the gravel indicated the presence of a walkway behind the south wing or perhaps was placed there to drain water falling off the

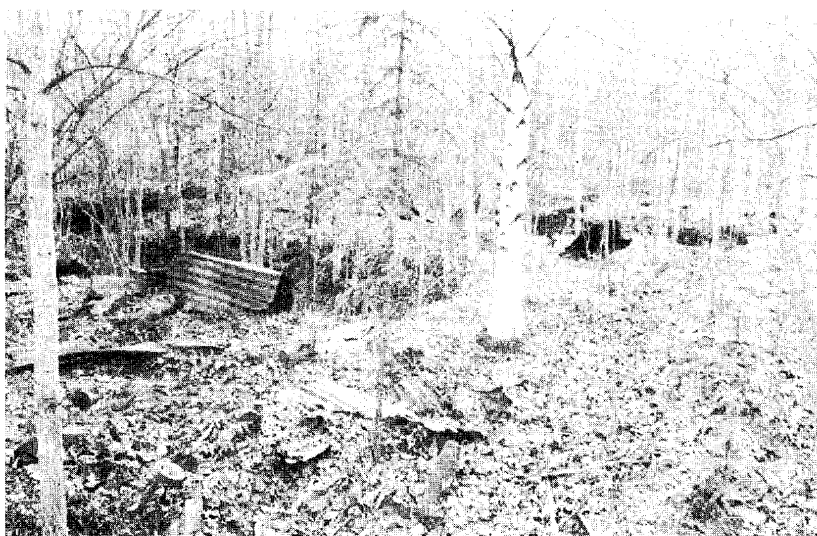
Fig. 21. Site of Building 3 (Officer's Quarters)--1977.

Both structures were removed from their locations, according to reports. Building 3 was first turned over to the Department of Justice, presumably to function as the U. S. Marshall's office, as noted on a 1925 map. Later it

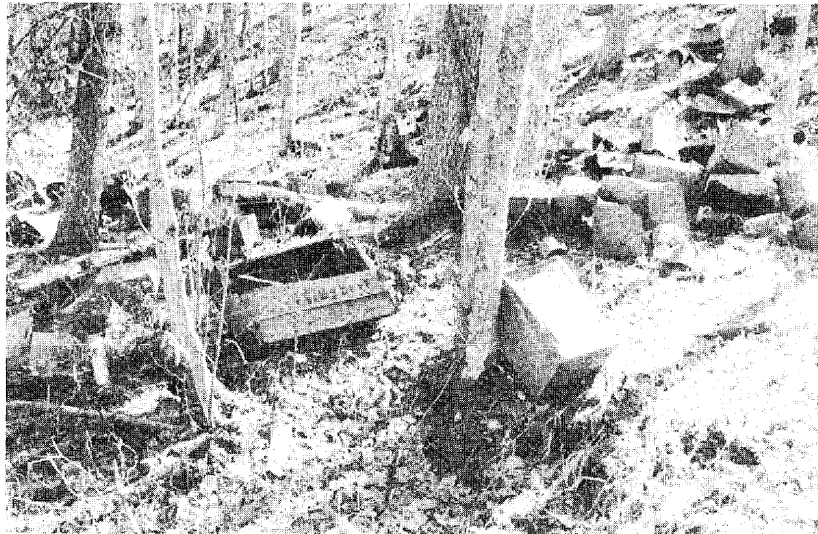
Fig. 22. Material items in refuse area near Building 3 (Officer's Quarters)--1977.

was dismantled by the Office of Indian Affairs (Record Group 49; Grauman n.d.). Building 38 was sold for \$5 in 1932 (Record Group 49). Building 3, however, shows extensive signs of burning. Almost every item noted and the few structural remains are charred, and a thick concentration of ash is at one locality within the structure site. Several limited test excavations with a soil auger revealed a brown organic level (cultural) two inches thick beneath the leaf mat covering the site. This level is underlain by at least 11 inches of bar sand, which is present throughout the terrace on which the fort is situated. Another test showed an ash level underlain by red-brown soil (presumably altered from the burn). Metal and wood fragments prevented augering in one of the deep pits, but in another, a brown organic level nearly nine inches in depth was revealed. On the basis of these few auger tests it is difficult to make any firm conclusions about the significance of the remains. It is possible that the building was turned over to the Office of Indian Affairs to be dismantled, but may have burned prior to this action. If this were the case, however, much more debris should have remained unless it was removed after the fire. Sites containing structures that have burned often provide much archeological information. This may not be the case with the site of Building 3 since the history of the building does not seem clear. Still, more material items and a wider variety of them were observed at this site than at any other building site in the core area. Thus, systematic, but not necessarily extensive, archeological test excavations could determine

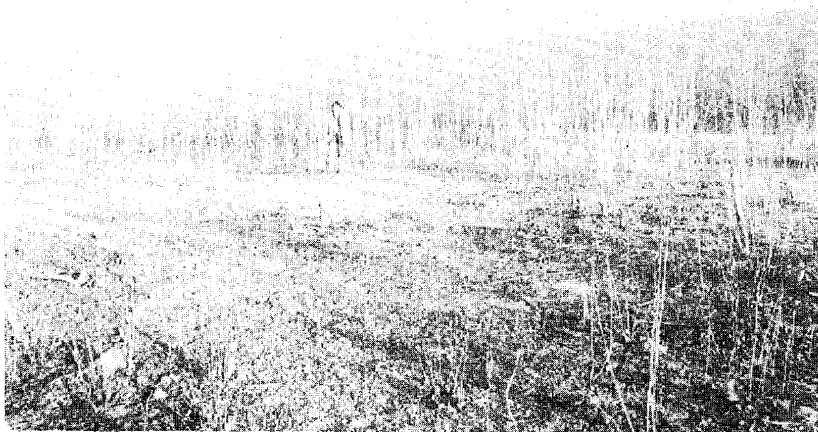
Fig. 23. Site of Building 10 (Ice House)--1977.

Eleven buildings, nearly 25 percent of the original 45 structures, are represented only by faint outlines or sandy depressions where the buildings once stood. Some areas still contain a few items of debris or remnant machinery which linked the site with its original function. Six building sites were characterized only by a sandy expanse or outline (sites of Buildings 10, 15, 27, 33, 37, 45). These features consisted of either a predominantly

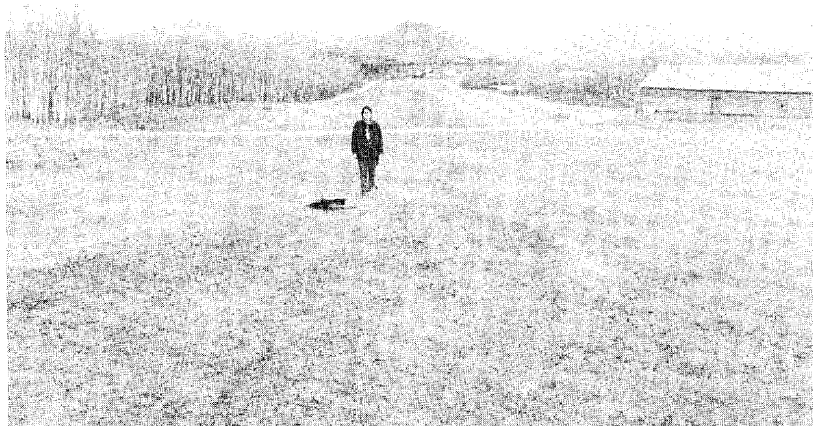
Evidence of more than half of these building sites was probably obliterated during construction of the airfield which nearly bisects the main activity and structural area of the fort (sites of Buildings 2, 4, 5, 6, 7, 16, 18, 22a, 26, 28, 43/44, 44/45) (Figs. 25, 26, 27). The results of this construction appear today in the level, but gradually sloping, airstrip, with its short grass ground cover. Two dirt roads cross the airfield and two dirt roads parallel the north and south limits. Other building sites have perhaps been disguised by natural vegetative growth in the area or cannot be seen because buildings were removed early in the century (sites of Buildings 8, 9, 11, 25, 29, 42,

Fig. 25. Airfield at Eagle and obscured sites of Buildings 2, 4, 5, 6, 7, 16, 18, 22a, 26, 28, 43/44, 44/45--1977.

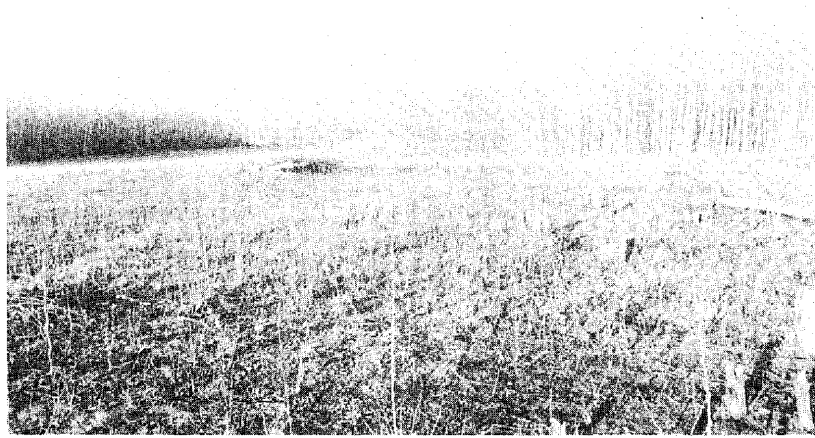
43/0) (Fig. 28). Vegetative growth at these sites ranges from the dense willow, rose bush, and cottonwood in a moist area near the site of Building 25 to the comparatively open aspen forest which has succeeded at the formerly cleared areas about Buildings 9, 29, and 42. One building site was additionally obscured by fill activity in 1975 (site of Building 11) and two others (Buildings 16, 26) were further disturbed during the same year by ground grading activity (Sprague 1975).

Fig. 28. Site of Building 8 (Post Commissary) (foreground) and Buildings 6 (Administration Building) and 7 (Ice Storage House, Old Guardhouse)--1977.

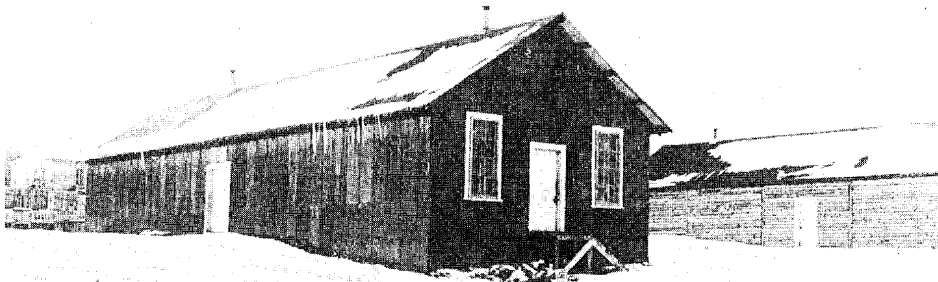
Commissary Salesroom & Store House

Fig. 30. "Commissary Salesroom & Store House" (Building 26), early twentieth century (C. S. Farnsworth Collection, University of Alaska Archives).

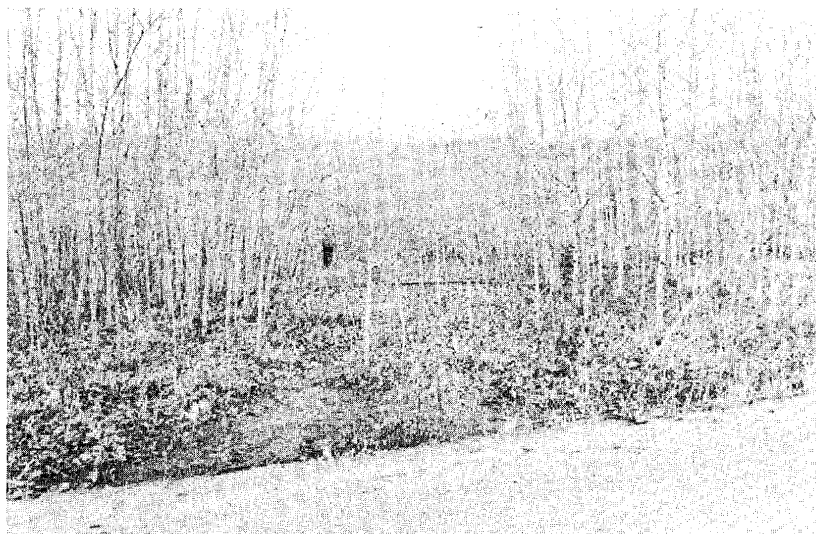
Fig. 33. Road cut south of Buildings 11 and 14--1977.

chapter on the archeological excavations. There is no evidence of the remainder of this road between Building 11 and the edge of the bank above the Sawmill (Building 23), since it has been obliterated by the construction of more recent roads and the airfield or by natural growth. The extension of the other road which once passed in front of most of the officers' quarters and connected them with the Guardhouse (Building 33) at the city limits has clearly been obscured by the presence of the airfield and a more recent road linking the city with the airfield and the State Highway Department garage. Another road (Fig. 5) has apparently suffered a similar fate along its northern extension between Building 19 (NCO Quarters) and Building 15 (Wagon Shed), although its southern extension to C Street is heavily overgrown but partially defined by a berm which may mark the line of a fence that once paralleled part of the road. It appears then that portions of the remainder of the core area roads can still be delineated in spite of varying degrees of vegetative growth which do not completely obscure former road cuts. However, it is clear that other historic, but more recent construction, i.e., the airfield, has obscured some of the formerly major thoroughfares of the core area, while intense vegetative growth has disguised portions of others.

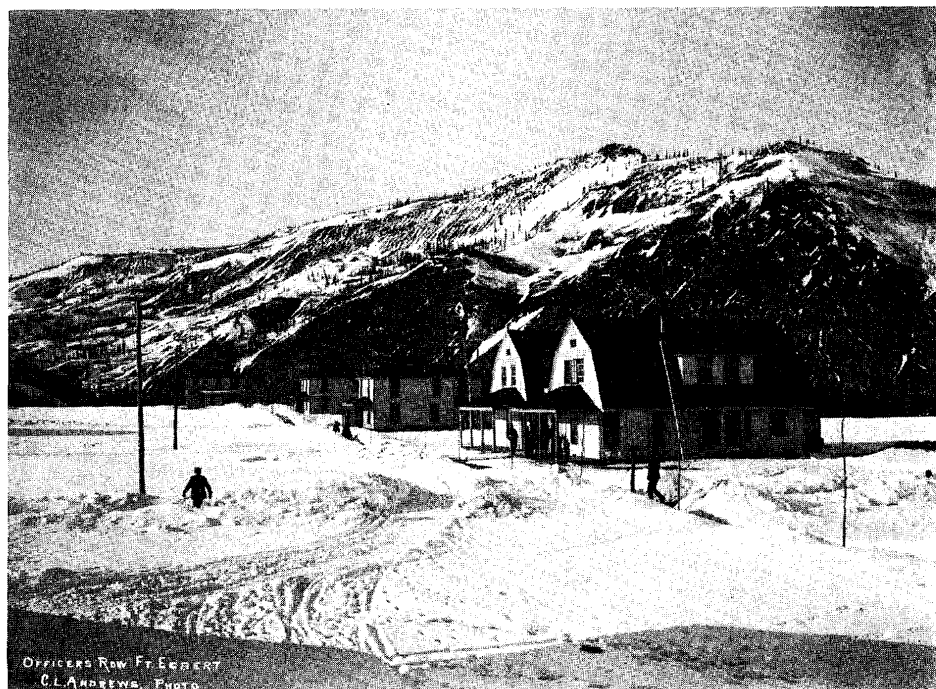
None of the three gravel walks (Fig. 36) was visible on the ground surface. These walkways originally linked the Enlisted Men's Barracks (Building 21) with the Commissary (Building 8) and provided access between the Officer's Quarters row and Post Headquarters (Building 6) and the

Fig. 36. Walkways near "Officer's Row" at Fort Egbert, winter 1905-1906 (C. L. Andrews Collection, University of Oregon Archives).

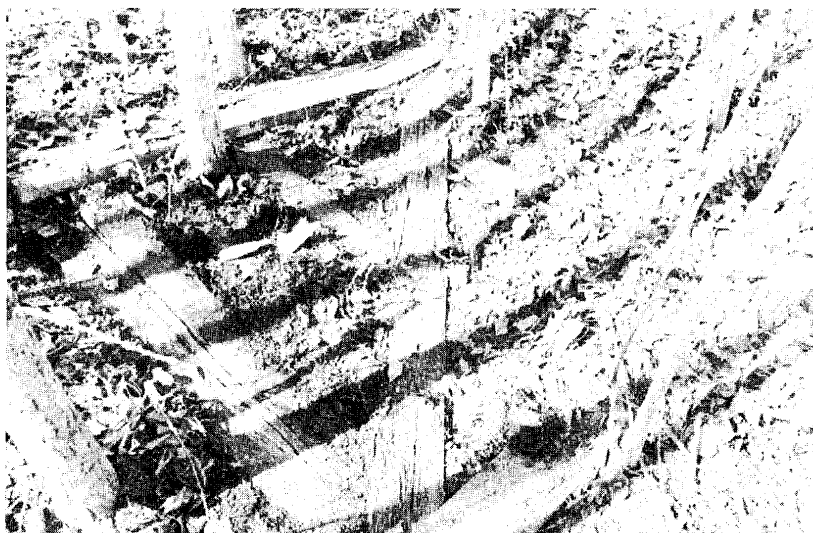
Fig. 38. Corral gate in the ground surface near the site of Building 15--1977.

Group D includes gates which were present in the core area. Only Peek's map indicated the presence of a "Main Gate" southeast of the Guardhouse (Building 33) at the junction of Third Avenue and C Street. It is unclear, however, whether Peek's designation referred to an actual gate; perhaps it only represented the official entryway to the core area of Fort Egbert. In either event, no surface evidence of any type of gate or gateway remains was found in this area. One gate (Fig. 38) was found south of the road that extended between Buildings 14 and 15 (a drawing is in Appendix III). This gate was found embedded in the ground surface, and a superficial clearing of loose leaves revealed that it was intact although rather decayed. Its

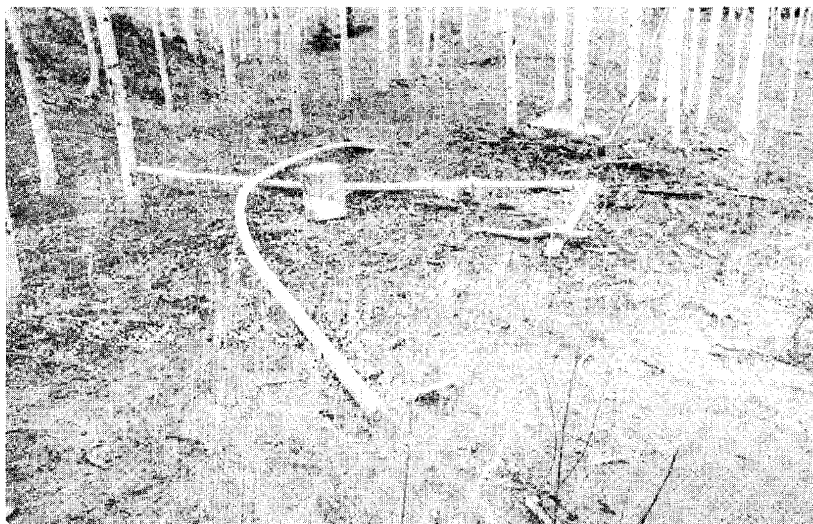
Fig. 42. Lead pipe probably for water line at Fort Egbert--1977.

From these tanks water was pumped through 3-inch lead pipes which terminated at the corral. According to historic documents, the water pipes were encased in 14-inch square wooden boxes and six warming houses with oil stoves were built along the waterline to keep the water from freezing. Here, the historic record coincides with the survey findings, as all six warming houses (Fig. 41) in various states of disrepair were located along the route. Also, evidence of the wooden encasements for the pipe were present in the ground surface along most of the western half of the route. Lead pipe (Fig. 42) was found near the northwest corner of the corral area, although the exact terminus of the waterline could not be determined. About two-thirds of the way along the route from the source, another tank, possibly an overflow tank, was located. This tank was not mentioned in the documents relating to the construction and operation of this waterline. A later map of the fort (1912) did locate an overflow tank. It was placed much farther west, however, than the site of the one recorded during our survey. Most of the route and the locations of the structures associated with the operation of the waterline are still apparent, admittedly not always well-defined, and have probably been better preserved than other activity areas because of their relative remoteness. Only the natural processes of vegetative growth and the

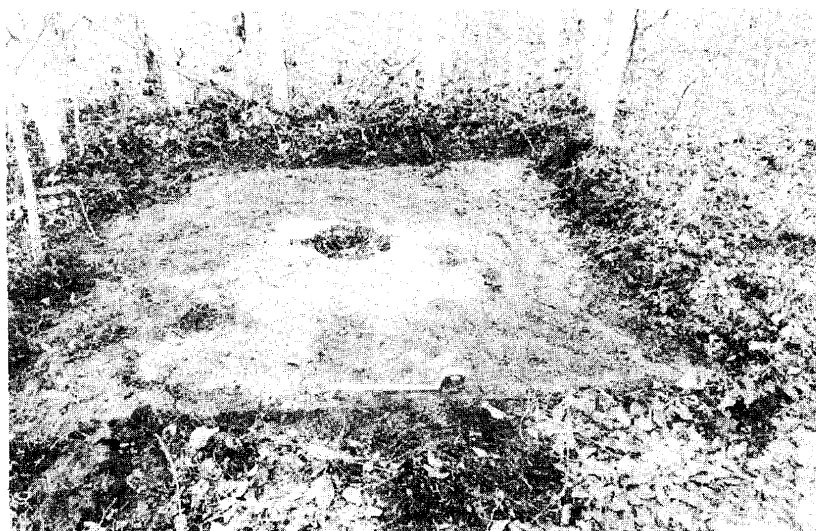
Fig. 44. Flagpole platform for south flagstaff--1977.

The sites of flagpoles are included in Group H. One cement platform (Fig. 44) was located in the core area south of the former Parade Ground and north of the Guardhouse (Building 33). This exact location was noted on Peek's map of the fort dating to the later period of the garrison's occupation (Peek n.d.). The site of the flagpole about 200 feet farther north and within the limits of the parade ground could not be located. This northern flagstaff is shown in the same location on several of the original maps of the fort, e.g., Fitzpatrick's 1901 map, Kelly's 1904 map. This location is further confirmed by a photograph taken by historian-traveler C. L. Andrews when the fort was occupied (Fig. 45). The earlier flagpole apparently did not have a concrete platform surrounding it. We repeatedly checked the area for the site of the flagpole with negative results. This area appears not to have been disturbed except by natural changes. No sign of a posthole was found. There is no information in the historic record as to whether the site of the southern flagstaff ever replaced the more northern one or even if they were ever used simultaneously or alternately during the same time.

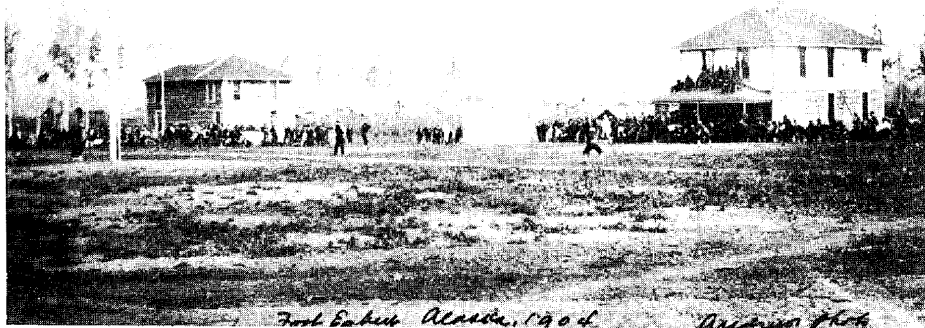
Fig. 45. North flagpole and Parade Ground, Fort Egbert, early twentieth century (C. L. Andrews Collection, University of Oregon Archives).

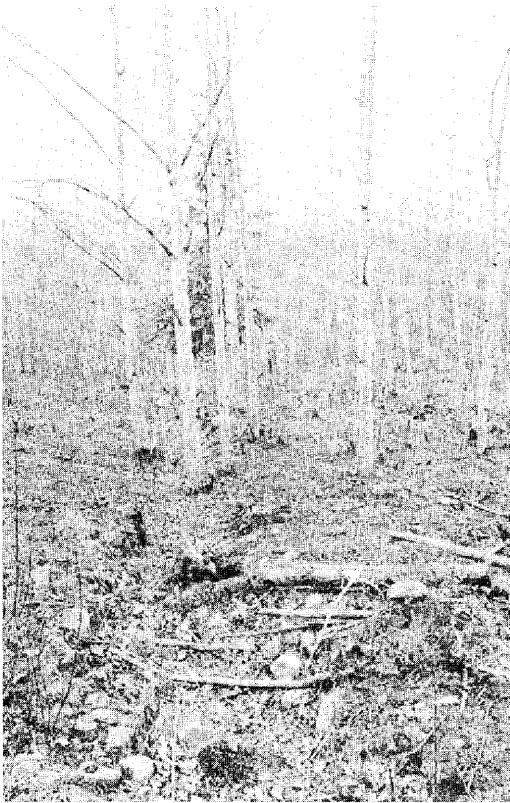
The remains of a stone-lined ditch which is included in Group I were found east of the site of Building 11 (Quartermaster's Storehouse). This 4-1/2-foot-wide ditch extends for nearly 100 feet (Fig. 46). Portions of the ditch have been obliterated by recent fill activity near the site. It is unclear what its function may have been. It may have been a drainage ditch but it crosses a very low slope and because no remains are at the site of Building 11, the original grade around the structure is hard to determine.

Fig. 46. Stone-lined ditch
near Building 11--1977.

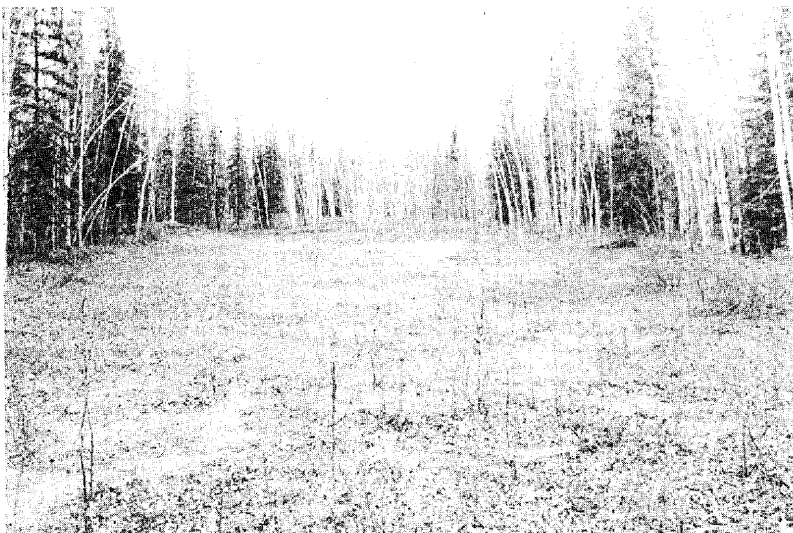
Group J consists of the Target Range, which was located several hundred yards west of the New Hospital (Building 34) site and extended some 600 yards toward American Creek (Fig. 5). Only one section, about one-sixth the size of the original range according to fort maps, was found (Fig. 47). When trees were cleared from the area, the sand beneath the humus level provided a natural base for the Target Range. It is difficult to explain why this apparently once extensive area has been so intensely

Fig. 47. Target
Range--1977.

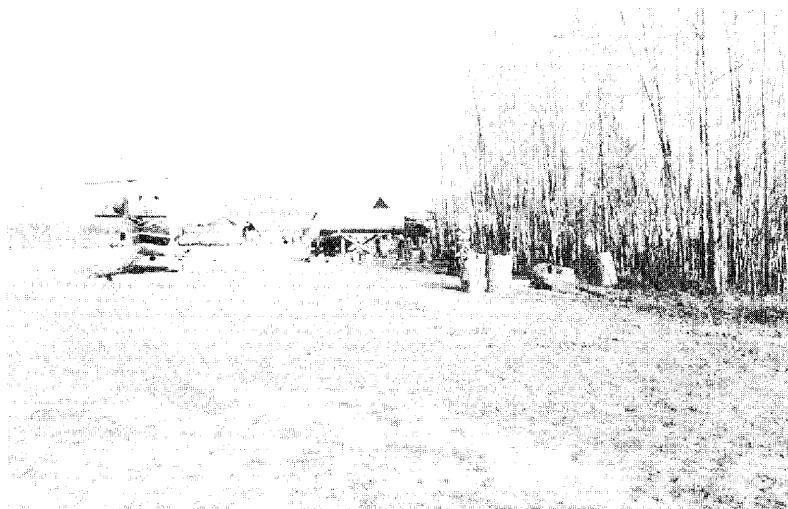
Category 7. Prehistoric Sites in the Core Area. Six prehistoric localities (Fig. 5) were found in the core Fort Egbert area (Appendix III). Four of these consisted of flake scatters and one contained a finished tool. As a group, artifacts which were observed on the ground surface included a unifacially retouched boulder spall, two possible core fragments, two retouched flakes, a probable core tablet, fire-cracked rocks, a fragment of retouched glass, and a unifacially flaked end and side "thumbnail" scraper. As elsewhere in the survey area, no test excavations were undertaken to determine if more prehistoric materials might be found beneath the surface. These four localities are all within 250 yards of each other. Two are near the current heliport, near where the Double Set Officers' Quarters (Building 28) once stood (Fig. 48), and two are along the road at the north limit of the airfield near the Officer's Quarters (Building 3) remains.

Fig. 48. Prehistoric locality at current airfield and near site of Building 28--1977.

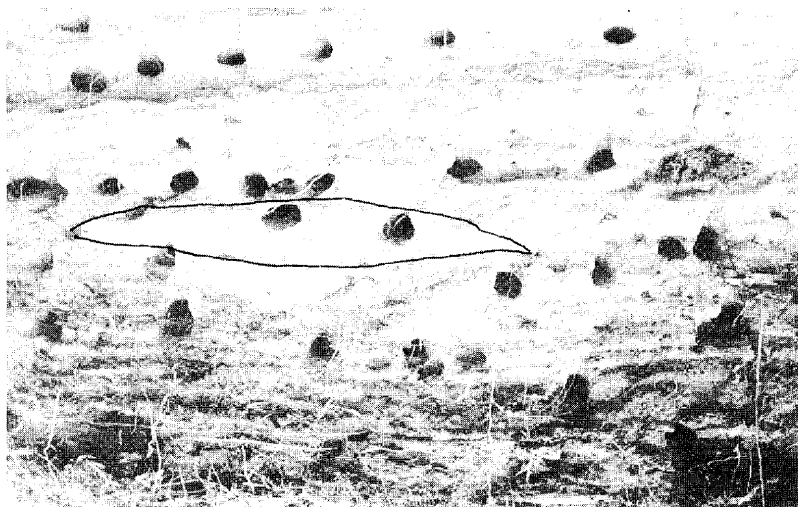
Fig. 49. Prehistoric hearth in cut bank near site of Building 23--1977 (outlined).

Two additional prehistoric localities were found in the core area and were visible in the cut bank along the eastern and river limit of Fort Egbert (Fig. 49). One was visible in the relatively low cut bank near the site of the Sawmill (Building 23). It consisted of at least seven and possibly eight prehistoric hearths, seven of which were located within 100 linear feet of one another. Although our observations revealed the presence of ash, calcined bone, and fire-cracked rock in the exposed surface, test excavations undertaken by Western Interstate Commission for Higher Education (WICHE) interns for the BLM in 1976 uncovered historic material above one hearth and flakes, charcoal, and ceramic fragments in the hearth level (Waldman 1976). It is noteworthy that no volcanic ash horizon is visible in this lower cut bank. This area has been severely disturbed because of the presence of the fort sawmill, evidenced in the sawdust and wood debris in the sod level and just beneath, but it is also constantly eroding and is further disturbed by swallows (Fig. 49).

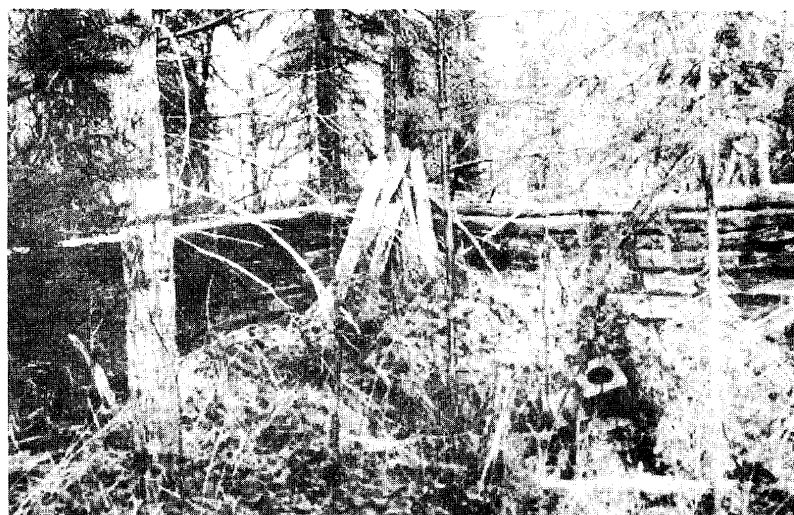
Fig. 55. Cabin remains at O. H. Walters' abandoned mining claim.

Seven remains of cabins were located and were found to be in various states of disrepair. Remains ranged from intact walls on all four sides to no structural debris present on the ground surface. The remains of one cabin (F.S. #8) (Fig. 55) was once part of a mining claim which was noted on a 1906 map of Fort Egbert (Forsyth 1907). The site today consists of the cabin remains, as well as features indicating either associated outbuildings or cold-storage cellars along with scattered debris such as wash tubs and five-gallon cans which may originally have contained kerosene. Three cabin sites (F.S. #20, 70, 71) were located near the core area of the fort, west of the corral area. Portions of the walls remained at one locality along with several unidentifiable but probably associated pits. Material debris such as a wooden crate, cans, and a barrel were also found in the area. The other two cabins consisted only of floor remains embedded in the ground surface, although a few items such as a Yukon-type wood-burning stove and an enamelware wash basin were found. One of the cabin sites has been almost completely removed in the construction of the adjacent road. Elsewhere in the vicinity of Fort Egbert, along the Taylor Highway, a depression (F.S. #33), which probably indicates the site of a cabin, was also located. No material or structural

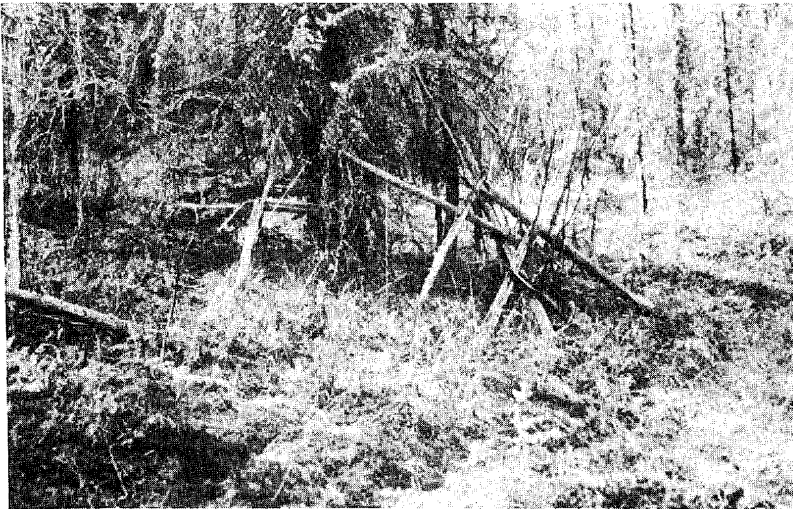
Fig. 56. Moose fence remains near American Creek.

One moose fence (F.S. #7), west of American Creek at the edge of a muskeg area along a moose trail, represents a traditional method employed by Han Indians to acquire moose. The remains of the pole fence, which was probably much more extensive, revealed that it was constructed with narrow spruce timbers (Fig. 56). Wire nails were used in constructing some parts of the fence. One native man described similar fences used by the neighboring Upper Tanana Indians. These fences were extended between two hills where a small creek flowed. Snares were placed in the fence at intervals and covered with willow branches so that when a moose passed through the opening its head would be caught in the snare (Paul 1957:14-15). These fences were also used by neighboring Athapaskan Indians as well (McKenna 1959).

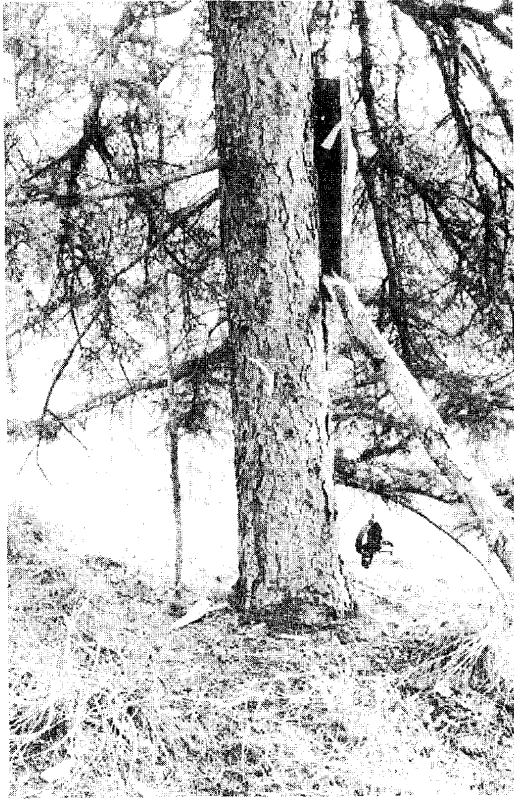
Fig. 59. Marten trap set.

Five sites where traps had been set were found in the survey area. Three of these still contained a metal trap in the set. Two trap sets (F.S. #2, 5) were located about 200 yards from one another near the edge of a 70-foot-high bank terrace, overlooking the valley at the junction of American and Mission creeks. Both appeared to be pole sets for the trapping of marten and were constructed of spruce timbers attached to the trunk of a large spruce tree (Fig. 59). Similar sets have been described for the trapping of marten in neighboring regions (Nelson 1973). Dried salmon was used for bait, although only the fish skin remained hanging above each trap. A No. 1 trap was used at one set and a No. 0 trap at the other. Only the No. 1 trap had sprung, but nothing was caught in it. Both trap sets appeared to have been made by the same individual since the same imported materials (yarn and flagging tape) had been used to hold the bait and mark the trap set along the trail.

A third trap set (F.S. #59), constructed and marked in the same manner, was found farther along the left bank of the Yukon River, about a mile below the mouth of Mission Creek. A No. 1 trap had been set and a squirrel caught in it. All three trap sets appear to constitute part of one person's traplines and probably all were set in the 1976-1977 season. None had trapped a marten, although the bait had been taken by some animal.

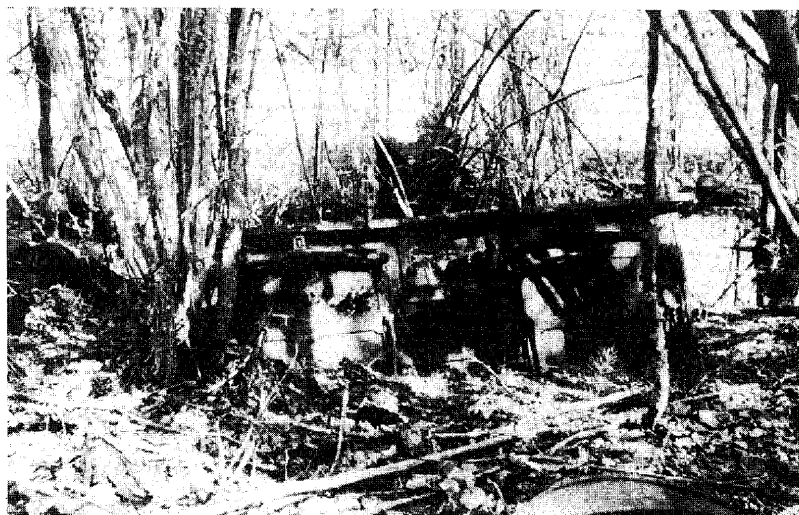
Fig. 61. "Army Range" at site of
Wireless Telegraph Station.

some structural remains appear to mark the locations of buildings which were either occupied by military personnel or used as outbuildings in association with the nearby Wireless Station. Also, wire, electrical equipment, a bedpost, and cement pilings were found in this area.

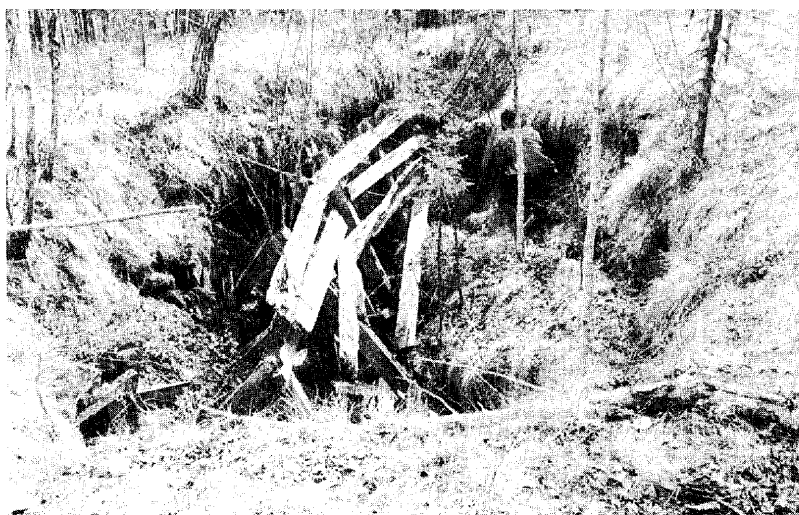
Fig. 62. Remains at long-range target pit near American Creek.

Only one site found in the survey area west of American Creek reflects the presence of the U. S. Army at Eagle. This was the site of the long-range targets (F.S. #69), labeled on original maps of the fort as "Collective fire targets" and "Long range target pit" and "Col. Fire Targets Long Range Targets" (Langdon 1906; Hill 1908). Unfortunately, the remains found at the site did not provide us with evidence that this in fact was the function of the site, but the location marked on Hill's map led us to the exact site location. One large and deep pit with a narrower ditch extending east was the only surface feature at the site (Fig. 62). Rather extensive, but fallen, structural remains were found in the pit, but we could not determine what the original structure might have looked

like. Nearby were small wooden boxes which resemble recent styles of ammunition crates, but no markings were observed on the boxes nor was any spent ammunition or other indications of target practice observed in the area.

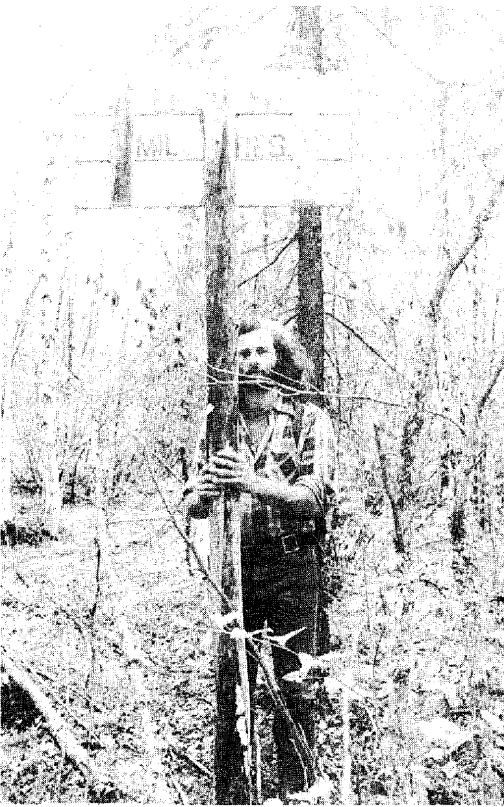
Fig. 63. South boundary sign of Fort Egbert--1977.

The final site relating to U. S. military activities beyond the core area and within our survey limits contained a single object--a sign marking the south boundary of the Fort Egbert Military Reservation. The sign (F.S. #63) was constructed of milled lumber pieces attached to a spruce log post. The lettering on the front of the sign was barely visible and read "U. S. MILITARY RESERVATION SOUTH BOUNDARY" while the reverse and back side read simply "U. S. MIL. RES." (Fig. 63). The sign was located along a trail which extended beyond the Wireless Station and was noted on one map as the trail to "Steel Creek 50 miles" (Hill 1908). Steele Creek was a small mining community located along the trail between Eagle and Chicken. A post office and roadhouse were maintained there between 1907 and 1951 (Haynes 1976). Thus, the sign no doubt alerted travelers that they were officially entering or departing property under the jurisdiction of the U. S. military. Since the sign was found along this trail and at the southern boundary, as noted on Hill's 1908 map, it is probable that it was not far from its original location.

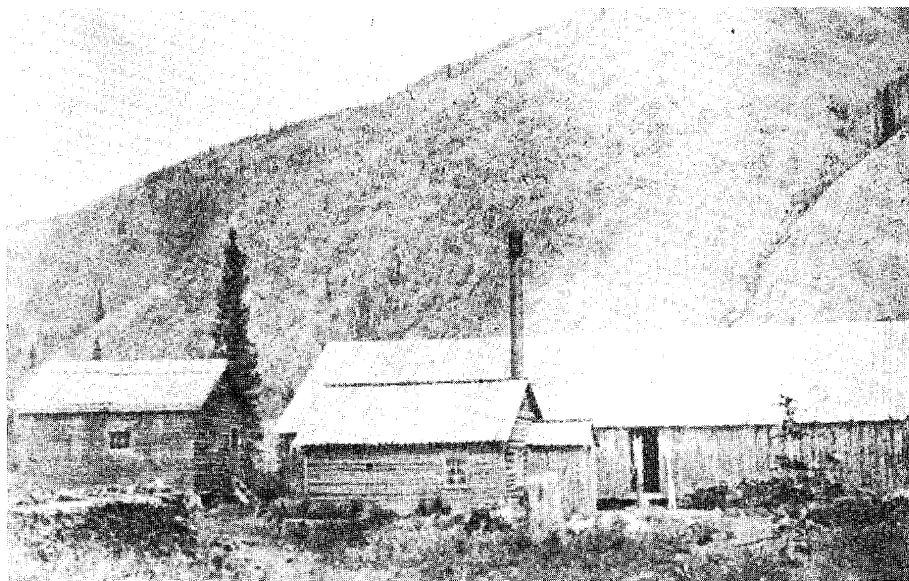
Fig. 64. Johansen's sawmill at Eagle, ca. 1901 (C. S. Farnsworth Collection, University of Alaska Archives).

No structural or material remains were found at the site of Johansen's sawmill, which was indicated only by a broad and deep deposit of sawdust along a road from the airfield toward a slough which extends between Mission Creek and the Yukon River. At one time three structures belonging to Johansen (Fig. 64) were situated on and about this deposit on his 18.30-acre tract of land, located only 300 feet from the Fort Egbert Sawmill (Building 23). In 1906 Johansen abandoned the site, however, moved the machinery to Fairbanks, and left the three structures intact on his property (Langdon 1906). Between 1906 and 1908 the military made several recommendations to purchase the buildings and acreage in order to have more control of the waterfront, to be able to handle more easily "saw logs" and

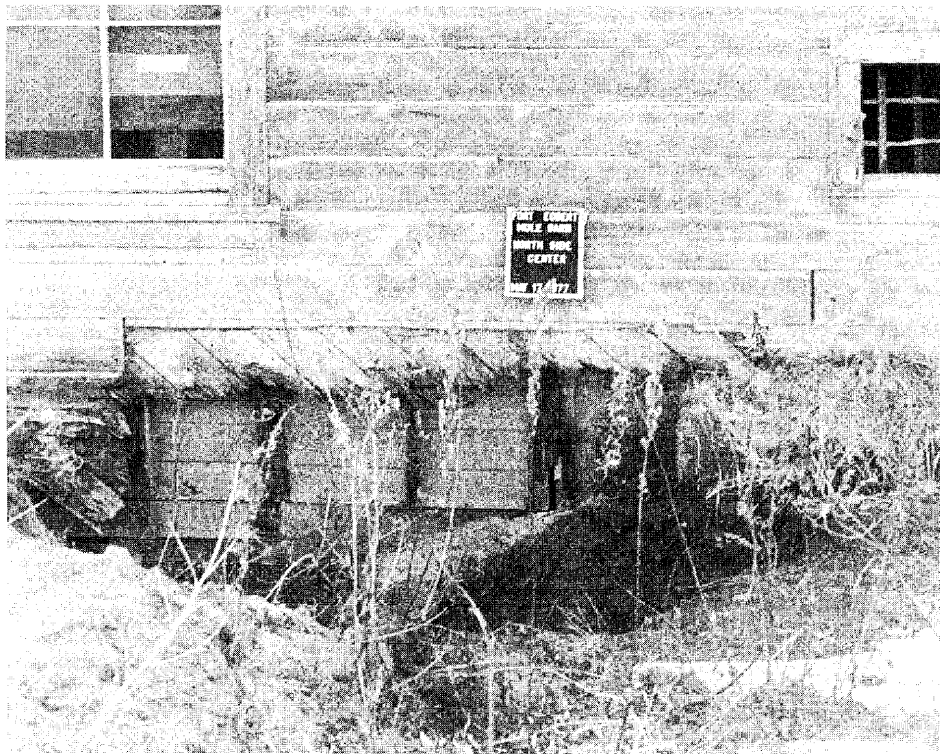
Fig. 66. BLM's 1975 test pit in area adjacent to suspected door on north side of the stables.

The research strategy suggested by us was designed to answer these questions. However, the question regarding the former presence of a door on the north side was dispensed with immediately. Inspection of exterior siding on this wall during summer 1976 revealed no break in the siding and various archival photographs contained no door. Subsurface evidence of any entryway would have been destroyed already since the suspected door fell within the area test pitted by BLM in 1975 (Fig. 66). This test

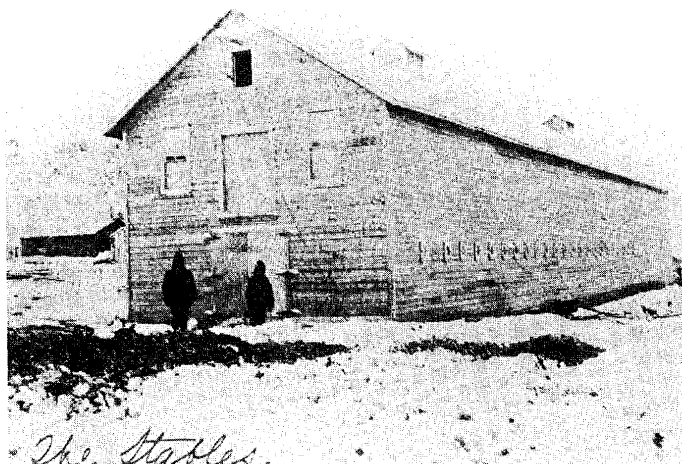
Fig. 71. Stables as they appeared upon completion in 1901 (C. S. Farnsworth Collection, University of Alaska Archives).

The Quartermaster's Stables were constructed in two phases. The first included the construction of the main floor which was completed sometime prior to May 1900 and was built by the troops at a cost of \$500 to the government for materials (Wright 1900). This portion was a one-story frame structure with drop siding, designed to house 53 animals and replaced an earlier barn. The second phase was the construction of a hay loft above the main floor which was built in 1901 (Bellamy 1909, Anonymous 1902a). The completed structure (Figs. 71, 72) was a two-story frame building measuring 30 feet (north/south axis) by 150 feet (east/west axis) with shingle roof and terra cotta chimneys, two harness rooms in addition to the 53 stalls on the main floor and two rooms on the second floor for the storage of hay and grain. The total cost for the construction of the stables was \$6,216.48 (Anonymous 1902a). In 1904, new floors were put in the stalls and the exterior of the building was painted (Anonymous 1904).

In determining activity patterns around the structure, the north and west sides can only be dealt with quickly because of their disturbance and the little information obtained through test pitting. Even so, it appears that these two sides of the stables were used less than the south or east sides. This would be expected for the west side because it faced away from the core area of the fort. An early photograph (Fig. 71) suggests that the west doors were used for removing manure from the stables.

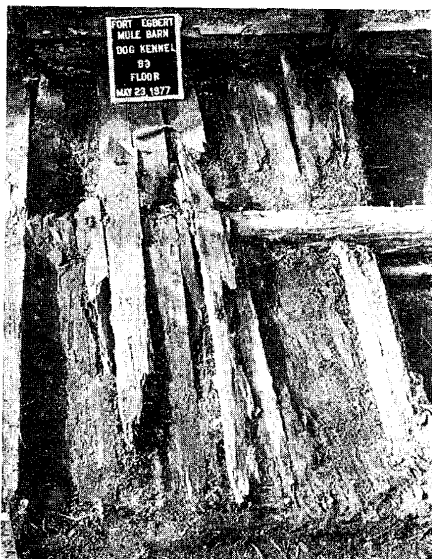
Fig. 79. Floorboards of Kennel B-3.

Because of their state of deterioration, the original kennels could not be preserved. They lacked roofing and consisted only of original walls and flooring. The walls were recorded for reconstruction and removed by the stabilization crew prior to excavations leaving the flooring to be cleared and removed by the archeological crew (Fig. 76). All the flooring was covered with vegetation (moss and grass) as well as debris (Fig. 77) that required clearing. The majority of cultural material that was retrieved from the kennels was found in the moss and grass covering (Level I). Level II was composed of excavations beneath the floor boards, extending 20 cm below the ground surface. The floor boards, once cleared, varied in their state of preservation (Figs. 78, 79).

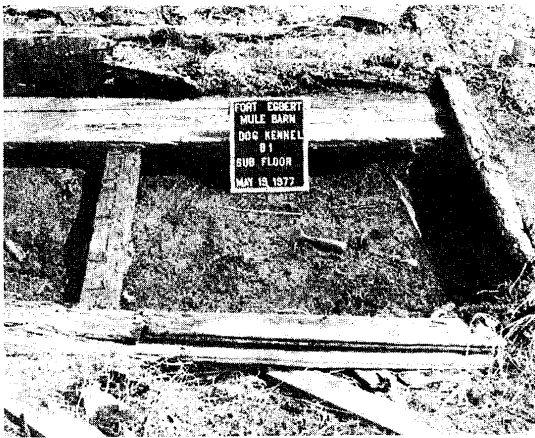
Fig. 80. Subflooring of Kennel B-1.

m in width. Construction involved the use of three 4" x 4" stringers (Figs. 74, 80)--one under the edge of the stable's south wall, one in the center of the kennel parallel to the stable's south wall, and one at the kennel's southern limit parallel to the structure's south wall placed on sandy soil. The floor boards (1-3/4" x 8" boards) were placed on top of the stringers, perpendicular to the structure's south wall. On top of the floor boards, aligned with the southern stringer, a 1-1/4" x 3" board was placed (Figs. 75, 80) as the heel plate for the kennels' wall framing.
