FORT EGBERT AND THE EAGLE HISTORIC DISTRICT

summer-1977

Results of Archeological and Historic Research

Anne D. Shinkwin, Elizabeth F. Andrews, Russell H. Sackett, and Mary V. Kroul
University of Alaska Anthropology Program—Fairbanks, Alaska

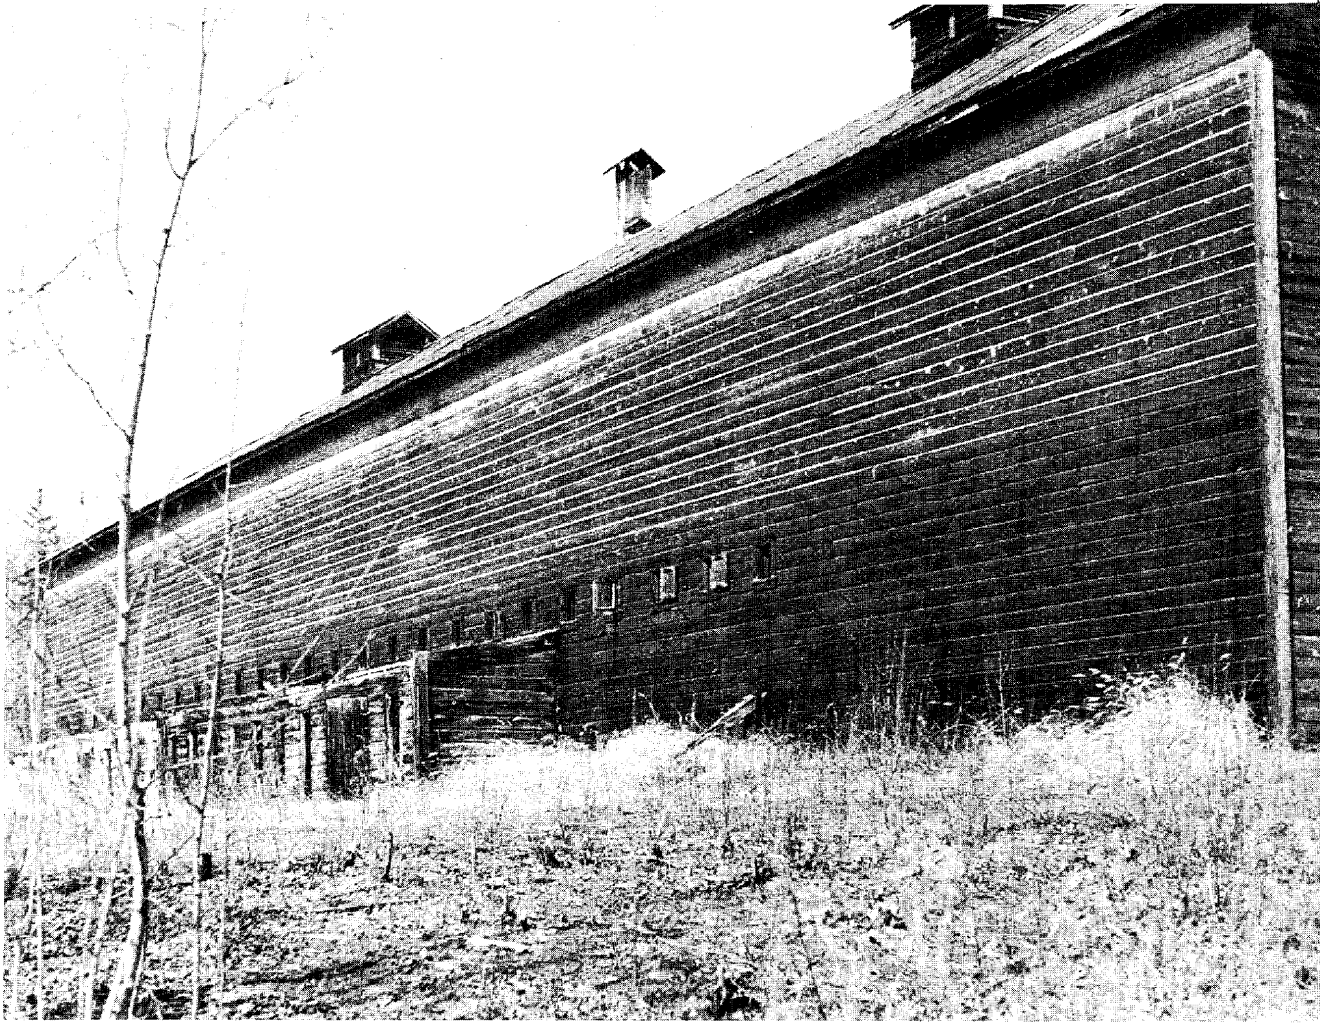
Fig. 82. Shed outline on the south wall of stables.

The second structural feature (Fig. 74) correlates with the shed that is visible in Fig. 73. This shed probably existed prior to the construction of the dog kennels, as discussed above, and its outline can be seen on the stable's south wall, defined by the absence of white paint (Fig. 82) which is still visible between the boards. This unpainted area begins 18.91 m east of the southwest corner of the structure and continues to the southeast corner defining the length of the shed as 28.37 m. The roof height of the shed was 3.3 m against the stable, slanting south to an unknown height. The width of the shed was defined by a coal deposit along what would have been the structure's west wall and two post holes (Figs. 74, 83) from its south wall. The coal deposit extended from the stable's south wall to a point 5.2 m south. The centers of both post holes (30 cm in diameter) were 4.7 m south of the stable's south wall. On the south side of one post hole (Fig. 83), a line (15 cm wide) of stained soil that denoted the shed roof's drip line was found. From these remains, it can be determined that the shed's dimensions were approximately 5 m x 28 m.

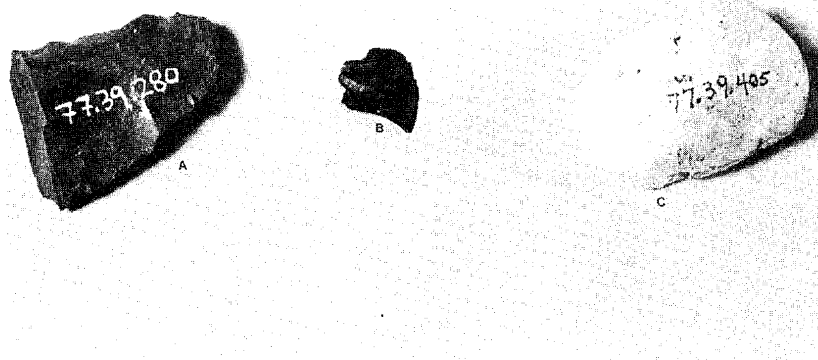
The bulk of this material consisted of eight flakes (Fig. 100:b). Stone types include: basaltic glass (#565), devitrified obsidian (#228, 352), and chert (#219, 401). All of this debitage is of interior flakes with six (#219, 228, 352, 401) representing fine retouch flakes.

One biface fragment (#280, Fig. 100:a) recovered from the shed area is of chert and measures 3.5 cm long, 2.7 cm wide, 1.0 cm thick, and weighs 9.4 gr.

Fig. 100. Lithic material: A--Biface fragment; B--Flake; C--Retouched quartz pebble. (Length of A = 3.4 cm)

The remaining lithic piece is a quartz pebble (#405) that has been flaked on one end. This pebble (Fig. 100:c) is 3.6 cm long, 2.5 cm wide, 1.5 cm thick, and weighs 20.8 gr.
