1993 SHORELINE ASSESSMENT DATA REPORT: VOLUME 2 (Ground Surveys EV037A through KN136A)

Alaska Department of Environmental Conservation (ADEC)
Exxon Valdez Oil Spill Restoration
410 Willoughby Avenue
Juneau, Alaska 99801

Project #930380

SEGMENT: EV 037 A

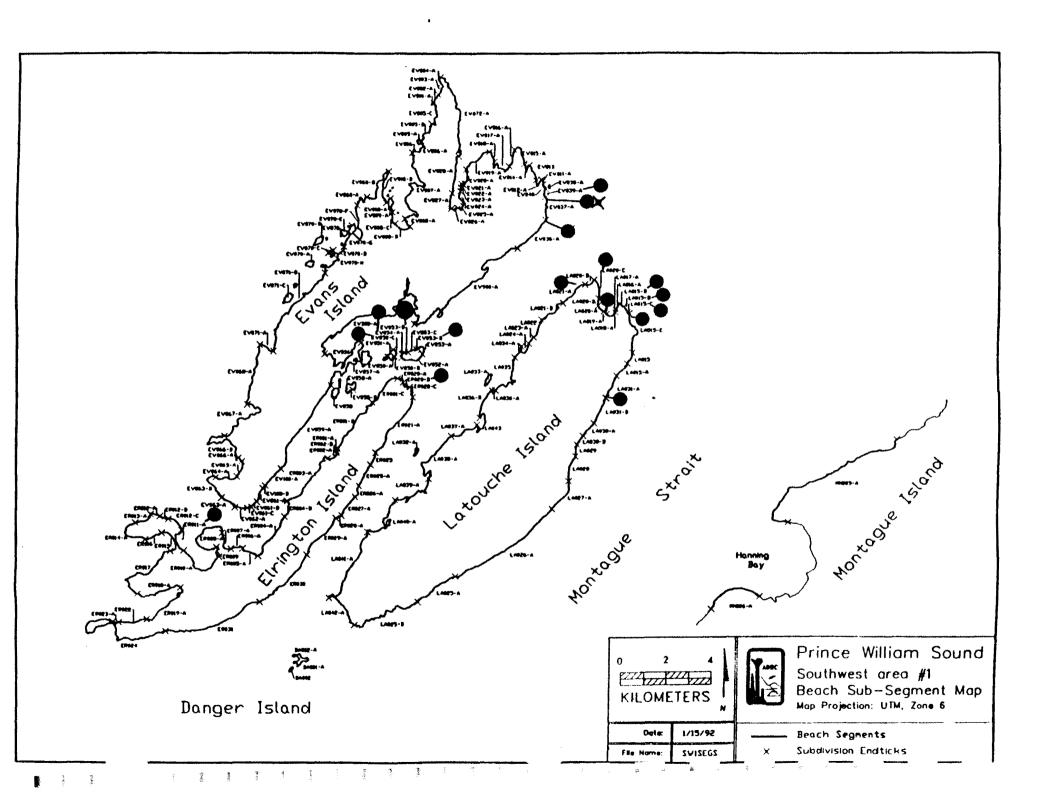
In beach 'A' one area with significant subsurface oiling remains. This area is associated with surface location 'A' on the 1993 survey. Here OP oil is associated with AP among boulders. Another area described by the pits 3 through 9, 11, and 12 showed great improvement since 1992 and 1991. Aggressive treatment in 1992, which included oiled-sediment removal, caused this improvement. In beach 'B' newly discovered subsurface oil, including OP, was found to occur discontinuously across the central part of the beach. Overall, the amount of subsurface oil surveyed greatly increased from 1991 to 1993. This is largely due to a more thorough 1993 survey in the area of surface location 'A' (see sketch map).

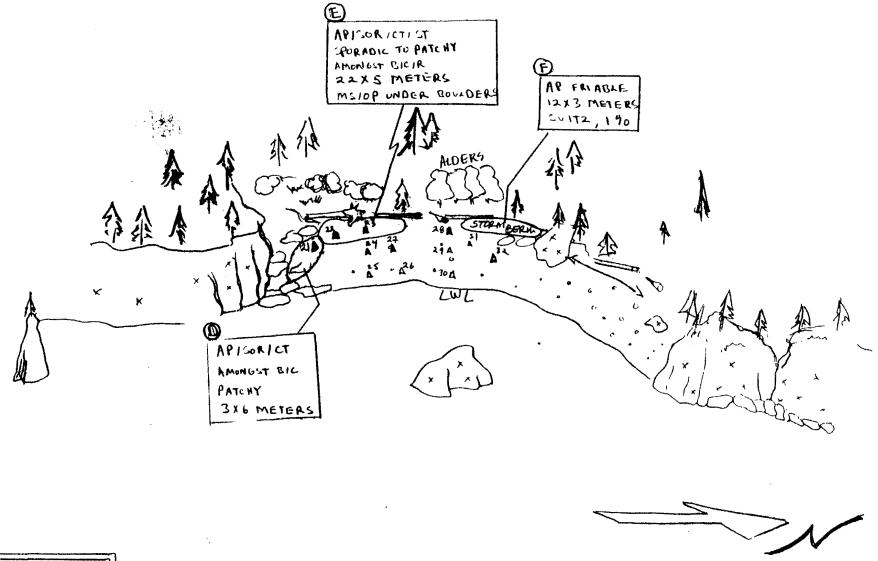
EV-37A SKETCH "B" 8/1/93

BOLLING IN SKETCH "A"... at southern end of Beach, oil persists as patchy AP in BOLLING IN SKETCH "A"... at southern end of Beach, oil persists as patchy AP in BOLLING FIELD " 8 THE IOM WIDE - inling appears to HAVE permeated surface secundary to underlying peat in area of purs #3-5- viling then reappears at worthern end as prisisting AP interstially located under Boulders.

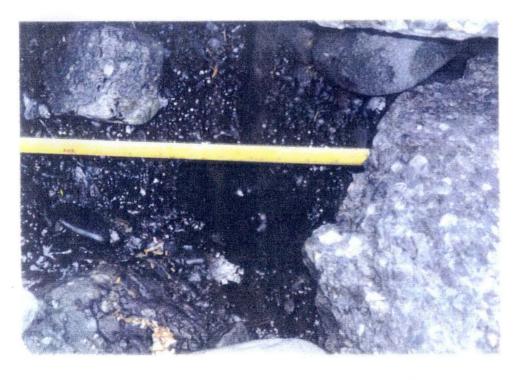
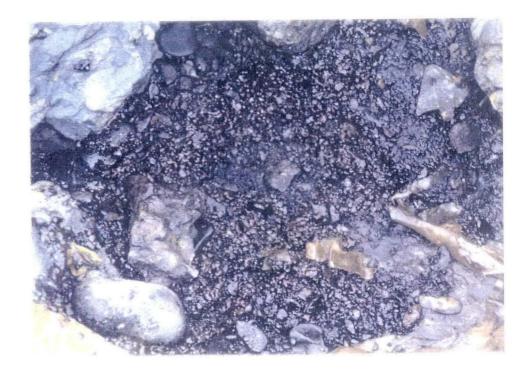
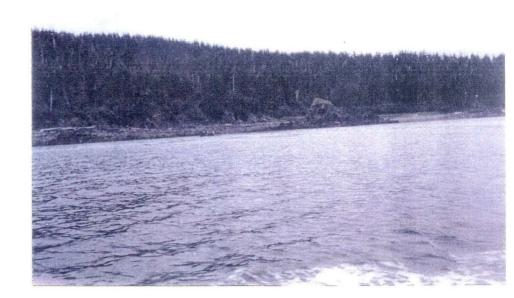
TAKEN BY: RUSSELL	KUNIBE FRAME #:	4	INITIALS: O
DUIL #: 3341400-	•

IS A CLOSE UP OF THE SAME AP.

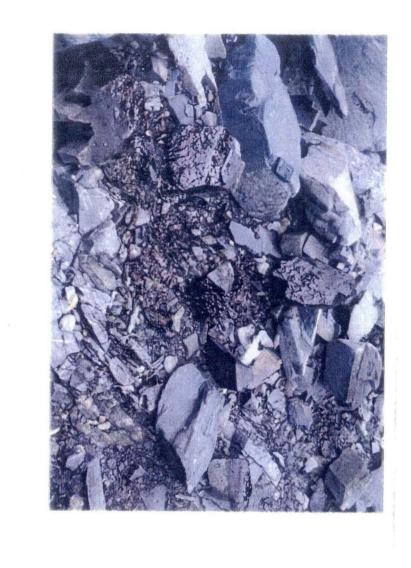
TAKEN BY: RUSSELL KUNIBE INITIALS: ROLL #: 93RTK002 FRAME #: 16 EVIDENCE ID#:

REASON FOR TAKING PHOTO: PHOTO OF SURFACE AP AND AND SOR OILING IN LOC D BEACH B. PHOTO 93RTK002 #17 IS AN OVERVIEW OF THIS AREA.

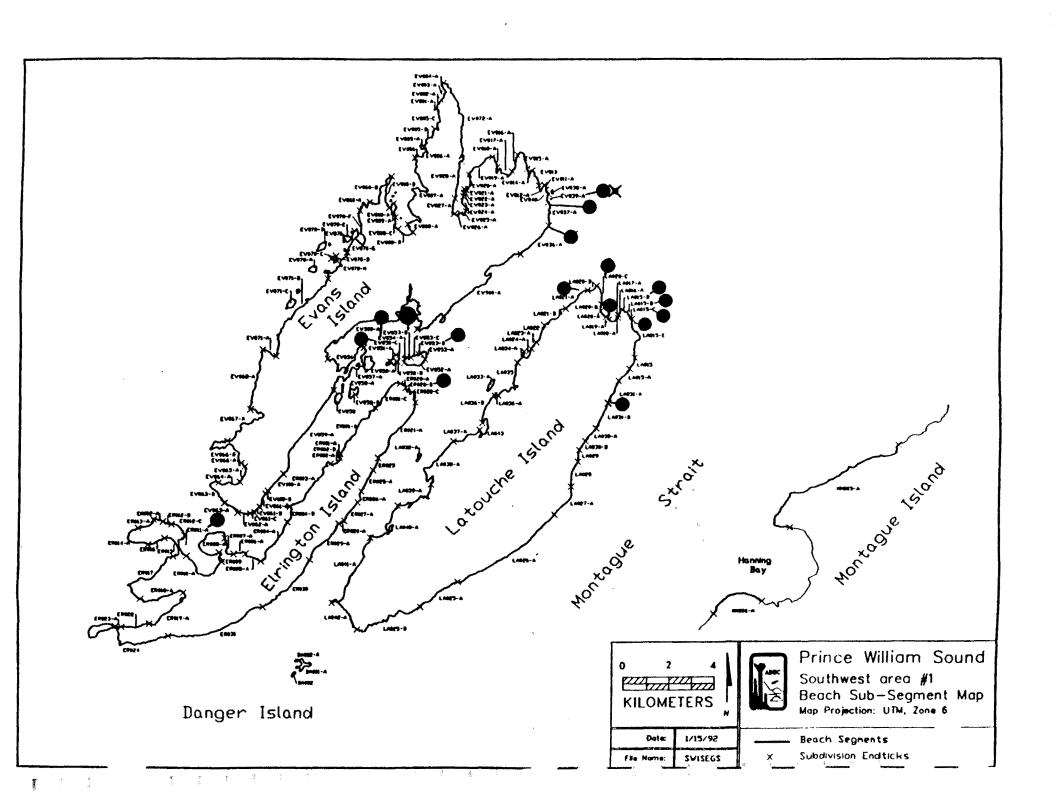
A large area of soft and friable AP is present on the south part of this site (surface location 'A'). The AP is as much as 25 cm thick and thus, by definition, is associated with subsurface oil. The oil is among boulders and in bedrock fractures. Two other smaller and less concentrated areas of AP and SOR also are present in boulder and bedrock settings. There has been no measurable improvement in the amount of surface oil since 1991.

The only significant subsurface oil remaining at this site coincides with AP in surface location 'A' as described above. There have been significant decreases in subsurface oil at several locations at this site. Much of the decrease can be attributed to aggressive treatment in 1991 that included mechanical tilling and oiled-sediment removal.

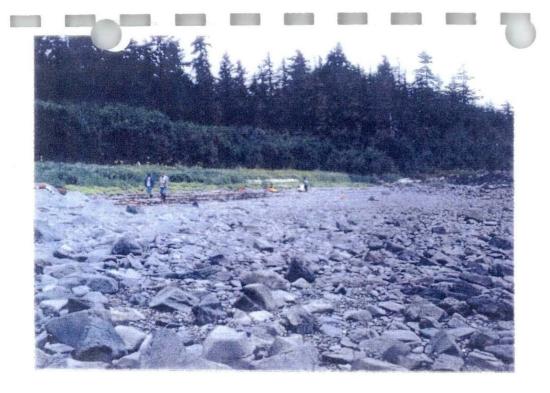
ROLL #: 93RTK002 FRAME #: 25 EVIDENCE 1D#:_____

REASON FOR TAKING PHOTO: PHOTO OF OILING IN THE FRACTURES OF

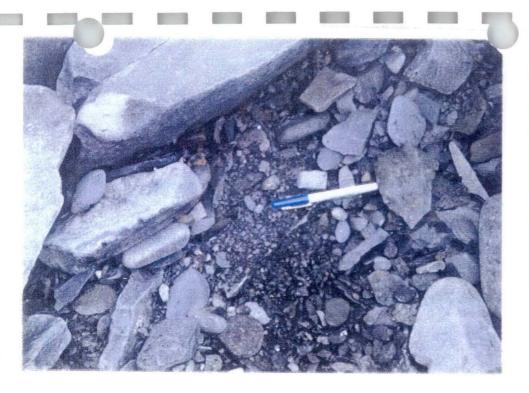
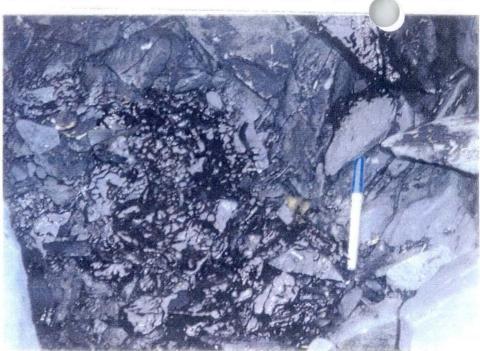
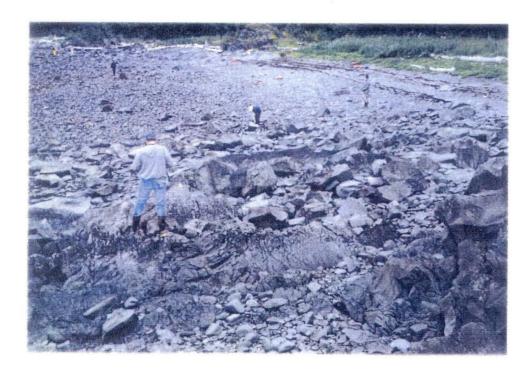
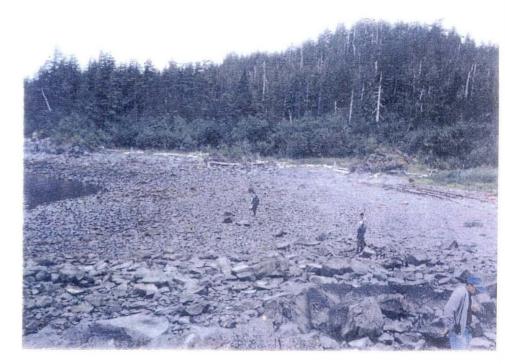
TAKEN BY: RUSSELL KUNIBE INITIALS: Kt K PROLL #: 93RTK002 FRAME #: 29 EVIDENCE ID#:

REASON FOR TAKING PHOTO: PHOTO OF PIT # 15 (OVERVIEW) C CROSBY AND D.MUNSON ARE KNEELED OVER THE PIT. THE PIT WAS LOCATED JUST BELOW THE LAST HIGH TIDE LINE.

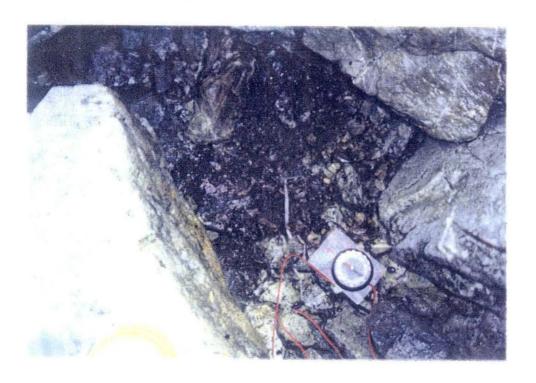
KEYWORDS: SHORELINE EVALUATION-SRVY REASON FOR TAKING PHOTO: PHOTO CLOSE UP OF BROKEN AP IN THE HITZ. IN LOCATION F.

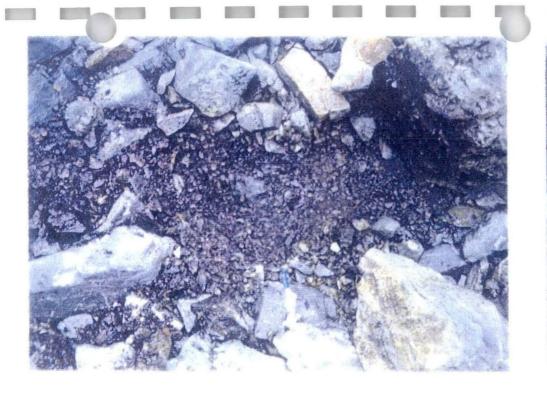
TAKEN BY: RUSSELL KUNIBE ROLL #: 93RTK003 FRAME #: 6 EVIDENCE ID#:

REASON FOR TAKING PHOTO: OVERVIEW PHOTO TO THE SOUTH. GOES WITH 93RTK003 #07 TO SHOW THE ROCK WHICH ARE INFRONT OF THIS BEACH DURING LOW TIDE.

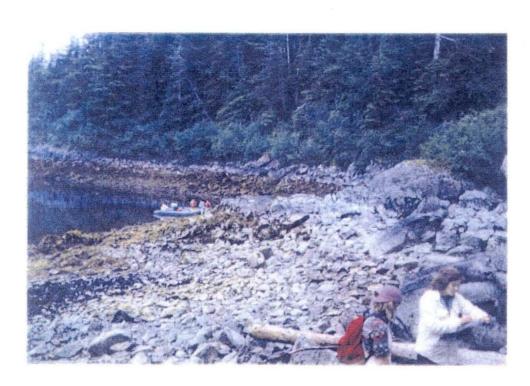
FRACTURES IN LOCATION B.

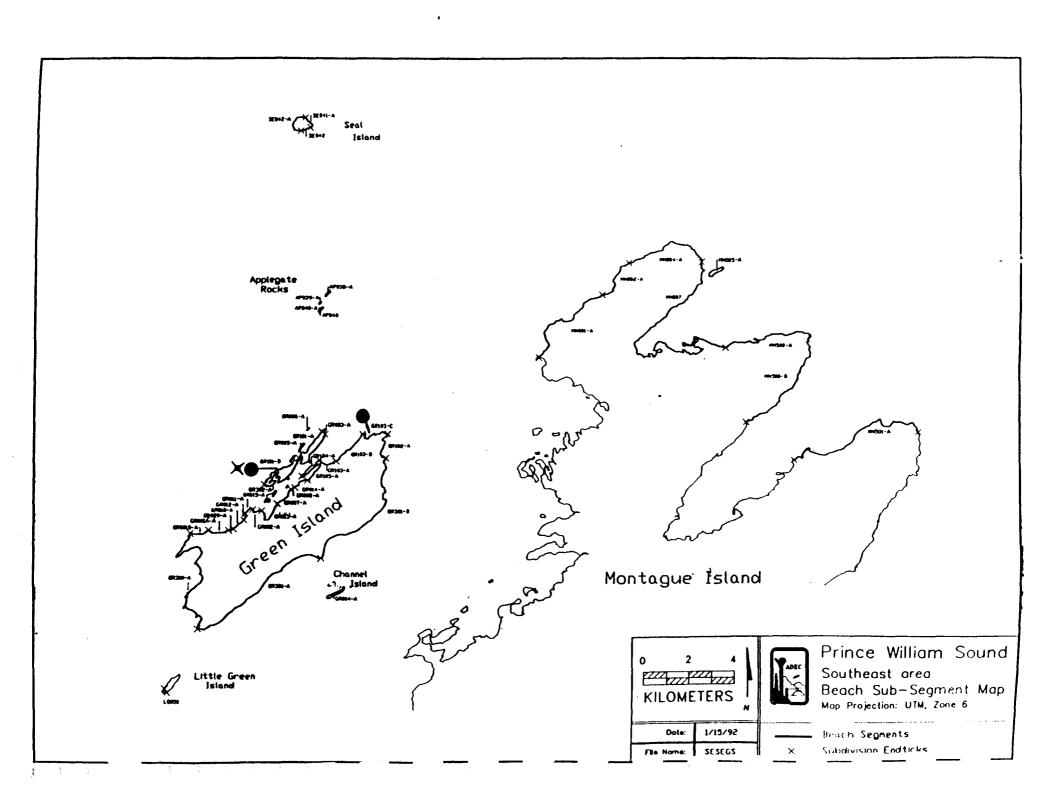
Subsurface oil occurs as an MOR area encompassed by a LOR area. of considerable extent. This same location had HOR oil in 1992 and thus has probably experienced significant improvement since 1992. The actual amount of oil measured is greater in 1993 than in 1992, but this is due to an under estimation of the size of the affected area by surveyors in 1992.

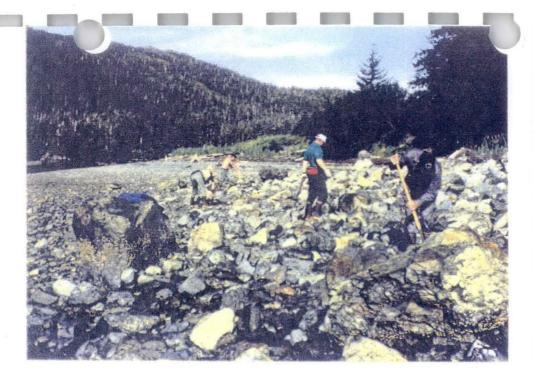
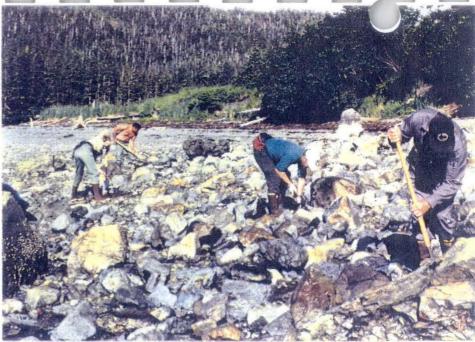
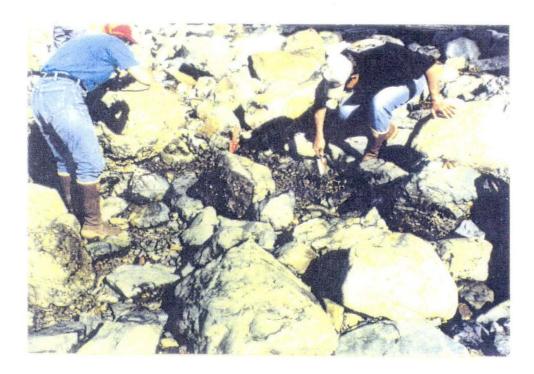
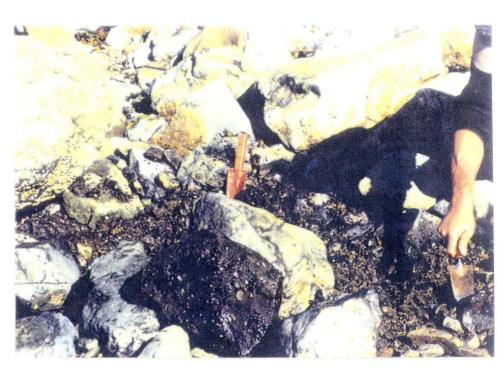
DATE: 06/24/93 OFFICE: ANCHORAGE STATION: -0-SEGMENT: IN031 LOCATION: INGOT ISLAND KEYWORD: -0-EASON FOR TAKING PHOTO: SURVEY CREW LOCATION B-BOULDER FIELD WITH ASPHALT AND SUBSURFACE HOR. INITIALS: KEN BY: MARIANNE PROFITA 5 EVIDENCE ID#: FRAME #: LL #:93MSP004 OFFICIAL PHOTOGRAPH ADEC EXXON VALDEZ OIL SPILL OFFICE: ANCHORAGE DATE: 06/24/93 TIME: -0-SEGMENT: IN031 STATION: -0-LOCATION: INGOT ISLAND KEYWORD: -0-REASON FOR TAKING PHOTO: HOR UNDER BOULDER COBBLE. TAKEN BY: MARIANNE PROFITA INITIALS: ROLL #:93MSP004 FRAME #: 7 EVIDENCE ID#: Taken by:

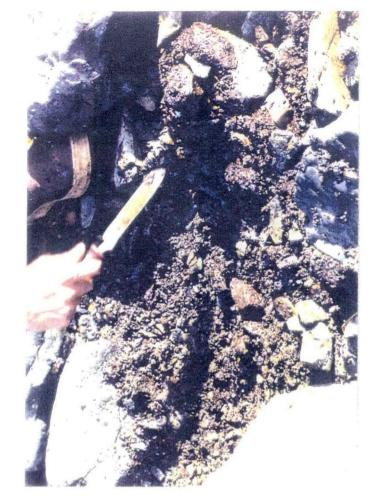
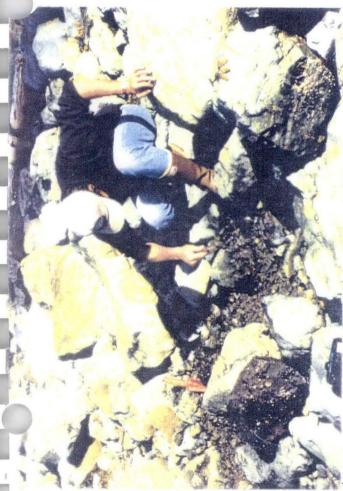
TAKEN BY: MARIANNE PROFITA INITIALS: ROLL #:93MSP004 FRAME #: 9 EVIDENCE ID#: OFFICIAL PHOTOGRAPH ADEC EXXON VALDEZ OIL SPILL OFFICE: ANCHORAGE DATE: 06/24/93 TIME: -0-SEGMENT: IN031 STATION: -0-LOCATION: INGOT ISLAND KEYWORD: -0-REASON FOR TAKING PHOTO: SUBSURFACE HOR IN COBBLE PEBBLE. TAKEN BY: MARIANNE PROFITA INITIALS: ROLL #:93MSP004 FRAME #: 11 EVIDENCE ID#: Roll #: 93msp004 Frame #: 18

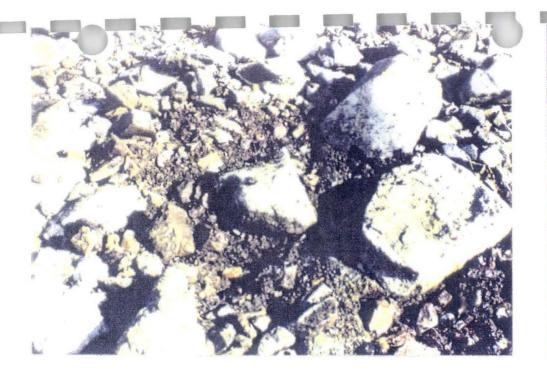
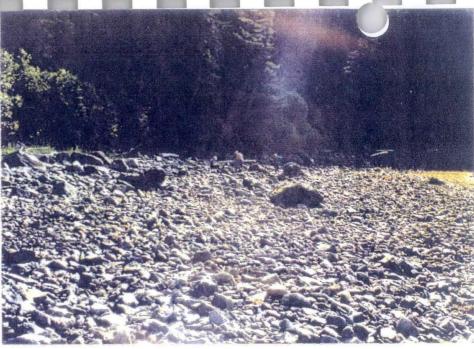
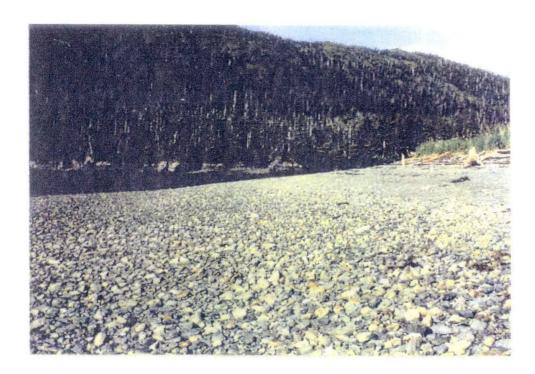
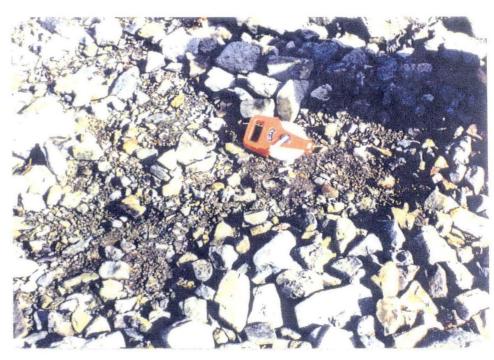
OFFICE: ANCHORAGE DATE: 06/24/93 TIME: -0-	
SEGMENT: IN031 STATION: -0- LOCATION: INGOT ISLAND KEYWORD: -0-	
ASON FOR TAKING PHOTO: OVERVIEW LOCATION B AND C LO EAST.	OKING
EN BY: MARIANNE PROFITA INITIALS: L #:93MSP004 FRAME #: 15 EVIDENCE ID#:	_
Taken by: M. PROK h	
Roll #: 93/1159 004 Frame #:	
e somprosenta energia de la compresa esc	T
	464
OFFICIAL PHOTOGRAPH ADEC EXXON VALDEZ OIL SPIL	L
OFFICIAL PHOTOGRAPH ADEC EXXON VALDEZ OIL SPIL DFFICE: ANCHORAGE DATE: 06/24/93 TIME: -0-	
OFFICE: ANCHORAGE DATE: 06/24/93 TIME: -0- SEGMENT: IN031 STATION: -0- LOCATION: INGOT ISLAND	
OFFICE: ANCHORAGE DATE: 06/24/93 TIME: -0- SEGMENT: IN031 STATION: -0-	
SEGMENT: IN031 STATION: -0- LOCATION: INGOT ISLAND (EYWORD: -0- LSON FOR TAKING PHOTO: ASPHALT BEFORE BREAKUP IN LOC	ATION
SEGMENT: IN031 STATION: -0- LOCATION: INGOT ISLAND SEYWORD: -0- ISON FOR TAKING PHOTO: ASPHALT BEFORE BREAKUP IN LOC A. EN BY: MARIANNE PROFITA INITIALS: #:93MSP004 FRAME #: 18 EVIDENCE ID#:	ATION

SEGMENT: IN031 STATION: -0- LOCATION: INGOT ISLAND SEYWORD: -0- ASON FOR TAKING PHOTO: ASPHALT BEFORE BREAKUP IN LOC A. EN BY: MARIANNE PROFITA INITIALS:	ATION

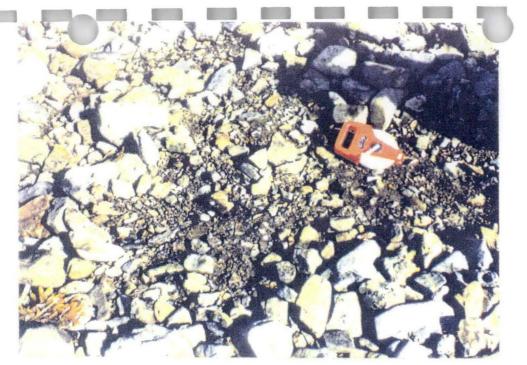
OFFICIAL PHOTOGRAPH ADEC EXXON VALDEZ OIL SPILL
OFFICE: ANCHORAGE DATE: 06/24/93 TIME: -0-
SEGMENT: IN031 STATION: -0- LOCATION: INGOT ISLAND KEYWORD: -0- REASON FOR TAKING PHOTO: ASPHALT WHICH EXTENDS SUBSURFACE HOR.
TAKEN BY: MARIANNE PROFITA ROLL #:93MSP004 FRAME #: 13 EVIDENCE ID#:
Taken by: M. PROFITA
Roll #: 93/15/004 Frame #: 13/13
And the second s
OFFICIAL PHOTOGRAPH ADEC EXXON VALDEZ OIL SPILL
OFFICE: ANCHORAGE DATE: 06/24/93 TIME: -0-
SEGMENT: INO31 STATION: -0- LOCATION: INGOT ISLAND KEYHORD: -0-
REASON FOR TAKING PHOTO: OVERVIEW LOOKING WEST TO LOCATION A.
AKEN BY: MARIANNE PROFITA INITIALS:OLL #:93MSP004 FRAME #: 16 EVIDENCE ID#:
Taken by: M. PROfita-
Roll #: 93/h5/'004 Frame #:

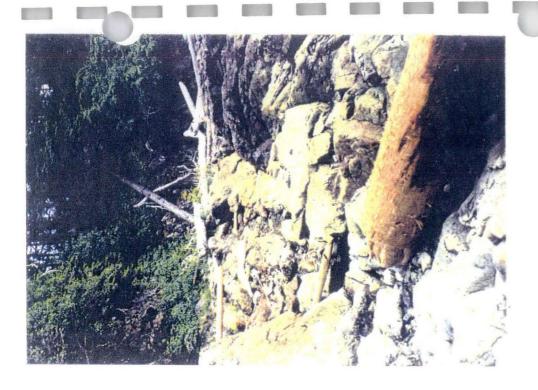
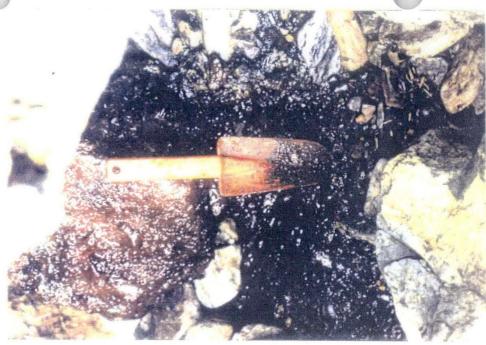
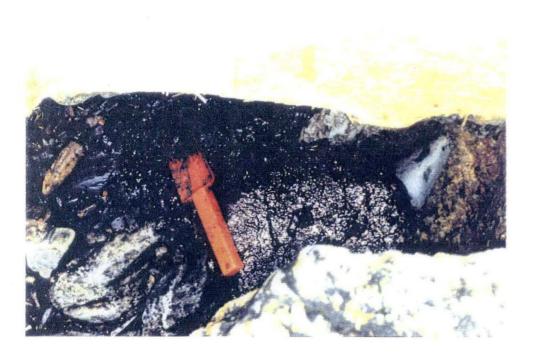
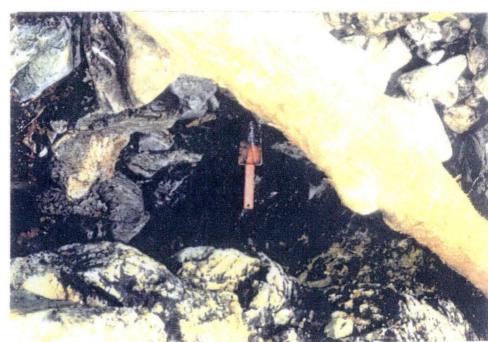
OFFICIAL PHOTOGRAPH ADEC EXXON VALDEZ OIL SPILL
	OFFICE: ANCHORAGE DATE: 06/25/93 TIME: -0-
R	SEGNENT#: IN033 STATION#: -0- LOCATION: INGOT ISLAND KEYWORDS: -0- EASON FOR TAKING PHOTO: MS/OP UNDER BEDROCK CLIFF OVERHANG IN BOULDER/COBBLE.
	KEN BY: MARIANNE PROFITA INITIALS:
	Taken by: Pa ofita
	Roll #: 93MSPOST Frame #:30
Dec 1181	
5-20	
	OFFICIAL PHOTOGRAPH ADEC EXXON VALDEZ OIL SPILL
	OFFICE: ANCHORAGE DATE: 06/25/93 TIME: -0-
KEY	SEGMENT#: IN033 STATION#: -0- LOCATION: INGOT ISLAND WORDS: -0-
REAS	ON FOR TAKING PHOTO: OVERVIEW OF AREA CONTAINING MOUSSE/OP UNDER BOULDER/COBBLE.
	BY: MARIANNE PROFITA INITIALS:
	Taken by: M. Pasifita
	Roll #: 93/115P005 Frame #: 27

OFFICIAL	PHOTOGRAPH	ADEC	EXXON	VALDEZ OIL SP	ILL
0	FFICE: AND	CHORAGE D	ATE: 06	5/25/93	TIME: -()-
KEYW	LOCATION: ORDS: -0- N FOR TAKI	T#: INO33 INGOT ISLAN NG PHOTO: P ER/COBBLE U	D HOTO SH	OWING OT	TATION#: -O- LING CONDITION ERHANG	IN
TAKEN E ROLL #:		NE PROFITA		INITI	ALS:	
Tak	en by:	11. 1	PROS	+110-		
Ro	11 #:931m	1005 F	rame #:	3	1	_
o la	OFFICIAL F	HOTOGRAPH	ADEC	EXXON V	ALDEZ OIL SPIL	L
OF	FICE: ANCH	ORAGE DA	TE: 06/	25/93	TIME: -0-	
KEYWOR	DCATION: I	#: INO33 NGOT ISLAND G PHOTO: MS			ATION#: -0- ER/COBBLE.	
AKEN BY	': MARIANNI 93MSP005	PROFITA FRAME #:	28 E	INITIAL EVIDENCE	S:ID#:	_
Take	n by:	19. 6	Roti	itz		
			distant attended to	THE PERSON NAMED IN

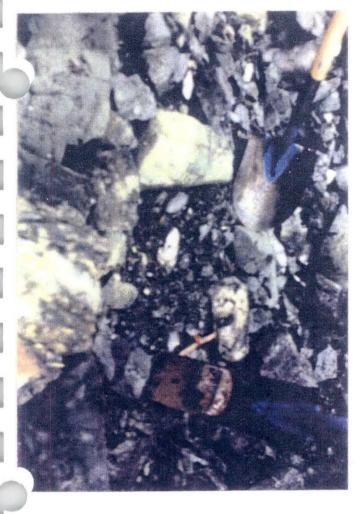
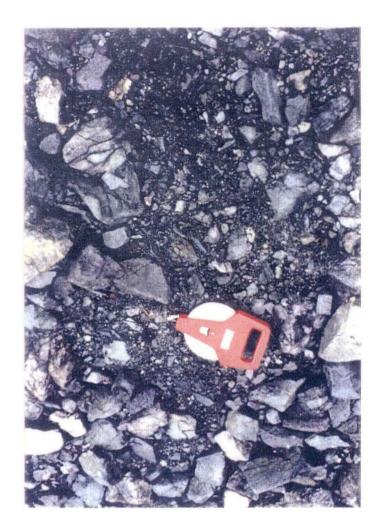
REYMORD: -0- REASON FOR TAKING PHOTO:Broken up asphalt - same area as photos #22-#24. REASON FOR TAKING PHOTO:Broken up asphalt - same area as photos #22-#24. REASON FOR TAKING PHOTO:Broken up asphalt - same area as photos #22-#24. REASON FOR TAKING PHOTO:Asphalt patches below large boulders with spruce needles attached. REASON FOR TAKING PHOTO:Asphalt patches below large boulders with spruce needles attached. TAKEN BY: Marianne Profita INITIALS: ROLL #: 93MSP002 FRAME #: 30 EVIDENCE ID#:	
OFFICIAL PHOTOGRAPH ADEC EXXON VALDEZ OIL SPILL OFFICE: ANCHORAGE DATE: 06/22/93 TIME: 0900 SEGMENT#: KN0132 STATION#: -0- LOCATION: Knight Island KEYWORDS: -0- REASON FOR TAKING PHOTO: Asphalt patches below large boulders with spruce needles attached.	FOR TAKING PHOTO:Broken up asphalt - same area as photos #22-#24.
OFFICIAL PHOTOGRAPH ADEC EXXON VALDEZ OIL SPILL OFFICE: ANCHORAGE DATE: 06/22/93 TIME: 0900 SEGMENT#: KN0132 STATION#: -0- LOCATION: Knight Island KEYWORDS: -0- REASON FOR TAKING PHOTO: Asphalt patches below large boulders with spruce needles attached.	93MSP002 FRAME #: 26 EVIDENCE ID#:

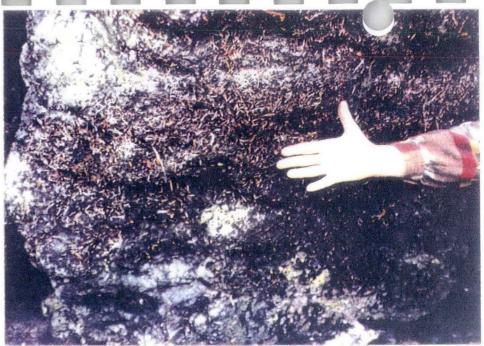
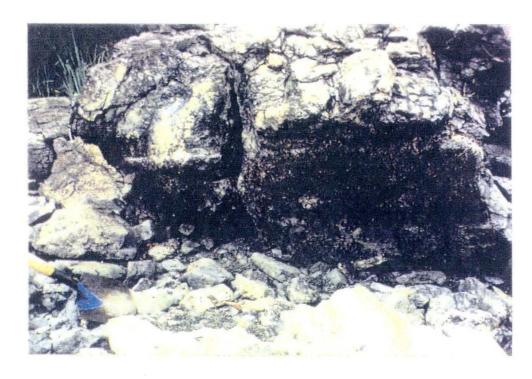
OFFICE: ANCHORAGE DATE: 06/22/93 TIME: -0
SEGMENT#: KN0132 STATION#: -0LOCATION: KNIGHT ISLAND
KEYWORDS: -0REASON FOR TAKING PHOTO:SPRUCE NEEDLES IN TAR STUCK TO LARGE
BOULDERS.

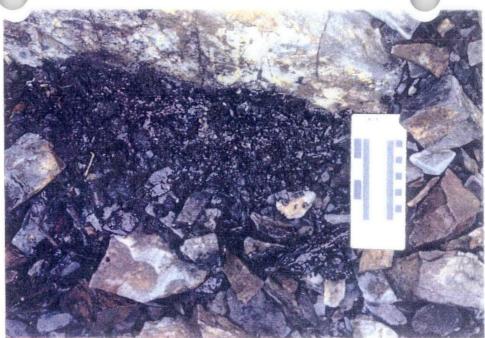
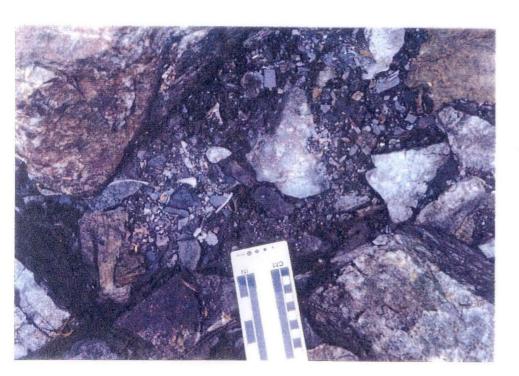
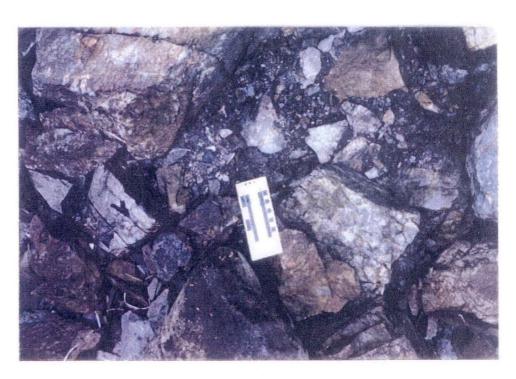
Date:	July	19,	1993	_Time:	09:37	(9:37	am)
	on (segn			KN13	5 Area		
Reasor	n for tak	lna ph	oto: _	SOR,	weather	red or	top,
HSC							
Taken I	by:L.	J. E	vans	196)		
	LJ			/

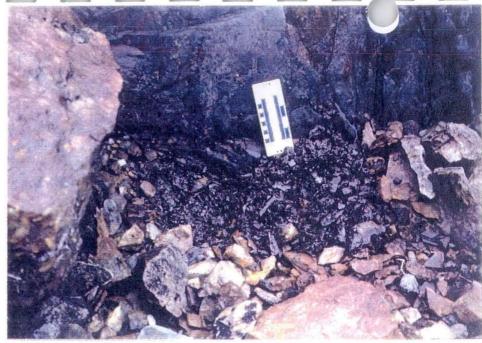
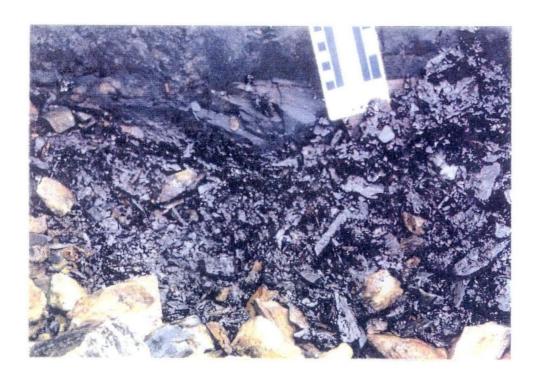
Date: July 19, 1993 Time: 10:00 (10:00 am) Location (segment #): KN135 Area E Reason for taking photo: ${\color{blue} {HSOR}}$ in boulders Taken by: L.J. Evans Roll #: __LJE002 Frame #: __017

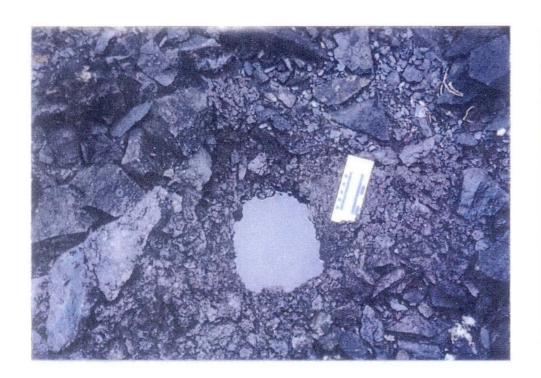
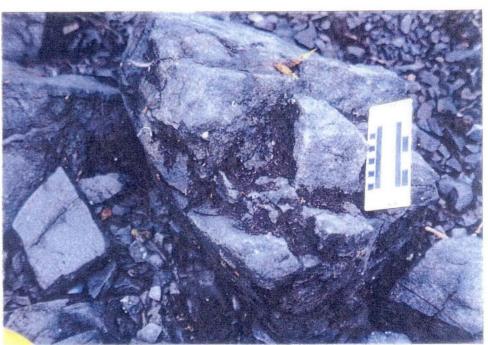
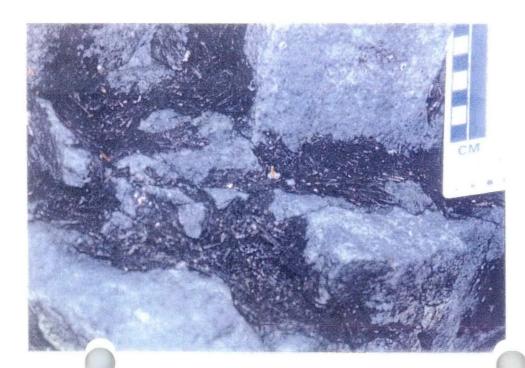
Reason for taking photo: Closeup of cover/coat
with spruce needles, located in Area C
