# 1993 SHORELINE ASSESSMENT DATA REPORT: VOLUME 5 (Transect Surveys)

Alaska Department of Environmental Conservation (ADEC)  
Exxon Valdez Oil Spill Restoration  
410 Willoughby Avenue  
Juneau, Alaska 99801

Project #930380

January, 1994

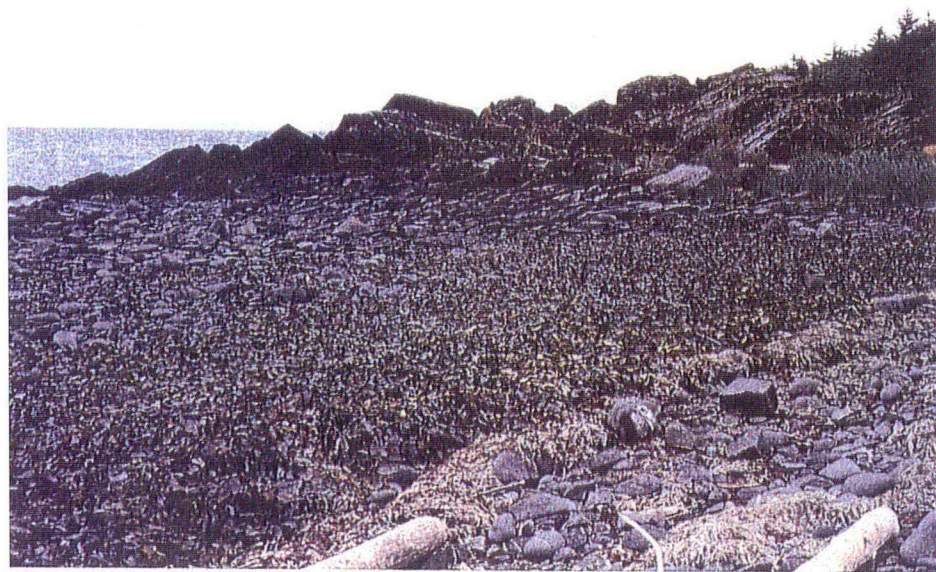
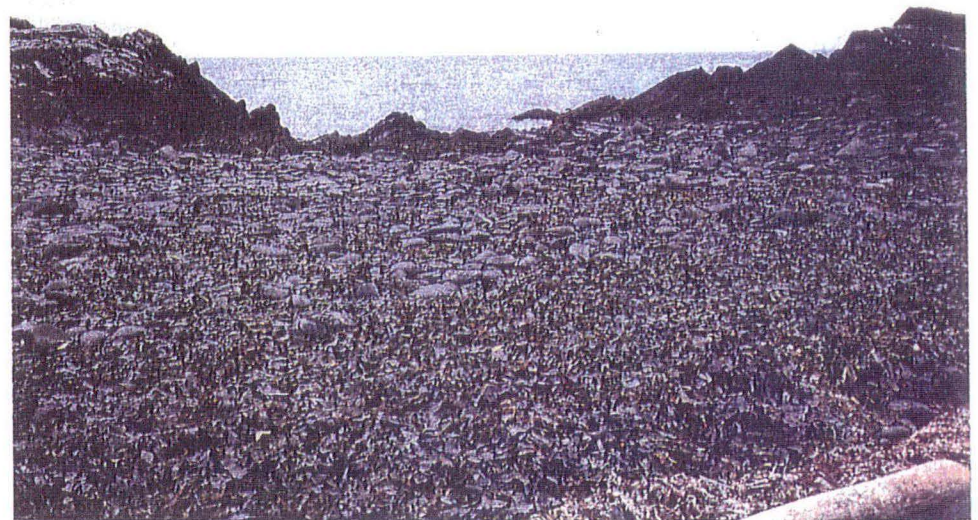
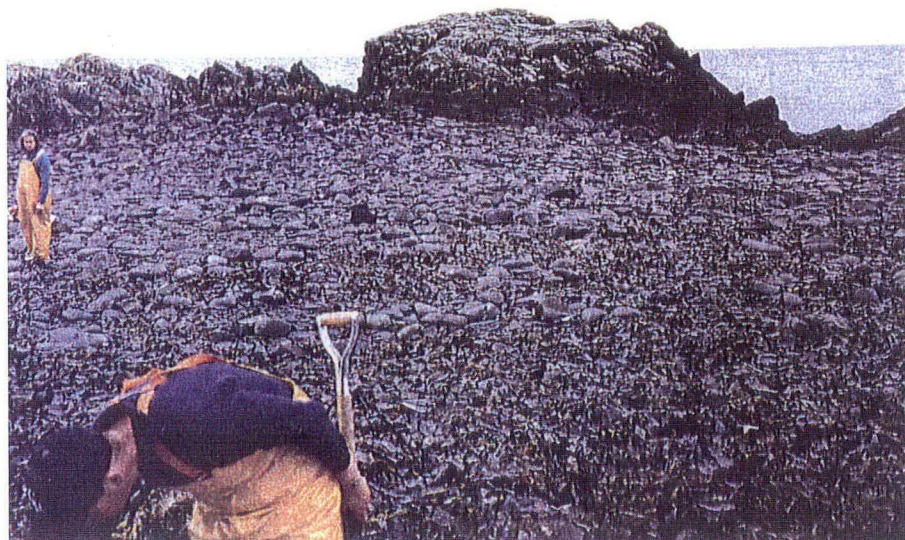
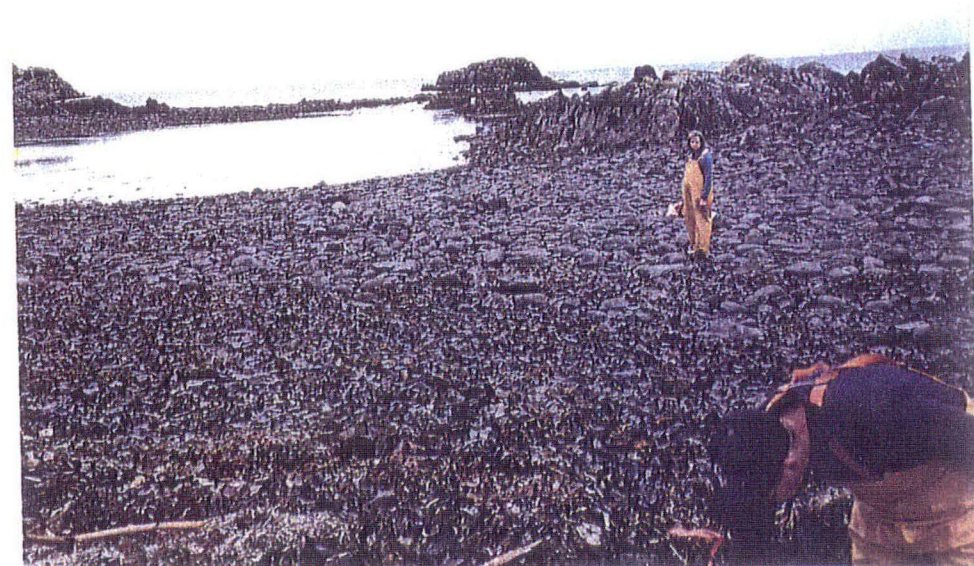
REASON FOR TAKING PHOTO: Pan (27-29) of beach to the south of  
ADEC station #20 showing bedrock outcrop and  
weather station. Orange flagging mark pit  
locations.

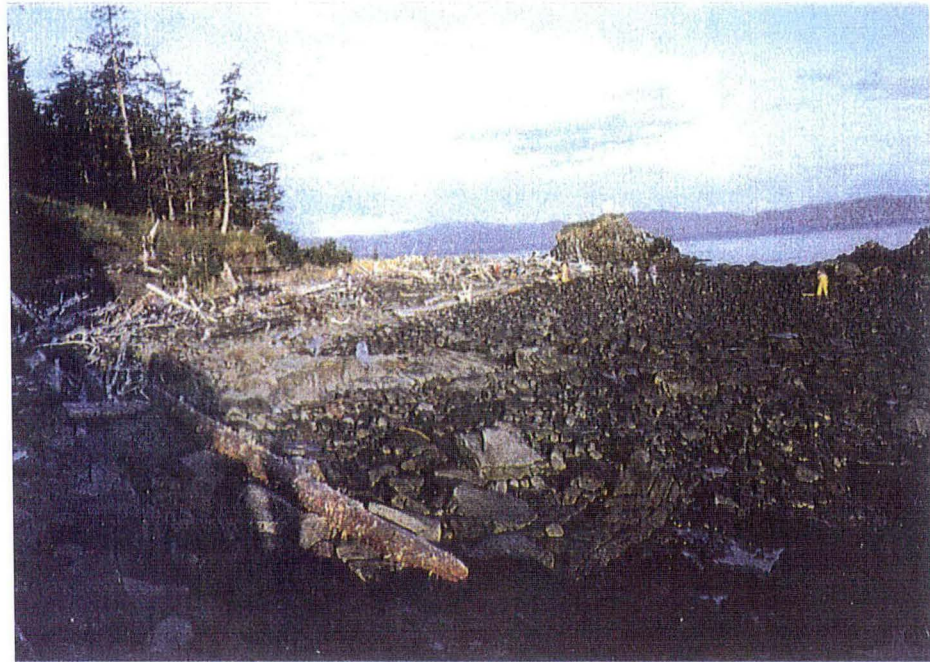
OFFICIAL PHOTOGRAPH ADEC EXXON VALDEZ OIL SPILL  
OFFICE: ANCHORAGE DATE: 08/18/93 TIME: 1000  
STATION#: NOAA #3  
SEGMENT#: SM006  
LOCATION: Smith Island, P.W.S.  
KEYWORDS: -0-  
REASON FOR TAKING PHOTO: Pan (13-24) from eastern end of  
sub-segment to north and west. The survey crew is  
located along transect profile.  
TAKEN BY: Clara S. Crosby INITIALS: \_\_\_\_\_  
ROLL #: 93CSC002 FRAME #: 24 EVIDENCE ID#: \_\_\_\_\_

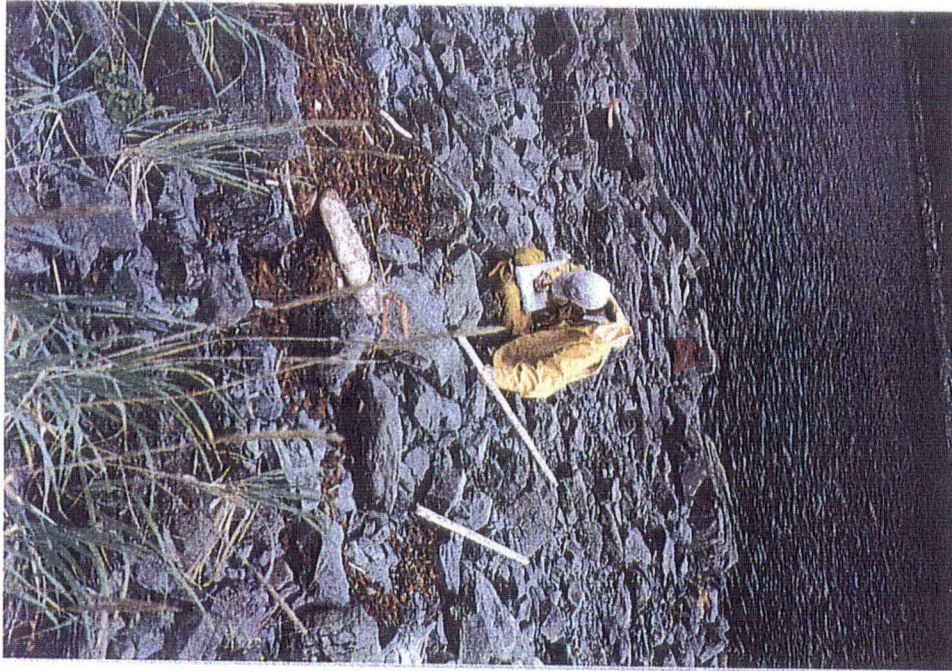
REASON FOR TAKING PHOTO: NOAA station #6; view is from western side of transect and of location of pit "D" (orange flagging)

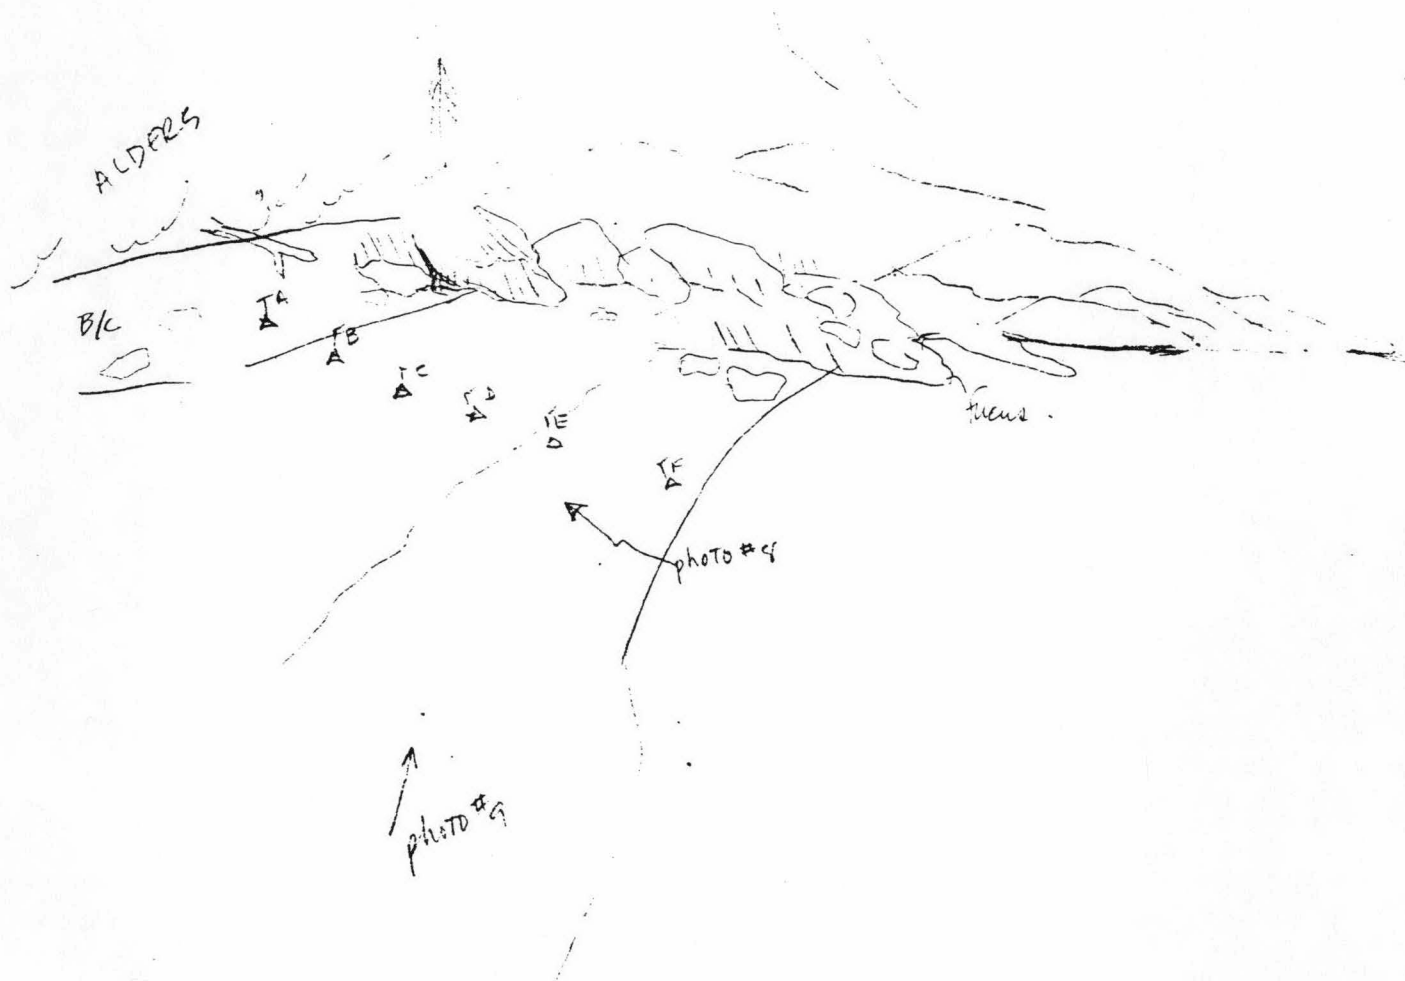
N-13  
General overview -

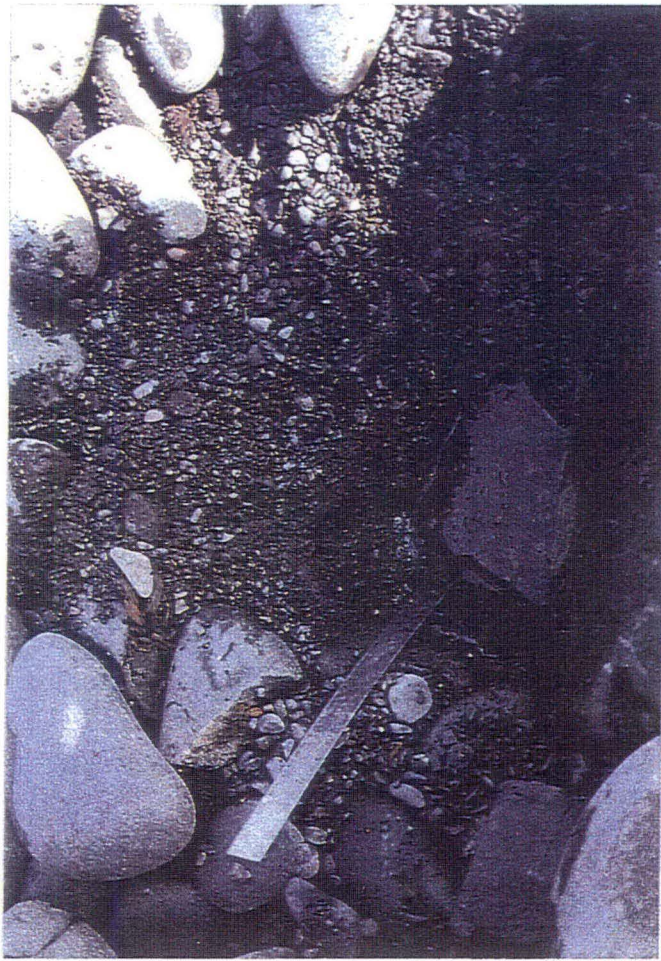
OFFICIAL PHOTOGRAPH ADEC EXXON VALDEZ OIL SPILL  
OFFICE: ANCHORAGE DATE: 09/14/93 TIME: 0930  
SEGMENT#: LA015  
STATION#: NOAA #15  
LOCATION: LATOUCHE ISLAND, P.W.S.  
KEYWORDS: -0-  
REASON FOR TAKING PHOTO: PIT A ALONG TRANSECT LINE SHOWING  
OILING AND SEDIMENT.  
INITIALS: CSC  
TAKEN BY: CLARA CROSBY  
ROLL #: 93CSC007 FRAME #: 26 EVIDENCE ID#: \_\_\_\_\_

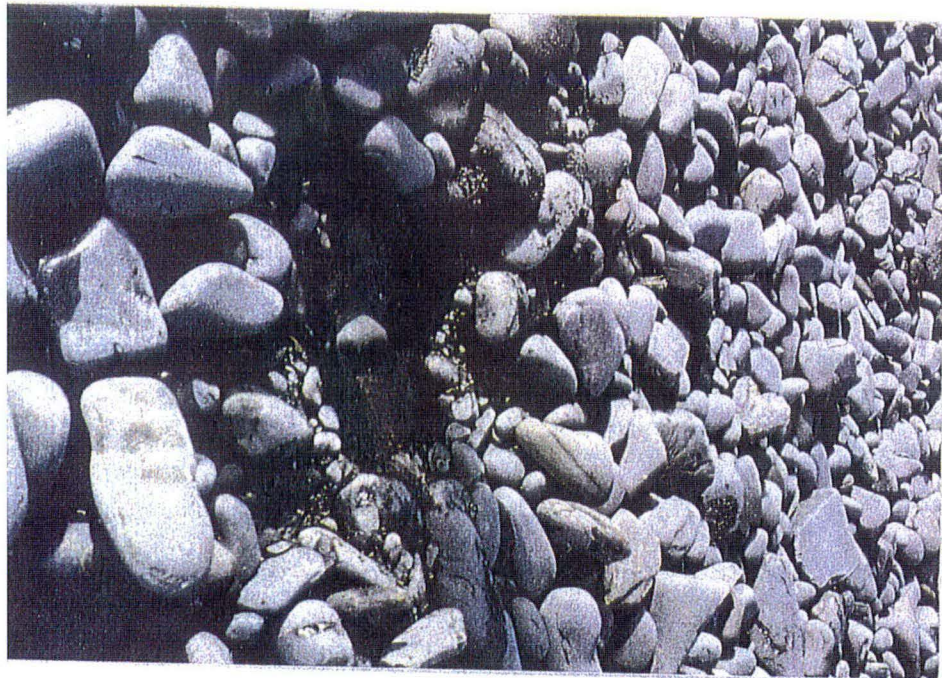
SEGMENT#: LA015 STATION#: NOAA #15  
LOCATION: LATOUCHE ISLAND, P.W.S.  
KEYWORDS: -0-  
REASON FOR TAKING PHOTO: LOOKING UP TRANSECT FROM PIT E. BACK  
STAKE AT BASE OF DEAD SNAG AT EDGE OF WOODS.

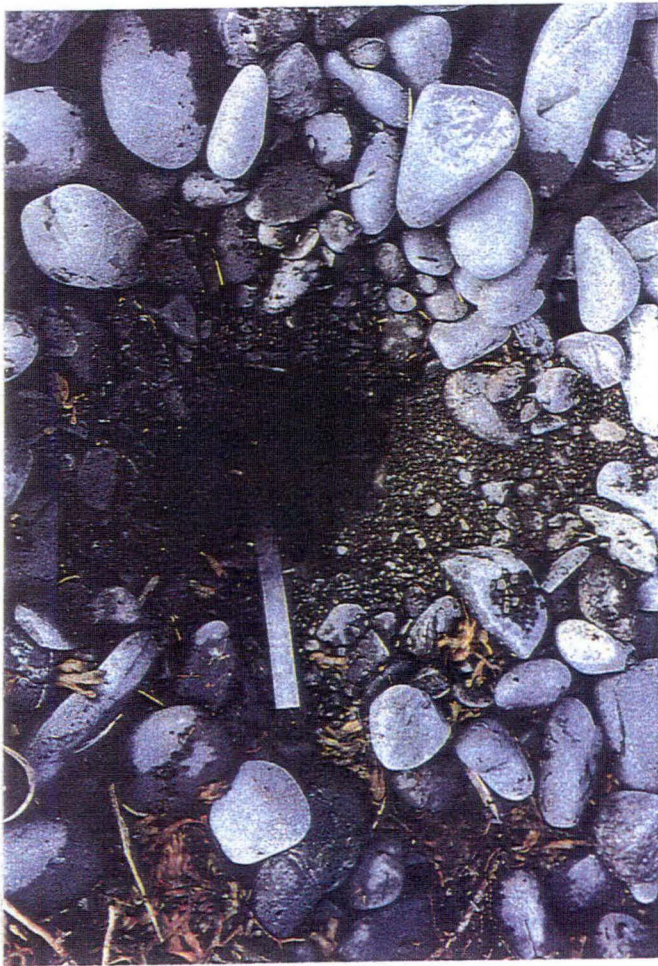
SEGMENT: LA015 STATION: NOAA #15  
LOCATION: LATOUCHE ISLAND, P.W.S.  
KEYWORD: -0-  
REASON FOR TAKING PHOTO: PIT G
