## RESTORATION IMPLEMENTATION PROJECT

### 1992 DRAFT STATUS REPORT

**Project Title:** Survey and Evaluation of Instream Habitat and Stock Restoration Techniques for Wild Pink and Chum Salmon

**Project Number:** R105

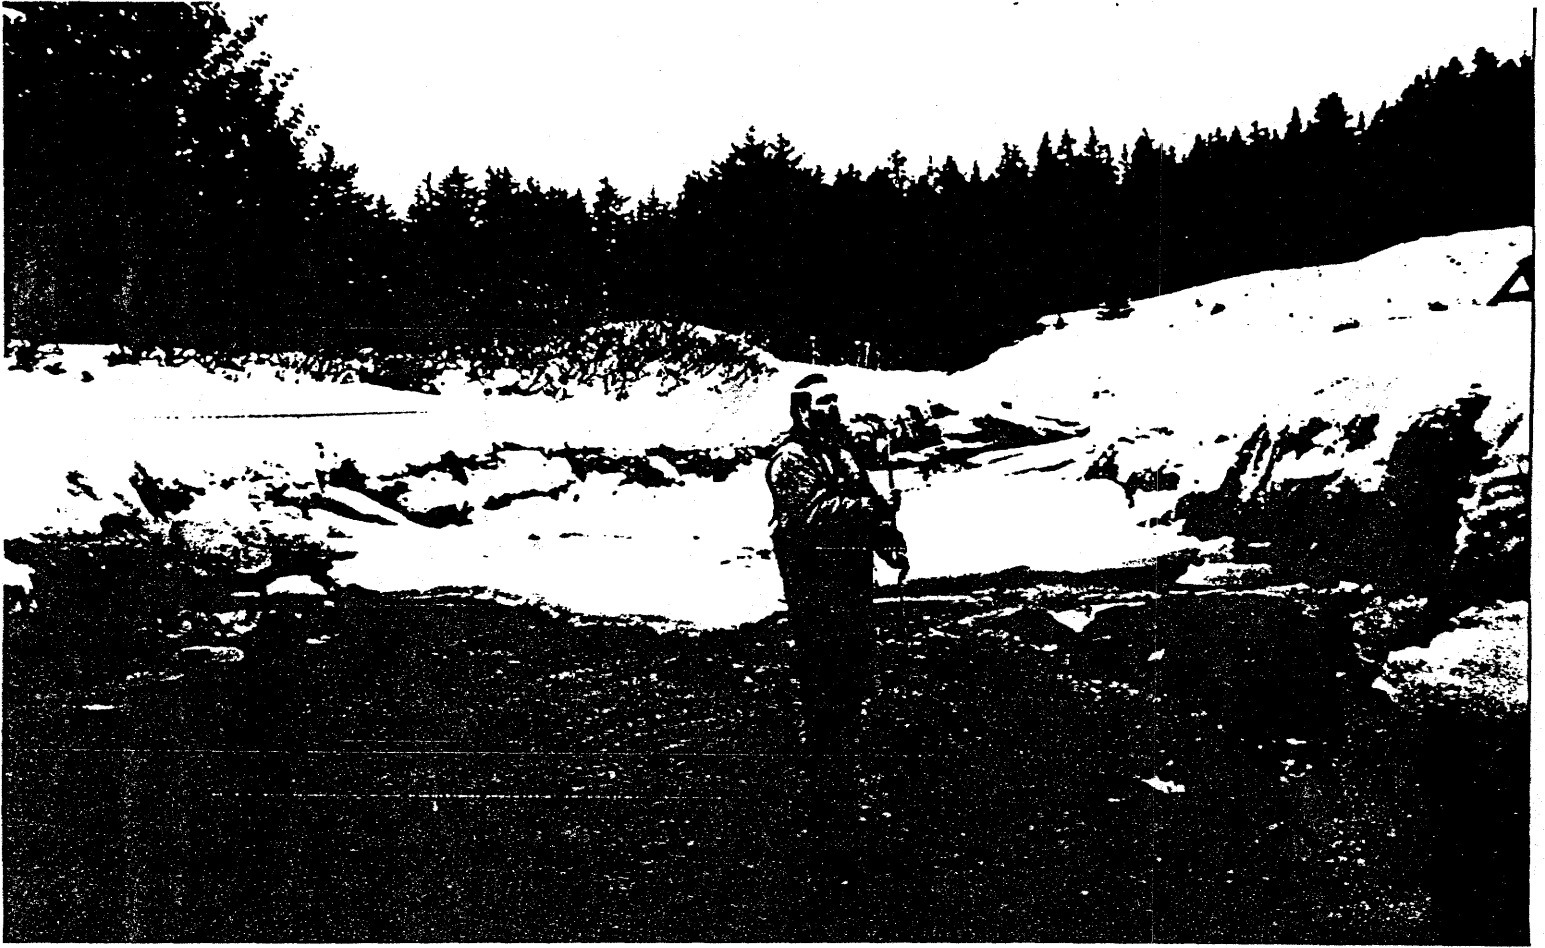
Figure 3. Collecting stream discharge data, 1992 pink restoration survey, Afognak Island.

The height, length, and slope of system barriers was measured with a clinometer and measuring tape. Clinometer readings were recorded as percent (%) slope while all other reading were in meters (m). Stream discharge was measured with a staff gauge and flow meter above and below barriers and above and below each tributary stream (Figure 3). Water velocity and water depth was measured at 0.3 m intervals across the stream for each transect. Other barrier and stream channel characteristics were also noted. Each system and all barriers were aerial photographed from a Bell 206 helicopter.

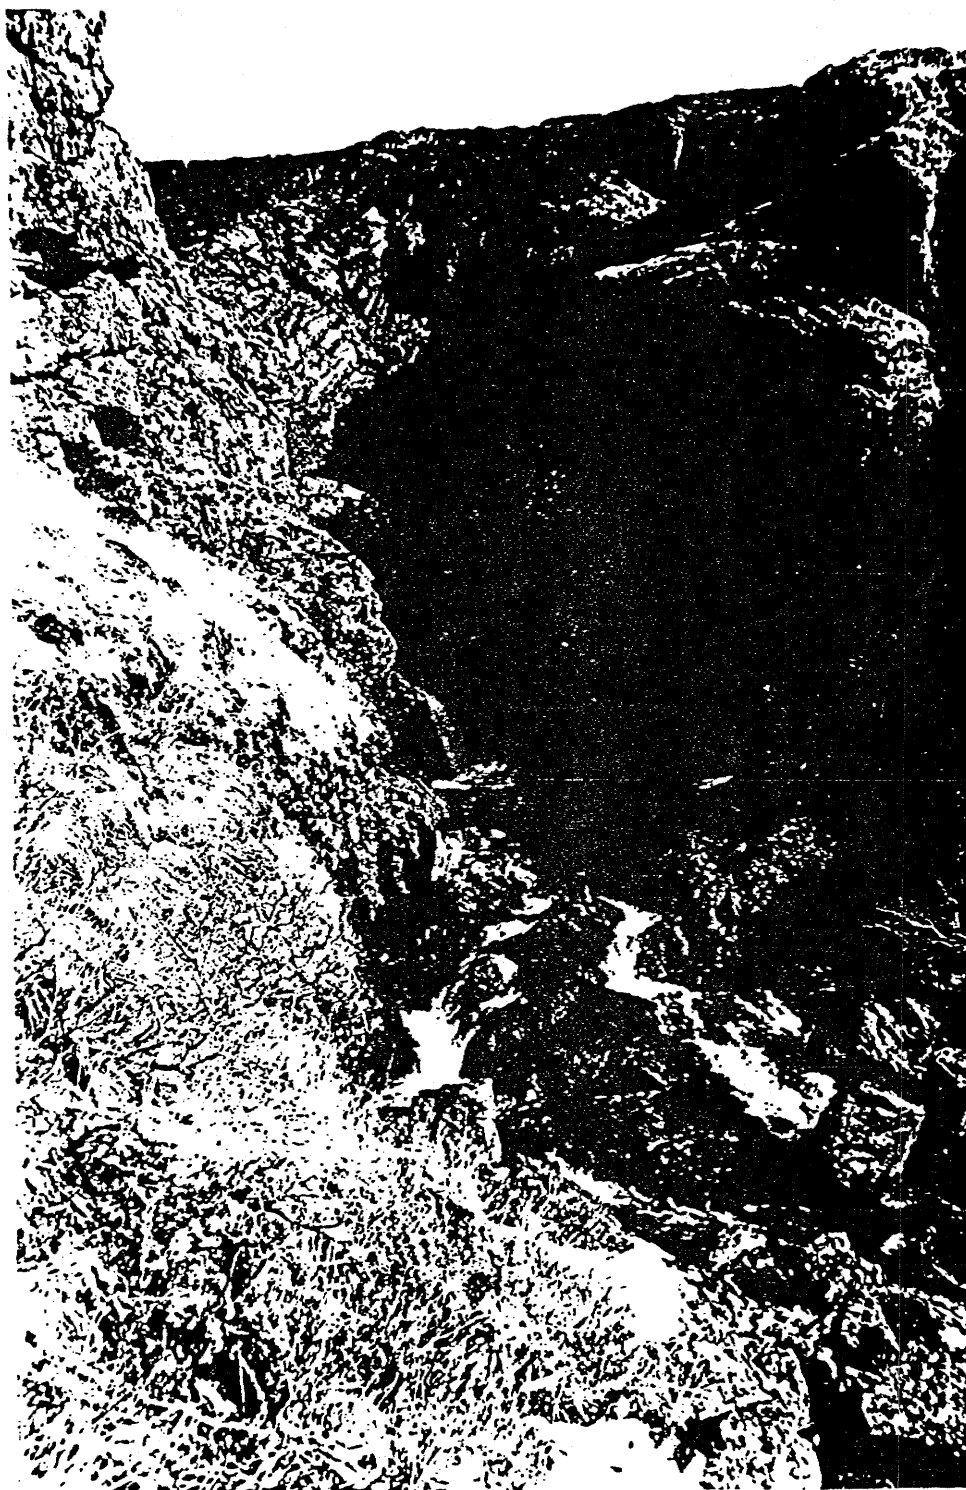
Figure 22. Photograph of first and second barriers, located upstream of salt water on the west fork of Seven Rivers Creek.

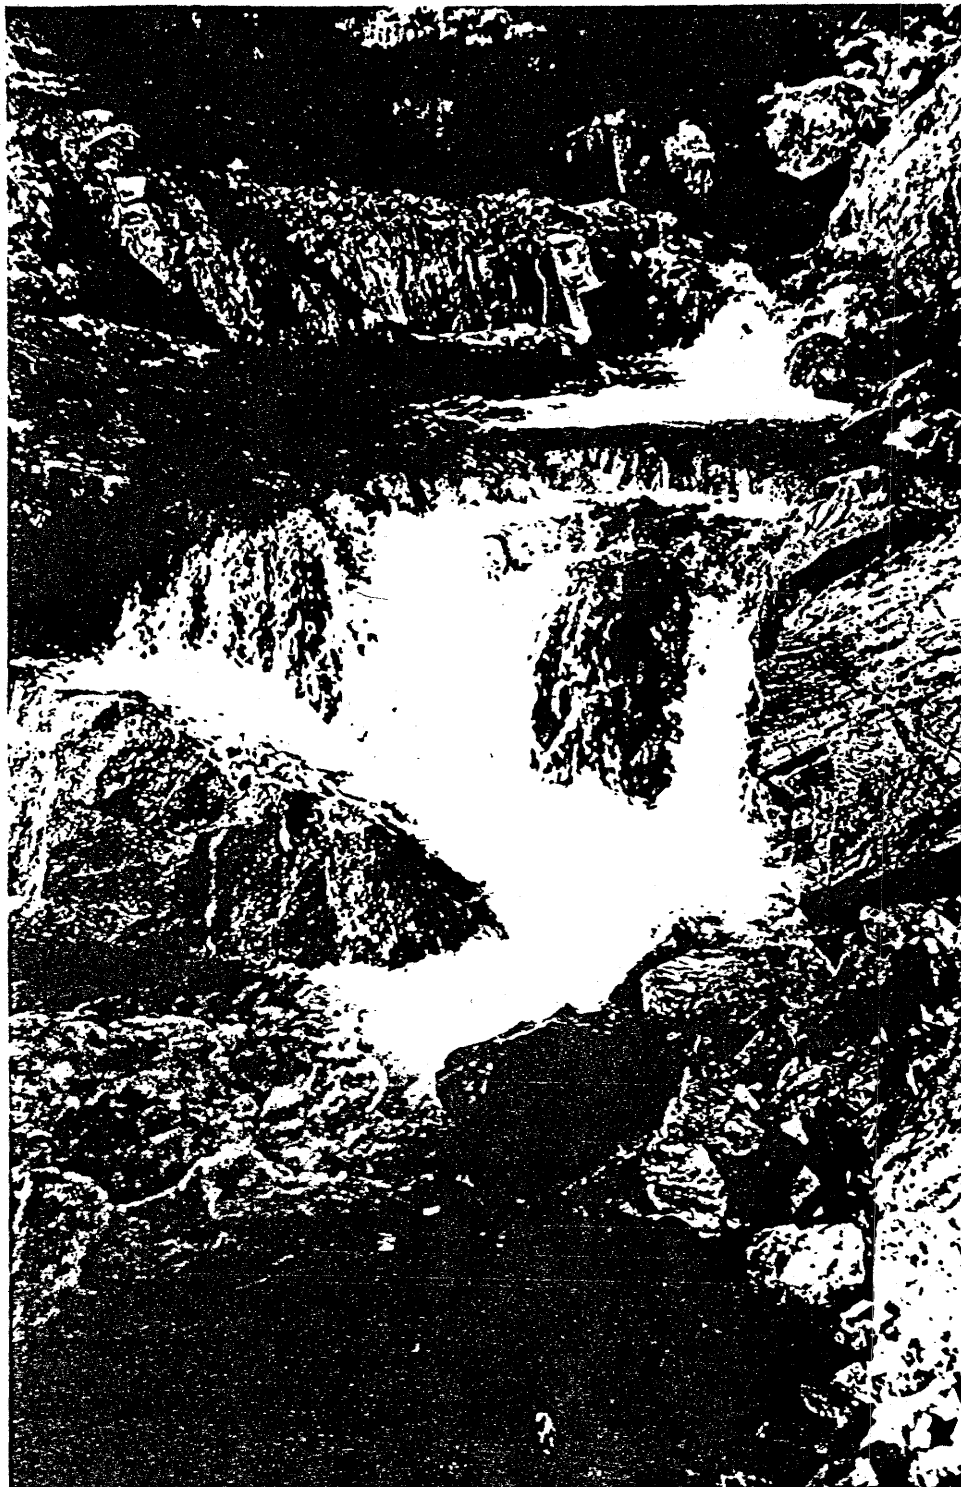
Figure 23. Photograph of third barrier, located upstream of salt water, on the west fork of Seven Rivers Creek.

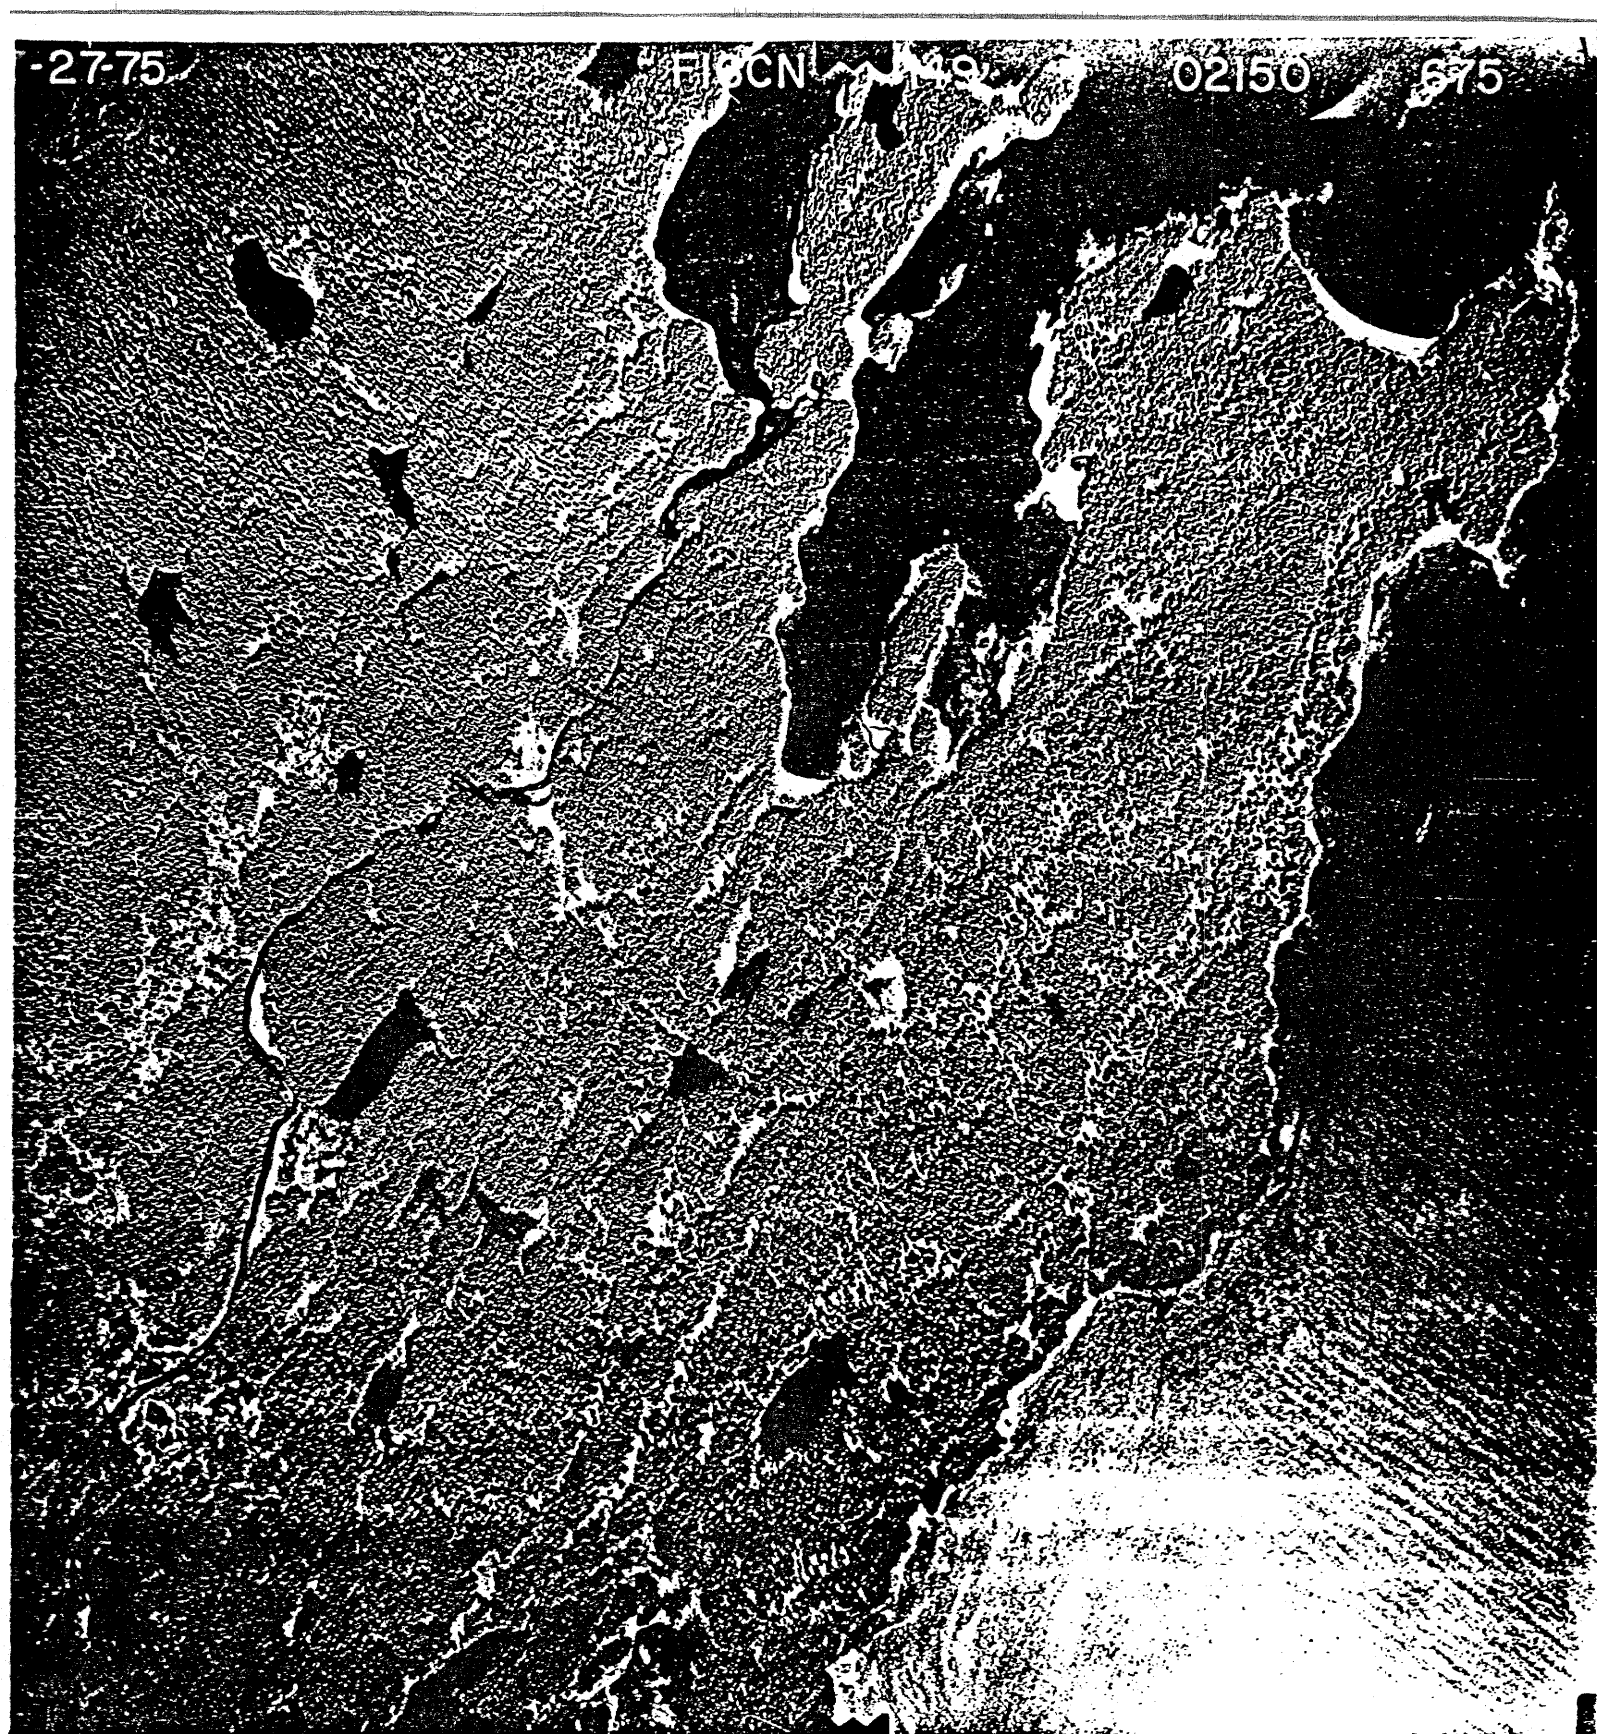
Figure 28. Satellite photograph of Little Waterfall Creek, Afognak Island; lines indicate the location of barrier falls.

Little Waterfall Creek is located on the north side of Afognak Island, draining into Little Waterfall Bay (Figures 1, 2, and 28). The system has three operational fish passes constructed in the late 1970's and early 1980's that allow pink salmon to bypass falls and reach upstream spawning habitat (Figure 29). The area that originally blocked pink salmon migration upstream begins approximately 200 m upstream from salt water. The first falls upstream from salt water is 1.5 m high and 1.0 m long (Table 3). The second and third falls are 2.4 m and 7.9 m in height and 3.0 m and 1.5 m in length, respectively. The stream width below the first, second and third falls is 3.0 m, 7.0 m, and 7.9 m, respectively. The stream width above the first, second and third falls is 6.0 m, 9.1 m, and 5.4 m, respectively. The stream bed is composed of bedrock in the immediate areas of the falls. Stream discharge information was not collected.
