## **[Shoreline evaluations, 1989].**

Volume 6

Chenega Island

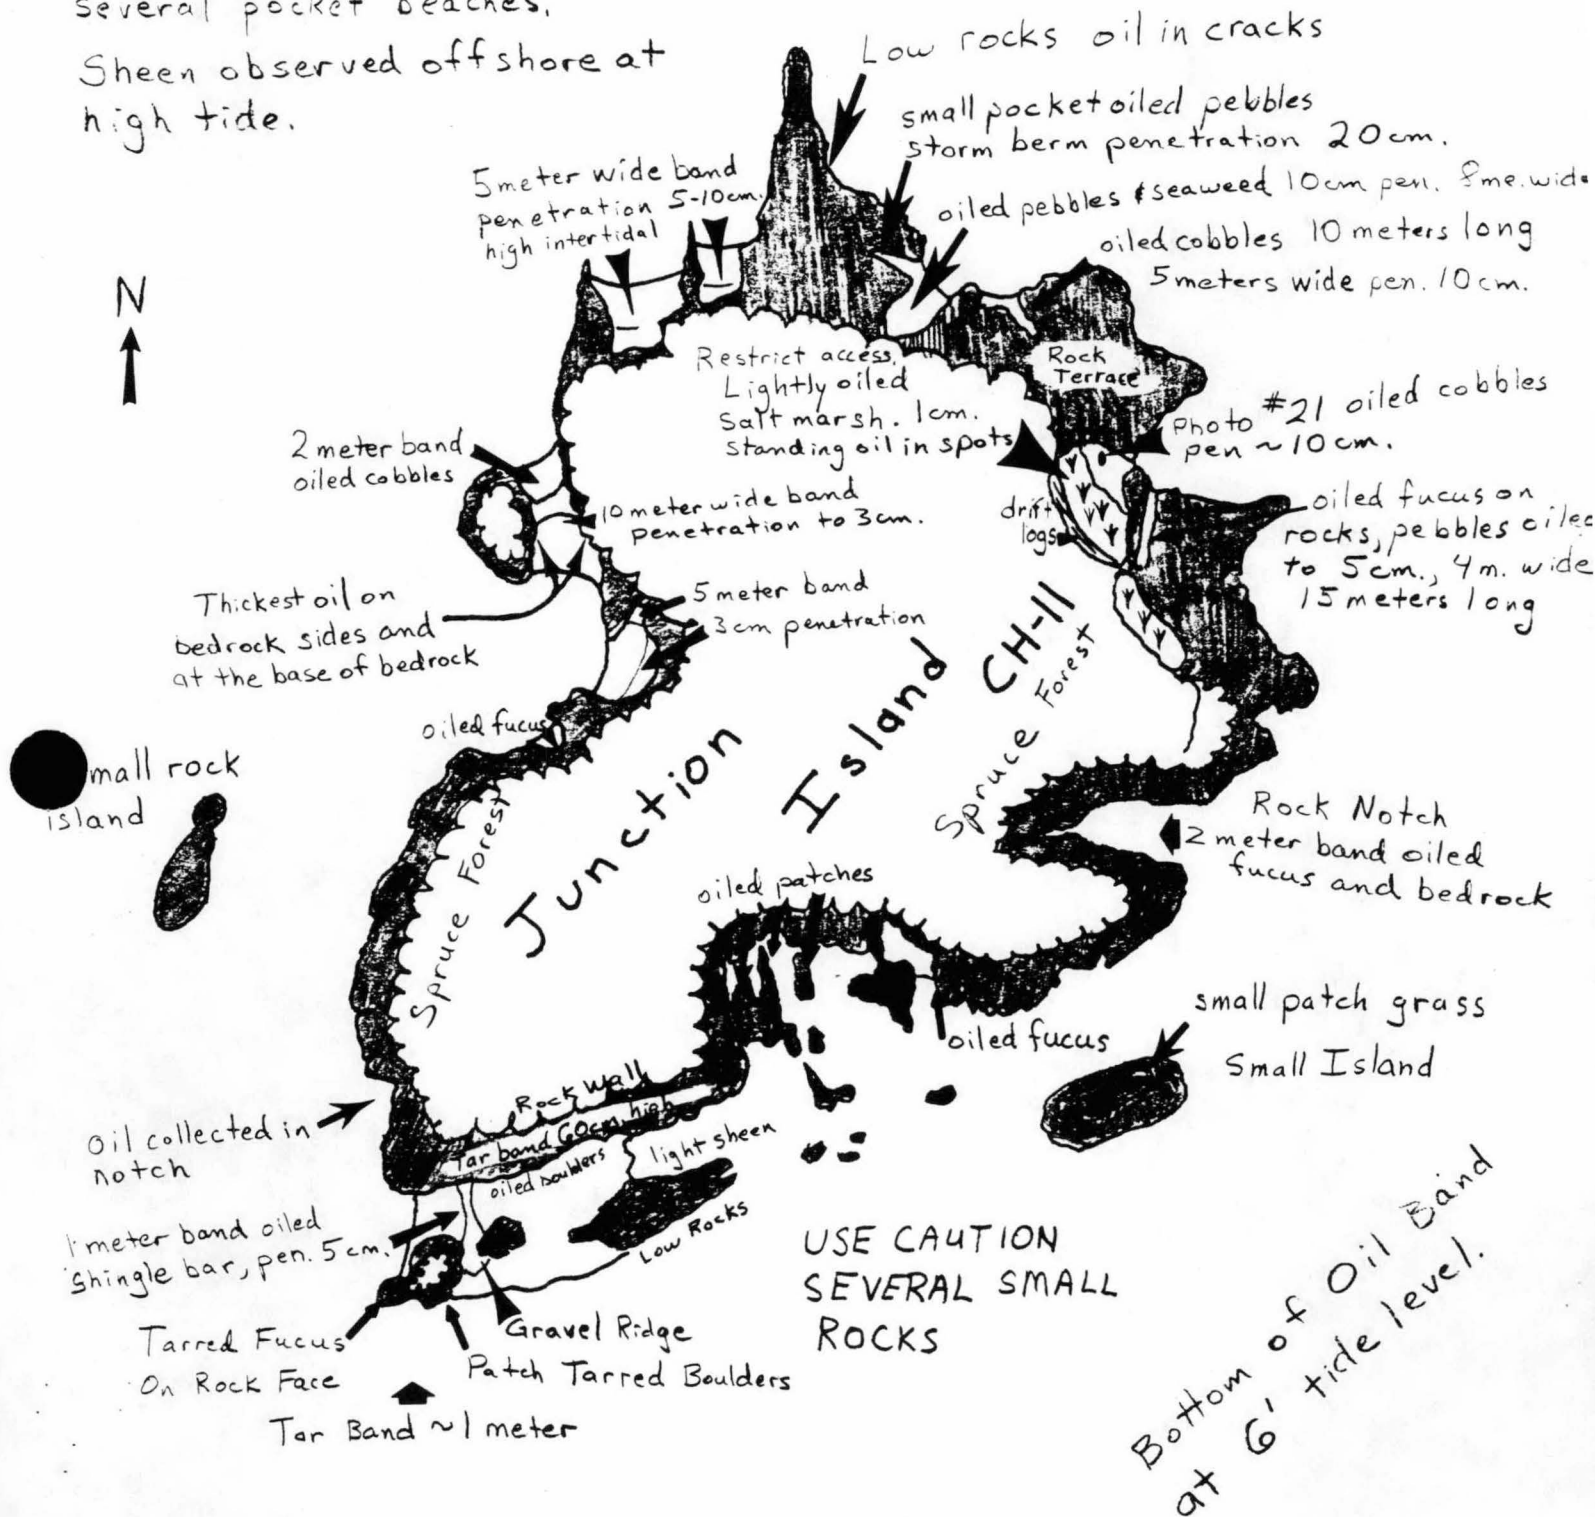
Shoehn observed off shore at high tide. Peat layer under most beaches has kept pen. to a minimum but oil is concentrated on surface as a result. Very small pockets of standing oil were observed in cracks in bedrock outcrops.

Oil tends to stay near the surface because the beaches are underlain with an impermeable peat layer. Relic submerged stumps are found on several pocket beaches.

Sheen observed offshore at high tide.

Hand wands and Vacuums may prove useful in cleaning out standing oil in small cracks and crevasses in bedrock

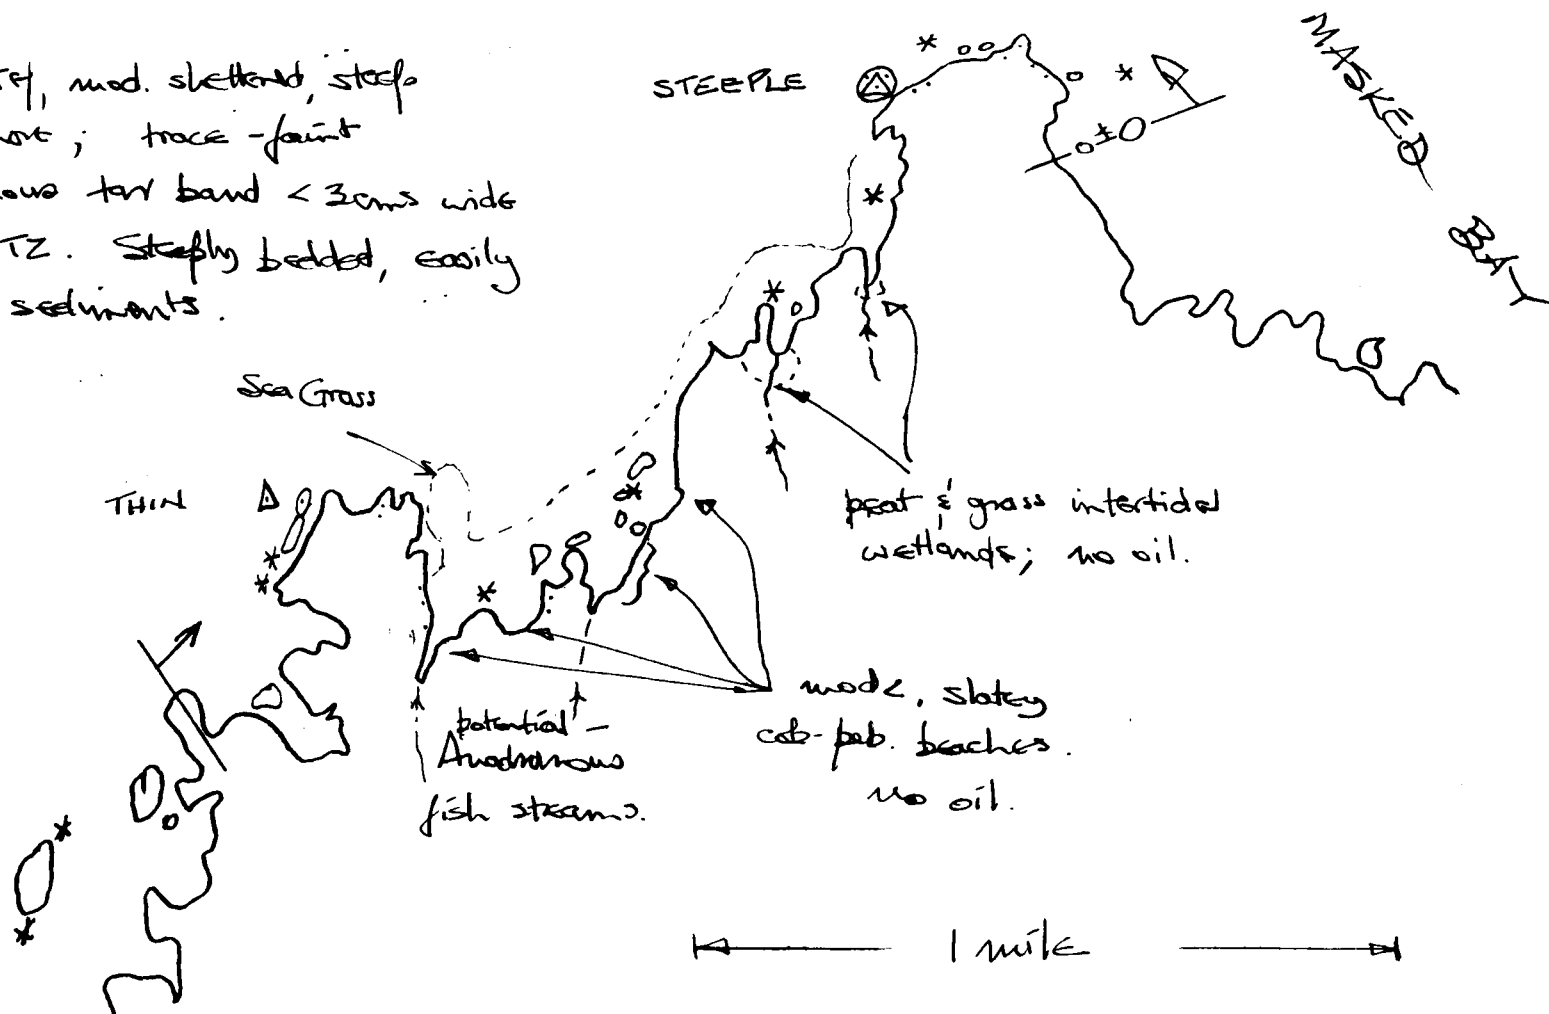
trace oil  
(< 0.1m wide)

stream.
