## **[Shoreline evaluations, 1989].**

Volume 26

Kodiak section 4

SHORELINE CLEANUP PROGRAM

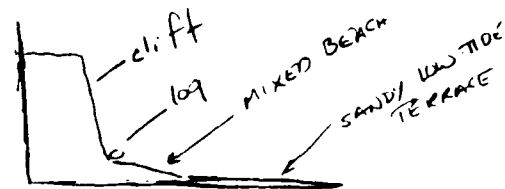
ESTIMATE CROSS-UNIT PROFILE

- MIXED BEACH  
Texture varies from:
- ① cobble pebble beach over sandy gravels
  - ② cobble sand pebble beach

LOCATION: SW side of SURGEON LAGOON SITE: \_\_\_\_\_ OBSERVER: D. McCormick  
LOCATION PREFIX: SL SEG. NO.: 4 LENGTH: 2390 (M)  
DATE: 6/4/89 TIME (HHMM): 1240 TIDE HT.: -1.5 (M)  
OILED ZONE: Splash High Medium Low No Oil  
SUBSTRATUM: Rocks Boulder Cobble Gravel Sand Mud

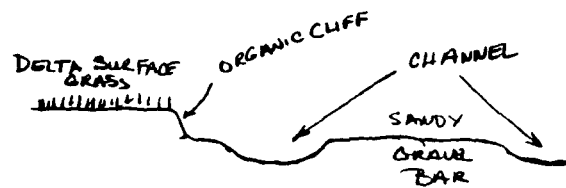
ESTIMATED CROSS-PROFILE  
OF UNIT

SL-12 - ESTUARY/DELTA

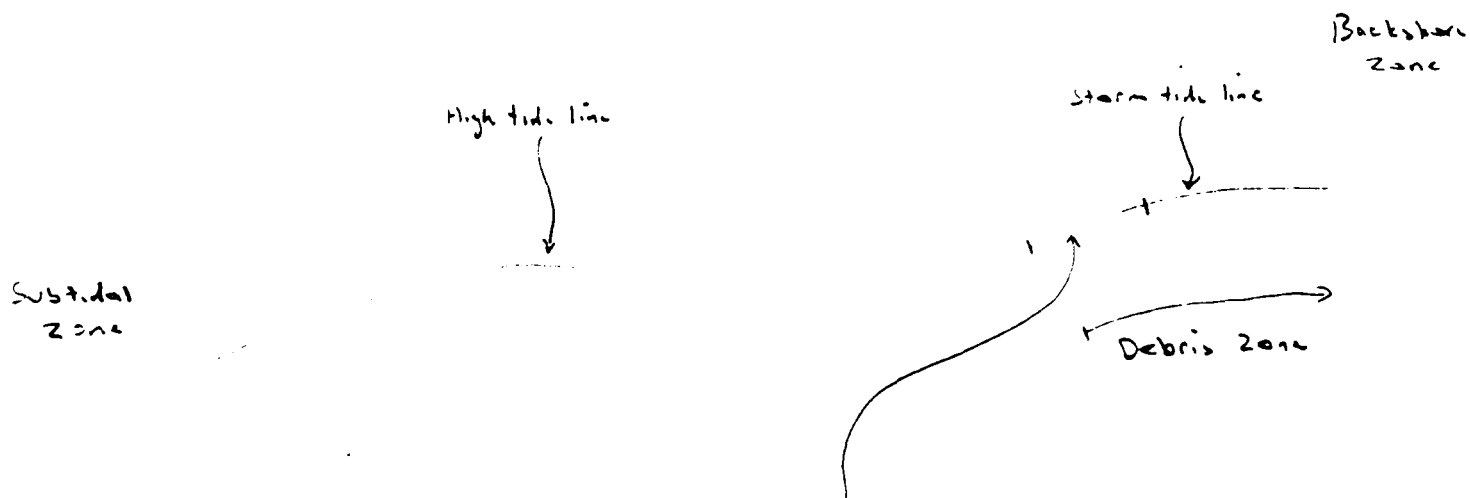
# Note Map #1

5m (3-7m) band in SP zone of mussels and  
oil/sand pads on surface down to approx 5cm BGS  
Band extends from approx 0.5km W of of Rad Duff to  
2 km east of Rad Duff  
Seaweed oiled in driftline

1400 hrs      Tide approx +4'
