# SEGMENT INSPECTION RECORD

Shoreline Segment: BW-2

SHORELINE PRE-CLEANUP ASSESSMENT BLOCK REPORT

# RELINE OIL EVALUATION

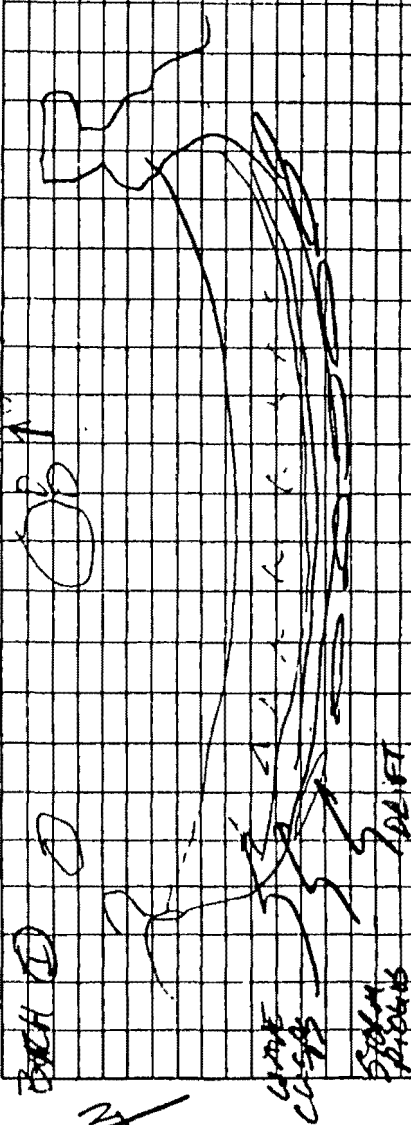
(13)

1315 - WALKED WEST TO (E)  
SEA CAVES; ROCKY CLIFFS  
FOUNDED SCHISTOSE TO PINKISH  
INTERIOR & BACKSHORE  
ENVIRONMENT. LOCAL POCKET  
COBBLE/BOULDER BEACHES  
SOME SCARCE SANDY  
AREAS
