ADF&G MULTI-ASSESSMENT FORM  
1991 GENERAL ENTRY CHECKLIST

STREAM#: 2621010090  
SEGMENT: CD020

LOCATION: CAPE DOUGLAS

# Clear Creek / Monument Creek

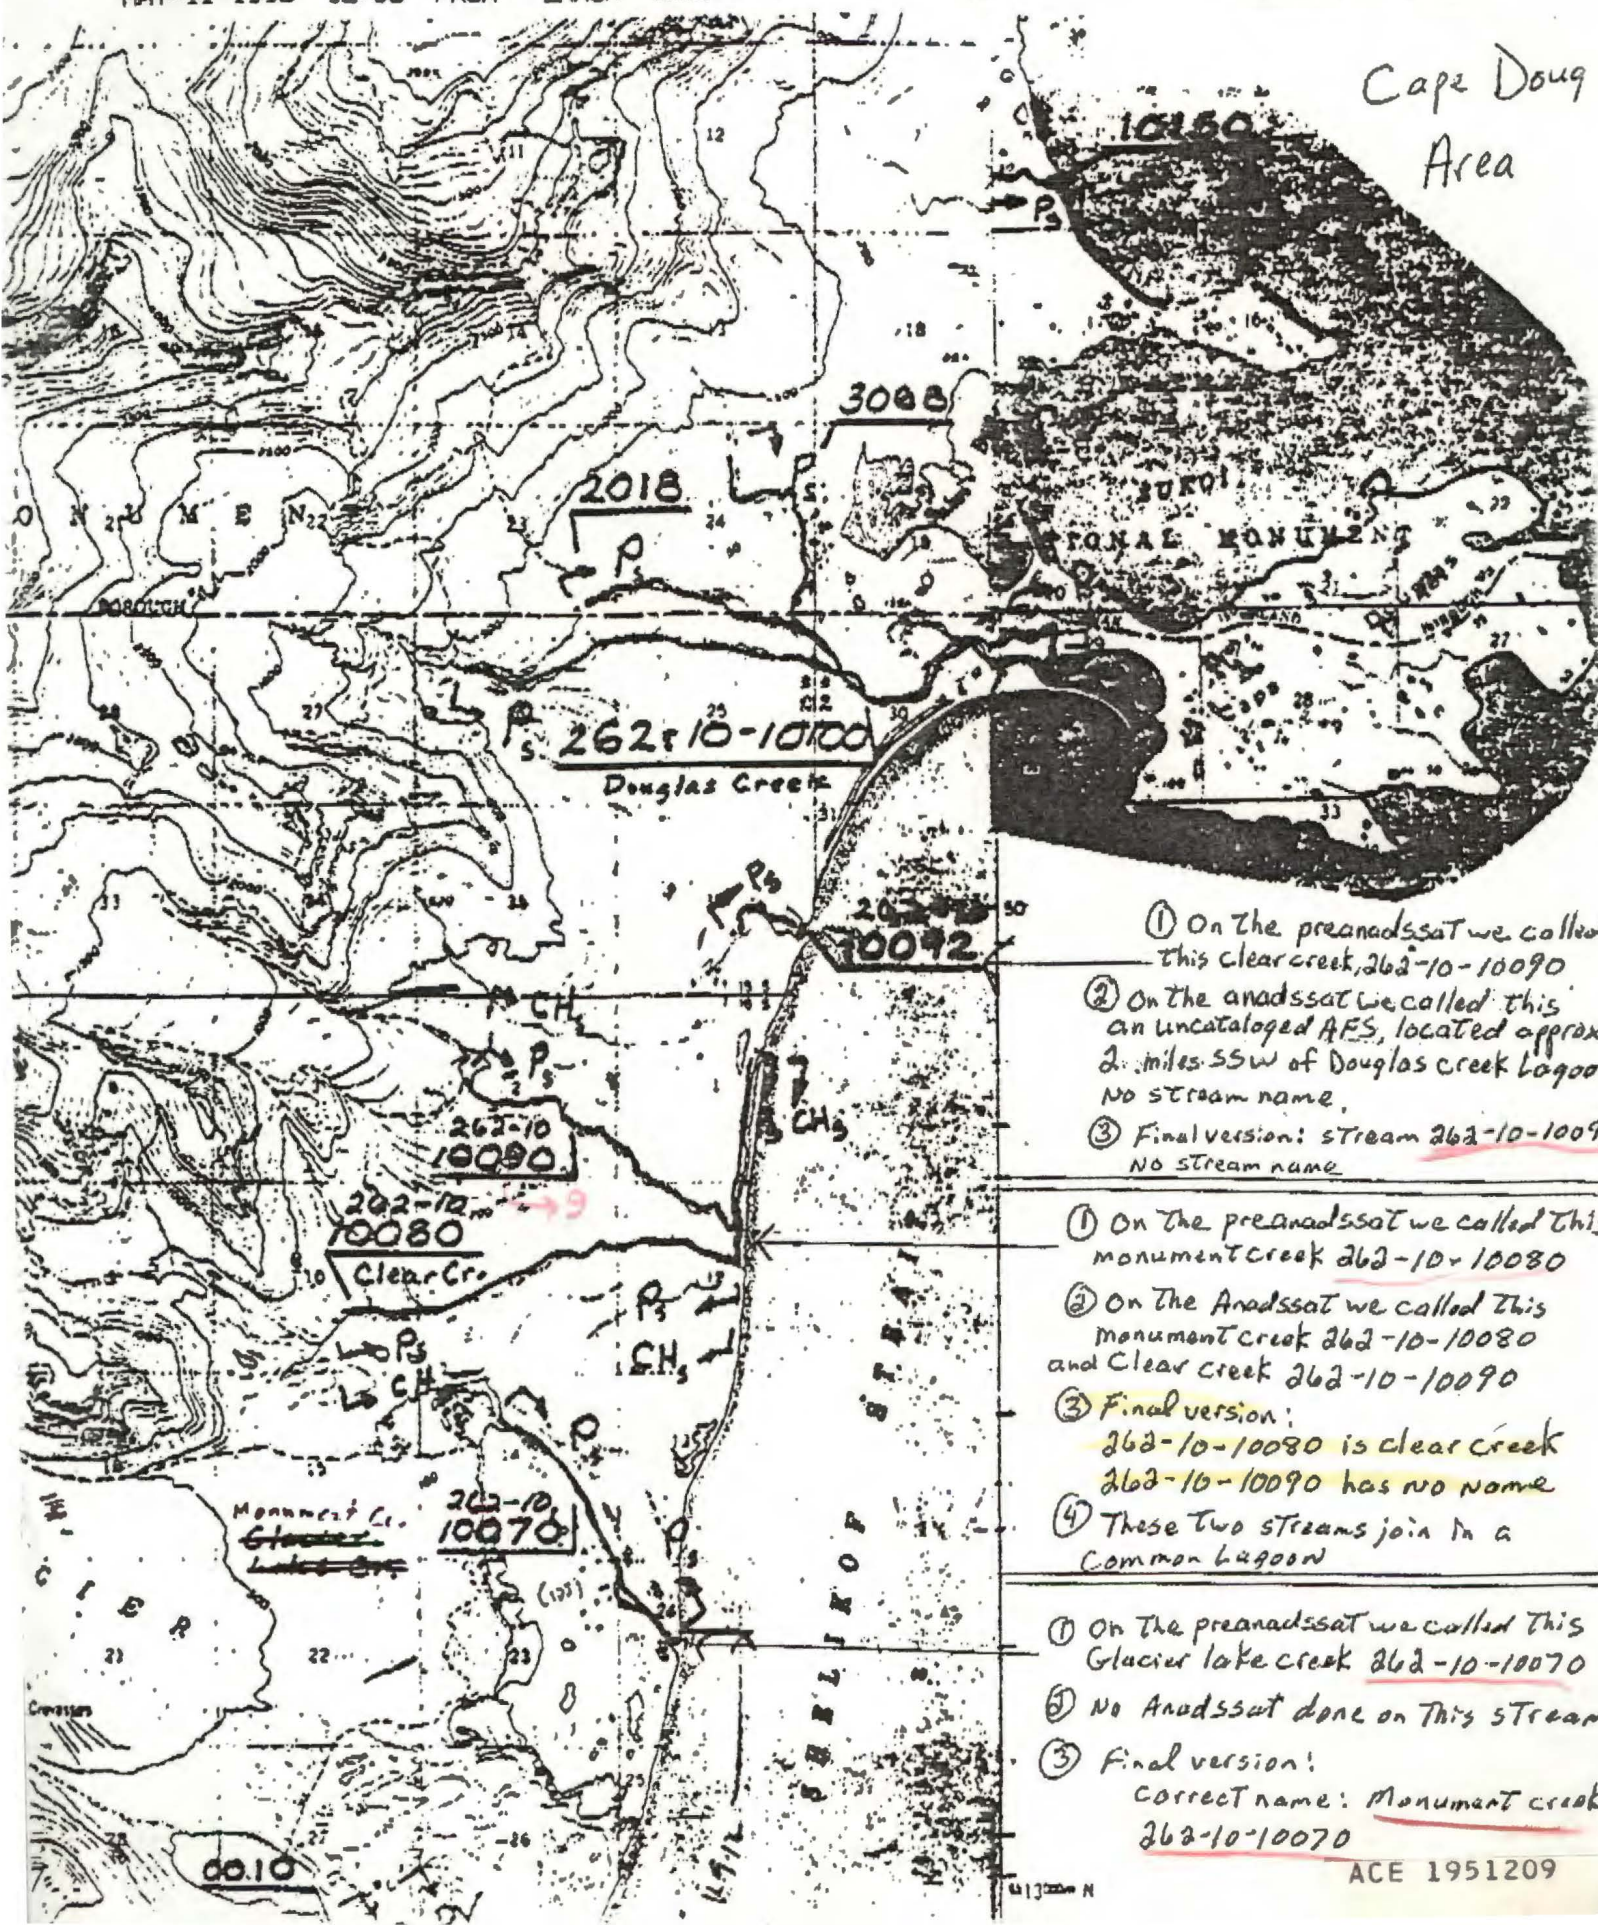
Cape Doug  
Area

① On the preanadssat we called this clear creek, 262-10-10090

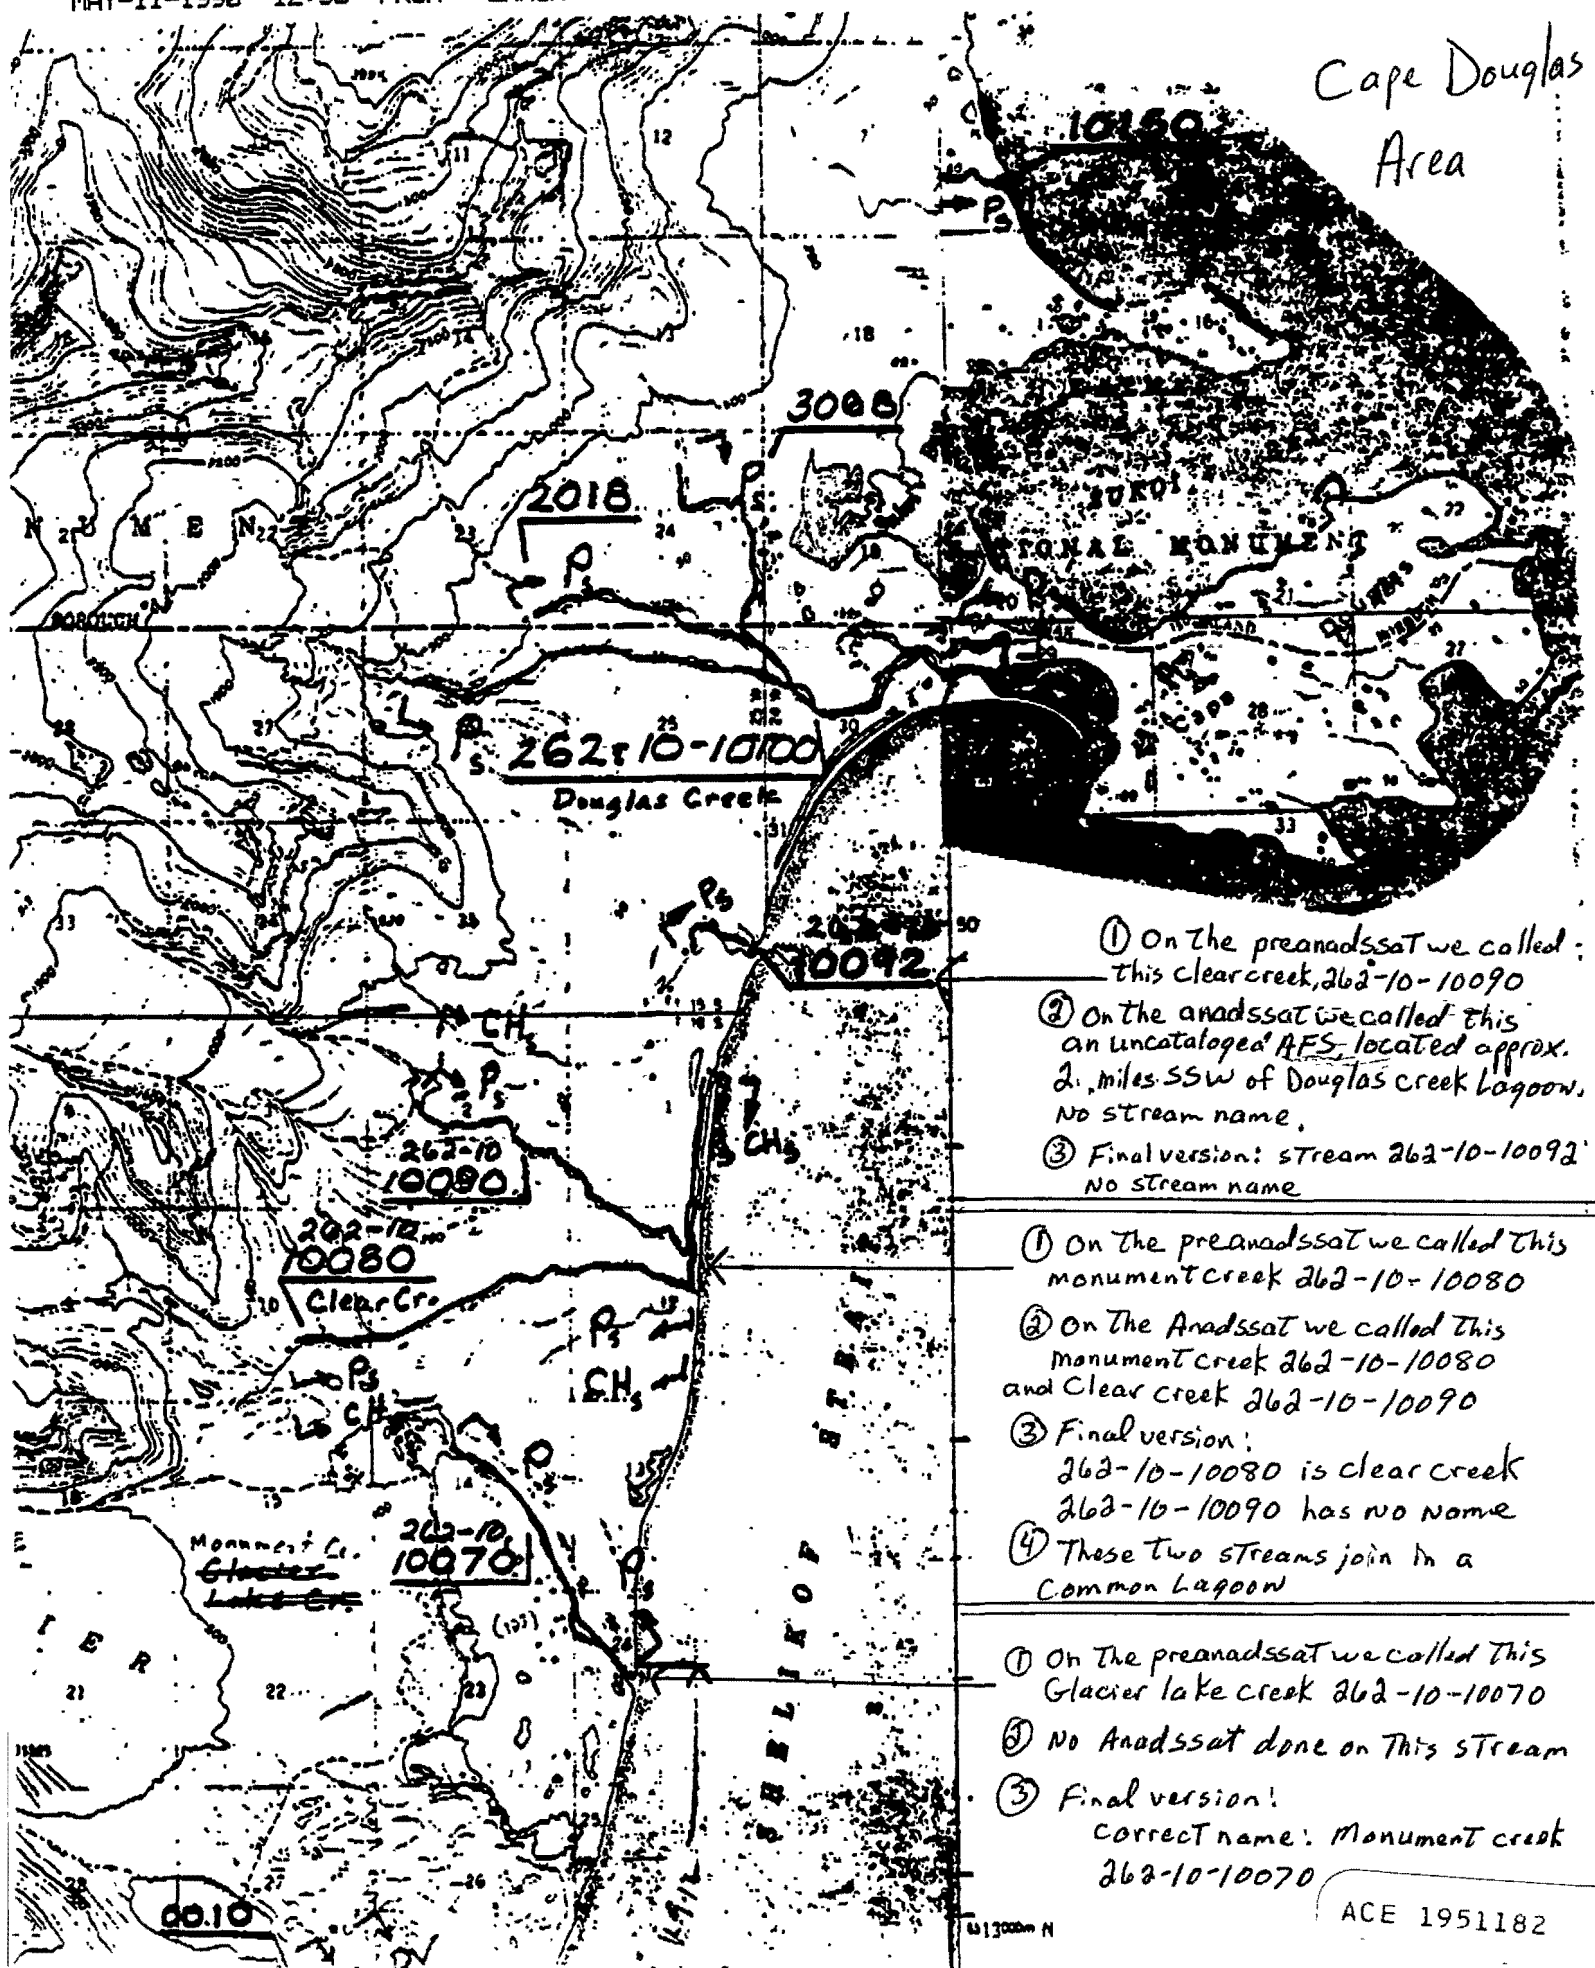
① On the preanadssat we called this clear creek 262-10-10090

② On the anadssat we called this an uncataloged AFS, located approx. 2. miles SSW of Douglas creek Lagoon. No stream name.
