K9-35 KA-03 AFS 262-60-10040  
Kashvik Creek 1990

ADF&G MULTI-ASSESSMENT FORM  
1991 GENERAL ENTRY CHECKLIST

SURVEY TYPE: 90 CLEANUP MONITORING

# EVOS CLEANUP MONITORING, 1990.

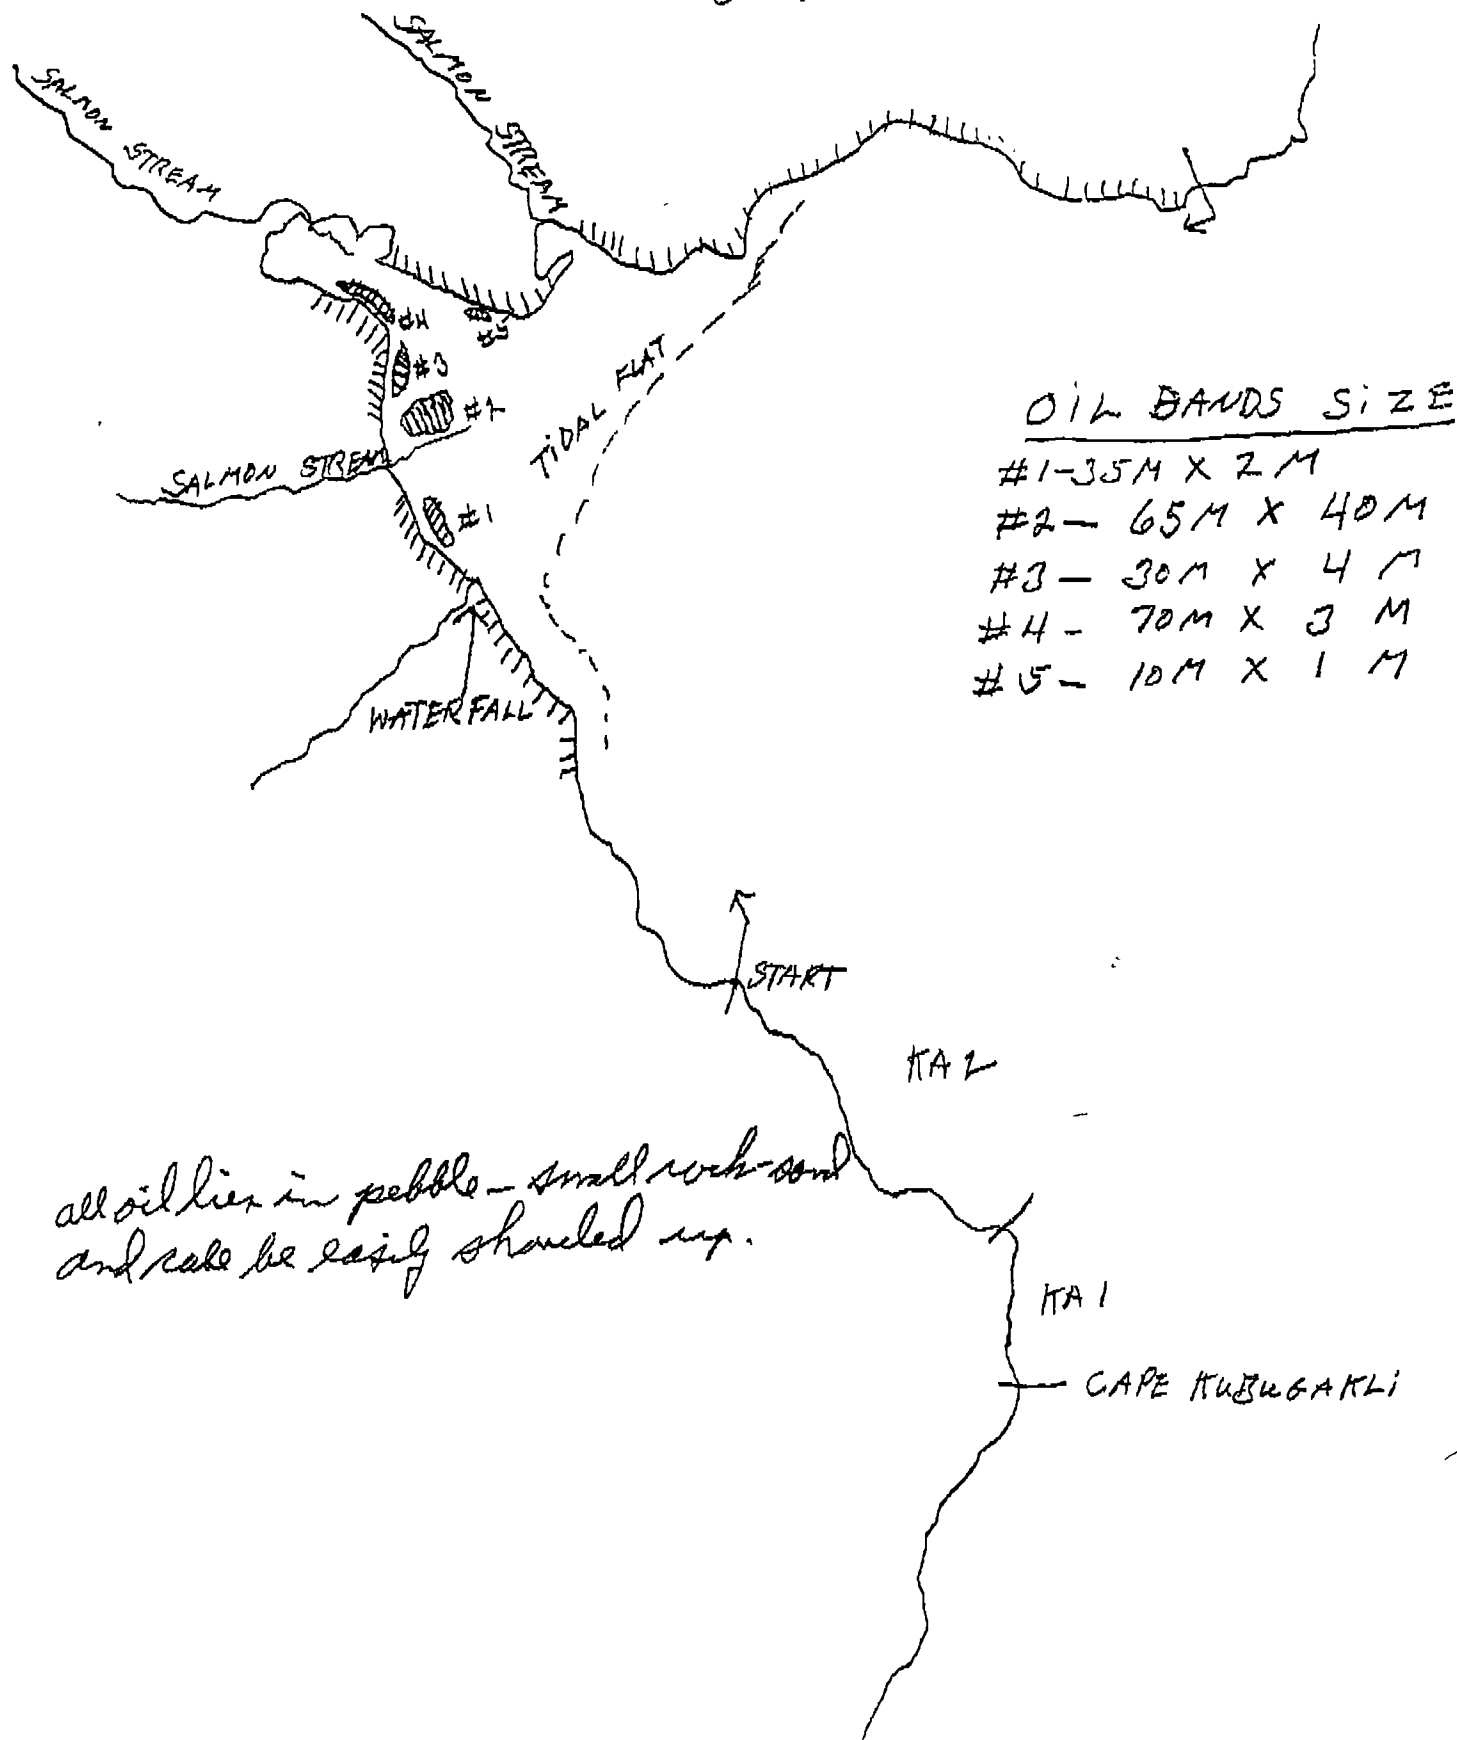
SEGMENT K09-35-HA3 (HASHVIT BAY HEAD)

On July 11, 1990, myself, Bill McDonald and Paul Purifoy started to walk H9-35-HA3. We did not finish it because we found so much oil the tide came in before we finished. The head of the bay contains extensive tidal flats and we decided to walk this first.

I checked this area last year and found petroleum oil in the flats then but never knew if it had been cleaned up. The SSAT team this year indicated they found no oil in this area but when I reviewed their report I noted they did not walk the last mile at the head of the bay on the south side. So we decided to walk this section first. We found four major bands of oil in this area as indicated on the attached map. Three of these were at the base of the tidal flat slope where the rock sediment meets the sand. The largest one was in the shallow flats in pebble-rock-sand. Huge sections were solid mouse sometimes 15 feet by 10 plus feet in diameter. This is one of the most extensive oiled areas I have seen, yet it will be easy to remove. The rocks are small enough so they and the mouse can be shoveled into bags. Almost every inch of this can be removed and a team could probably get all of it in a day or so. Much of the mouse is far up in the tide flats and will take a helicopter crew to remove or it will require a boat crew to walk in a long way and get picked up on high tide.

The area on the north side was treated, however we found a section about 10 M x 1 meter that was missed. This is on the edge of the salmon stream and is in the form of thick mouse patches, sometimes 18" in diameter. I marked this with a pink ribbon. It's near the cliffs. It could be picked up when the south side is treated.
