KN129A ASC: NONE site #1  
South Arm Herring Bay

ANADROMOUS FISH STREAMS/OILING CONDITION

Segment # KN129A ASC# UNDOCUMENTED Location KNIGHT IS.

## ADF&amp;G MULTI-ASSESSMENT DATA FORM

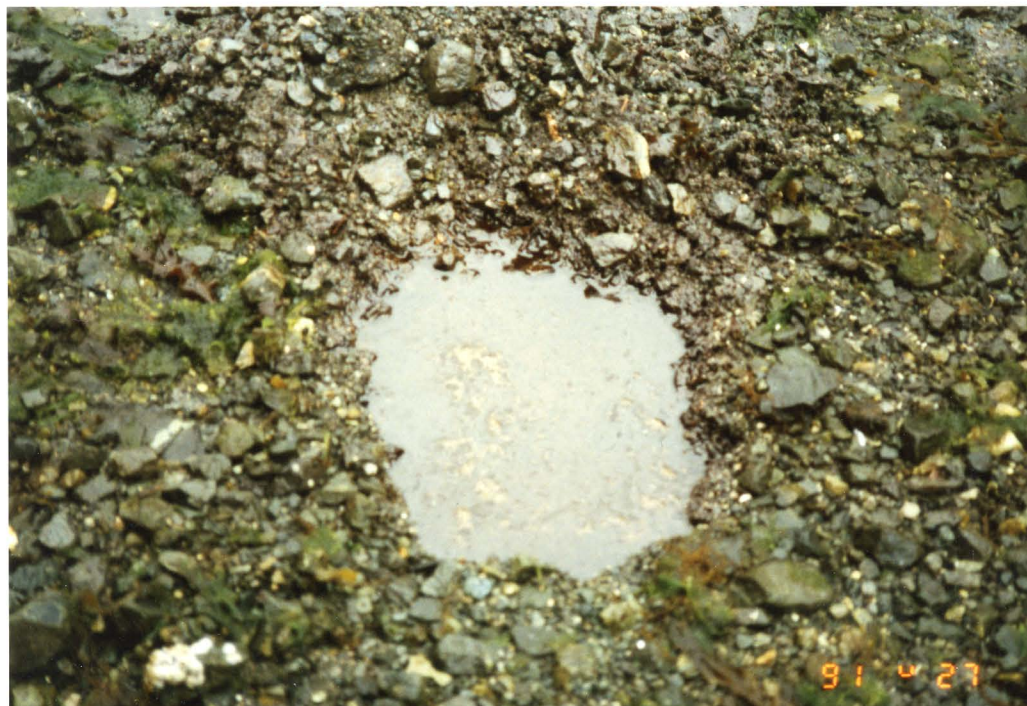
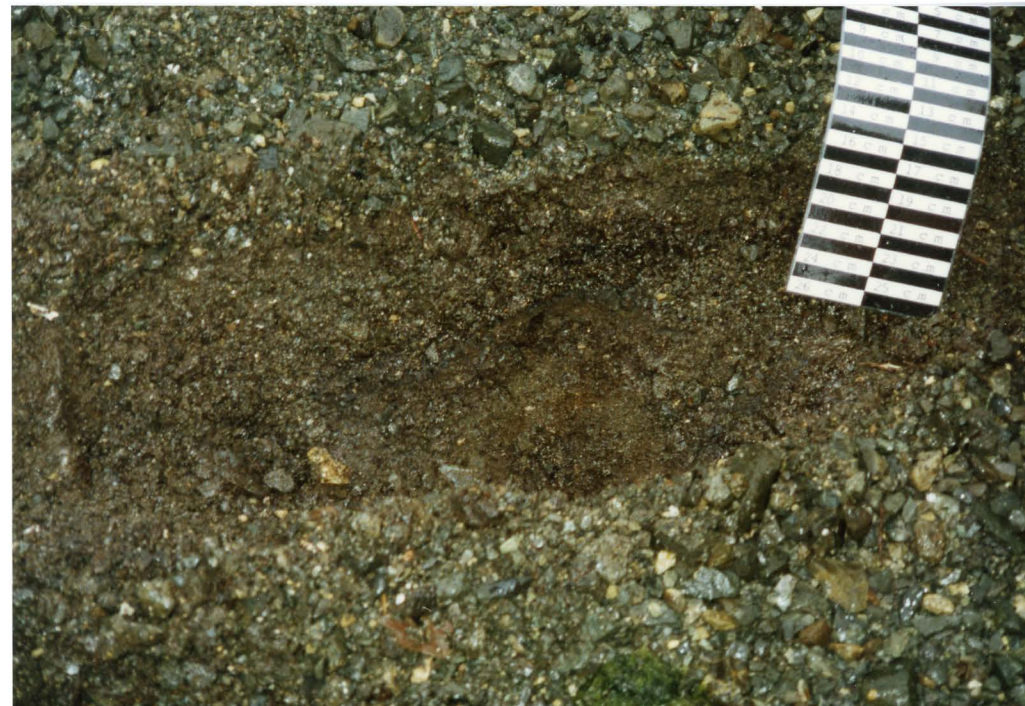
KN0129A

Segment No KN0129 Subdivision A  
Date 4/27/91 Log Frame No 19  
Photographer REBECCA HOFF  
Location KNIGHT ISLAND  
Comments OVERVIEW LOOKING ACROSS  
SEGMENT ACROSS STREAM

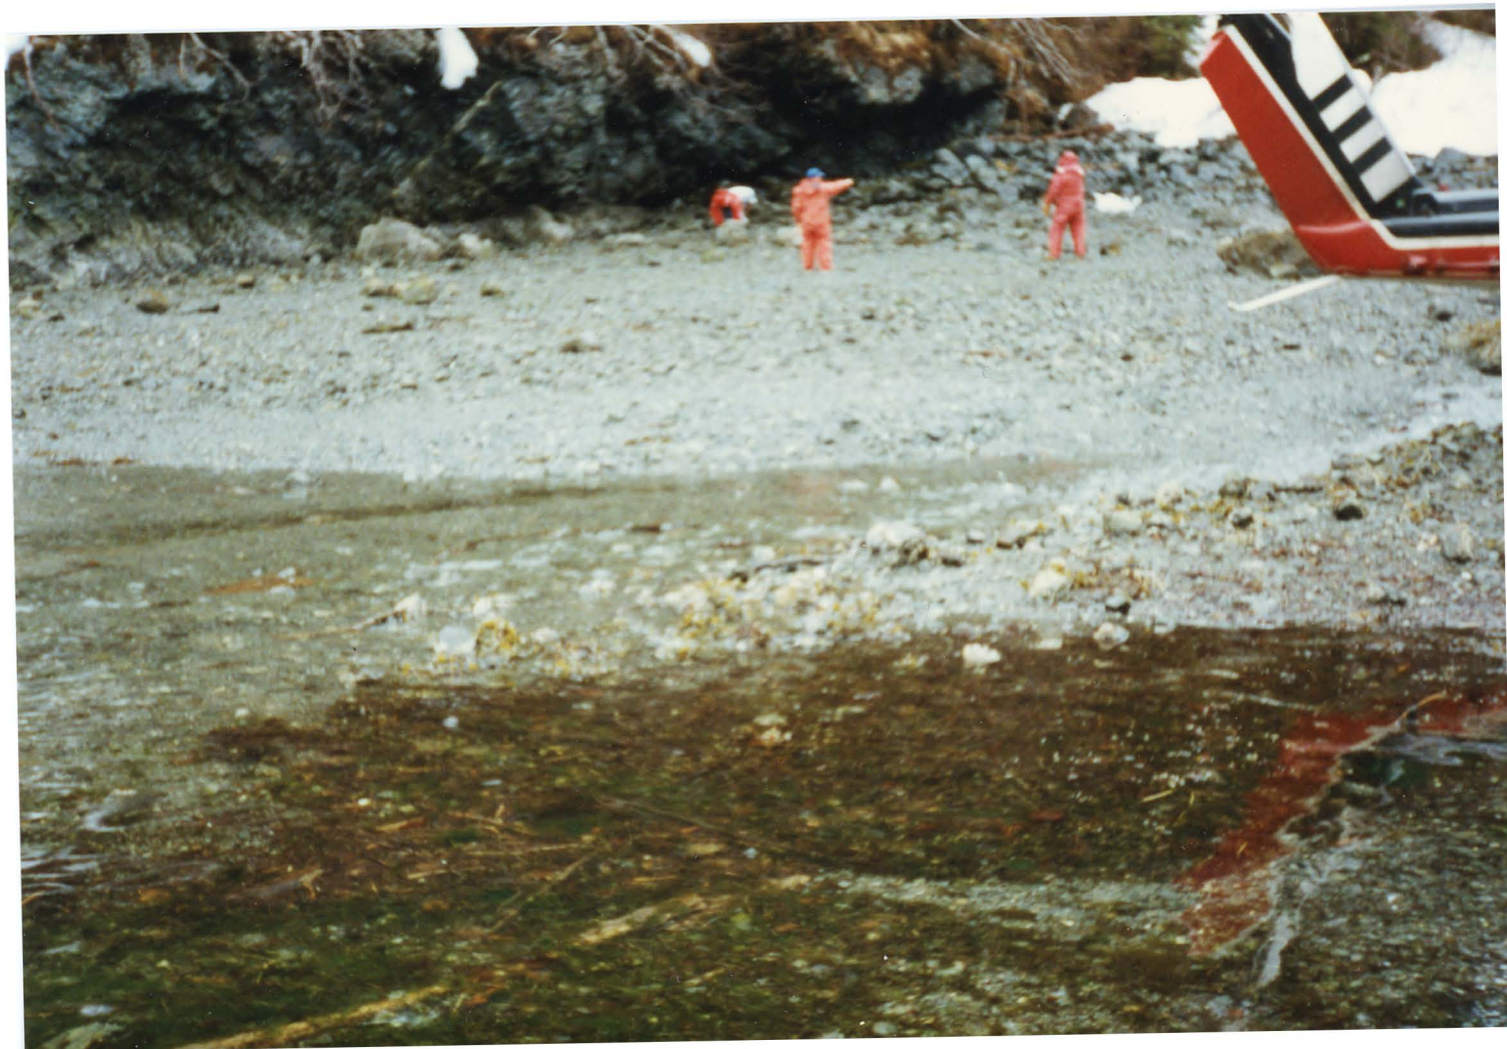
Segment No KN0129 Subdivision A  
Date 4/27/91 Log Frame No 19  
Photographer REBECCA HOFF  
Location KNIGHT ISLAND  
Comments OVERVIEW LOOKING ACROSS  
SEGMENT ACROSS STREAM

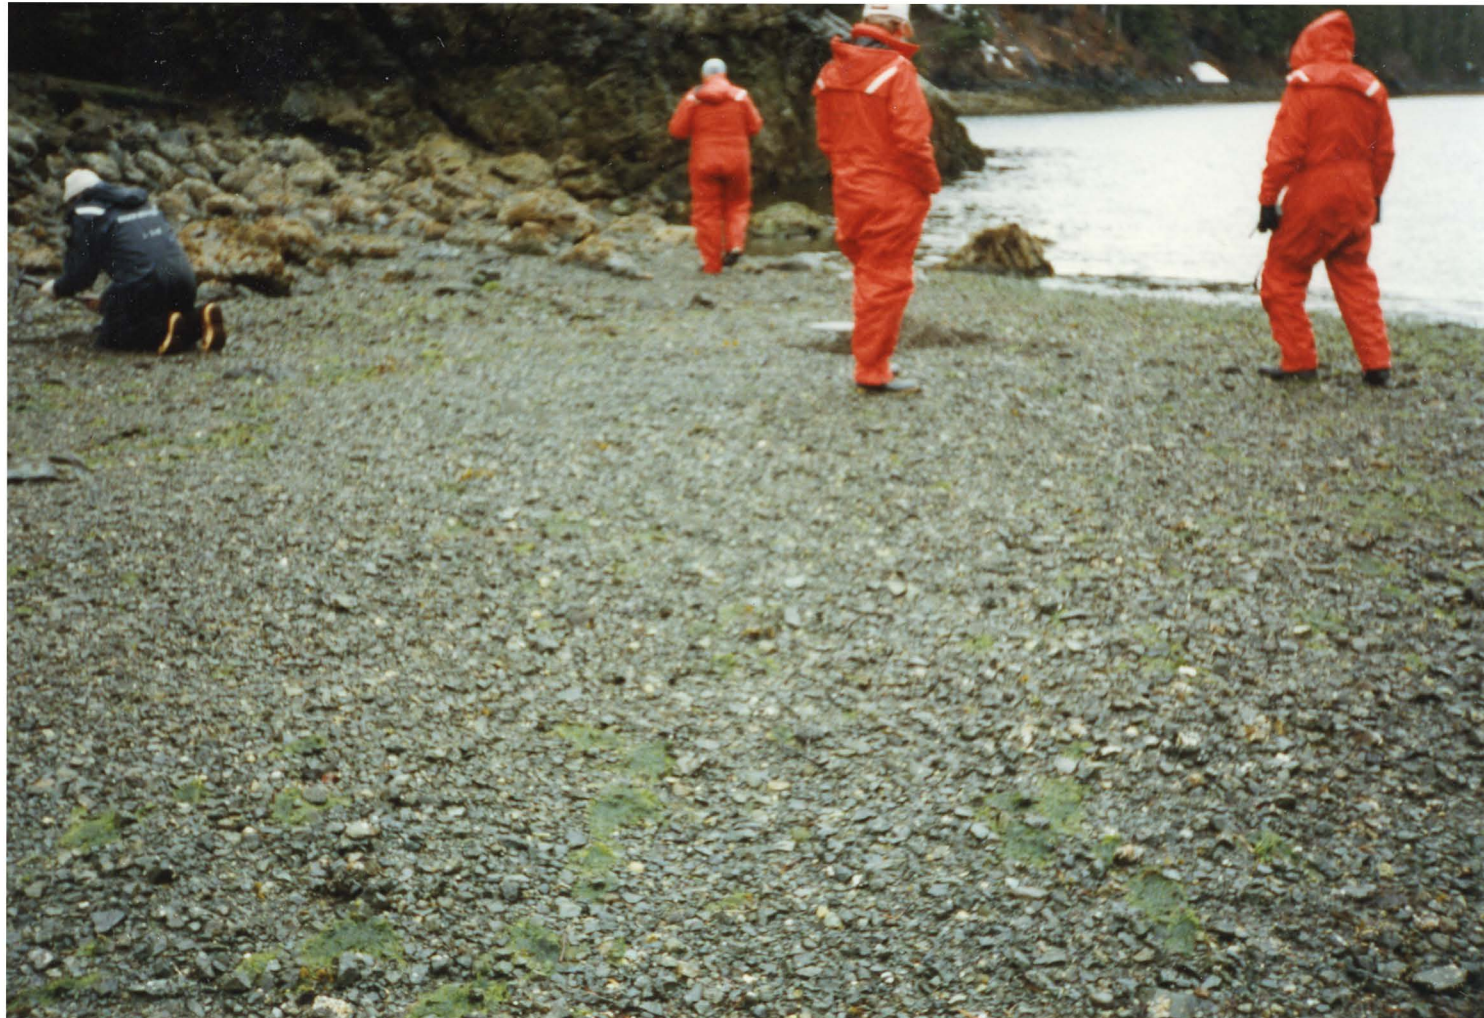
Segment No KN0129 Subdivision A  
Date 4/27/91 Log Frame No 20  
Photographer REBECCA HOFF  
Location KNIGHT ISLAND  
Comments OVERVIEW LOOKING DOWN AT  
WATER

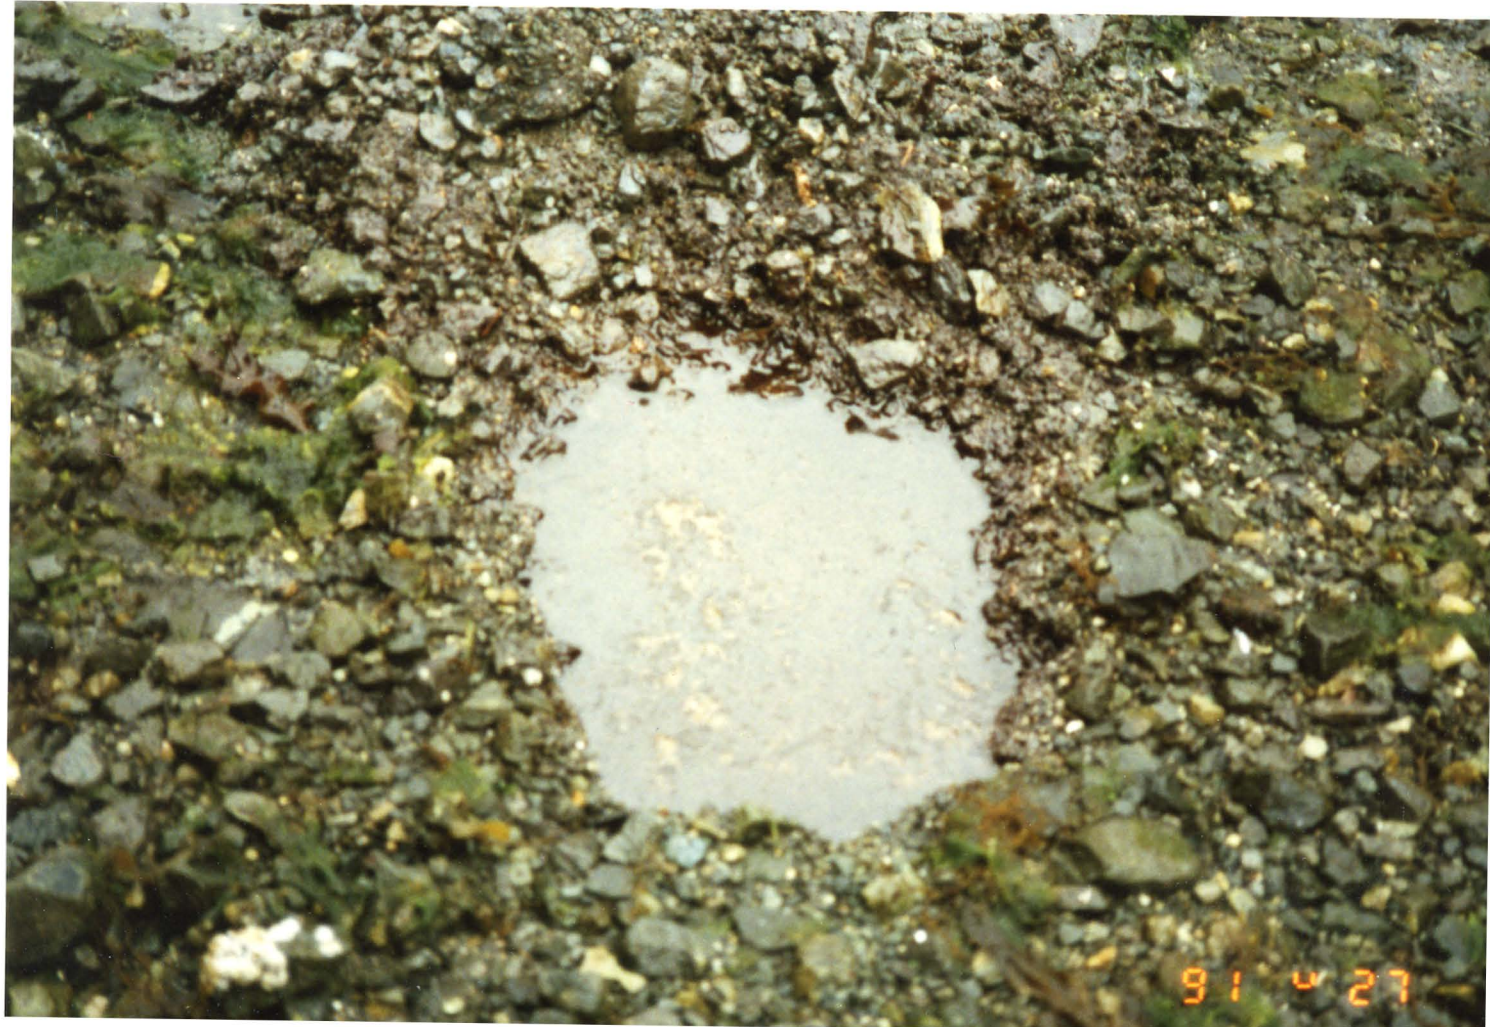
Segment No KN0129 Subdivision A  
Date 4/27/91 Log Frame No 21  
Photographer REBECCA HOFF  
Location KNIGHT ISLAND  
Comments PIT WITH SOR (#2) RIGHT  
ABOVE WATER LINE

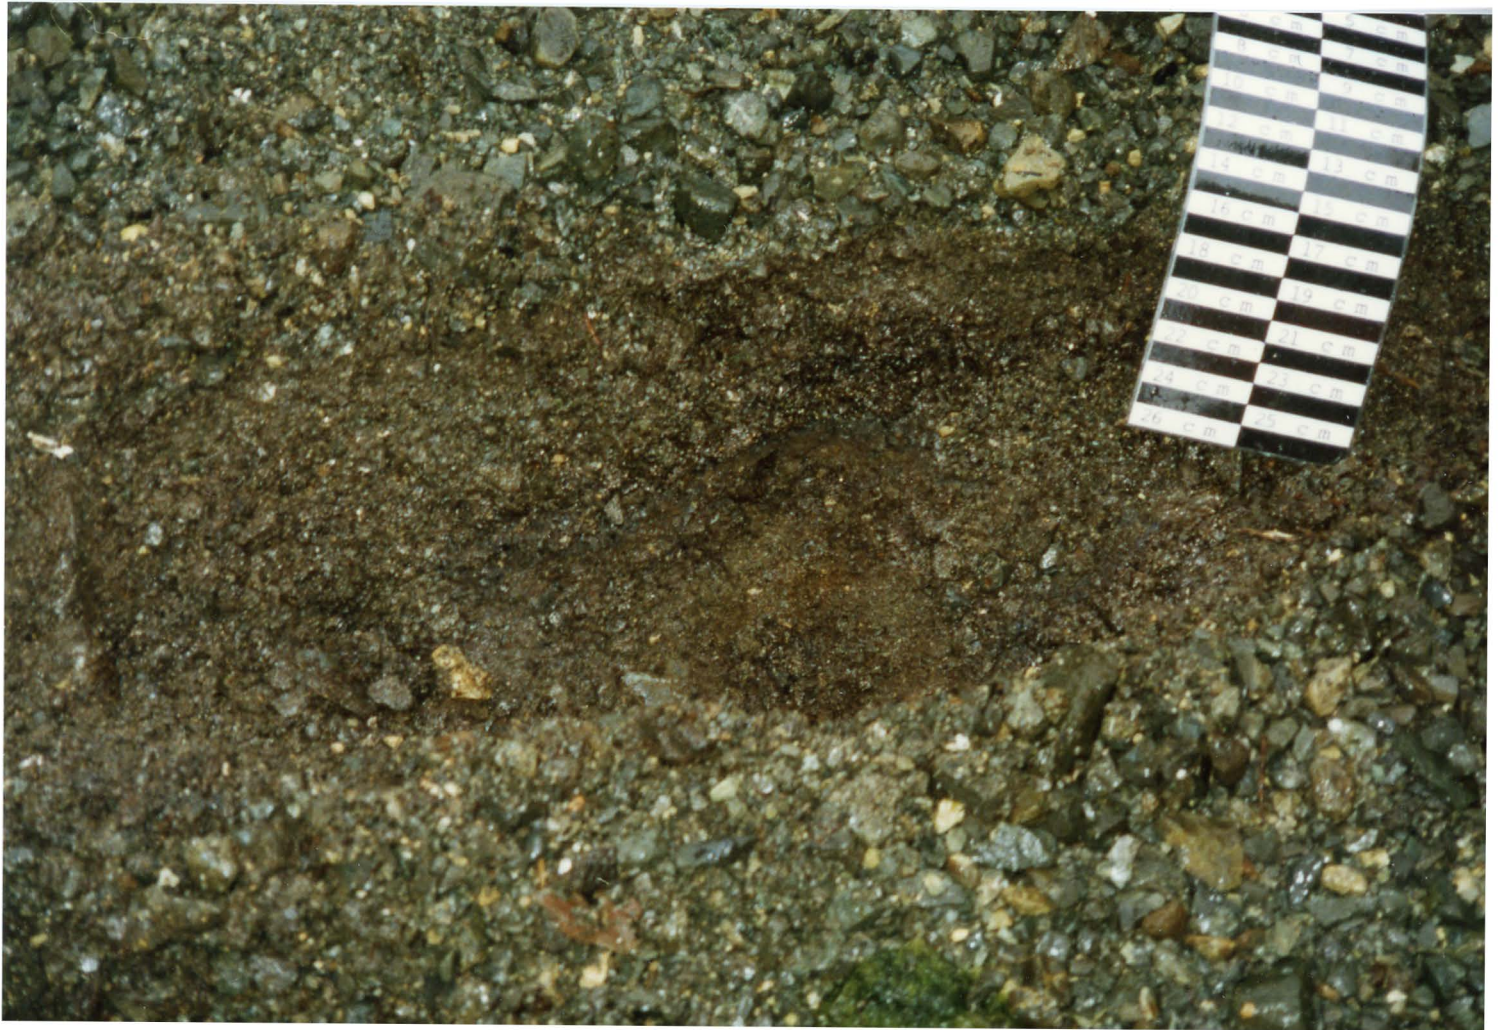
Segment No KN0129 Subdivision A  
Date 4/27/91 Log Frame No 22  
Photographer REBECCA HOFF  
Location KNIGHT ISLAND  
Comments PIT #5 IN GRAVEL AREA
