EL-052 ASC 16902 site #  
NORTHWEST BAY (Eleanor Island)

Prince William Sound

## ADF&amp;G MULTI-ASSESSMENT DATA FORM

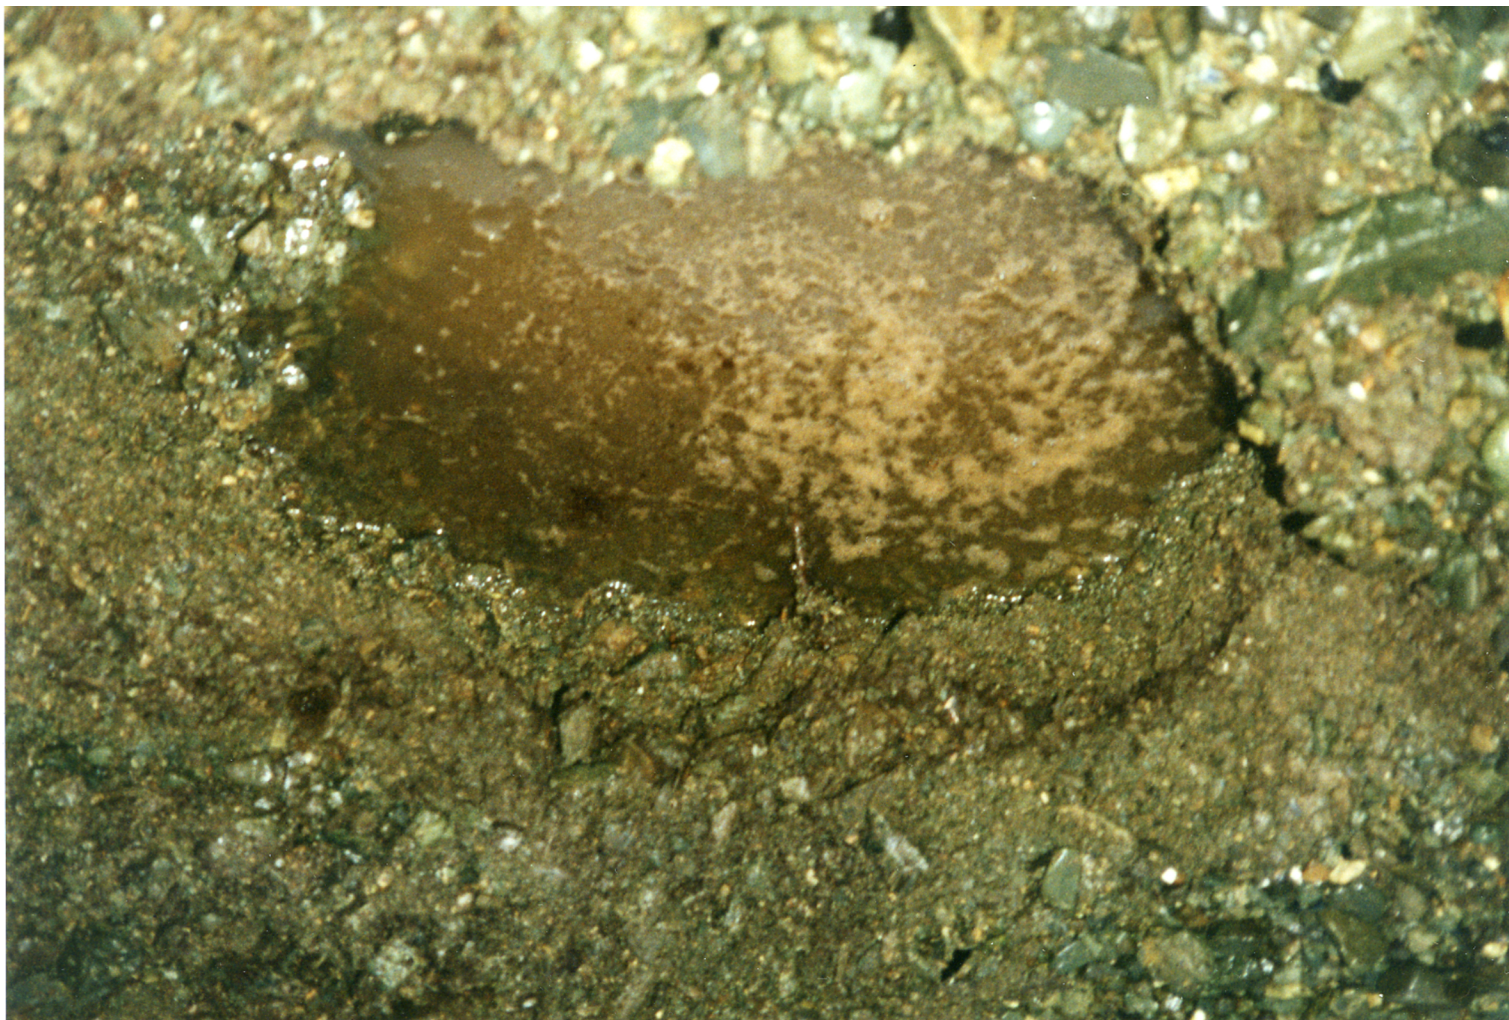
Segment No ELOS2 Subdivision B  
Date 4/27/91 Log Frame No 4  
Photographer Rebecca Hoff  
Location \_\_\_\_\_  
Comments Pit #5  
\_\_\_\_\_  
\_\_\_\_\_  
\_\_\_\_\_  
Roll No MAYSAP- 6-02 Neg. No 3  
Control No 818 (Office Use Only)

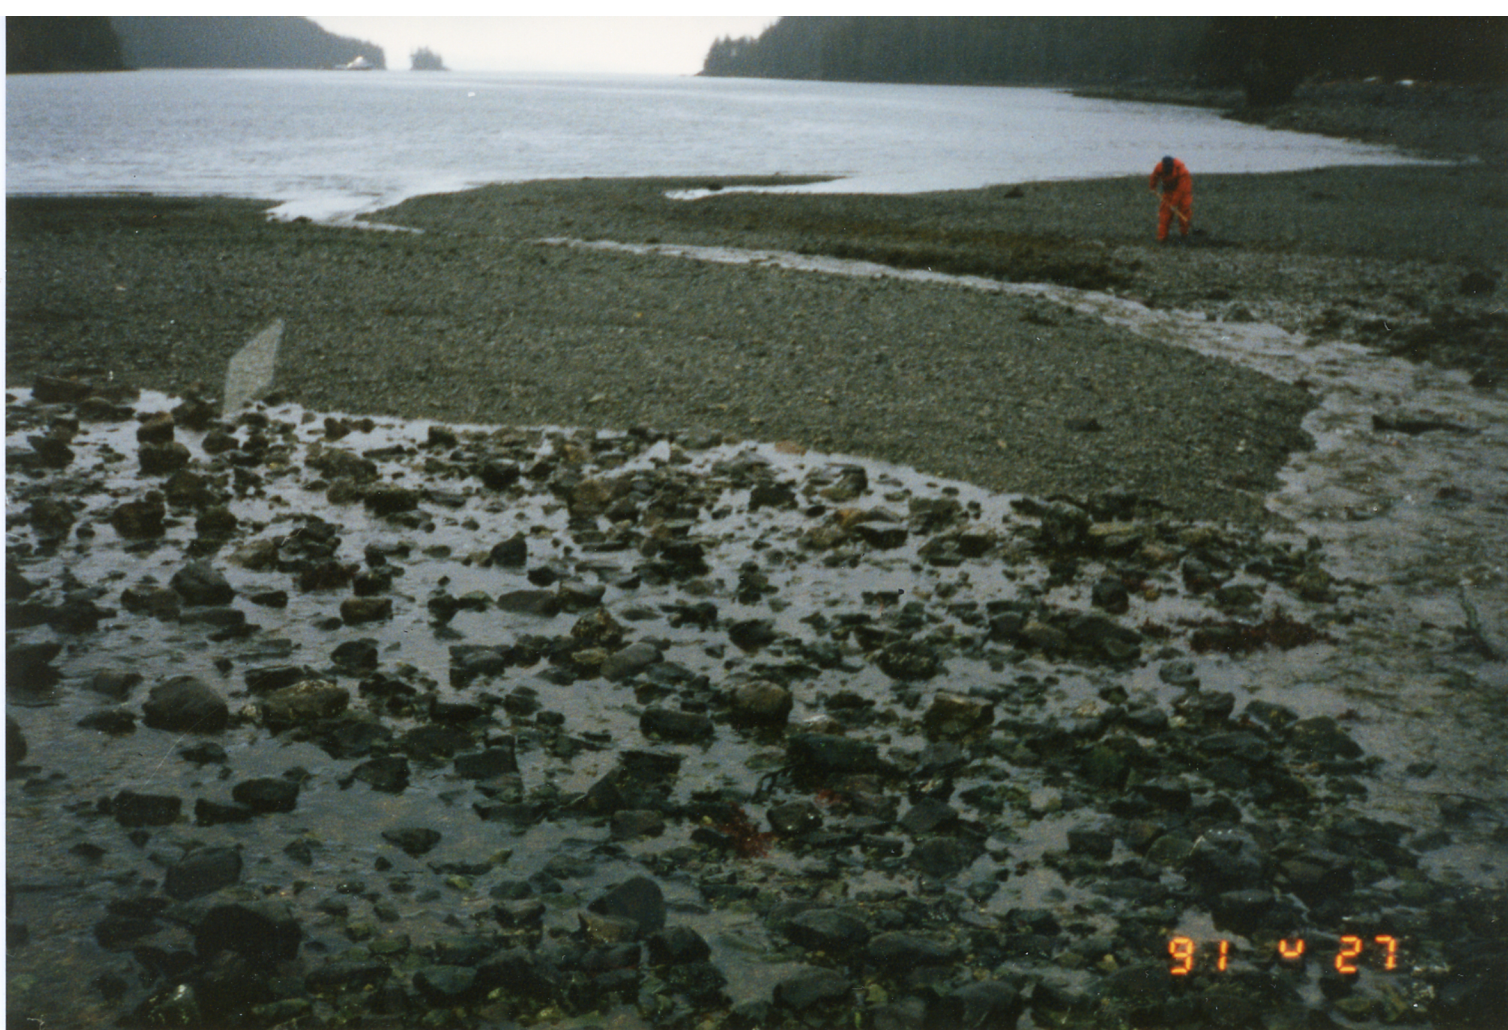
Segment No E6052 Subdivision B  
Date 4/27/91 Log Frame No 1  
Photographer Rebecca Hoff  
Location \_\_\_\_\_  
Comments Overview looking downstream  
\_\_\_\_\_  
\_\_\_\_\_  
\_\_\_\_\_
