KN-103 A ASC 16922 site 2  
LOWER PASSAGE

KN103U01MM  
 OPAL CREEK LOWER PASSAGE  
 KNIGHT ISLAND

# ADF&G HABITAT STUDY SITE DESCRIPTION FORM

ANADROMOUS FISH STREAM EVALUATION (226-10-16922)

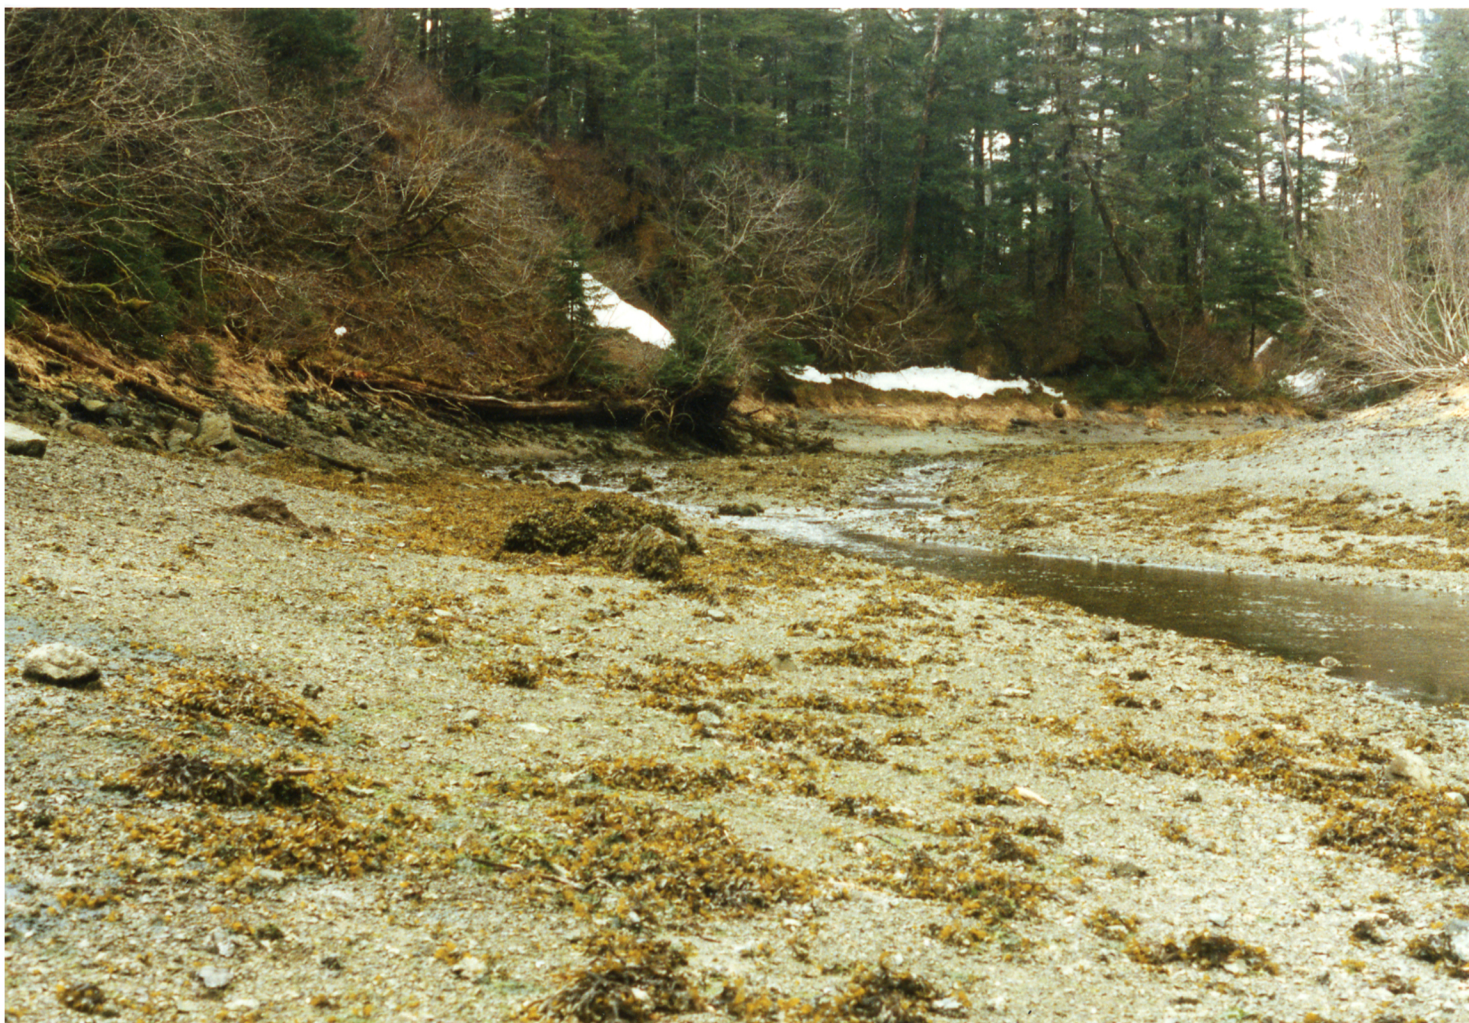
18

Segment No KD103 Subdivision EA  
Date 5/1/91 Log Frame No 116  
Photographer Rebecca Hoff  
Location \_\_\_\_\_  
Comments View upstream from outlet

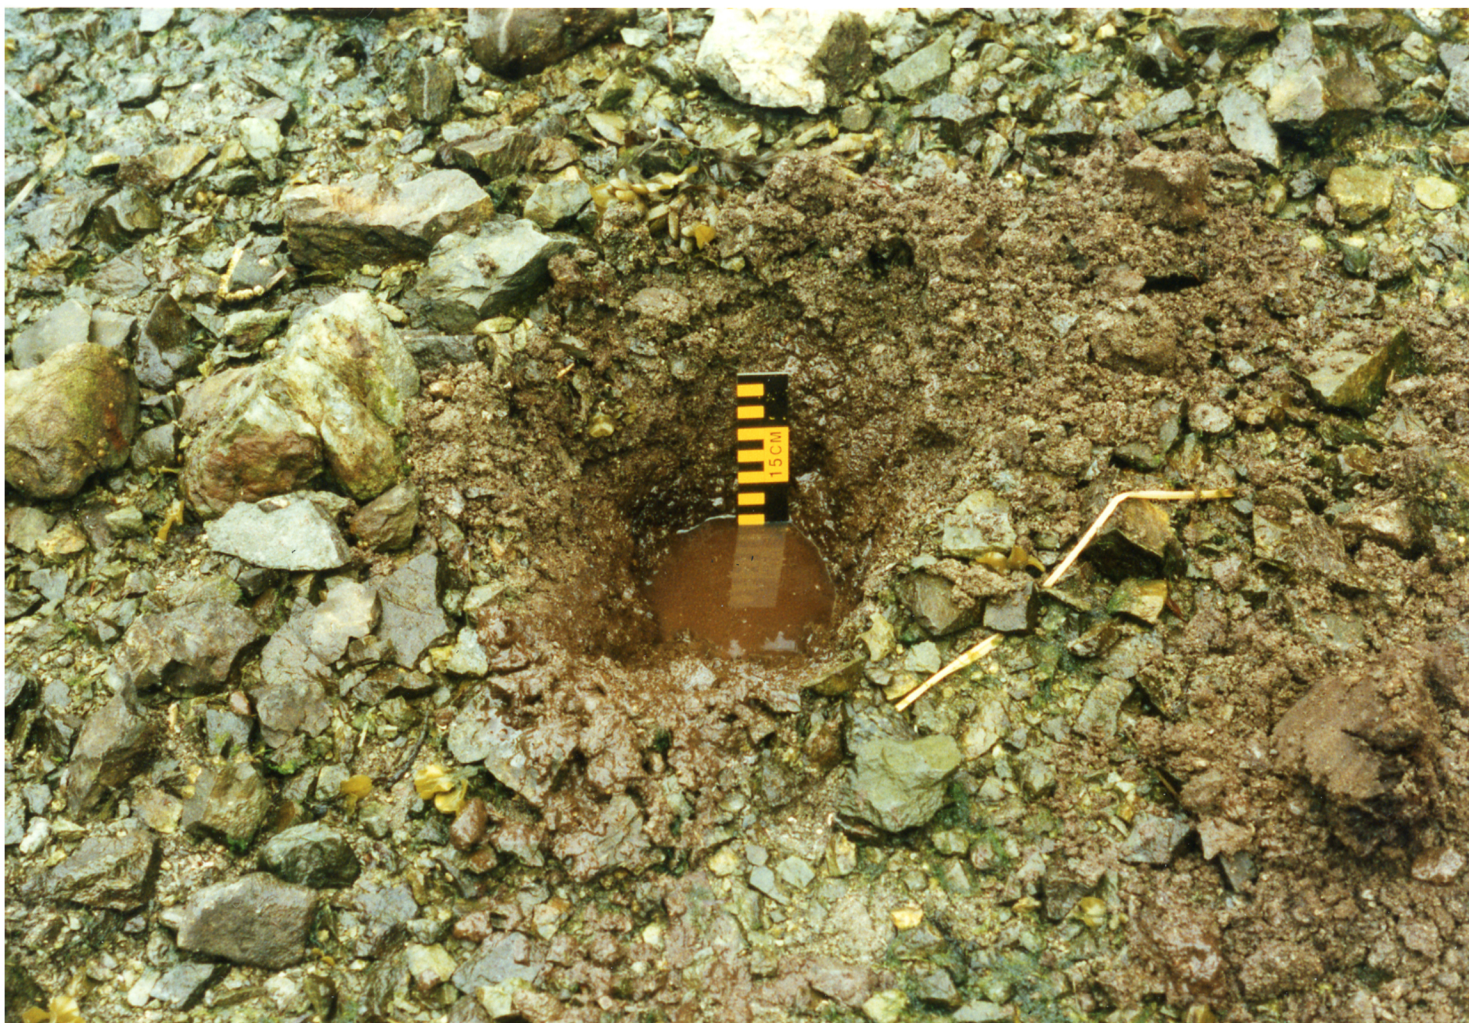
19

Segment No KN103 Subdivision A  
Date 5/1/91 Log Frame No 17  
Photographer Rebecca Hoff  
Location \_\_\_\_\_  
Comments View of pit in upper intertidal  
along stream with peat + no oil  
pit #3)

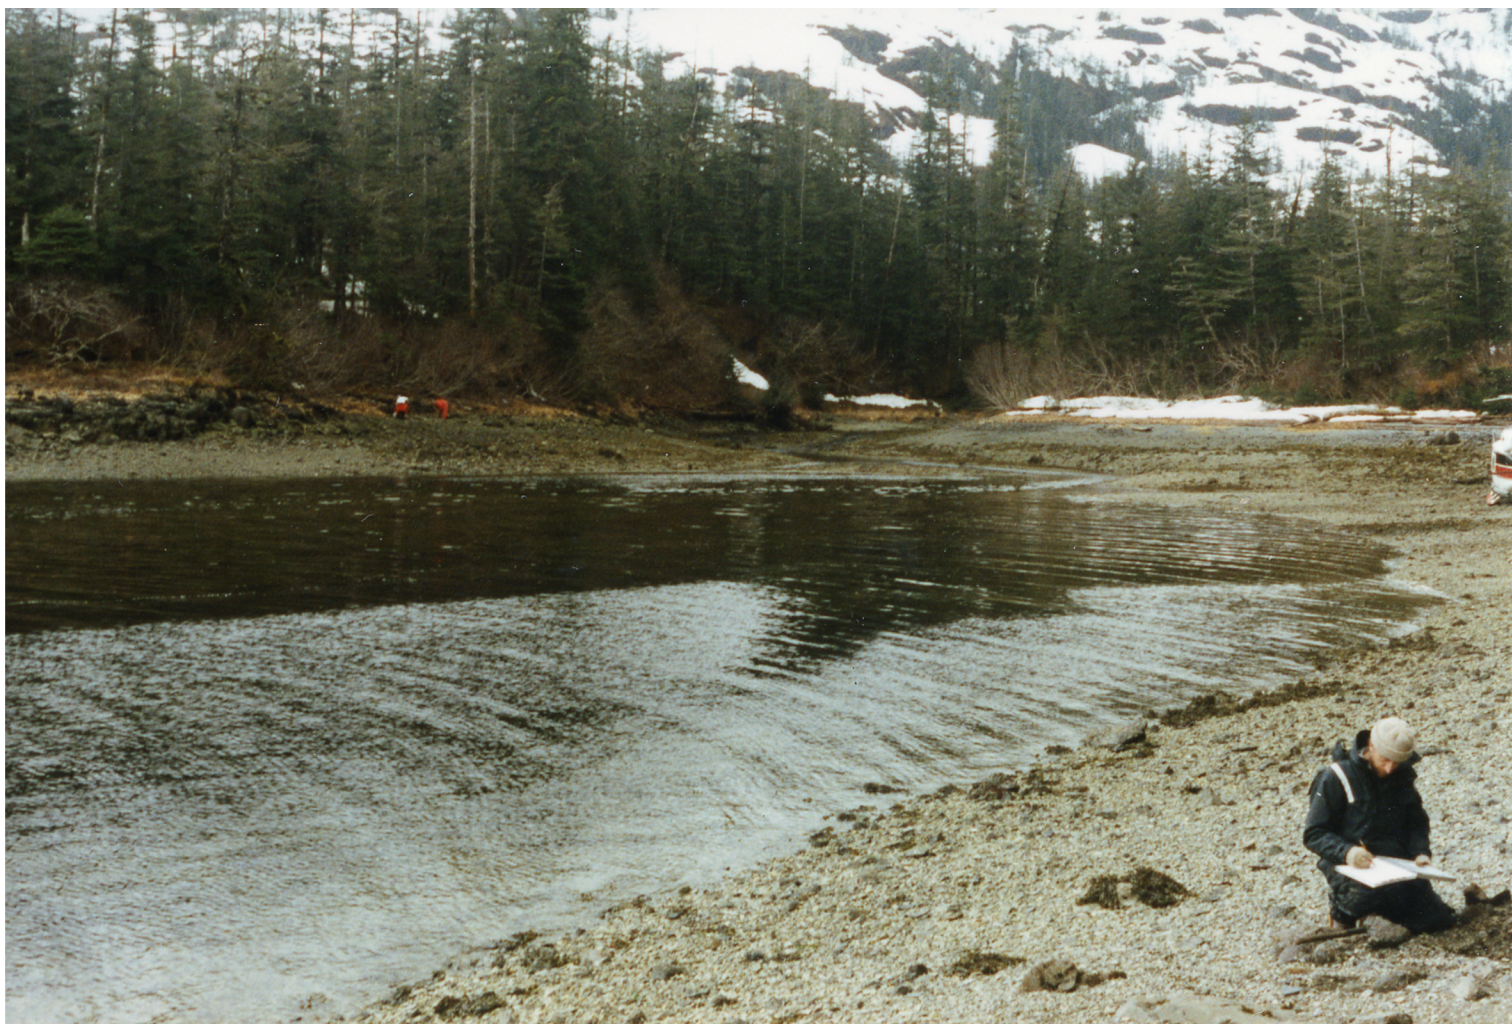
Segment No KN103 Subdivision A  
Date 5/1/91 Log Frame No 18  
Photographer Rebecca Hoff  
Location \_\_\_\_\_  
Comments Overview of segment  
\_\_\_\_\_  
\_\_\_\_\_  
\_\_\_\_\_  
Roll No MAYSAP-6-04 Neg. No 20  
Control No 847 (Office Use Only)
