KN-129<sup>B</sup> ASC: 226-10-16975 site 1  
South End Herring Bay - Knight Island

Prince William Sound

Post-treatment assessment  
ADF&G MULTI-ASSESSMENT DATA FORM

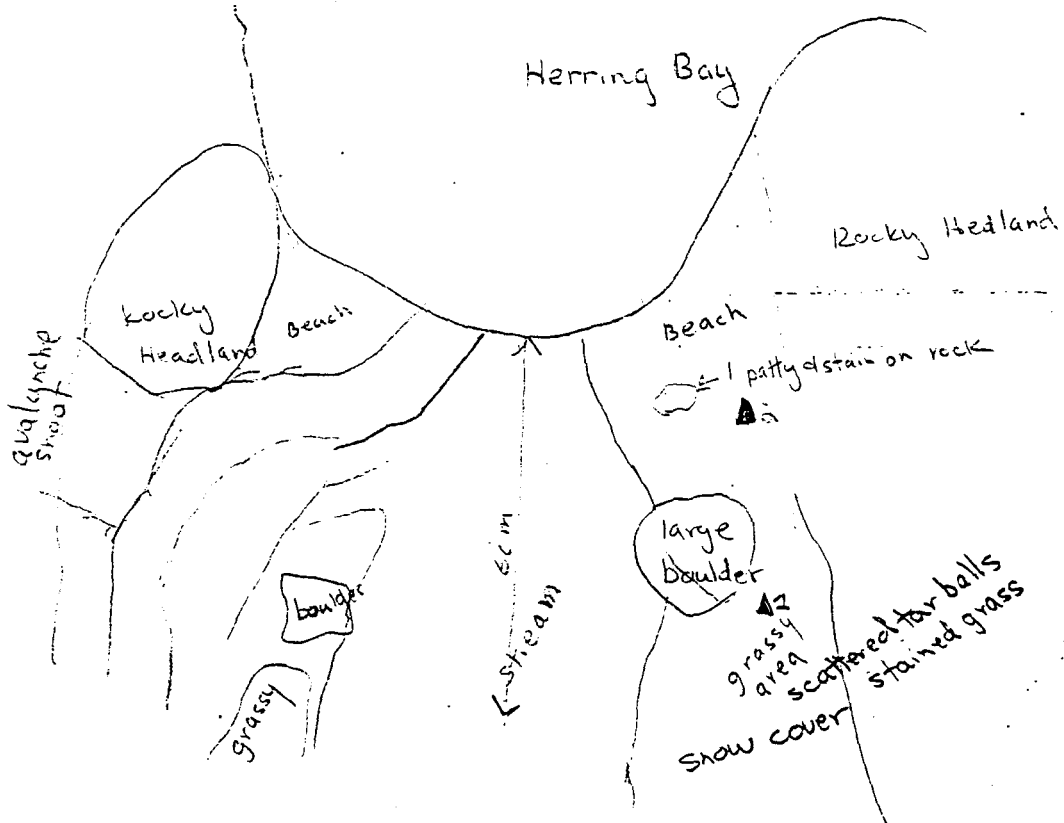
48 OIL DISTRIBUTION DIAGRAM

COMMENTS: snow pack covering upper portions of stream  
noted several tar balls in grassy area surrounding houlder & across from shoot  
looks much better than last year - no visible sheen at this time

Recommended - treat after resurvey

assess after snow melts & periodically check for sheening  
remove scattered tar balls in grassy area by boulder & chute

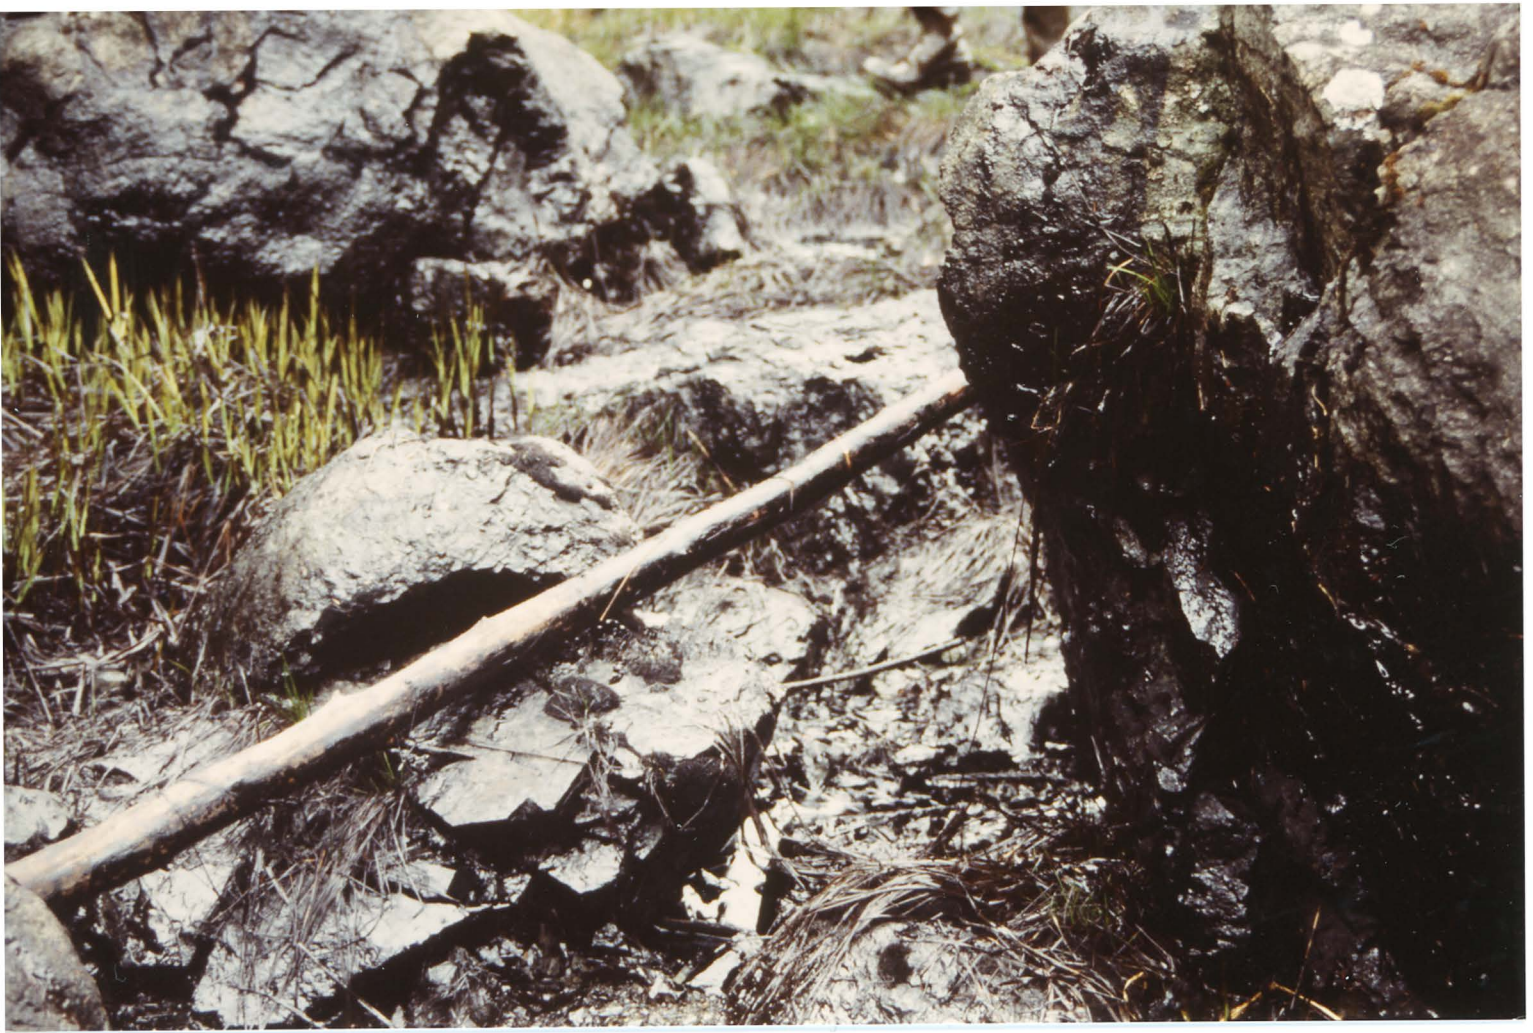
ACE 7378593

ACE # 7378593: Reason for taking photo: Looking downstream.  
Frame #: 32, ACE # 7378594: reason for taking photo:  
Looking downstream, Frame #: 33, ACE # 7378595: reason  
for taking photo: Shoreline, Frame # 34, ACE # 7378596:  
reason for taking photo: Shoreline, Frame #: 35, ACE # 7378597:  
reason for taking photo: Pooled oil in grass between  
stream channels frame # 36.

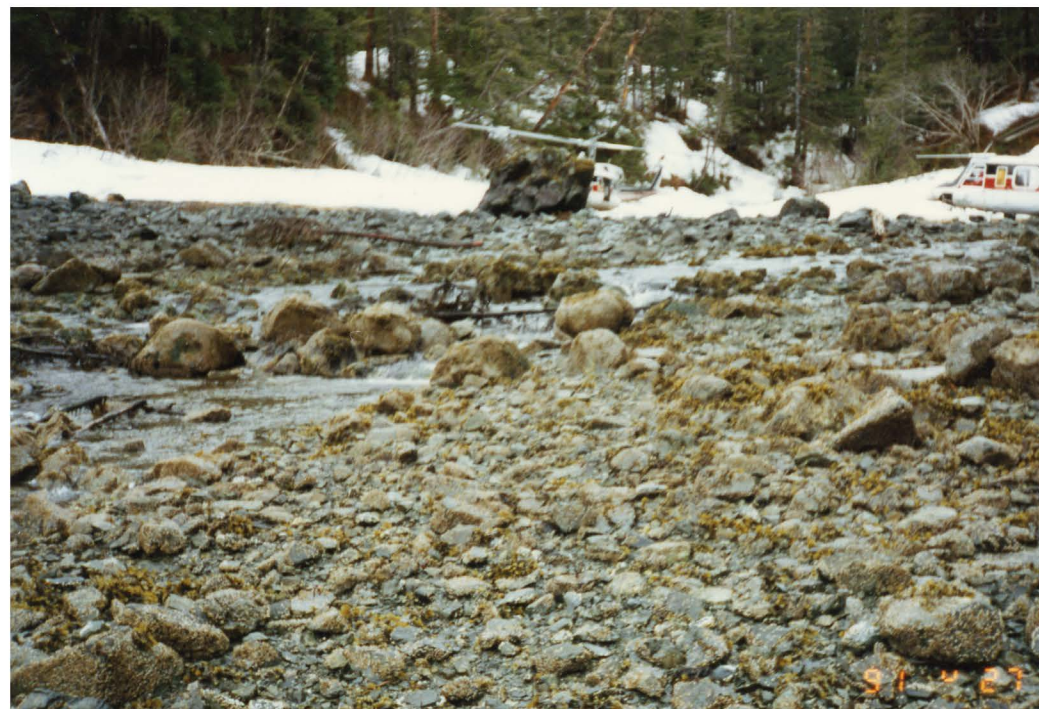
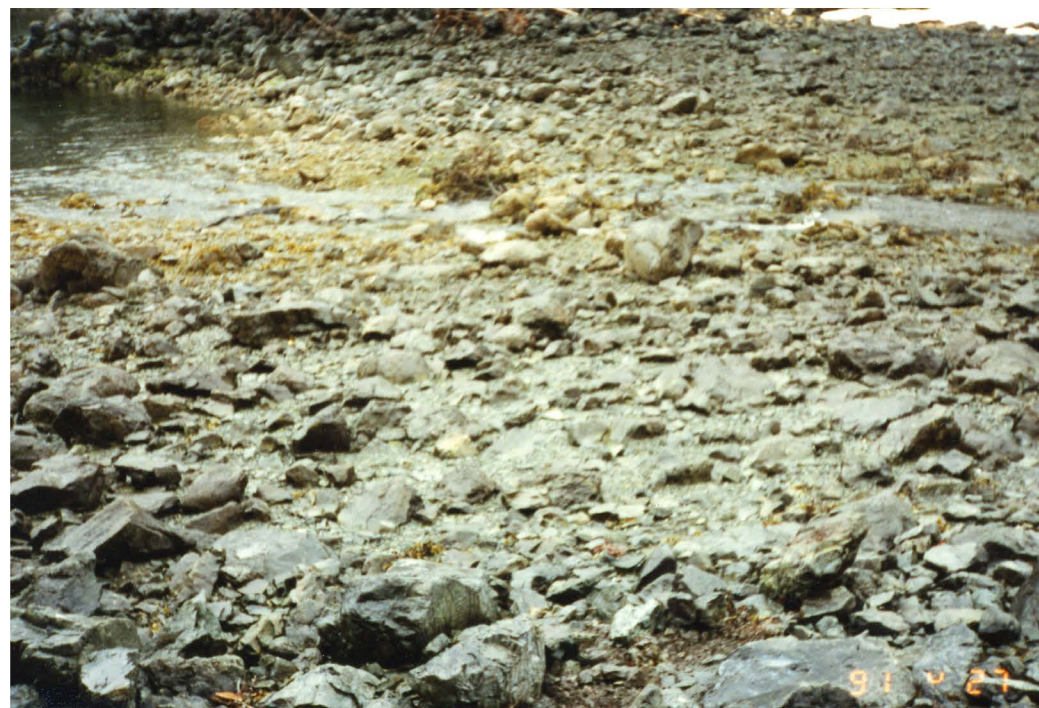
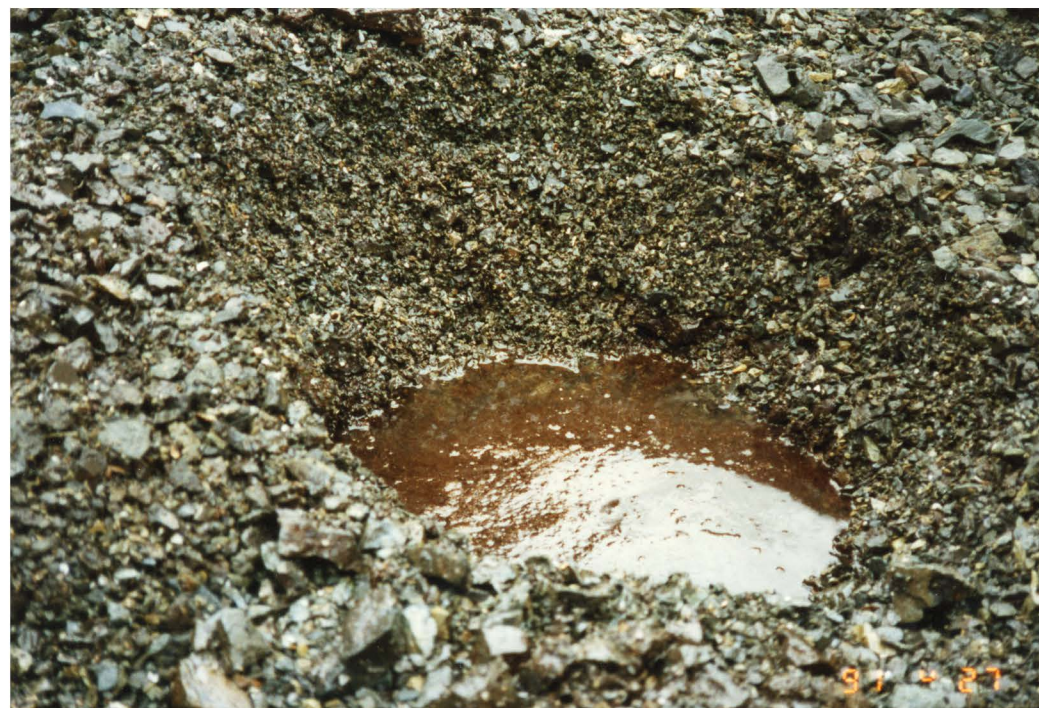
NO. 814

Segment No KN0129 Subdivision B  
Date 4/27/91 Log Frame No 15  
Photographer REBECCA HOFF  
Location KNIGHT ISLAND  
Comments SURFACE OIL RESIDUE

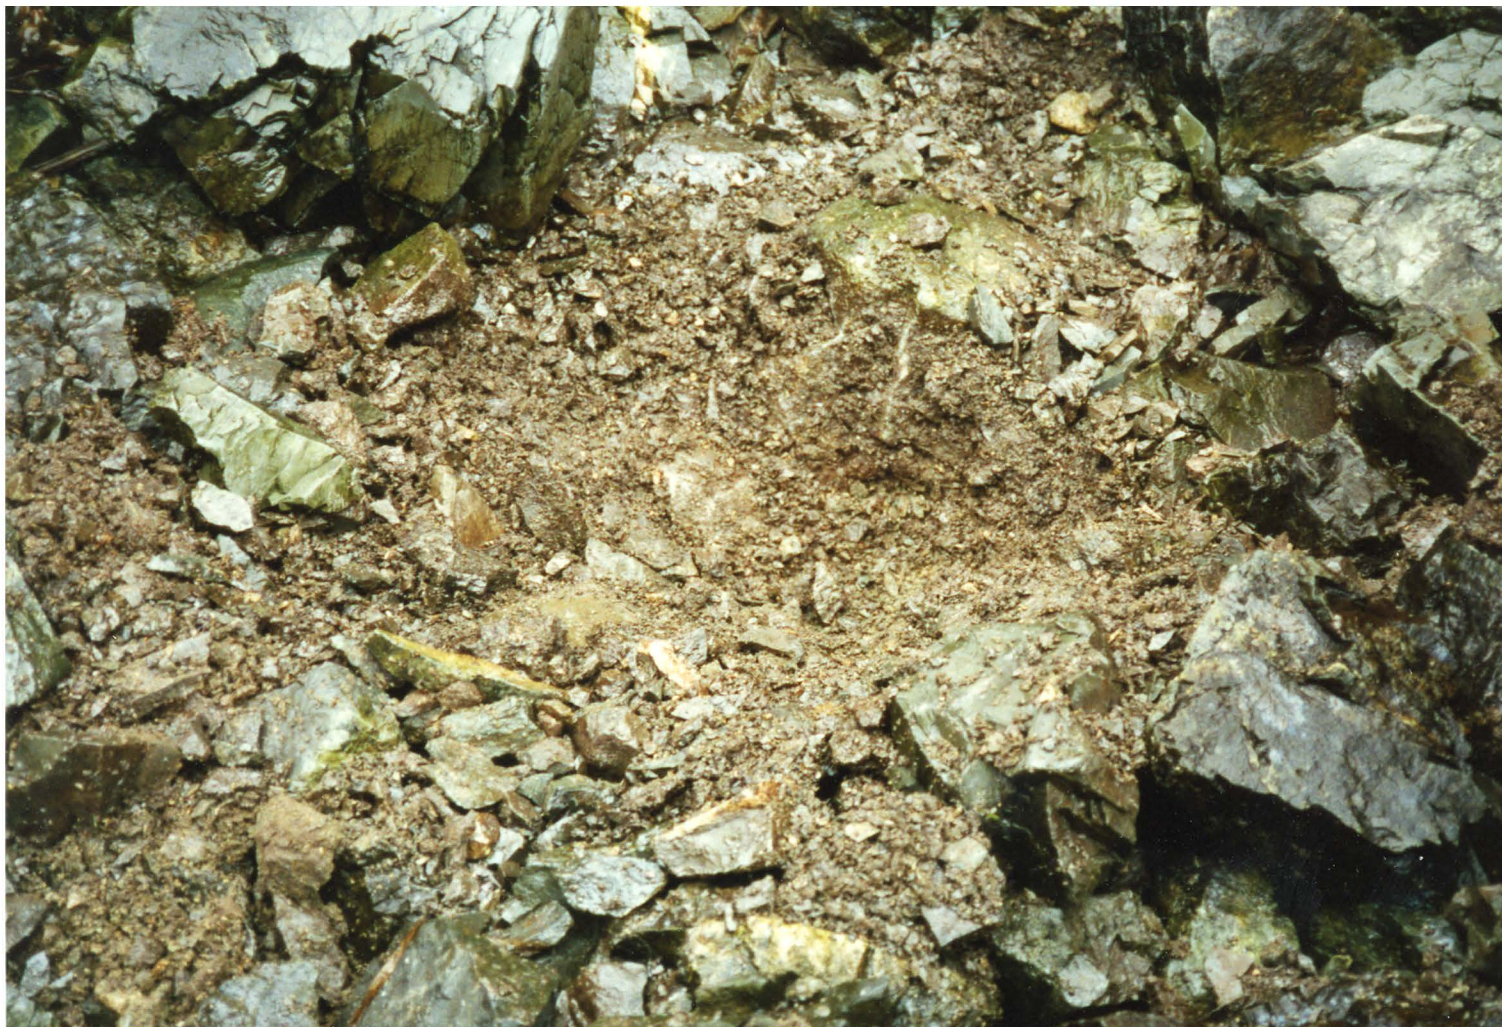
Segment No KN0129 Subdivision B  
Date 4/27/91 Log Frame No 15  
Photographer REBECCA HOFF  
Location KNIGHT ISLAND  
Comments SURFACE OIL RESIDUE

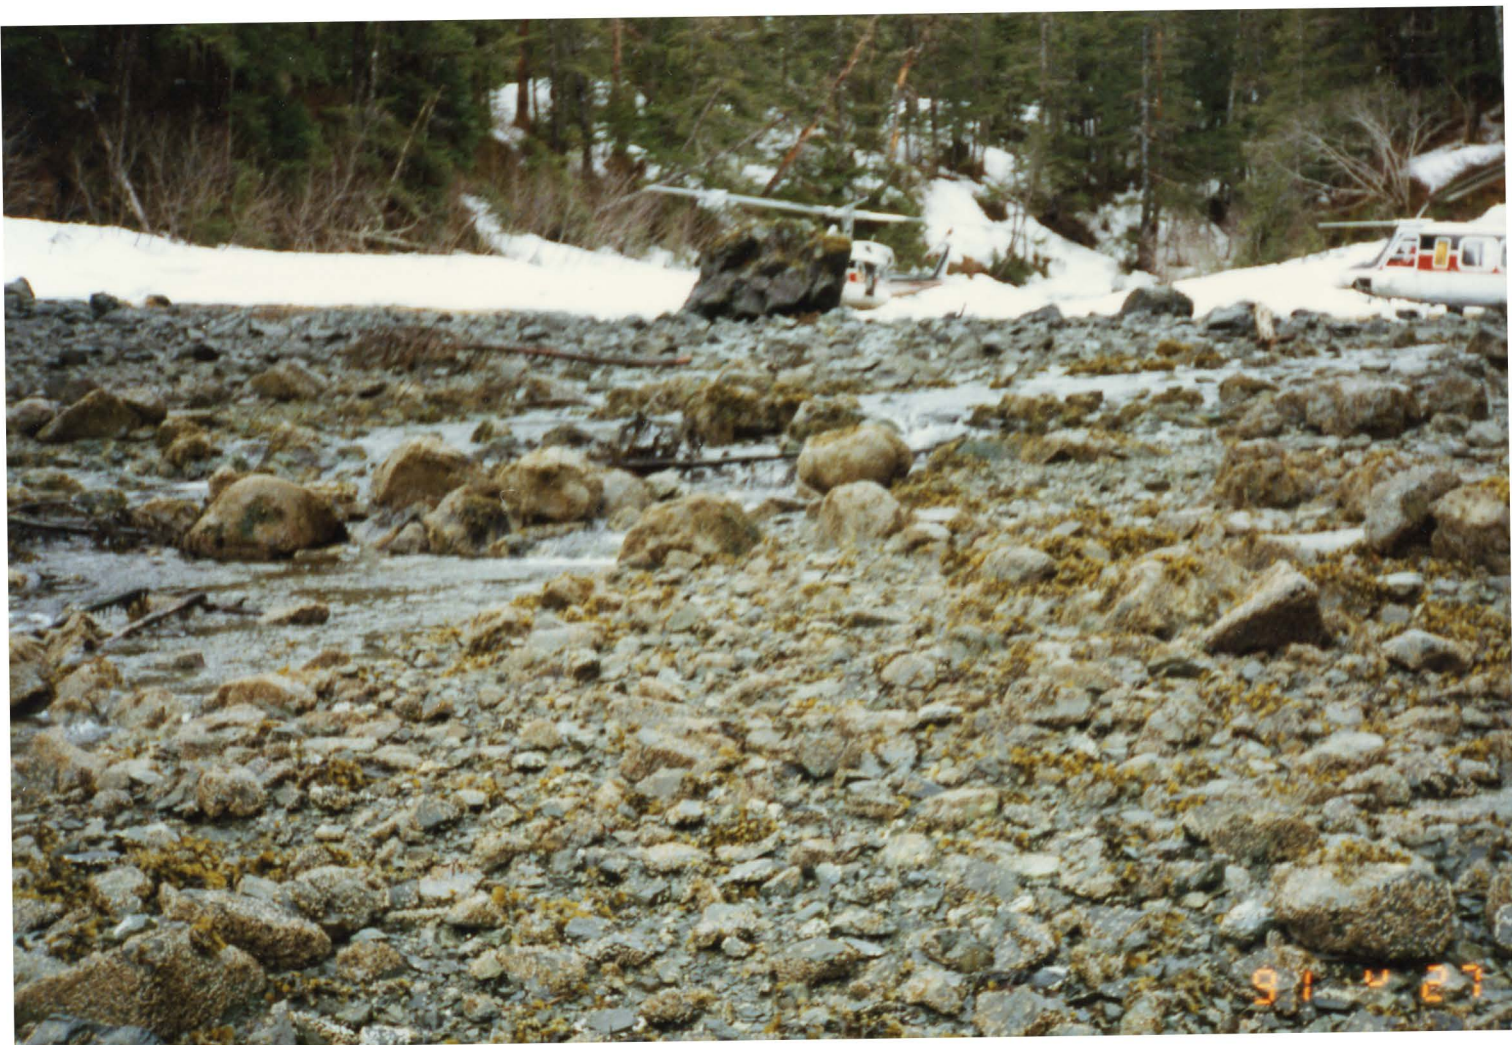
Segment No KN0129 Subdivision B  
Date 4/27/91 Log Frame No 16  
Photographer REBECCA HOFF  
Location KNIGHT ISLAND  
Comments OVERVIEW OF BEACH LOOKING  
UPSTREAM

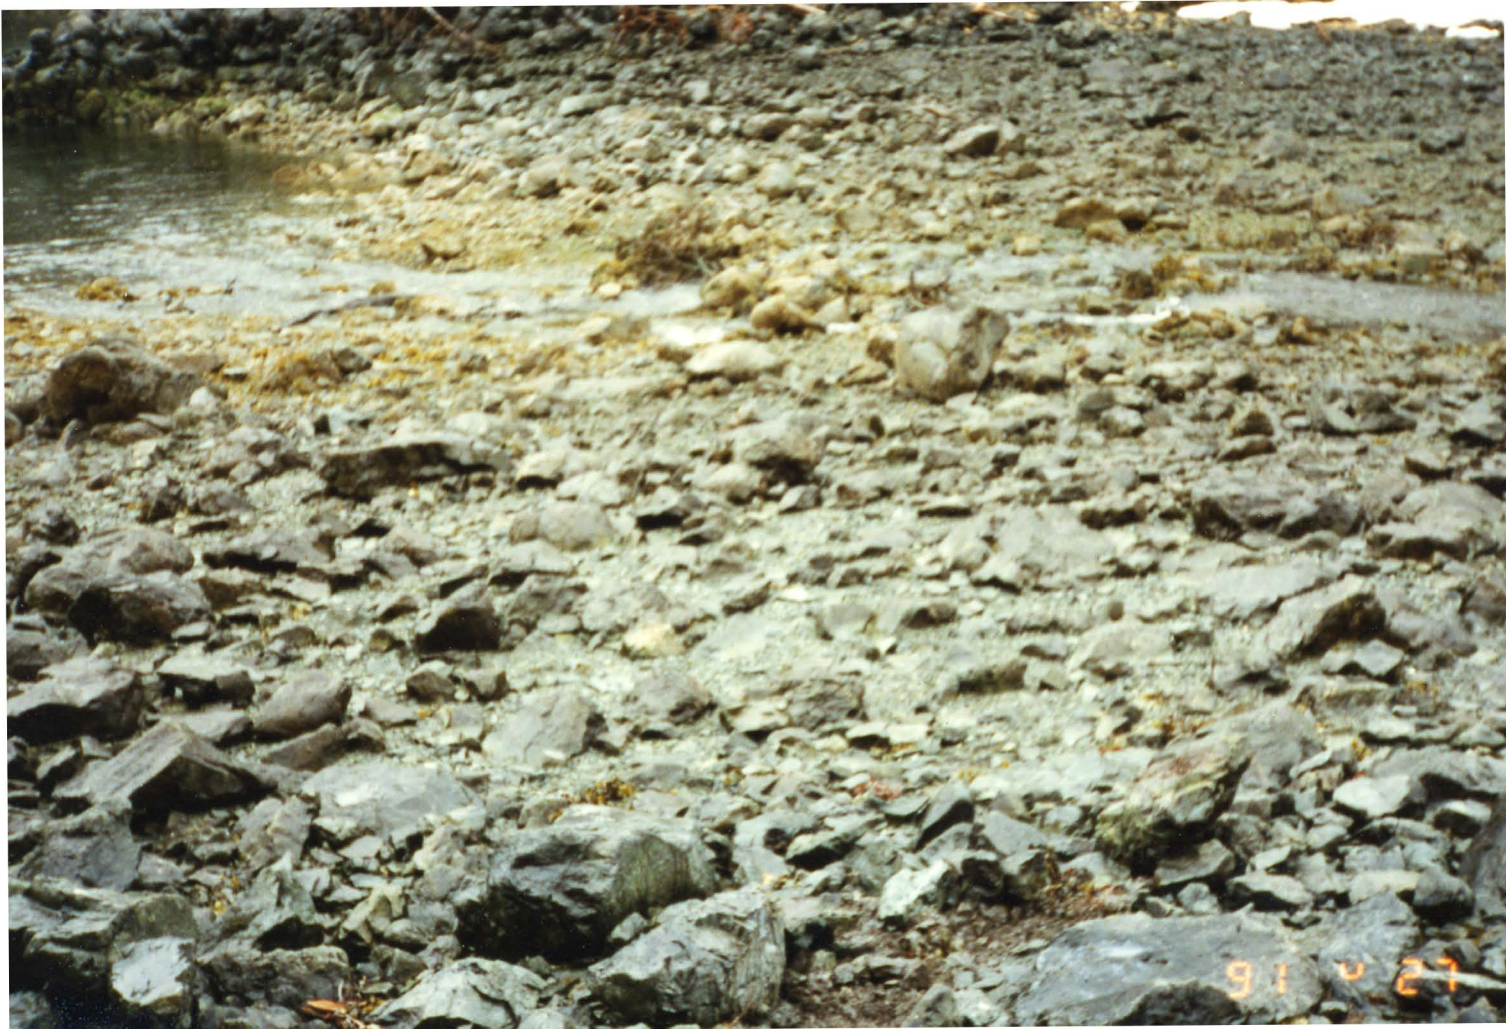
Segment No KN0129 Subdivision B  
Date 4/27/91 Log Frame No 17  
Photographer REBECCA HOFF  
Location KNIGHT ISLAND  
Comments VIEW FROM BOULDER LOOKING  
DOWN TOWARDS THE WATER

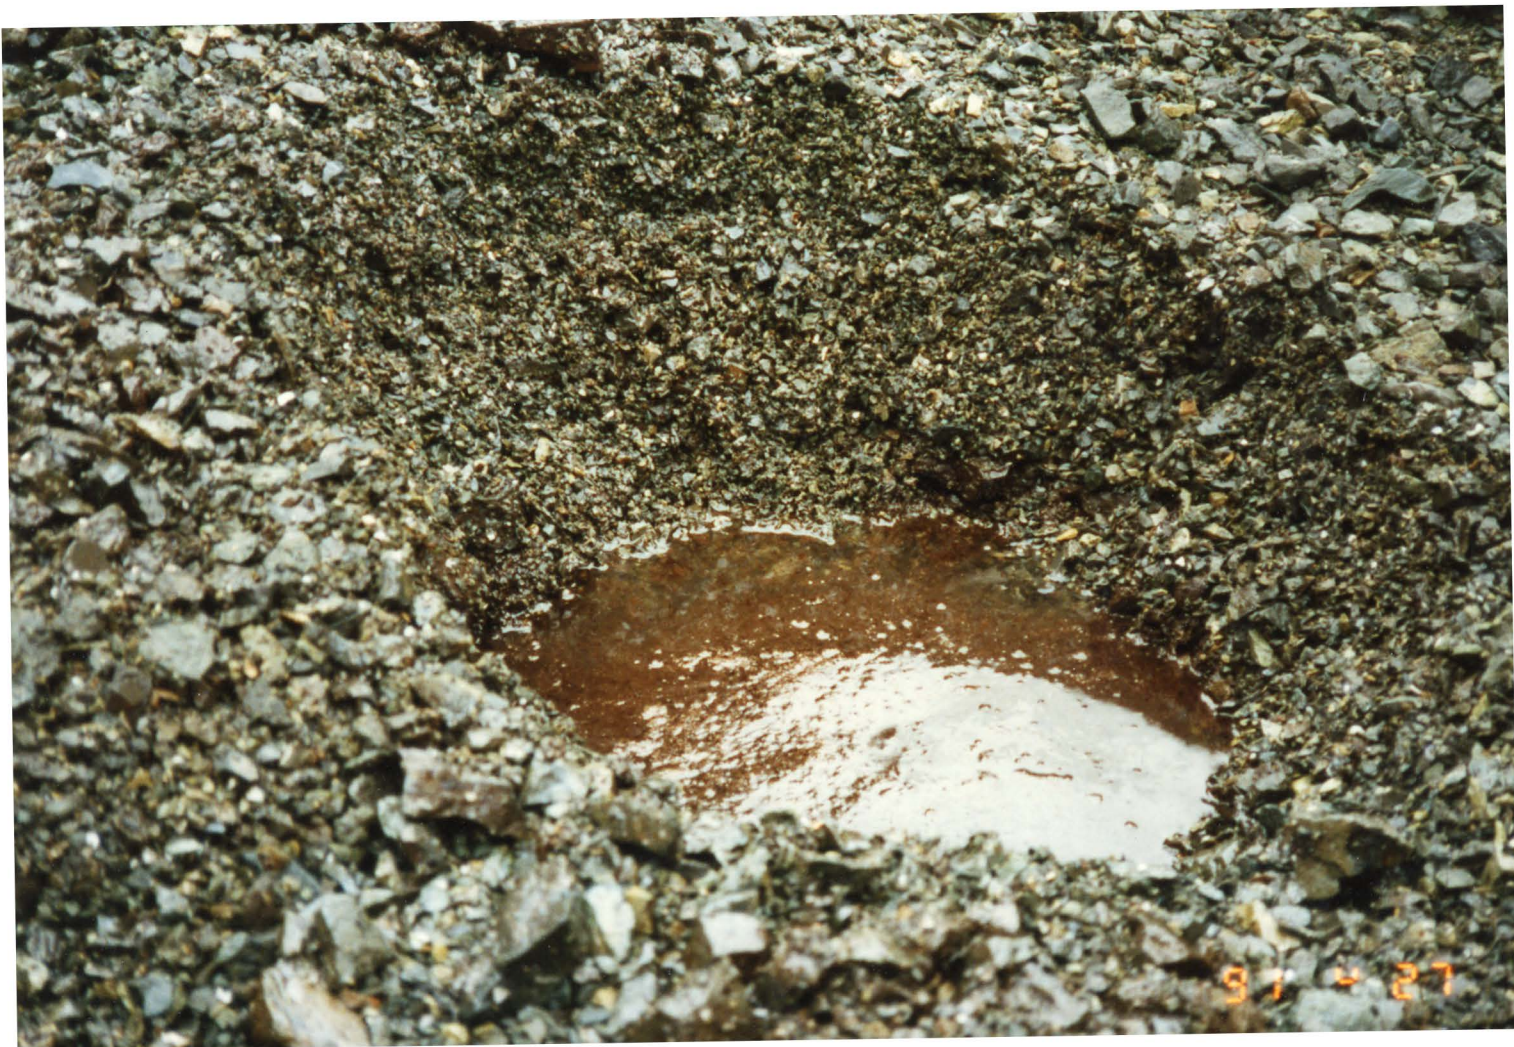
Segment No KN0129 Subdivision B  
Date 4/27/91 Log Frame No 18  
Photographer REBECCA HOFF  
Location KNIGHT ISLAND  
Comments PIT #3 IN GRAVEL NEAR  
STREAM BY POOL FROM SNOWMELT SHOW-  
ING SUBSURFACE OIL
