KN-132 B ASC: 226-10-16982  
West side Herring Bay

### 3.20 Station 110, Herring Bay, Knight Island

This site is located along the bank of an anadromous stream that empties into the middle of the western shore of Herring Bay. The beach is composed primarily of gravel and cobble overlying a compacted matrix of sandy gravel. The upper berm is constructed of fine gravels. Treatment was limited to manual sorbant pad oil collection. Transects from 22 October 1989, 24 November 1989, and 22 March 1990, are compared.

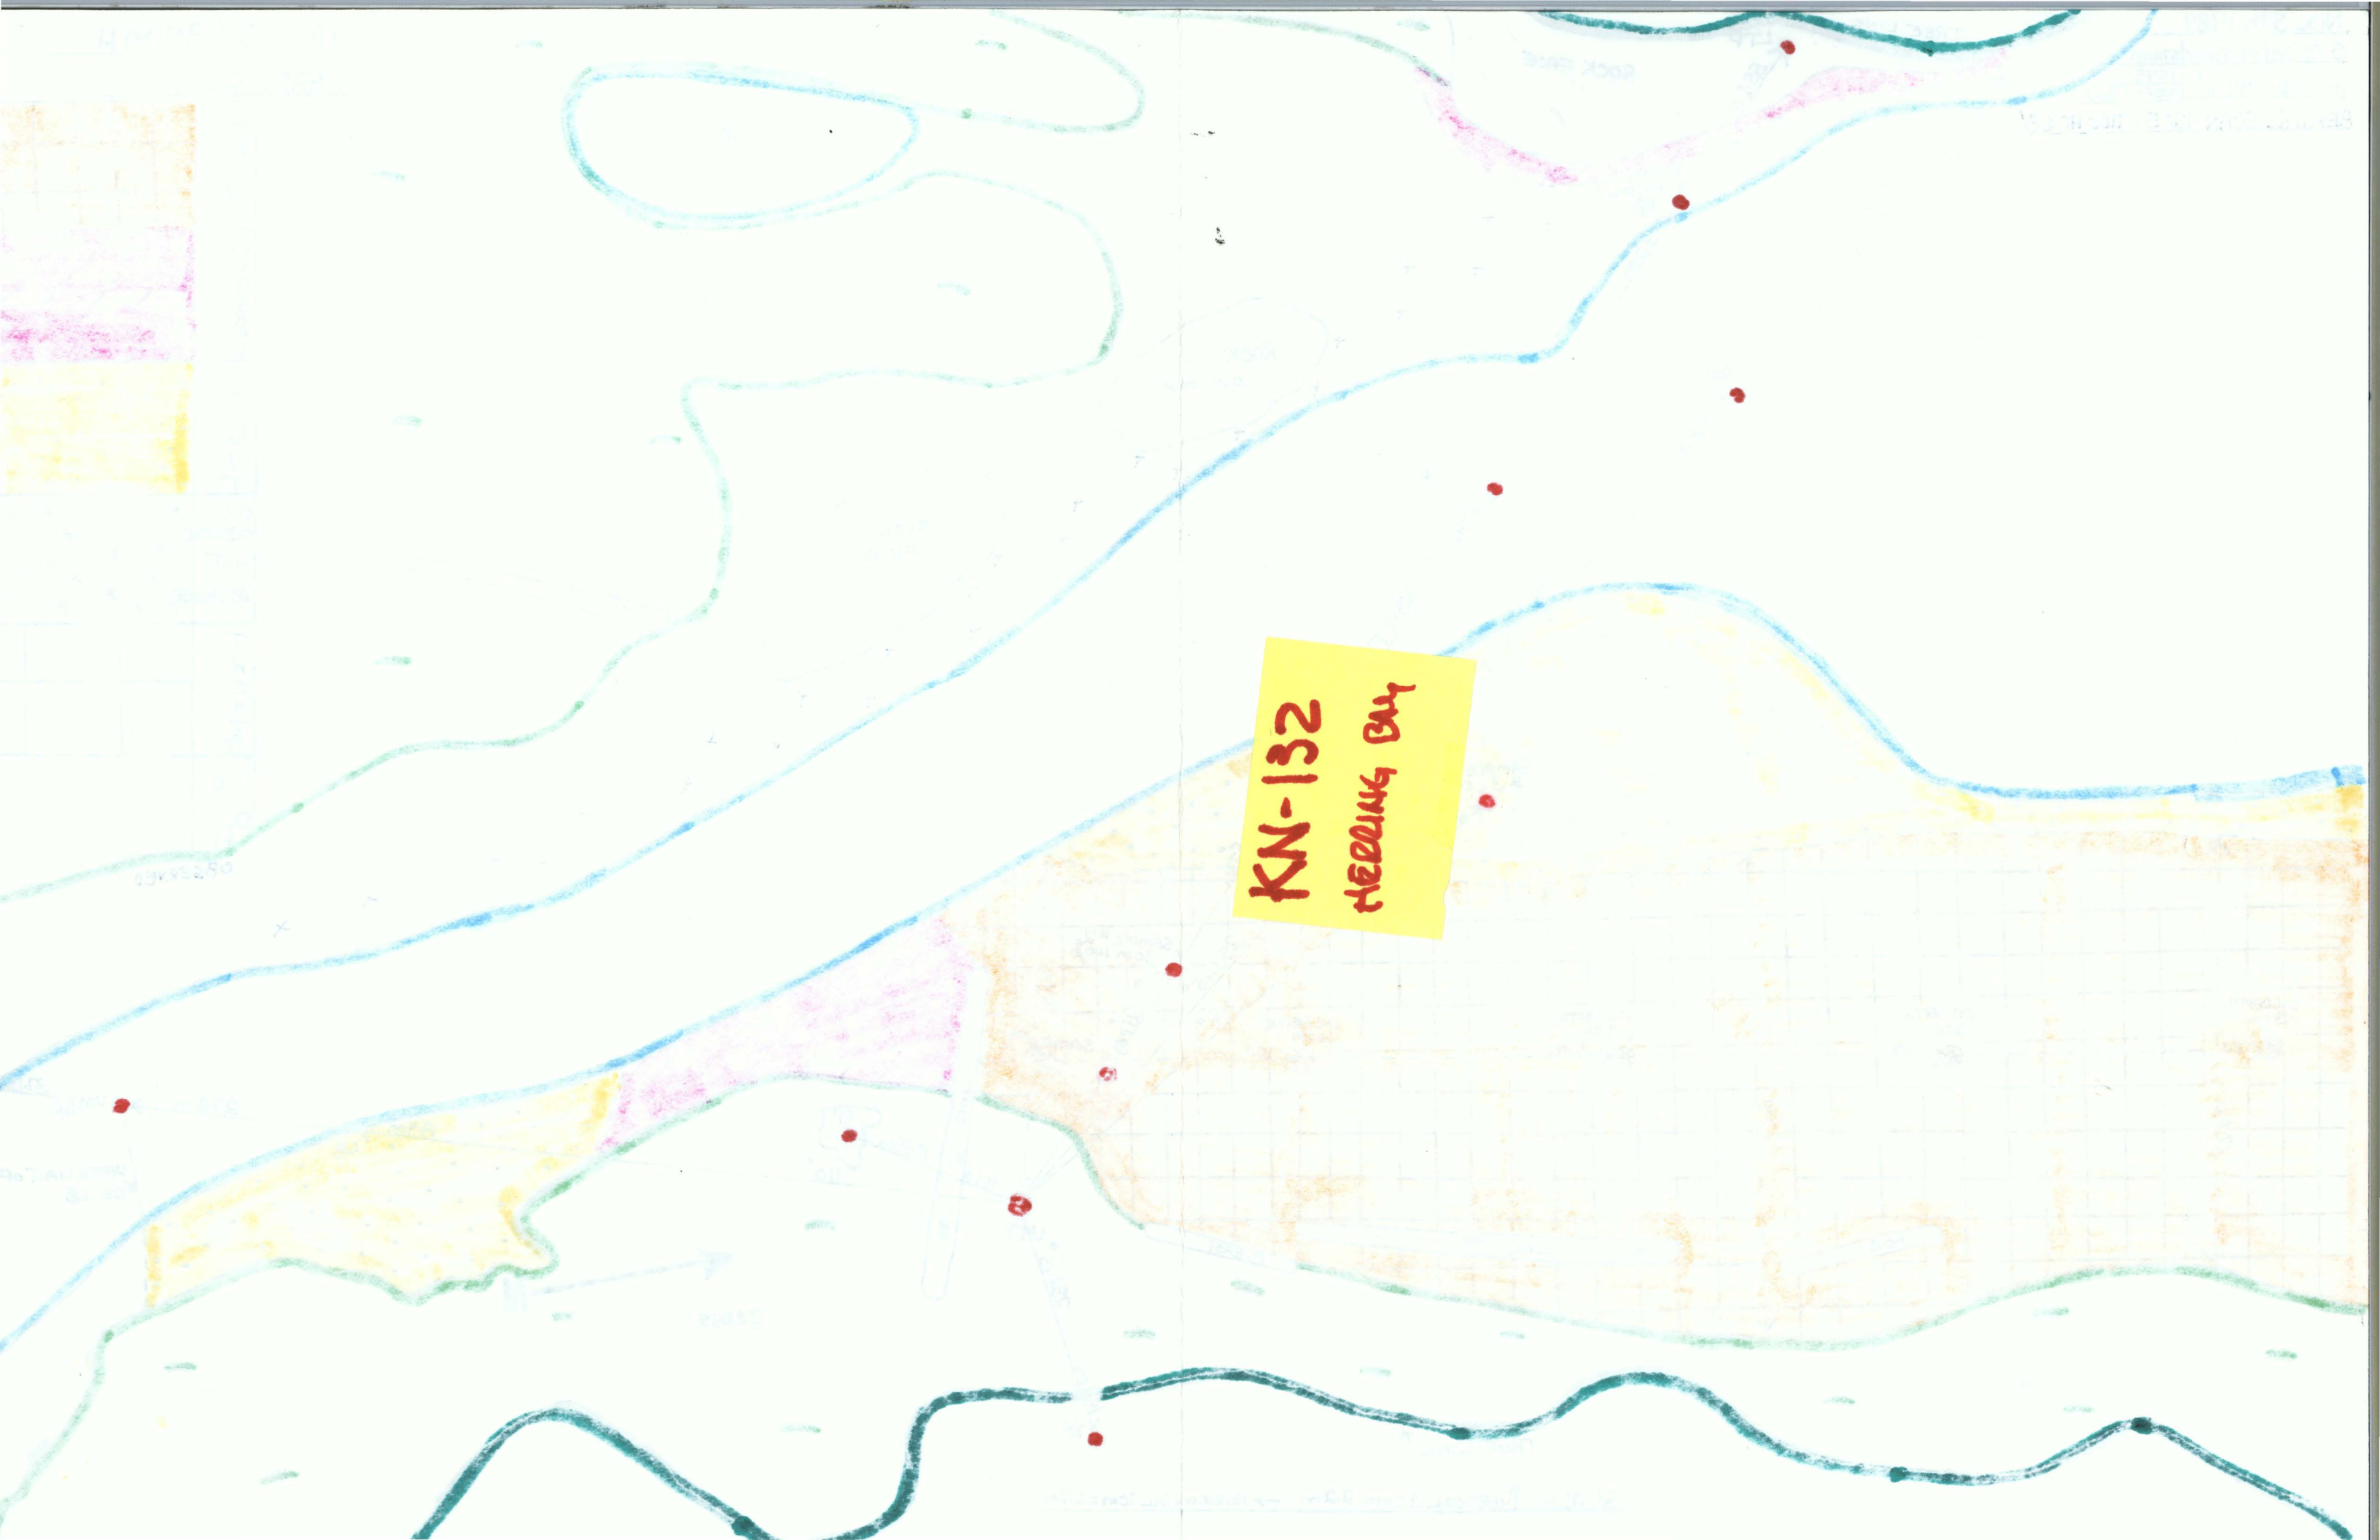
KN-132  
HEELING BAY

NOV 5 IN 1987  
 SITE SETUP TIME START 1045 STOP 1300  
 LOW TIDE: 111 6' PERIAL SCAN 1205 TIDE HT 6.3'

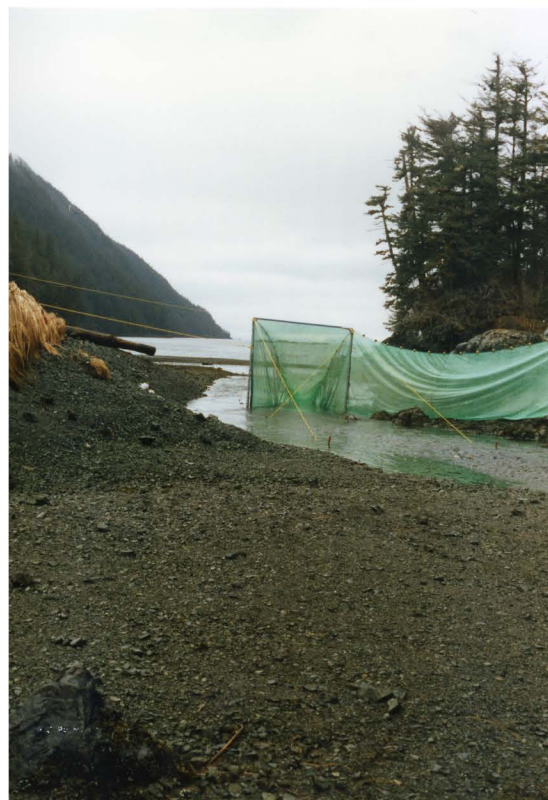
2  
Segment No KN132 Subdivision B  
Date 5/1/91 Log Frame No 1  
Photographer Rebecca Hoff  
Location \_\_\_\_\_  
Comments looking down to base of  
stream from upper intertidal

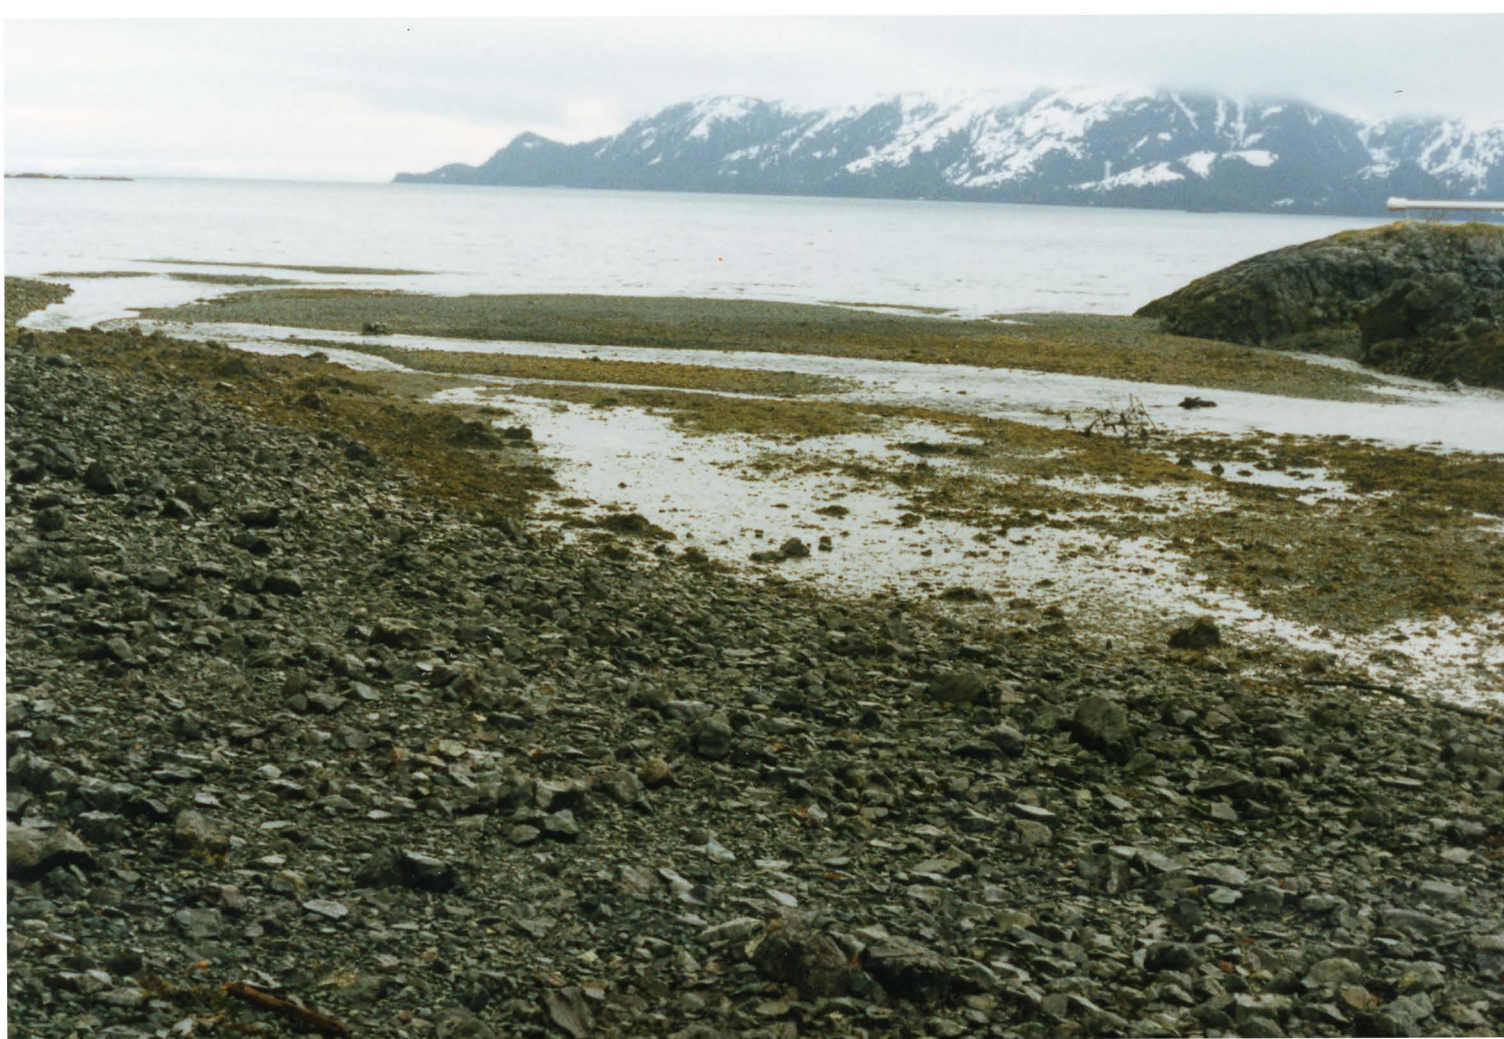
3  
Segment No KN132 Subdivision B  
Date 5/1/91 Log Frame No 2  
Photographer Rexcen Hoff  
Location \_\_\_\_\_  
Comments Looking across stream to  
peat bog on east side of stream (in  
132A)

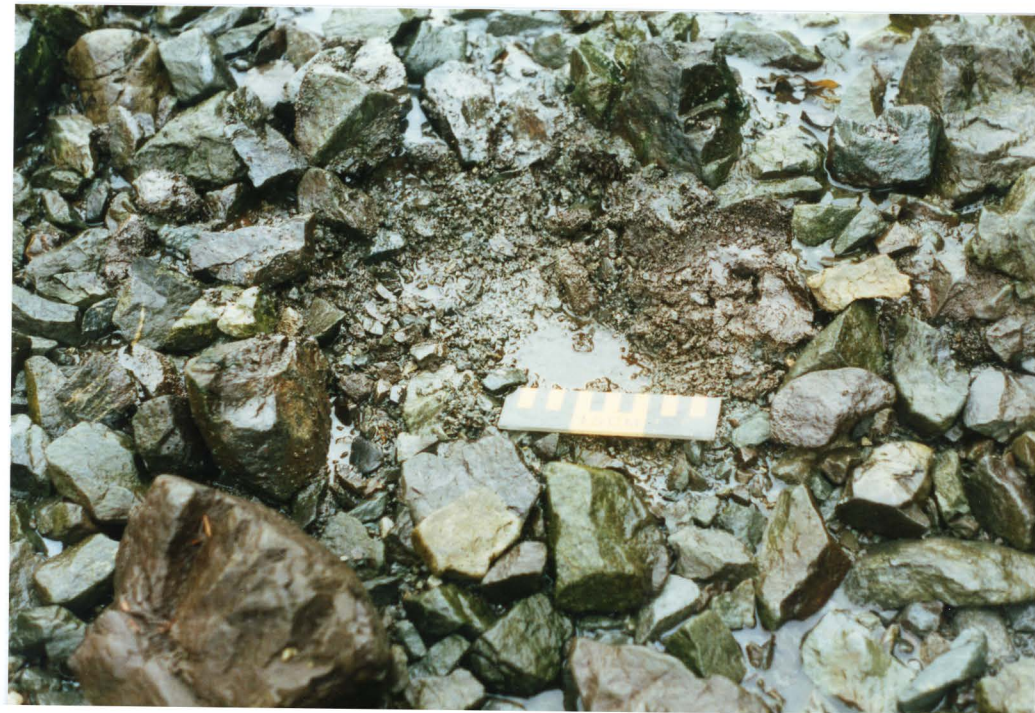
KN132B 5/01/91 NO847

6  
Segment No KN132 Subdivision B  
Date 5/1/91 Log Frame No 5  
Photographer Rebecca Hoff  
Location \_\_\_\_\_  
Comments Overview of entire segment  
including stream and flycatcher

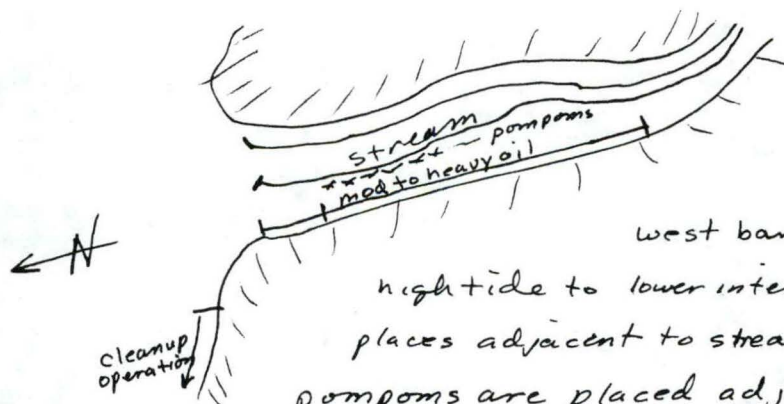
west bank oiled from high tide to lower intertidal - in some places adjacent to stream. A string of pompoms are placed adjacent to the stream. More sorbents will need to be placed in the stream to pick up any oil from cleanup of the west bank. East side appears relatively free of oil at this time.
