CH-016 A ASC 16258  
near Chenega Village (old)

ADF&G MULTI-ASSESSMENT DATA FORM

| CATALOG NUMBER: 2262016258      SEGMENT#: CH016 A      LOCATION: CHENEGA ISLAND, NEAR OLD CHENEGA VILLAGE | | | | | | | |

ANADROMOUS FISH STREAM EVALUATION

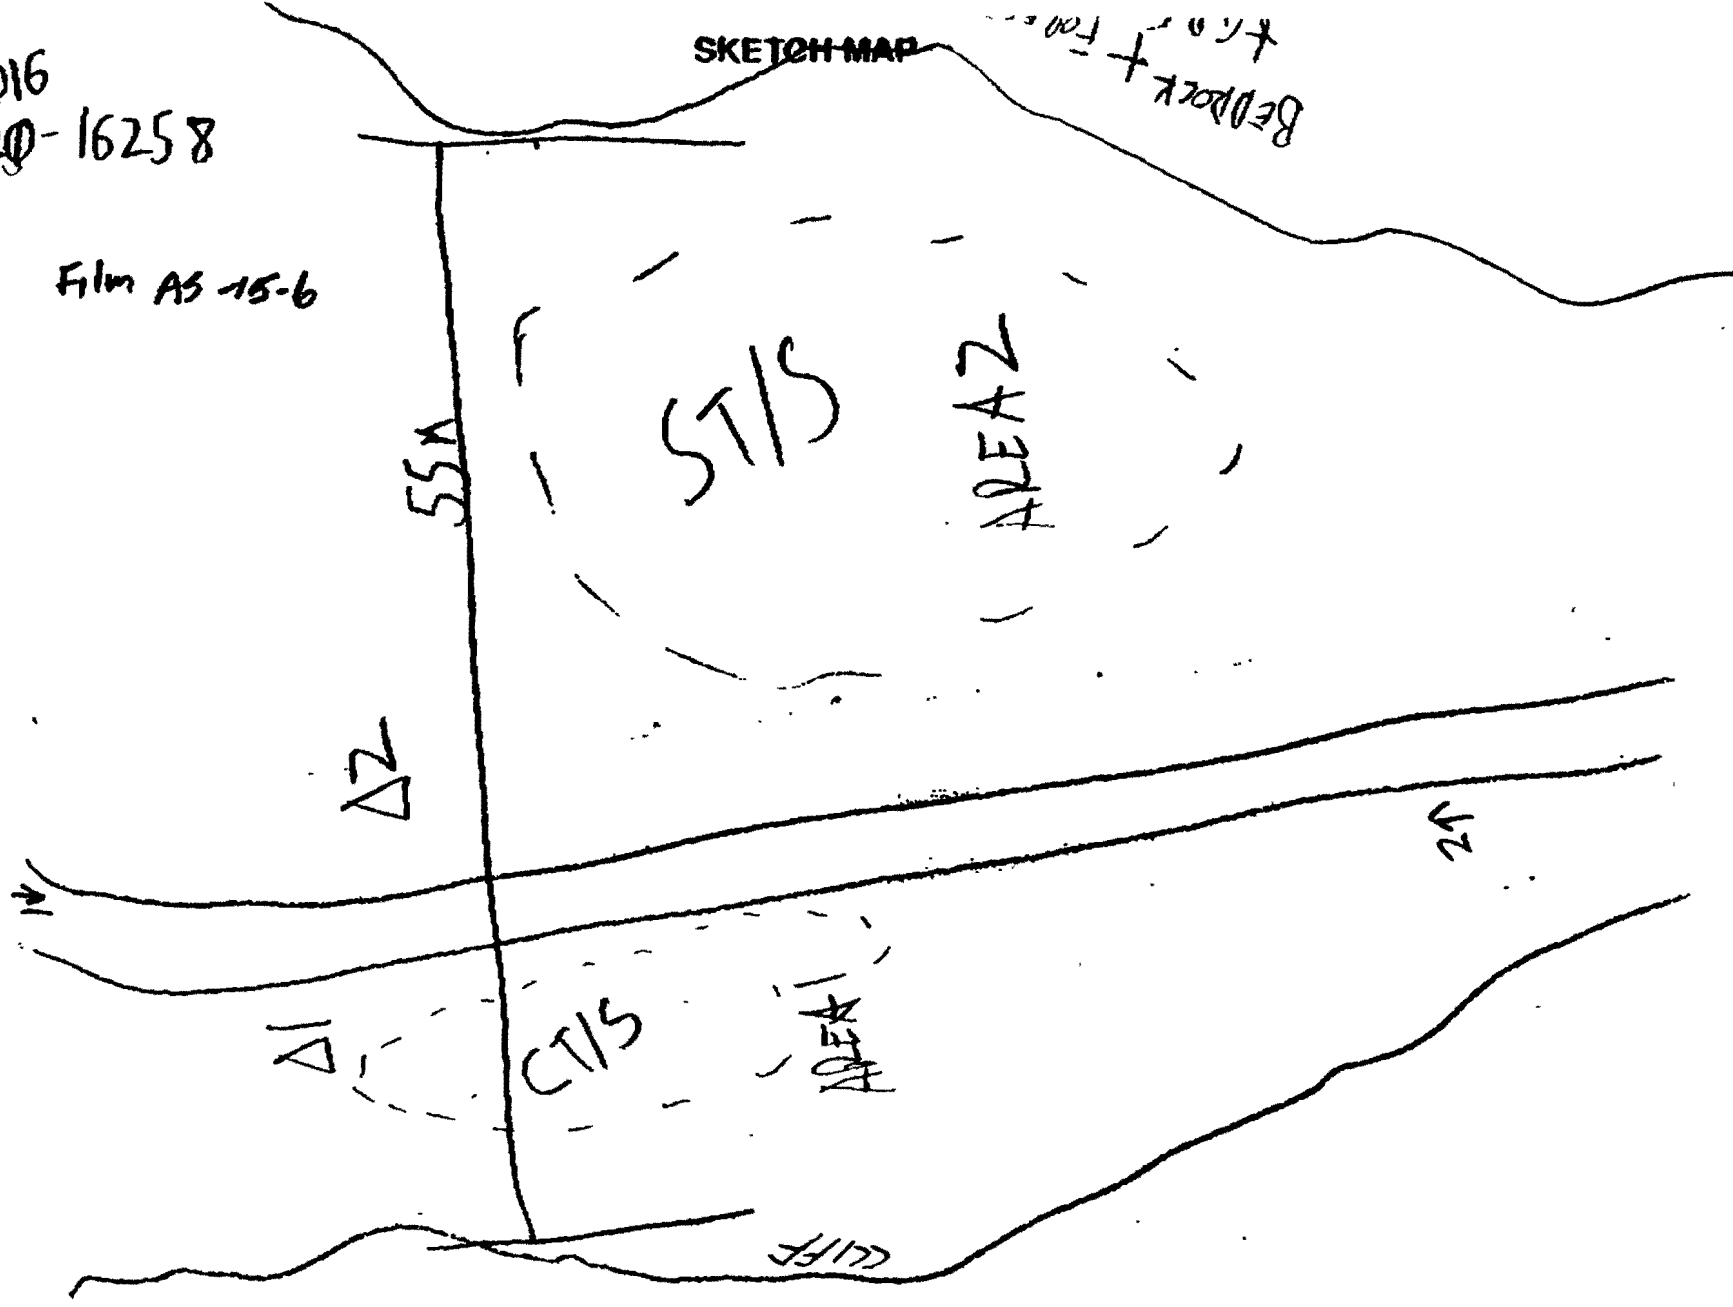
SKETCH MAP

Observations One tar patty was found along the boulder rubble east of the channel. A very light and sporadic stain coated a region of the lower and mid intertidal zone west of the channel. No significant amounts of subsurface oil were observed.

Treatment Recommendations The insignificant quantities observed at the site do not warrant further treatment.

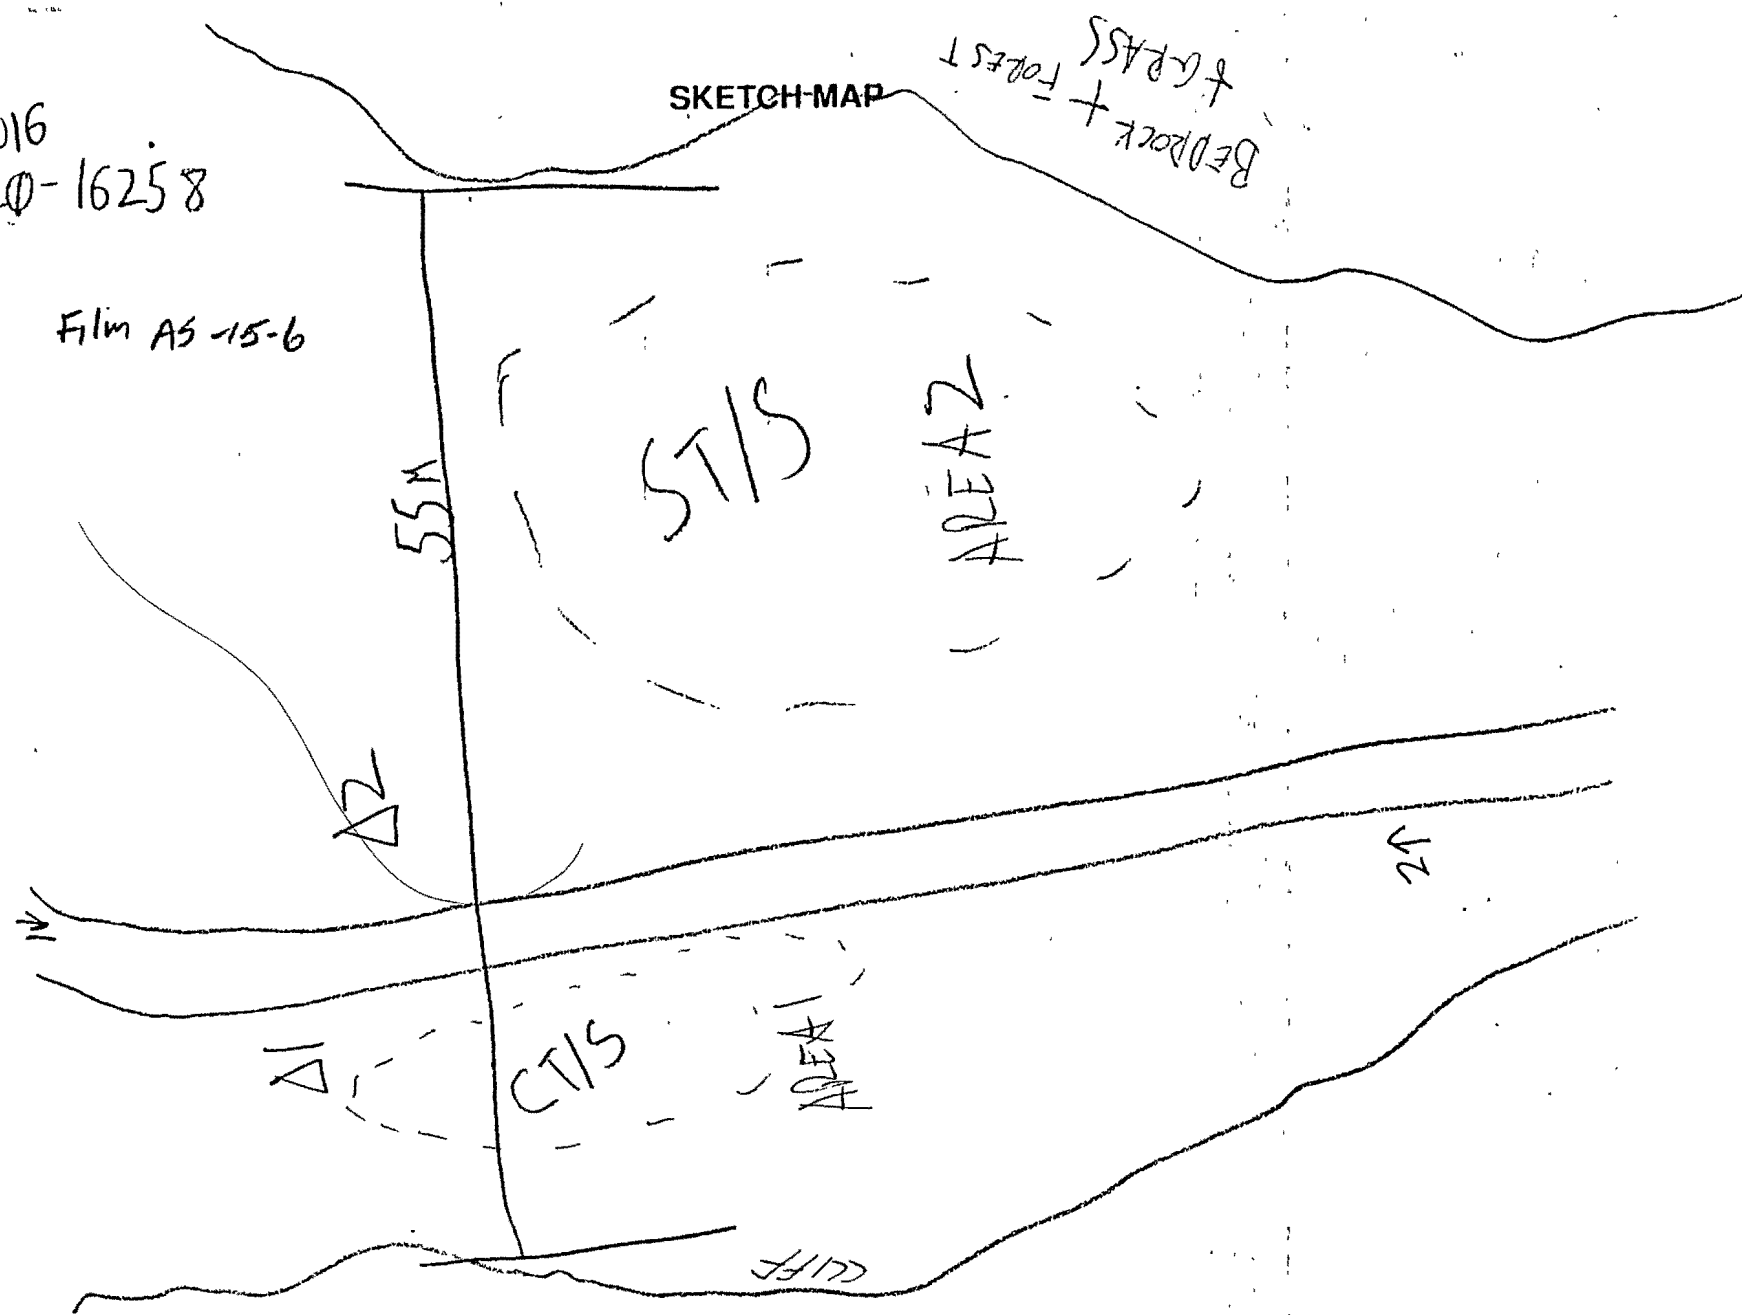
SKETCH-MAP

- 1  $\Delta$   
Plt - No Subsurface Oil
- 2  $\blacktriangle$   
Plt - Subsurface Oil
- $\boxed{CT/C}$   
Continuous Distribution
- $\boxed{CT/B}$   
Broken Distribution
- $\boxed{CT/P}$   
Patchy Distribution
- $\boxed{CT/S}$   
Splashed Distribution
- $\lll$   
Oiled Vegetation
- 1  $\rightarrow$   
Photo location, direction, and number

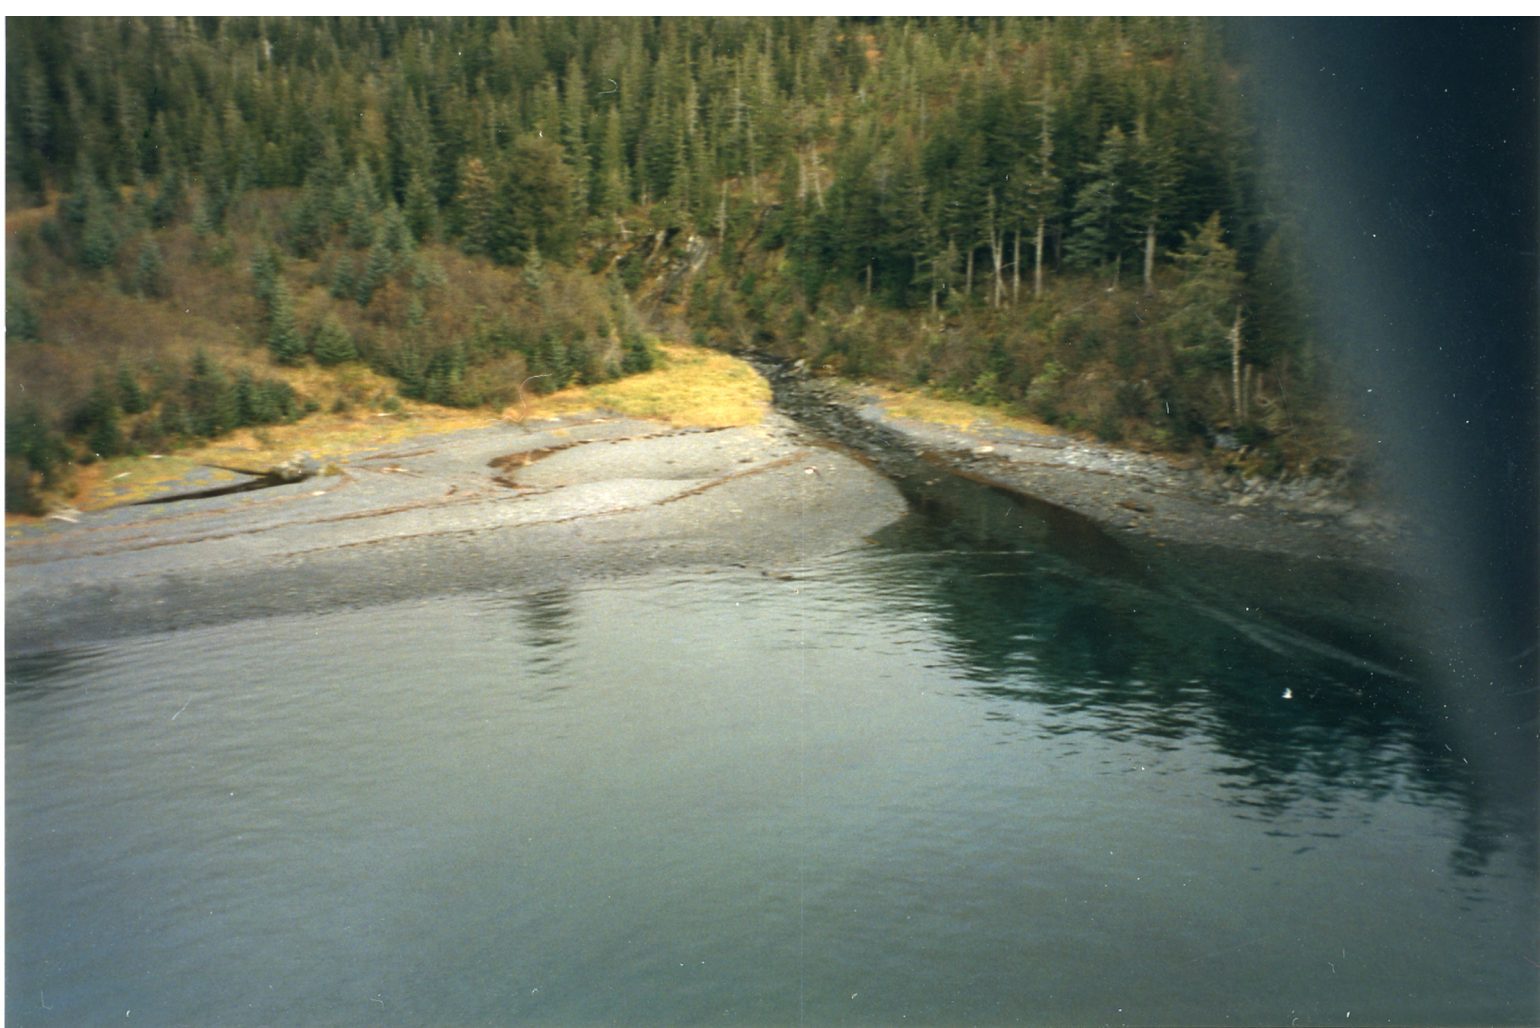
This is a medium-sized stream and a relatively unstable shale cobble/pebble beach. Dense Fucus and barnacles occur around the stream mouth in MTZ-LTZ, otherwise the intertidal biota sparse. Remaining oil consists of very light sporadic tar mats, which were broken up by the crew. No cleanup needed.
