AN-213B  
RUA COVE

ASC 16853

ADF&G MULTI-ASSESSMENT DATA FORM

Alaska Department of Fish and Game  
ANADSCAT Observations and Recommendations  
Team 15 - Michael Wiedmer and Tom Crowe

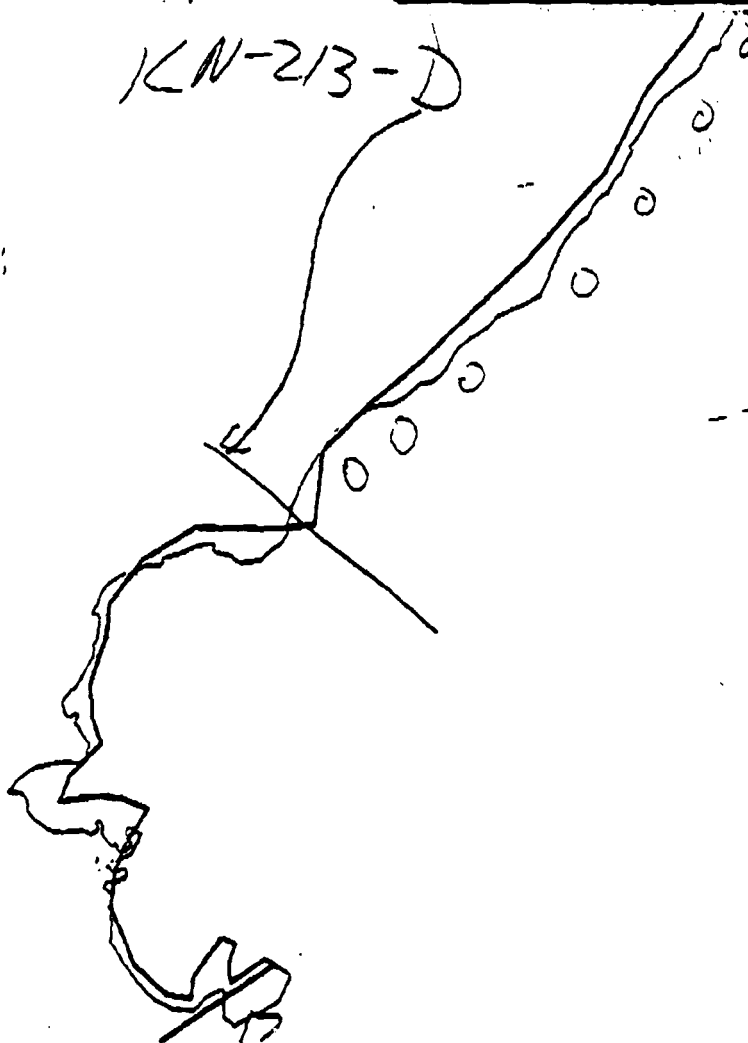
KN-213-D

Wide 0 m: Medium 89 m: Narrow 0 m: V.Light 213 m: No Oil 381 m  
Subsurface Oil Observed: Yes X No \_\_\_\_\_ Maximum Depth 9 cm

COMMENTS: Recommend bioremediation in area of surface cover. Work 6/1 - 7/10 based on salmon constraints, and with approval from ADF&G and USFWS regarding eagles.

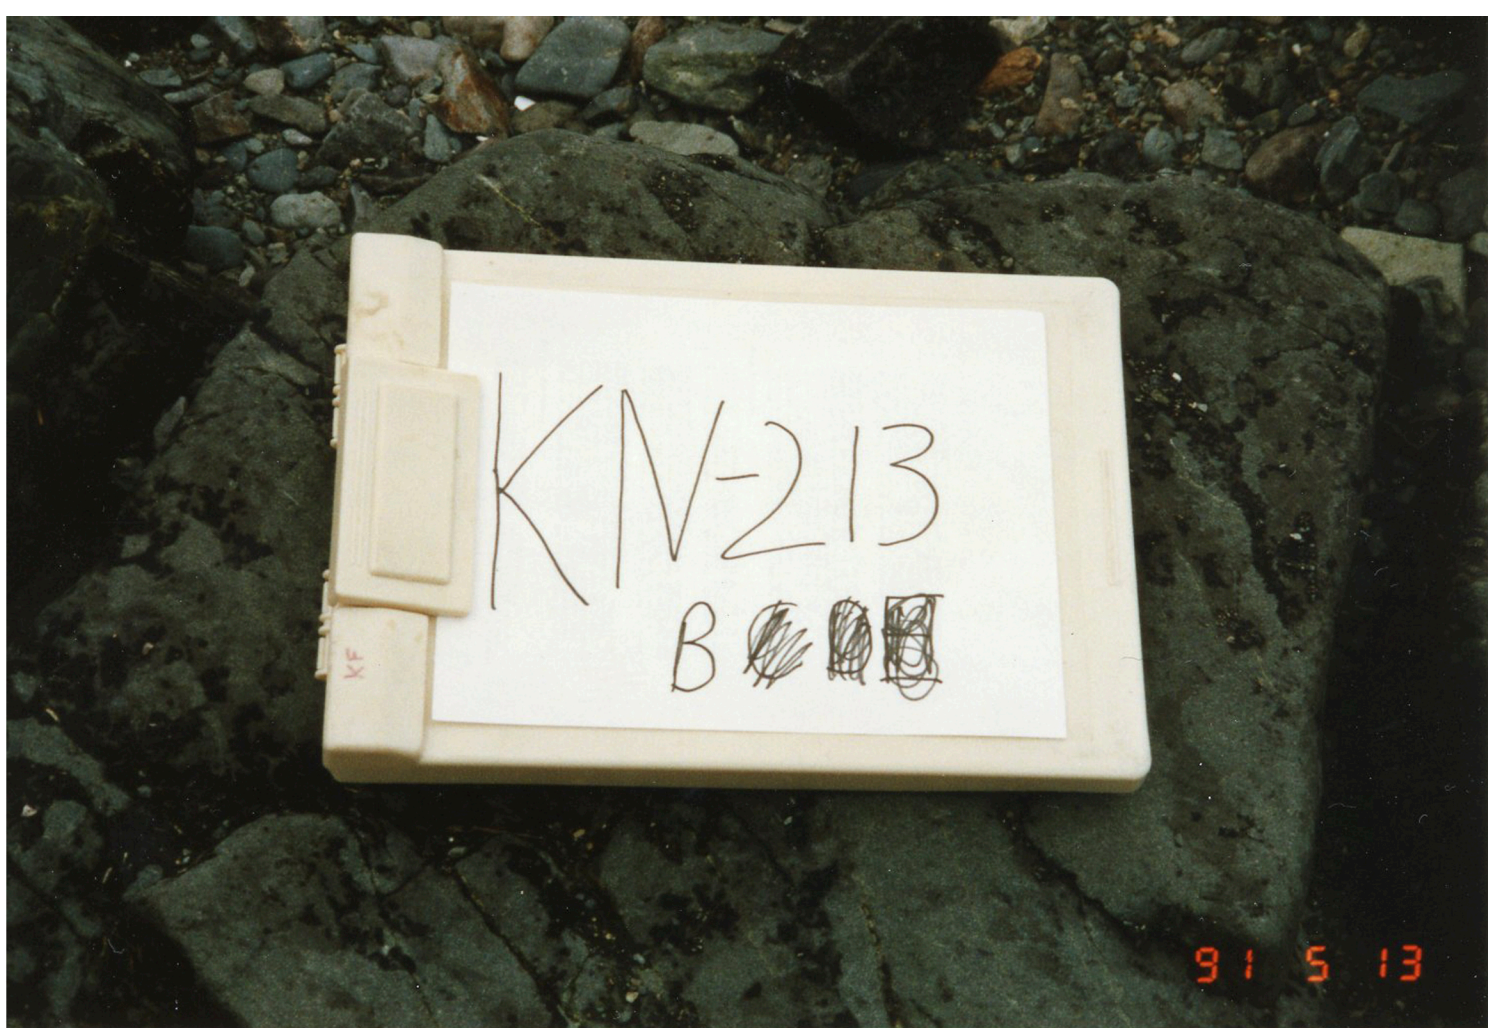
KN213B 5/13/91 #900

Segment No KN0213 Subdivision B  
Date 5/13/91 Log Frame No 17  
Photographer JEFFREY DAHLIN  
Location KNIGHT ISLAND  
Comments START FRAME FOR KN0213-B

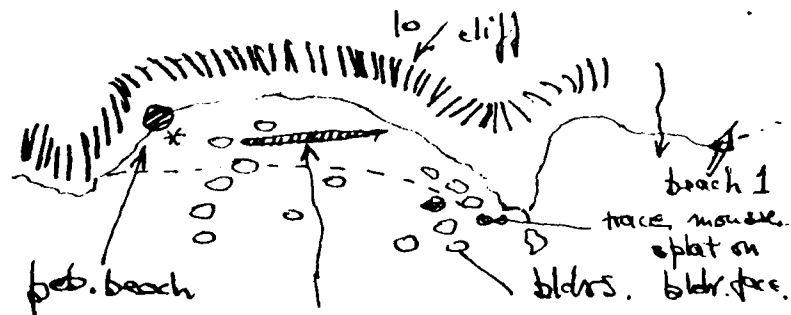
v. light coat of dk. choc brn moss, only a few pbs, one totally stained. BEACH 2, seg 213.

07:30; oily coated cliff \* could be hand wiped w/ solvent, < 10' x 4'. soft mousse.

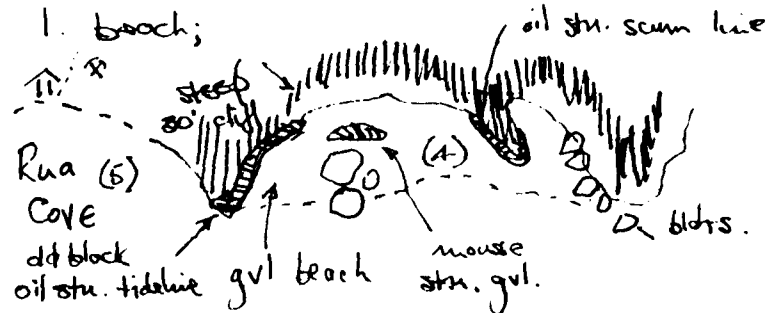
BEACH 5 seg 213 ; 09.20 ; 50m wide  
80% bldr, 10 cbs, 10 pbs,
