EV-017A#3 ASC 16630  
LITTLE SHELTER BAY

- Prince William Sound -  
DOCUMENTS IN STREAM FILES

ADF&G MULTI-ASSESSMENT DATA FORM

| CATALOG NUMBER: 2264016630      SEGMENT#: EV017 A      LOCATION: EVANS ISLAND, LITTLE SHELTER BAY | | | | | | | |

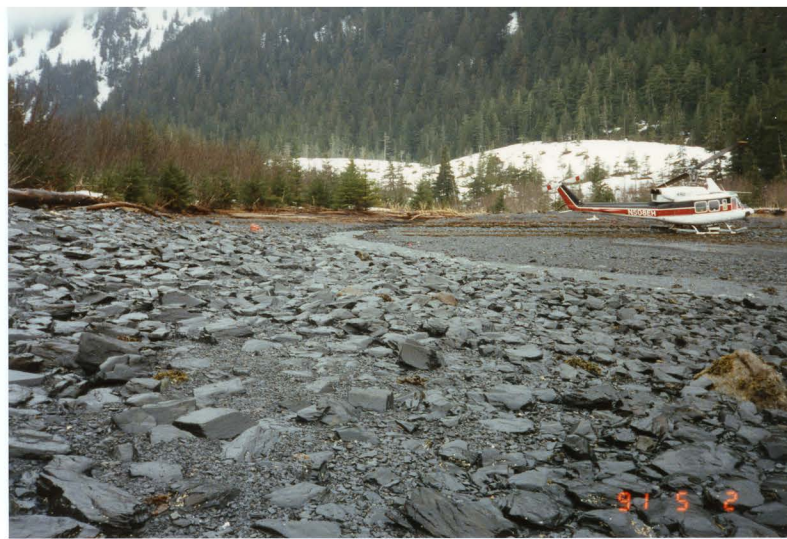
Title: EV017A

Segment No EVD17 Subdivision A  
Date 5/2/91 Log Frame No 15  
Photographer Rebecca Hoff  
Location \_\_\_\_\_  
Comments Overview of core with  
anadromous stream from east side  
of stream  
\_\_\_\_\_  
\_\_\_\_\_  
Roll No MAYSAP- 605 Neg. No 14  
Control No 868 (Office Use Only)

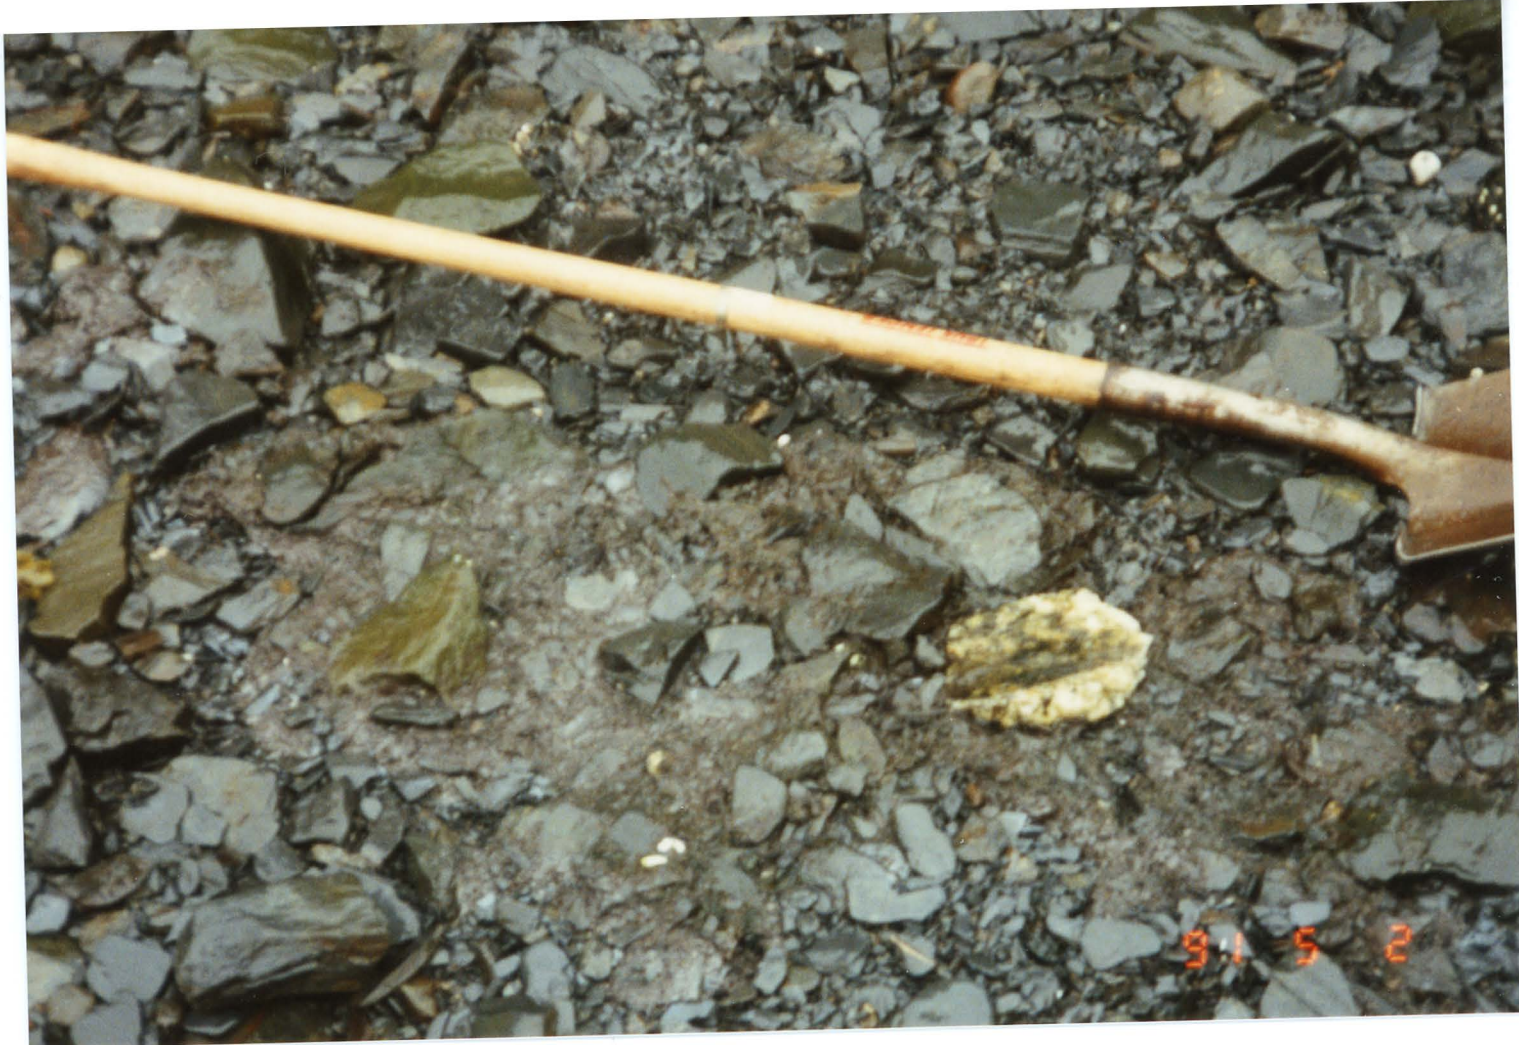
Segment No EVO17 Subdivision A  
Date 5/2/91 Log Frame No 13  
Photographer Rebecca Hoff  
Location \_\_\_\_\_  
Comments Close-up of asphalt patch  
on east side of 2nd stream  
(picked up) (area D on map)

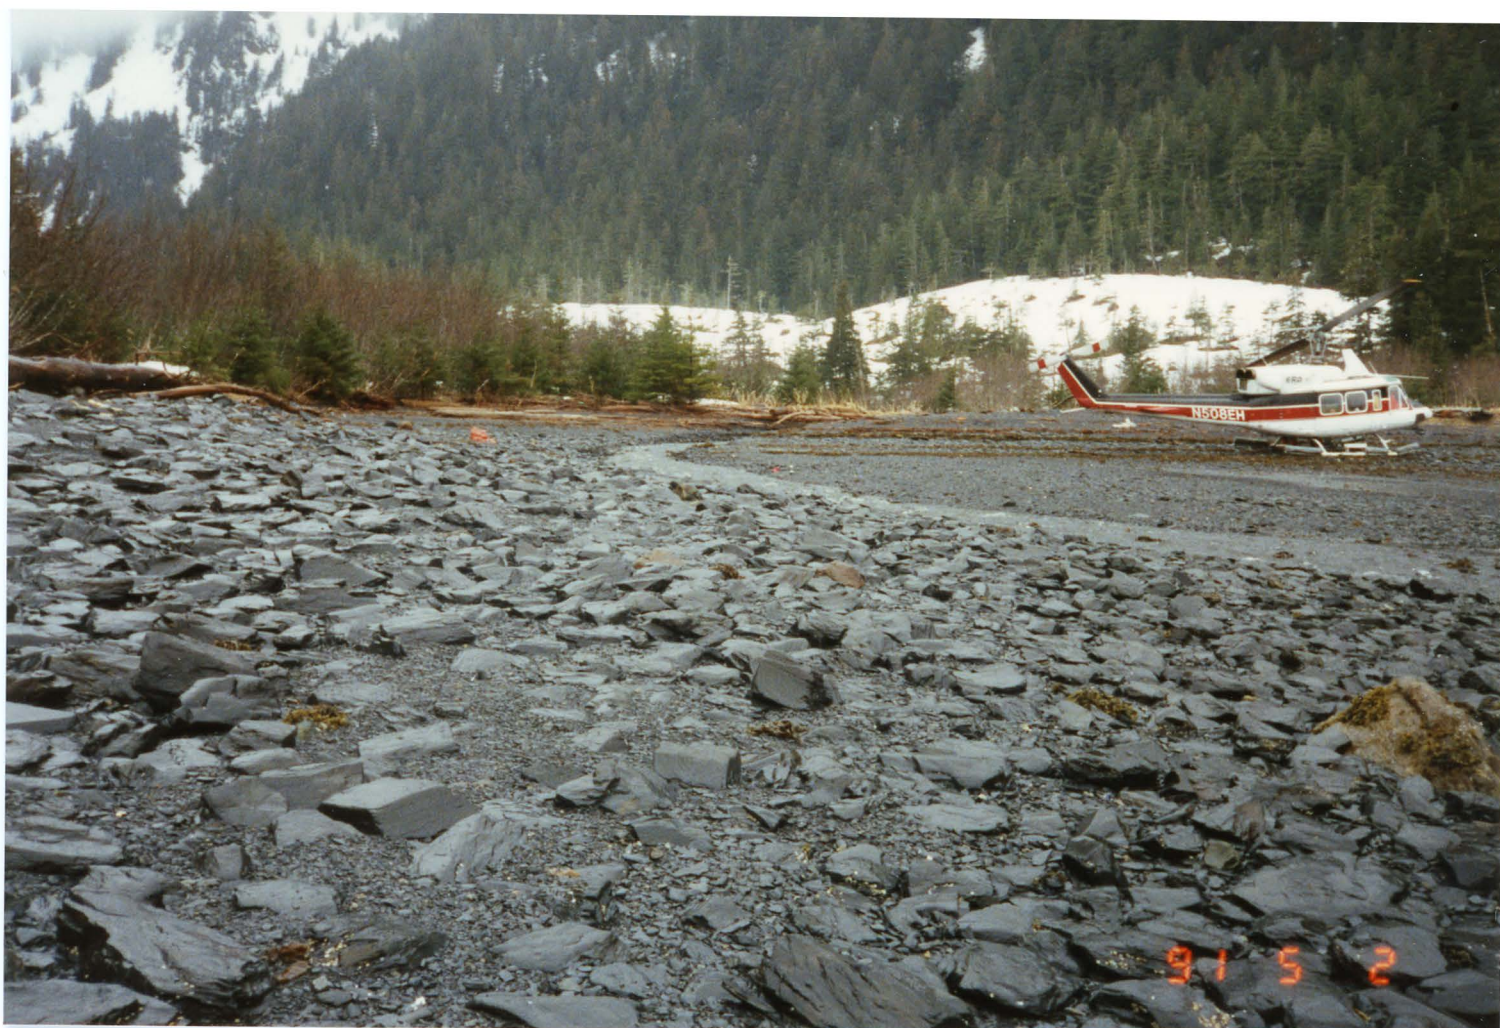
Segment No EVO17 Subdivision A  
Date 5/2/91 Log Frame No 14  
Photographer Rebecca Hoff  
Location \_\_\_\_\_  
Comments View upstream of 3rd stream  
(and stream)
