ASC: 226-50-16428

ELRINGTON ISLAND

- Prince William Sound -

LOCATION: WEST SIDE OF ELRINGTON ISLAND 16428

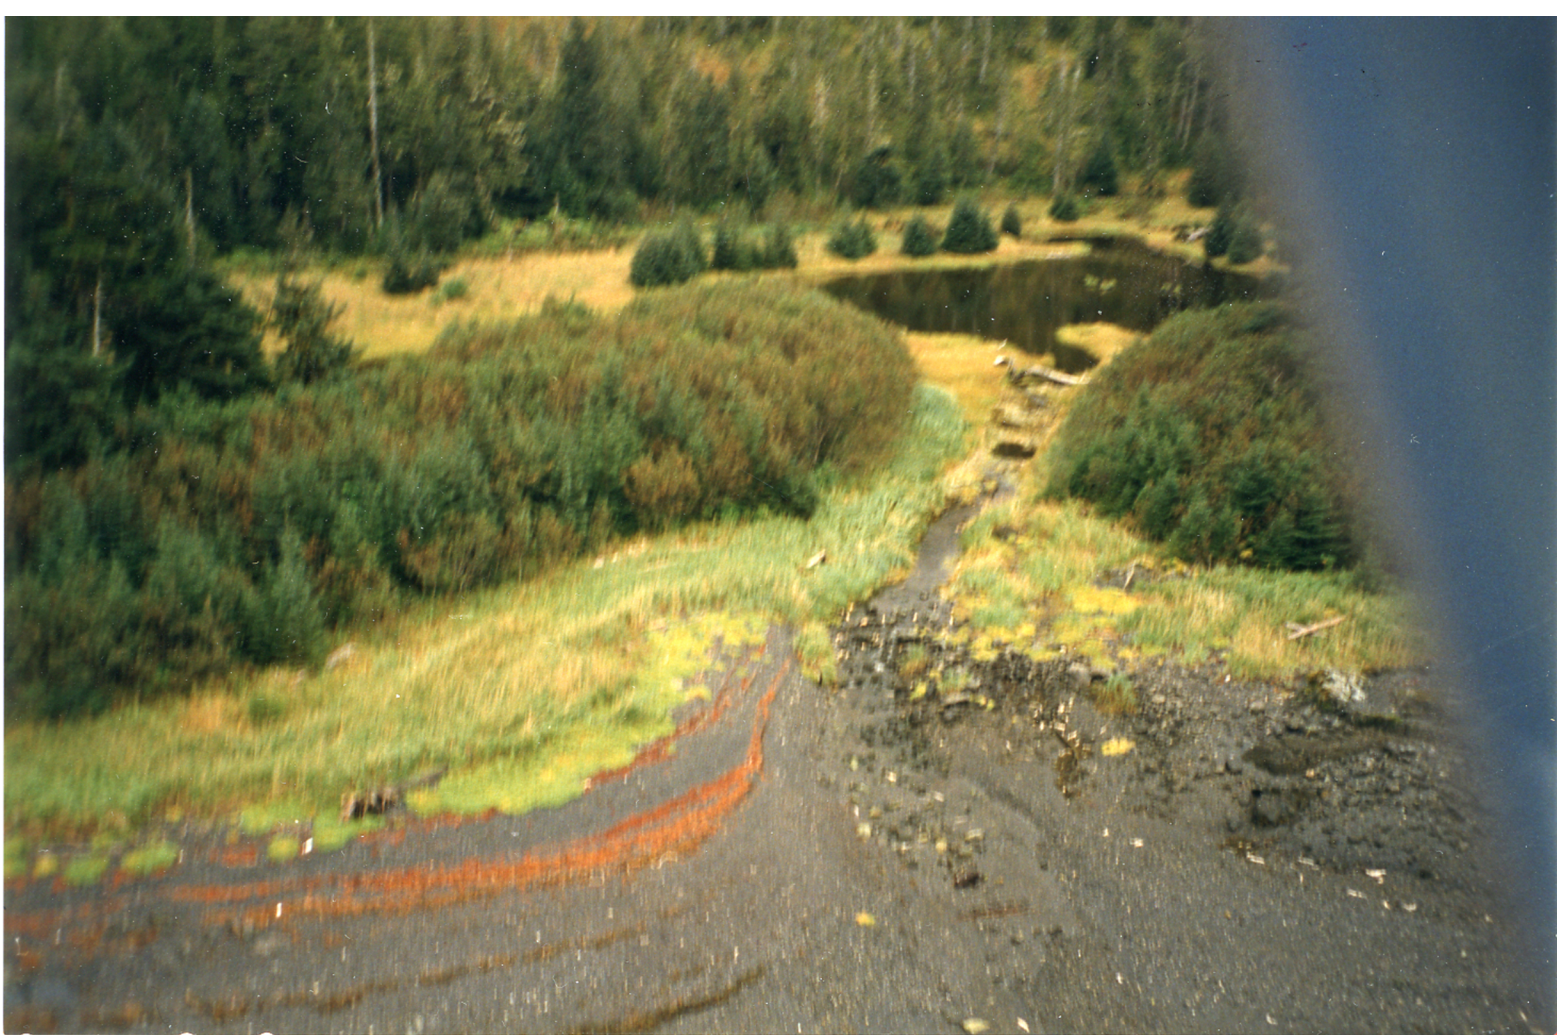
ROLL #: 89RLG007V FRAME #: 05

REASON FOR TAKING PHOTO: DOCUMENTING UNDOCUMENTED SALMON SPAWNING  
SITE (148°08'13"/59°58'09"). (AERIAL PHOTO).

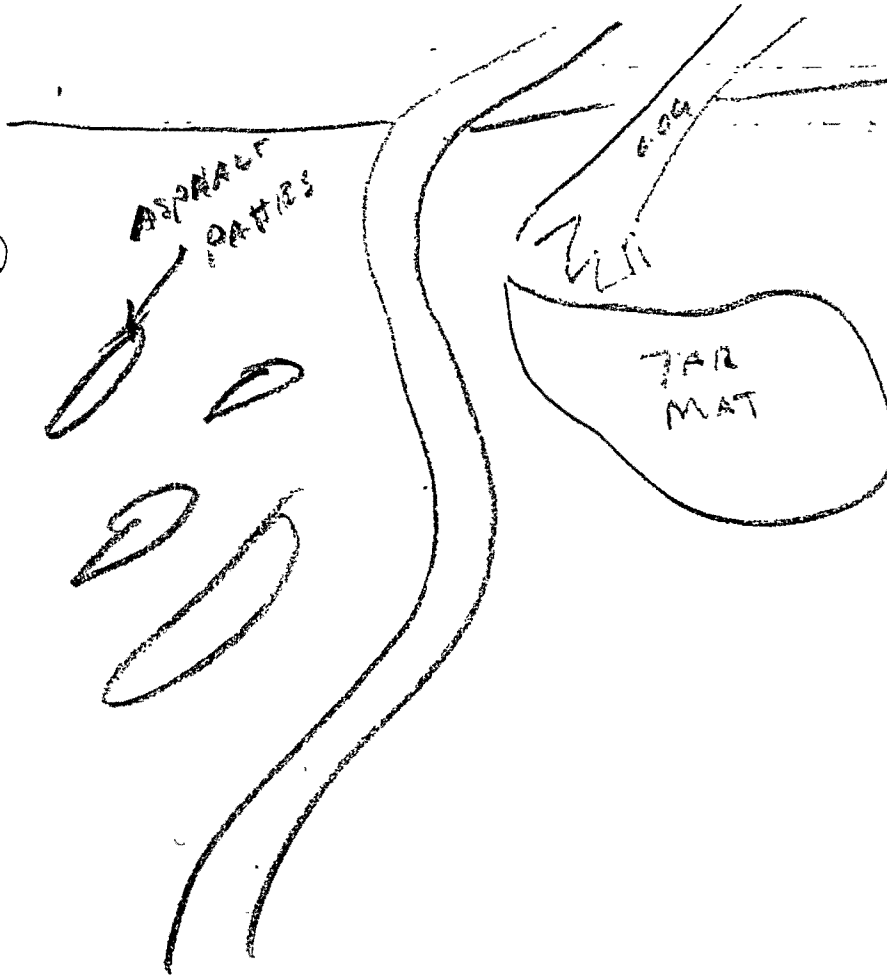
## 46 OIL DISTRIBUTION DIAGRAM

TAR/ASPHALT PATCHES IN SAND

THROUGH STREAM AT UPPER INTERTIDAL
