ELRINGTON PASSAGE

- Prince William Sound -

SHORELINE CLEANUP PROGRAM

SHORELINE SEGMENT ER-04

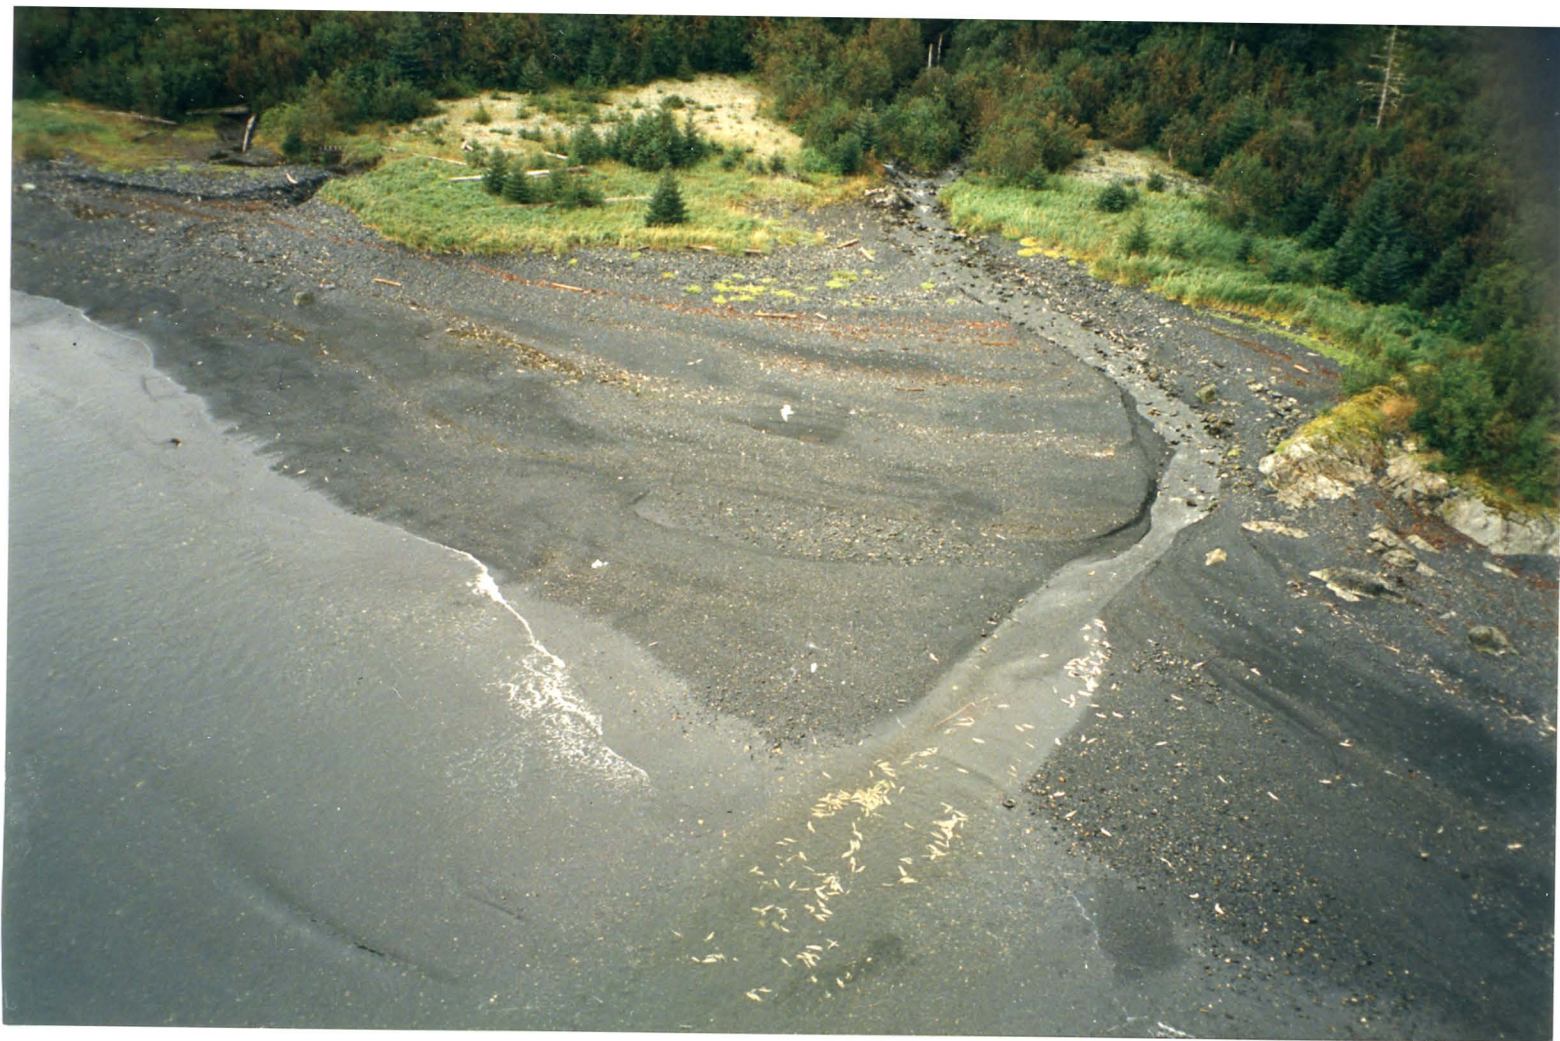
EVIDENCE ID#: 10210

LOCATION: WEST SIDE OF ELRINGTON ISLAND 16436

REASON FOR TAKING PHOTO: DOCUMENTING UNDOCUMENTED SALMON SPAWNING  
SITE (148°05'42"/59°58'03"). (AERIAL PHOTO).
