# ***Barriers to Adult Pacific Lamprey at Road Crossings: Guidelines for Evaluating and Providing Passage***

*Living Document: Version 1.0*

*June 29, 2020*

***Lamprey Technical Workgroup***

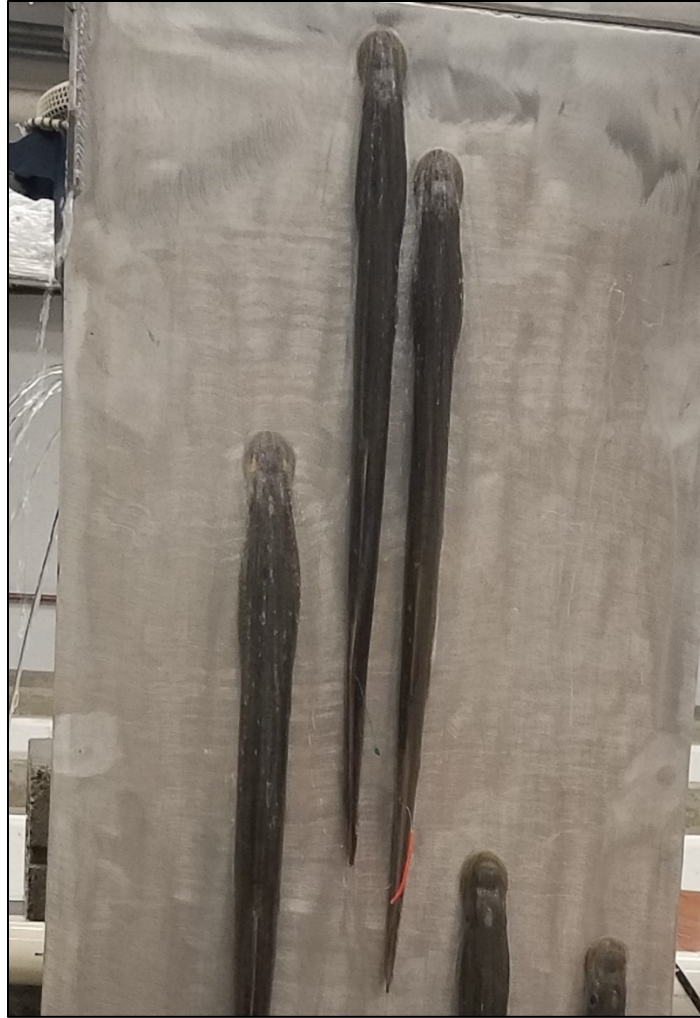
**Figure 2.** Example of Pacific Lamprey climbing a vertical surface during evaluation of wetted-wall structures designed to improve passage at dams. Credit: D. Lumley, Yakama Nation Fisheries.

The ability and inclination of Pacific Lamprey to climb steep surfaces also has important implications for designing retrofits to improve passage at barrier sites. Lamprey passage structures consisting of inclined ramps or vertical wetted-walls have been successfully used to improve passage through both mainstem Columbia River dams and smaller, low-head dams (Moser et al. 2011; Jackson and Moser 2013; LTW 2017). More recently, a flexible 4-inch PVC tube was installed to provide an alternate passage route for lampreys to climb around a pool-and-weir fish ladder at a dam on the upper Eel River in California. Initial testing has shown dramatic improvement in passage success and decrease in passage time (Goodman and Reid 2017; D. Goodman, USFWS, pers. comm., 2018). As discussed in Section 5, downscaled versions of such ramps or tubes have potential to improve lamprey passage at perched road crossings or sites with infrastructure that impedes lamprey passage such as fishways, tailwater control weirs, or internal baffles. Such retrofits should only be applied at road crossings where (1) it is not feasible to replace the barrier with a bridge or properly sized open-bottom arch culvert and (2) where sufficient monitoring of passage success at the retrofit can be conducted.

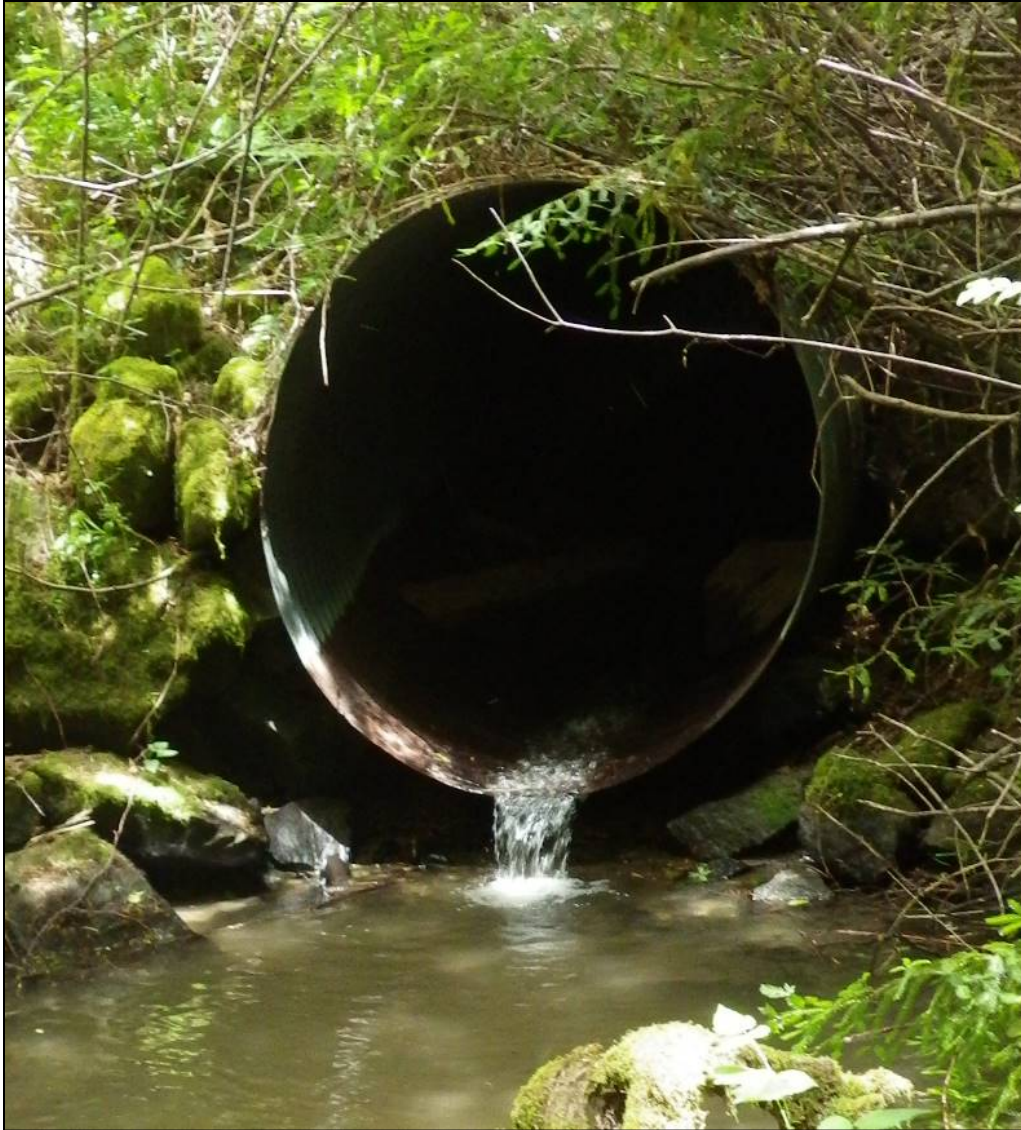
**Figure 3.** Example of perched and impassable road crossing, Strawberry Creek, Eel River basin, CA. Credit: Wiyot Tribe Natural Resources Department.

Due to their body type, relatively poor swimming ability, and lack of paired fins, Pacific Lamprey have extremely limited ability to leap. Consequently, their upstream passage is expected to be precluded by perched culverts or similar impediments that perched above the water surface (Moser and Mesa 2009; Figure 3). Some culverts have hydraulic control points downstream that can act to raise water surface elevation to the height of the culvert outlet when flows are high enough (Taylor and Love 2003; e.g., Appendix C, case studies 4 and 5), permitting lampreys to enter and pass upstream when hydraulic conditions allow. These factors must be considered during lamprey passage evaluations.

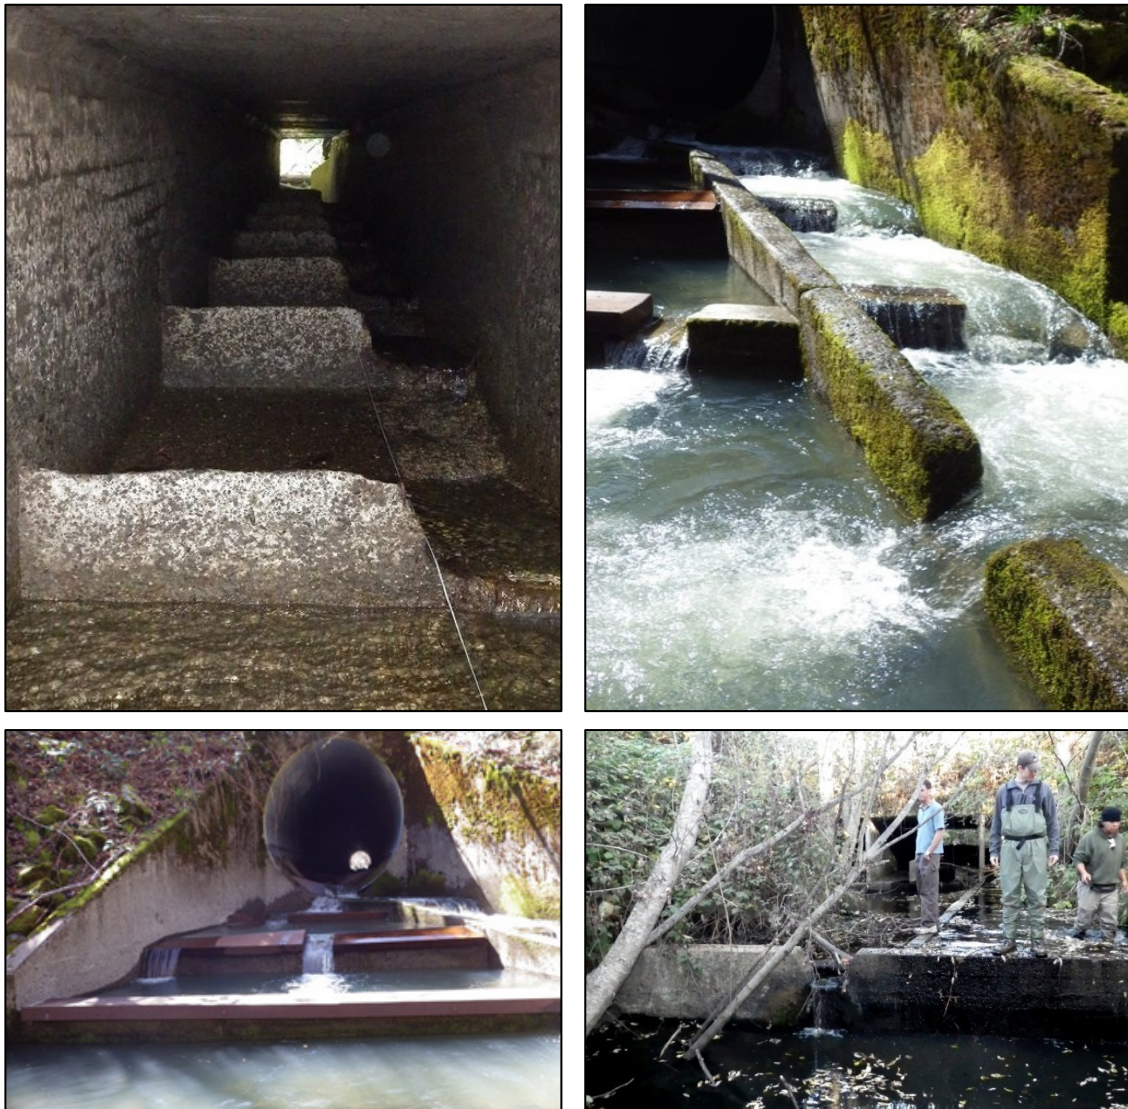
**Figure 4.** Examples of internal structures and modifications at road crossings that can impede lamprey passage in the Eel River basin, CA. Internal baffles with squared corners in undersized crossing (top left), step-pool fishways with square edges at outlet (top right and bottom left), and tailwater control weir with vertical drop and square edges (bottom right). Credit: Wiyot Tribe Natural Resources Department.

Many road crossings have associated infrastructure that can impair adult lamprey passage. Some crossings have been modified using internal structures such as baffles or weirs designed to improve upstream passage of salmonids by retaining natural streambed substrates, reducing water velocity, or increasing water depth (Figure 4). Some crossings have fishways leading into perched culvert inlets or manmade hydraulic tailwater control structures (e.g., concrete or rock weirs) designed to raise the water level of the pool at a culvert outlet. Laboratory and field experiments indicate that, when water velocities are high, adult Pacific Lamprey have difficulty passing features that have squared corners or edges such as vertical steps or vertical slot weirs in fish ladders (Moser et al. 2002; Daigle et al. 2005; Keefer et al. 2010). Such sharp angles prevent lampreys from maintaining attachment as they attempt to move around a corner or over a step (Moser et al. 2002; Moser and Mesa 2009). These same studies demonstrated that Pacific Lamprey have significantly higher passage success through fishways with rounded, instead of squared, corners on bulkheads. Examples of infrastructure at road crossings that can inhibit or delay lamprey passage are shown in Figure 4 and Appendix C (pre-project photos in case studies 3 and 7).

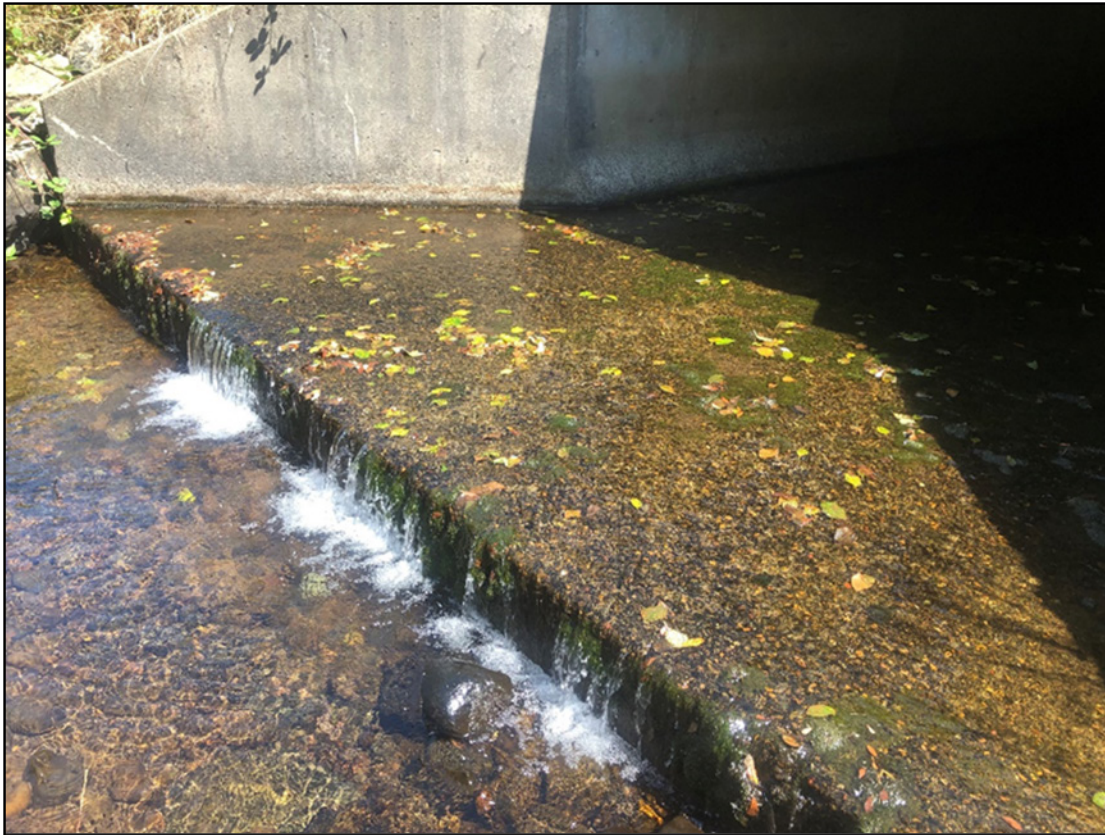
**Figure 5.** Example of culvert outlet apron with a vertical step at a crossing Munson Creek, Tillamook River watershed, Oregon. Credit: A. Gillette, ODOT.

Concrete outlet aprons with relatively short (4–8 inches) vertical steps with right angles are particularly common at road crossings (Figure 5). Due to uncertainties in the ability of Pacific Lamprey to pass over these features, we recommend taking a conservative approach when

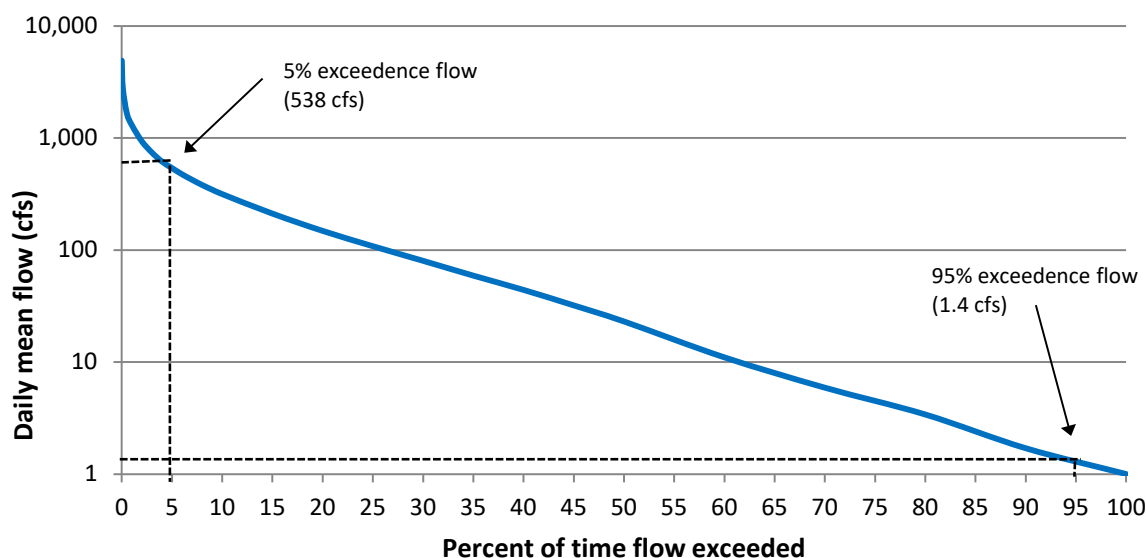
**Figure 8.** Example flow duration curve used to estimate fish migration flows. Data from Bull Creek, 1961-2013 (USGS gauge 11476600).

Because adult Pacific Lamprey are found in freshwater throughout the entire year and have the potential to move during any month, migration flows should conservatively be calculated for the entire year. For watersheds where more information on migration is available, the migration period can be adjusted. For example, Stillwater Sciences (2014) calculated migration flows for December–July, the “core migration period” for adult Pacific Lamprey in the Eel River.

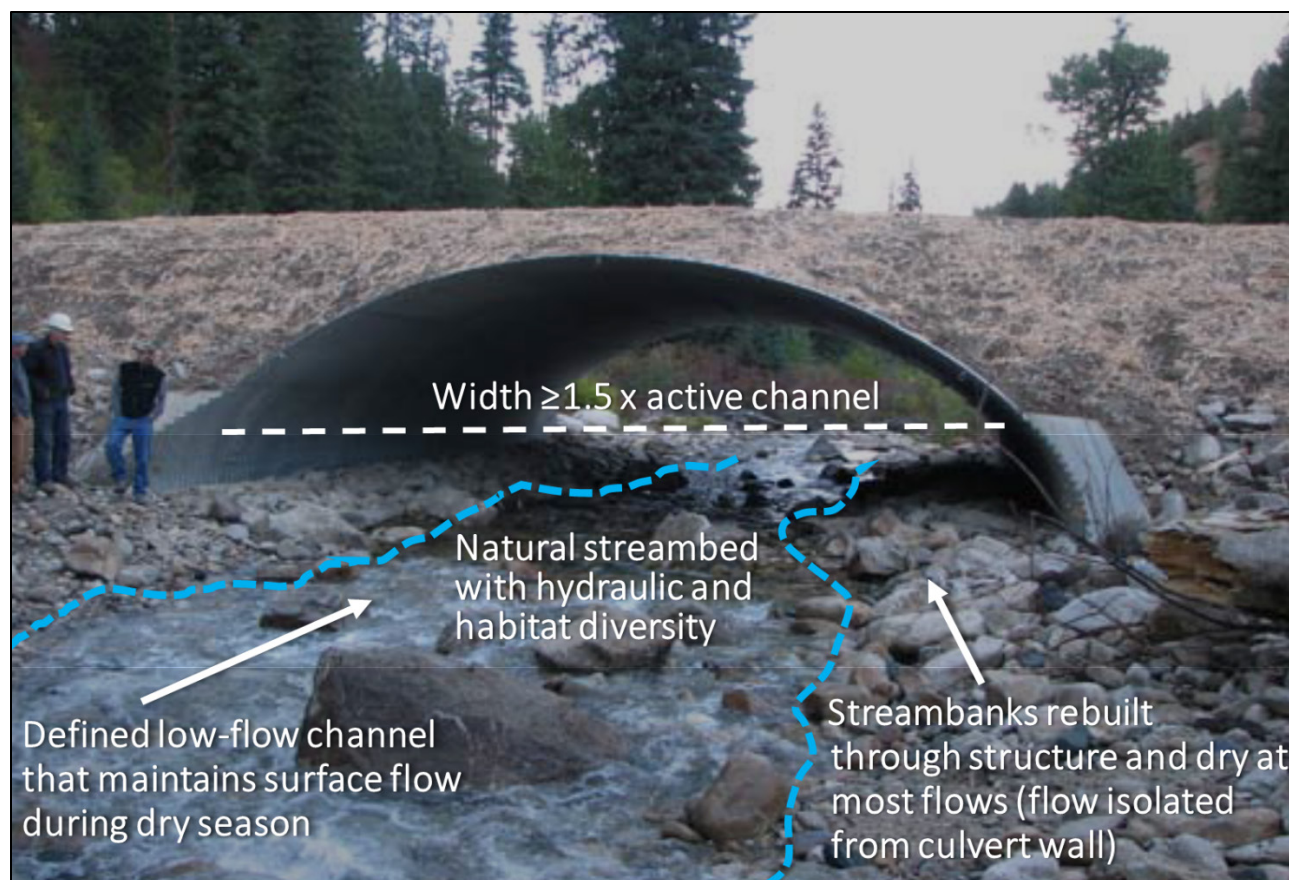
**Figure 9.** Example of a culvert replacement built with stream simulation design elements, Roaring River, Idaho. Credit: USDA Forest Service.

- Continuous streambed that simulates natural channel width, depth, slope, and substrate of adjacent channel (both upstream and downstream).
- Contains diverse water depths and velocities, hiding and resting areas, and moist-edge habitats that support connectivity for multiple aquatic species.
- Accommodates flood discharges and sediment and debris inputs without compromising passage or impairing geomorphic and ecological processes in adjacent reaches.
- Channel inside the crossing structure is at least as wide as bankfull width in a natural reference reach.
- Defined low-flow channel that maintains surface flow at lowest flows (95% exceedance).
- Stream banks are rebuilt through structure and remain dry at most flows, maintaining hydraulic separation from the culvert wall.

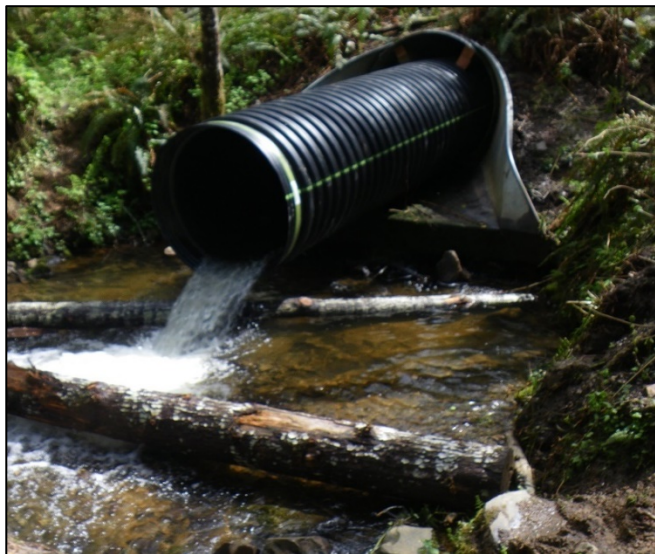
**Figure 1.** Coho Creek outlet prior to restoration. The perched, undersized and failing culvert was slip lined with a plastic pipe to prolong life.

Coho Creek is a small coastal tributary to the Necanicum Estuary in Oregon. The culvert had a 2-ft perch and was a full barrier to fish passage for both lamprey species and adult and juvenile salmonids due to the jump height, velocities that exceed fish swimming capabilities in the 160-ft pipe, and inadequate flow depths (Figure 1). The culvert was also a failure risk creating a human safety hazard on the only access/egress road to a local elementary school and a Community Tsunami Evacuation Route. Prior to restoration, the culvert was slip lined with a plastic pipe in an attempt to prevent catastrophic failure that would have released approximately 3,500 yd<sup>3</sup> of 20-ft high road fill into a high-quality wetland downstream. There was approximately one mile of spawning and rearing habitat upstream. The active channel width in the vicinity of the culvert was 10 ft, the active channel depth was approximately 1.5 ft, the substrate was dominated by gravel, the gradient was 3%, and the habitat bedforms were dominated by riffle and pool features.

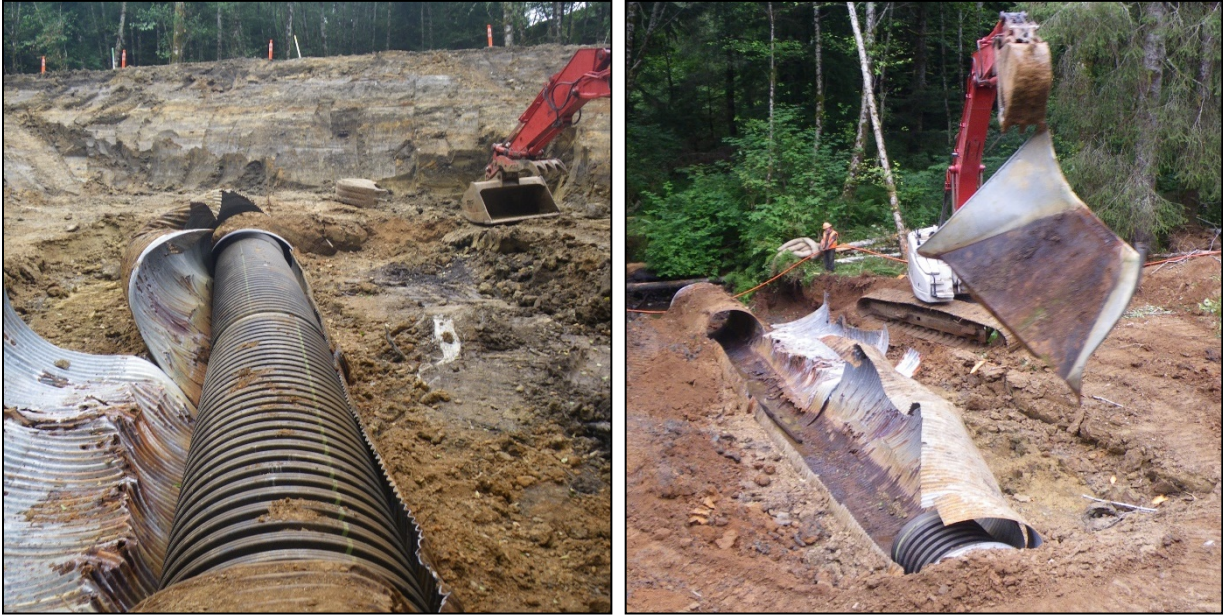
**Figure 2.** Deep road fill was excavated and stockpiled, the failing culvert was carefully removed allowing for reuse of the temporary plastic liner. Degree of failure of the culvert is visible at right

This project involved substantial site preparation, material staging, and utility work (Figure 2). In addition to having an extremely deep road fill, this site had fiber optic cable, water, and buried power lines running on each side of the road. All utilities had to be managed and continuous service provided for the duration of the project. In addition, emergency vehicle road access had to be accommodated, which required building one lane at a time. Project staging, utility location, and road excavation began early, prior to the July 1 in-water work window.

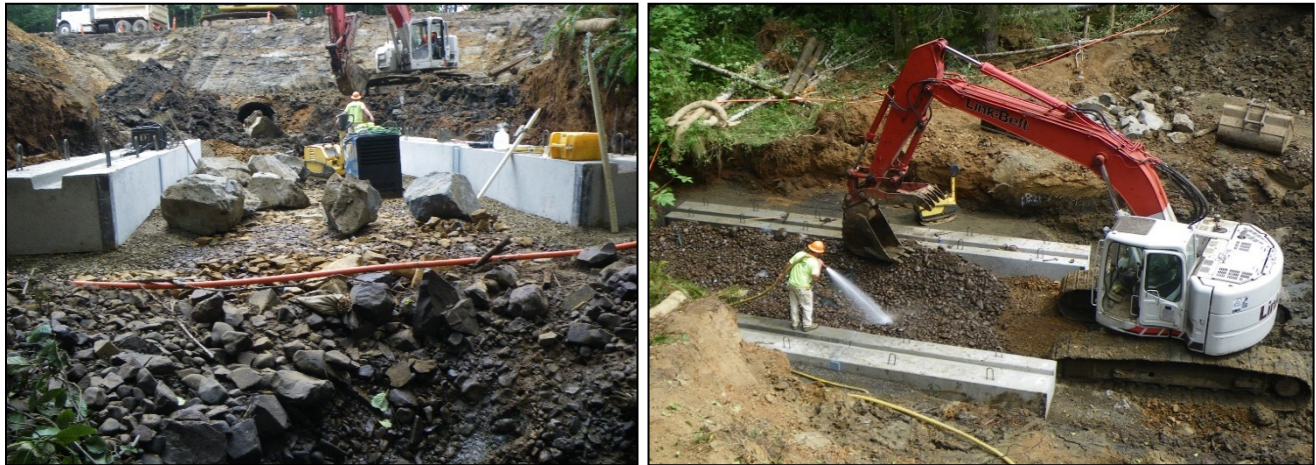
Figure 4. Proper sizing and installation of streambed materials is critical to success, including washing in fine sediment to ‘seal’ the streambed features. This ensures that when flow is returned to the channel, a low flow channel is maintained rather than flow going subsurface.

Proper construction of streambed simulation features is as critical as the design elements (Figure 3). Having the designer on site to oversee construction and to inspect and approve stream simulation materials is important to ensure it is installed per specifications. The contractor prepared the area for footers per design specifications at the appropriate grade. Footers were installed one section at a time and then welded together. Grade and location were measured and checked as each footer was placed. The gravel, rock rib, and boulder gradation specifications were based on instream conditions and hydraulic analysis. Gravels were specified to be free of fines, thoroughly mixed and placed in the culvert to specified depth. In addition, 30 2-3 ft partially buried oversized boulders were placed near the surface of the gravel (50% embedded) to create hydraulic shadows and maintain the low flow channel form. After the gravel was placed, the surface was washed to allow the fines to work into open spaces and form a seal. Sand was washed in until the gravel was sealed and wash water flowed on top of the gravel (Figure 4).

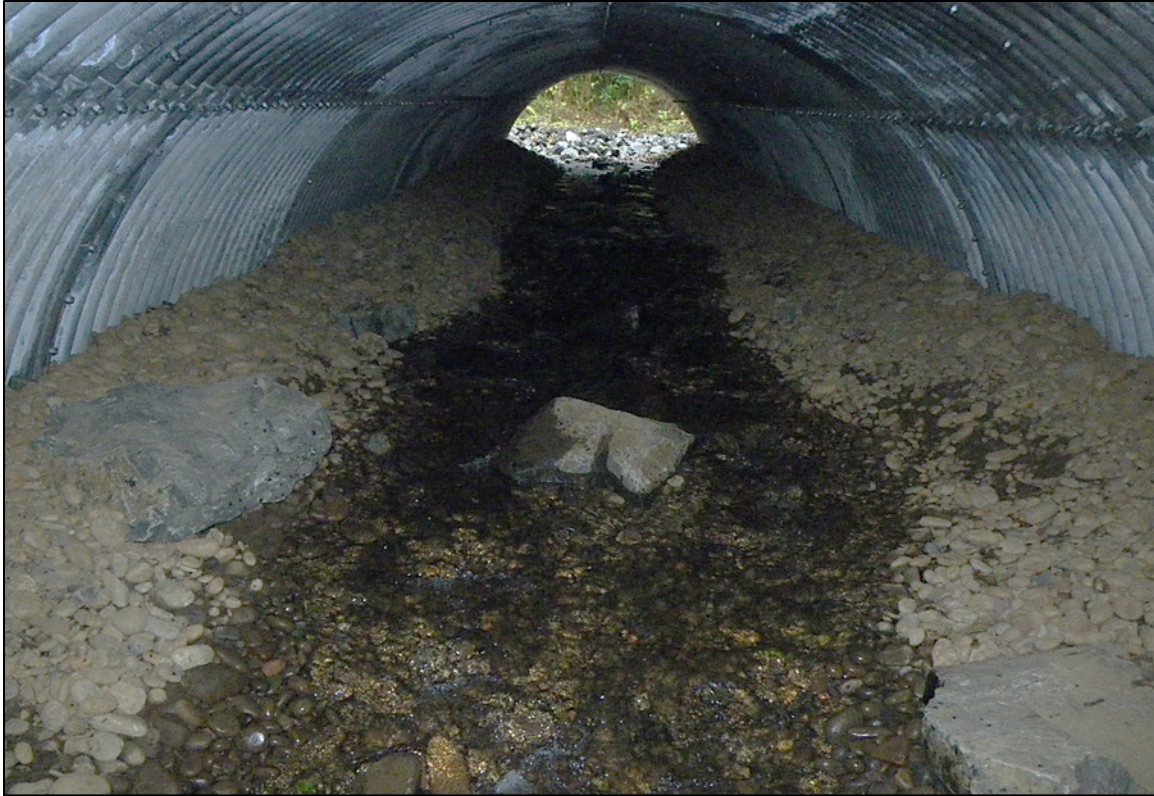
**Figure 5.** Completed structure has a defined low flow channel with minimum flow depths, hydraulic diversity, streambed and streambanks rebuilt inside the structure to mimic upstream and downstream conditions, and flood widths that meet or exceed 1.5 times active channel width.

The completed structure has several key features (Figure 5). It has a natural stream bottom with a defined low flow channel that provides fish passage at the low flow (95% exceedance). There is hydraulic diversity at a full range of flows and is passable to fish at the high fish passage flow (5% exceedance). The streambed and streambanks have been rebuilt inside the structure to mimic upstream and downstream conditions. The flood width meets or exceeds 1.5 times active channel width. In general, a simulated streambed approach strives to duplicate streambed geometry of the nearby channel reach within the new culvert, resulting in a streambed surrogate that is passable to fish by being geomorphically and hydraulically similar to the surrounding channel.

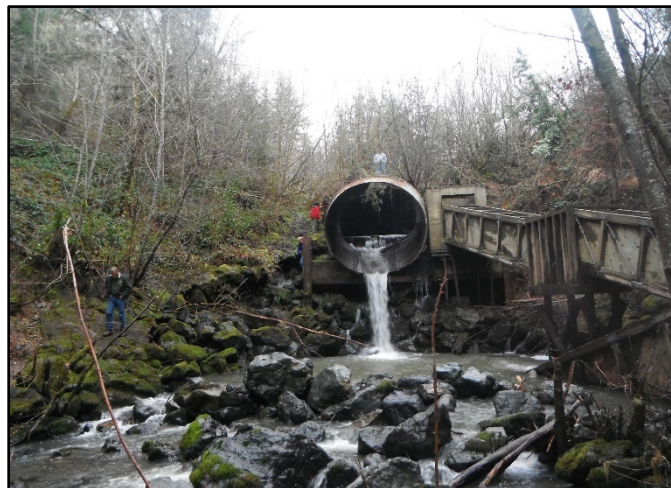
**Figure 1.** Pre-project photo: Large culvert perched high above stream and ineffective fishway on right.

Perched culverts are a common passage problem for upstream migrating adult Pacific Lamprey because there are no continuous attachment surfaces and lampreys can't jump. A 12 ft X 250 ft culvert perched approximately 18 ft above the stream bed (Figure 1) was removed from Baker Creek, a tributary of the South Fork Coquille River, Oregon, to eliminate this barrier. During the early 1950's a large culvert was installed through a section of failing wooden railroad trestles. This perched culvert was a total fish barrier when it was originally installed and for many years no migratory fish were able to move upstream into Baker Creek. In 1994, a Denil fish ladder (also known as an Alaskan fishway) was constructed to allow fish passage. The 25-ft wooden ladder was placed through a hole cut into the side of the culvert. Baffles were also added to the inside upper portion of the culvert to help passage through the steep grade. While this retrofit allowed for limited salmonid fish passage, there was very low, if any, potential for adult Pacific Lamprey passage. The Denil fish ladder was designed for salmonid passage with straight edges and did not consider lamprey passage needs. Additionally, high water velocities through the long culvert presented additional passage challenges.

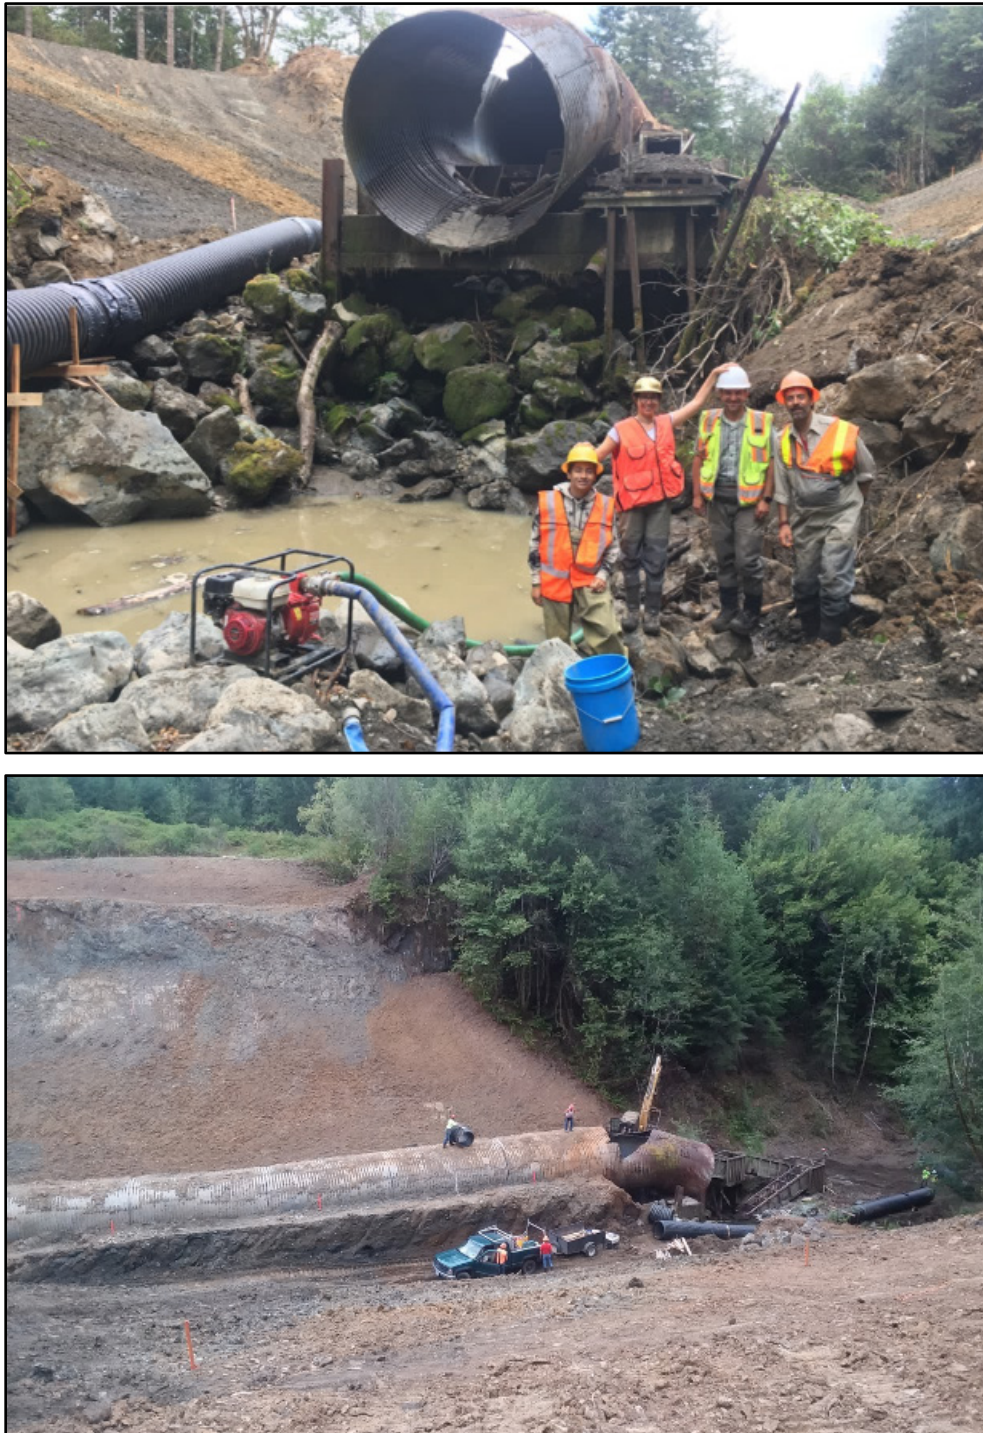
**Figure 2.** Project implementation photos: Fish salvage before removal of the culvert (top). Exposed culvert and slope grading during removal of the culvert (bottom).

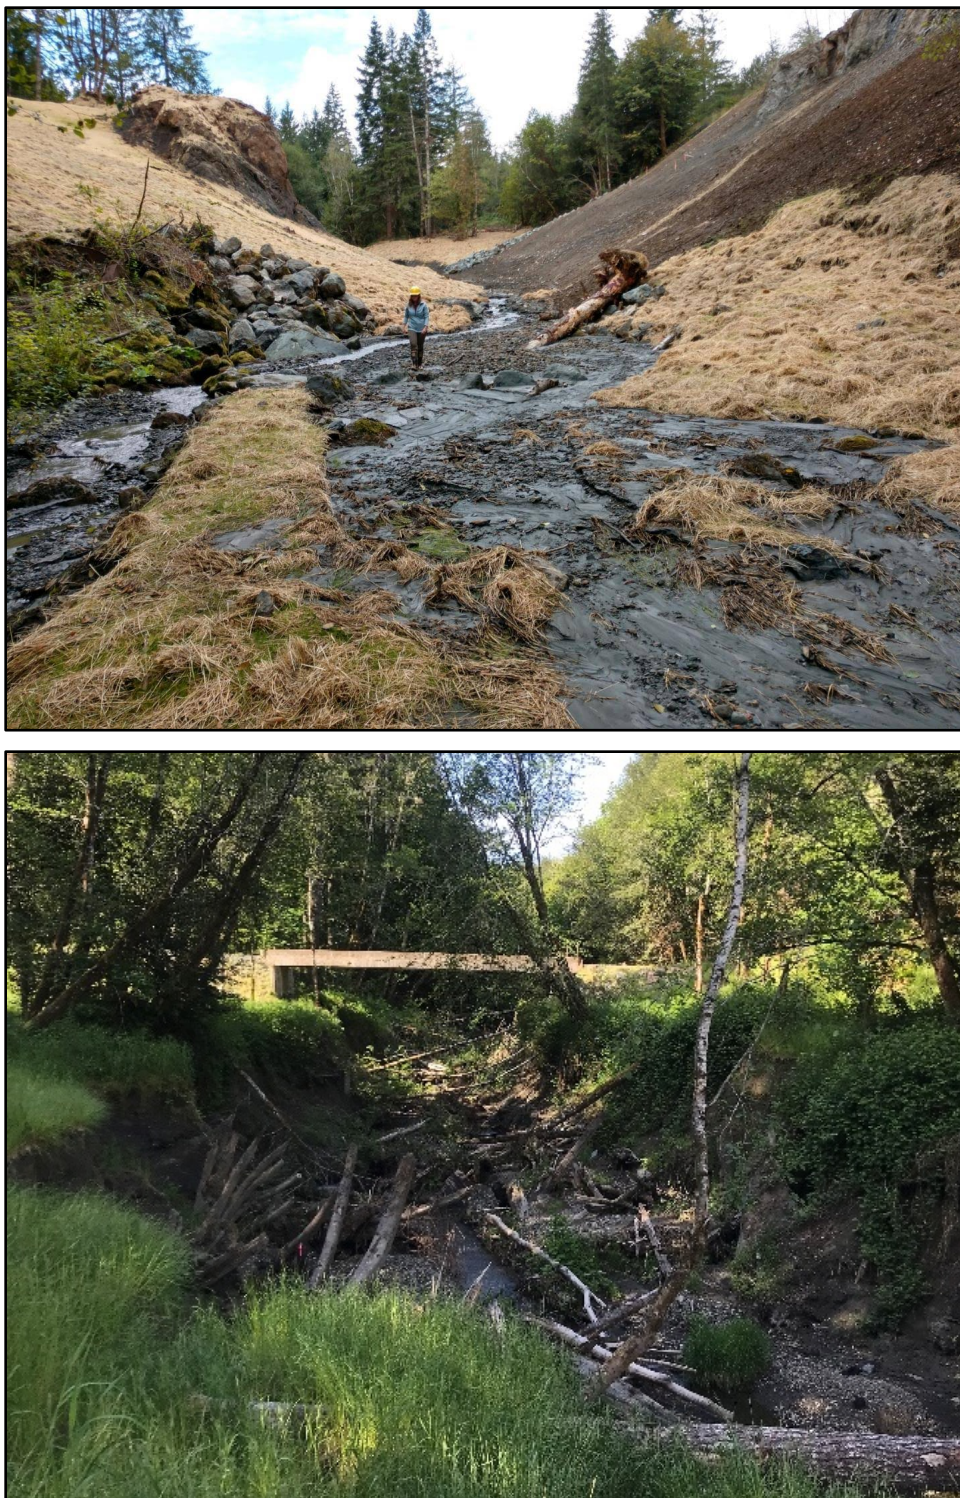
**Figure 3.** Pilot channel shortly after completion (top). Project site after first winter, showing natural recruitment of large wood. Constructed log jams will be placed in 2020 using the recruited wood in addition to larger pieces.

to further promote instream complexity. The removal of the culvert and placement of log structures has allowed for natural gravel export processes to provide spawning habitat in gravels and rearing habitat in fine sediment.

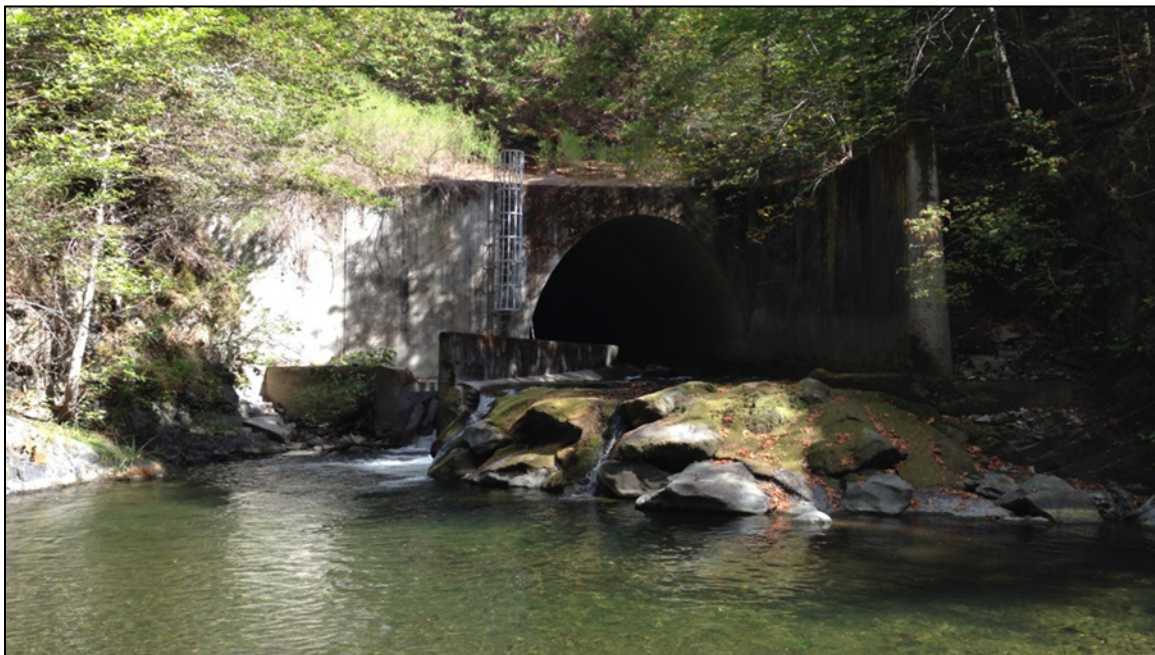
**Figure 1.** Pre-retrofit photo: culvert rock slope protection apron is perched above the water surface, Denil fish ladder for adult salmonid migration.

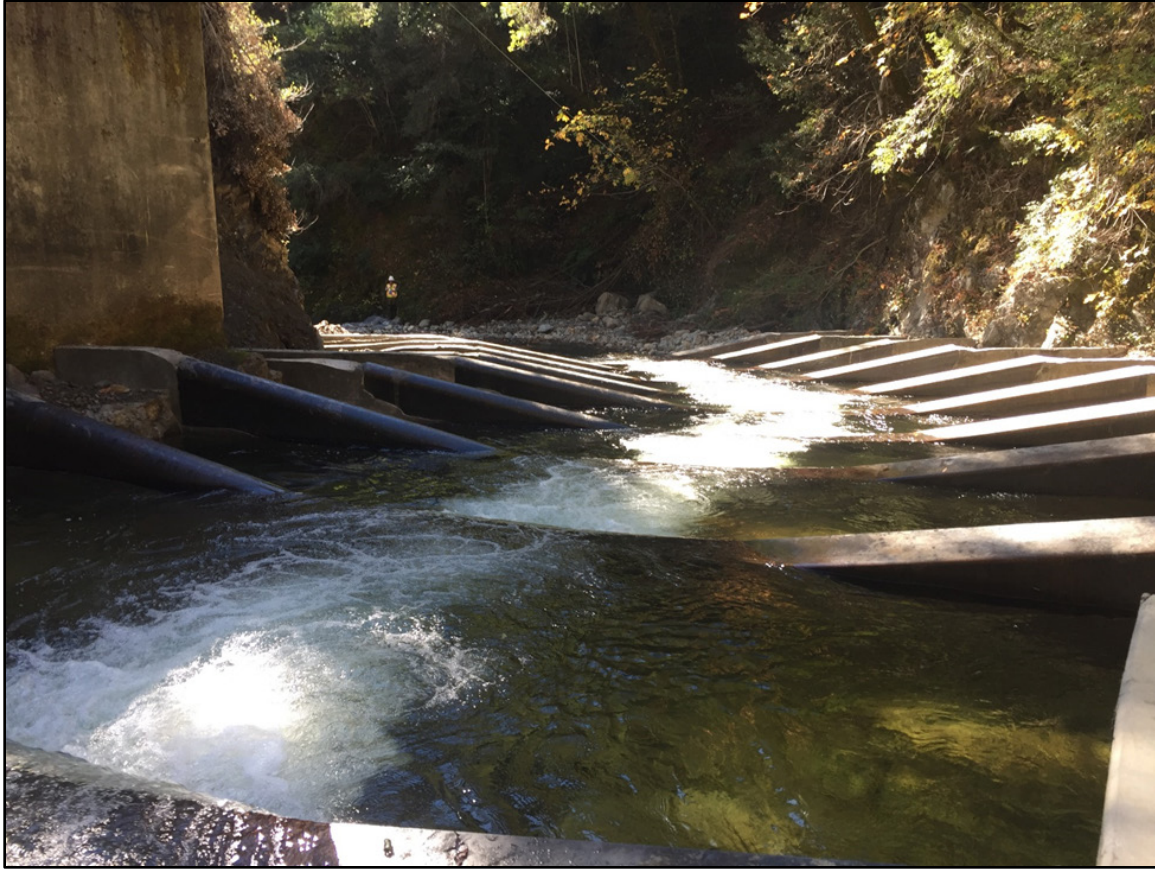
**Figure 3.** Post- project photo. Fishway with modified weir profiles installed downstream of the culvert. Rounded lamprey weir on left and squared salmonid weir on right.

Geomorphic solutions, such as stream simulation designs, are the preferred approach for all fish passage problems. However, because this culvert is so large, long and deep in the fill prism, it was not feasible to remove the culvert and fill prism and to construct a large bridge. To resolve the barriers to salmonid migration a hydraulic solution and fishway were necessary to make up the elevation difference of approximately 6 ft at the outlet. Since a typical weirs and baffles have sharp edges that impair Pacific Lamprey passage, the designer developed and worked with resource agencies to obtain approval for a design solution that modified weirs on one side of the fishway and baffles within the culvert to facilitate Pacific Lamprey migration. Design elements for Pacific Lamprey included a 6-inch radius on the top of one side of the fishway weirs and on baffles within the culvert (Figures 2 and 3).

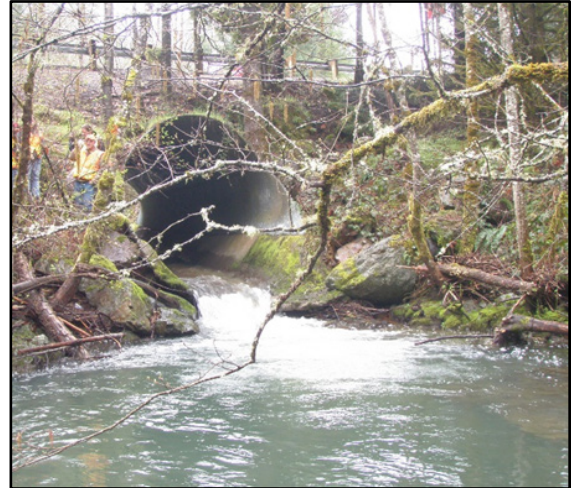
**Figure 1.** Pre-retrofit photo: culvert is perched above the water surface and undersized.

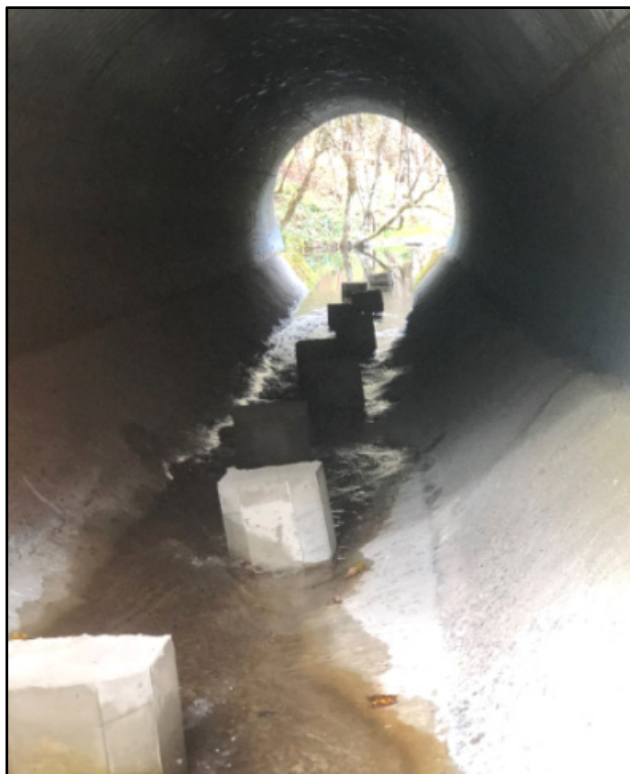
**Figure 3.** Post project photos. Fish blocks installed throughout the invert of the culvert to provide localized velocity reduction and resting areas for migrating fishes.

The blocks have a 90° corner on the downstream side, which would be better for lampreys if they were rounded. However, since lamprey may be using margins on side of culvert at waterline during upstream migration, square corners may not be an issue.

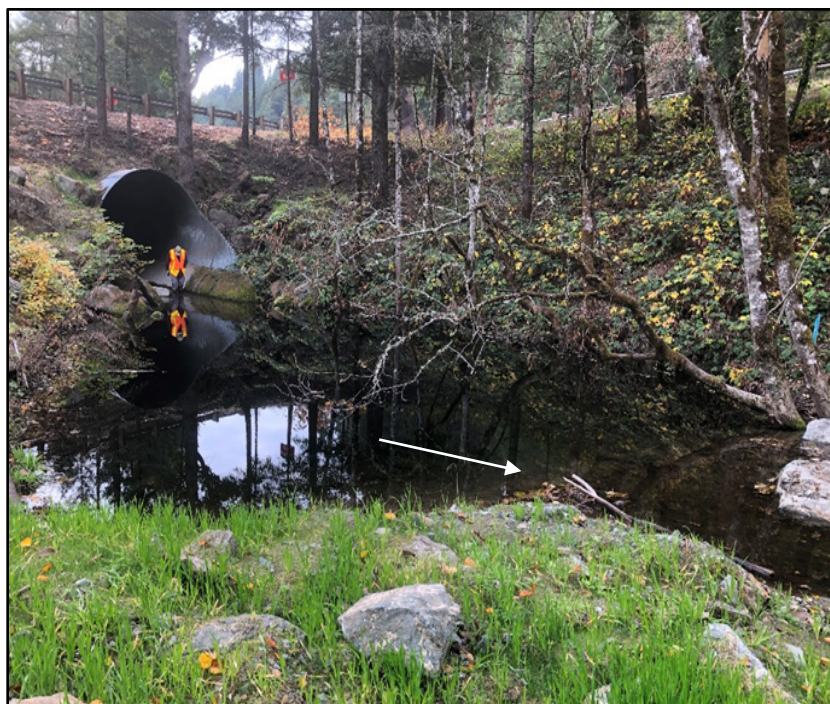
**Figure 4.** Post project photo: new boulder weir and roughened channel (designated by arrow) installed downstream of the culvert.

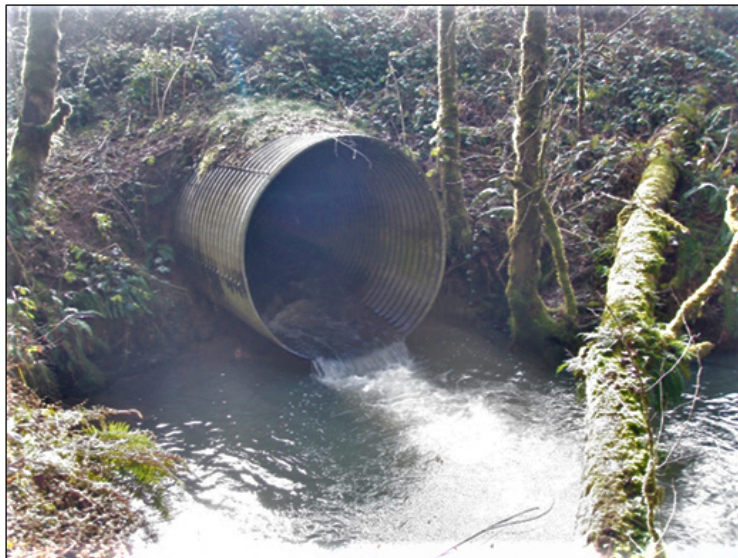
**Figure 1.** Pass Creek pre-retrofit, showing undersized culvert with perched outlet.

Perched culverts are a common passage problem for upstream migrating adult Pacific Lamprey because there are no continuous attachment surfaces and lampreys can't jump. Prior to the retrofit, the outlet of this culvert was perched approximately 1.0 ft above the water surface, preventing adult lampreys from entering the culvert (Figure 1). In addition, the culvert was undersized, creating very high-water velocities that prevented adult Pacific Lamprey from entering the culvert.

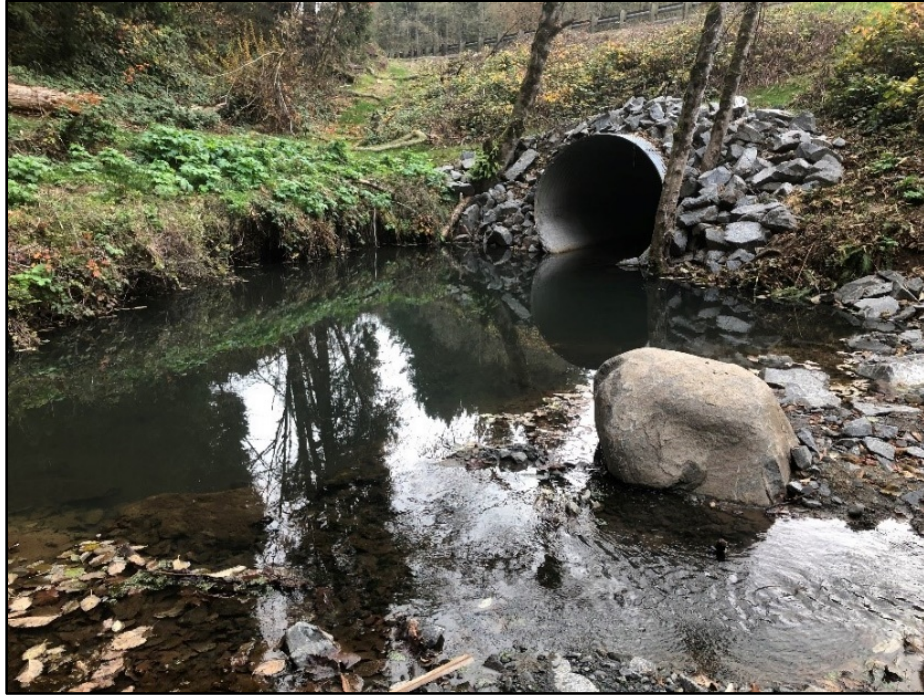
**Figure 2.** Pass creek post retrofit, showing boulder weir and roughened channel installed downstream of culvert to back-water outlet, eliminating perched condition and allowing fish and lamprey to swim into the culvert without jumping.

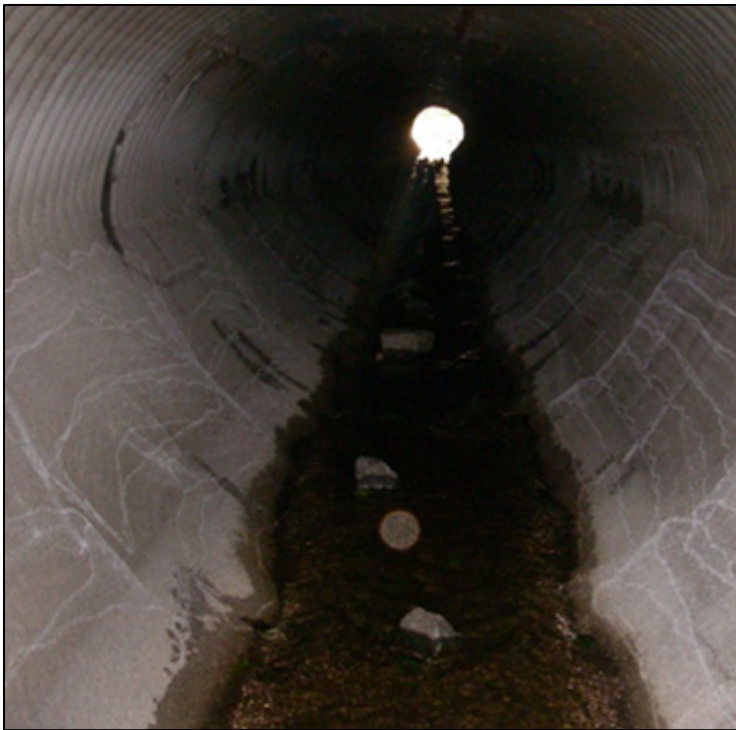
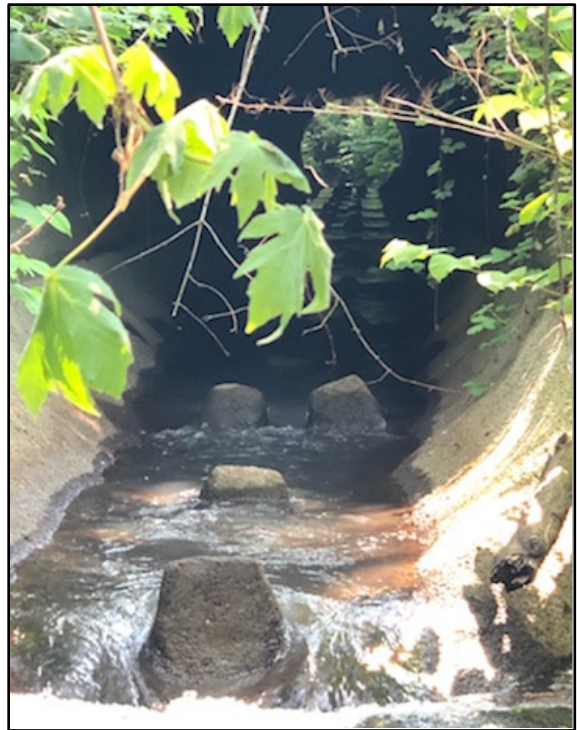
**Figure 3.** Pass Creek, post retrofit, showing smoothed concrete and “fish rocks” installed throughout invert of culvert to provide localized velocity reduction (left). Another example of “fish rocks” is shown (right) from a separate project, as the Pass Creek fish rocks were somewhat undersized for expected velocities.

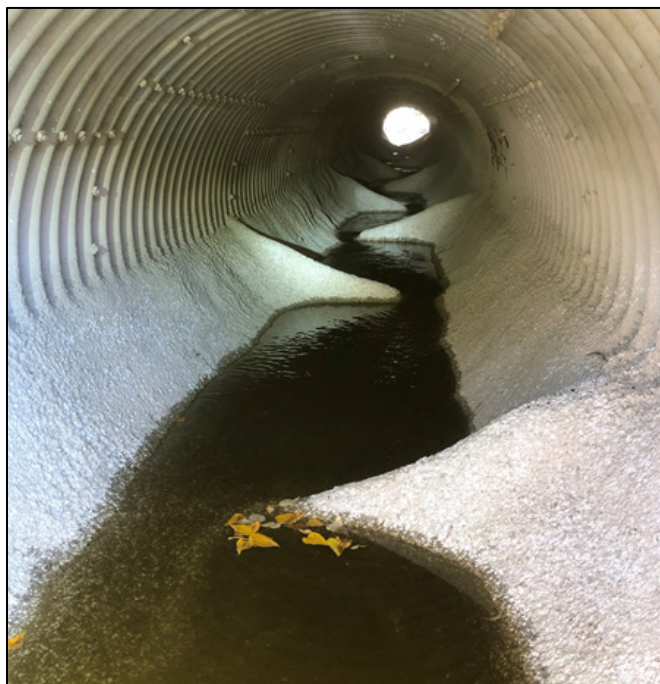
**Figure 1.** Culvert with rounded baffle design.

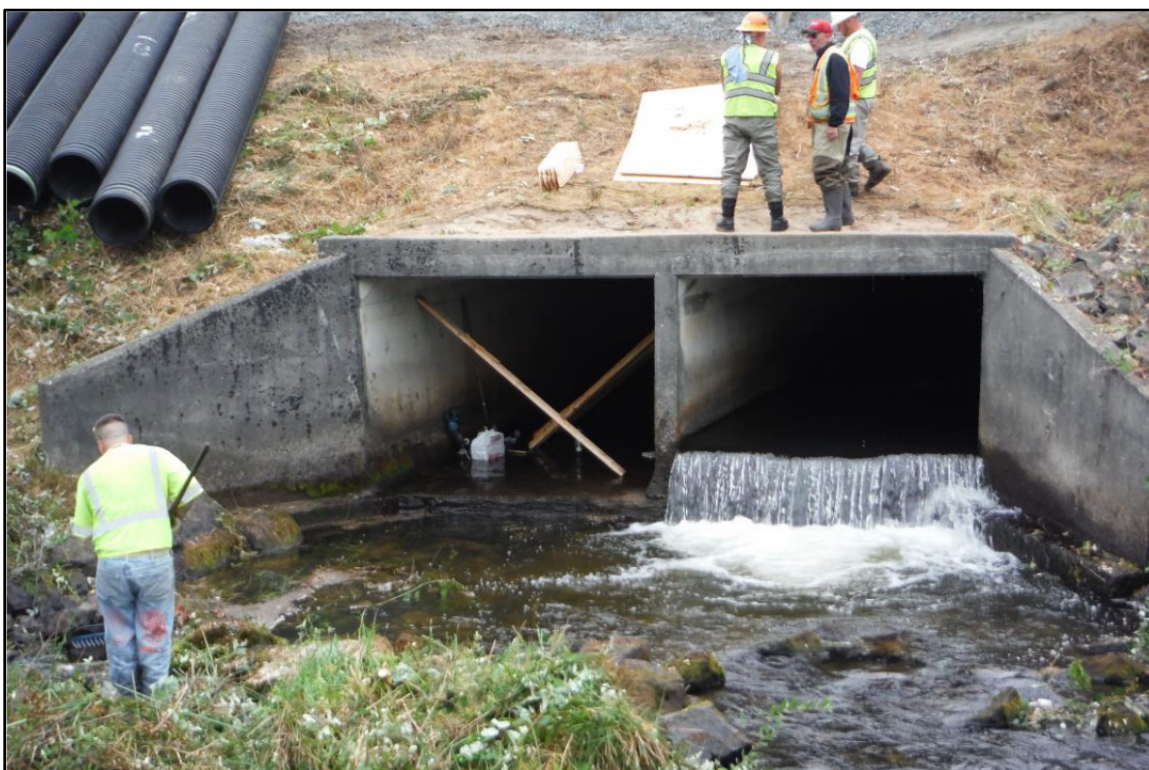
**Figure 1.** Pre-project photo showing how the baffle created a perched condition/waterfall on the right side of culvert.

Oregon Department of Transportation previously modified an existing culvert under Highway 101 in Lakeside for salmonid passage by the adding of baffles inside the culvert (north side of culvert), and constructing a jump pool below the culvert to allow salmon a resting area and acceleration room to jump over the first baffle and into the culvert. However, Pacific Lamprey had difficulty negotiating the 90° corners of the baffles, and during low flow, the culvert was effectively perched (Figure 1). These conditions created a partial passage barrier for Pacific Lamprey.
