# ***Barriers to Adult Pacific Lamprey at Road Crossings: Guidelines for Evaluating and Providing Passage***

*Living Document: Version 1.0*

*June 29, 2020*

***Lamprey Technical Workgroup***

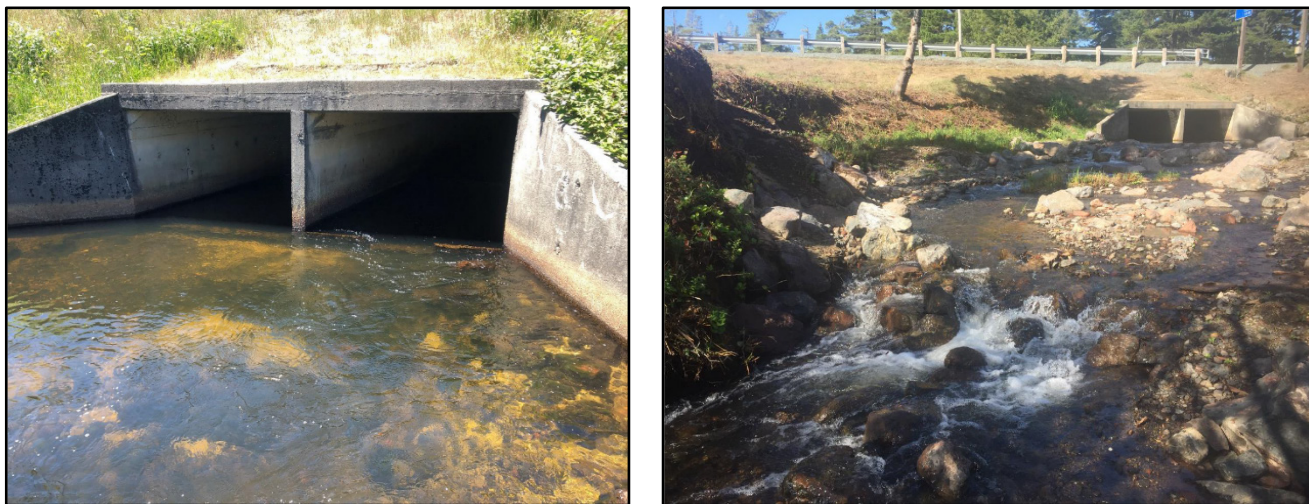
**Figure 2.** Post- project photos showing the modified baffle at culvert outlet and increased elevation of the outlet pool providing continuous passage into the culvert without requiring a jump (left) and the roughened channel downstream of the culvert (right).

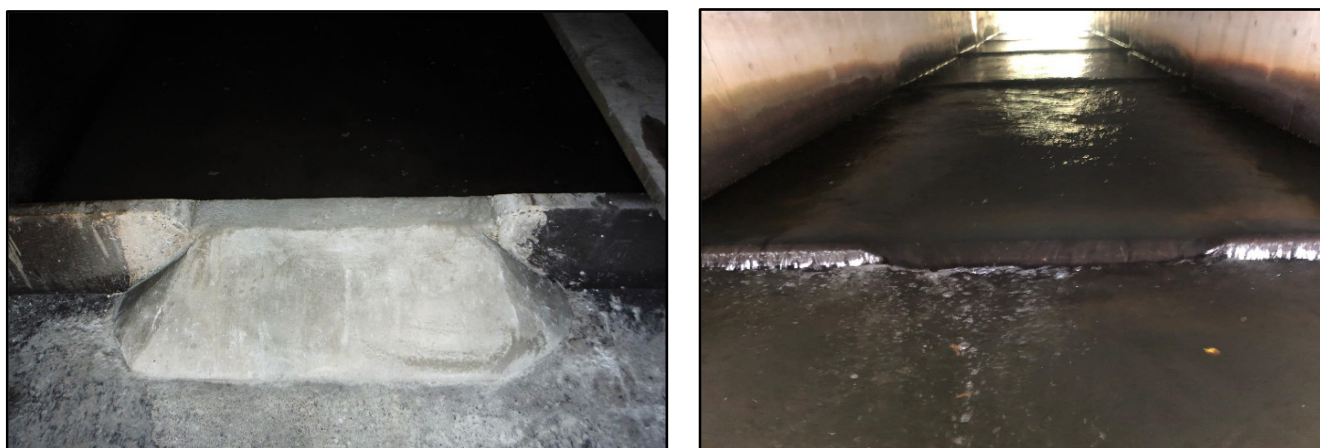
**Figure 3.** Photos of the modified baffle and ramp in dry and watered conditions. Middle portion of the baffle was cut down and a ramp was installed on each side of that cut to provide lamprey with a continuous attachment surface.
