**SOIL MECHANICS AND BITUMINOUS MATERIALS
RESEARCH LABORATORY**

**THE TURNAGAIN HEIGHTS LANDSLIDE
IN ANCHORAGE, ALASKA**

by
H. BOLTON SEED
and
STANLEY D. WILSON

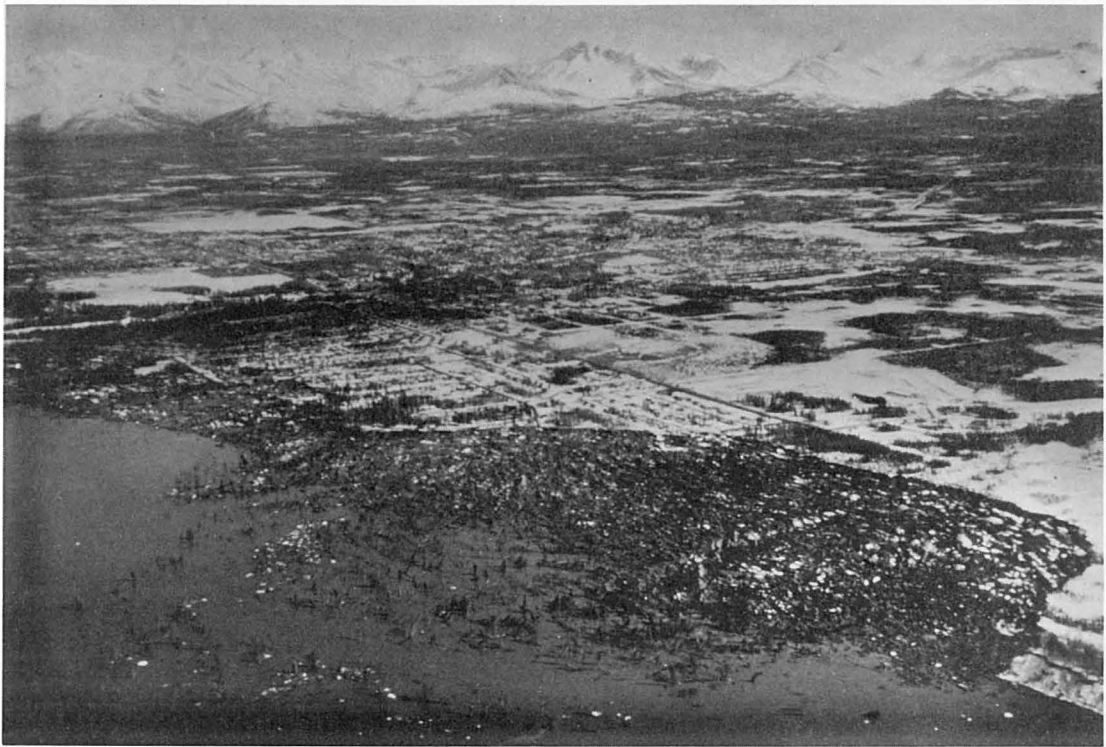
Fig. 1a AERIAL VIEW OF TURNAGAIN HEIGHTS LANDSLIDE

During the Alaskan earthquake of March 27, 1964 a number of major slides occurred in the City of Anchorage.^{1,2} The largest of these slides was that along the coastline in the Turnagain Heights area. An aerial view of the slide is shown in Fig. 1a and a plan of the slide area in Fig. 3.

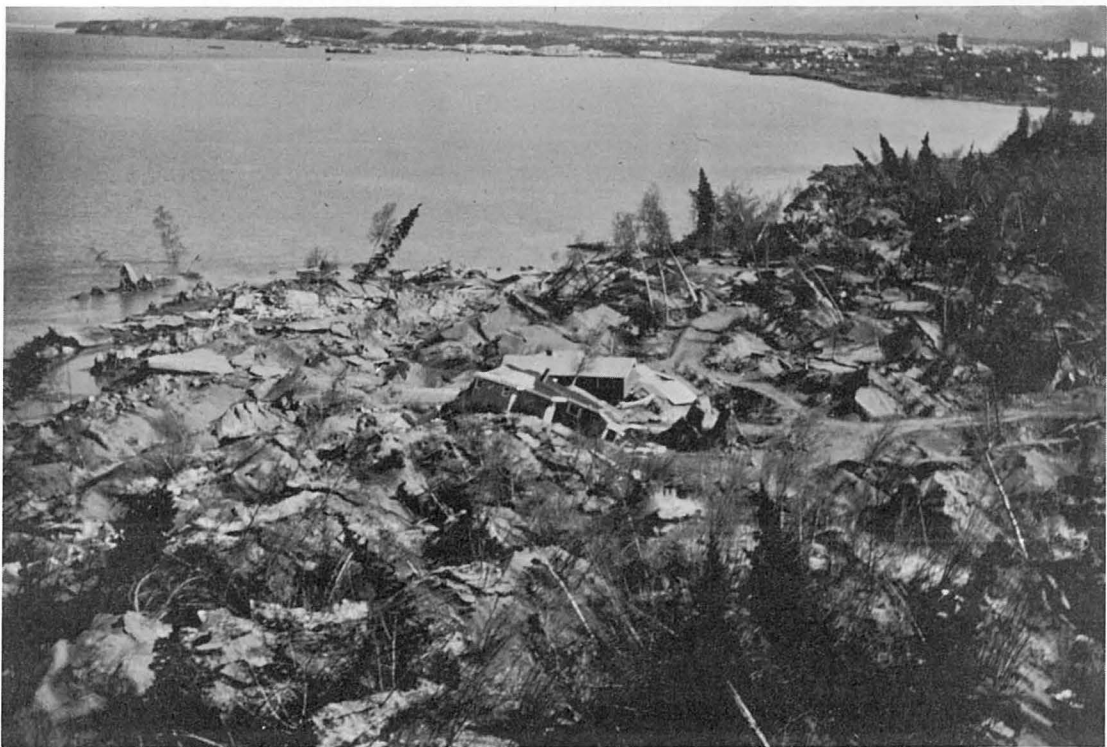
Fig. 1b CONDITIONS IN CENTRAL PART OF SLIDE AREA

The clay ridges, illustrated in Fig. 1b, were a characteristic feature of the slide area. Hansen² has described them as follows: "Hundreds of sharp crested clay ridges alternating with collapsed troughs, and oriented normal to the direction of slippage distinguished the disruption pattern of the Turnagain Heights slide....Most of the clay ridges ranged in height from about 10 to 15 ft but a few were more than 20 ft high. They were as much as 300 ft long and were spread 50 to 150 ft apart. Their steep sides, which sloped 60° to 70°, were furrowed and grooved by slippage of one surface against another. On the average the ridges were sharper crested and more closely spaced"... in the west end of the slide area than in the east end.

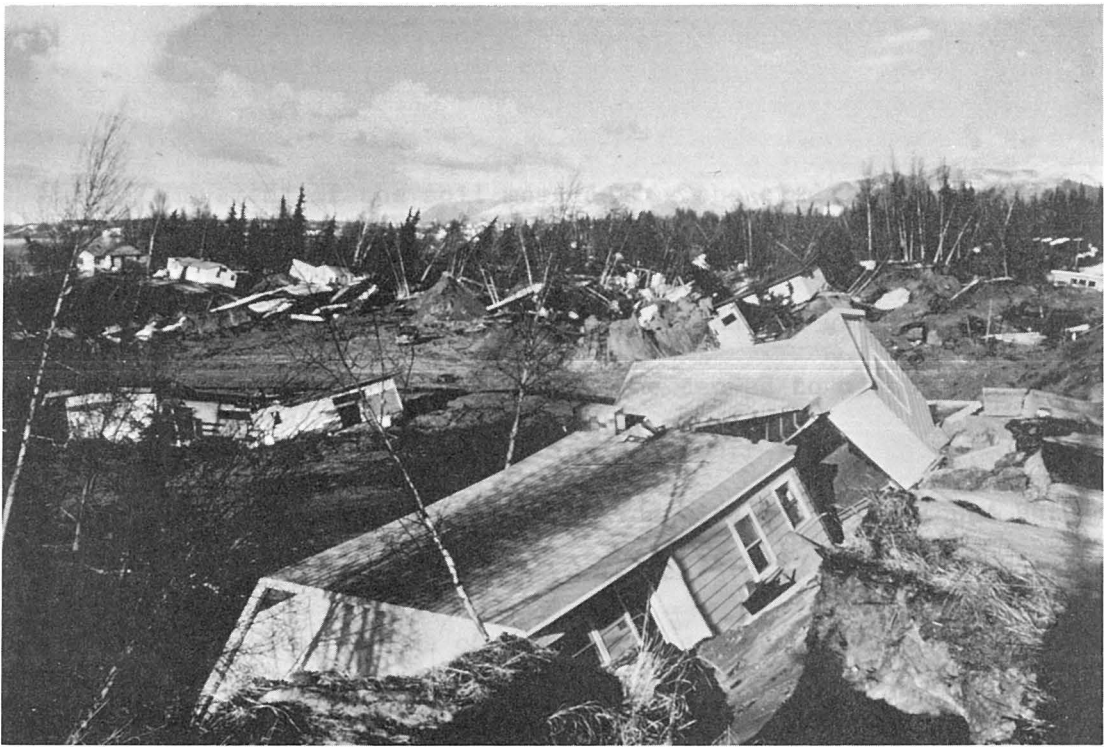
Fig.4 MOVEMENTS OF HOUSES IN SLIDE AREA

A study conducted by the Engineering Geology Evaluation Group in Anchorage reveals the extent of movement of some of the houses in the slide area. Fig. 4, prepared by this group, shows the initial and final positions of houses as determined by surveys before and after the earthquake. It may be seen that some of the houses moved laterally about

A study conducted by the Engineering Geology Evaluation Group³ in Anchorage reveals the extent of movements of some of the houses in the slide area. Fig. 4, prepared by this group, shows the initial and final positions of houses as determined by surveys before and after the earthquake. It may be seen that some of the houses moved laterally about 500 or 600 feet, usually, though not always, towards the original coast line. The transverse movement of some of these houses is indicative of the complex mechanism involved in the development of the slide.

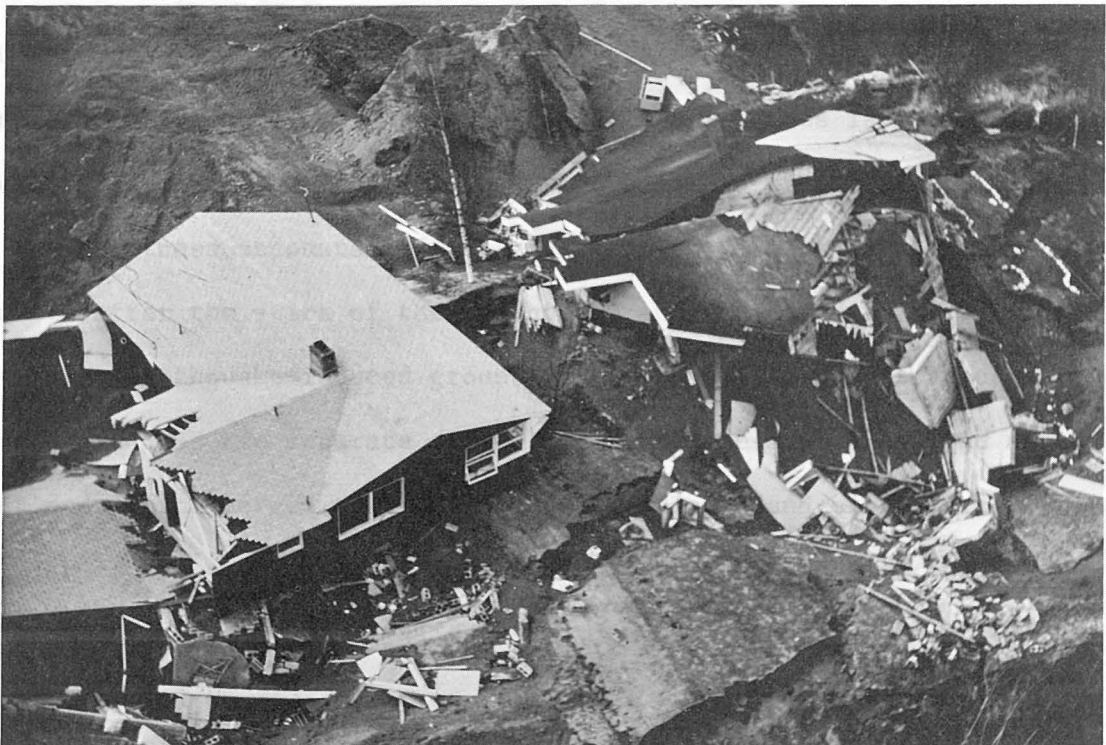
Fig.2b HOUSES DESTROYED BY SLIDE

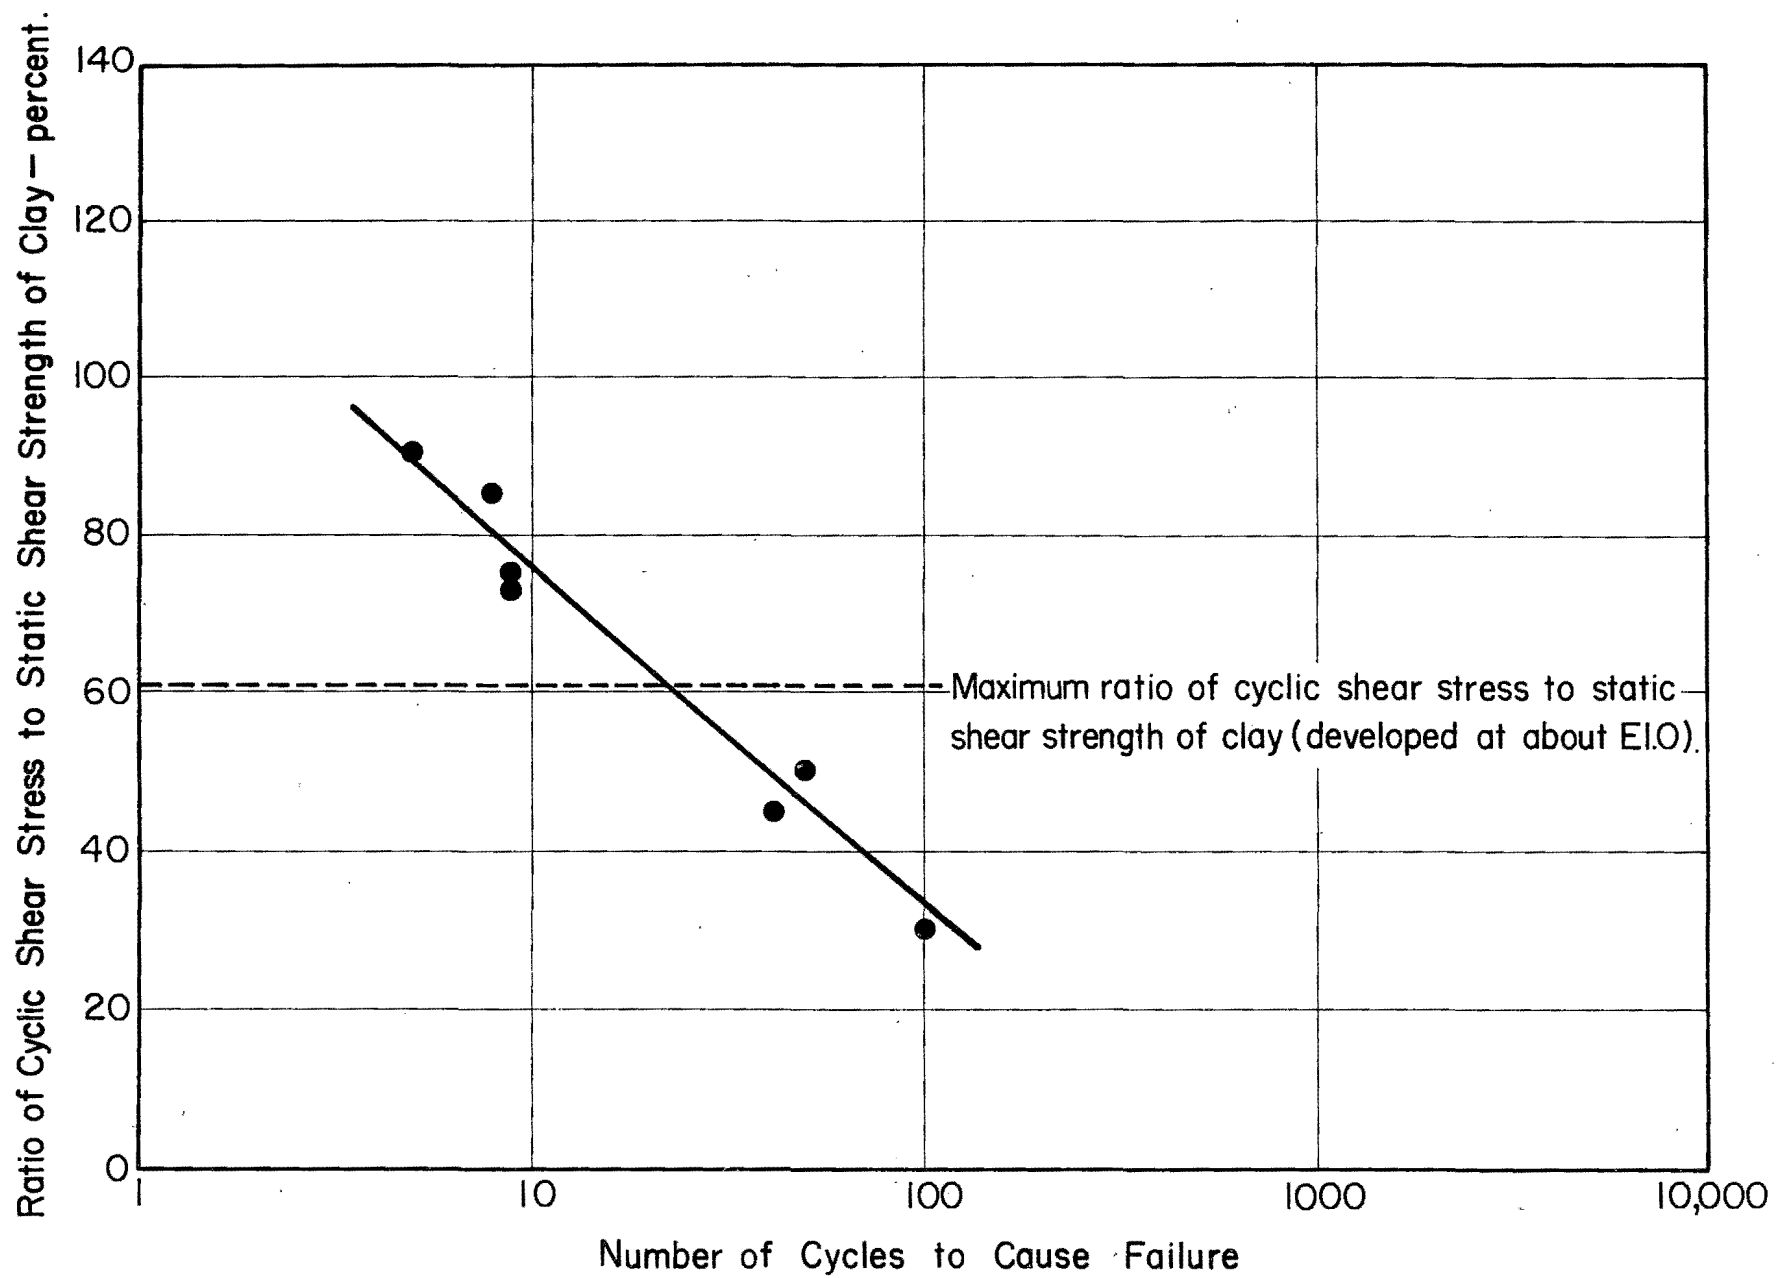
The results of such tests performed on undisturbed samples of the sensitive silty-clay are shown in Fig. 7. Some of these tests were performed using the simple-shear equipment developed by the Norwegian Geotechnical Institute,⁷ modified to permit the conduct of cyclic stress or cyclic strain tests. Other tests were performed using cyclic loading triaxial compression procedures.⁸ Both types of test gave essentially the same results, showing that failure of this clay could be induced by cyclic stresses substantially less than the static strength of the clay under undrained loading conditions. For 30 significant stress cycles, such as might have been developed during the earthquake, failure was induced by cyclic stresses equal to about 55 percent of the static strength; for the soft sensitive clay which might be considered to have an in-situ shear strength of about 850 psf, this corresponds to a cyclic shear strength of about 470 psf.

Fig.7 STRENGTH OF SAMPLES OF SILTY CLAY UNDER CYCLIC LOADING CONDITIONS.

τ_c/s_u with the values of this ratio required to cause failure of the clay as determined by cyclic loading tests. This comparison is shown in Fig. 7, from which it may be seen that for constant stress conditions, failure of the clay would require about 22 stress cycles, or about 1.5 minutes of ground shaking.

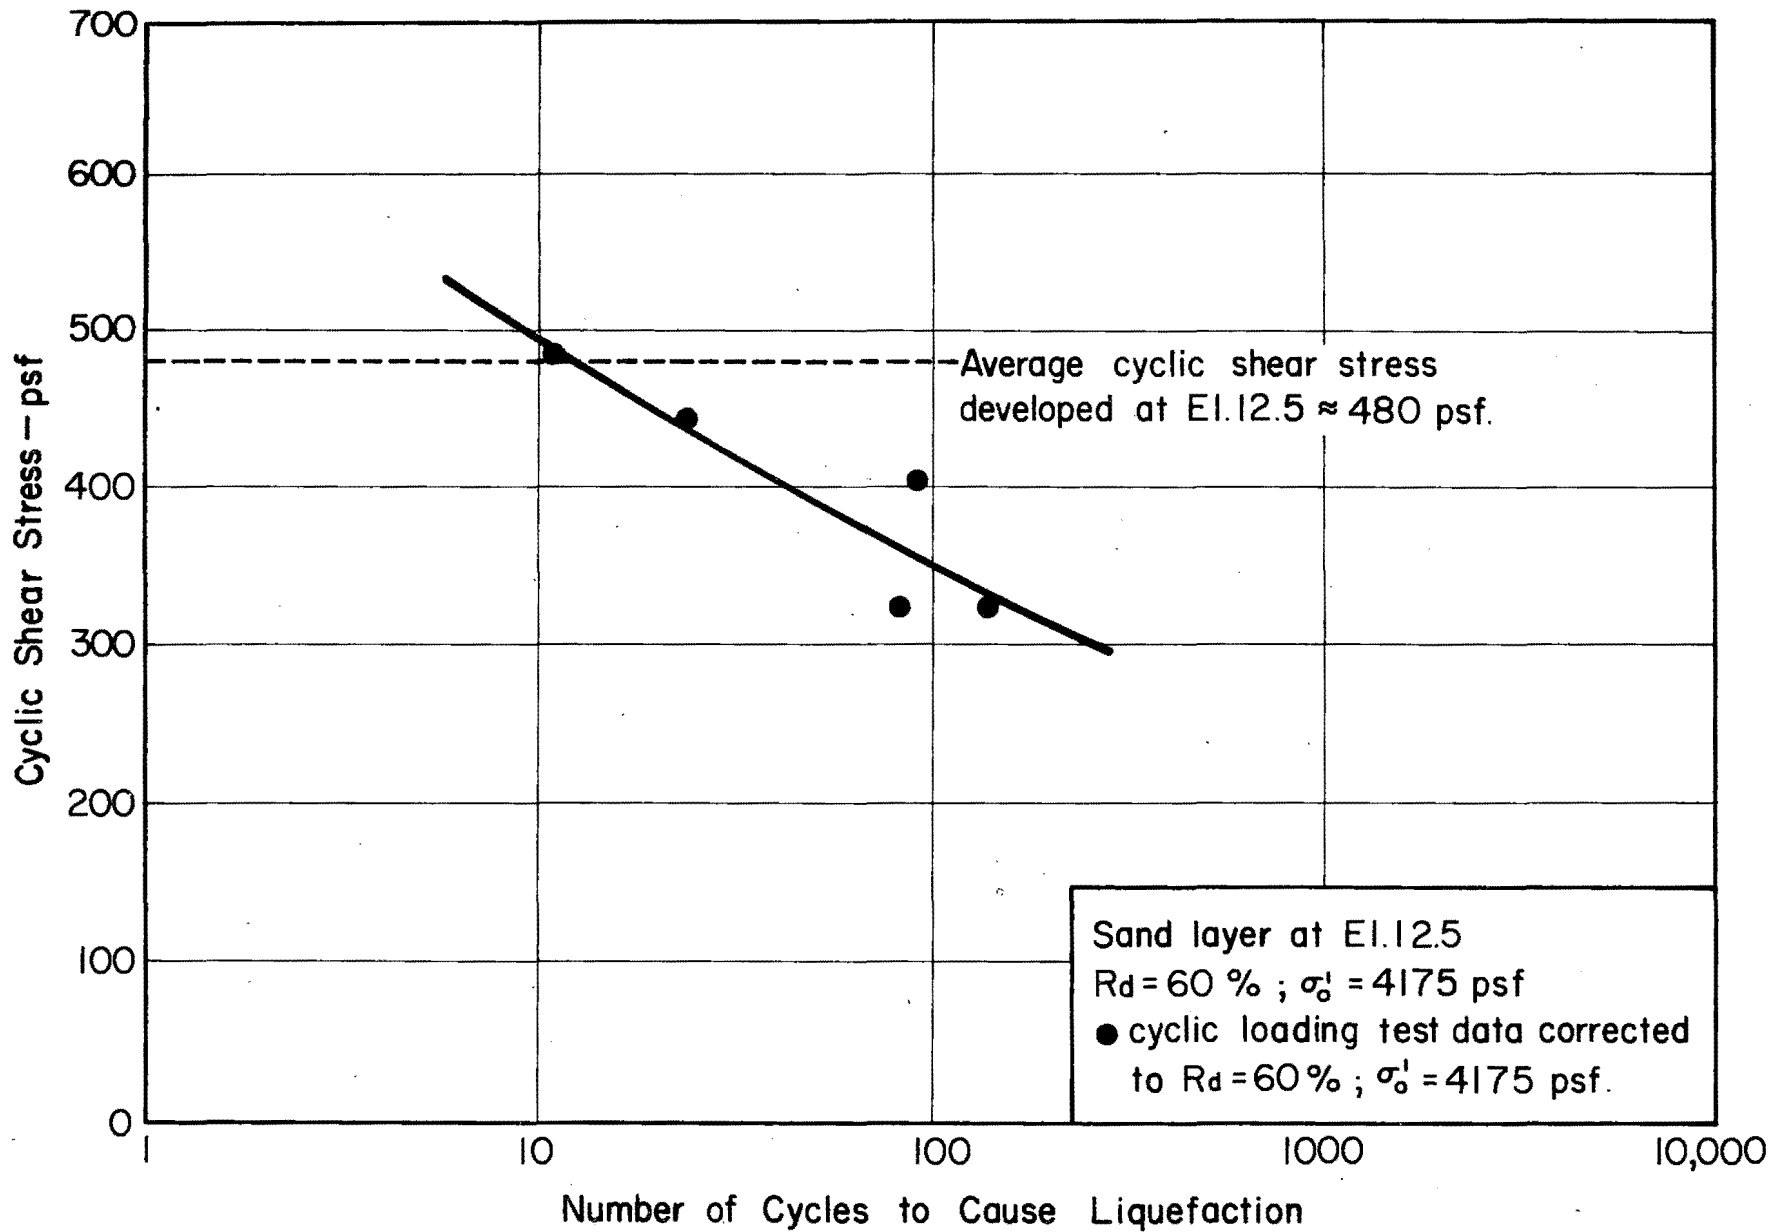
Under cyclic loading conditions, loose and medium dense saturated sands may fail by liquefaction. The cyclic shear stresses required to induce liquefaction of the sand seams were investigated by tests on a typical sample taken at about El. 20 at the east end of the slide area. For this purpose, the cyclic loading triaxial test procedure used previously by Seed and Lee⁹ was adopted. The results of such tests may be corrected to other void ratios and confining pressures on the basis of previous data for similar materials.¹⁰ It is also necessary to apply a correction to the data to convert the results to those corresponding to simple shear conditions. For samples of similar sand at about elevation 12.5 and for the approximate in-situ void ratio conditions as measured by field density determinations, the test data indicated the relationship between cyclic shear stress and number of stress cycles required to cause liquefaction shown in Fig. 8. It will be seen that liquefaction of the sand seams may be expected to occur in 30 cycles at an cyclic shear stress of about 420 psf, a value somewhat less than that required to induce failure of the soft clay in the same number of cycles. Thus for comparable shear stresses in the zone behind the bluffs, liquefaction might be expected in the sand before failure would develop in the clay.

Fig.8 STRESSES INDUCING LIQUEFACTION OF SAND UNDER CYCLIC LOADING CONDITIONS

The possibility of liquefaction occurring at El. 12.5 may be assessed by comparing the magnitude of the cyclic shear stress developed at this level with the cyclic stresses required to induce liquefaction of the sand in cyclic loading tests for comparable initial conditions. This comparison is shown in Fig. 8, from which it may be seen that the computed average value of the shear stress developed at this elevation would induce liquefaction in about 12 stress cycles; that is, in about 45 seconds of ground shaking. Since the actual stresses probably exceed the computed stresses as noted above, liquefaction of sand lenses or layers in the zone around El. 12.5 might reasonably be expected to occur within the first 45 seconds of the earthquake.

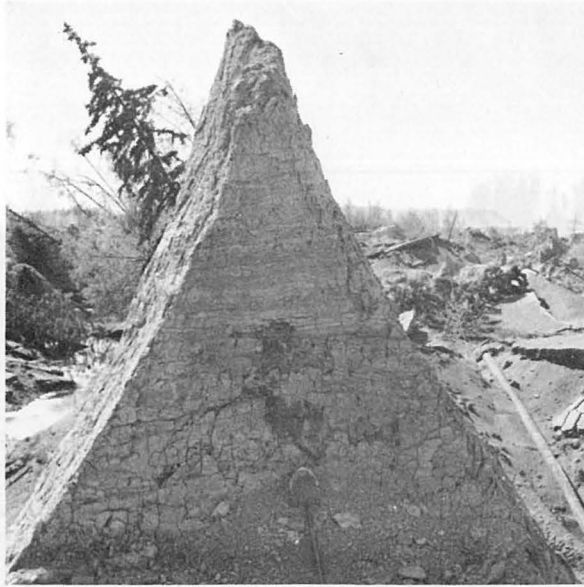
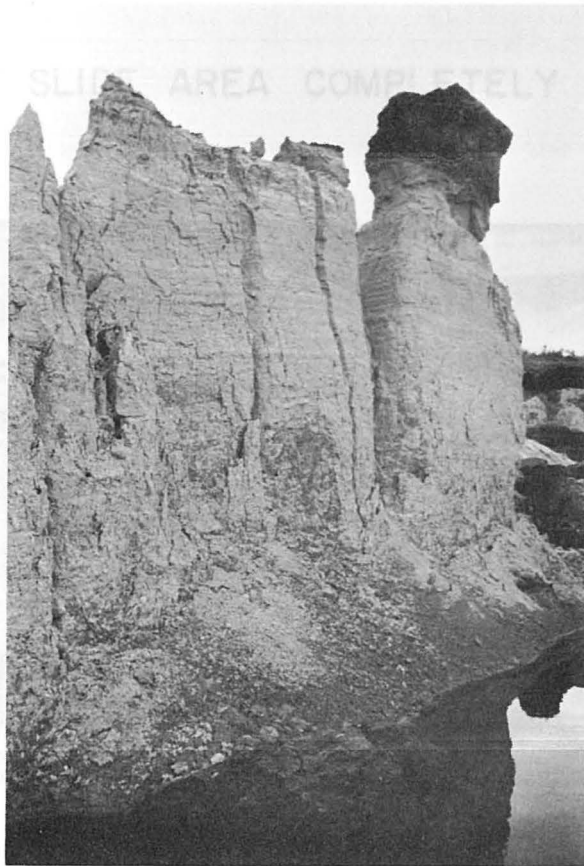
Fig.II RIDGES OF CLAY IN SLIDE AREA

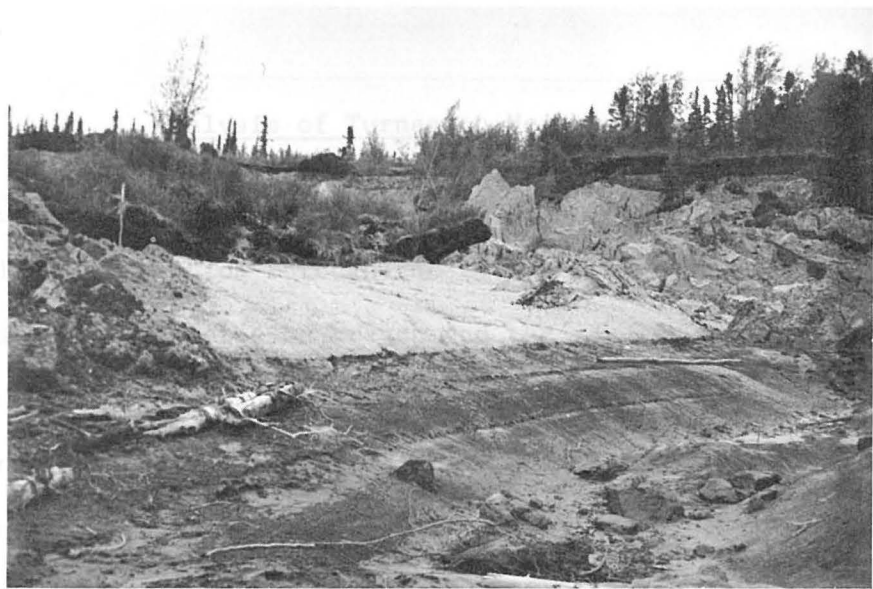
Fig.12a ZONE OF SLIDE AREA COMPLETELY FREE OF DEBRIS

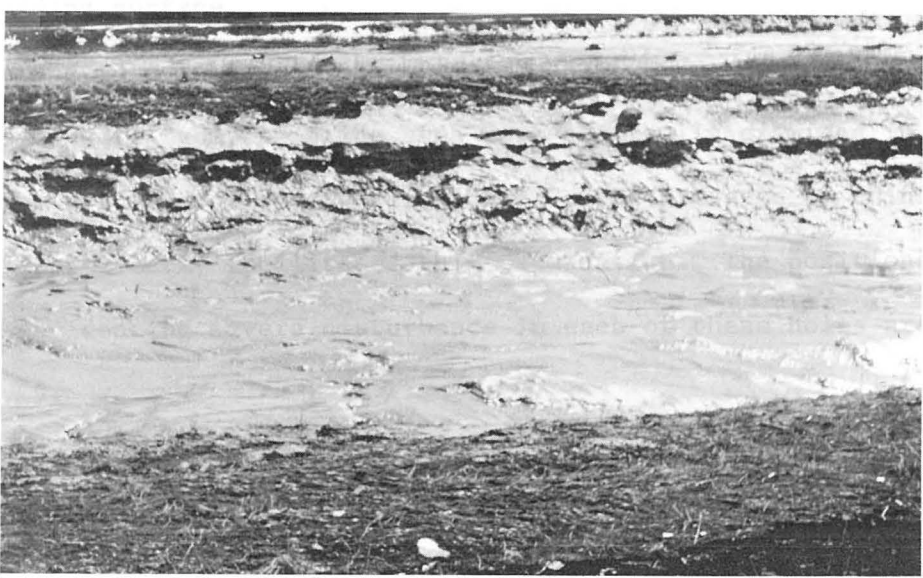
Fig.12b OFF-SHORE SILT DEPOSIT

One of the prime factors leading to the large inland regression of the slide was undoubtedly the presence of a sloping layer of estuary silt at the toe of the bluff. The nature of this material may be seen in the photograph, Fig. 12b, which was taken at an adjacent area of the coast line. During the earthquake this silt would liquefy and thereby provide a semifluid sloping surface to facilitate the translation of soil masses falling onto it. Thus failure of the bluff by any type of slide would cause the sliding mass to be deposited on the silt and thereby continue to slide outwards into the water. This would leave a new exposed face which might well fail by a repetition of the same mechanism, this process continuing as long as the earthquake continued. In fact the slide would be able to retrogress because there was no opportunity for a build-up of slide debris at the toe of the slope to buttress the unstable condition.
