# **Archaeological Monitoring for Sewer and Water Improvements Seldovia, Alaska**

# **Archaeological Monitoring for Sewer and Water Improvements, Seldovia, Alaska**

**2008**

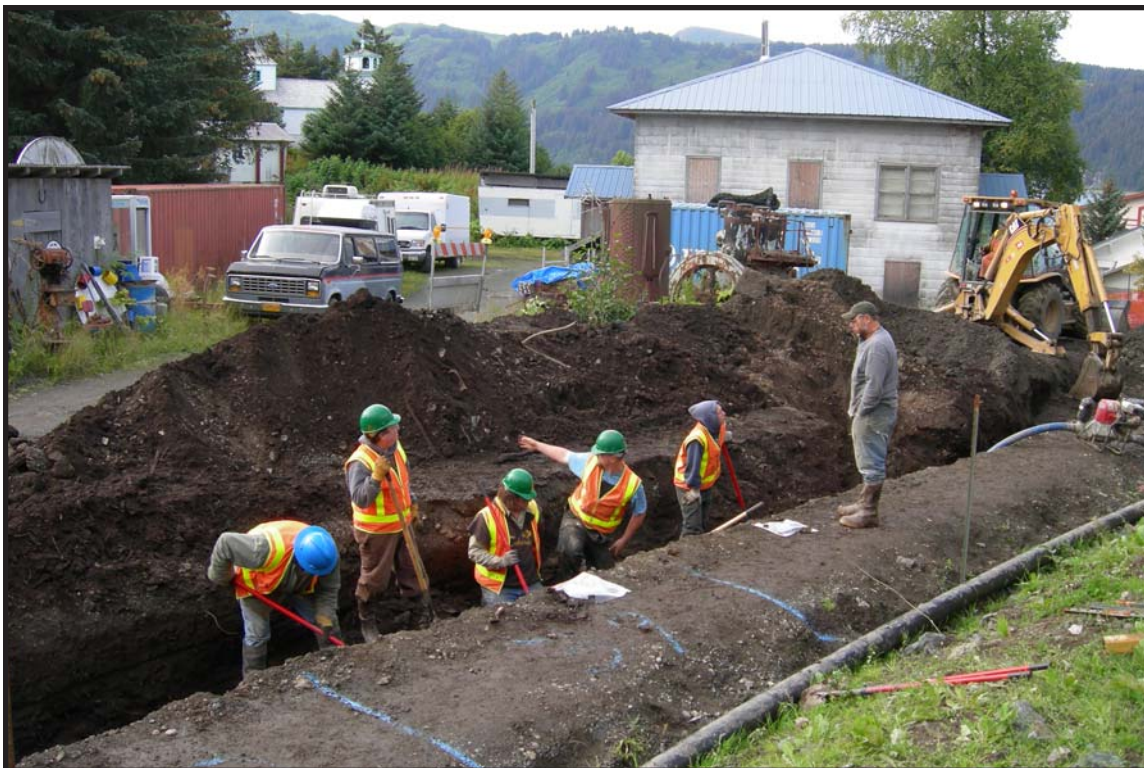
Figure 20. When an 18"-thick historic midden was found beneath English Road, construction crew members helped recover artifacts using hand tools. The old hospital (SEL-335) is at upper right.

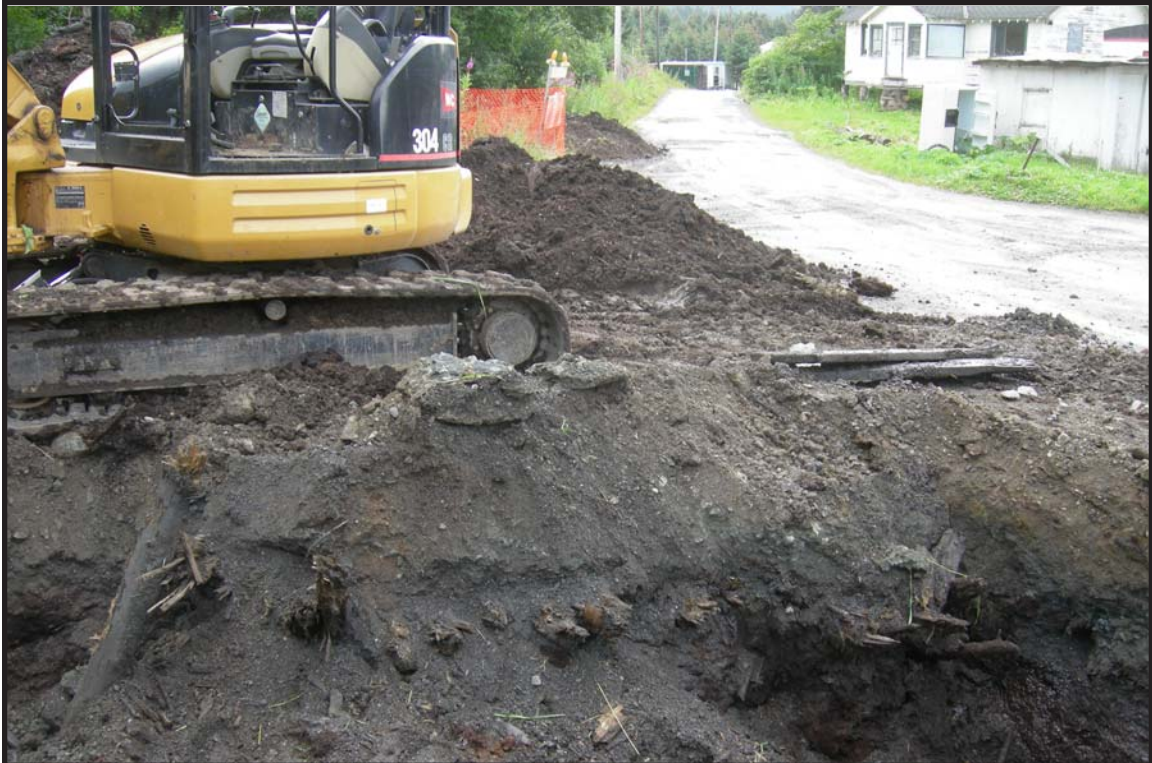
Figure 21. Excavations at the intersection of English Road and Alder Street (here looking southeast down Alder Street) revealed a pavement of parallel logs -- the remains of a corduroy road built to support vehicles traveling over the soft muskeg. The white house at far upper right is SEL-344.

Excavations for water main repair at the intersection of English Road and Alder Street uncovered a pavement of logs representing the buried remains of a corduroy road surface (Figure 21). The logs were oriented more or less perpendicular to English Road and were obviously part of its alignment rather than Alder

surface. At that depth we noted a light orange-yellow volcanic ash measuring between 1/2" to 4" thick, below which the homogenous peat continued down to the bottom of the excavation. According to equipment operator Steve Bond, when preparing a new foundation nearby for the next location of SEL-344 (Figure 21) he drove wood pilings down to a depth of 28', indicating considerable depth to the peat in this area. A few bits of clam shell were found mixed among the corduroy road logs. According to

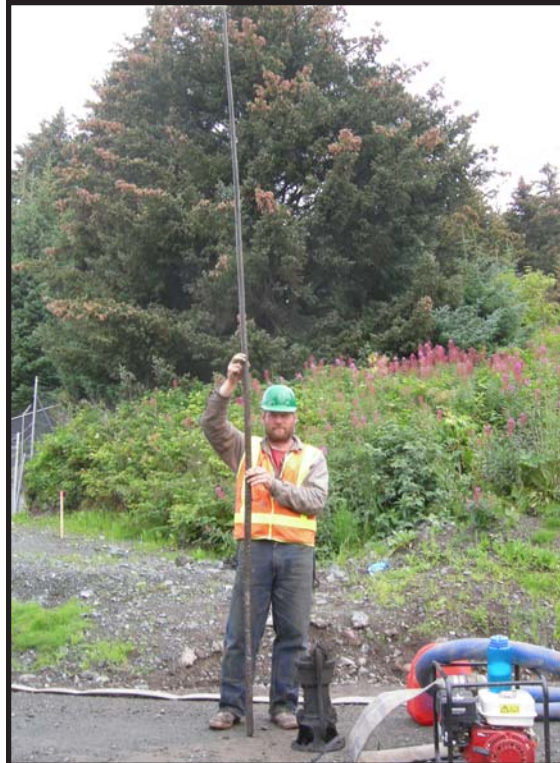
Figure 23. Curtis Dickson holds a 12'6" peeled pole found inside a wooden water catchment conduit near the pump at English and Alder Streets.

Immediately beneath the corduroy road at the intersection of English Road and Alder Street was another feature consisting of a water conduit made of rough-cut 2"x12" planks (Figure 22) running more or less parallel to the road and perpendicular to the corduroy logs. It is a separate feature from the corduroy road. The trough had a bottom and two sides but we didn't observe a capping plank on top. A void was maintained, however, due to the overlying corduroy logs, and from inside the void we pulled out a long peeled and shaved spruce pole cracked in two places but still with all three pieces connected (Figure 23). The artifact is 12'6" long, and less than 2" wide at the butt. About 6' west, from the bucket of the machine,

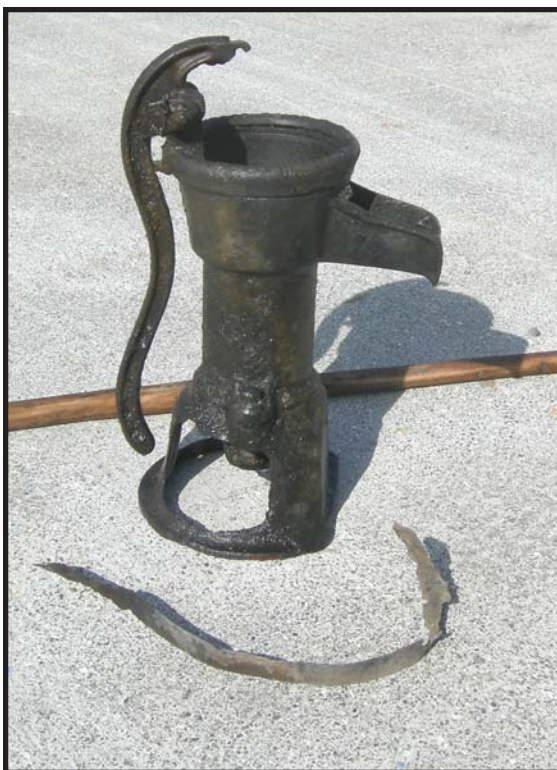
Figure 24. A pump from an early Seldovia water catchment system was found below the corduroy road at the English and Alder intersection.

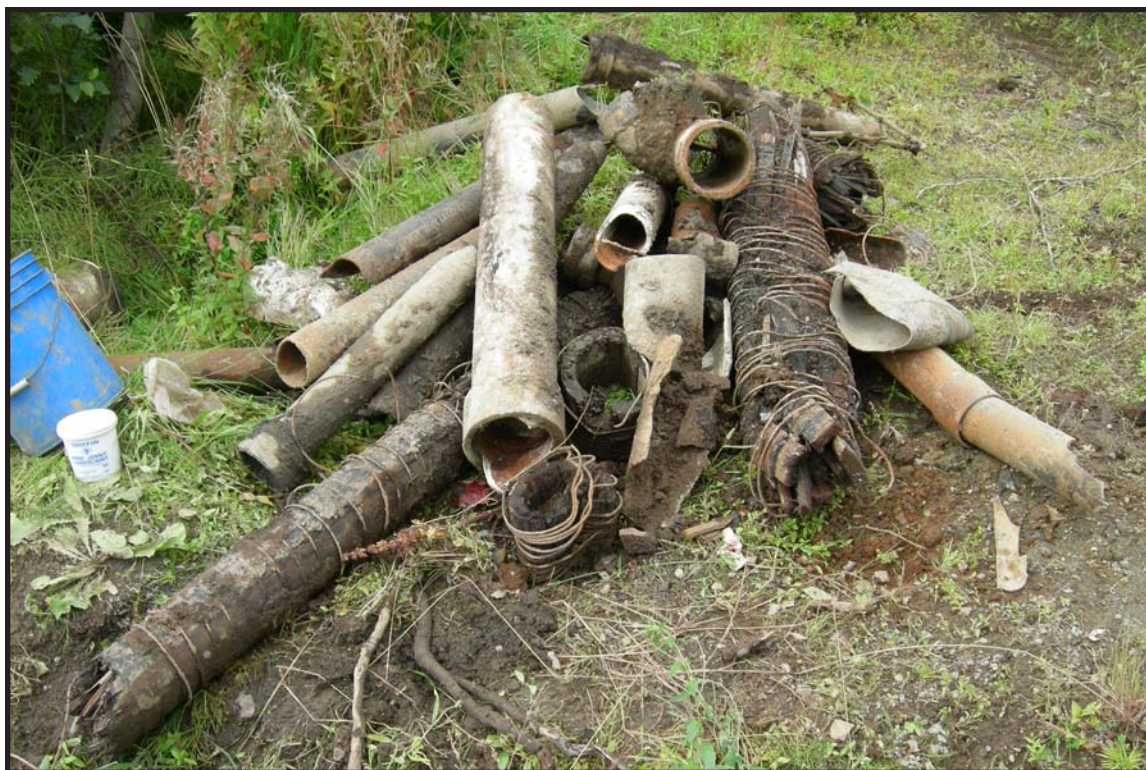
Figure 30. Wood-stave and metal pipe of various diameters was removed from beneath English Road.

Another structural artifact type encountered were pipes of various sorts, including wa-

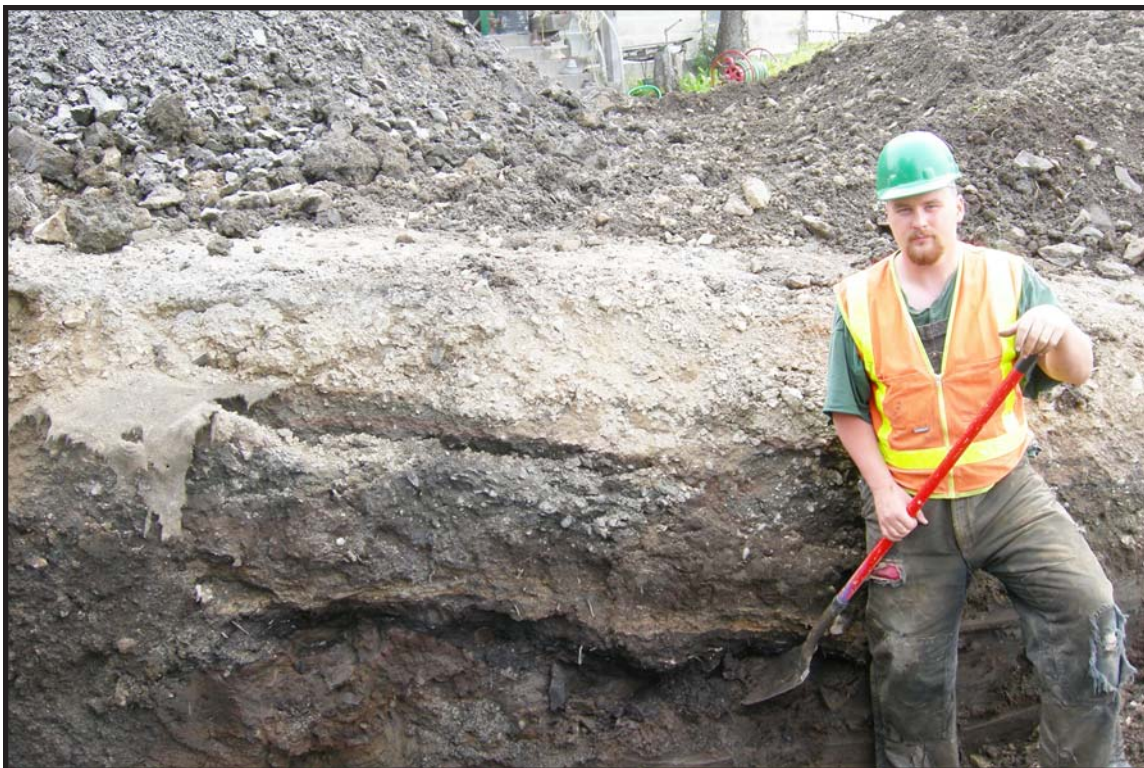
Figure 32. John Geagel points his shovel at the base of Midden Exposure 1, immediately below fill brought in to create English Road, with the old hospital (SEL-335) behind. View is south-southeast.

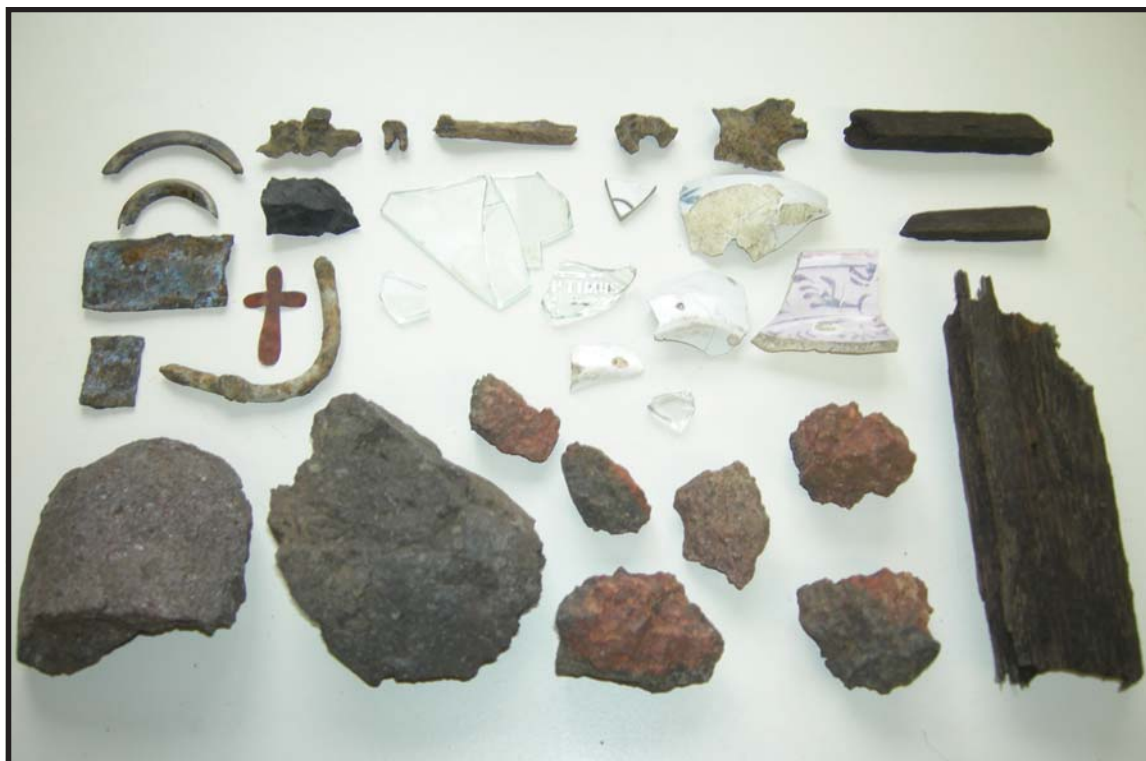
Figure 33. Midden Exposure 1 included (clockwise from upper left): two porcupine incisors, a lump of coal, several other small bones, window and bottle glass, ceramic shards, three pieces of wood, fire-cracked rocks, and four metal objects -- a nail, two small ferrous tablets, and a copper cross.

Midden Exposure 1 had artifacts of several different materials (Figure 33). A few small bones were recovered, including cranial parts and two incisors from a porcupine. Fragments of glass bottles and windows were found, as well as five white paste ceramic shards. Metal

objects consisted of two small rectangular ferrous plates, a bent nail, and a small cross cut out of copper sheet. Three pieces of rotten lumber were noted, as well as eight fire-cracked rocks and a lump of coal.

The artifacts from Midden Exposure 1 reflected several different aspects of occupation. The bits of wood and window glass are indicative of structures, while the bottle glass, ceramics, and bones reflect food and beverage serving and consumption. The cross measures 1 3/8" tall by 7/8" wide, and is less than 1/32" thick, and is of note for not being a Russian Orthodox cross. The fire-cracked rock is a cultural product and reflects either cooking as per the traditional Dena'ina practice using hot stones, or the typical Alutiq steam bath -- probably the latter. Interviewing with Susan Springer in 1988, local Seldovia Native elder Nick Elxnit told of their steam bath or "banya" tradition used at a now-abandoned historic village up Seldovia Bay (Springer 1997:56-57), and Fred Elvsaas dis-

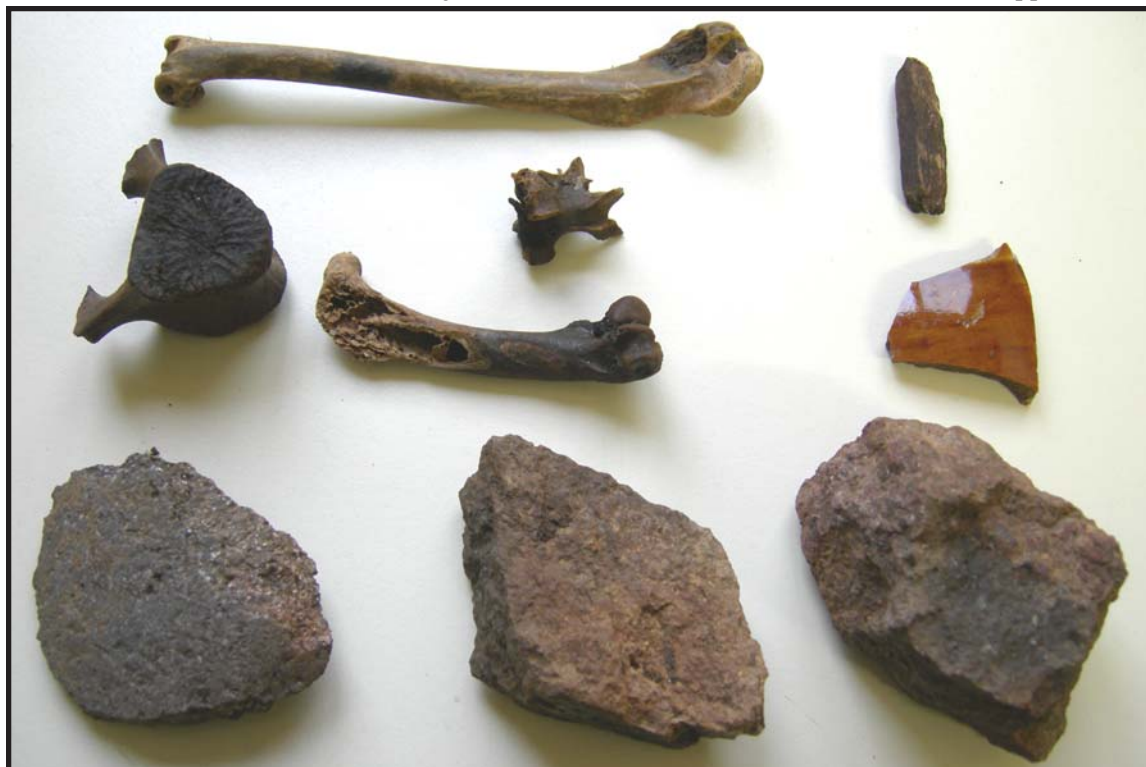
Figure 34. Midden Exposure 2, also in English Road, produced (clockwise from upper left): four bones, a piece of wood, one ceramic shard, and three fire-cracked rocks.

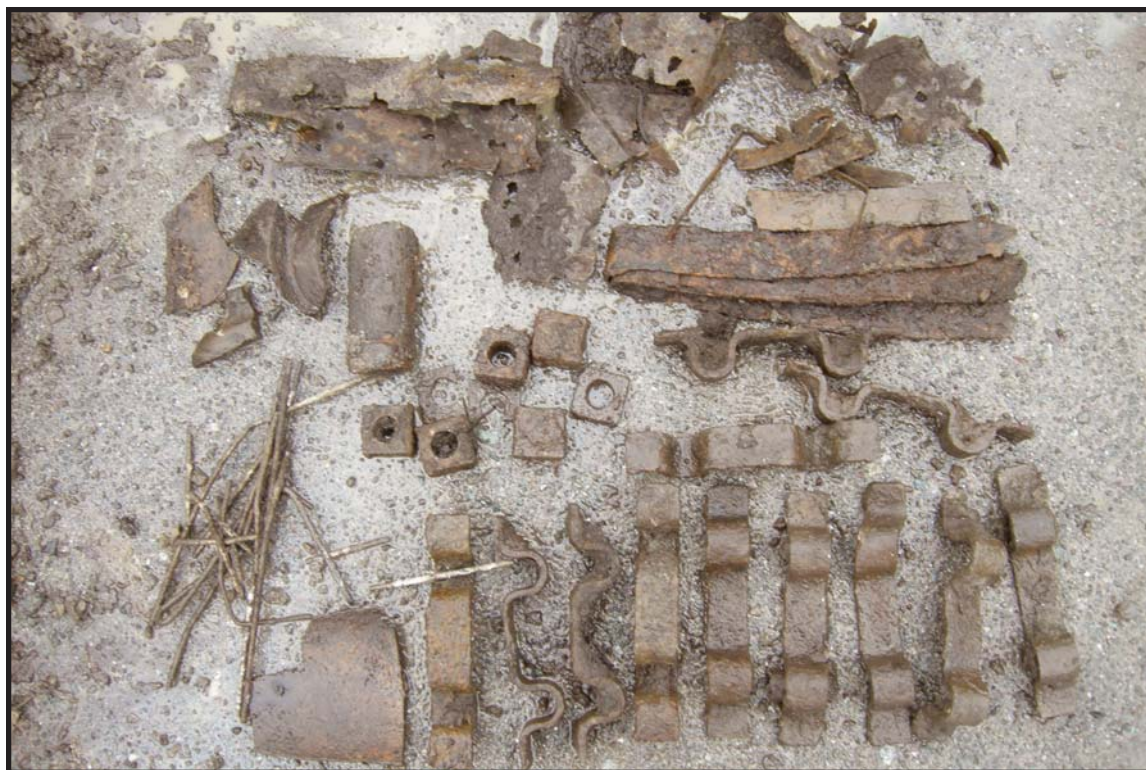
Figure 35. From a 10' section of upper English Road came a group of industrial shop items, including used welding rods, heavy metal conduit hangers, and square nuts.
