APPENDIX M—MITIGATION

M1.0—MITIGATION ASSESSMENT

Table M-1: Assessment of Mitgation and Monitoring Measures Identified During the EIS Process

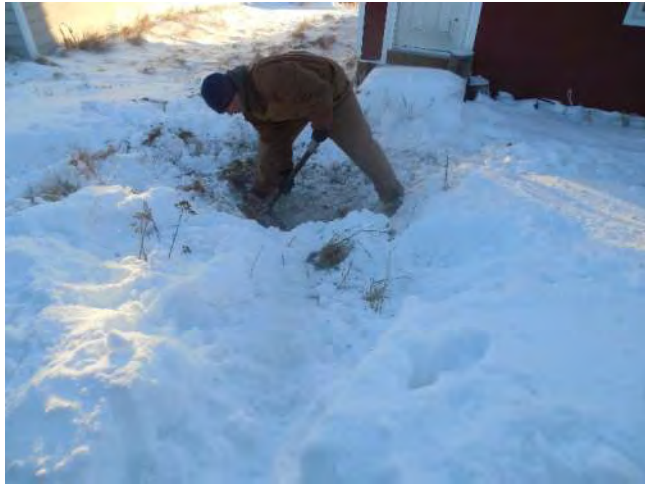
Barrel shows some degradation.

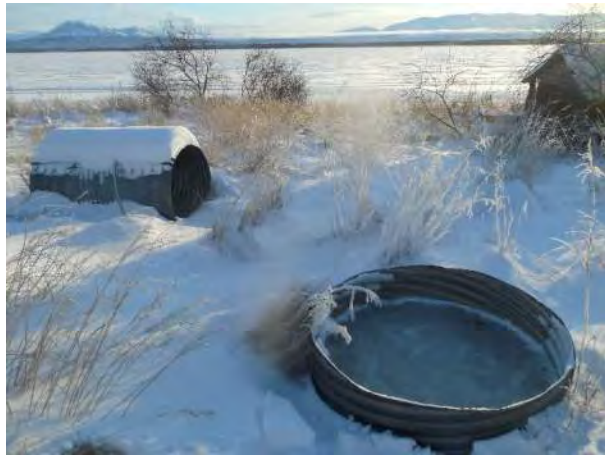
MH6A behind MH6.

Unfrozen wastewater was observed in MH. Fluid level nearly full. MH appears to be surcharged from lift station not operating.

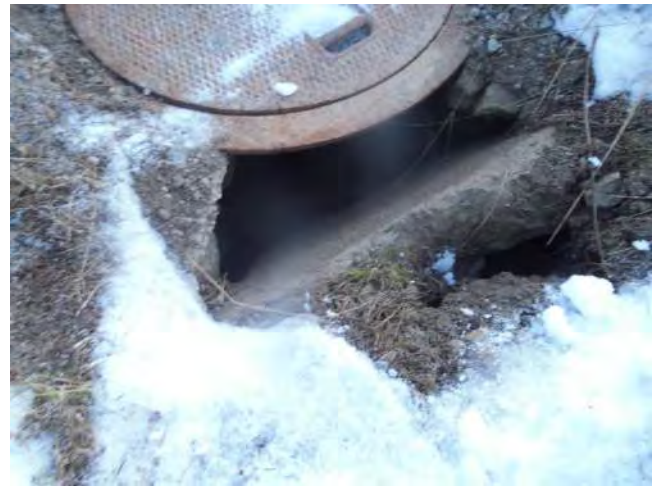
MH11 cement deterioration.

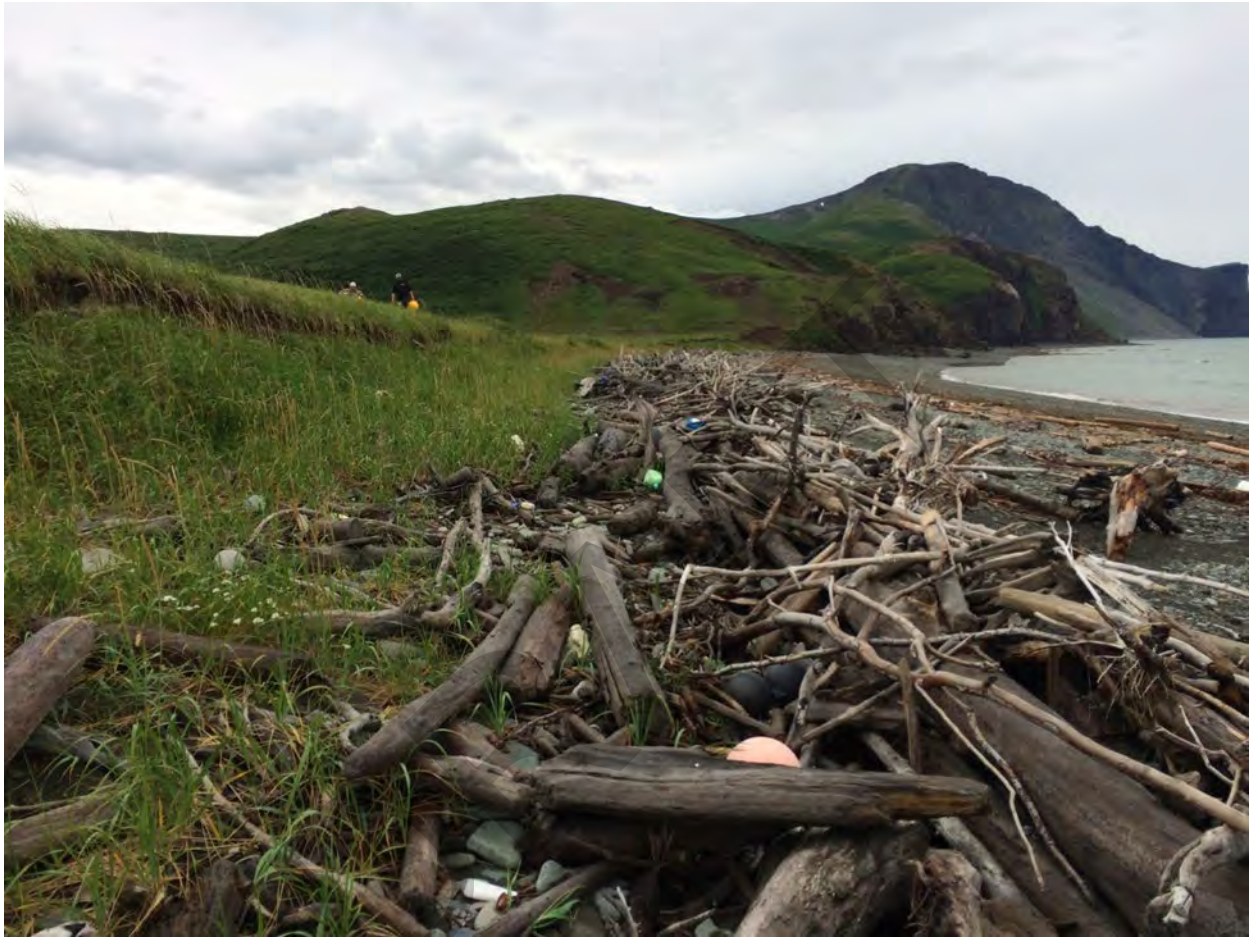
Figure 3. Marine debris at Amakdedori Beach (view north)

Marine debris observed at the restoration sites include buoys of a variety of materials (e.g., plastic, metal, polystyrene foam), insulation materials (e.g., polystyrene foam sheets and fragments), barrels, buckets, plastic bottles, propane canisters, fish nets and seines, rope, pallets, lumber, coolers, fish totes, pressurized cannisters for paint and lubricant, tarps and fabric (Figure 3, Figure 4).
