HARZA-EBASCO

Susitna Joint Venture  
Document Number

AAI FIELD BOOKS, GEOLOGY

STATION NOTES DEWMS  
CANYON & WATANA

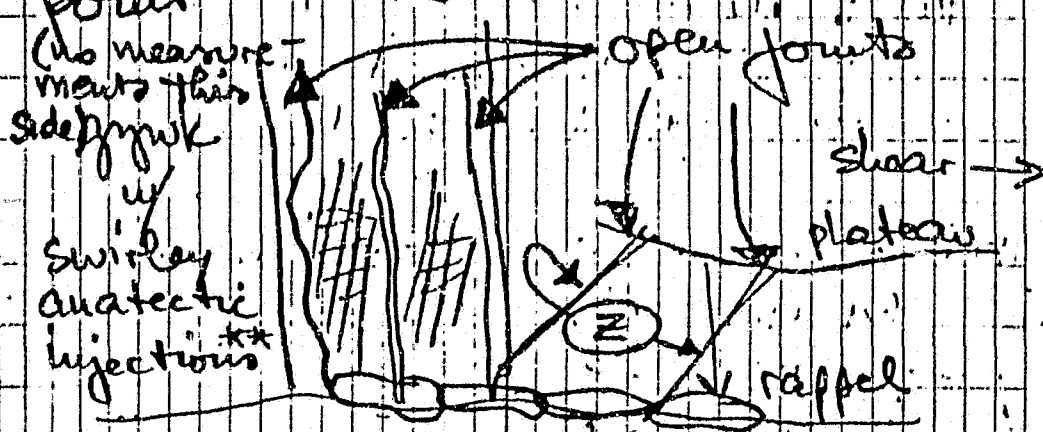
5-27-1981 (5)

Note (\*) on diagram - our position + 80 ft west projecting to other side of canyon there is a limestone stained zone. This may be similar felsic partial melt material - not distinctive from this vantage point.

looking up this gully  
gully 15 ft wide

\*\* from very close by 5-20 ft. irregular fracturing predominant here
