ENVIRONMENTAL AND ECONOMIC ASPECTS
OF
CONTEMPORANEOUS
ELECTRIC TRANSMISSION LINE
RIGHT-OF-WAY MANAGEMENT TECHNIQUES

GENERAL METHODS, SPECIAL STUDIES,
DISCUSSION OF TRENDS,

Empire State Electric Energy Research Corporation (ESEERCO)

**ASPLUNDH
ENVIRONMENTAL
SERVICES
BLAIR MILL ROAD
WILLOW GROVE, PA. 19090**

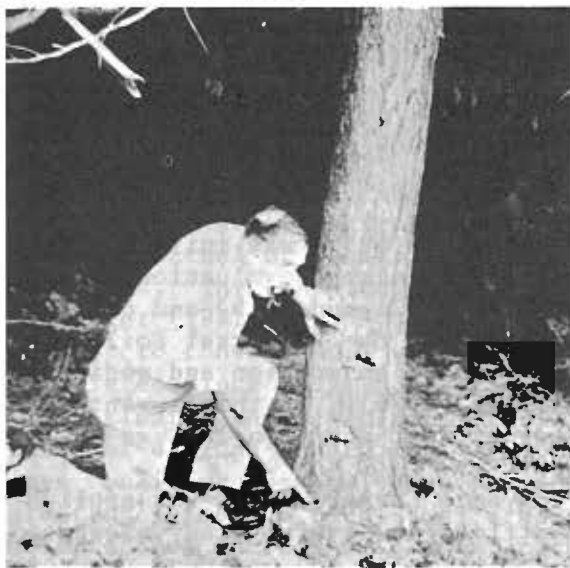
FIG. 5.1.1 Mechanical damage to hemlock at site 7, in the summer of 1976.

Mechanical damage was (Fig. 5.1.1) recorded for that portion of the tree bole facing the opening. This damage included scraping of bark and wood by heavy equipment, and other man-caused damage that would result in an entrance court for fungi or insects. The number of such damages per tree was determined whether or not the wounds were in the process of healing.

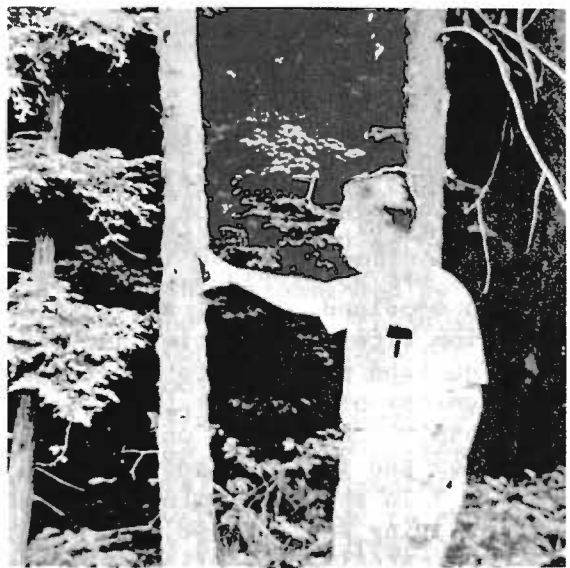
FIG. 5.1.2 Sunscald on red maple at site 7, in the summer of 1976.

Sunscald (Figs. 5.1.2 and 5.1.3) was recorded based on the number of such wounds on the tree trunks. Sunscald was differentiated from mechanical damage by the location on the bole, and the absence of sharp indentations or tears in the bark or wood.

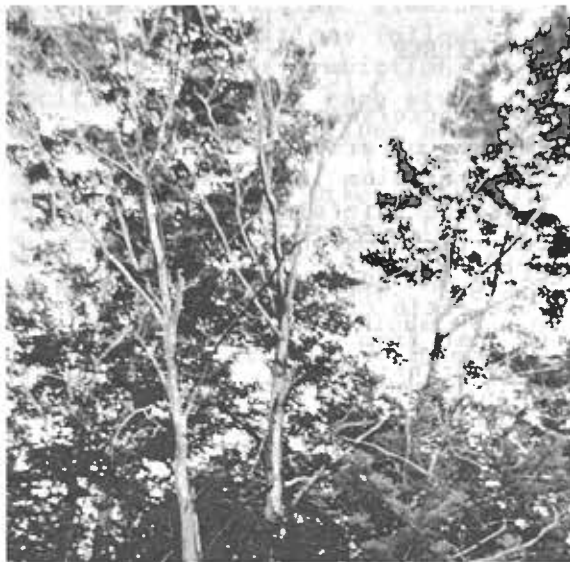
FIG. 5.1.3 Sunscald on beech at site 7, in the summer of 1976.

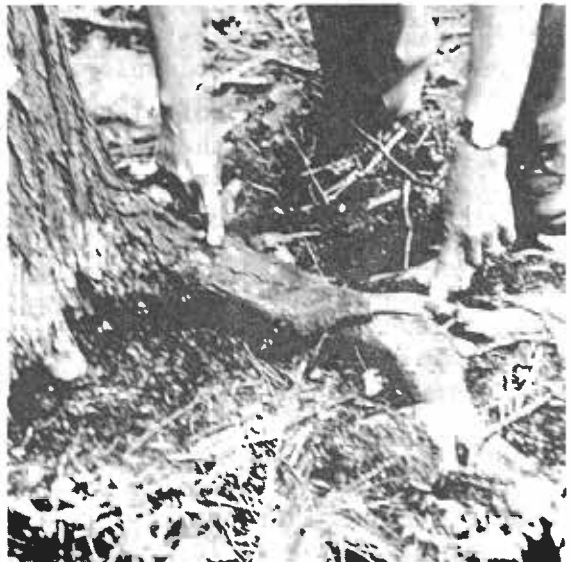
FIG. 5.1.4 Tree with exposed roots on site 7, in the summer of 1976.

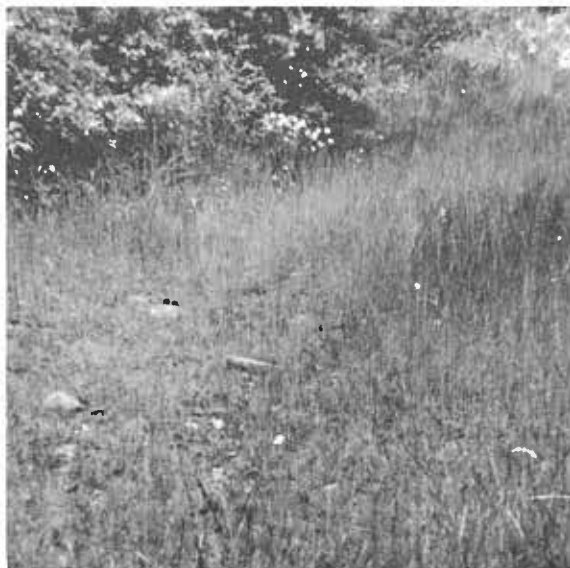
FIG. 5.1.5 Seeded area at site 14, in the summer of 1976.
