# **KNIK ARM CROSSING**

**TECHNICAL MEMORANDUM No. 16**

## **Freshwater & Terrestrial Habitat Studies**

**Dames & Moore**

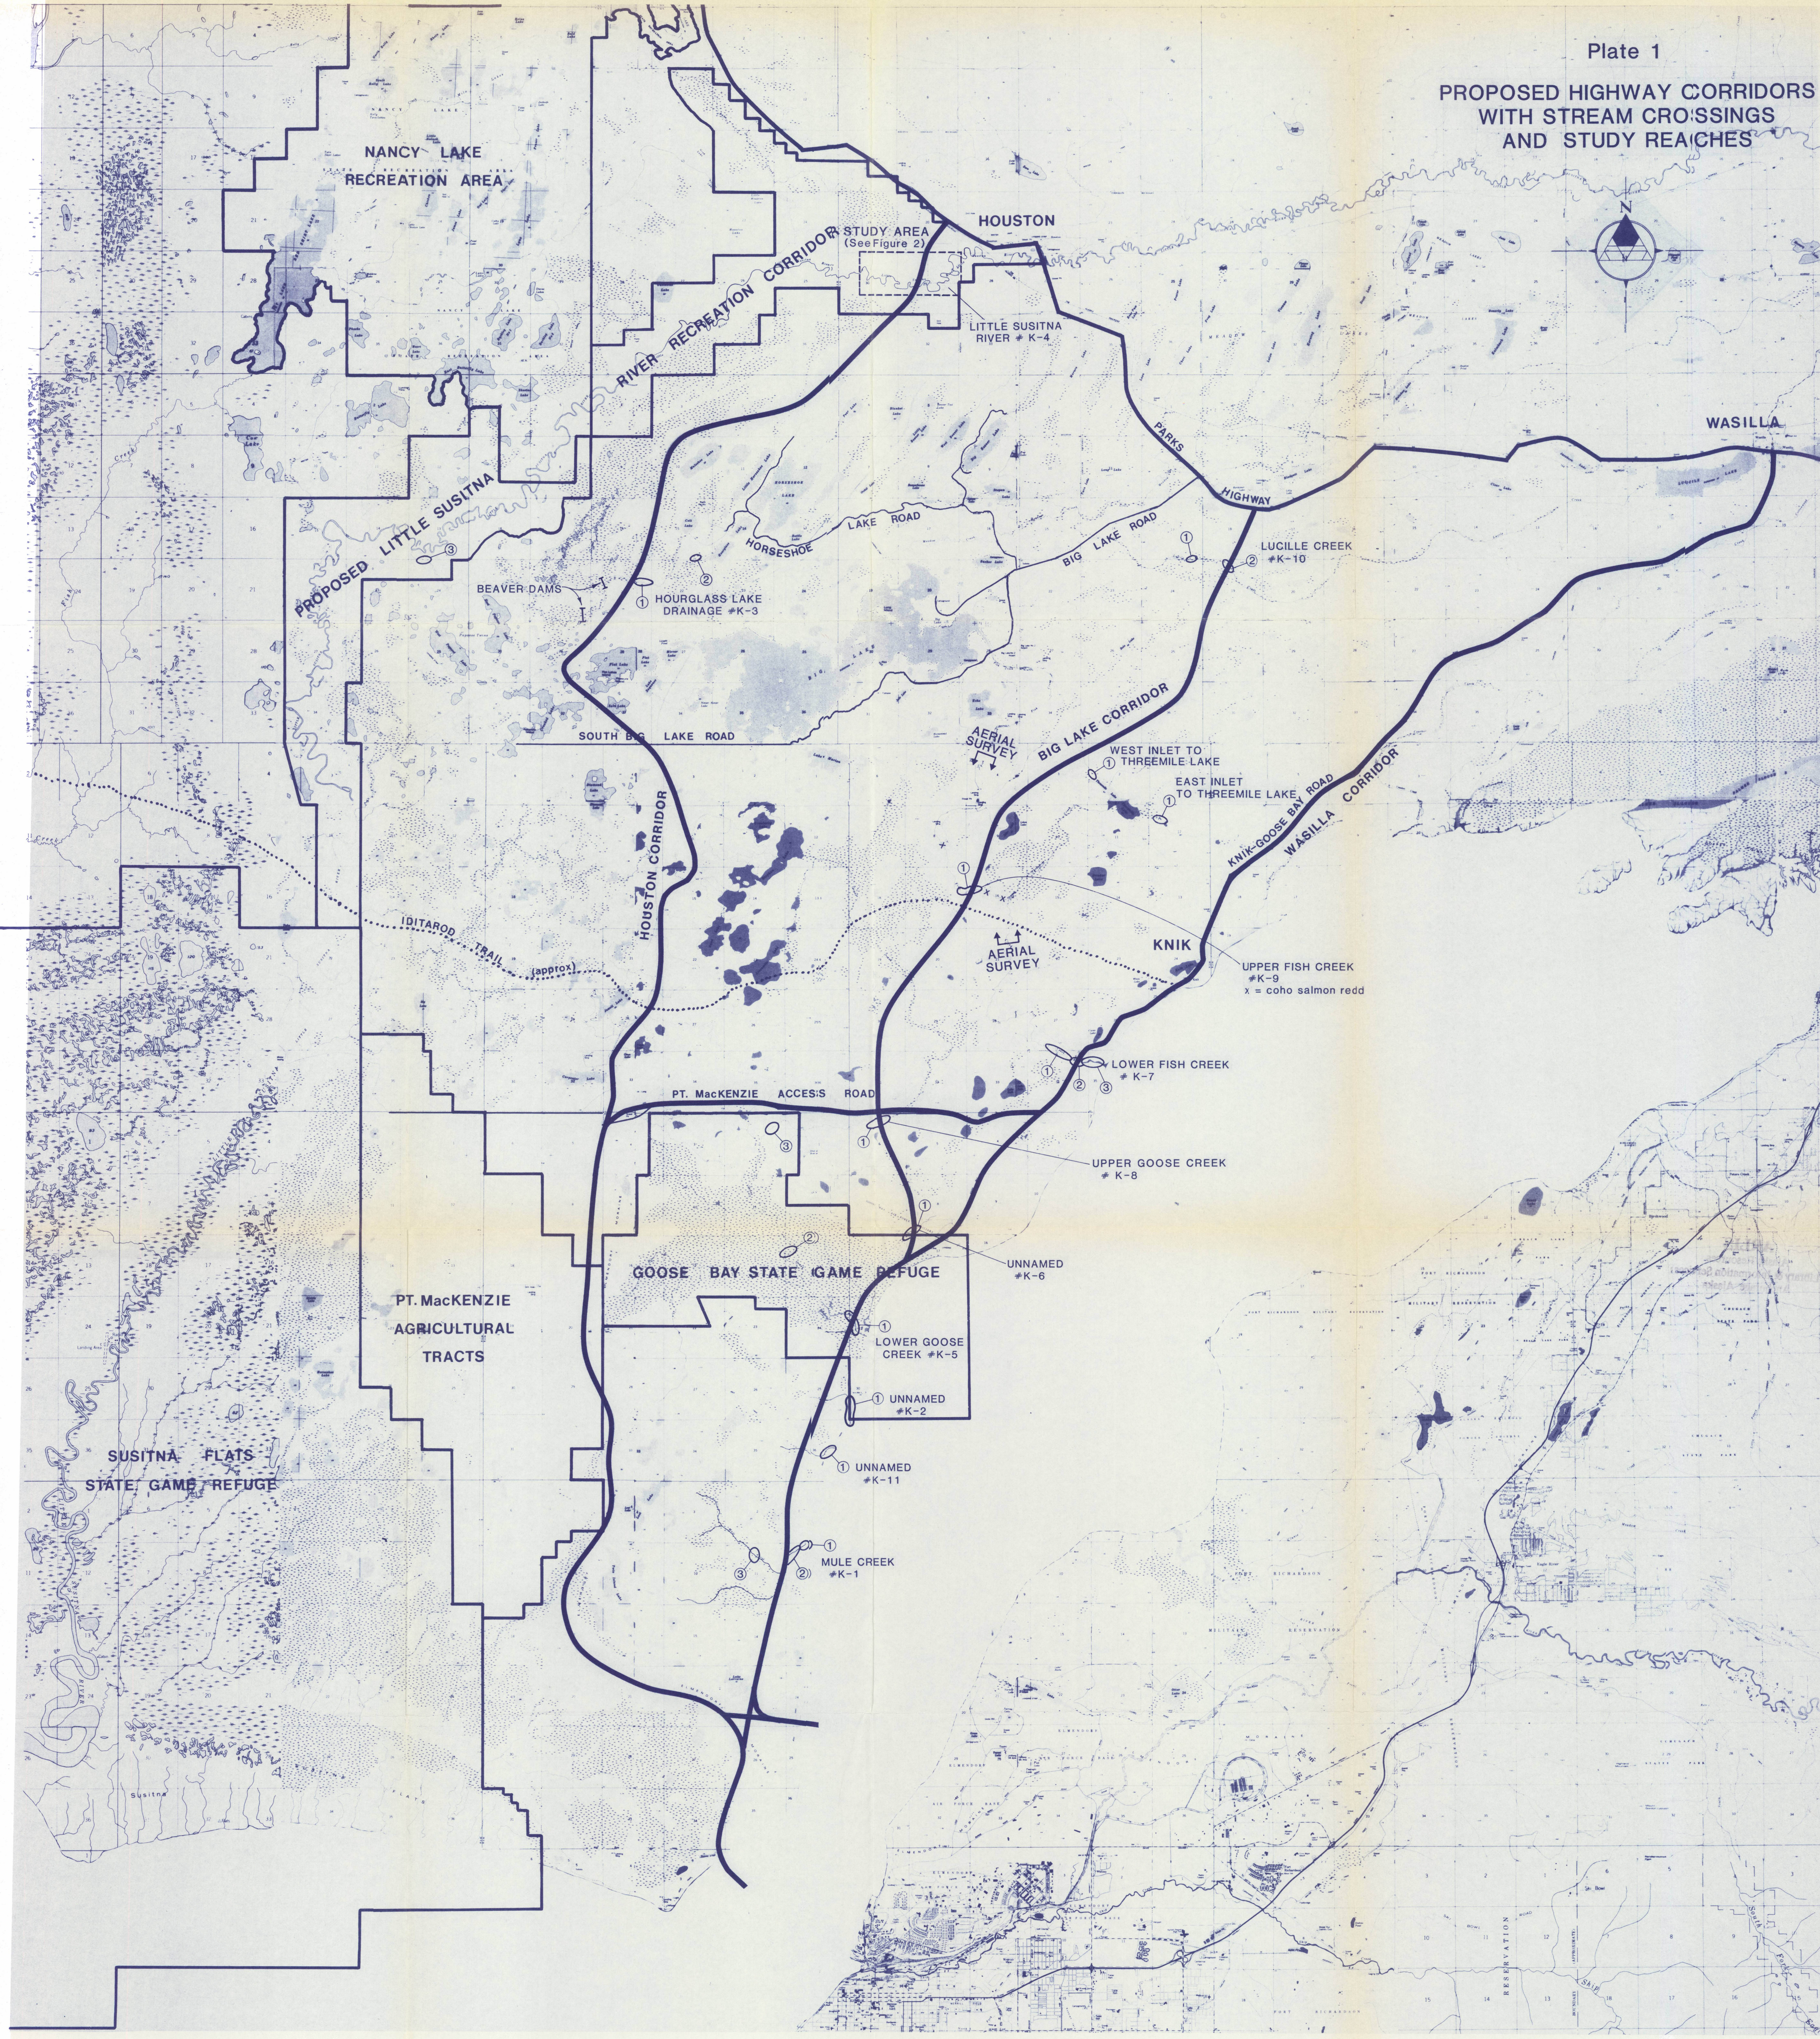
PROPOSED HIGHWAY CORRIDORS  
WITH STREAM CROSSINGS  
AND STUDY REACHES
