TASK 14 SUPPORT TECHNICAL REPORT

**HYDROLOGICAL INVESTIGATIONS AT SELECTED
LOWER SUSITNA RIVER STUDY SITES**

by: Timothy Quane, Patrick Morrow, and Isaac Queral
Aquatic Habitat and Instream Flow Project

**ALASKA DEPARTMENT OF FISH AND GAME
SUSITNA HYDRO AQUATIC STUDIES REPORT SERIES**

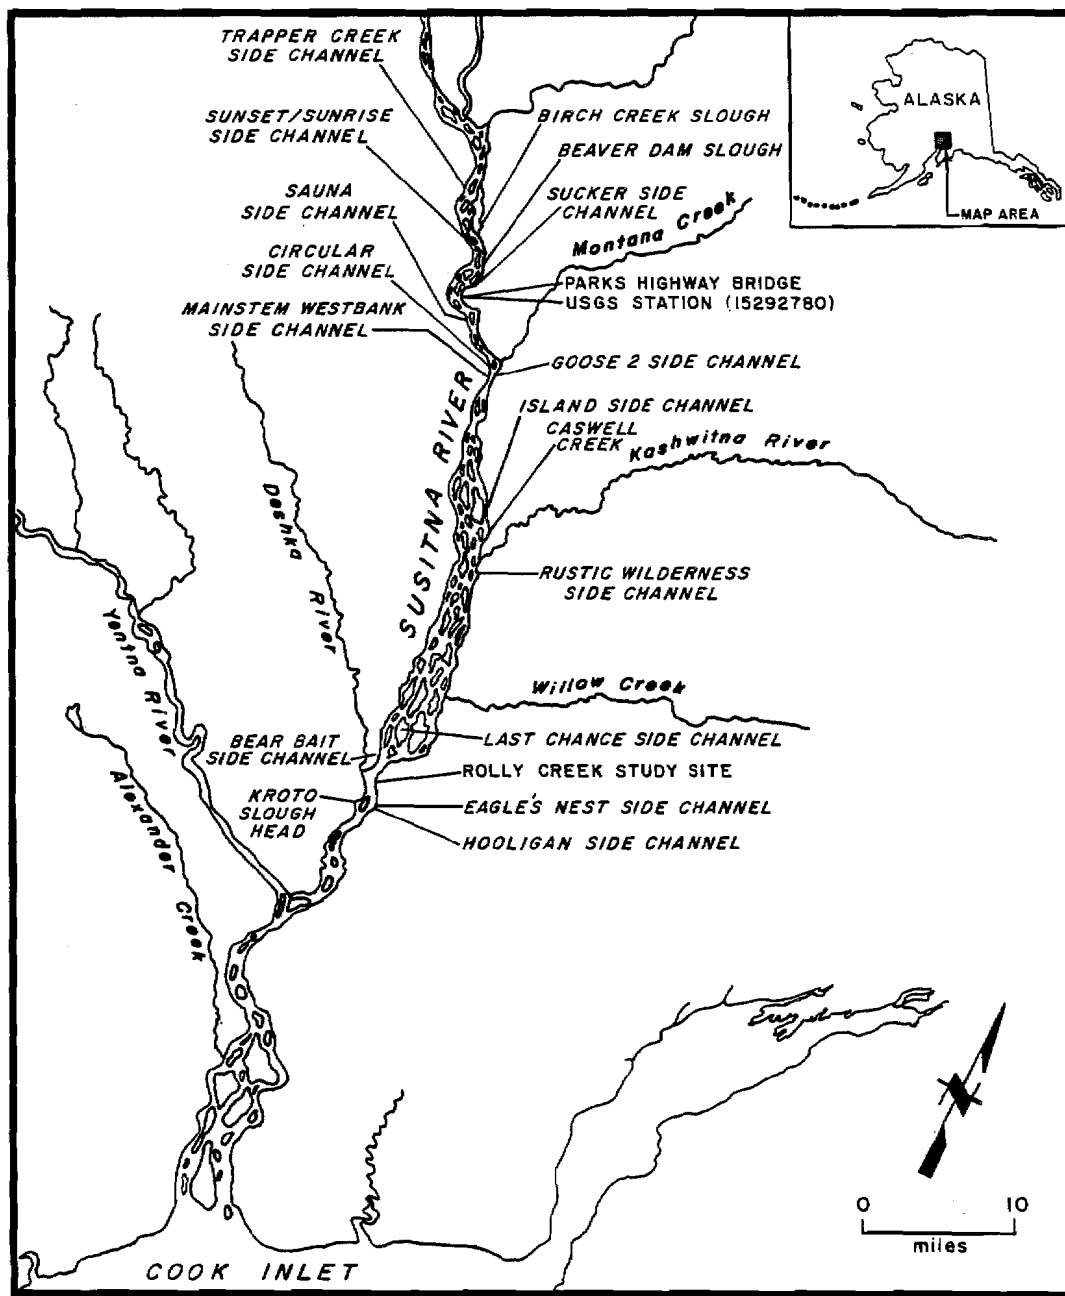
Figure 1. Task 14 study site locations.

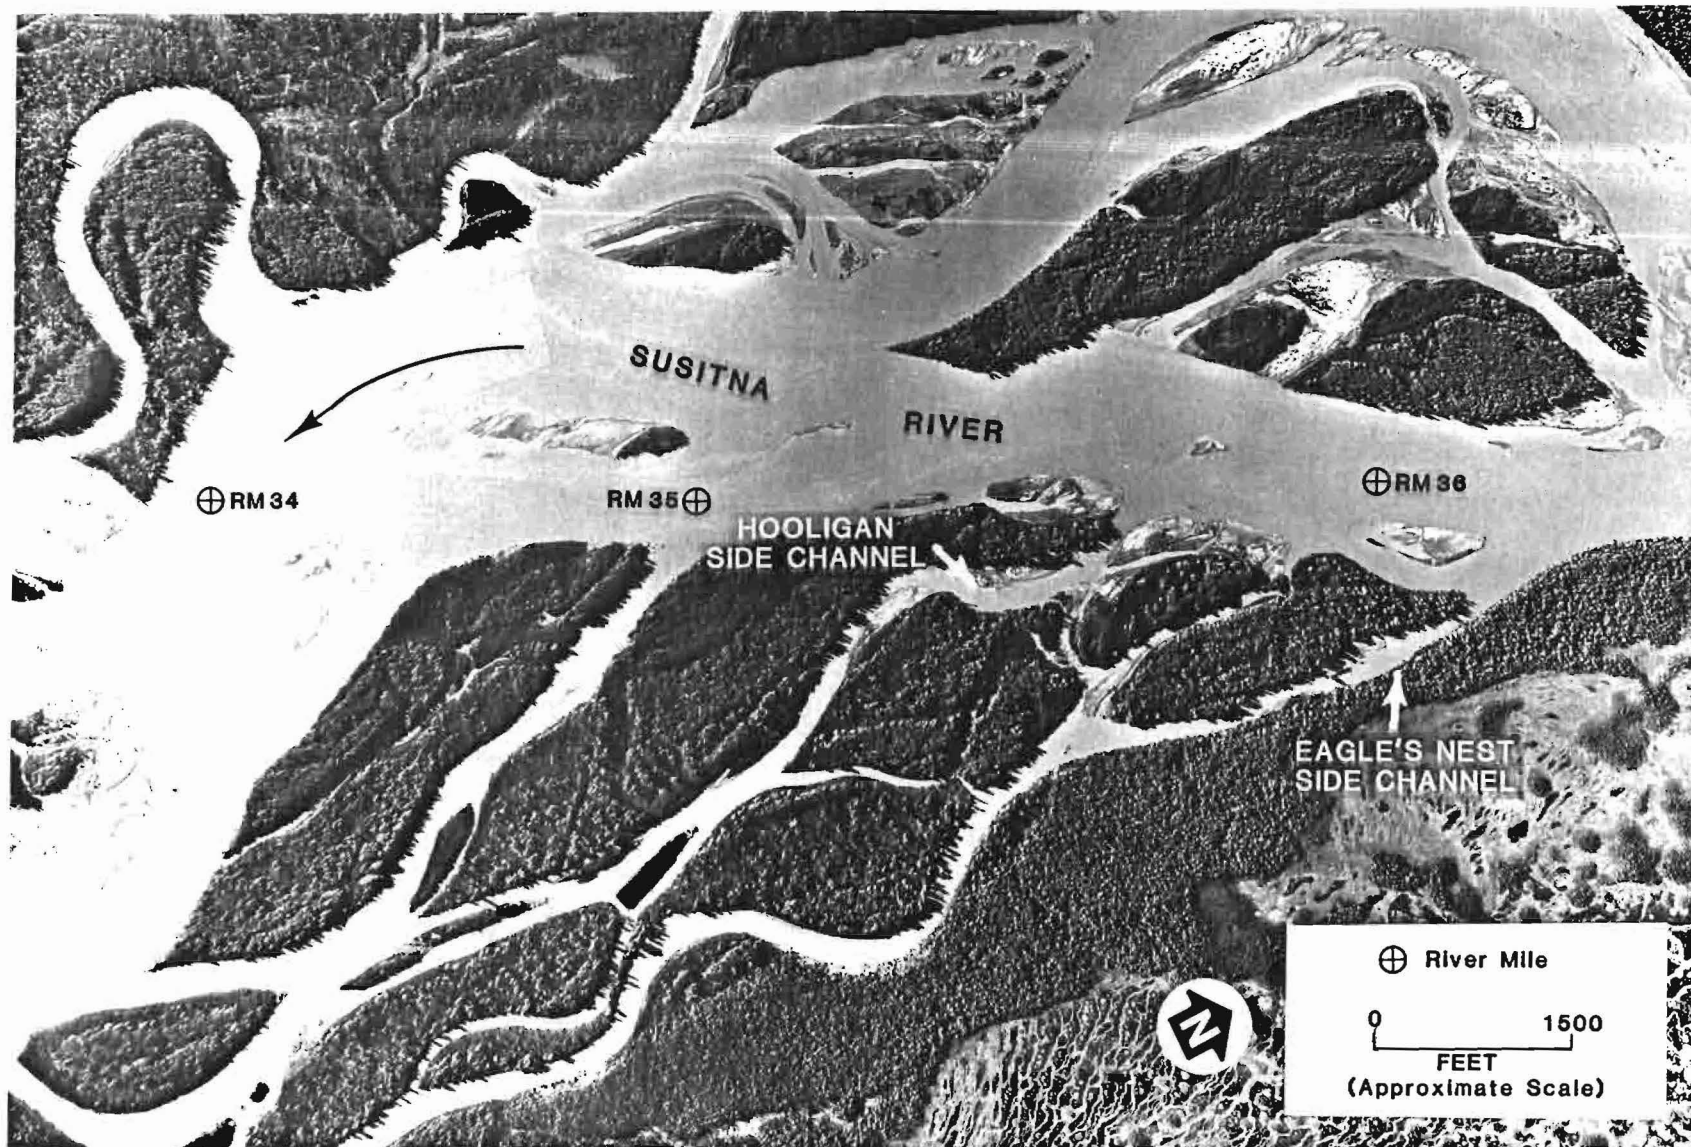
Figure 2. Overview of Hooligan (RM 35.2) and Eagle's Nest Side Channel (RM 36.2).

During the 1984 open water field season the study site selected for Hooligan Side channel was located in the upper portion of the side channel (Figure 2). Stage was monitored at one location and streamflow was measured at this stage monitoring station (Figure 3). Channel geometry data obtained from Hooligan Side Channel includes cross section and thalweg profiles. A cross section profile was obtained from the stage monitoring station and a thalweg profile was determined for that portion of the side channel that included the study site continuing upstream to the head of the side channel.

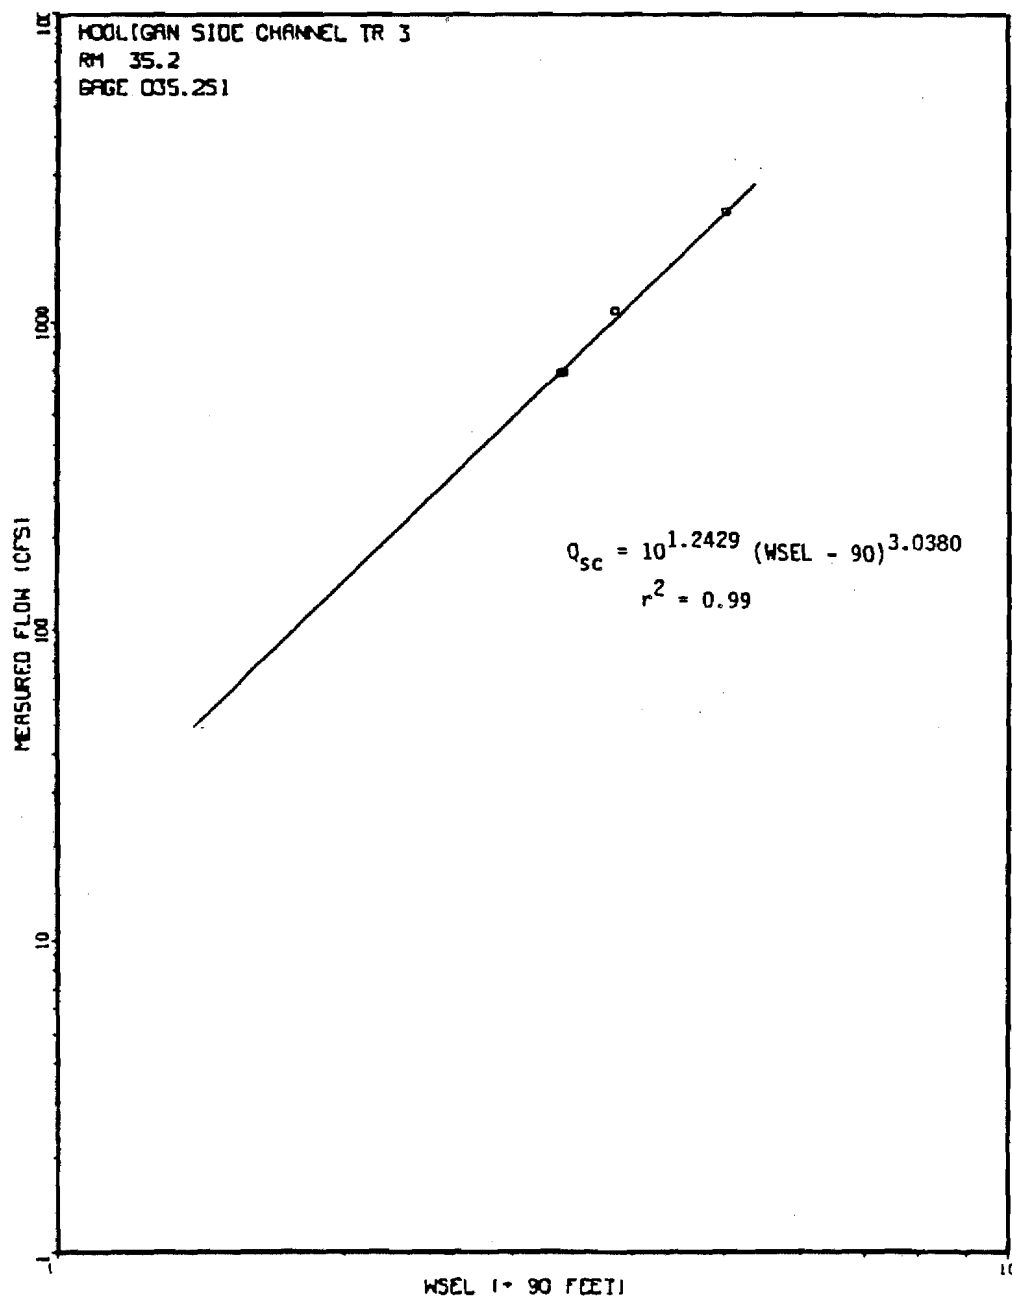
Figure 4. Hooligan Side Channel streamflow versus WSEL rating curve from Q site located 50 feet upstream from transect 3.

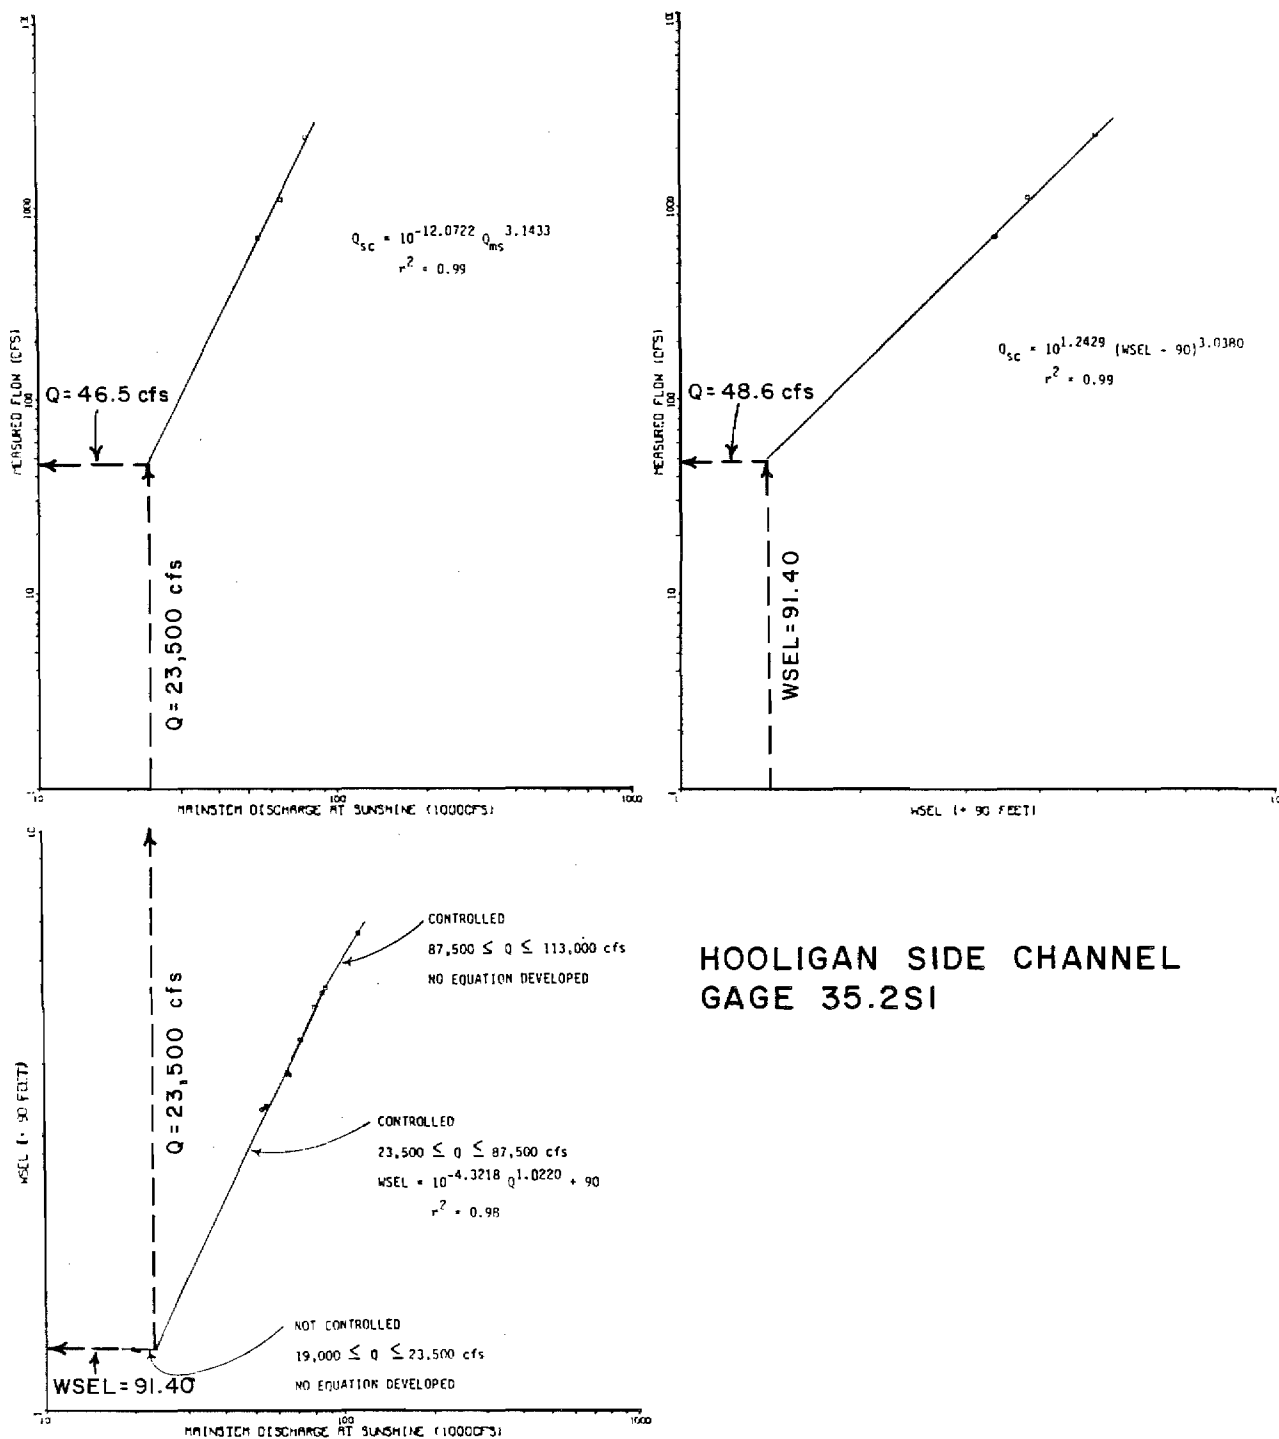
Figure 6. Comparison of rating curves for Hooligan Side Channel Q site located 50 feet upstream from transect 3.

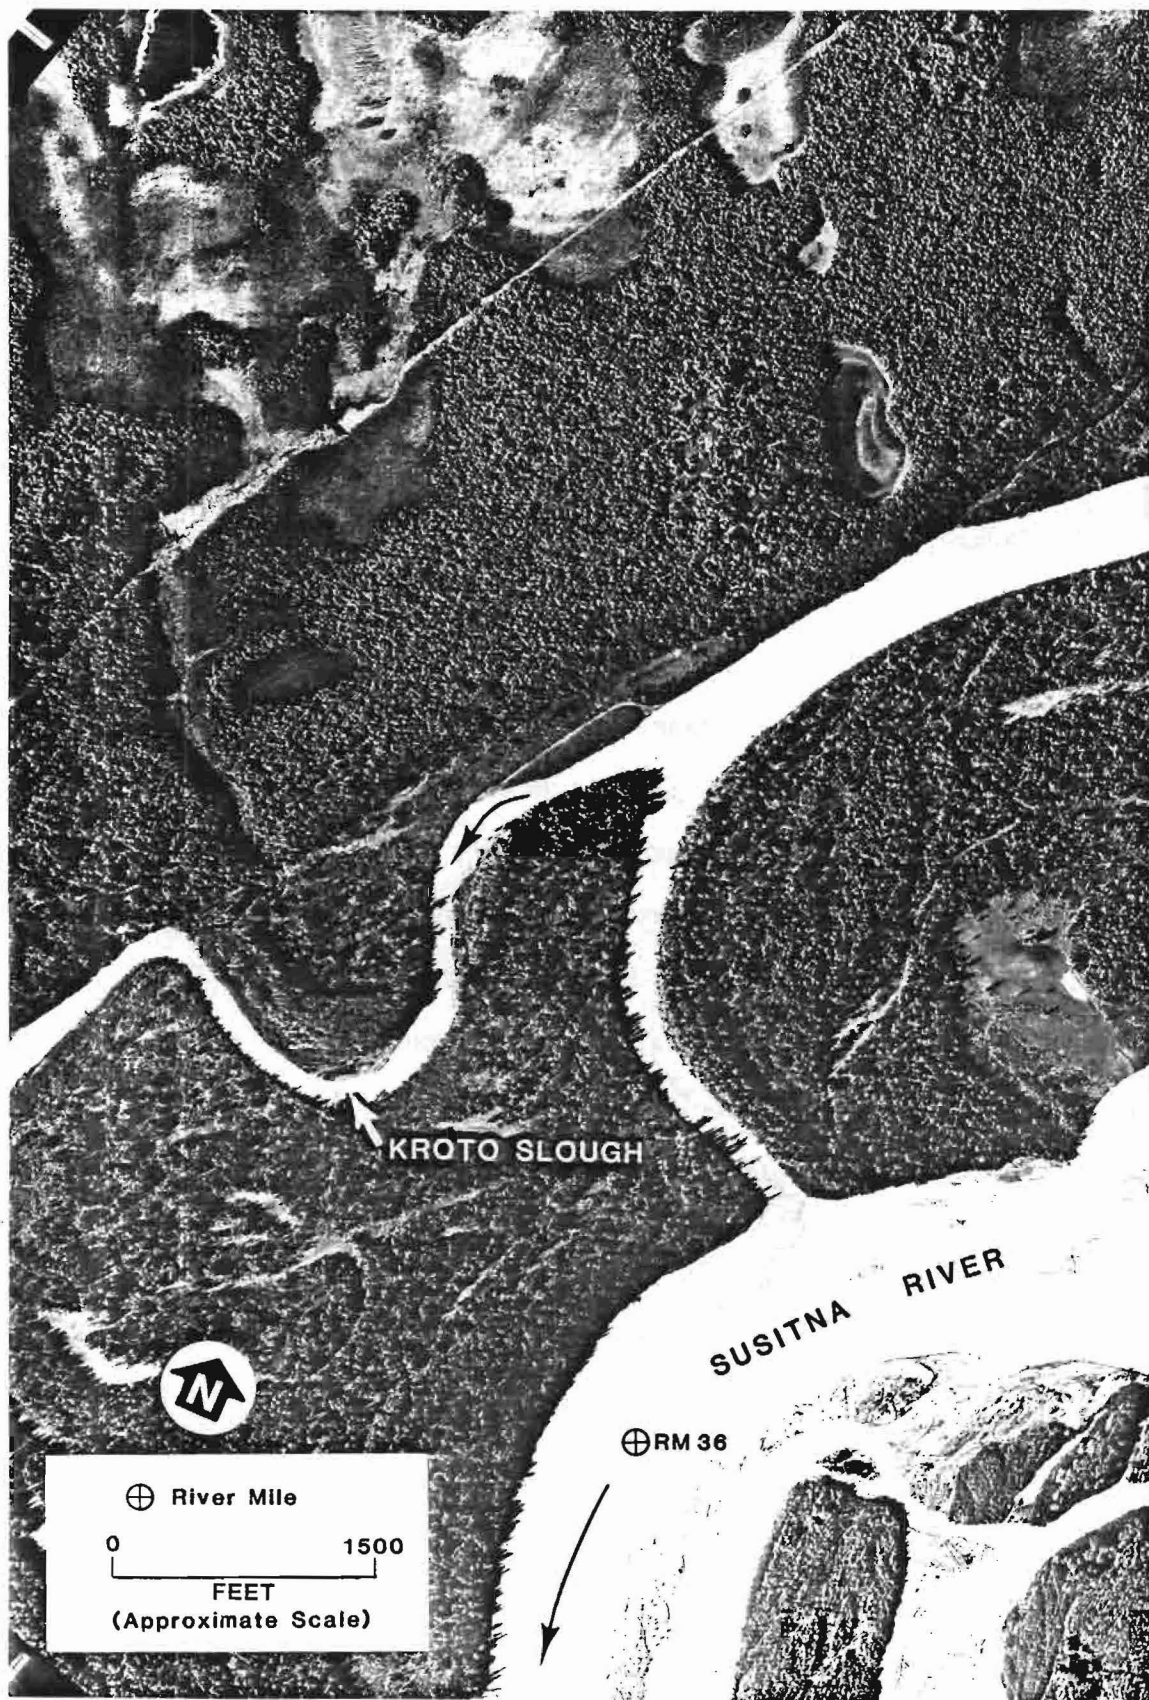
Figure 8. Overview of Kroto Slough Head (RM 36.3).

Kroto Slough is located on the west bank of the main channel of the Susitna River at river mile 36.3 (Figure 8). The slough consists of a

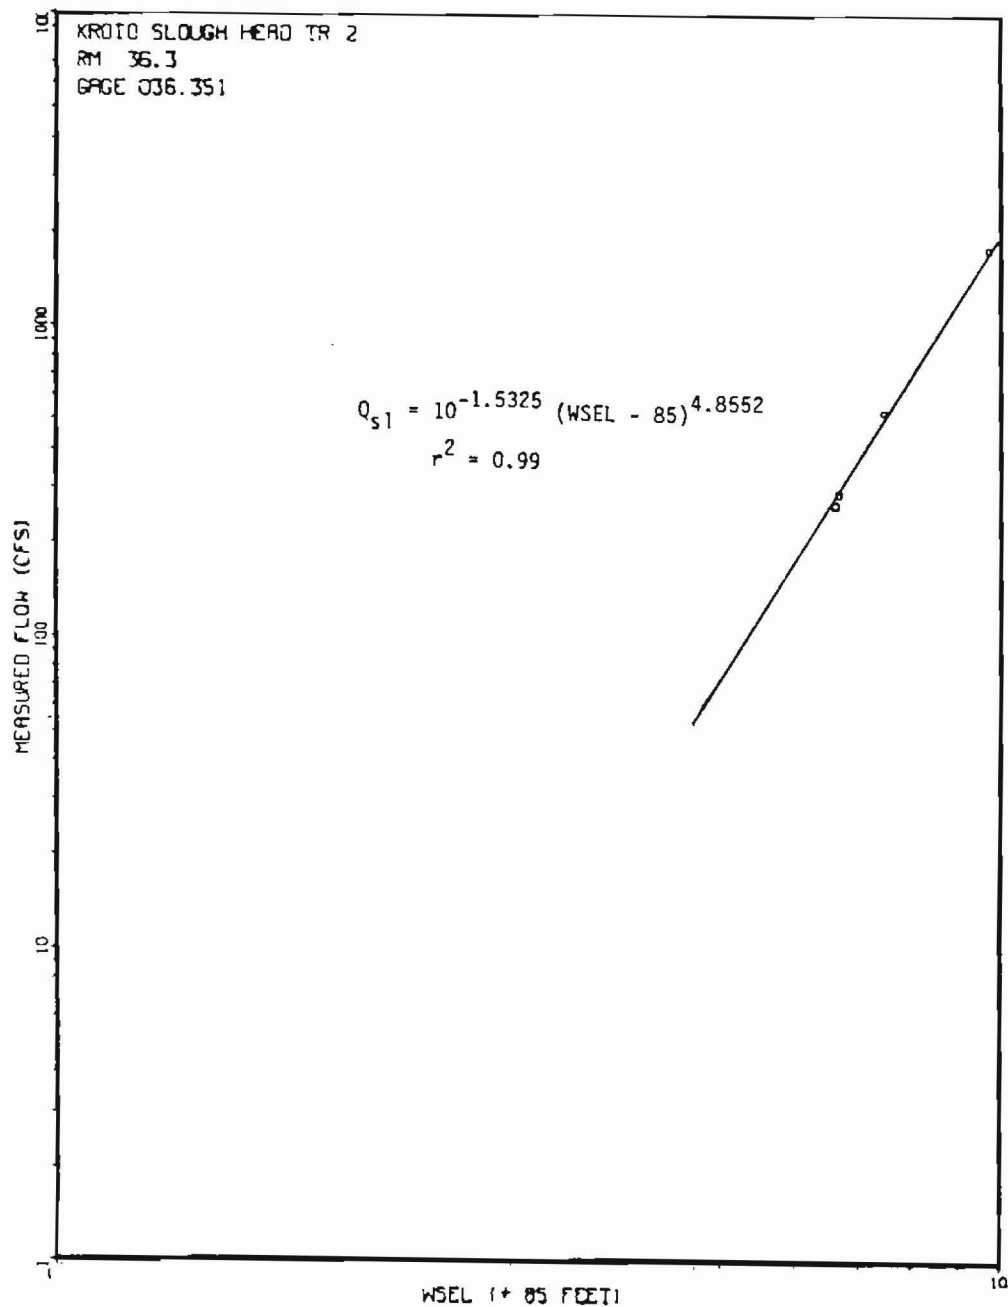
Figure 10. Kroto Slough Head streamflow versus WSEL rating curve at transect 2 Q Site.

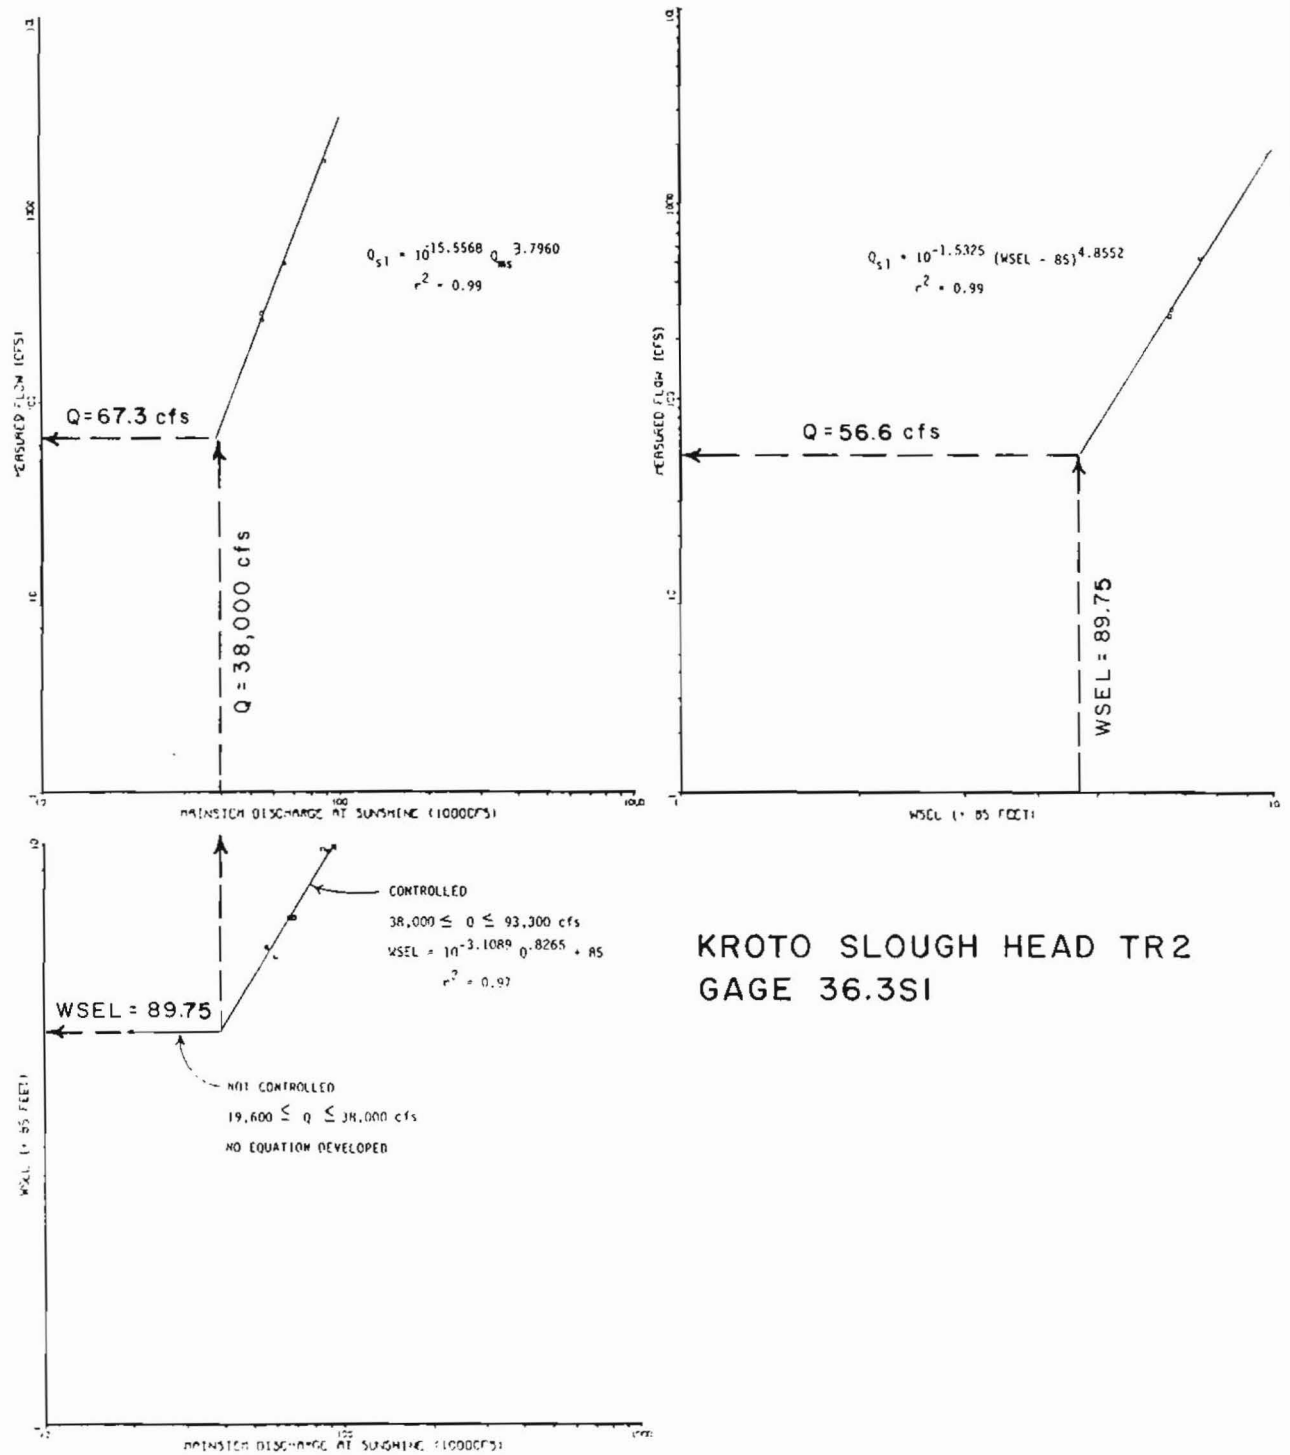
Figure 12. Comparison of rating curves for Kroto Slough Head at transect 2 Q Site.

The rating curves developed for Kroto Slough were compared to evaluate the influence of mainstem discharge on the hydraulic condition of the slough (Figure 12) Using the equation developed for the water surface elevation versus streamflow rating curve at transect 2, a streamflow of 56.6 cfs was estimated to occur at the controlling discharge of 38,000 cfs. This streamflow estimate is less than the flow estimate of 67.3 cfs which was determined using the flow versus mainstem discharge rating curve.

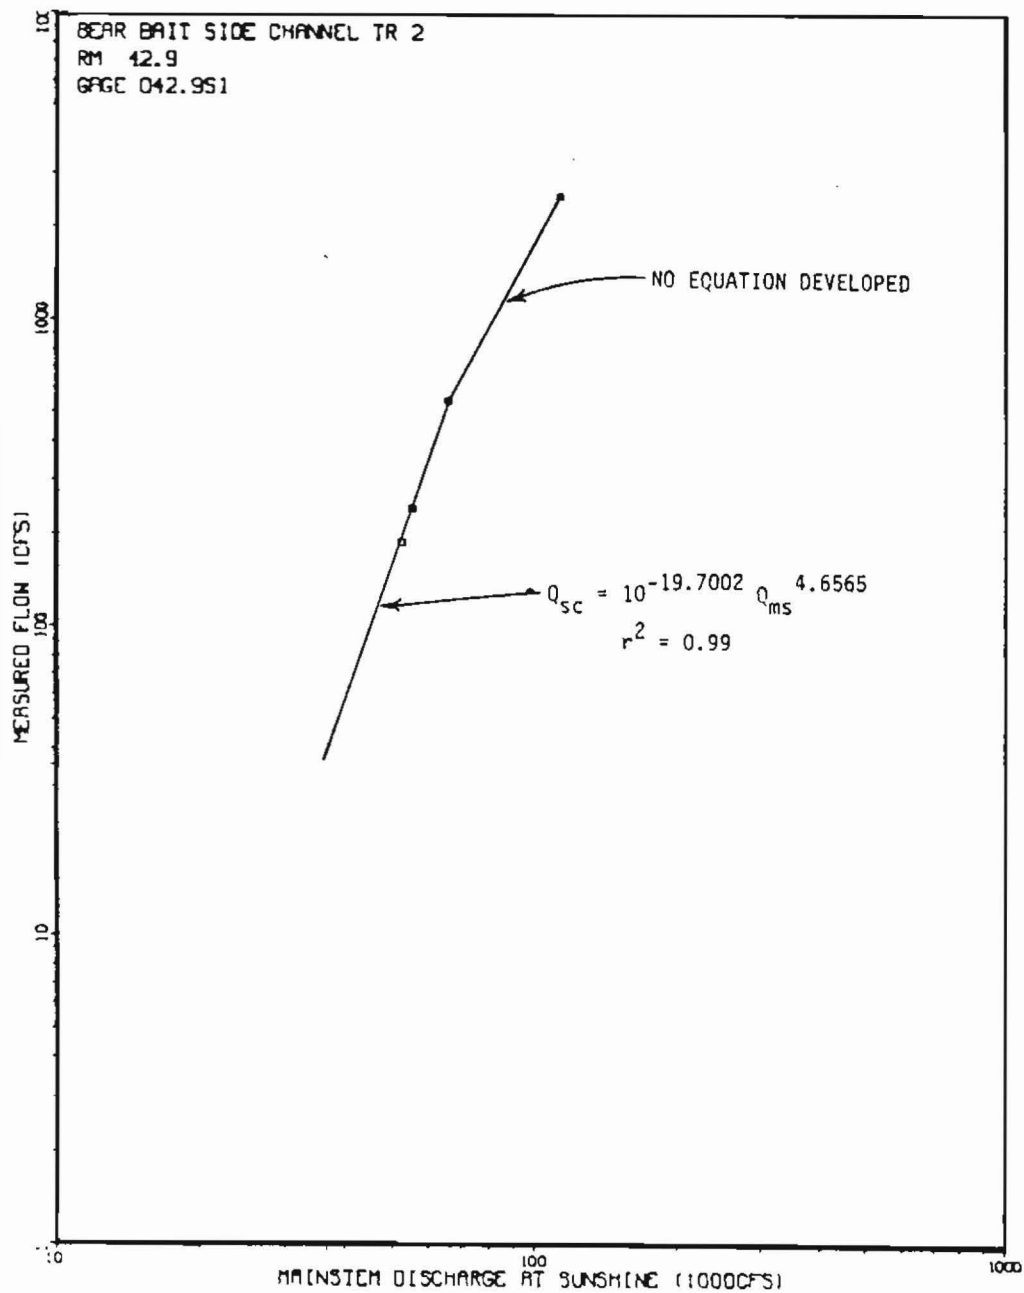
Figure 18. Bear Bait Side Channel streamflow versus mainstem discharge at Sunshine Station (USGS 15292780) rating curve at transect 2 Q Site.

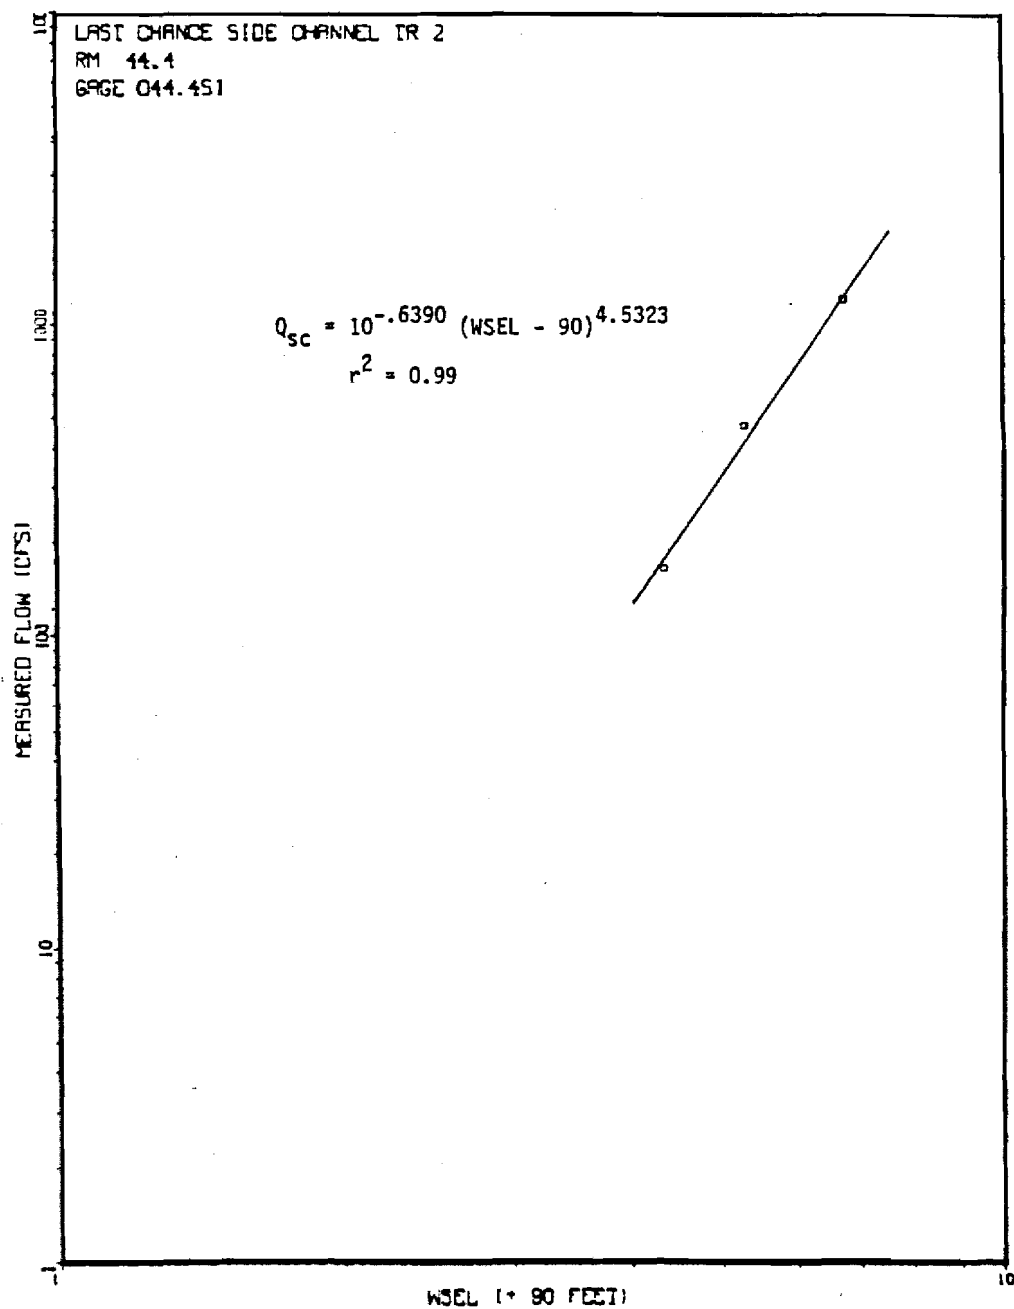
Figure 21. Last Chance Side Channel streamflow versus WSEL rating curve at transect 2 Q Site.

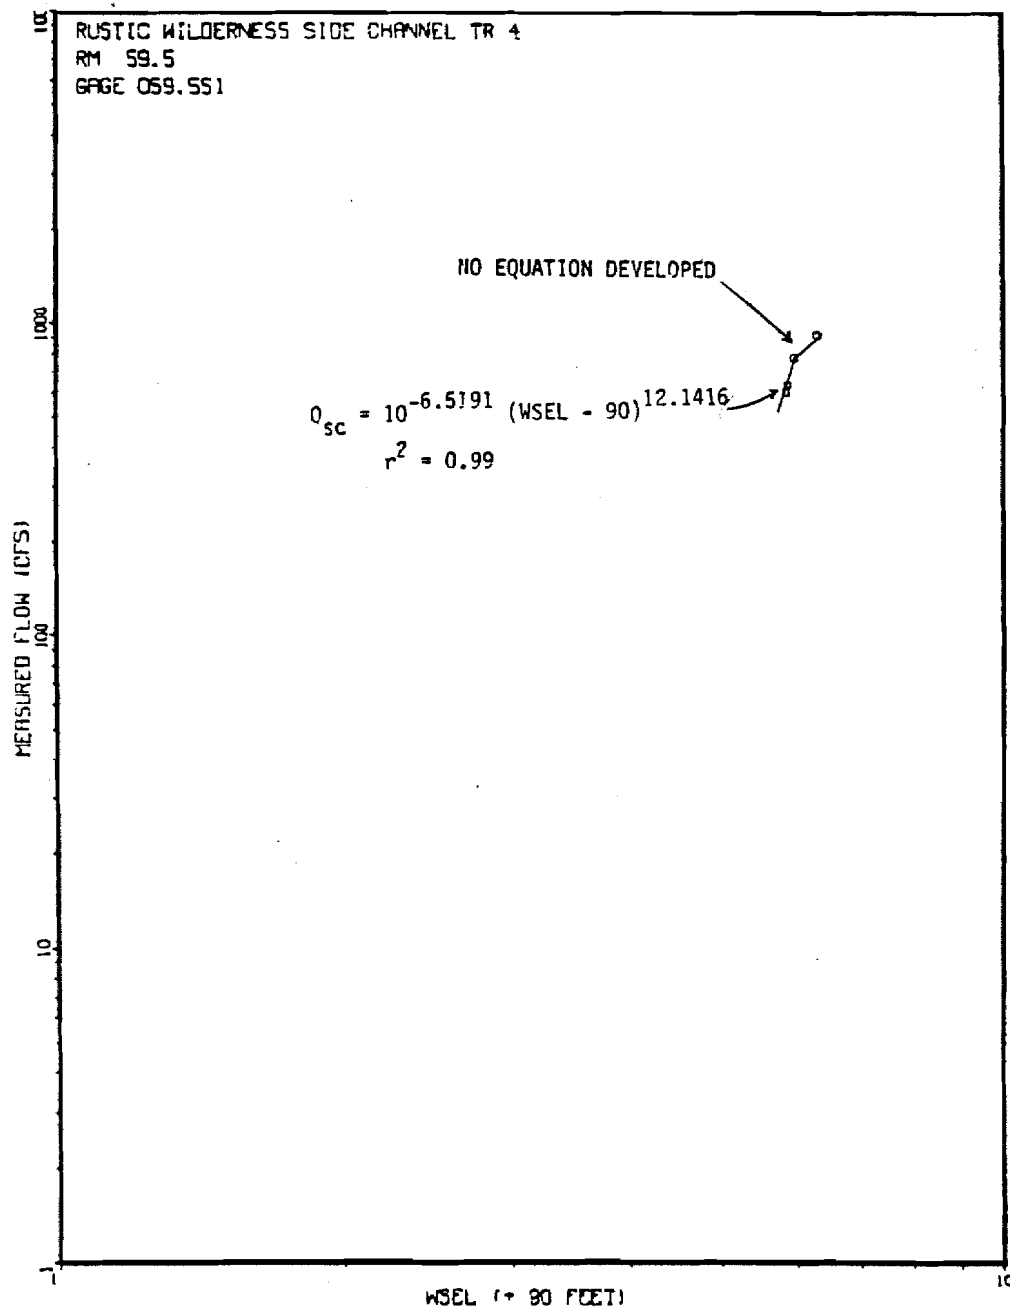
Figure 25. Rustic Wilderness Side Channel streamflow versus WSEL rating curve at transect 4 Q Site.

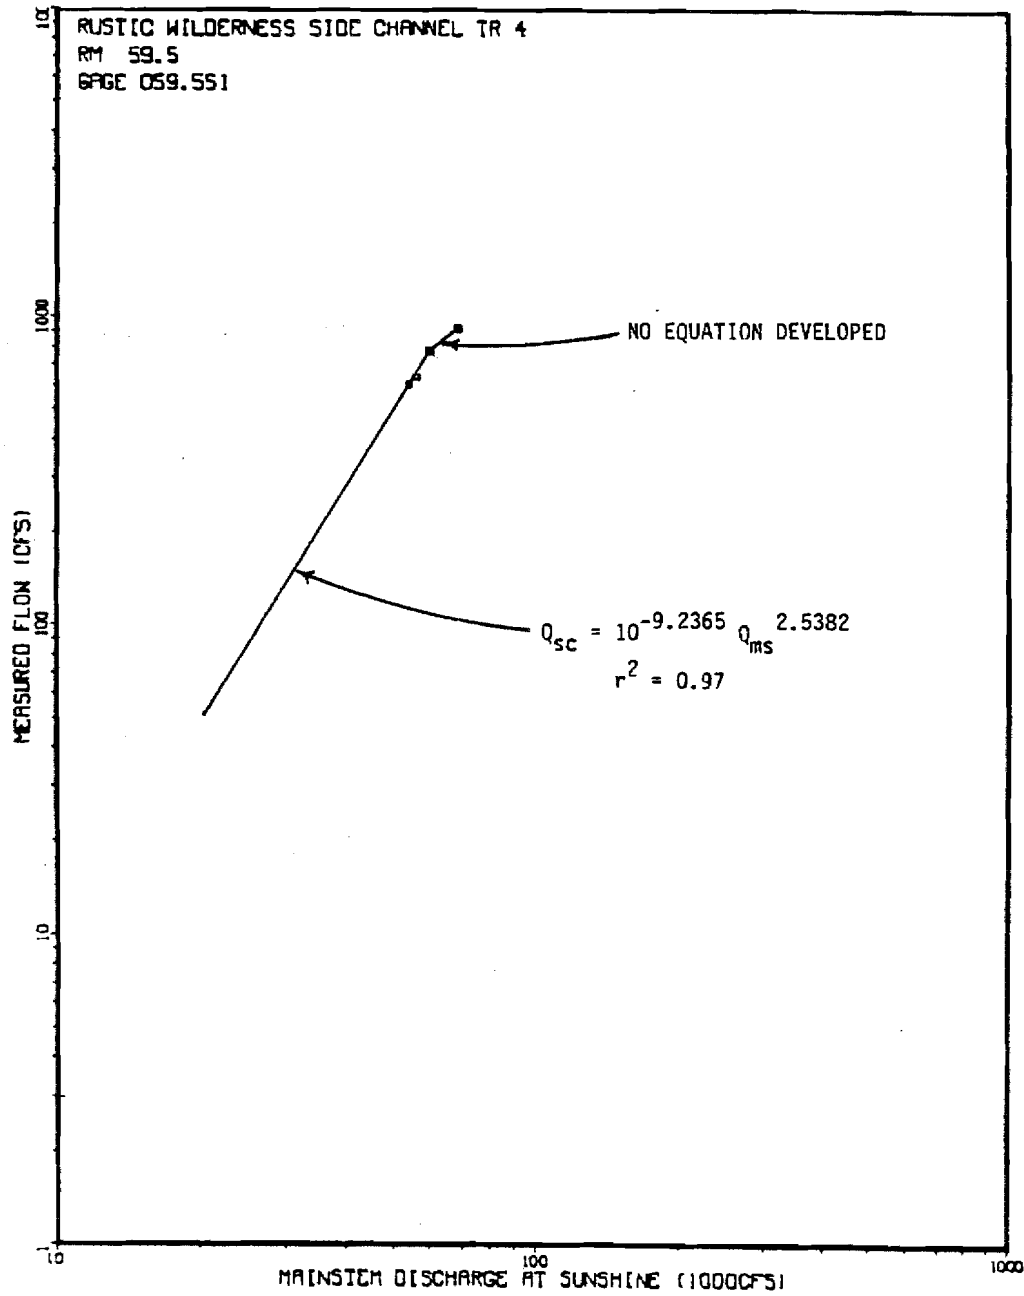
Figure 26. Rustic Wilderness Side Channel streamflow versus mainstem discharge at Sunshine Station (USGS 15292780) rating curve at transect 4 Q Site.

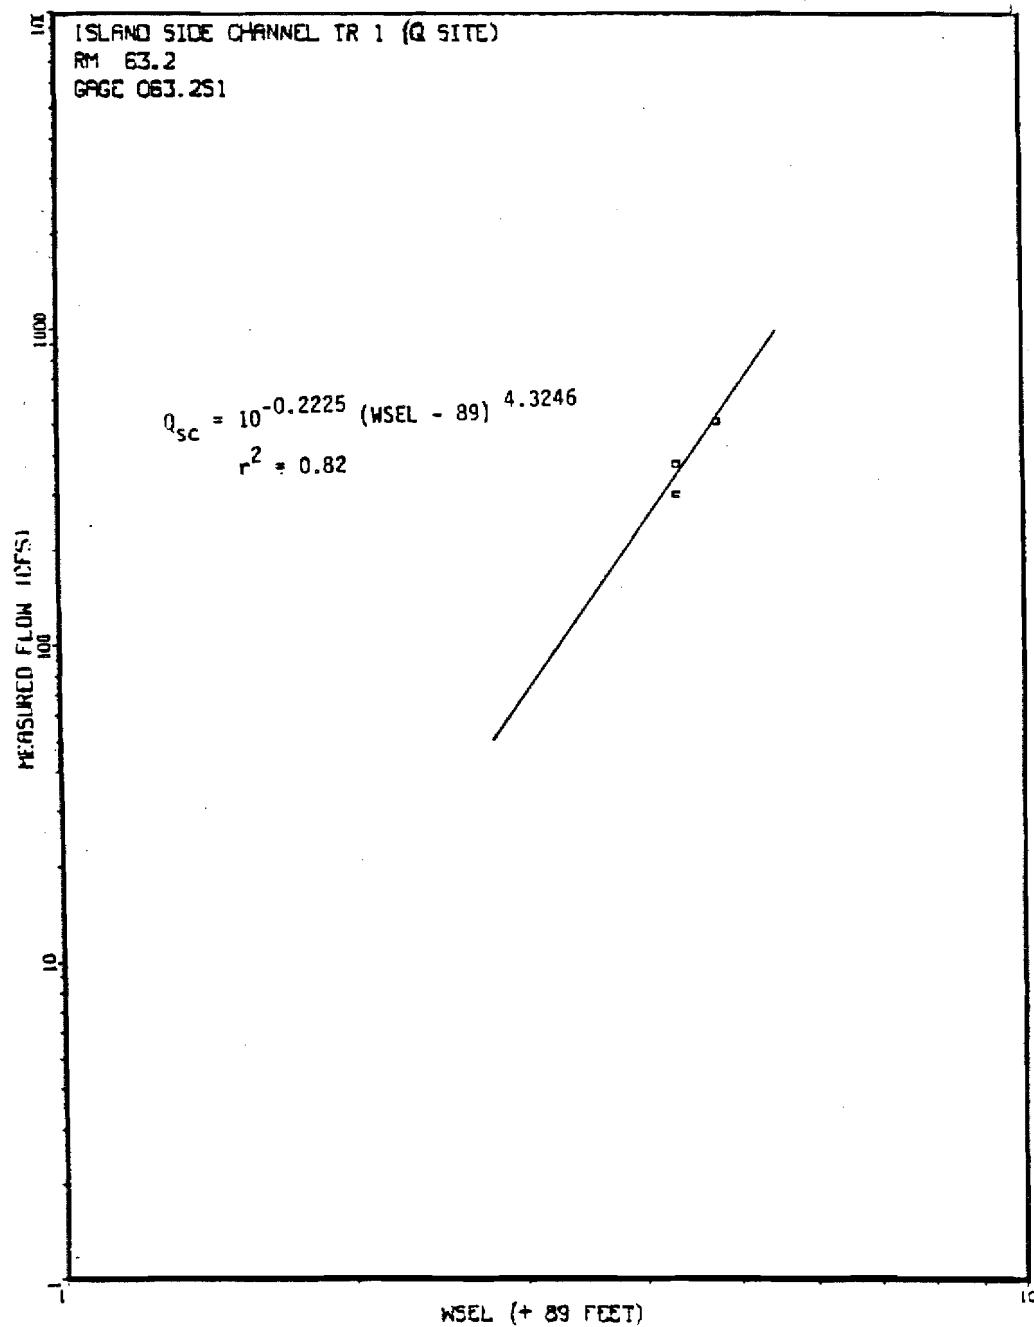
Figure 30. Island Side Channel streamflow versus WSEL rating curve at transect 1 Q Site.

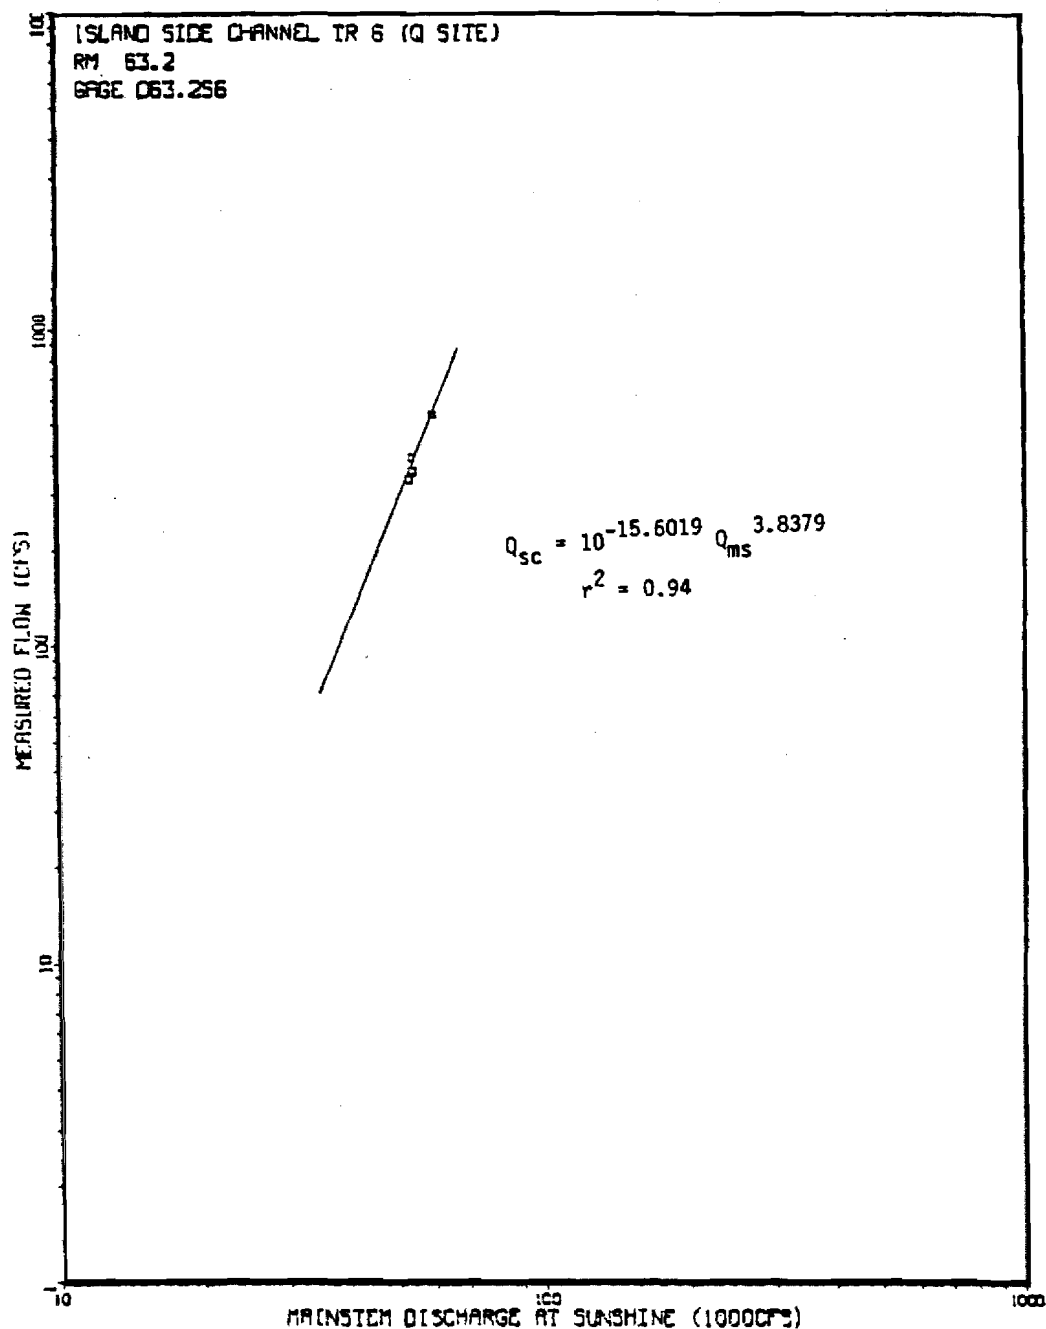
Figure 33. Island Side Channel streamflow versus mainstem discharge at Sunshine Station (USGS 15292780) rating curve at transect 6 Q Site.

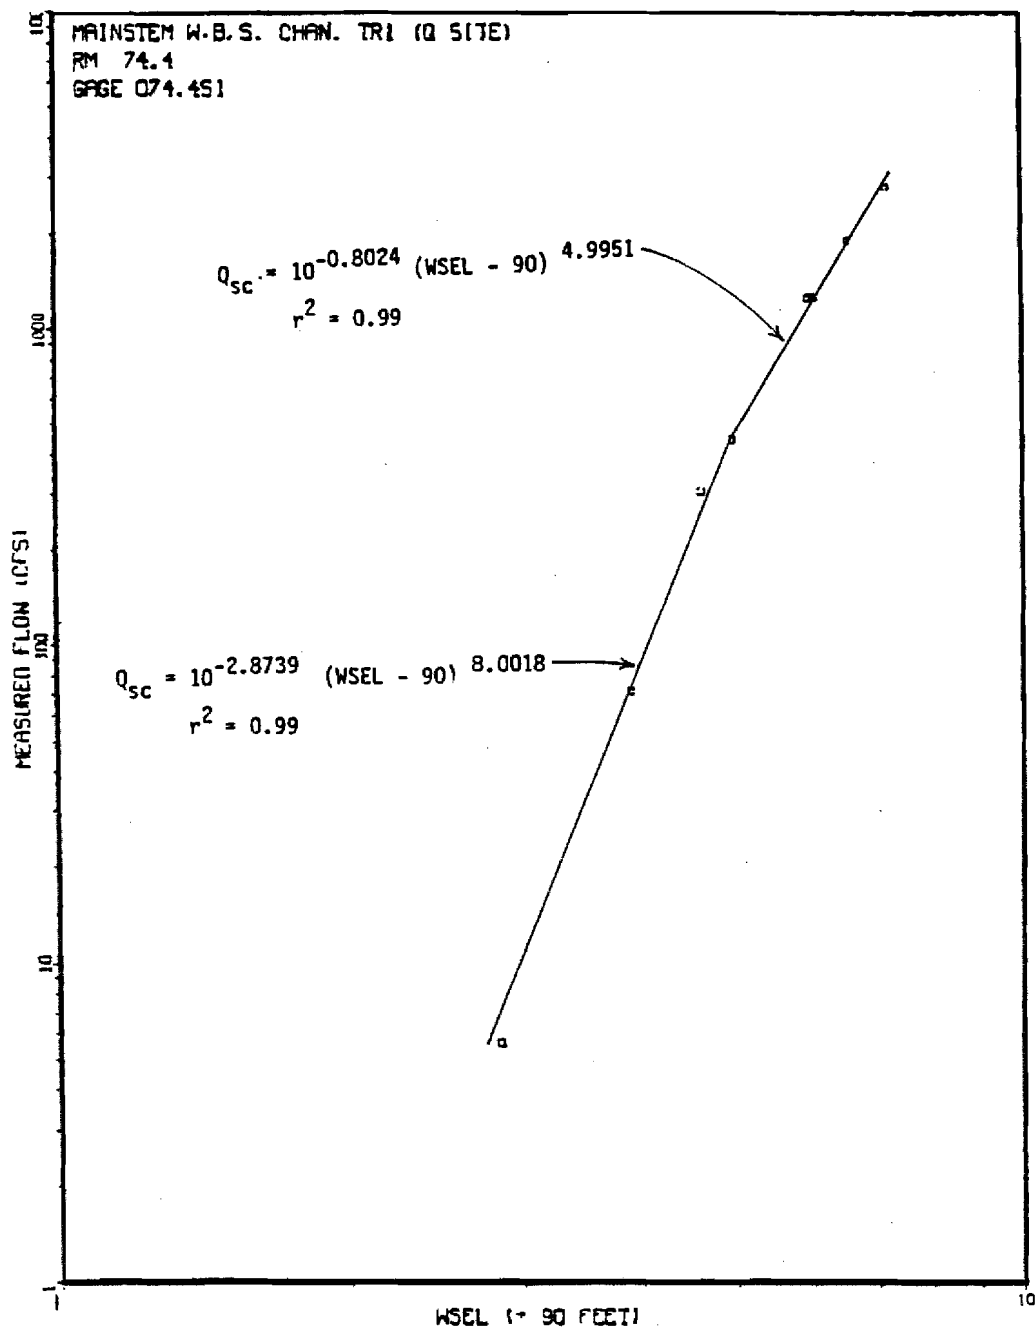
Figure 37. Mainstem West Bank Side Channel streamflow versus WSEL rating curve at transect 1 Q Site.

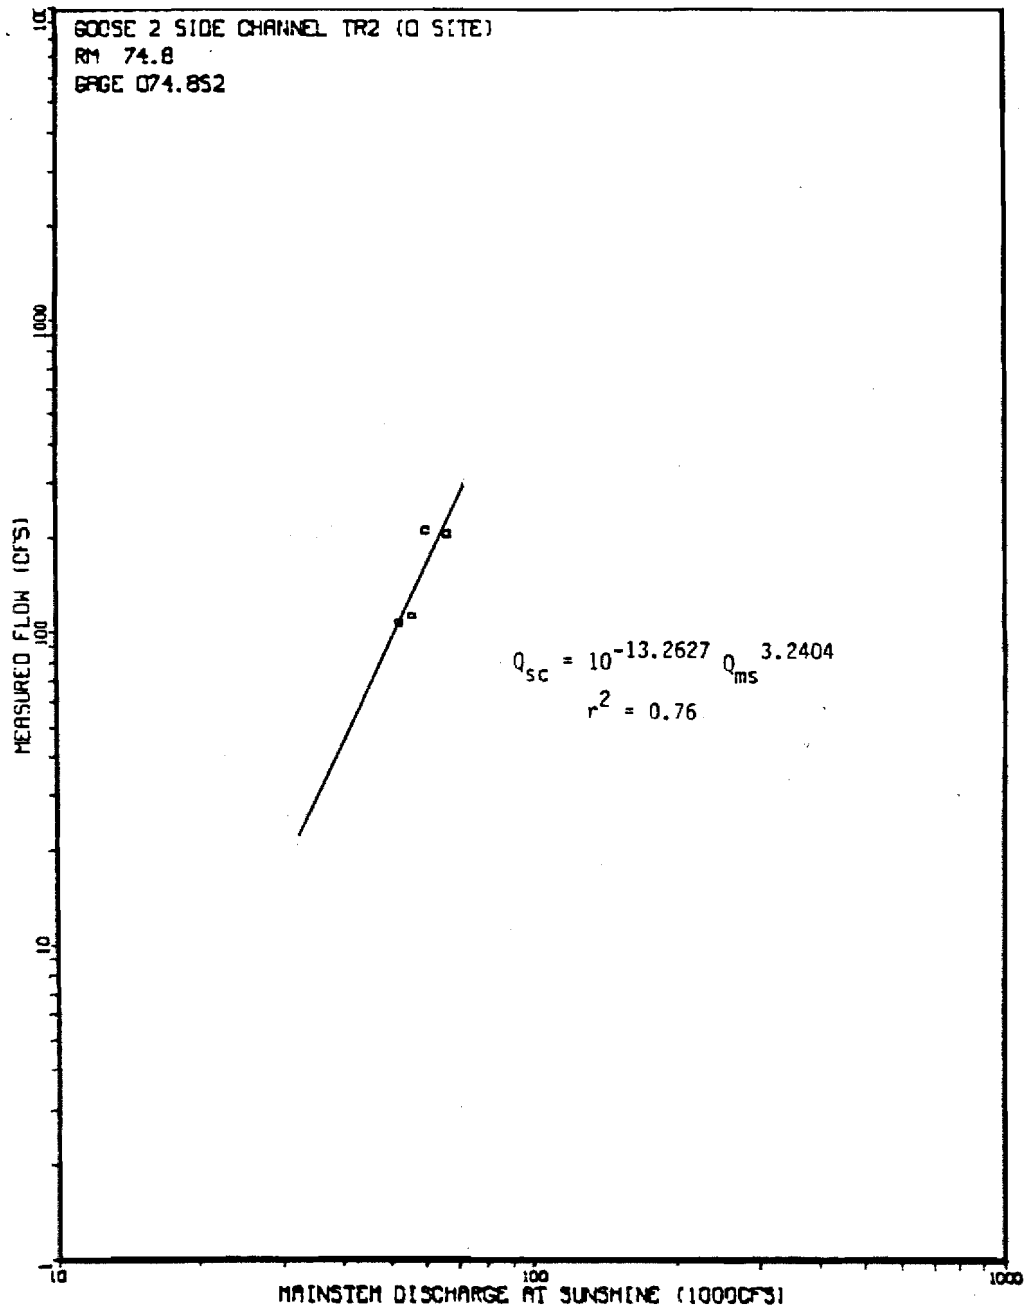
Figure 43. Goose 2 Side Channel streamflow versus mainstem discharge at Sunshine Station (USGS 15292780) rating curve at transect 2 Q Site.
