TASK 14 SUPPORT TECHNICAL REPORT

**HYDROLOGICAL INVESTIGATIONS AT SELECTED
LOWER SUSITNA RIVER STUDY SITES**

by: Timothy Quane, Patrick Morrow, and Isaac Queral
Aquatic Habitat and Instream Flow Project

**ALASKA DEPARTMENT OF FISH AND GAME
SUSITNA HYDRO AQUATIC STUDIES REPORT SERIES**

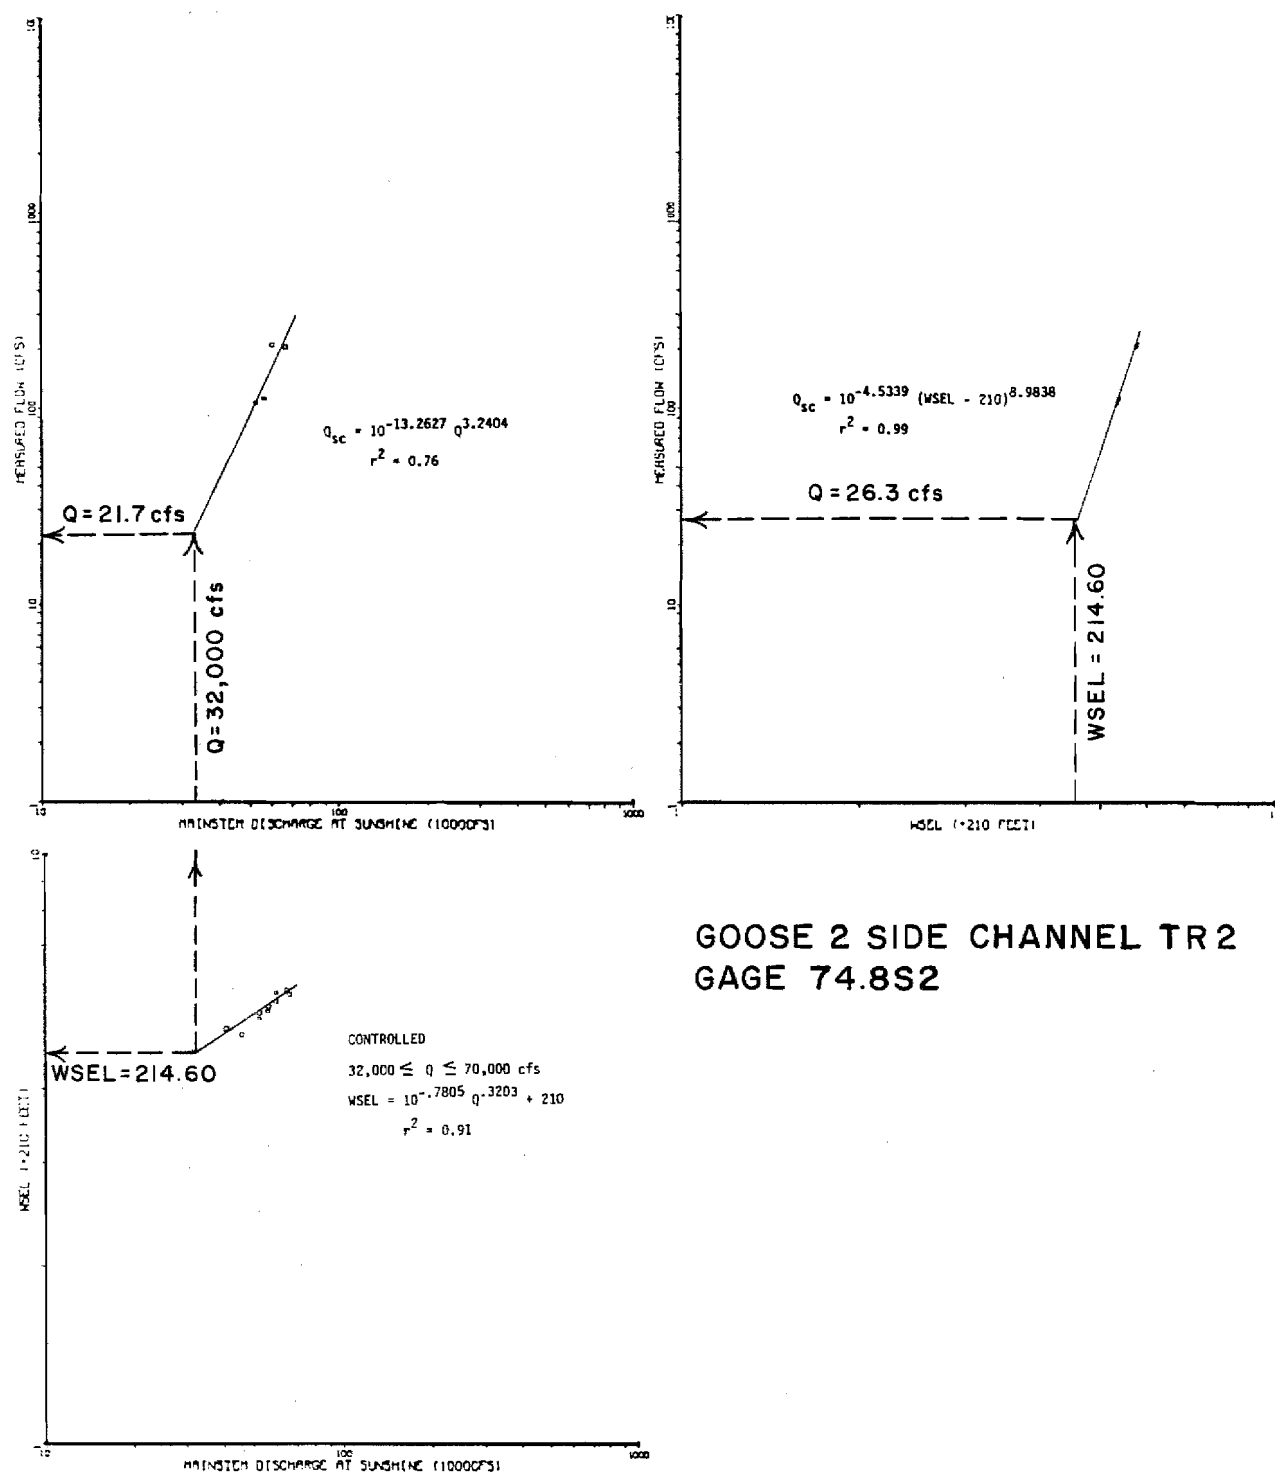
Figure 44. Comparison of rating curves for Goose 2 Side Channel transect 2 Q Site.

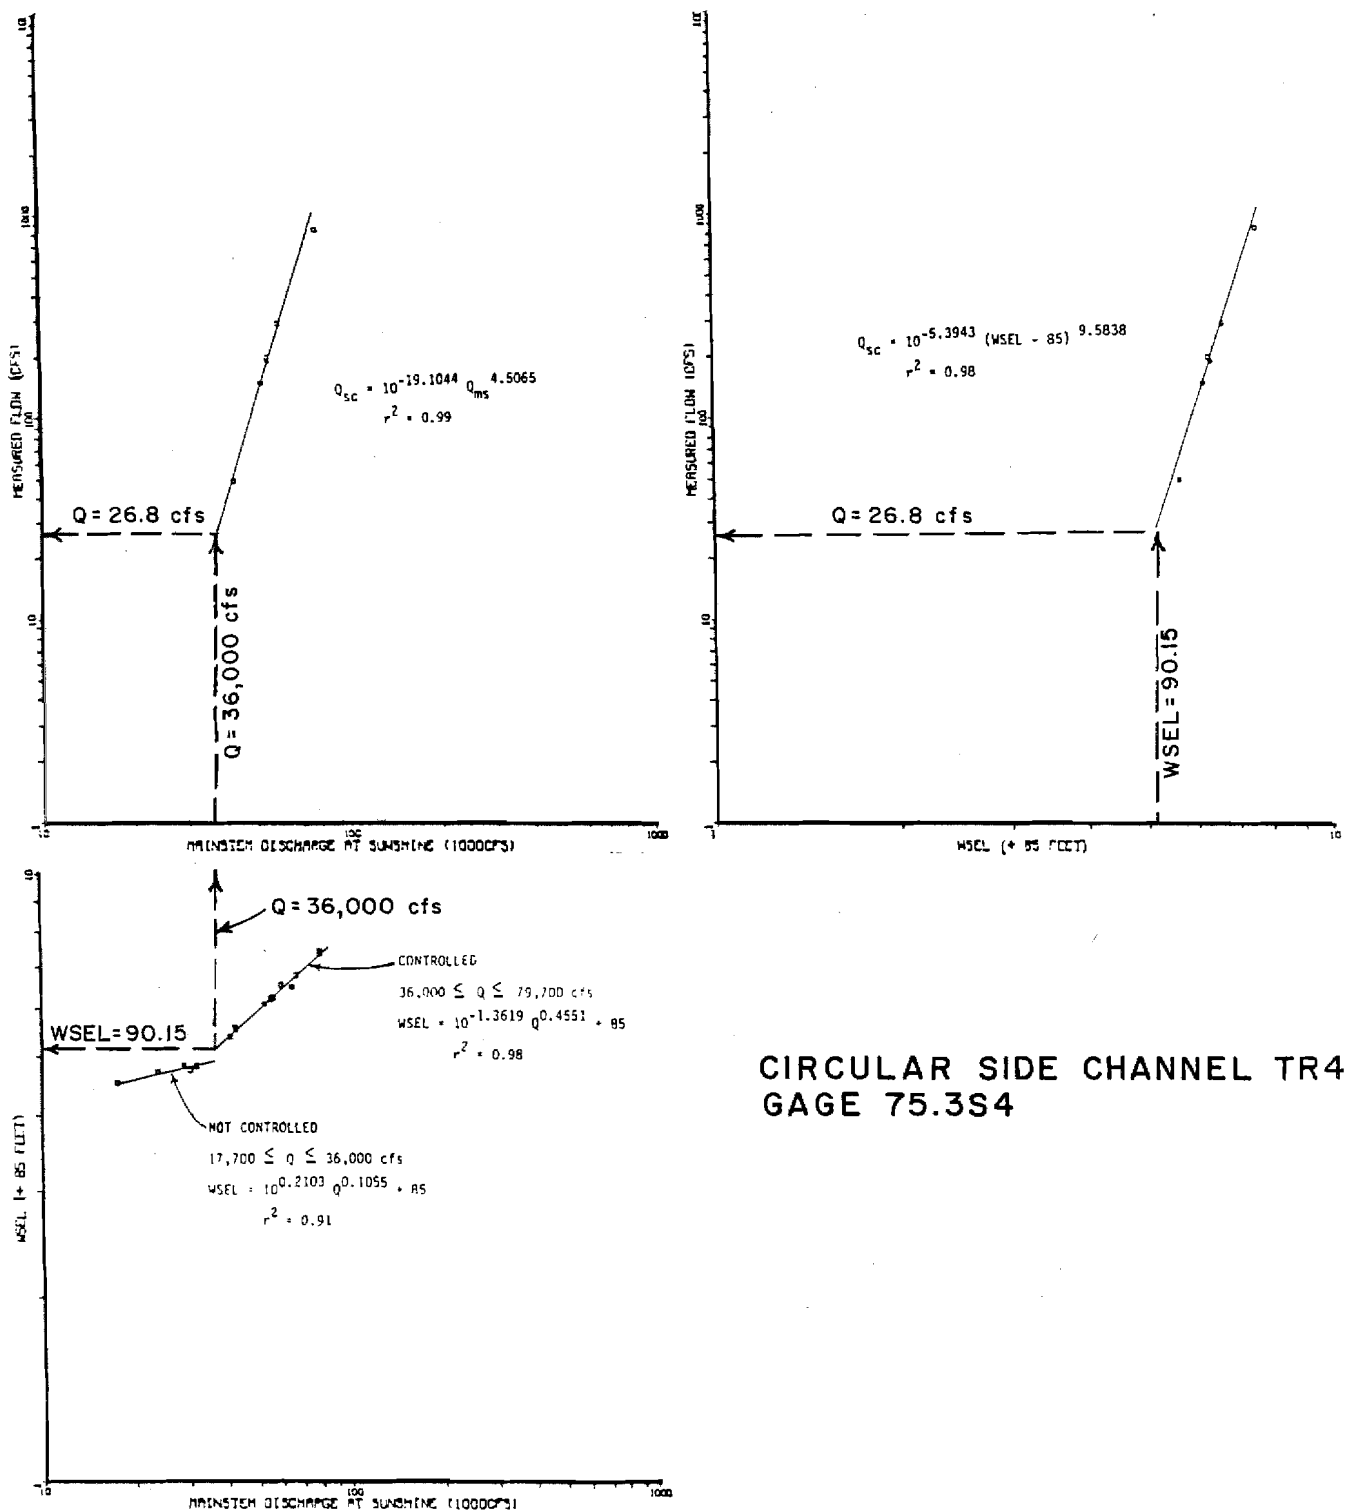
Figure 50. Comparison of rating curves for Circular Side Channel at transect 4 Q Site.

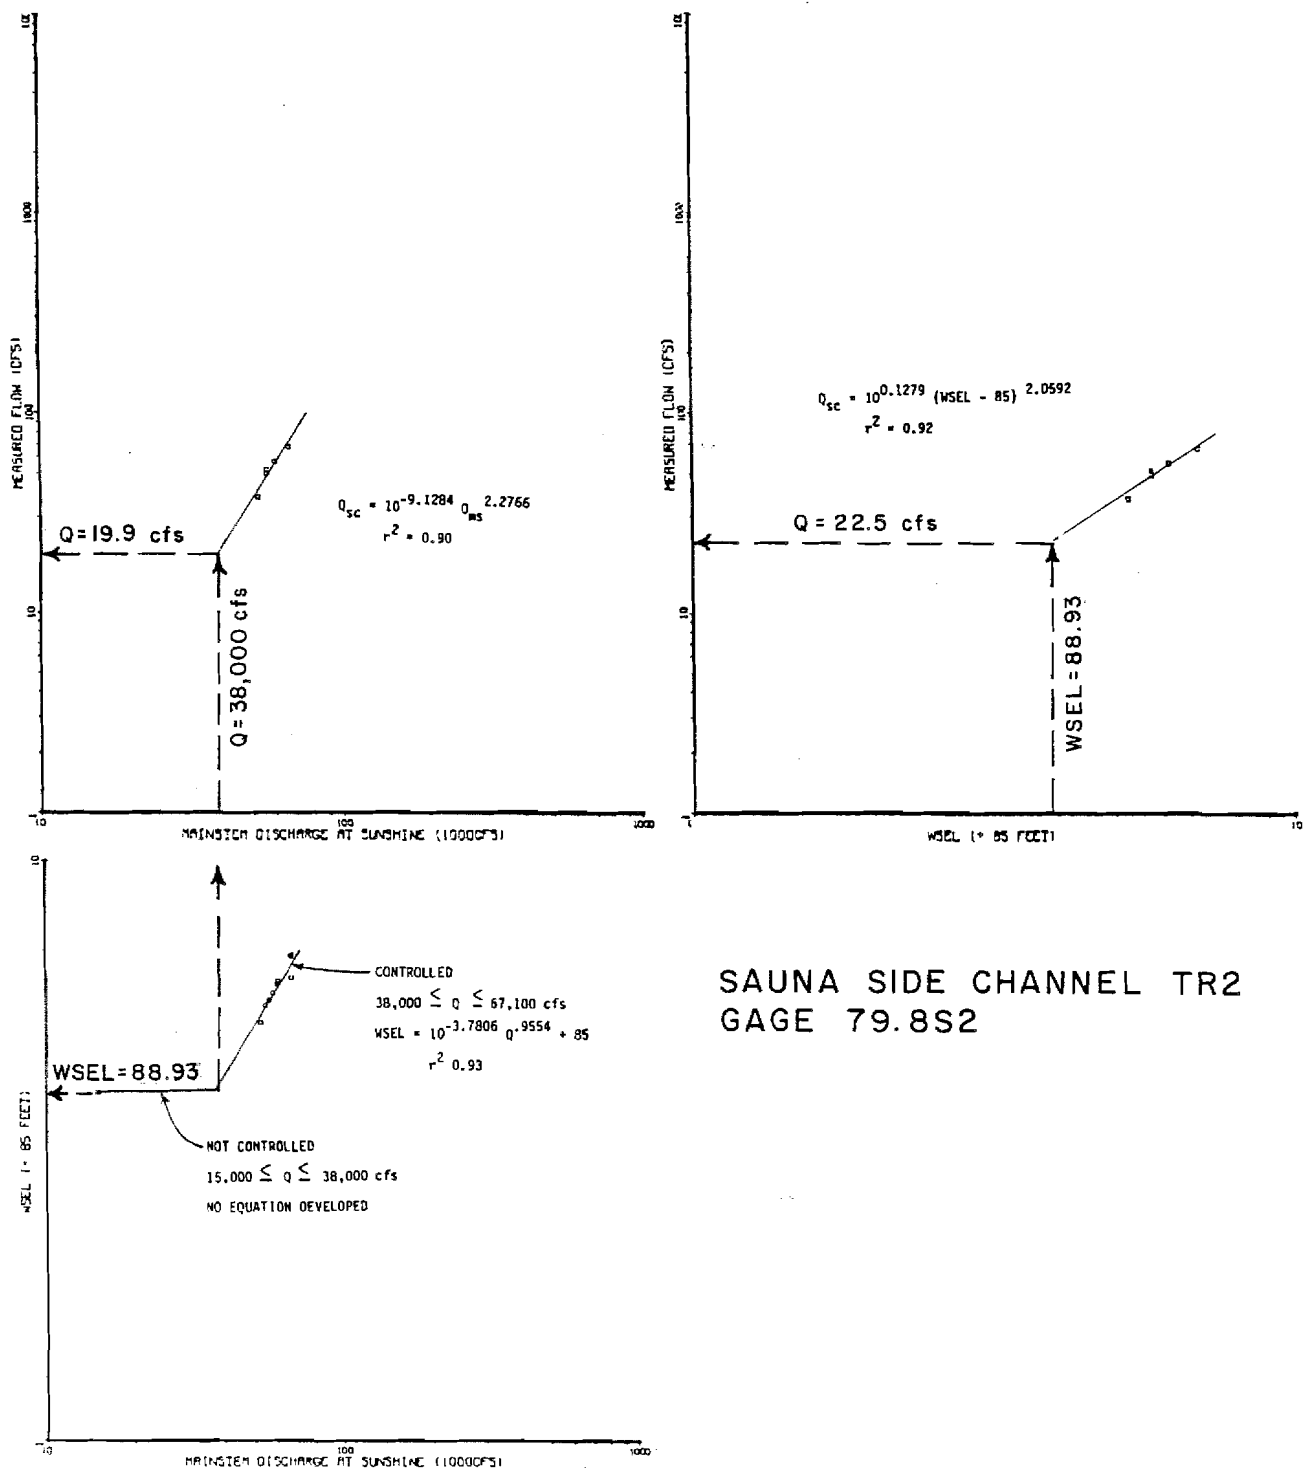
Figure 55. Comparison of rating curves for Sauna Side Channel transect 2 Q Site.

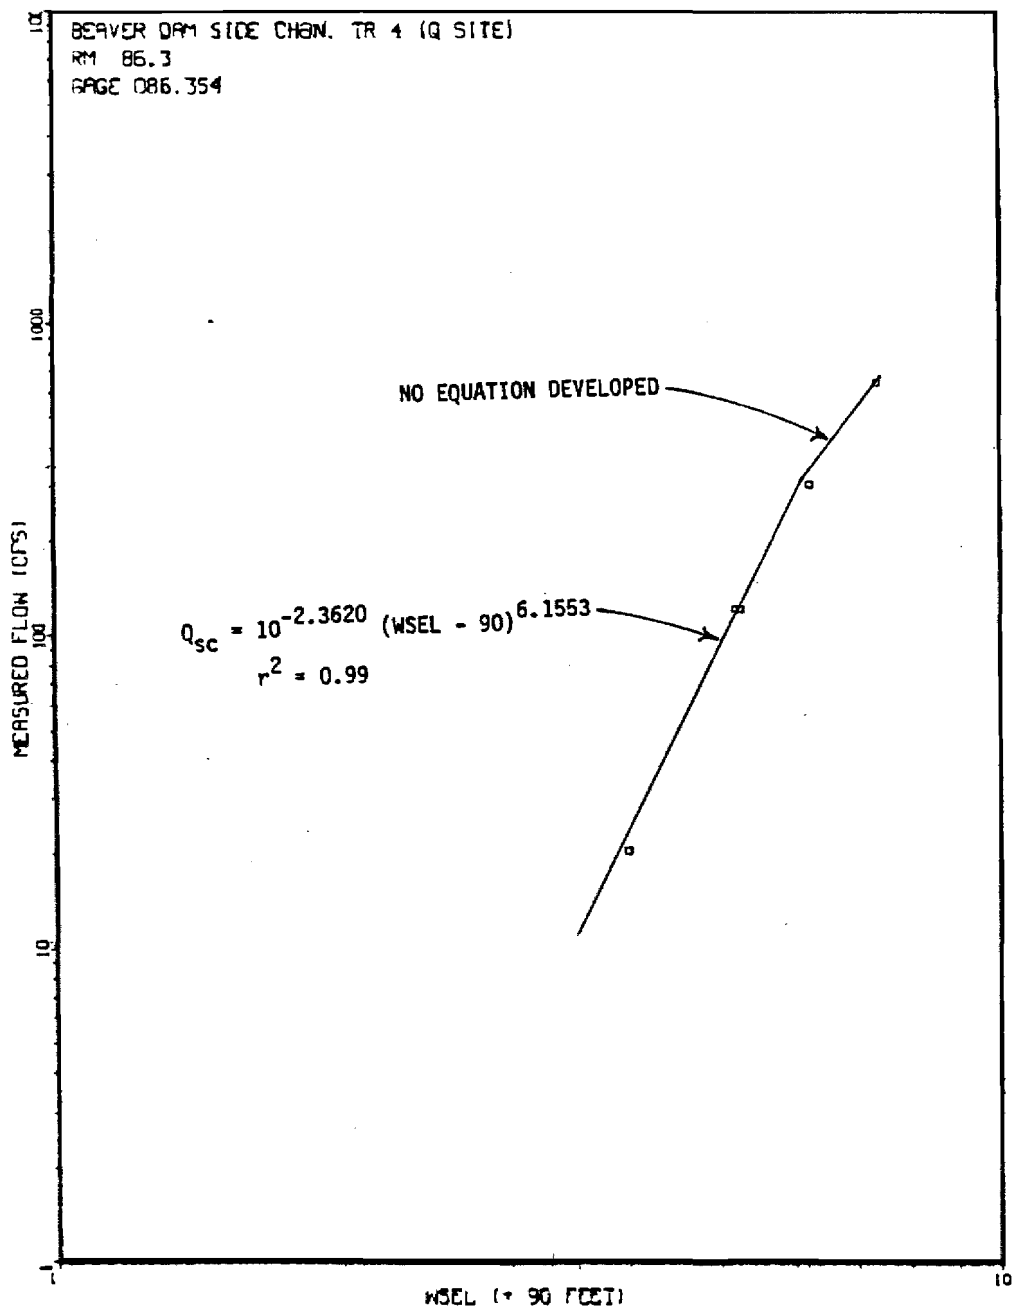
Figure 66. Beaver Dam Side Channel streamflow versus WSEL rating curve at transect 4 Q Site.

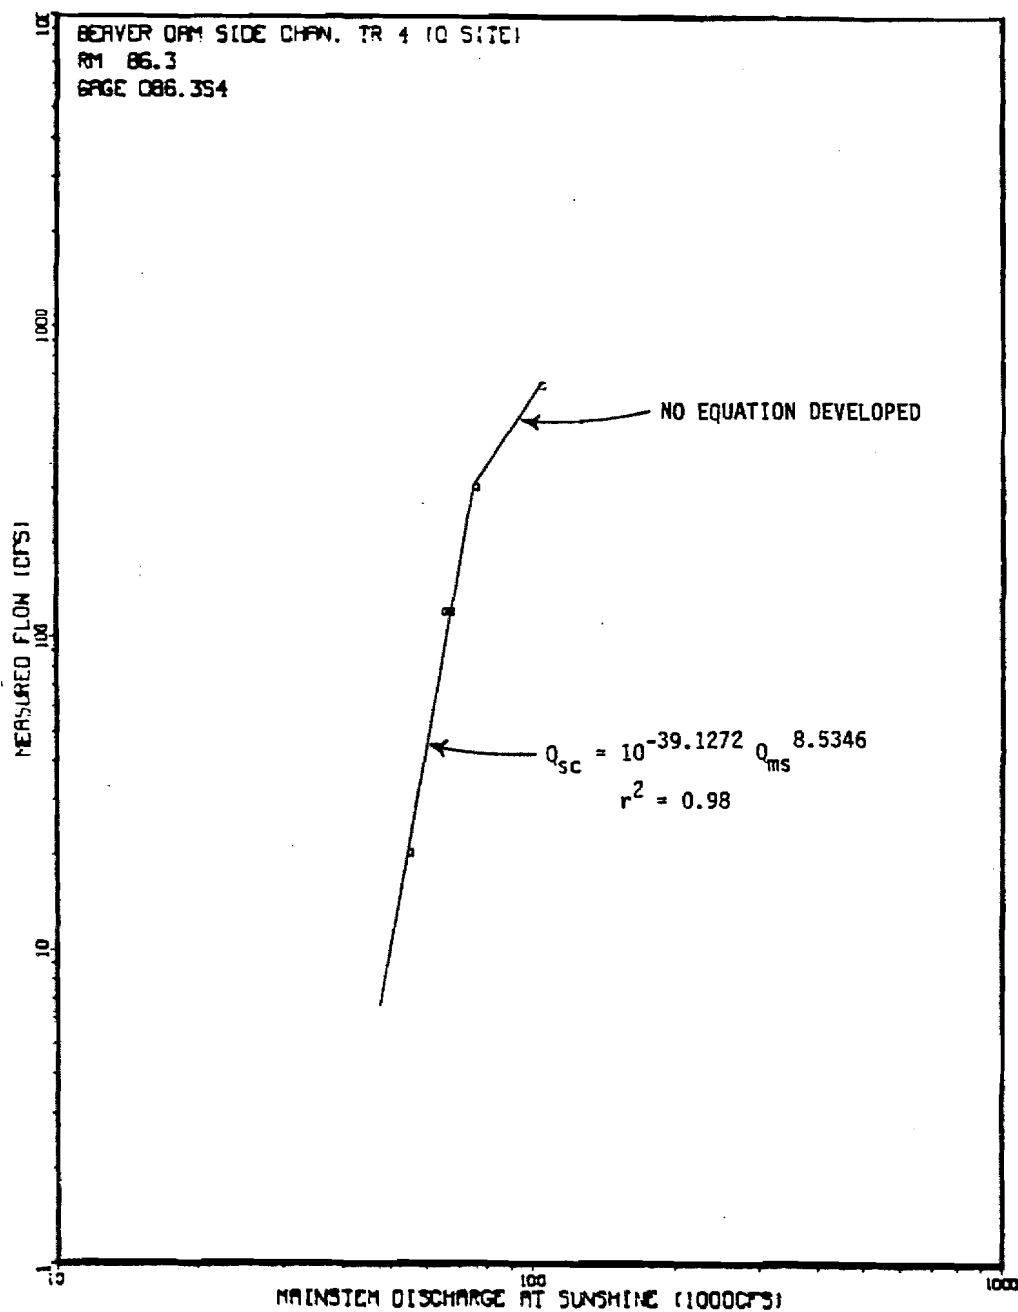
Figure 67. Beaver Dam Side Channel streamflow versus mainstem discharge at Sunshine Station (USGS 15292780) rating curve at transect 4 Q Site.

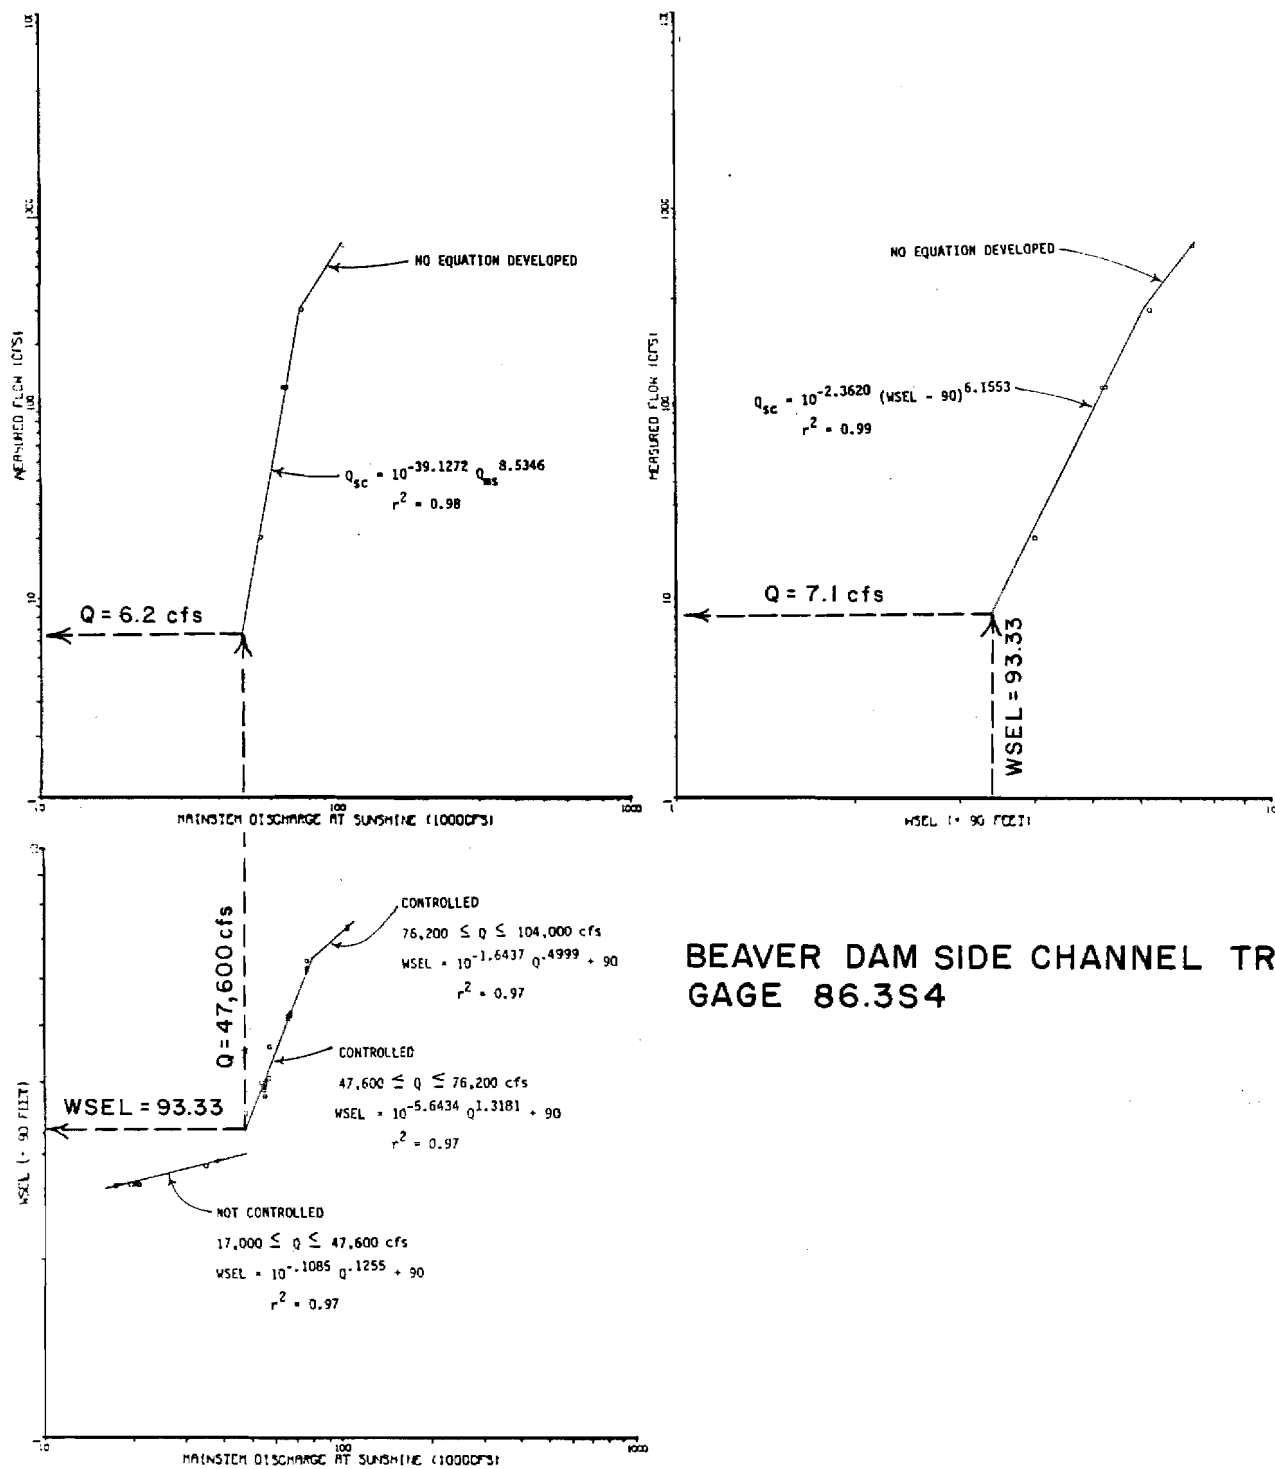
Figure 68. Comparison of rating curves for Beaver Dam Side Channel transect 4 Q Site.

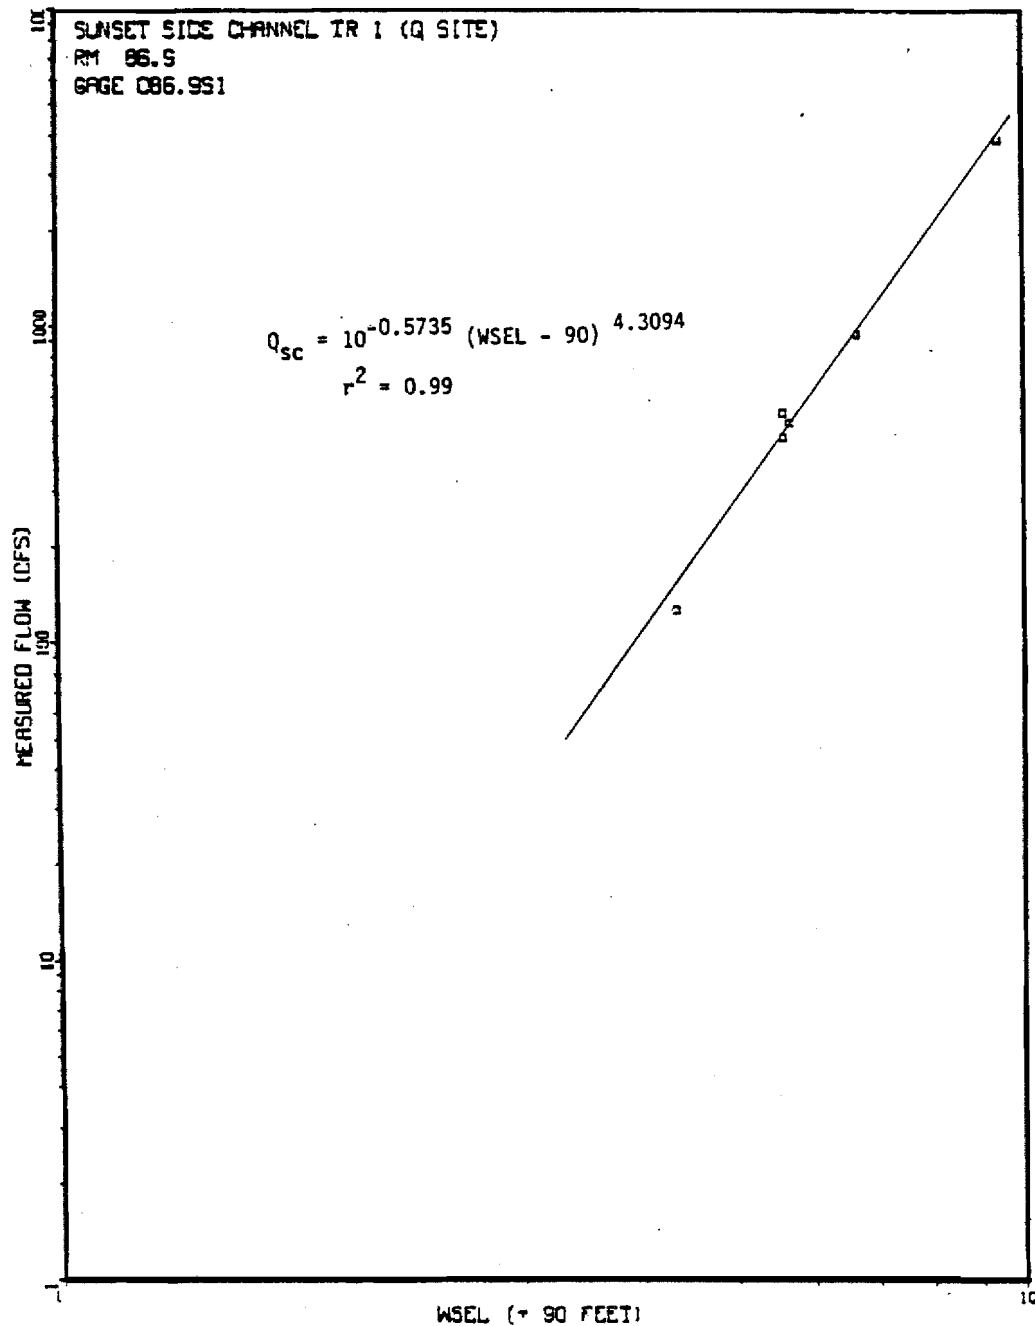
Figure 71. Sunset Side Channel streamflow versus WSEL rating curve at transect 1 Q Site.

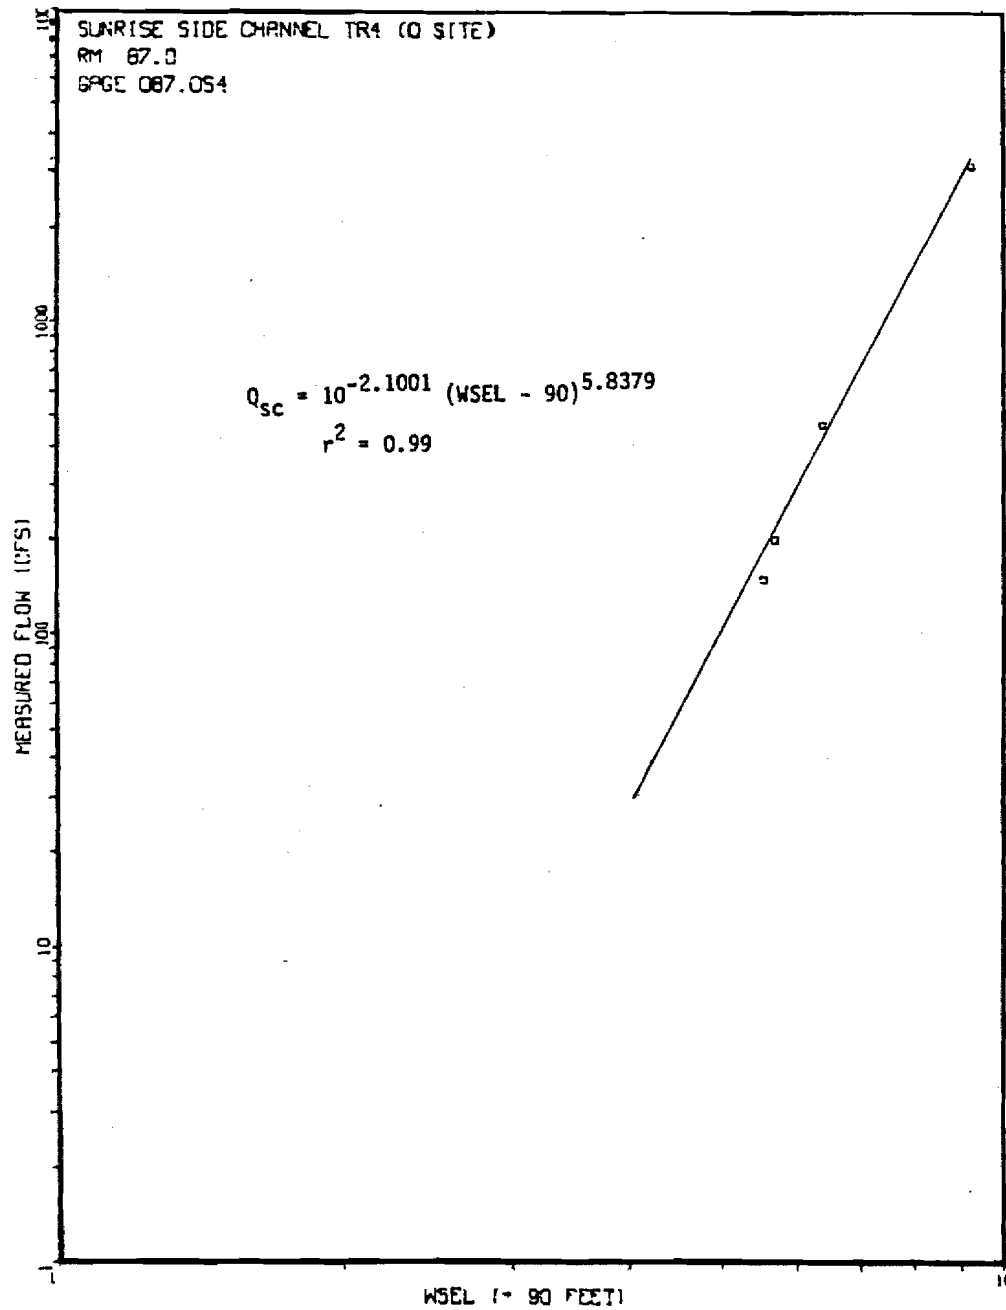
Figure 75. Sunrise Side Channel streamflow versus WSEL rating curve at transect 4 O Site.

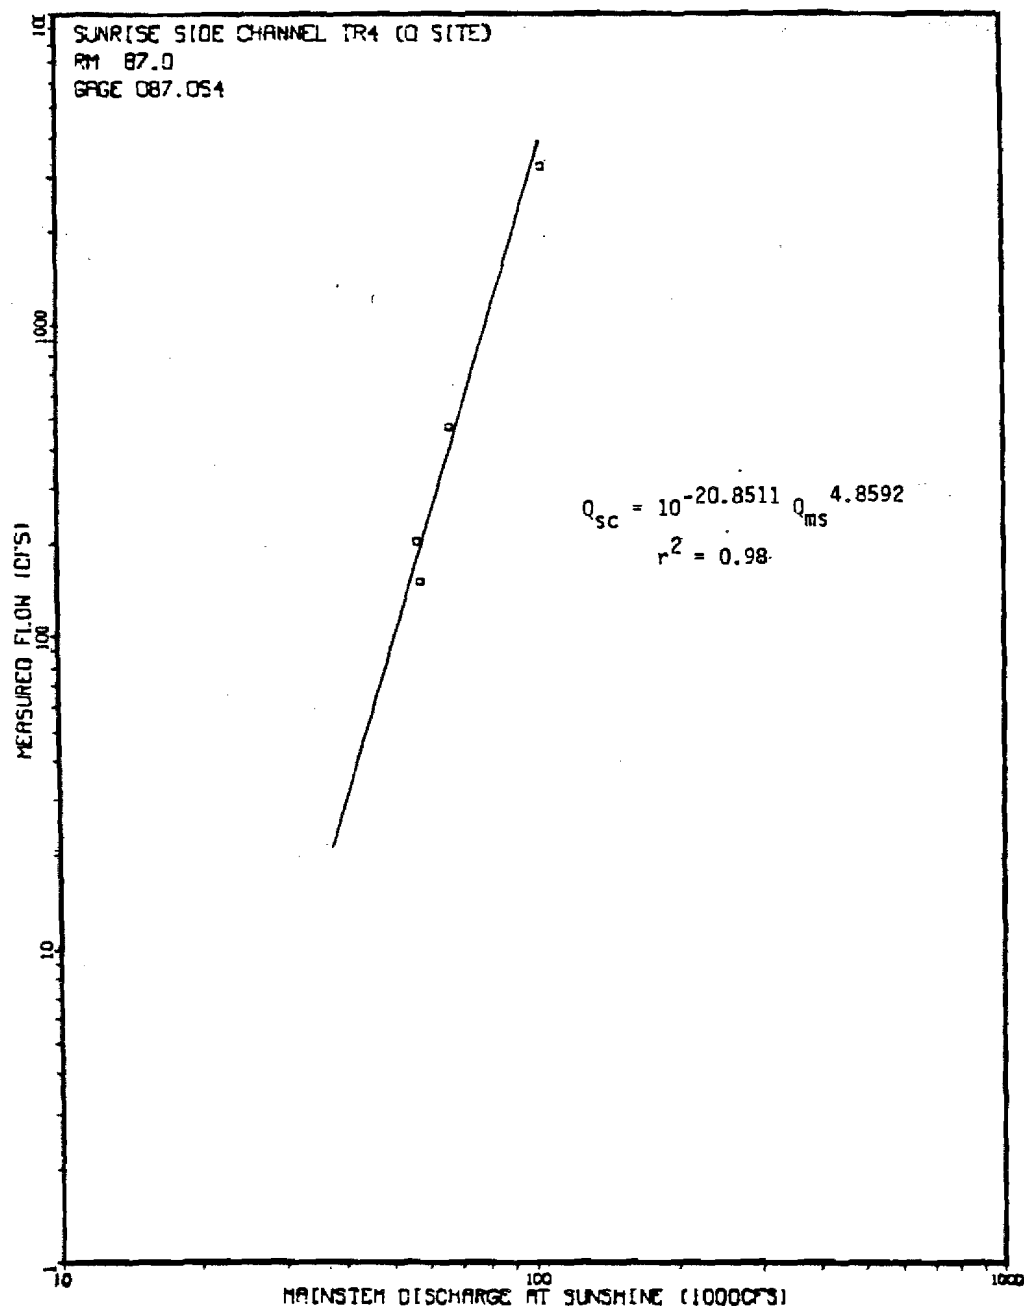
Figure 76. Sunrise Side Channel streamflow versus mainstem discharge at Sunshine (USGS 15292780) rating curve at transect 4 Q Site.

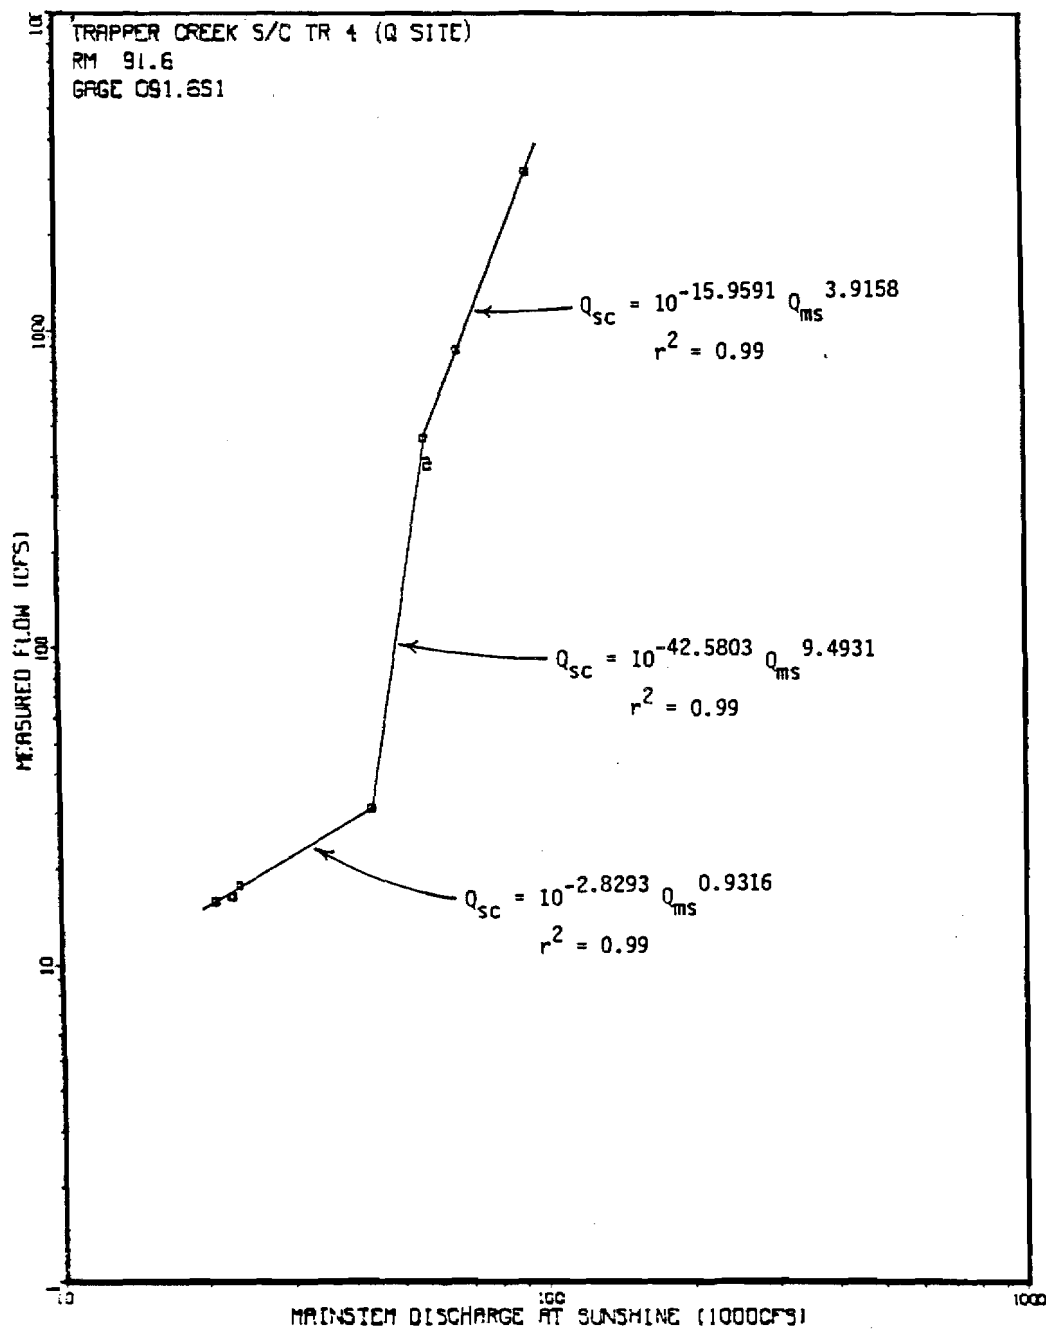
Figure 84. Trapper Creek Side Channel streamflow versus mainstem discharge at Sunshine Station (USGS 15292780) rating curve at transect 4 Q Site.

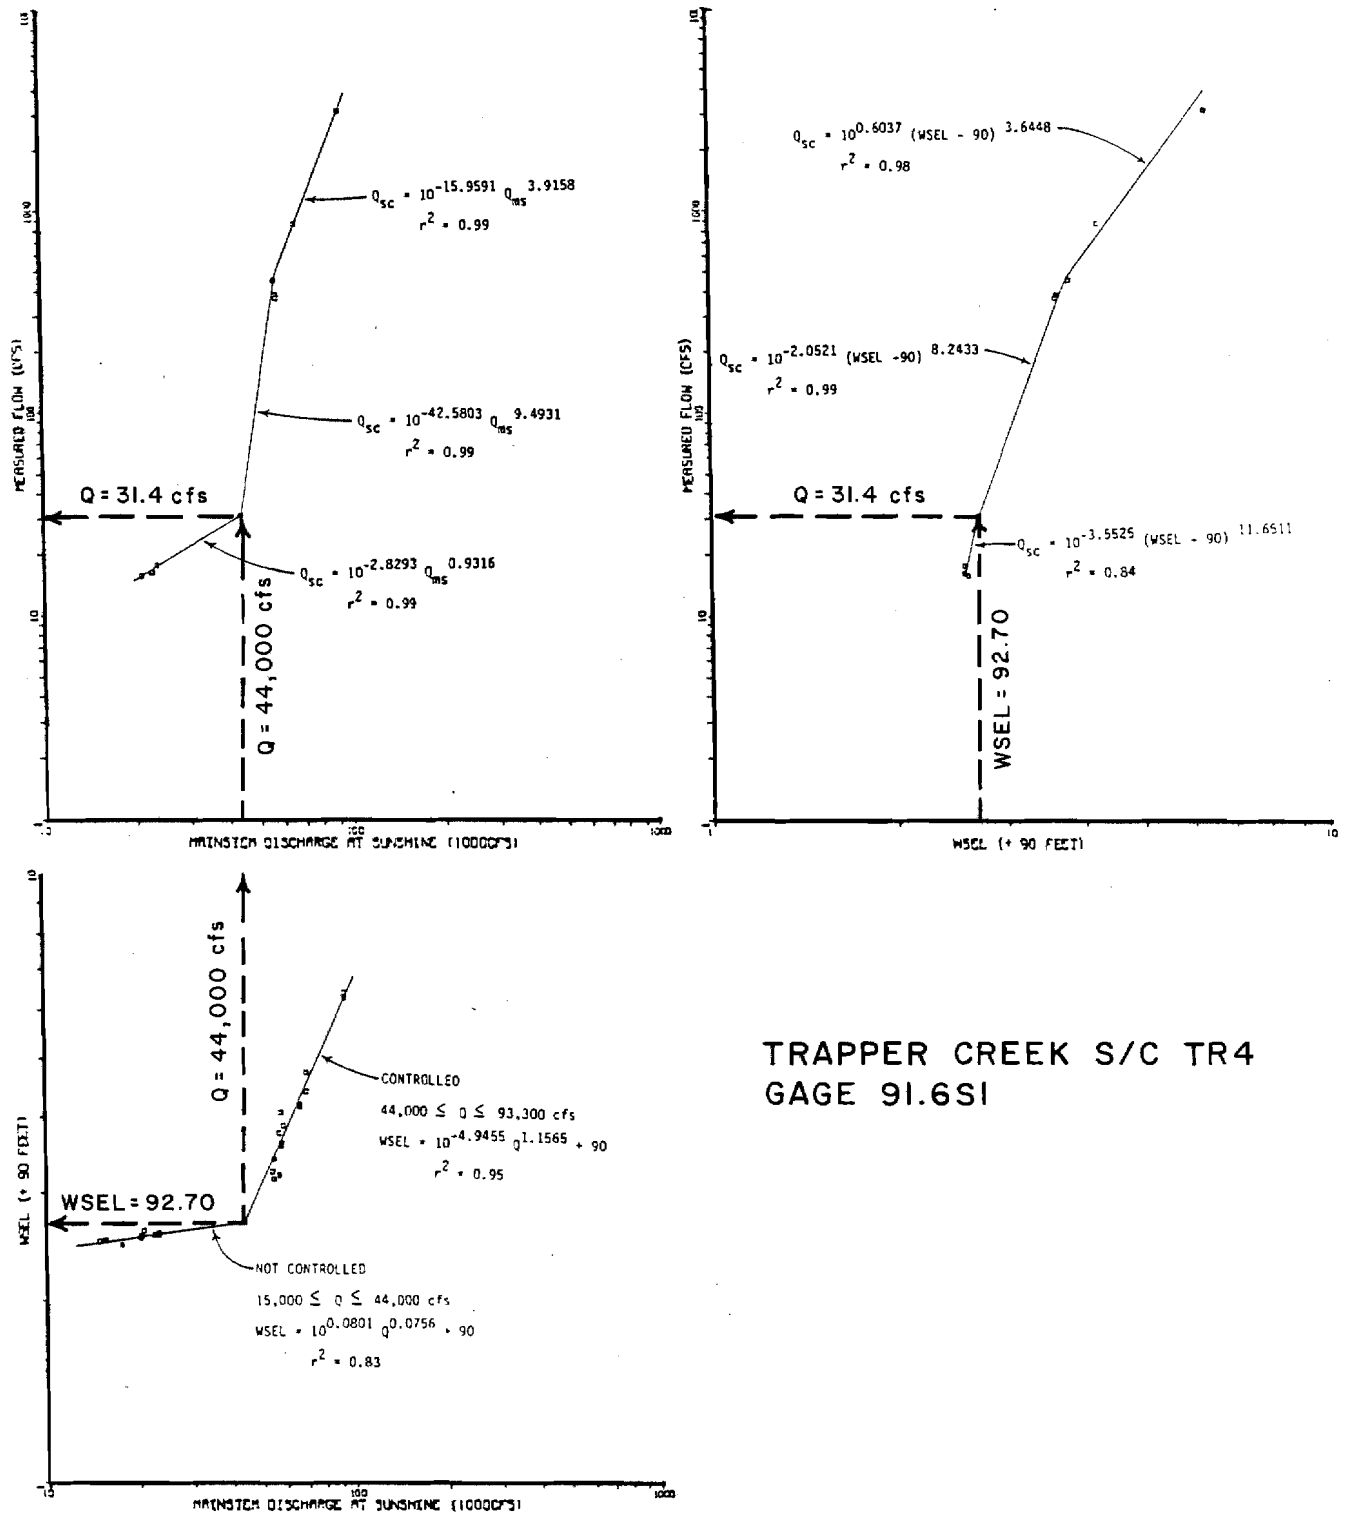
Figure 85. Comparison of rating curves for Trapper Creek Side Channel Transect 4 Q Site.

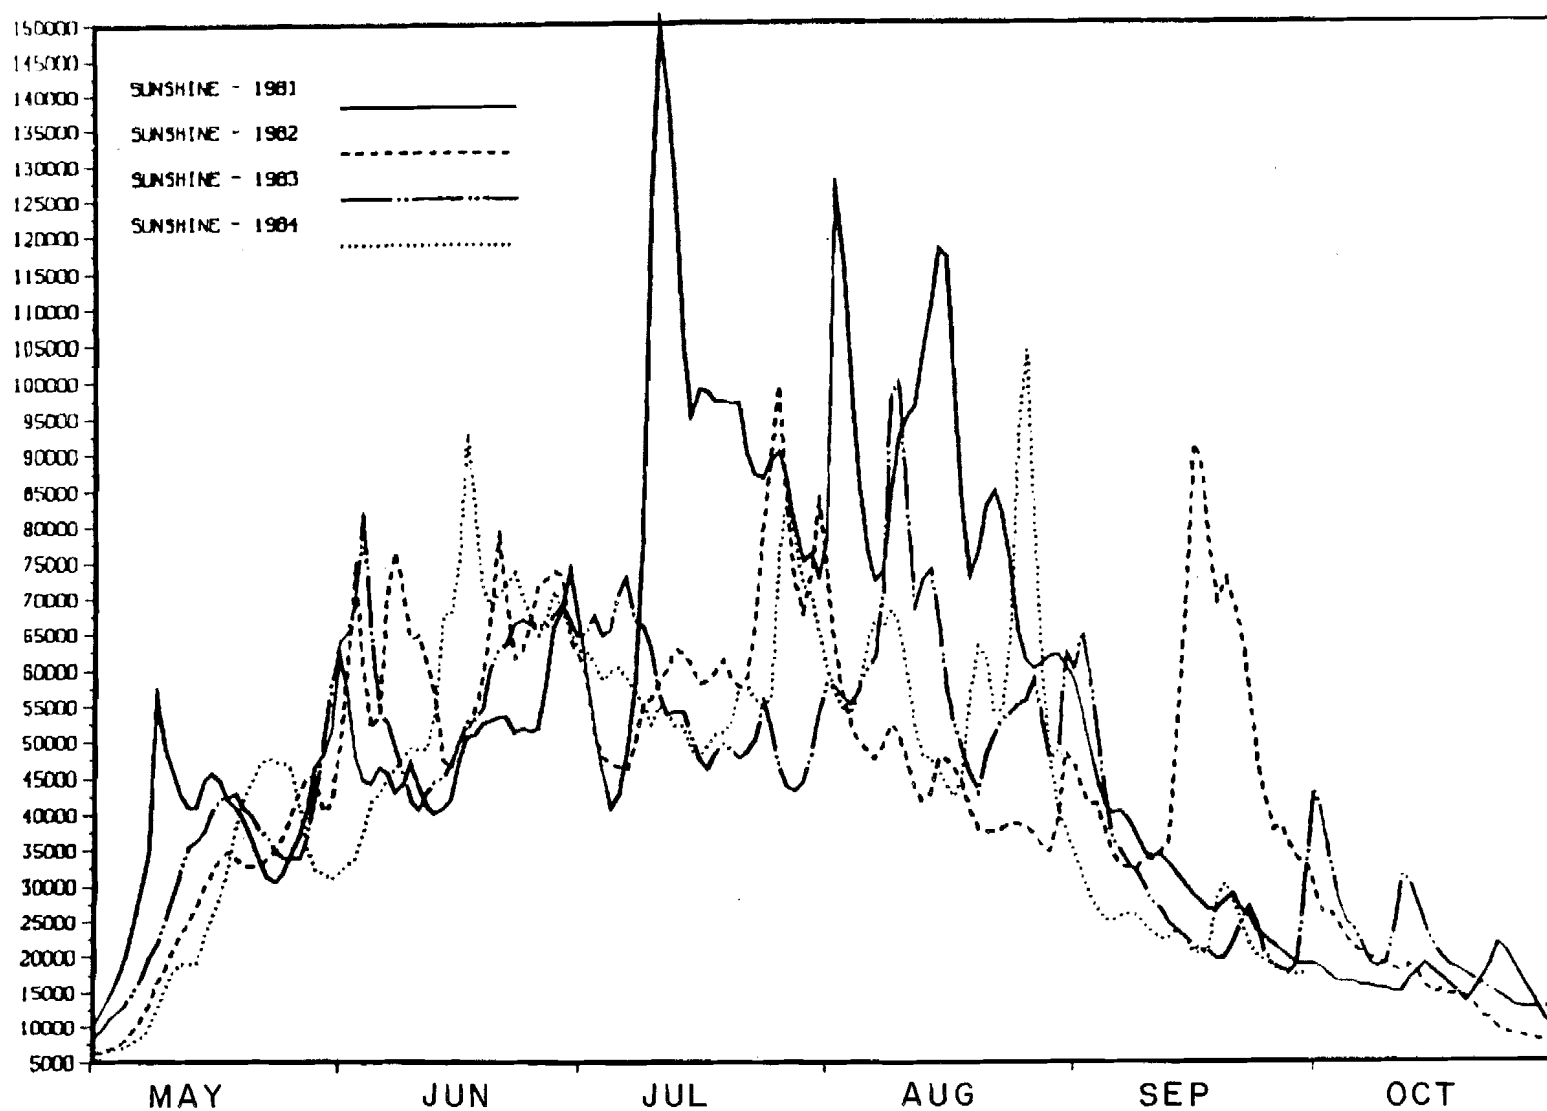
Figure 86. Susitna River hydrograph for May-October 1981, 1982, 1983 and 1984 at Sunshine Station (USGS 15292780).

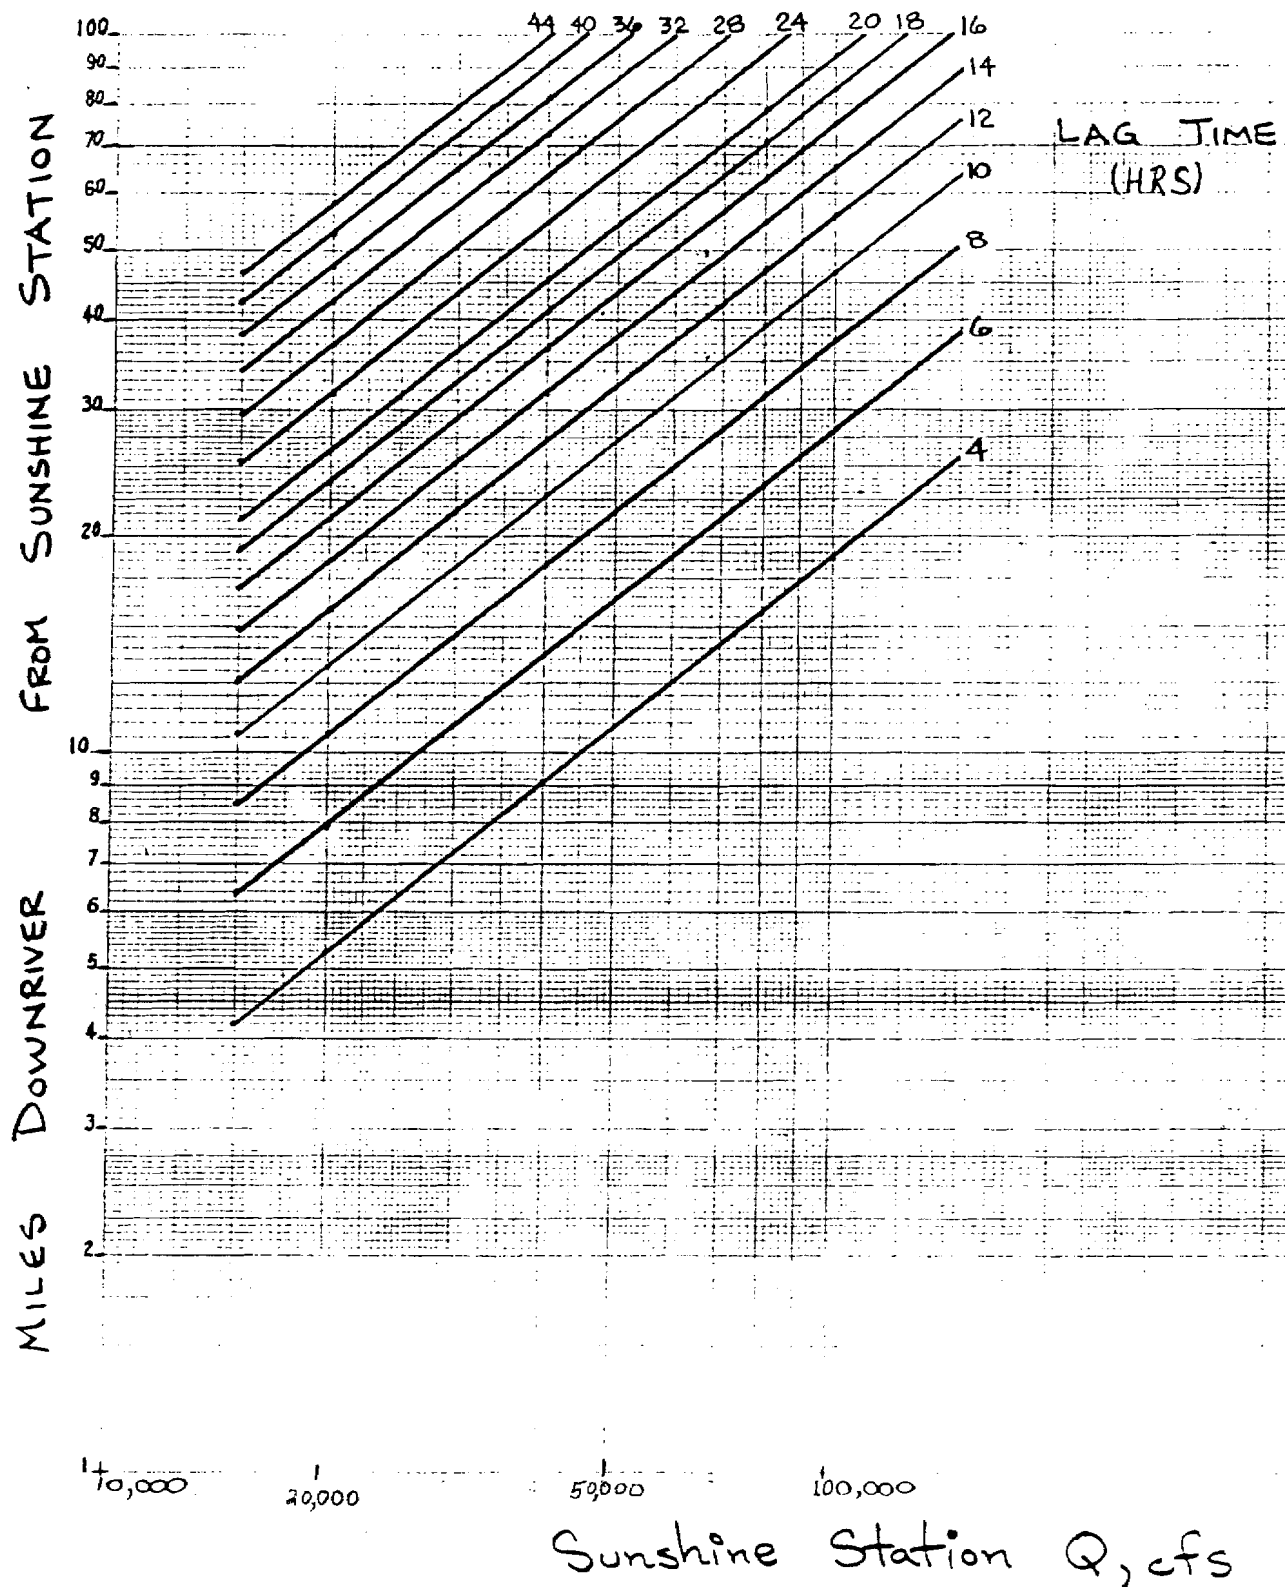
Attachment Figure A-1. Lower Susitna River Basin lag times referenced to Sunshine Station (USGS 15292780).

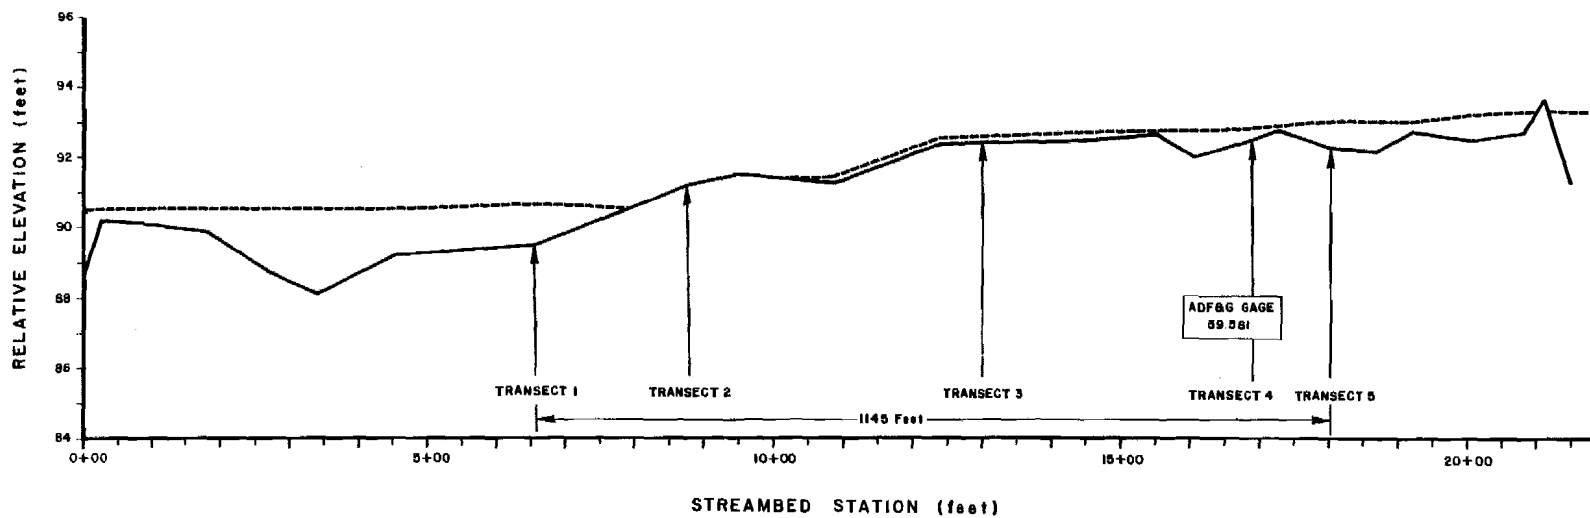
Attachment Figure C-7. Thalweg profile of the study site at Rustic Wilderness Side Channel.

Survey data for the development of a thalweg profile were obtained at Rustic Wilderness Side Channel during a non-breaching mainstem discharge of 17,700 cfs and an estimated side channel streamflow of less than 1 cfs. The survey data are presented in Attachment Table C-7 with the resultant thalweg profile presented in Attachment Figure C-7. The thalweg profile extends from the head of the side channel and continues downstream approximately 650 feet below transect 1. The streambed gradient for the portion of the side channel included in the thalweg profile was 8.7 feet/mile.
