TASK 14 SUPPORT TECHNICAL REPORT

**HYDROLOGICAL INVESTIGATIONS AT SELECTED
LOWER SUSITNA RIVER STUDY SITES**

by: Timothy Quane, Patrick Morrow, and Isaac Queral
Aquatic Habitat and Instream Flow Project

**ALASKA DEPARTMENT OF FISH AND GAME
SUSITNA HYDRO AQUATIC STUDIES REPORT SERIES**

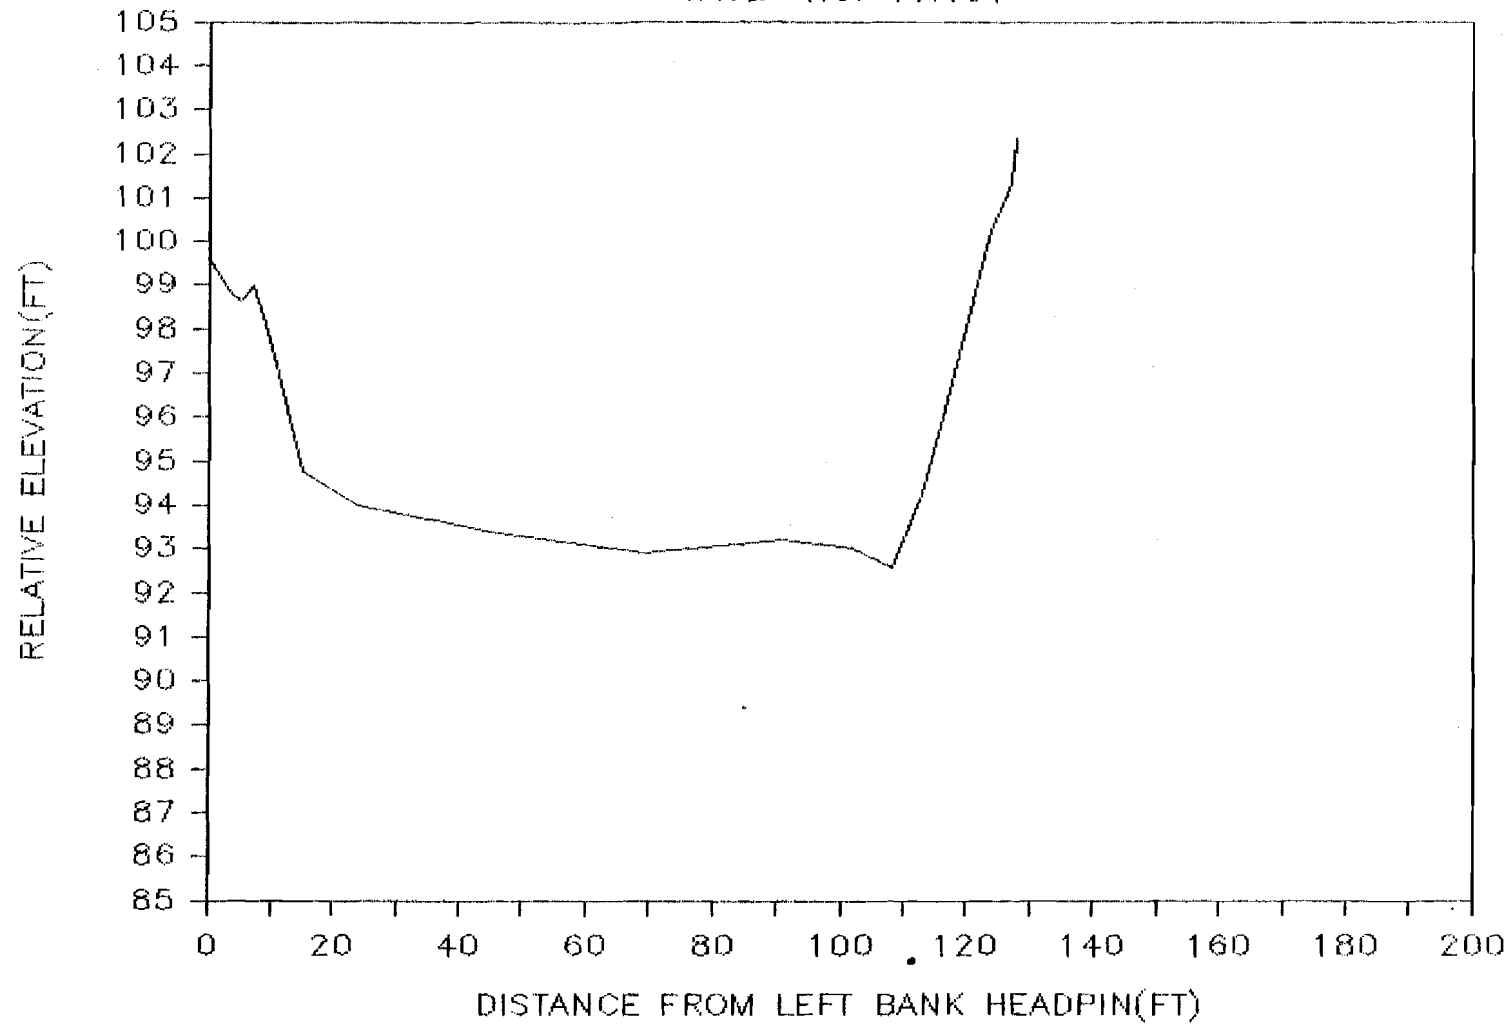
Attachment Figure D-6. Cross sectional profile obtained at transect 2 of Last Chance Side Channel.

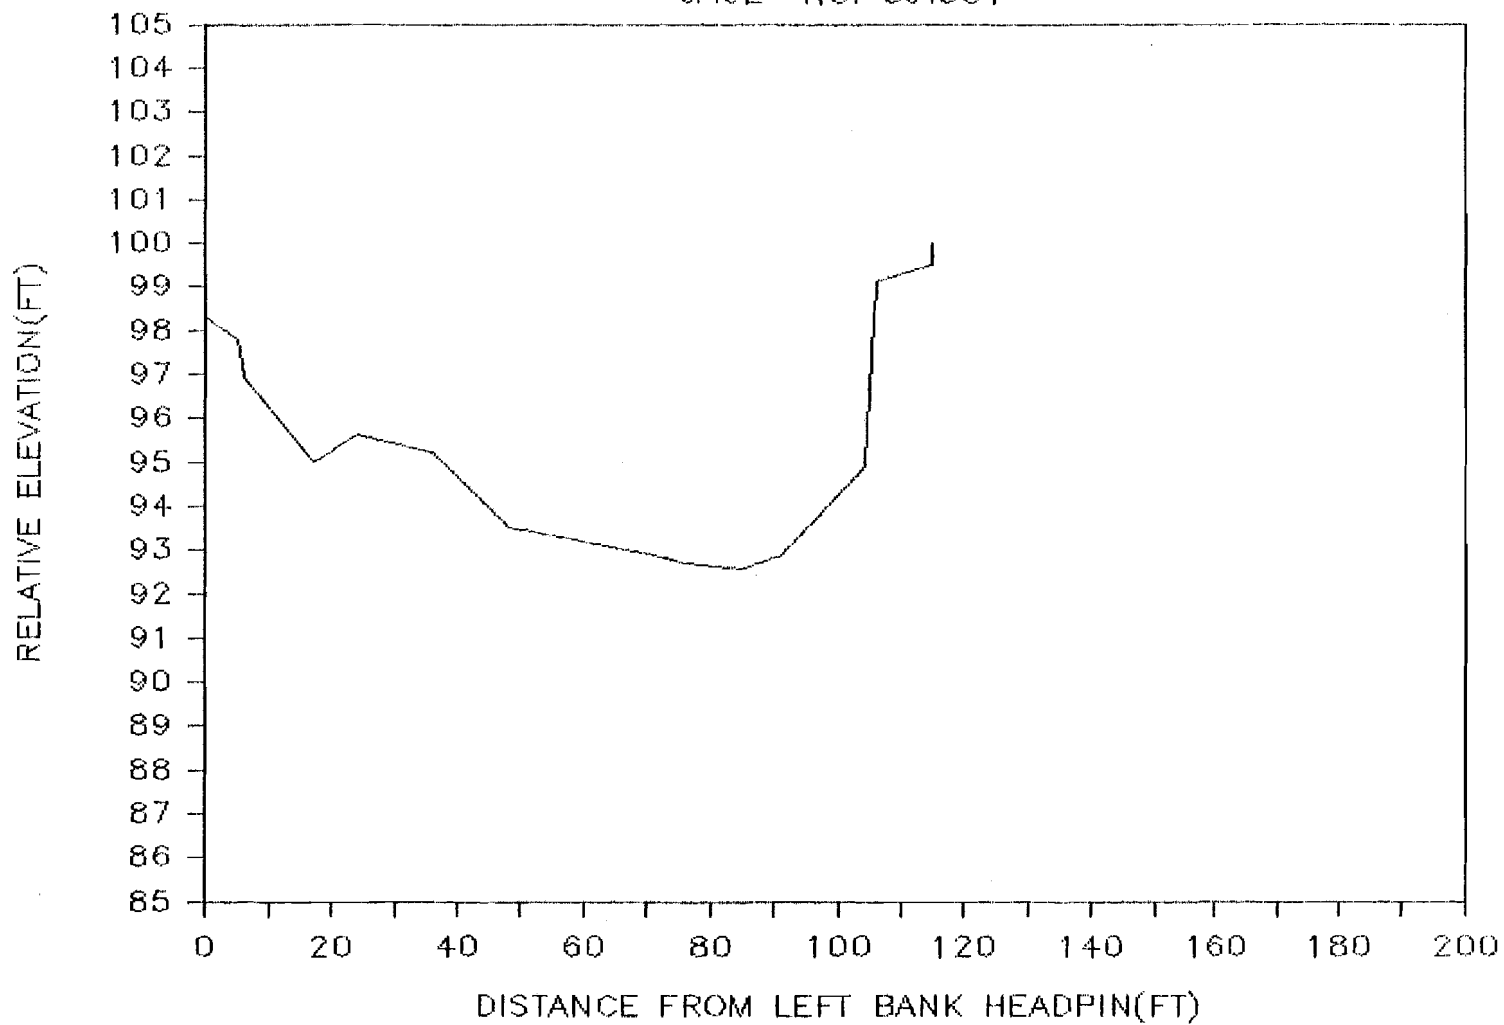
Attachment Figure D-7. Cross sectional profile obtained at transect 4 of Rustic Wilderness Side Channel.

Cross section data were recorded at the only stage monitoring station located in Rustic Wilderness Side Channel. This stage monitoring station was located in transect 4. The cross sectional data are

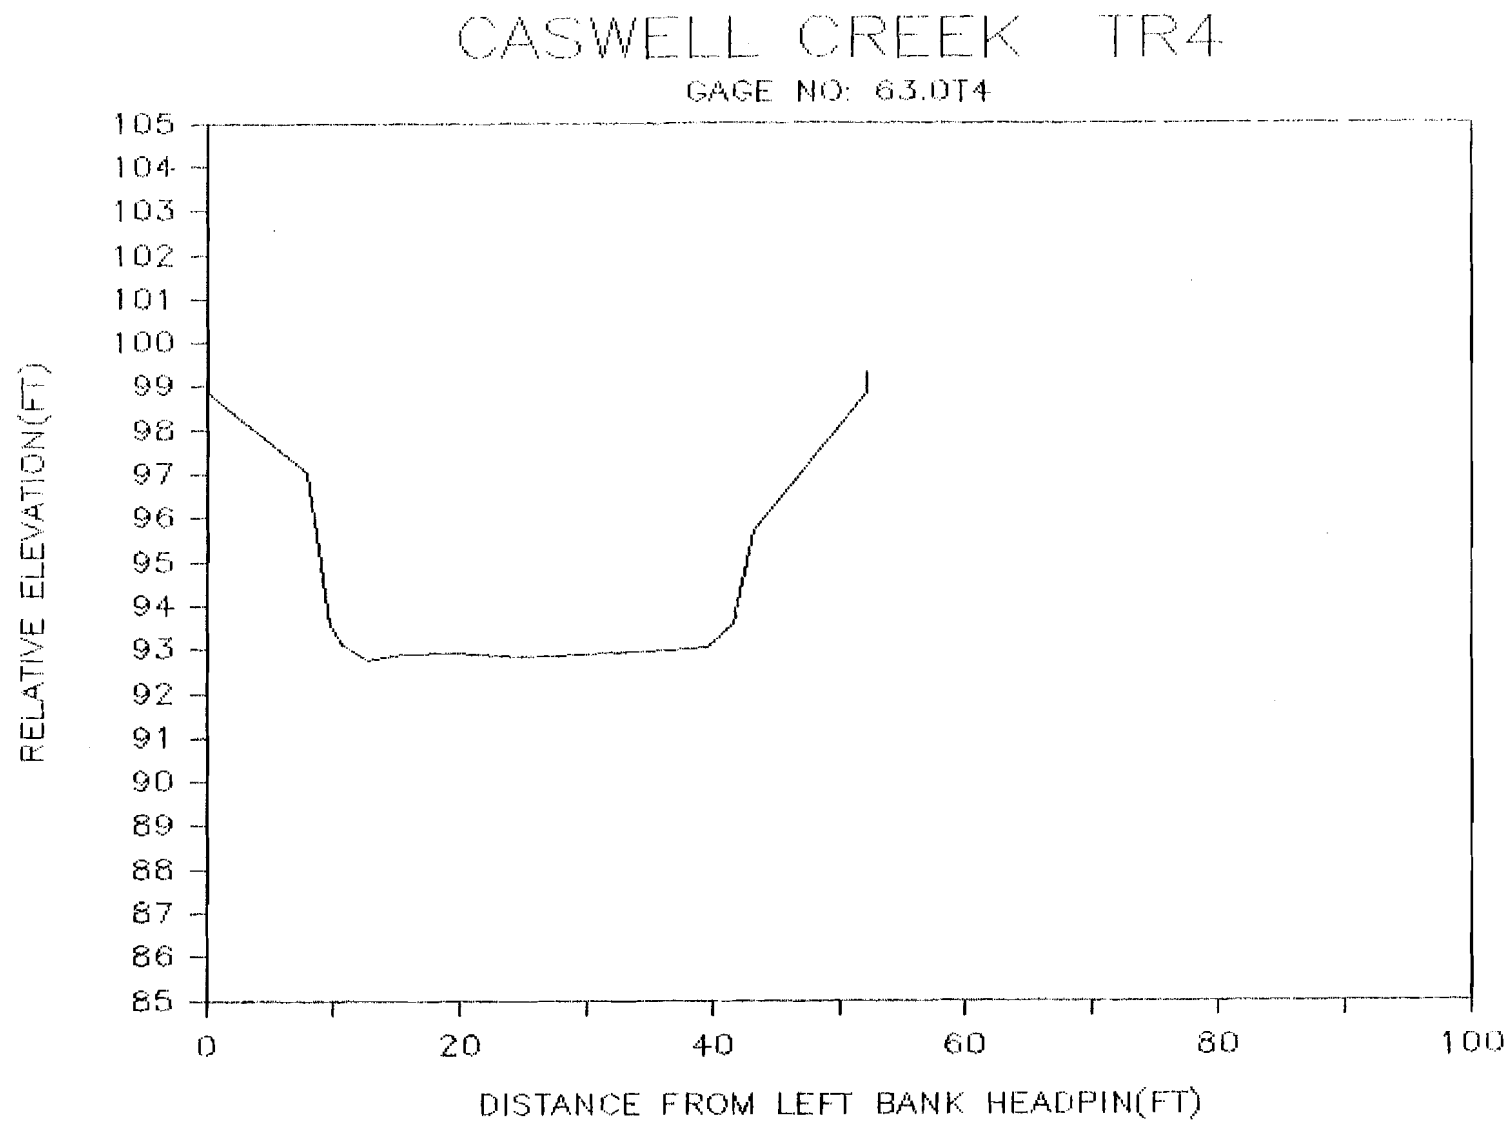
Attachment Figure D- 8. Cross sectional profile obtained at transect 4 of Caswell Creek.

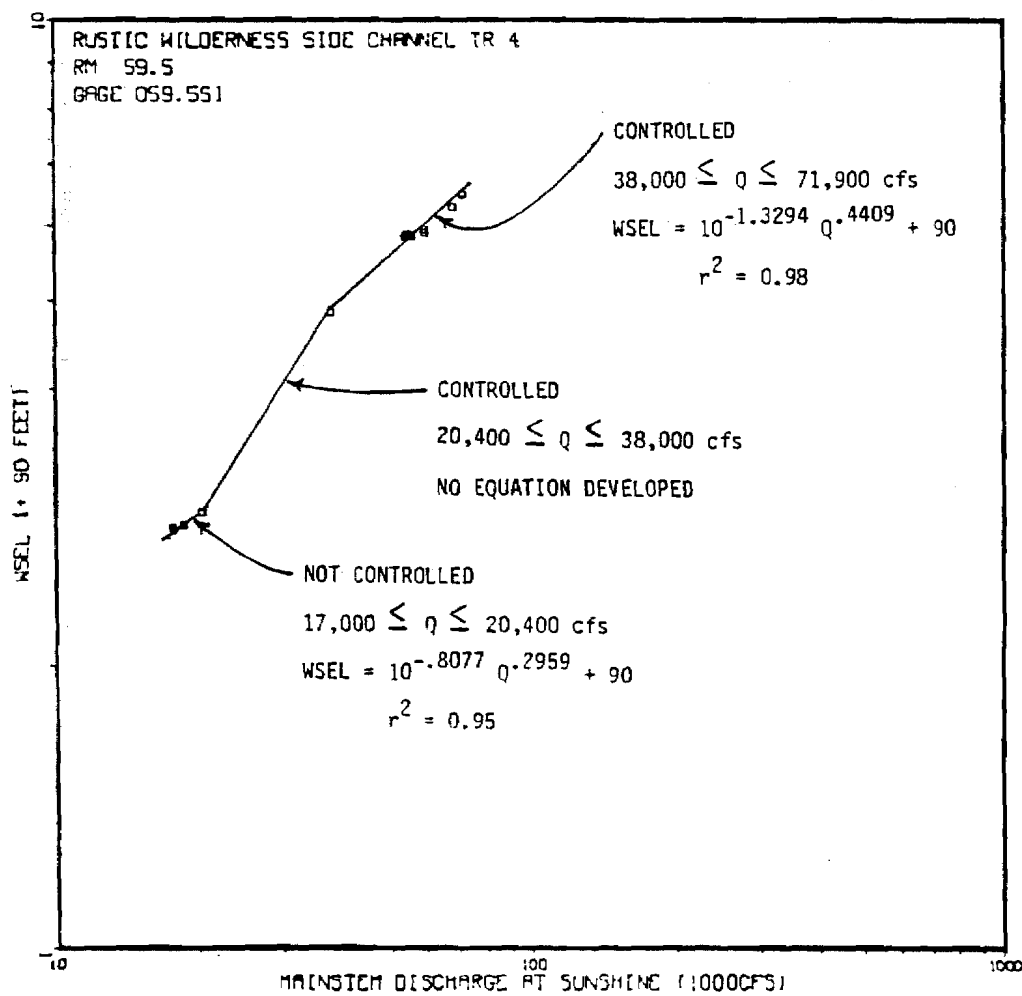
Attachment Figure E-6. WSEL versus mainstem discharge (USGS 15292780) at Rustic Wilderness Side Channel transect 4 (Q site).

From a review of the water surface elevation versus mainstem discharge rating curve presented in Attachment Figure E-6 the hydraulics of this

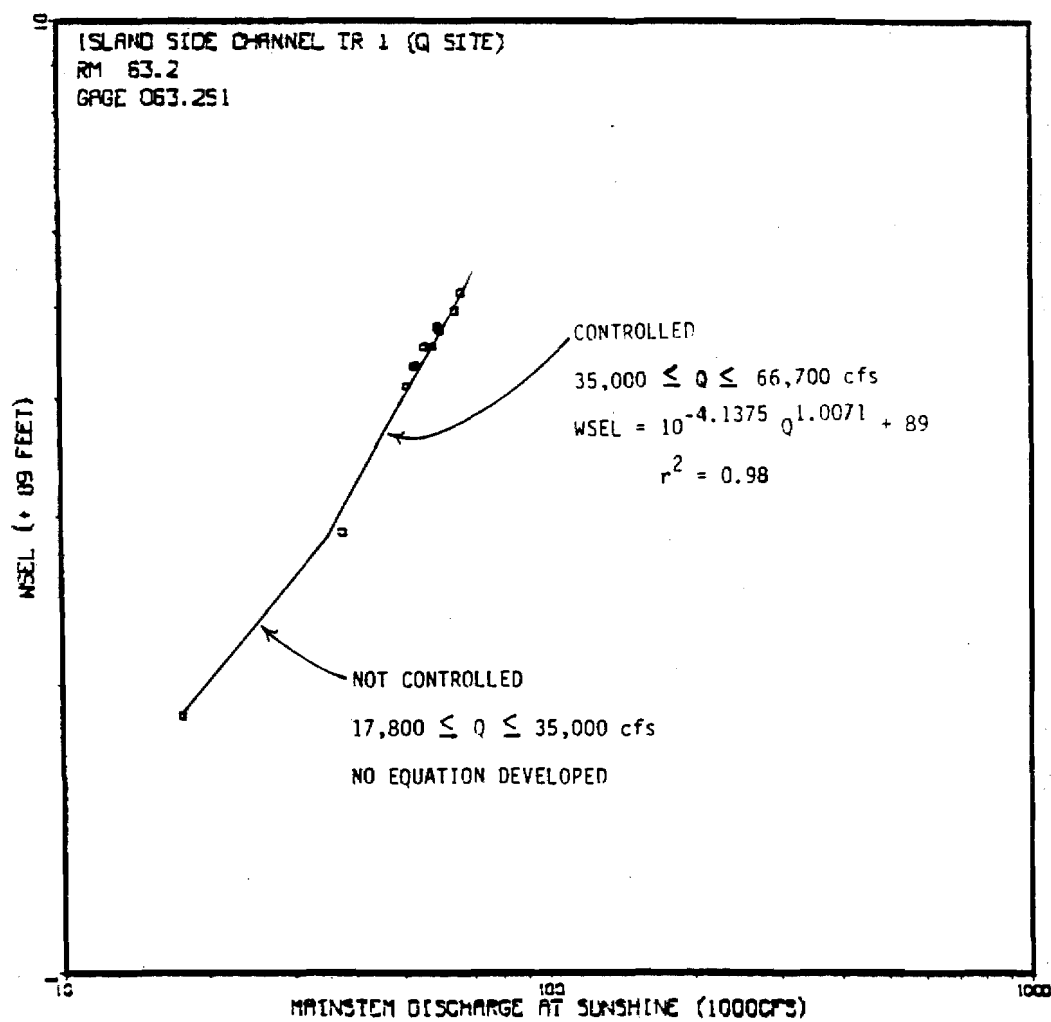
Attachment Figure E-7. WSEL versus mainstem discharge (USGS 15292780) at Island Side Channel transect 1 (Q site).
