**SUSITNA
HYDROELECTRIC PROJECT**

FEDERAL ENERGY REGULATORY COMMISSION
PROJECT No. 7114

**RIPARIAN VEGETATION
SUCCESSION REPORT**

JUNE 1985
DOCUMENT No. 3099

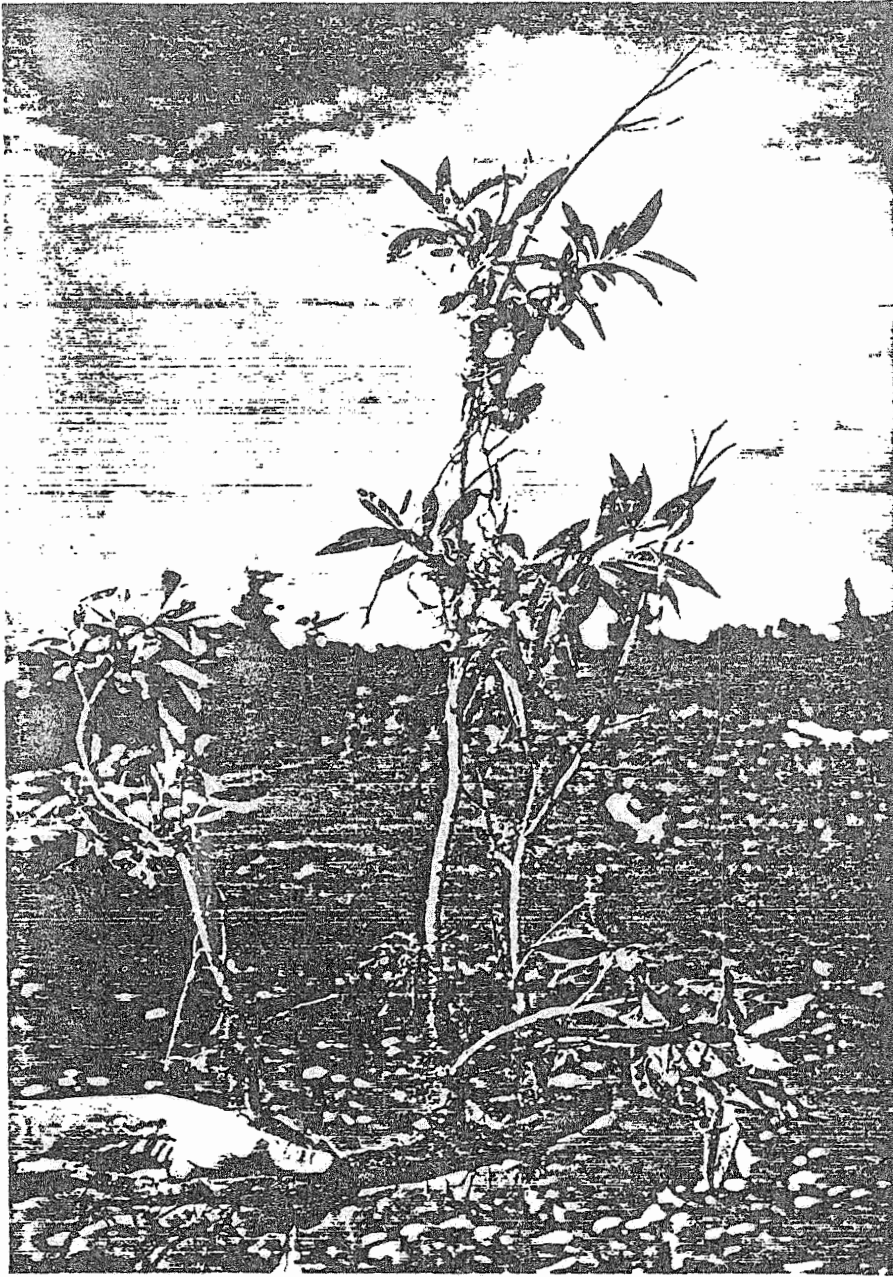
Figure 11. Feltleaf willow plant which has been buried and regrown.

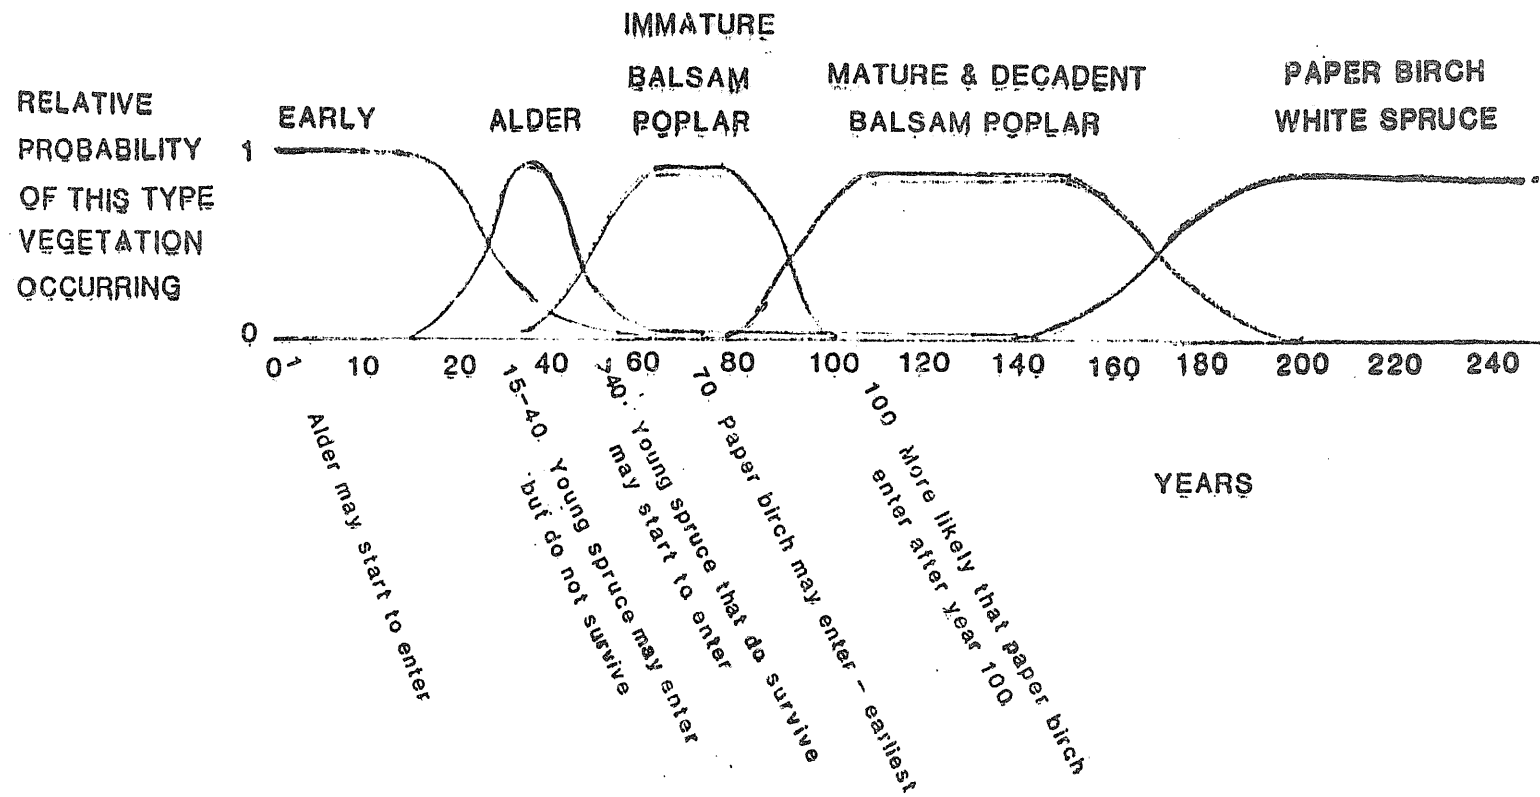
FIGURE 15. Time line indicating vegetation types and major events during succession along the Susitna River.

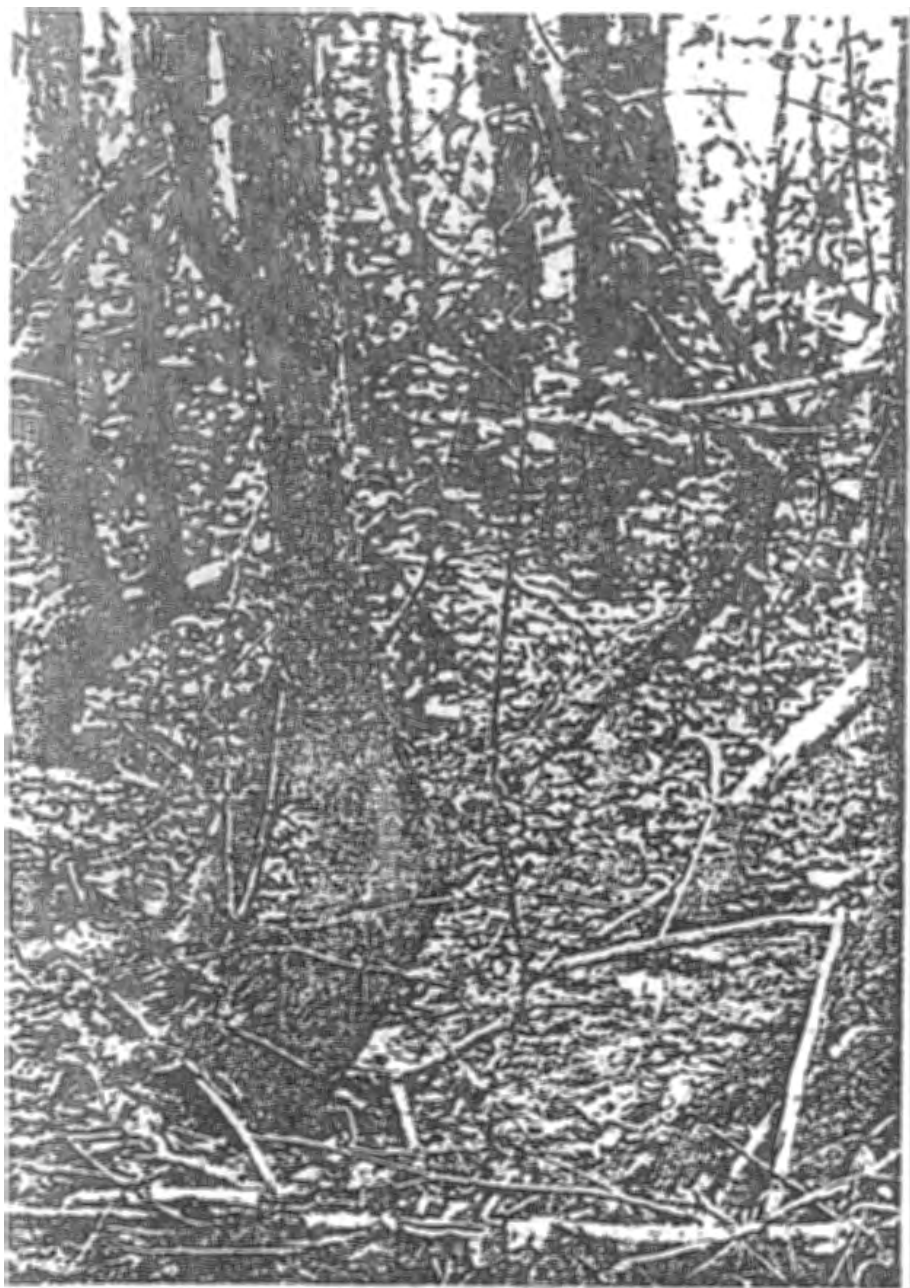
Figure 16. Alder and immature balsam poplar that have been bent during ice jam flooding, site 12.

Ice may strongly affect some of the stems in these intermediate sites. The stems are rigid enough that when they get knocked down by ice, they do not spring back as the more resilient stems of the early successional stages do. However, they are not so rigid that they are broken as in later successional stages. The bent stems may then resprout. The site is still basically in the same stage that it was before the ice scour, but it has a younger age structure. For instance, if a 20-year old alder stand were leveled by an ice jam flood, 1-year old stems would be present the next year growing vertically from the horizontal 20-year stems. Hence, the age distribution has been reduced from a mean of 20 years to a mean of 1 year. This may occur repeatedly along the same sections of the river, but it usually occurs only in localized positions where jams occur frequently (Figures 16, 17).

The amount of damage and vegetation stages affected would be determined by the size of the ice jam. For instance, near Whiskers Creek (cross section LRX-7, site 12), jams occur almost every year. The uppermost end of the island has early successional vegetation that gets knocked back and buried rather frequently. An alder stand occurs slightly downstream and portions of it were last leveled nearly 2 decades ago. Further downstream was an immature balsam poplar site with several scarred trees, some scars 2 m above ground, and some trees have several sets of scars from the several times they had been scraped. Repeated scraping may affect the vigor of the plant, but it does not usually cause retrogression to an earlier vegetation stage.

Site 12 was first visited approximately 2 to 3 weeks after an ice jam. Willows on the north side had been bent at approximately a 45 degree angle and may have received a few scrapes, but did not appear otherwise damaged. The upper end appeared barren at first with piles of sediment having been deposited by melting ice blocks and some areas of soil having been pushed by the ice (Figure 17¹⁸). Closer examination, however, revealed young willow plants poking through the debris. In addition to being matted down, they were also scraped in places, but they were beginning to leaf out. The portions above ground appeared to be only a few years old. However, the presence of even a few stems could make a big difference in successional rates because these stems could propagate vegetatively rather than waiting
