The Effect of the Hydro Dam  
on the  
Mayo River Fish Stocks

Report

January 31, 1973

Department of the Environment  
Fisheries Service  
Northern Division  
Whitehorse, Yukon Territory

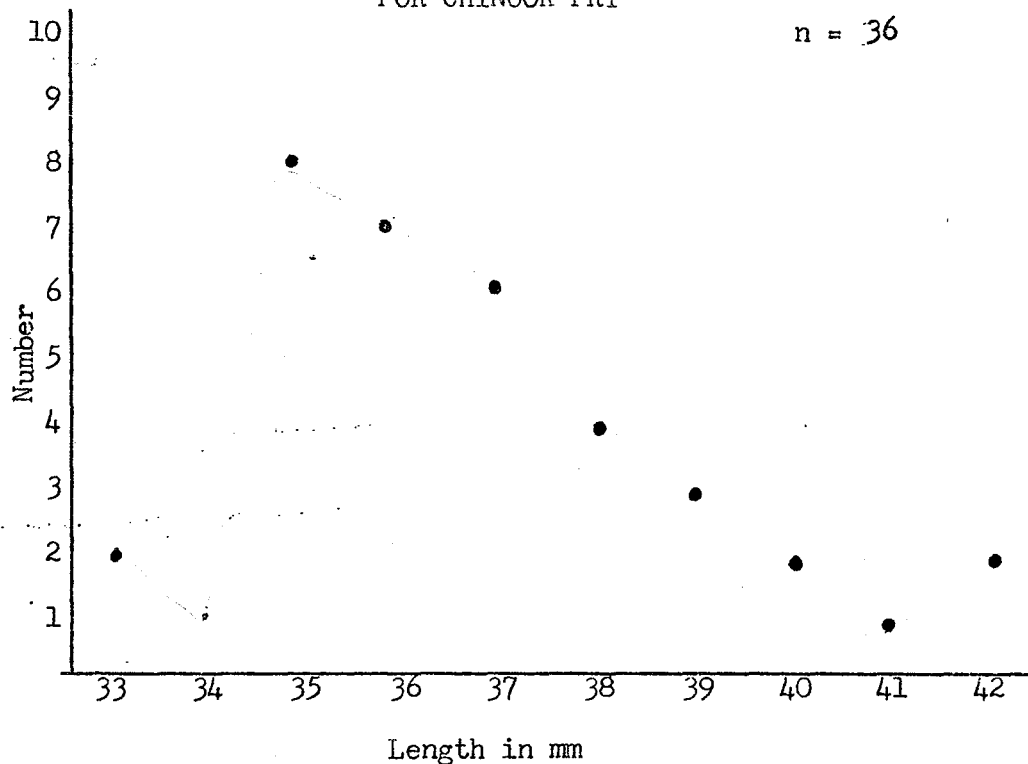
Seineing produced large numbers of immature grayling and round whitefish as well as numerous chinook salmon fry. Fig. #2 gives the length frequency distribution of 36 chinook fry captured by seine during the study period.

LENGTH FREQUENCY - JULY 1972  
FOR CHINOOK FRY

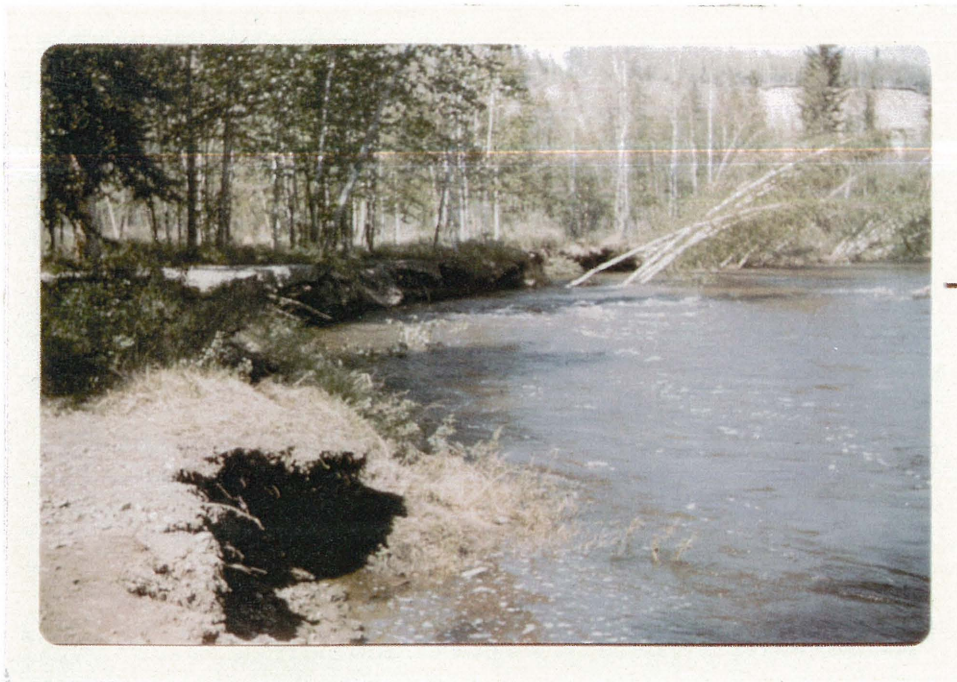
Fig. # 4 Bank erosion at Campground on Mayo River

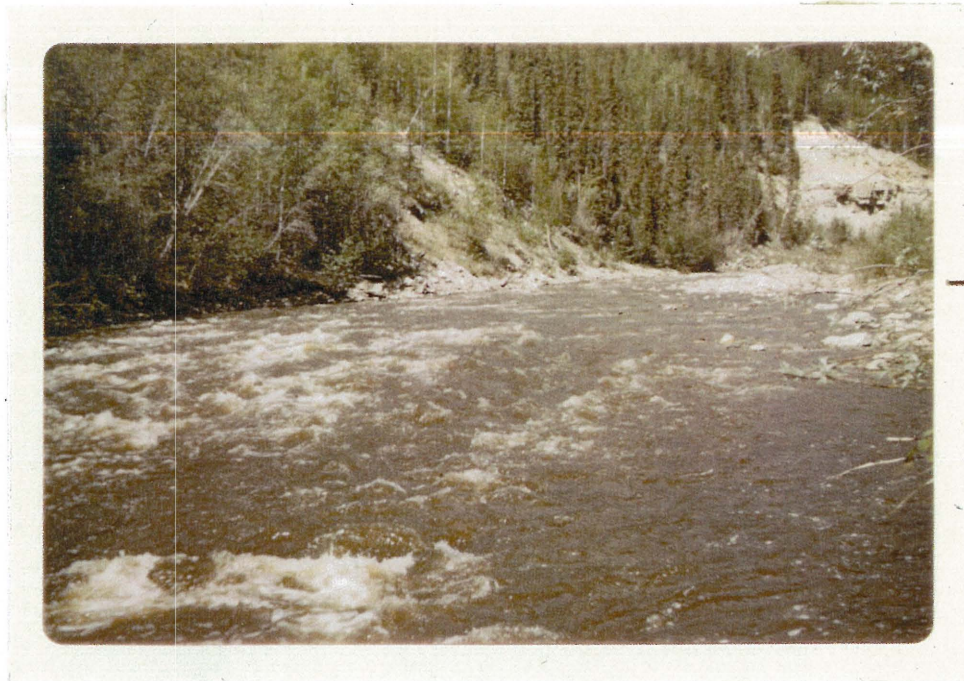
Fig. # 6

Area below Powerhouse where chinook are reported to spawn.

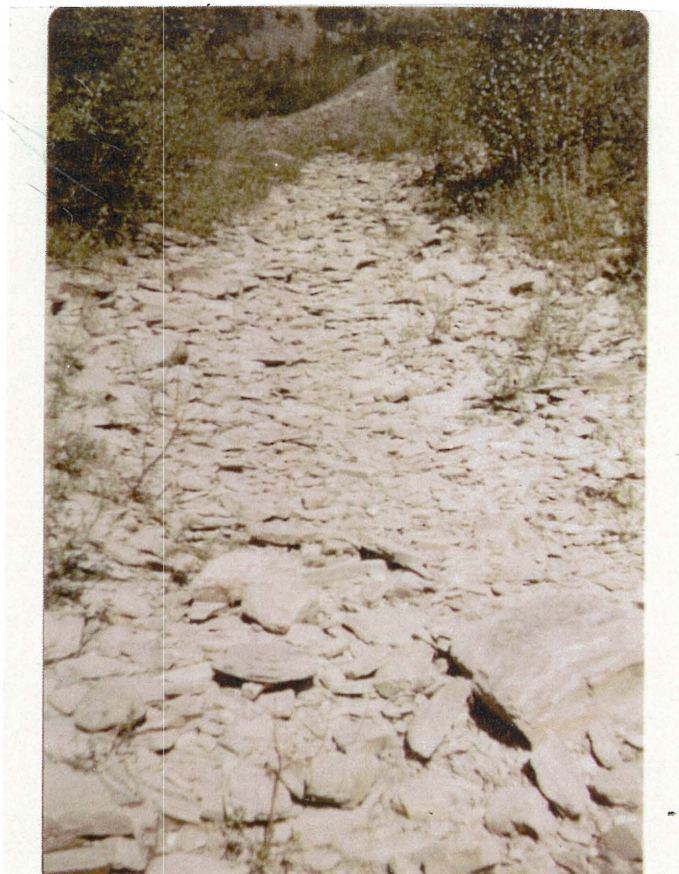
Fig. # 7

Dry channel between Dam and Powerhouse

- (1) The incomplete nature of findings from this years work suggests that further studies be undertaken in the Mayo area.
- (2) Some time should be spent in the area soon after break-up in order to assess the chinook smolt migration. Scale samples should be taken in order to establish an age index for these juvenile fish.
- (3) Efforts should be made to locate important spawning grounds for chinook salmon, chum salmon, grayling, suckers and round whitefish.
- (4) Spawning counts of chinook and chum salmon should be carried out in the Mayo River below the dam.
- (5) The operation of the N.C.P.C. Dam should be observed in order to prevent actions with potentially harmful results, ie. shut off of flows and continual fluctuation of discharge.
