Technical Memorandum, Susitna River Large Woody Debris Reconnaissance (March 2013)

Susitna River Large Woody Debris Reconnaissance

Susitna- Watana Hydroelectric Project
FERC No. 14241

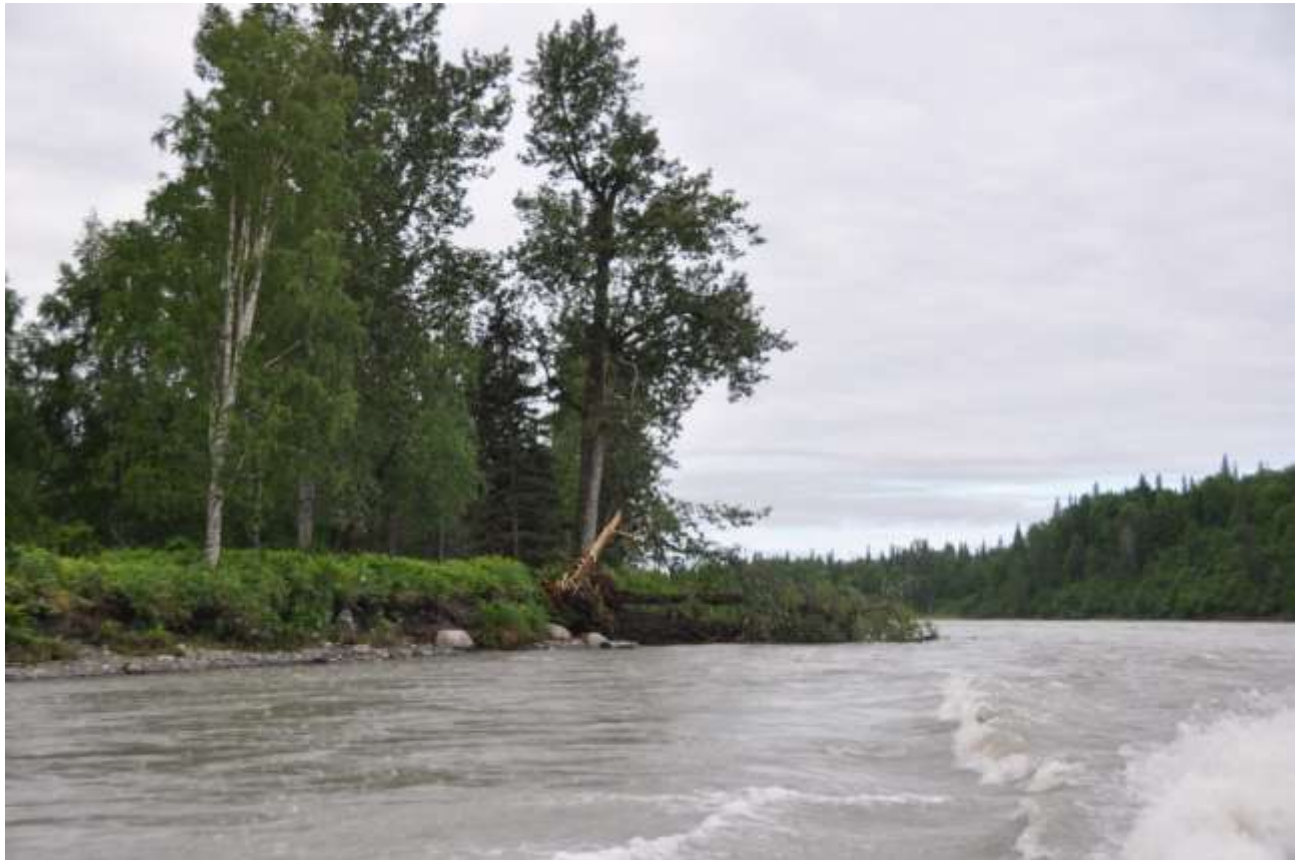
Photograph 1. June 26, 2012 Susitna Middle River between Three Rivers Confluence and Gold Creek. Wind snapped and wind throw balsam poplar recruitment to channel.

Incremental wind throw and wind snap of large trees, primarily Balsam poplar, along floodplain margins, and incremental bank erosion were the primary recruitment processes observed in summer 2012 (Photographs 1-3). Many mid-channel trees observed being transported below the Three Rivers confluence have attached root wads, evidence of a recent bank erosion recruitment (Photographs 4-8). Although details were not documented for this report, the 78,000 cfs flood event of September 22, 2012 (Gold Creek gage) was observed in early October, 2012 to have caused large scale recruitment of trees to the river as a result of bank erosion.

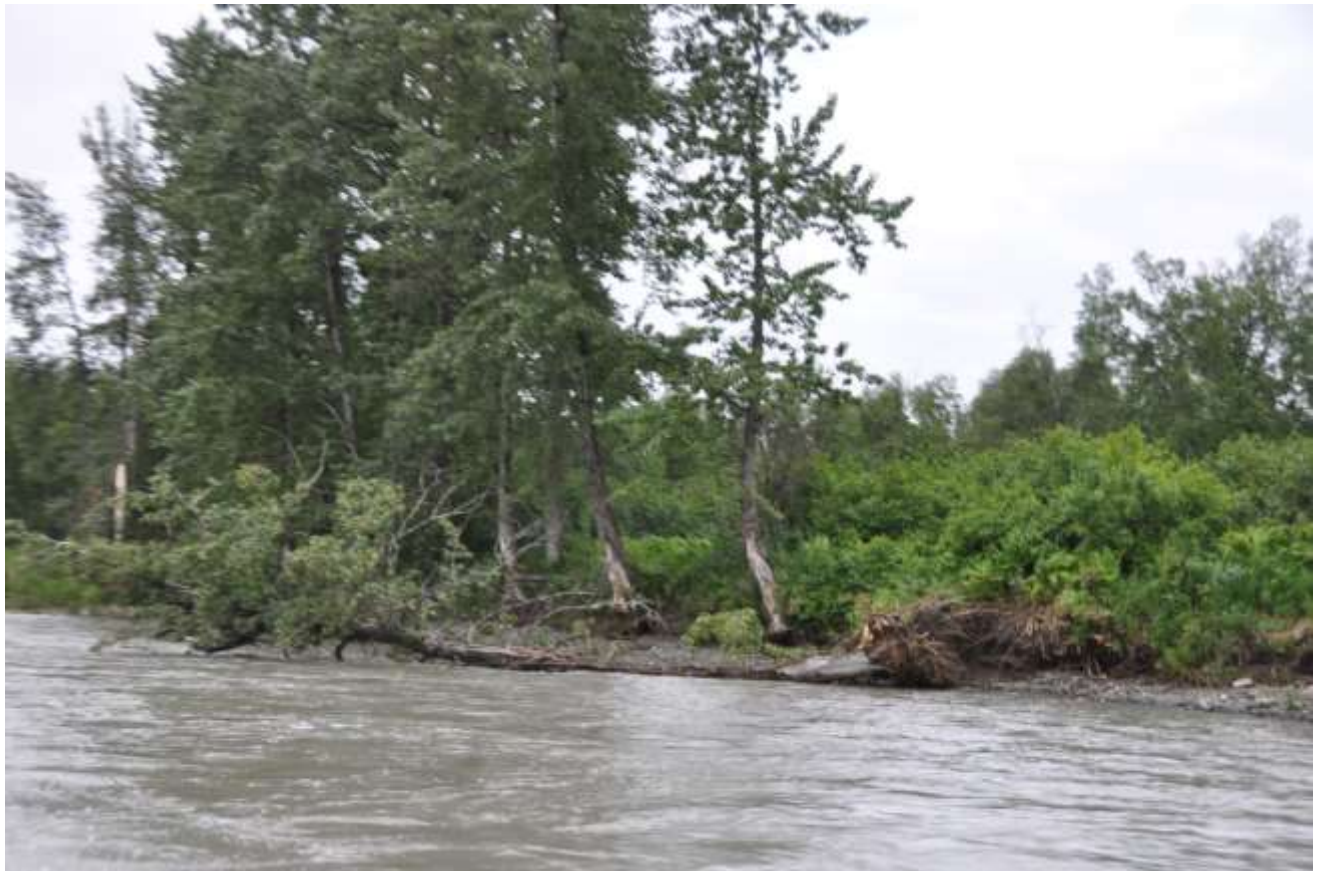
Photograph 2. June 26, 2012 Middle Susitna River between Three Rivers Confluence and Gold Creek. Bank erosion and wind throw balsam poplar wood recruitment.

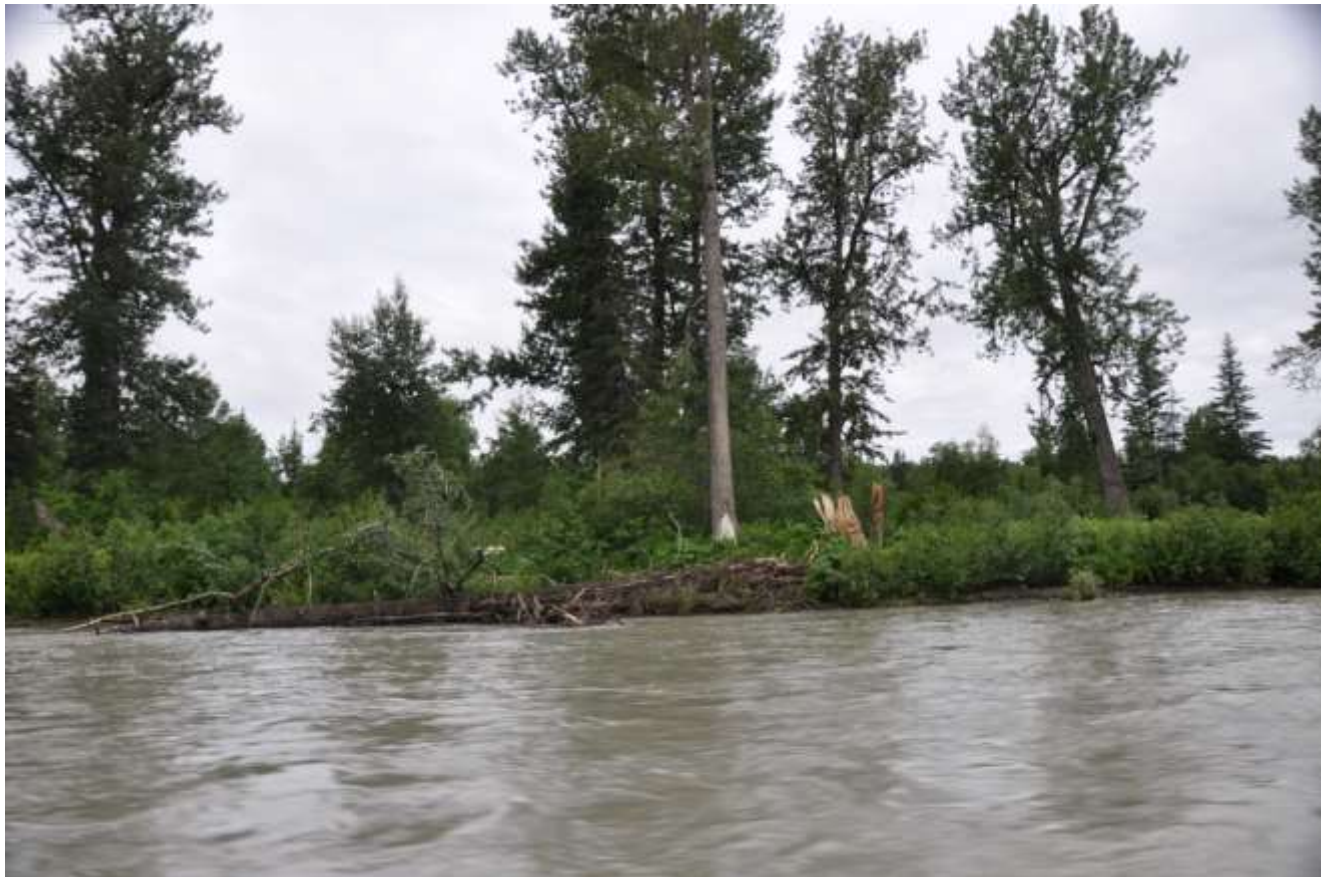
Photograph 3. June 26, 2012 Middle Susitna River between Three Rivers Confluence and Gold Creek. Wind snap balsam poplar recruitment.

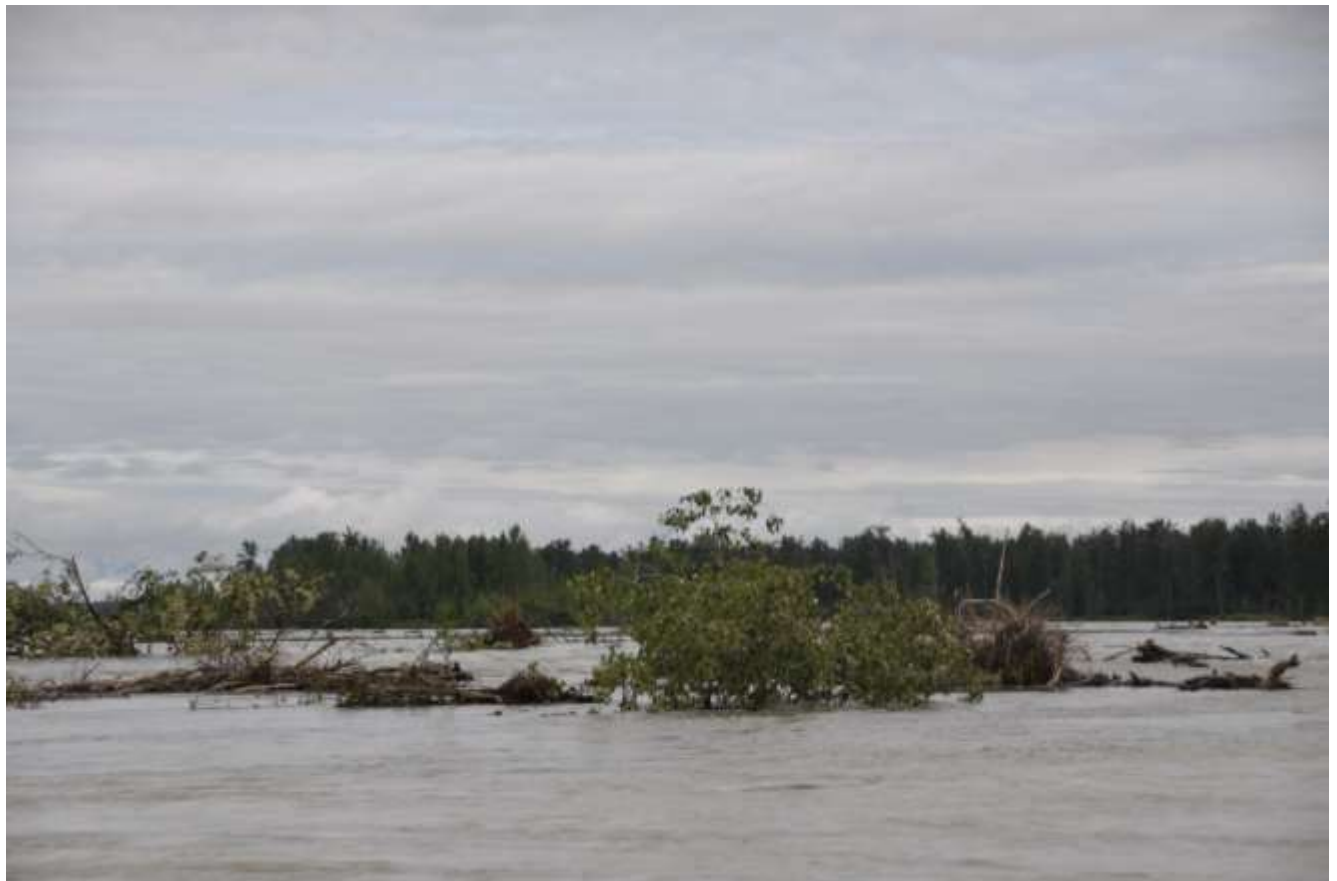
Photograph 4. June 26, 2012 Three Rivers (Susitna, Chulitna, and Talkeetna rivers) Confluence. Fresh recruited balsam poplar transport.

Wood transport, in June and July 2012, was observed to be predominantly occurring at and below the Three Rivers Confluence (Photographs 4, 5, 6, 9, 10). The Chulitna River appears to be a major source of the wood transported into the Lower Susitna River (Photographs 4-6) as large amounts of wood were observed in the main stem Chulitna River at Three Rivers Confluence. The braided reach below Three Rivers Confluence is a transport limited segment of the Susitna River as evidenced by both channel braiding and the large amount of deposited racked and unstable wood debris (Photographs 9 and 10). Wood transport was observed in the Middle Susitna; however, it was limited to single trees with root wads attached, evidence of incremental bank erosion recruitment (Photographs 7 and 8).

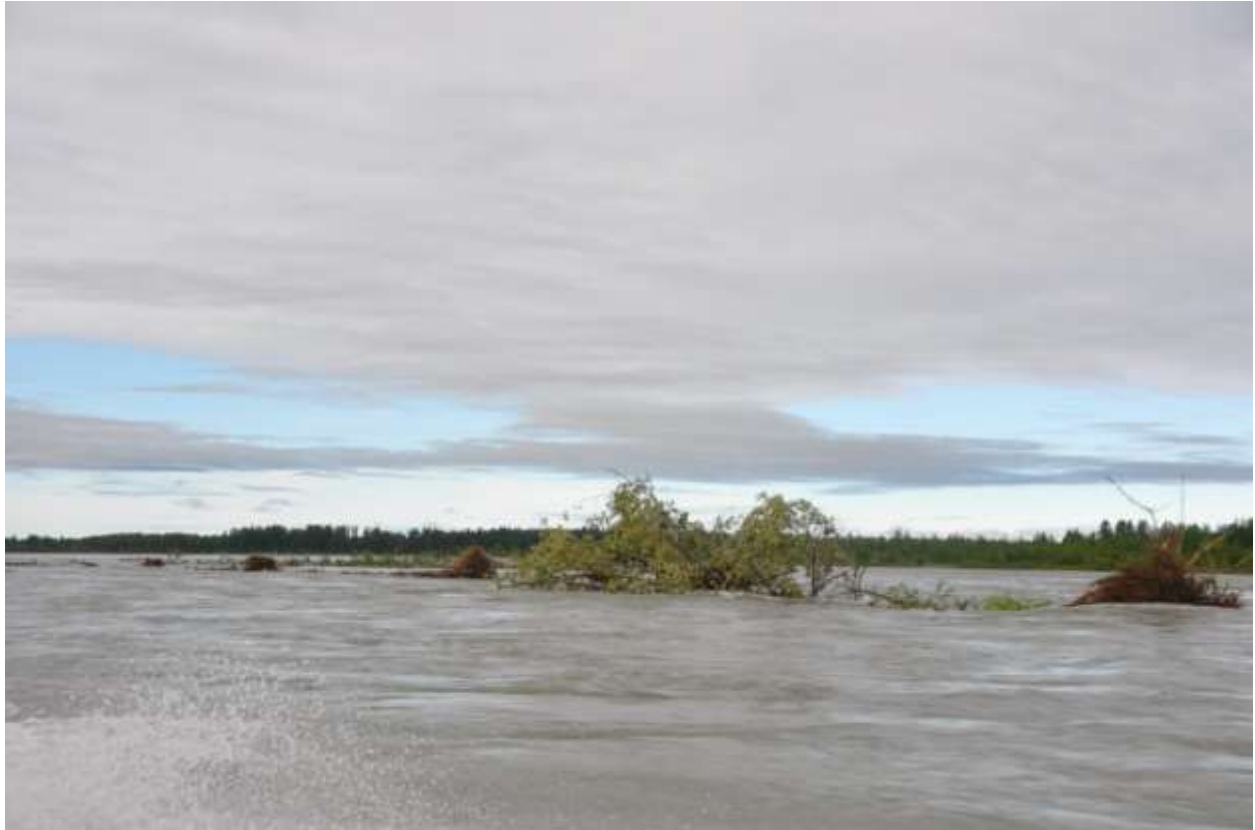
Photograph 5. June 26, 2012 Three Rivers (Susitna, Chulitna, and Talkeetna rivers) Confluence. Fresh recruited balsam poplar transport.

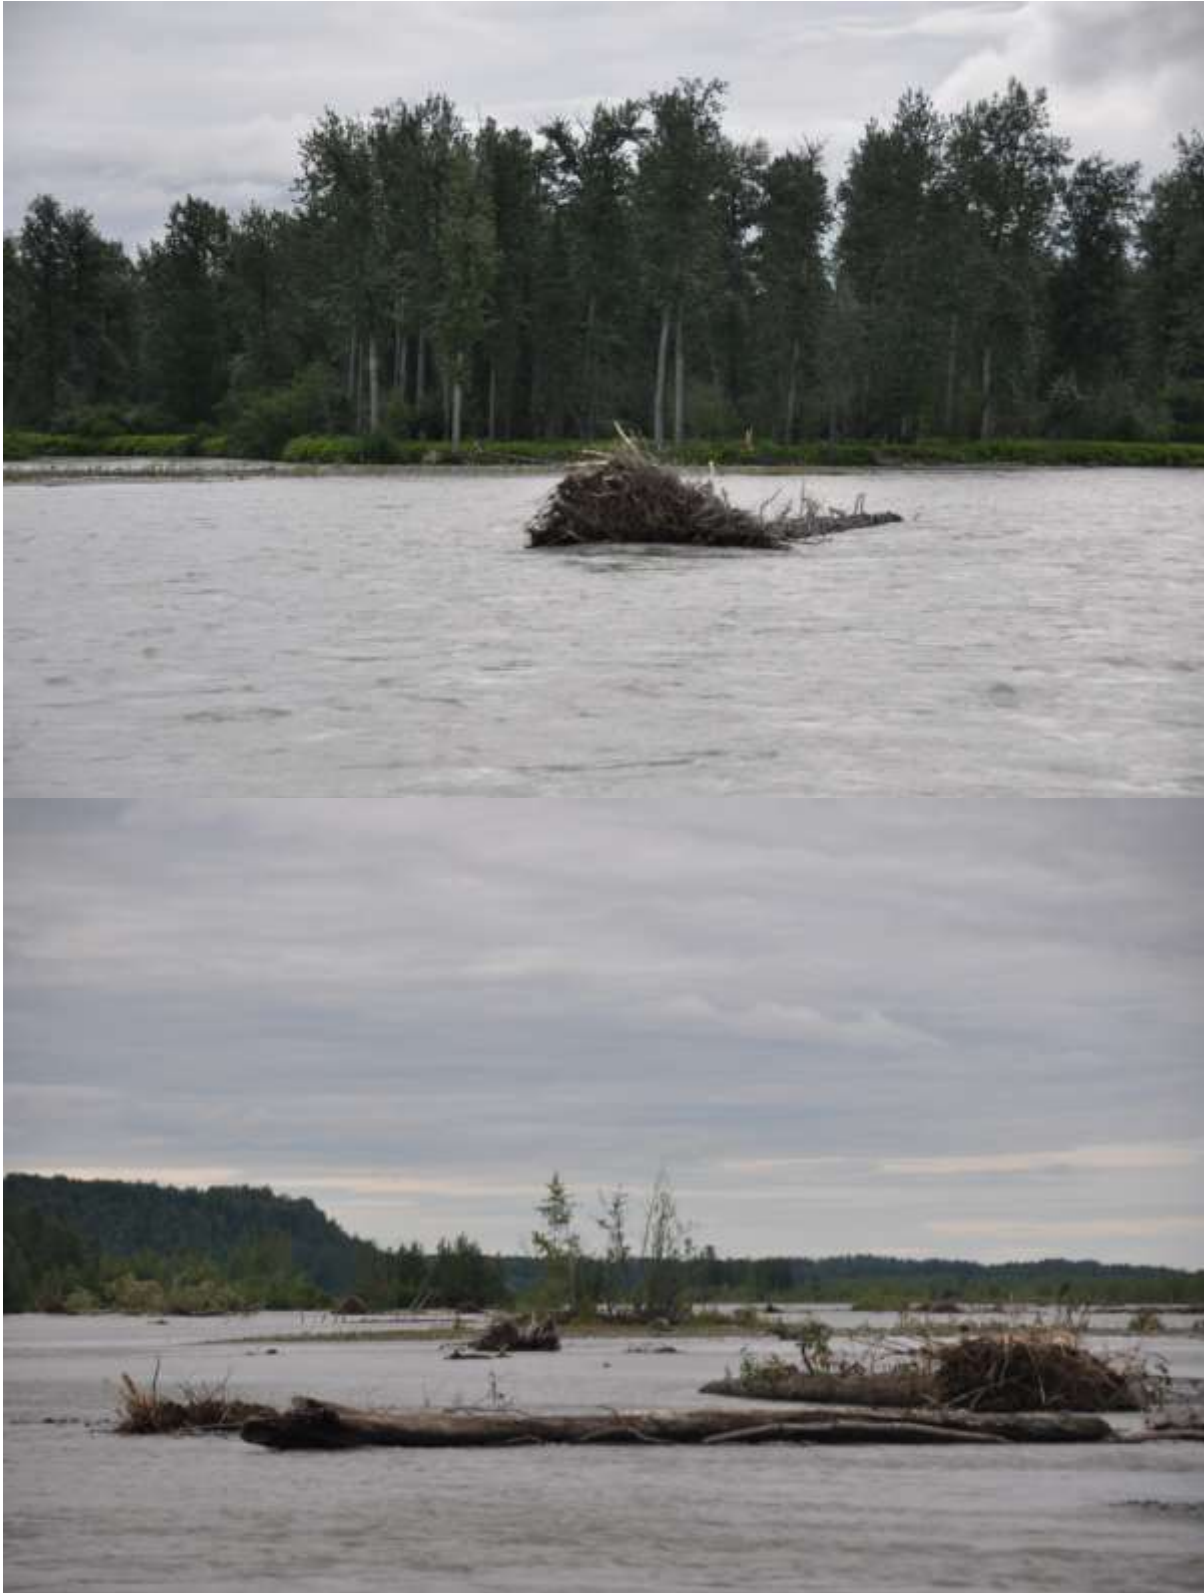
Photograph 6. June 26, 2012 Three Rivers (Susitna, Chulitna, and Talkeetna rivers) Confluence balsam poplar transport.

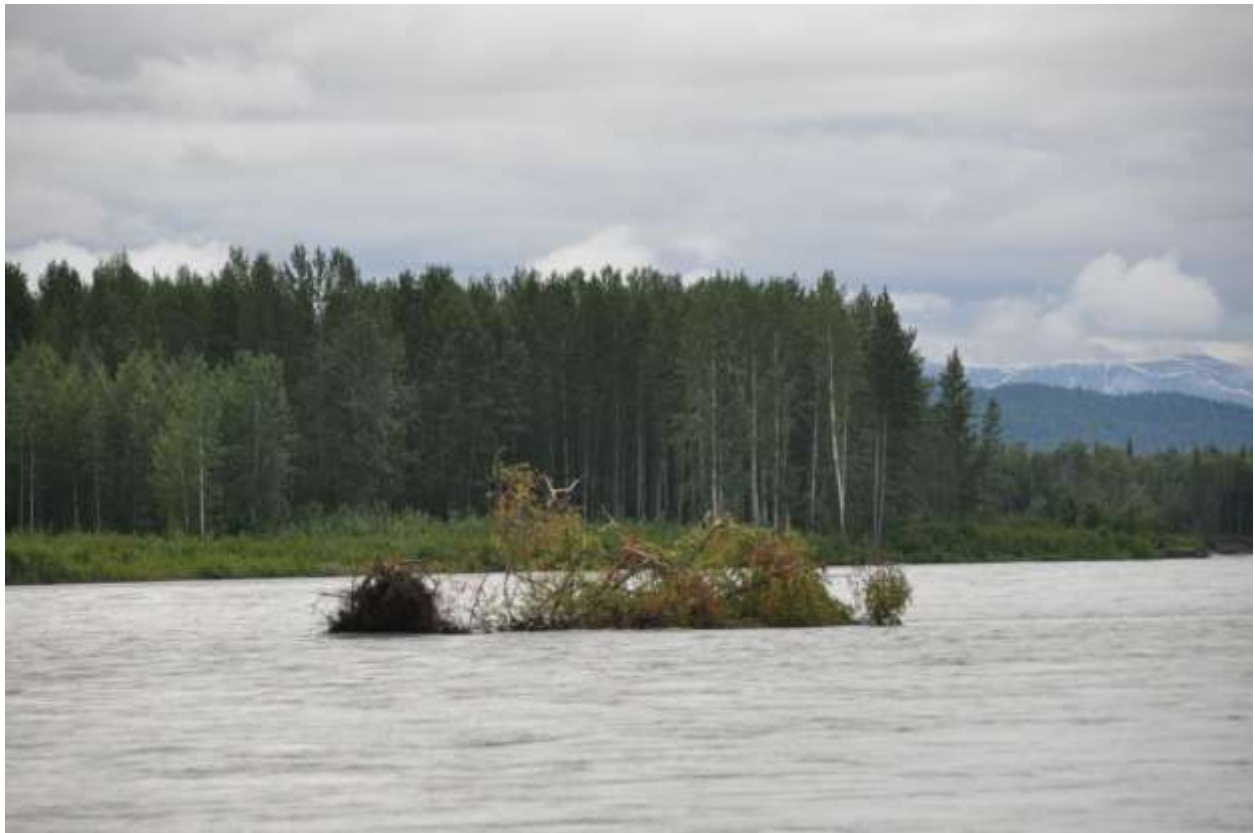
Photograph 7. June 26, 2012 Middle Susitna River immediately upstream of Three Rivers Confluence. Freshly recruited white spruce.

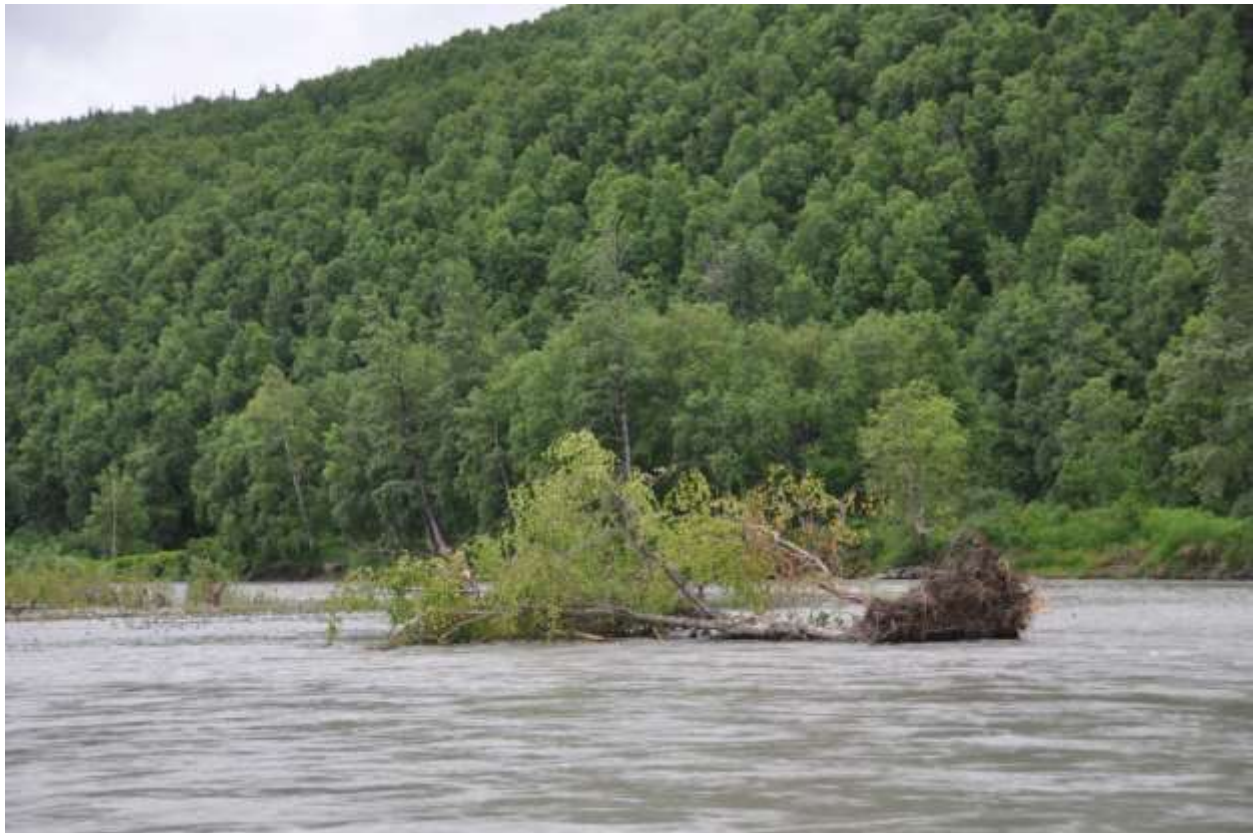
Photograph 8. June 26, 2012 Middle Susitna River wood transport. Paper birch deposited on a mid-channel island bar.

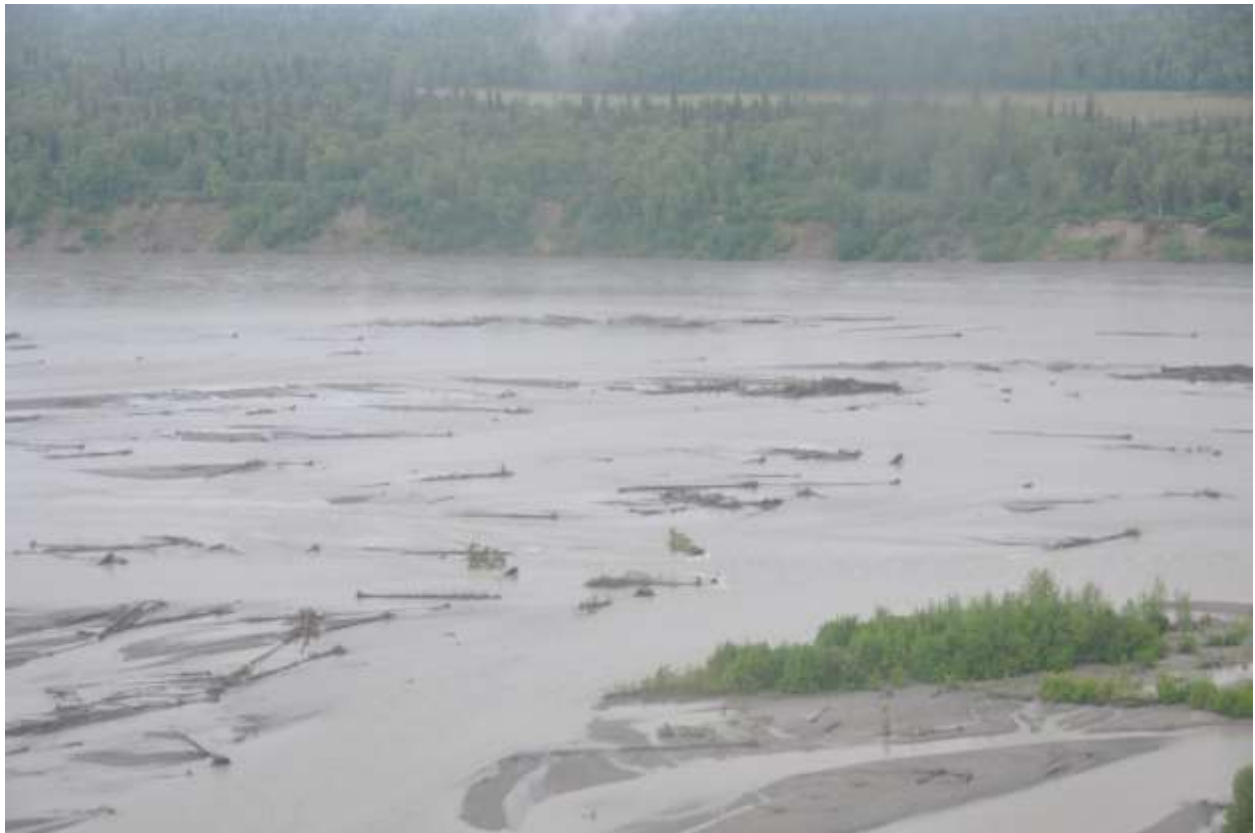
Photograph 9. June 30, 2012 Lower Susitna River between Talkeetna and Willow. Large wood transport and deposition. Root wads are facing upriver. Flow is from right to left.

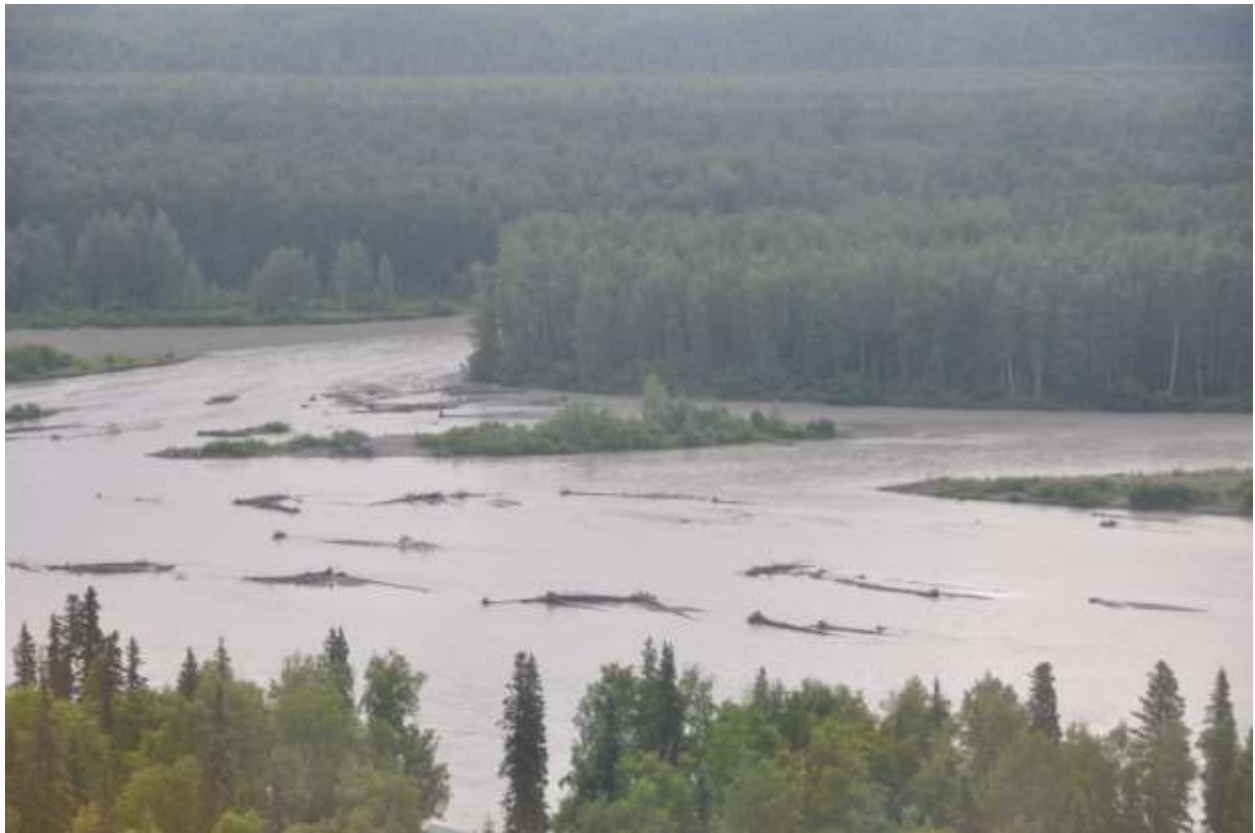
Photograph 10. June 30, 2012 Lower Susitna River between Talkeetna and Willow. Large wood transport and deposition. Root wads are facing upriver. Flow is from left to right.

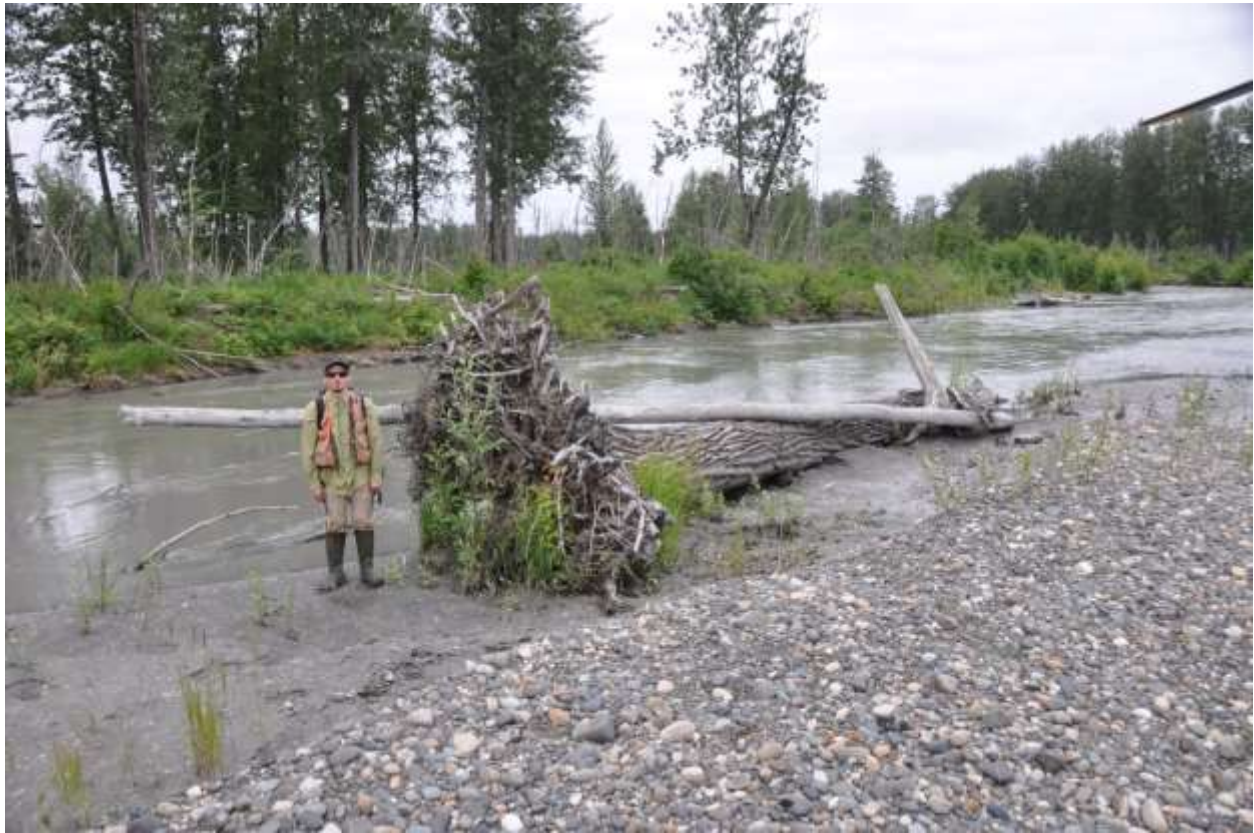
Photograph 11. July 2, 2012 Lower Susitna River below Talkeetna. Large balsam poplar (79 cm diameter, DBH) with root wad (210 cm diameter) and adjacent scour pool formation (Sample Plot T19_04).

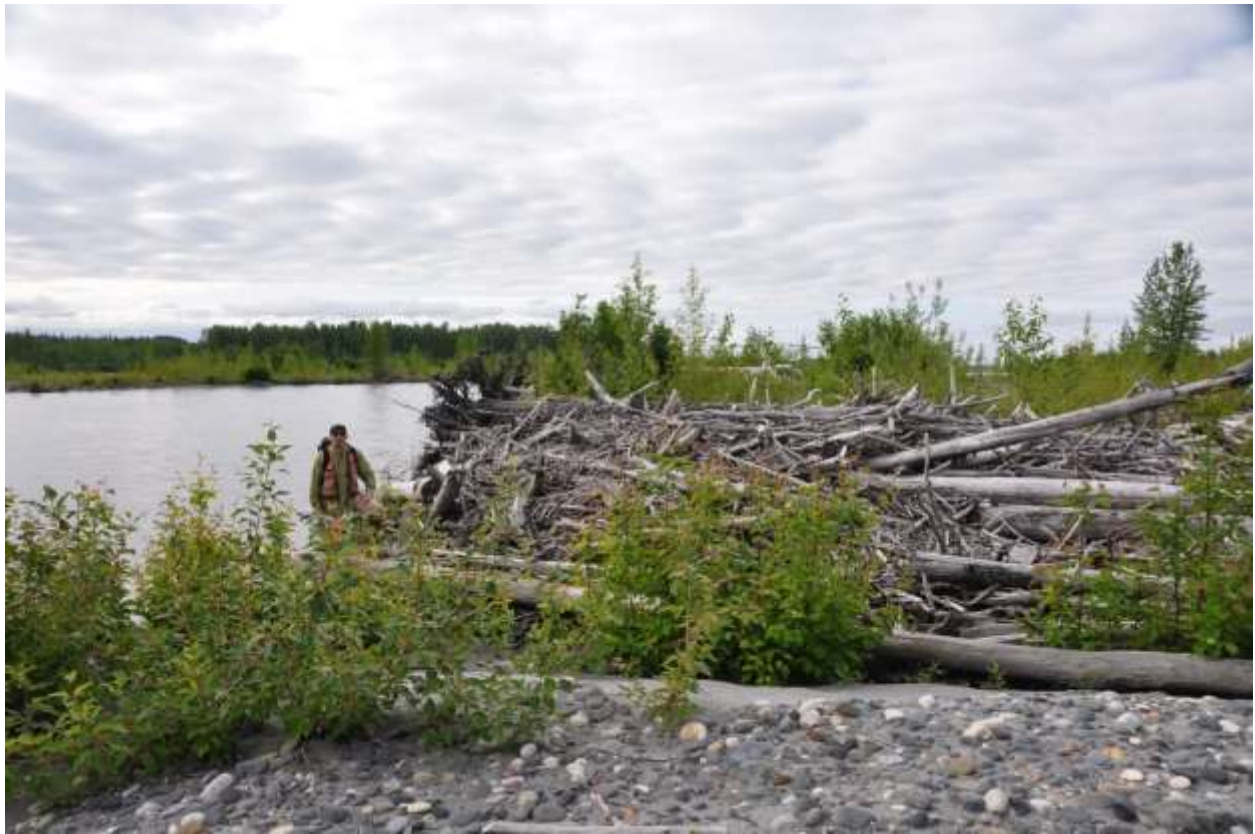
Photograph 12. July 2, 2012 Middle Susitna River near Talkeetna. Wood jam with key and racked members.

Also, observed stable wood jams were associated with scour pools, islands, channel embankments, and side channel complexes (Photographs 12-17, 19-30).

In large alluvial rivers, such as the Susitna, recruitment of floodplain streamside trees through bank erosion can result in wood debris structures composed of logs hydraulically aligned parallel to the channel bank that become embedded into the floodplain further stabilizing channel banks (Abbe and Montgomery 2003; Photographs 12, 17, 27, 28, 29, 30). Additionally, loose mobile wood debris was observed accumulating along river embankments forming unstable wood debris accumulations (Photographs 12, 17, 28, 29, 30).

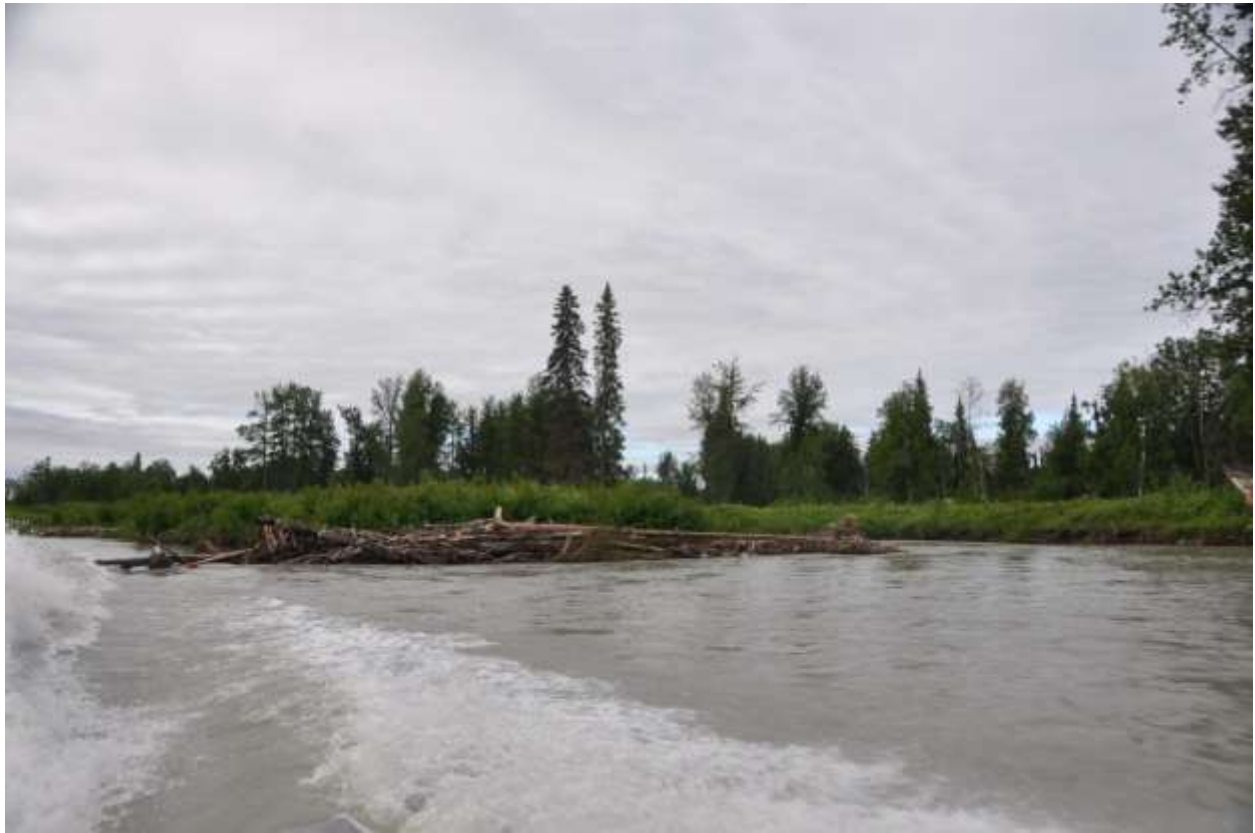
Photograph 13. June 26, 2012 Middle Susitna River wood jam at head of mid channel island and adjacent side-channel.

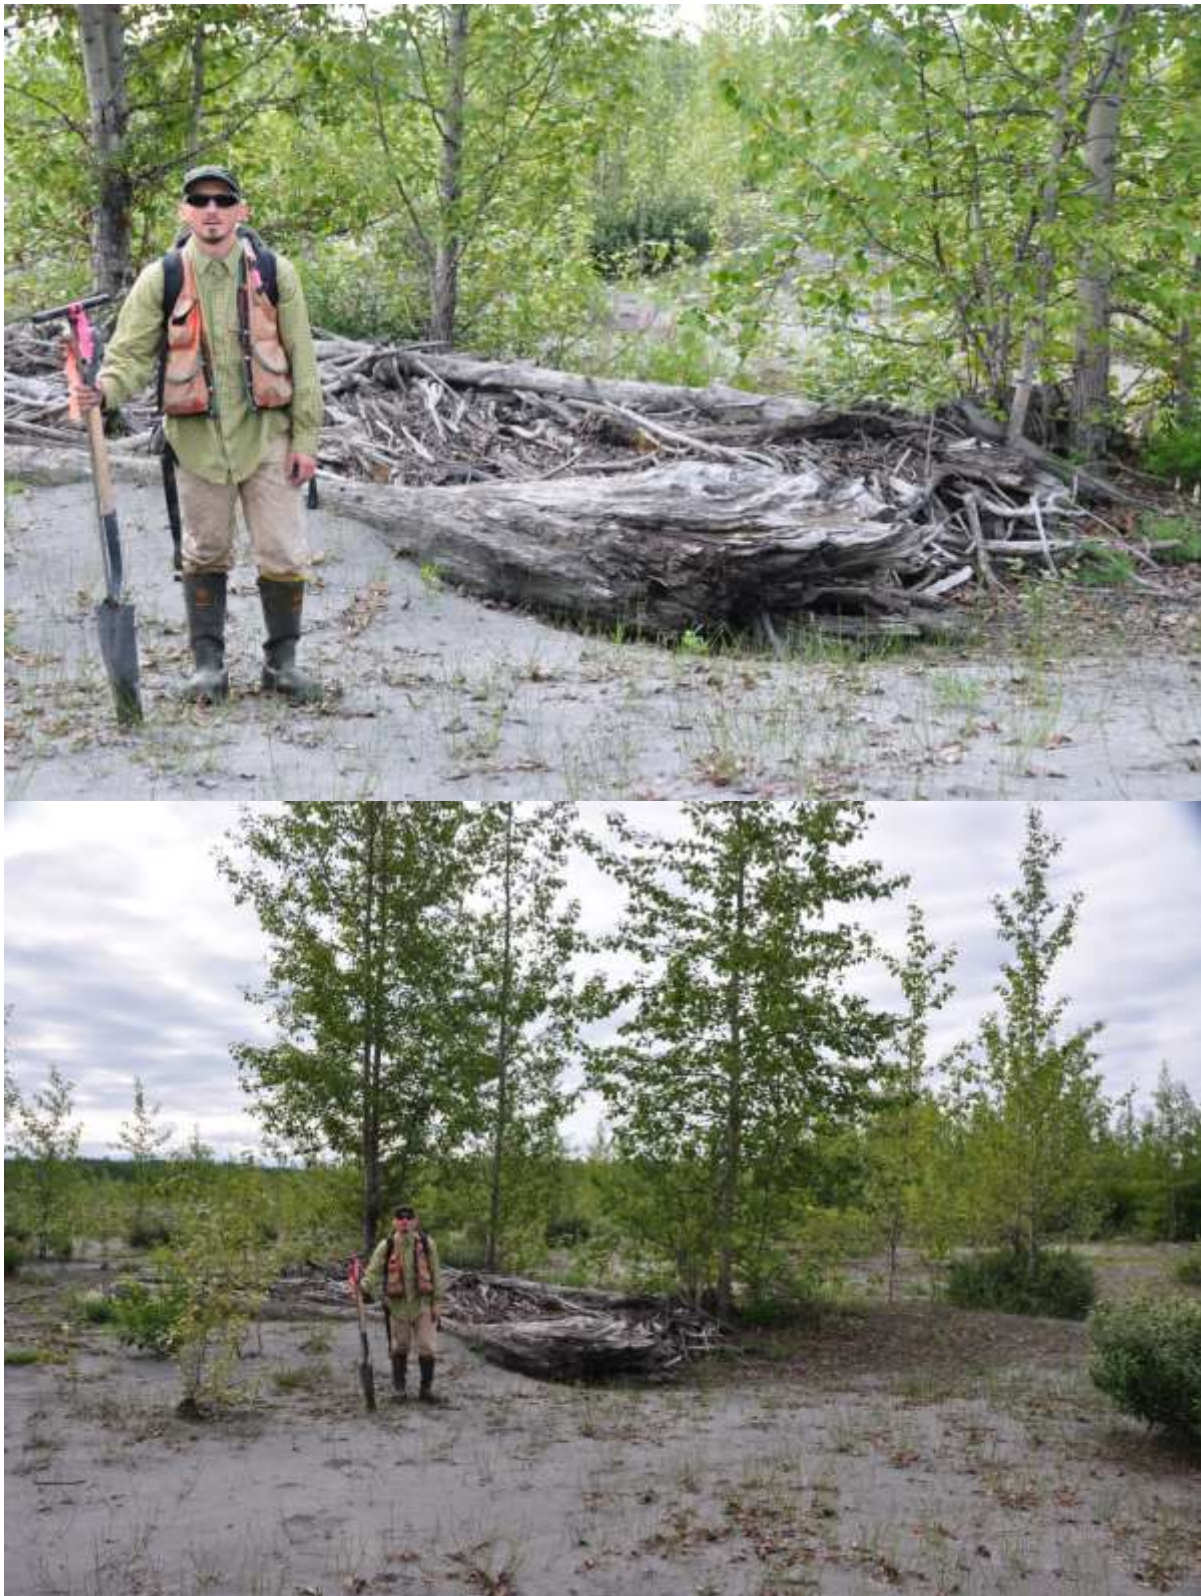
Photograph 14. July 2, 2012 Lower Susitna River near Talkeetna. Partially buried key member with racked members and unstable wood. Young balsam poplar establishment in association with wood jam.

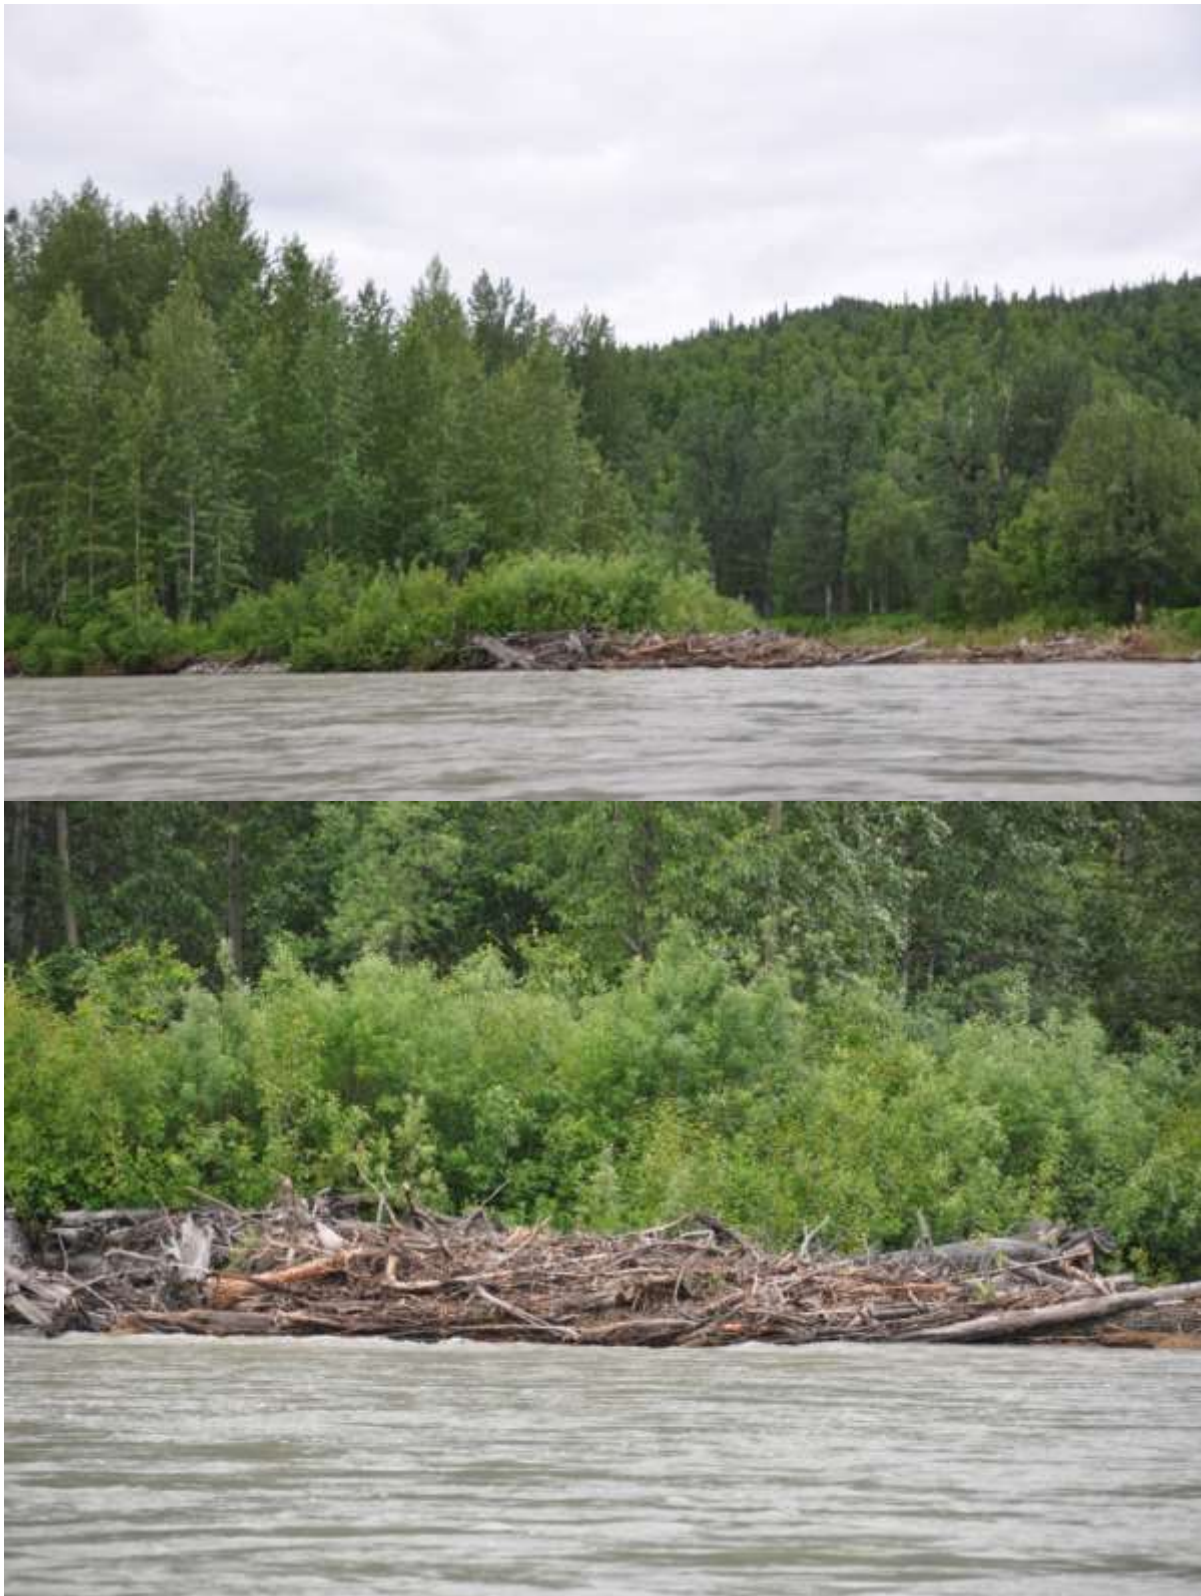
Photograph 15. June 26-27, 2012 Middle Susitna River above Three Rivers Confluence. Wood jam located at island apex and side channel entrance. Lower Photograph close up of wood jam with small diameter racked and loose members.

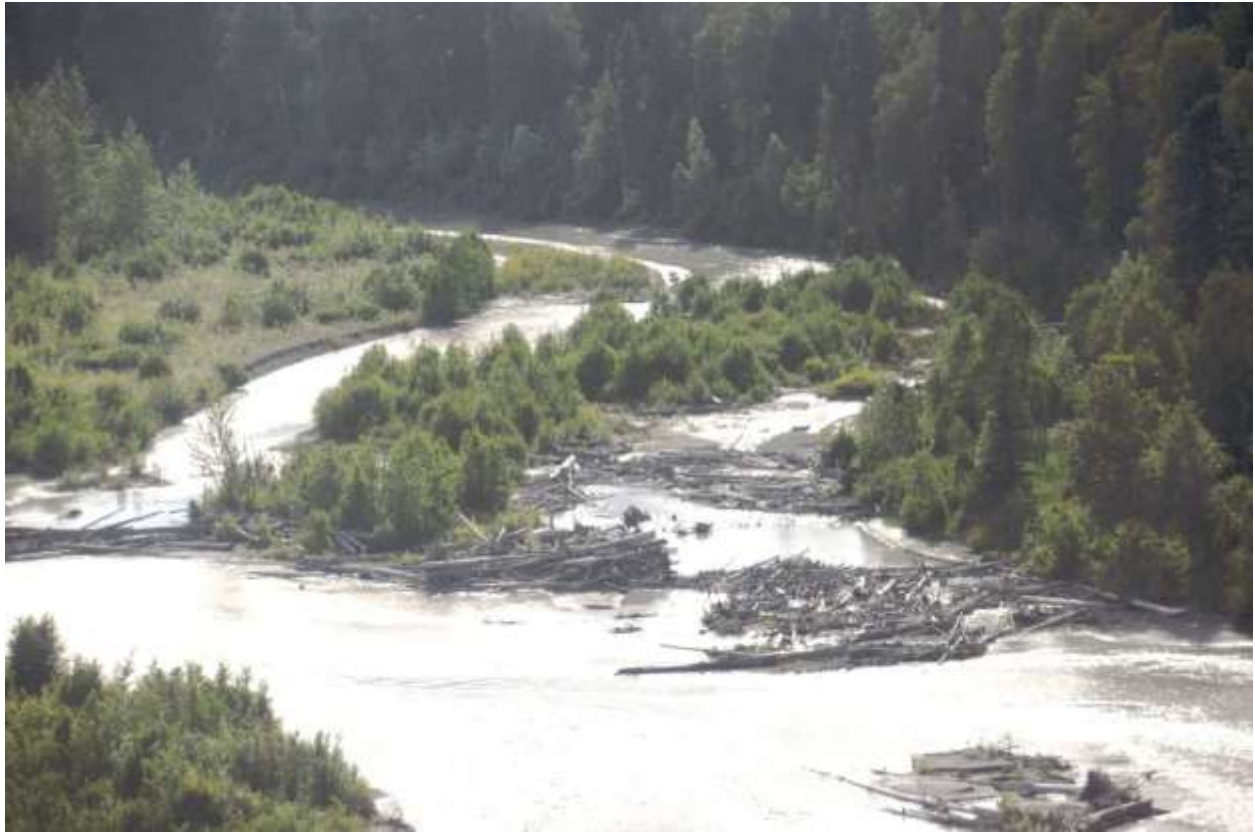
Photograph 16. June 30, 2012 Lower Susitna River below Talkeetna. Rafts of racked and unstable wood. Accumulations at island apex and main stem side-channels.

Bar top accumulations of unstable wood debris appear to be a defining characteristic of the Susitna River. Large quantities of unstable wood debris were observed throughout the Project study area with largest accumulations occurring in the Lower Susitna (Photographs 9, 10, 21) with apparently large contributions from the Chulitna River. However, unstable wood debris was observed throughout both Middle and Lower River segments during the 2012 aerial reconnaissance (Photographs 16, 21, 31, 32, 33, 34, 35, 36, 37). Loose, mobile wood was observed along river banks (Photographs 2, 3), mid channel islands (Photographs 18, 20), and throughout side channel complexes (Photographs 16, 17, 18, 21, 34).

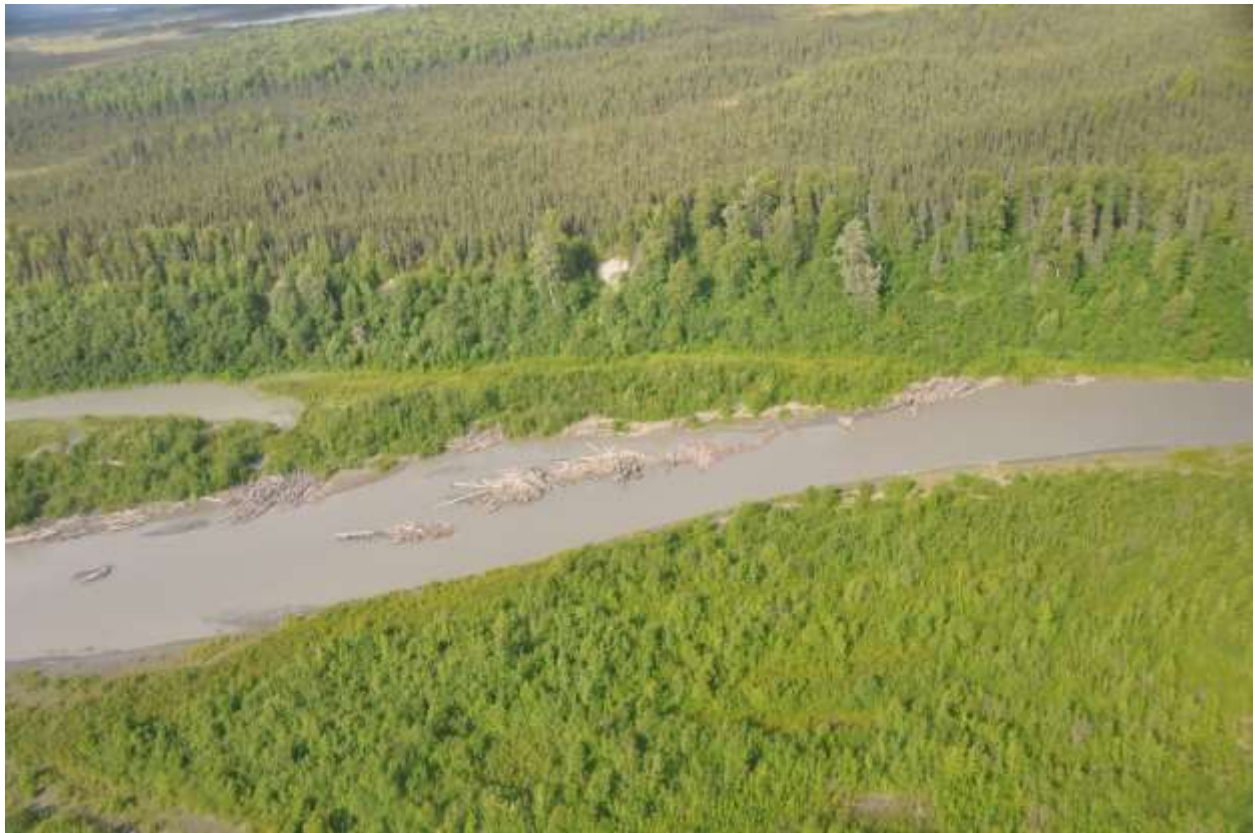
Photograph 17. July 2, 2012 Lower Susitna River side channel between Talkeetna and Willow. Rafts of wood debris in side channel and along floodplain embankment.
