Technical Memorandum, Susitna River Large Woody Debris Reconnaissance (March 2013)

Susitna River Large Woody Debris Reconnaissance

Susitna- Watana Hydroelectric Project
FERC No. 14241

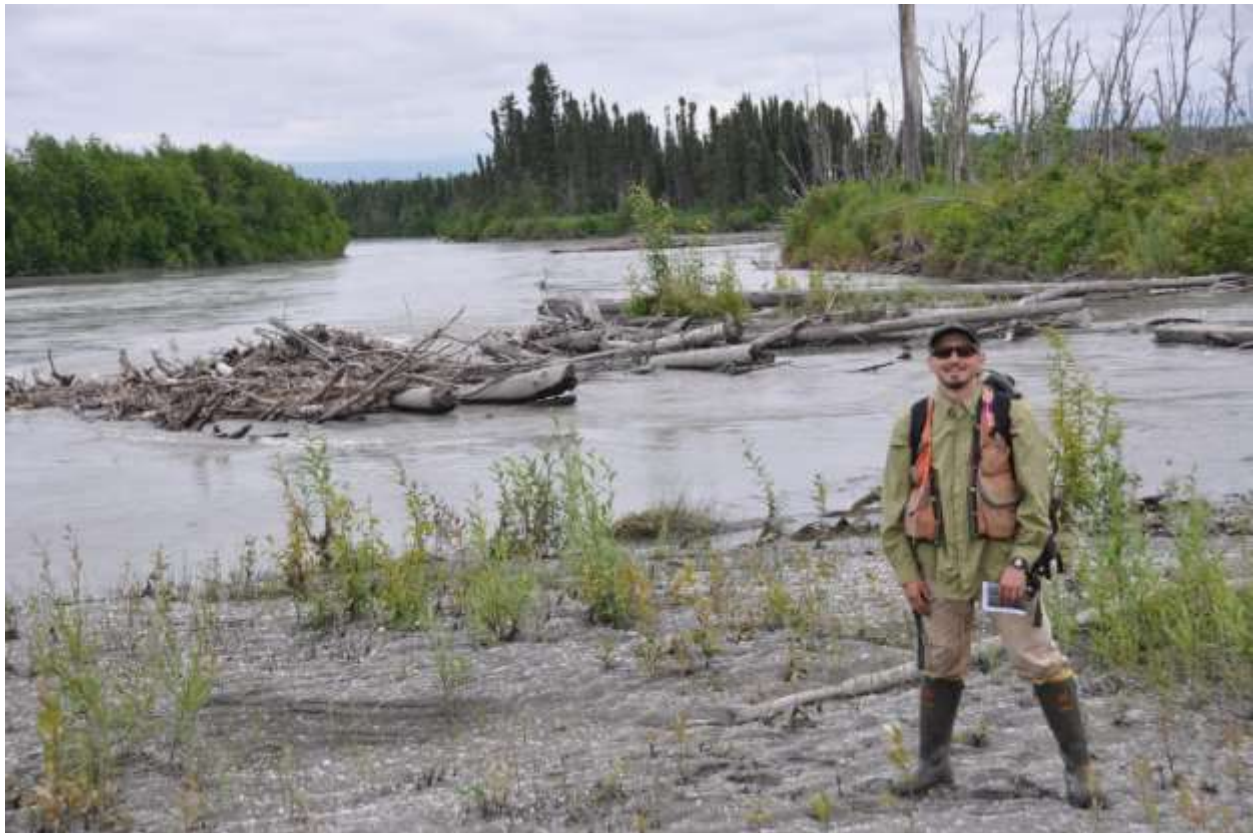
Photograph 18. July 2, 2012 Lower Susitna River between Talkeetna and Willow. Close-up of racked wood debris deposited on side channel gravel bar.

Bar top accumulations of unstable wood debris appear to be a defining characteristic of the Susitna River. Large quantities of unstable wood debris were observed throughout the Project study area with largest accumulations occurring in the Lower Susitna (Photographs 9, 10, 21) with apparently large contributions from the Chulitna River. However, unstable wood debris was observed throughout both Middle and Lower River segments during the 2012 aerial reconnaissance (Photographs 16, 21, 31, 32, 33, 34, 35, 36, 37). Loose, mobile wood was observed along river banks (Photographs 2, 3), mid channel islands (Photographs 18, 20), and throughout side channel complexes (Photographs 16, 17, 18, 21, 34).

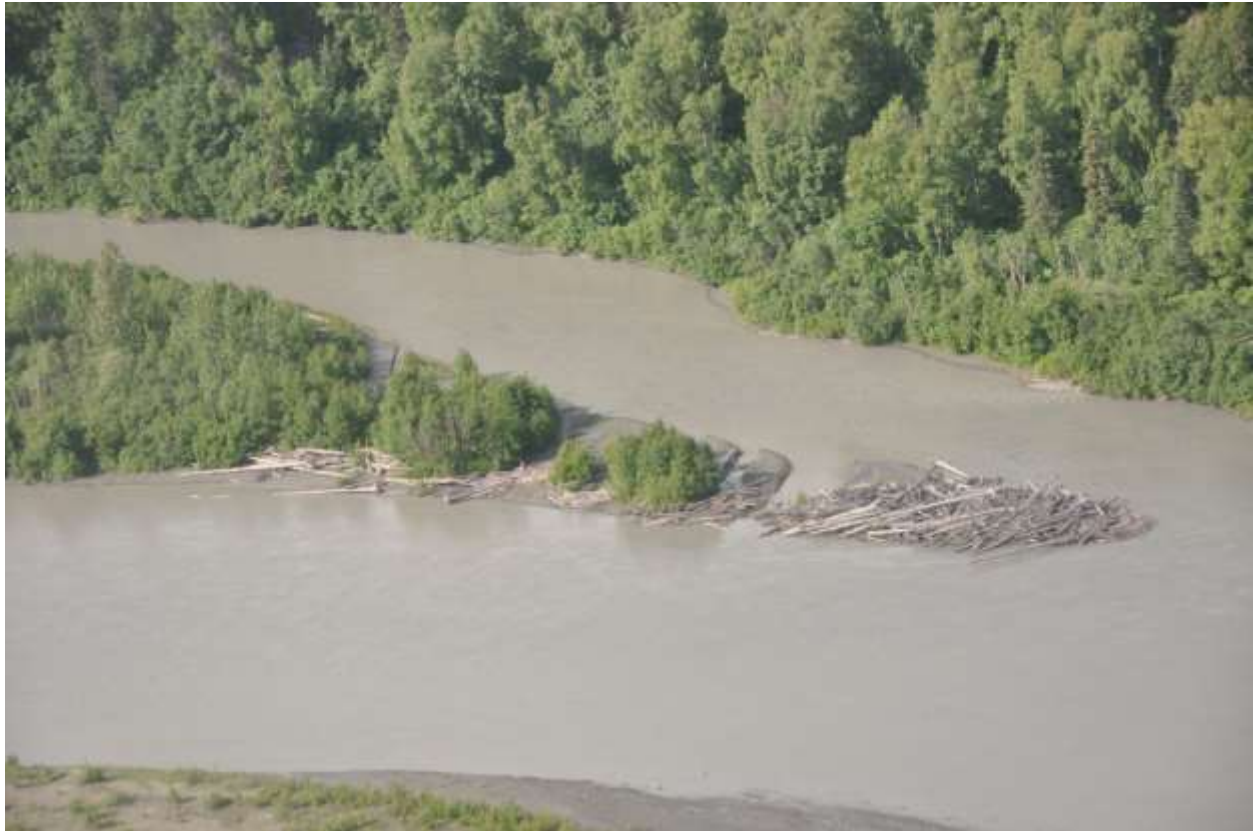
Photograph 19. July 2, 2012 Lower Susitna River between Talkeetna and Willow. Raked wood debris at island apex and side channel.

Also, observed stable wood jams were associated with scour pools, islands, channel embankments, and side channel complexes (Photographs 12-17, 19-30).

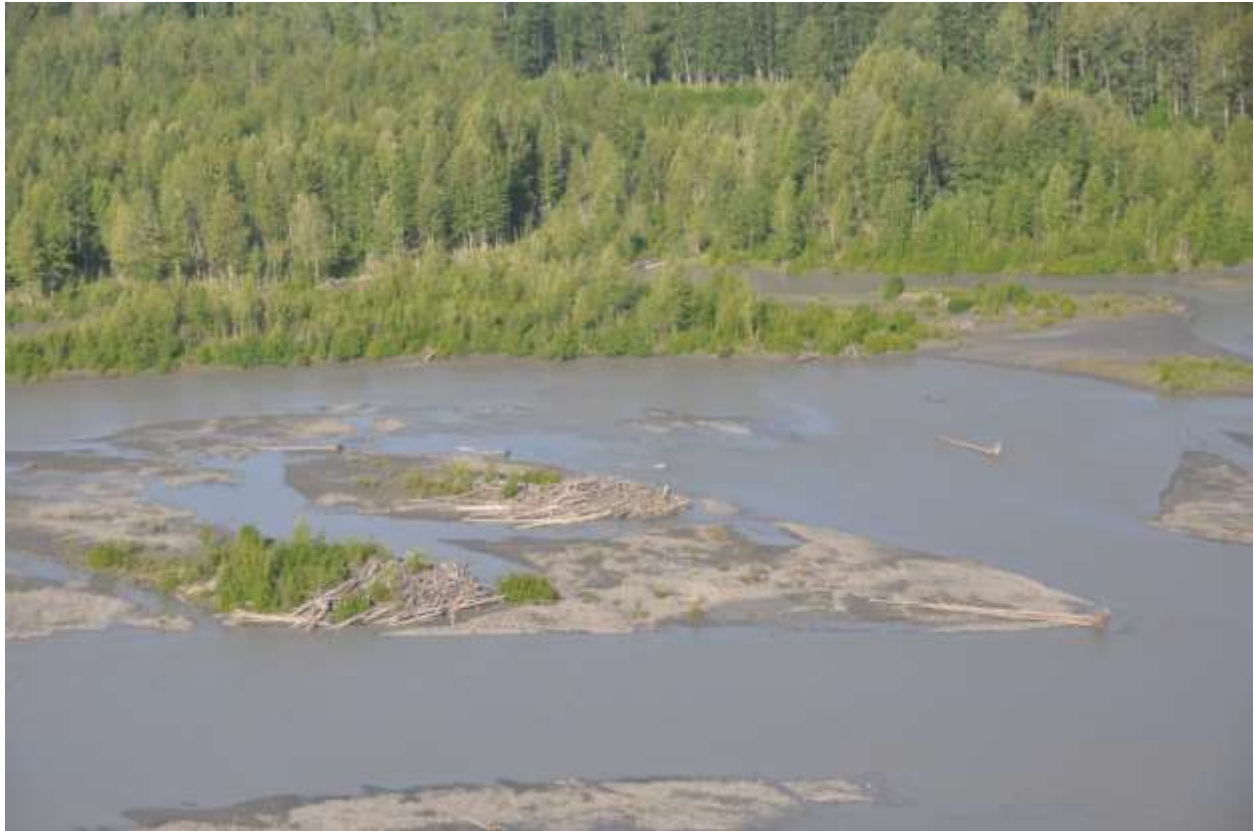
Photograph 20. June 30, 2012 Lower Susitna River between Talkeetna and Willow. Racked wood on mid channel islands.

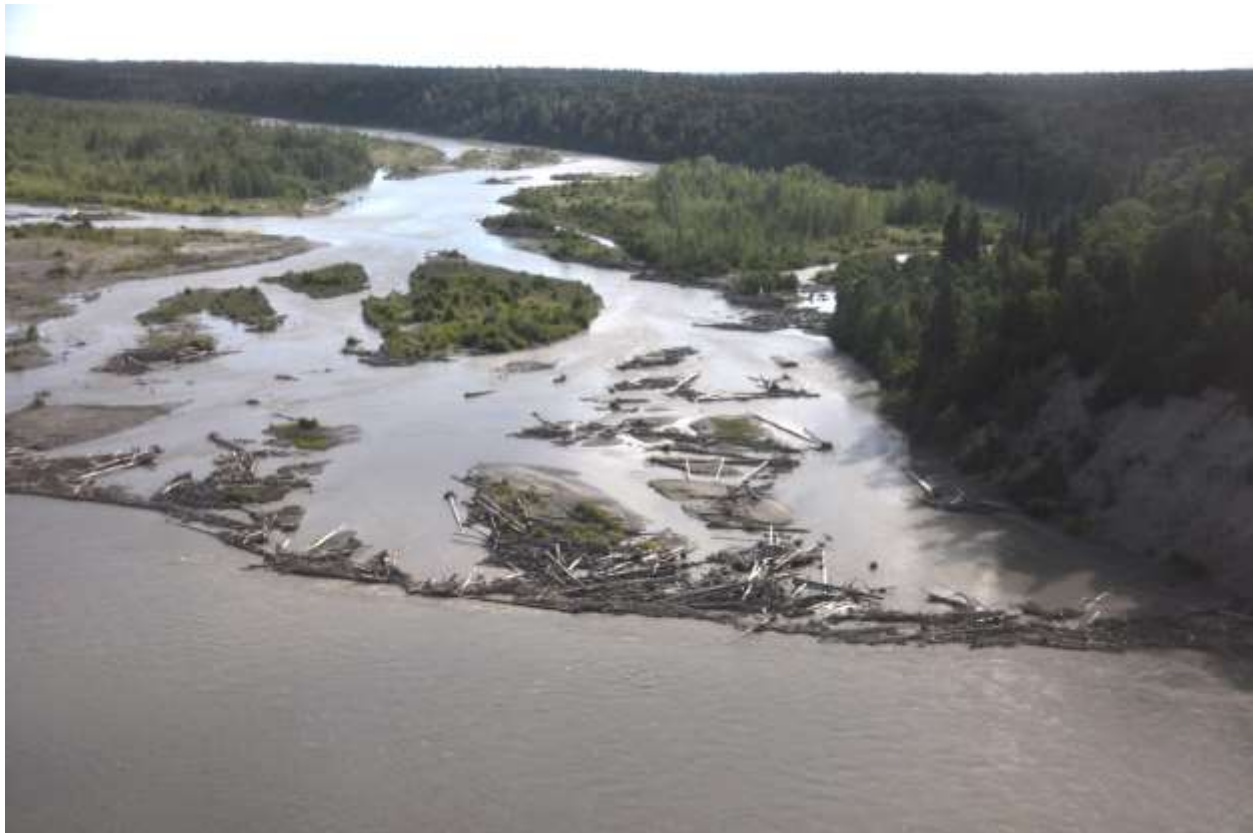
Photograph 21. June 30, 2012 Lower Susitna River between Talkeetna and Willow. Unstable accumulations of racked wood debris upon bars and stable island bar apex jams with racked members.

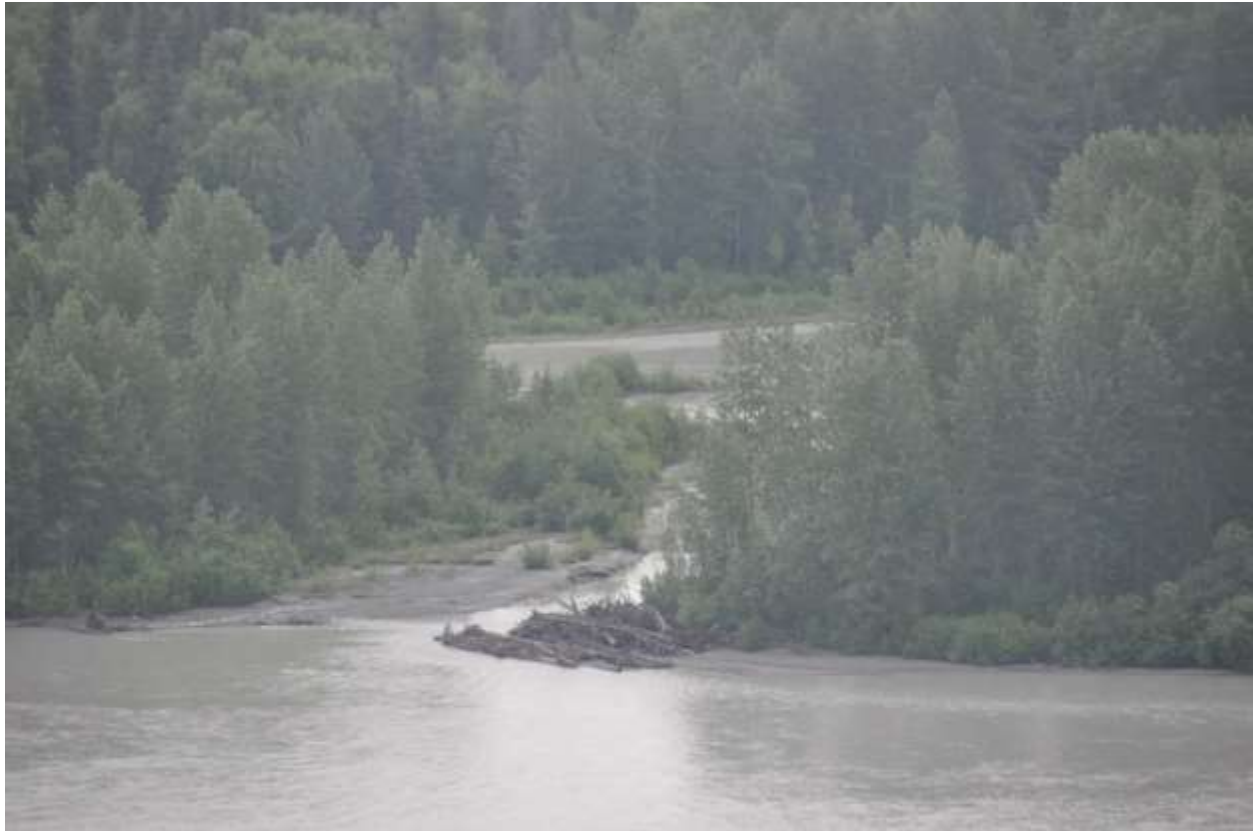
Photograph 22. June 30, 2012 Lower Susitna River between Talkeetna and Willow. Bar apex wood jam with racked members at island apex and side channel entrance.

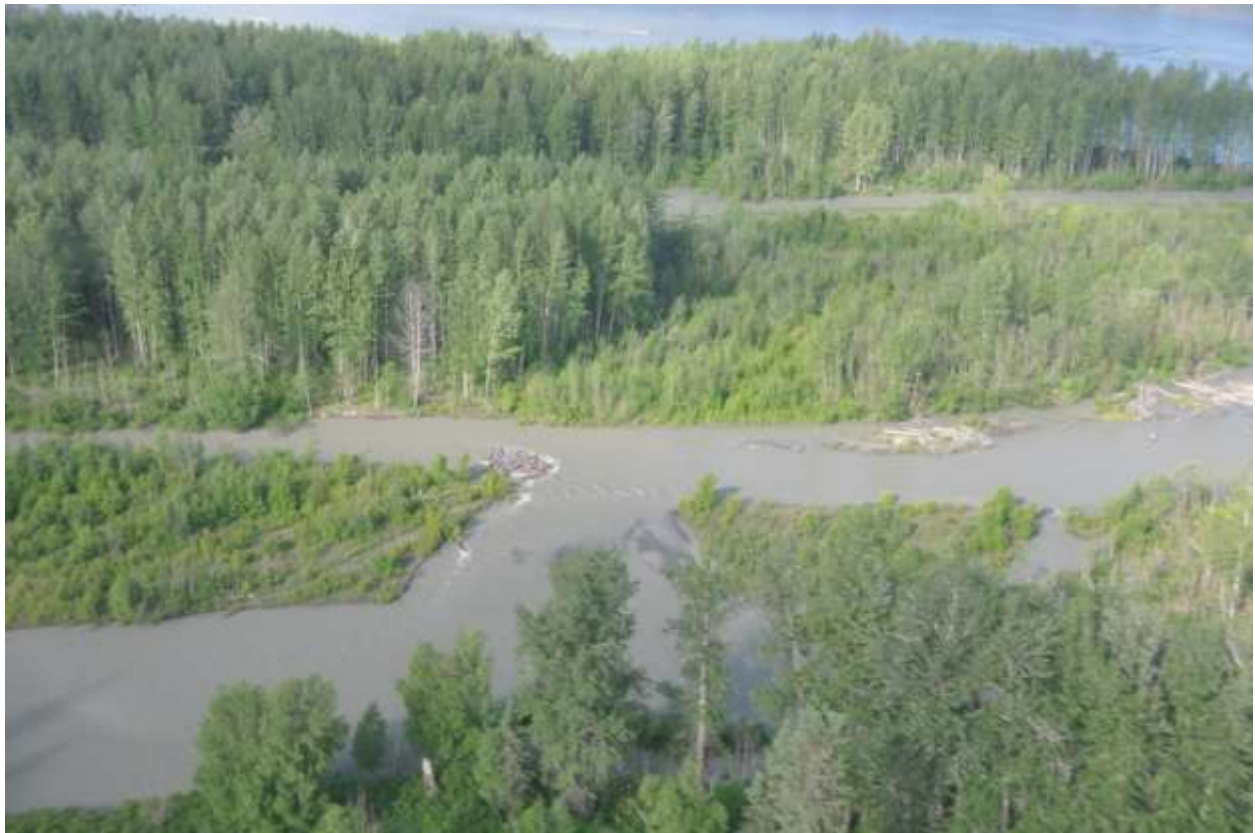
Photograph 23. June 30, 2012 Lower Susitna River between Talkeetna and Willow. Wood jams in side channel complex.

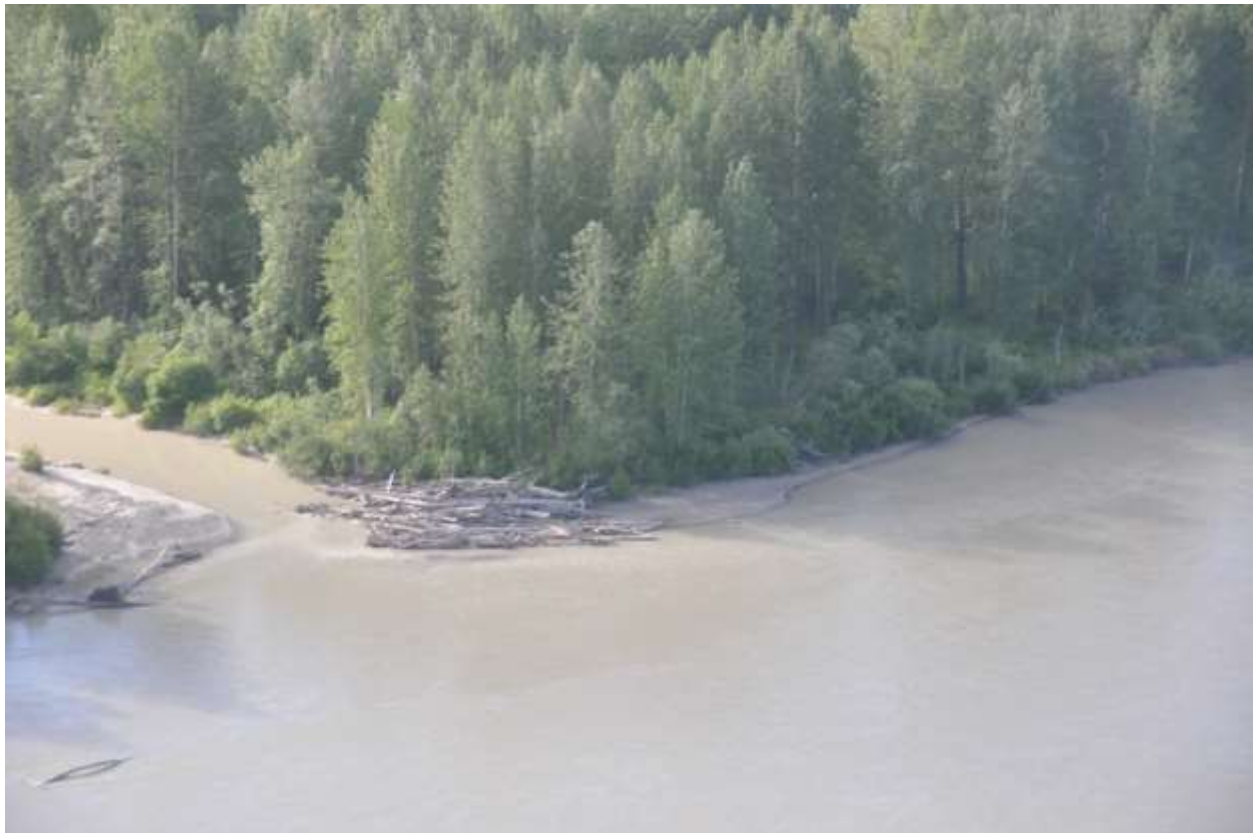
Photograph 24. June 30, 2012 Lower Susitna River between Talkeetna and Willow. Bar apex wood jam at side channel exit.

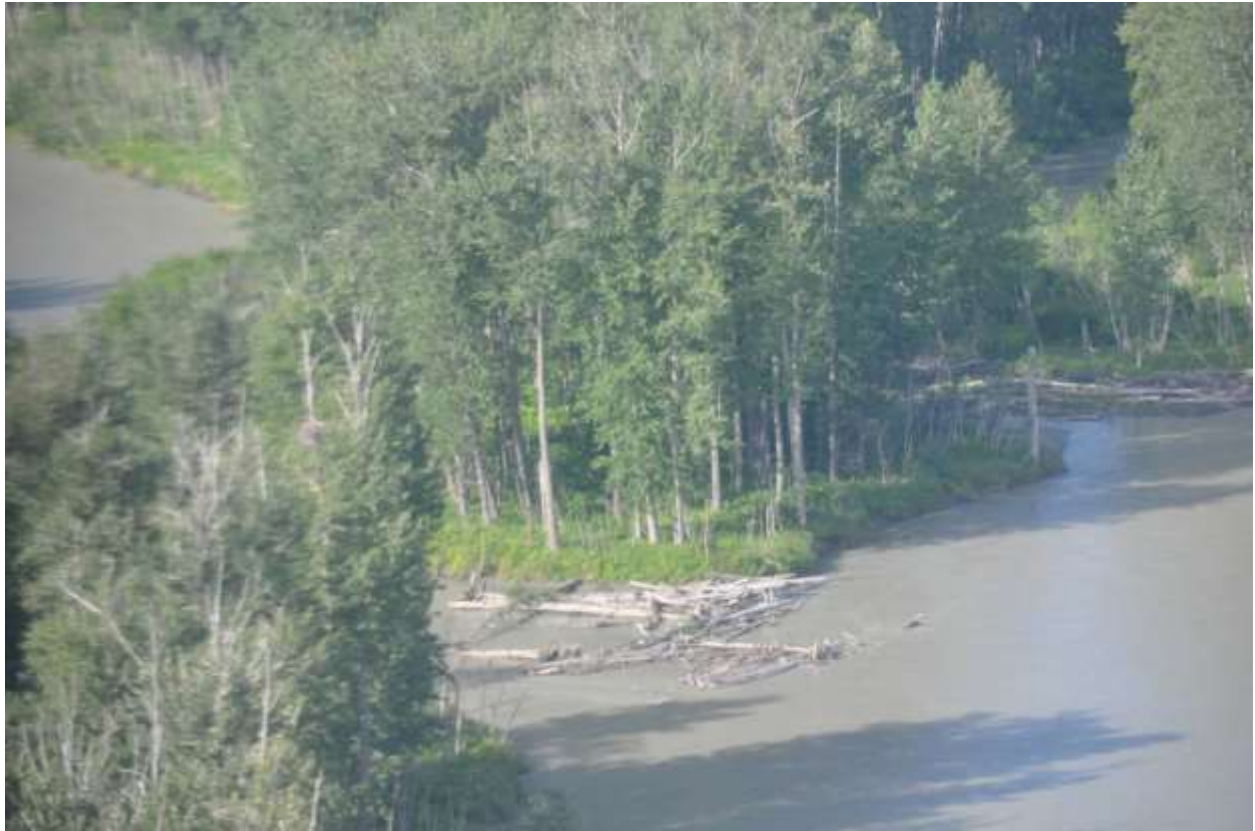
Photograph 25. June 30, 2012 Lower Susitna River between Talkeetna and Willow. Rafts of wood in side channel complex.

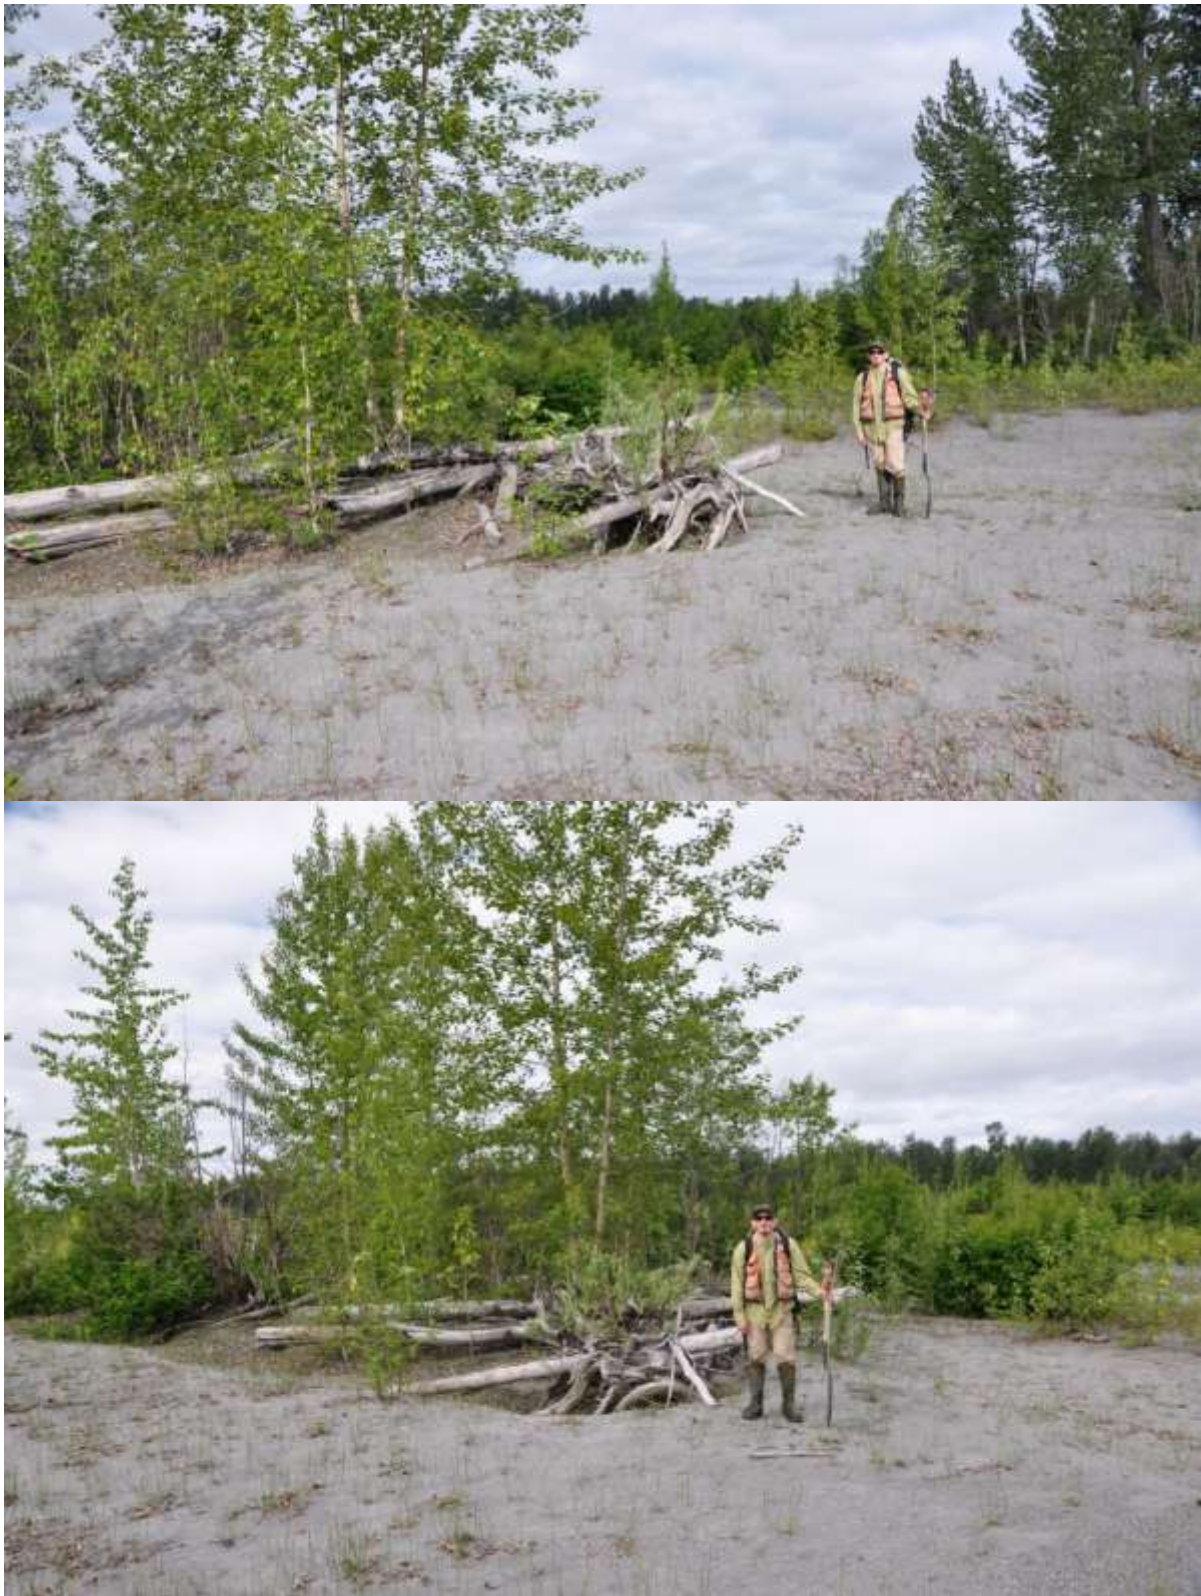
Photograph 26. July 2, 2012 Lower Susitna River below Talkeetna. Bar apex wood jam with buried key member and racked members. Young balsam poplar colonizing elevated wood jam surface.

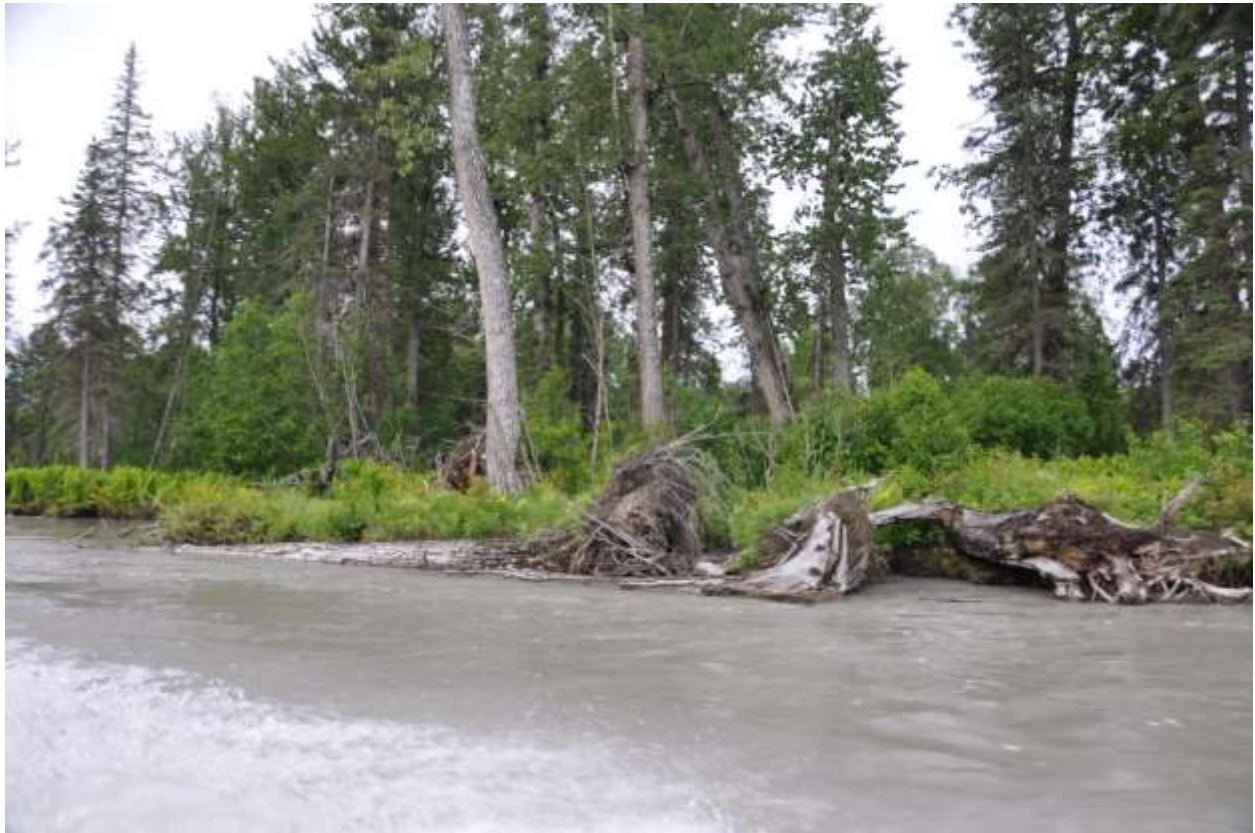
Photograph 27. June 26, 2012 Middle Susitna River above Three Rivers Confluence. In-situ key member forming floodplain bench.

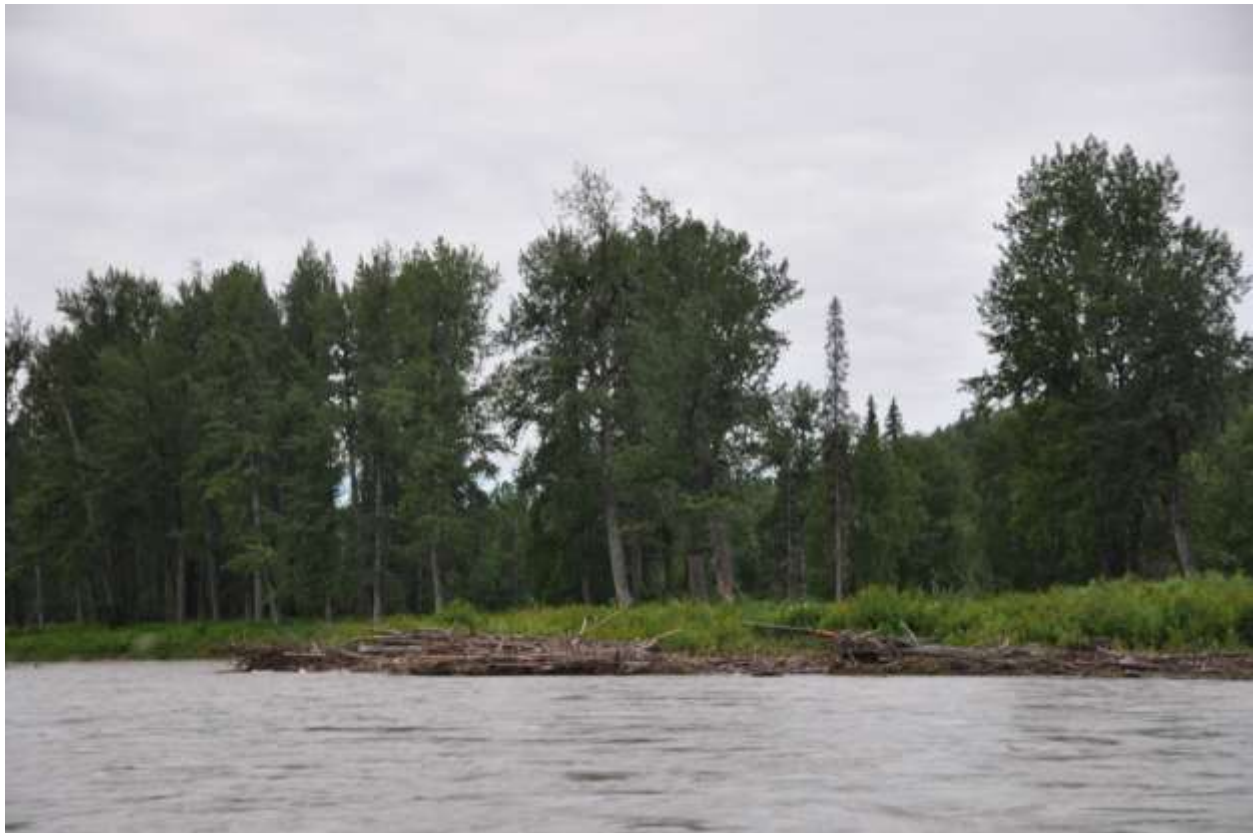
Photograph 28. June 26, 2012 Middle Susitna River above Three Rivers Confluence. Bench jam with racked members.

In large alluvial rivers, such as the Susitna, recruitment of floodplain streamside trees through bank erosion can result in wood debris structures composed of logs hydraulically aligned parallel to the channel bank that become embedded into the floodplain further stabilizing channel banks (Abbe and Montgomery 2003; Photographs 12, 17, 27, 28, 29, 30). Additionally, loose mobile wood debris was observed accumulating along river embankments forming unstable wood debris accumulations (Photographs 12, 17, 28, 29, 30).

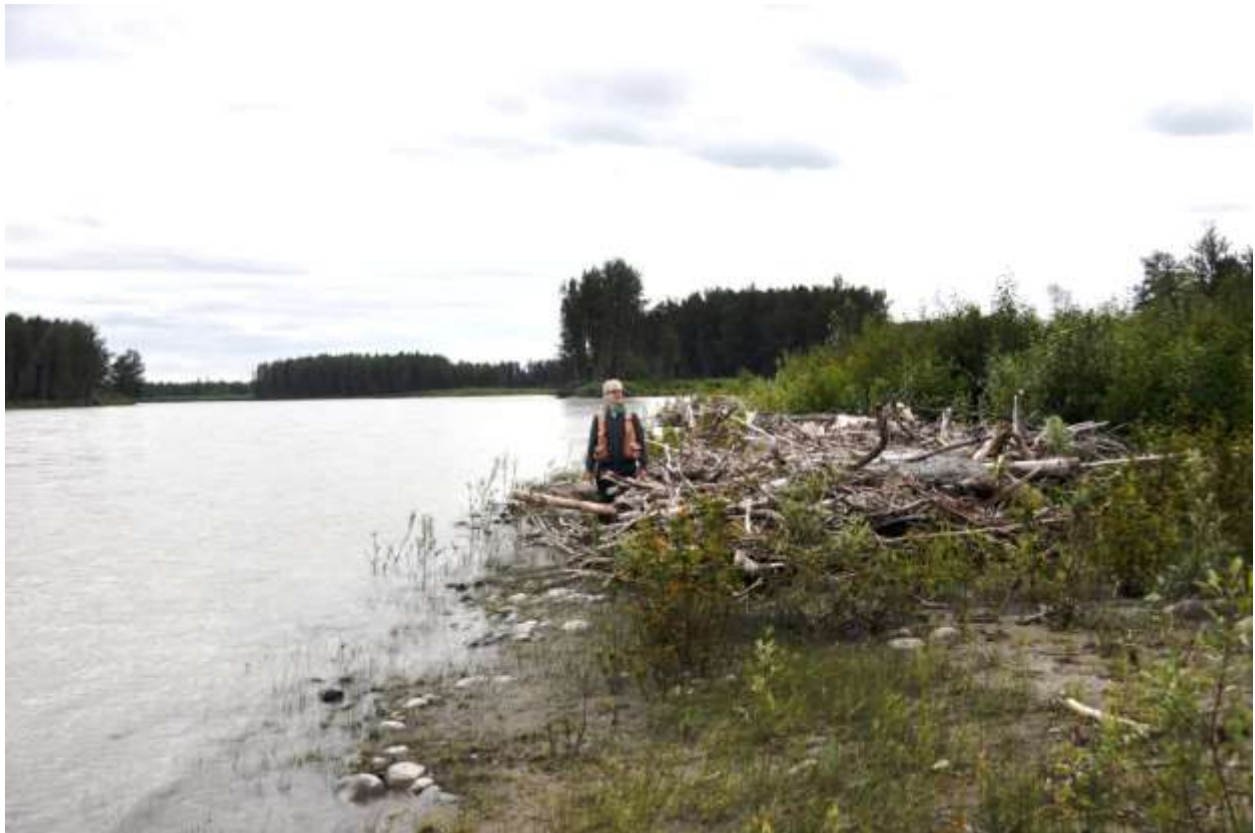
Photograph 29. July 1, 2012 Middle Susitna River immediately above Whiskers Slough. Bar apex jam with large accumulation of racked members upstream of jam.

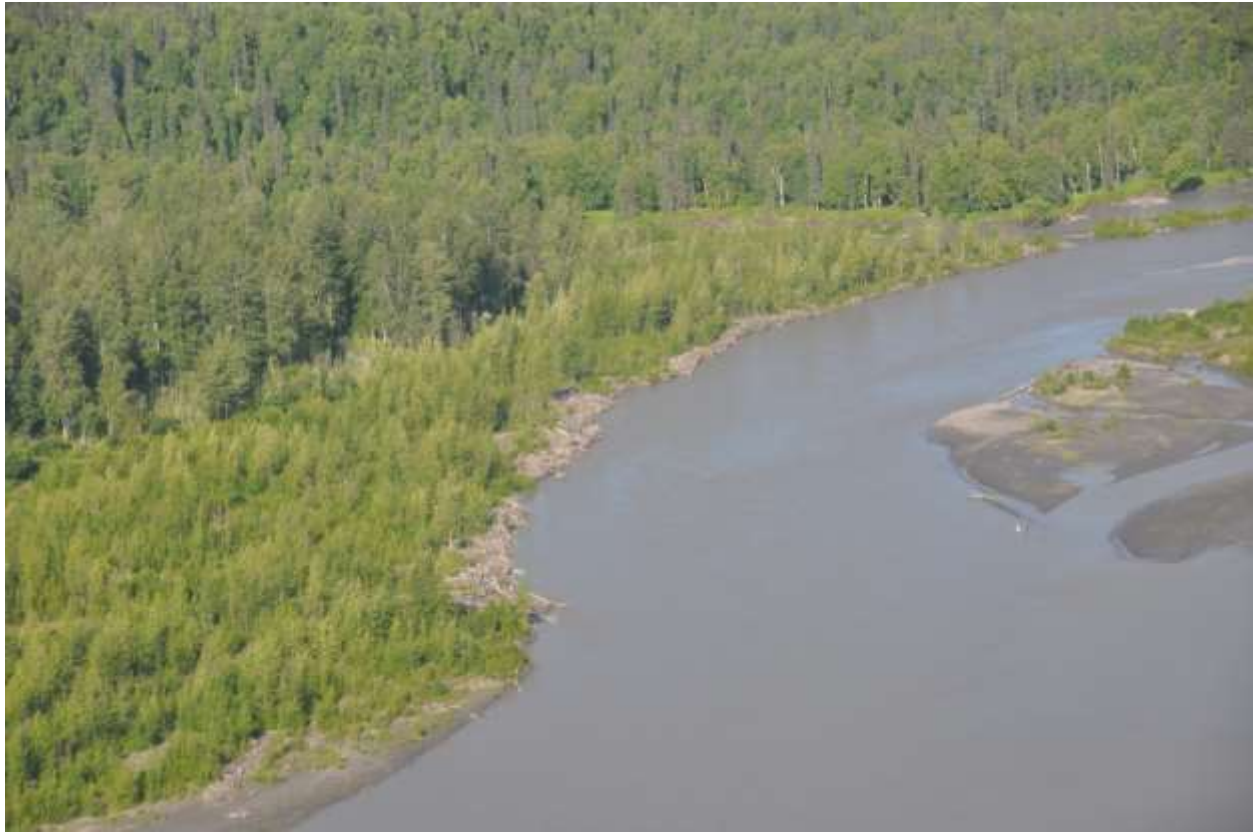
Photograph 30. June 30, 2012 Lower Susitna River between Talkeetna and Willow. Long bench jam with large accumulations of raked wood. Flow is from right to left.

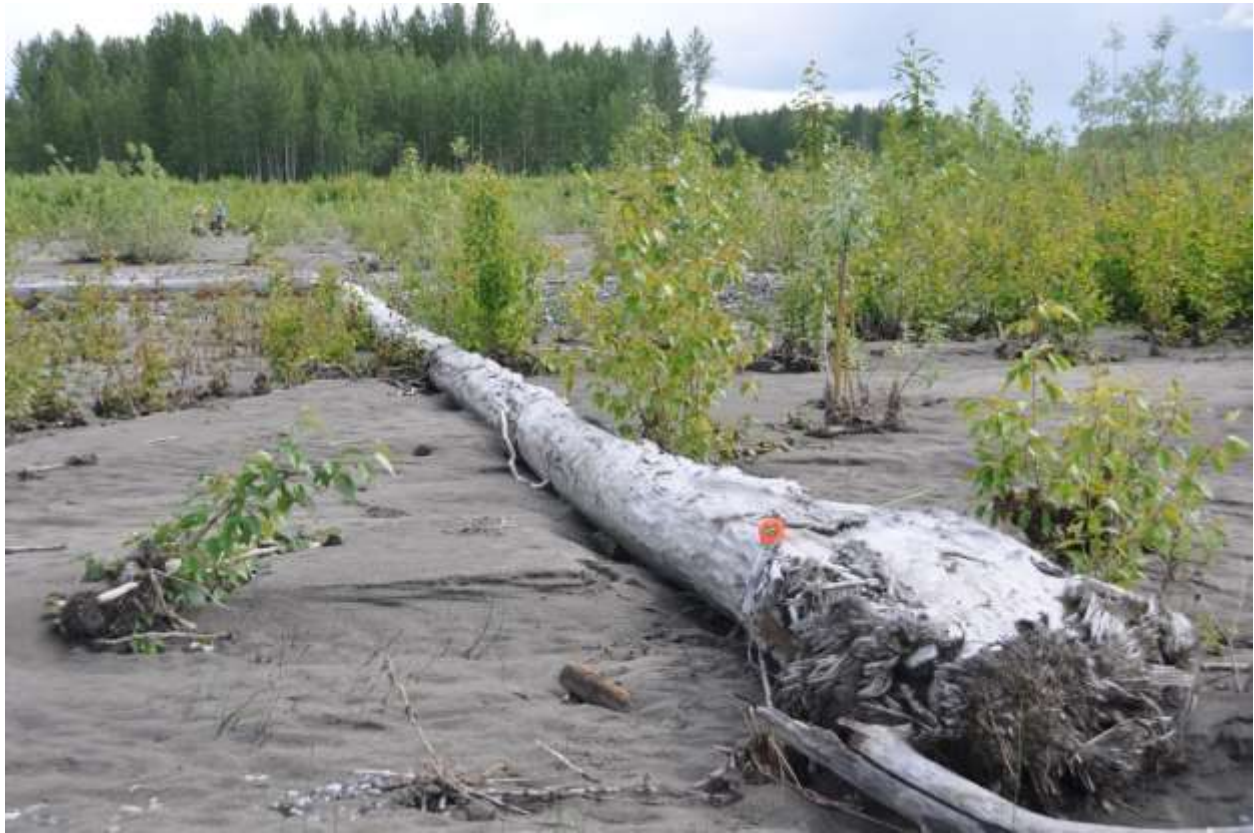
Photograph 31. July 2, 2012 Middle Susitna River immediately above Three Rivers Confluence. Typical unstable wood debris. Note orange tape measure for scale.

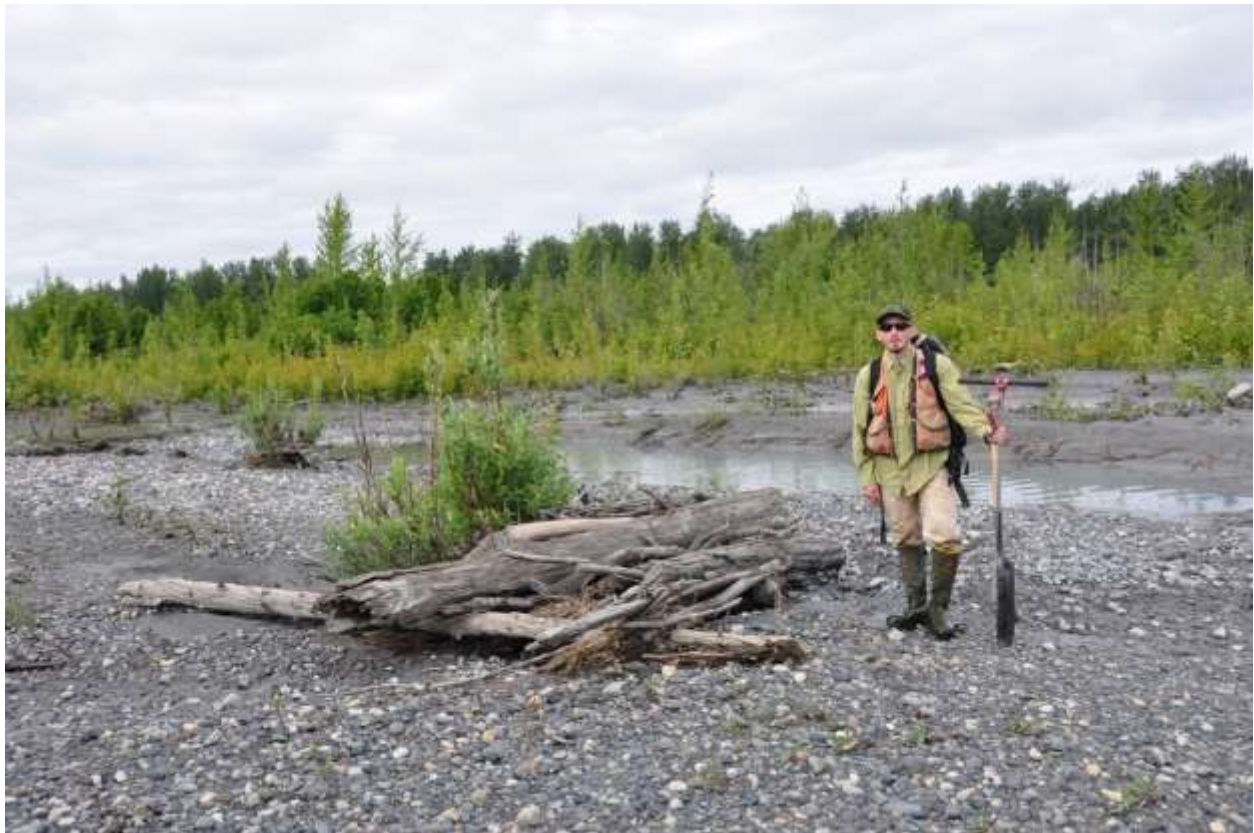
Photograph 32. July 2, 2012 Lower Susitna River below Talkeetna. Typical loose, unstable wood debris.

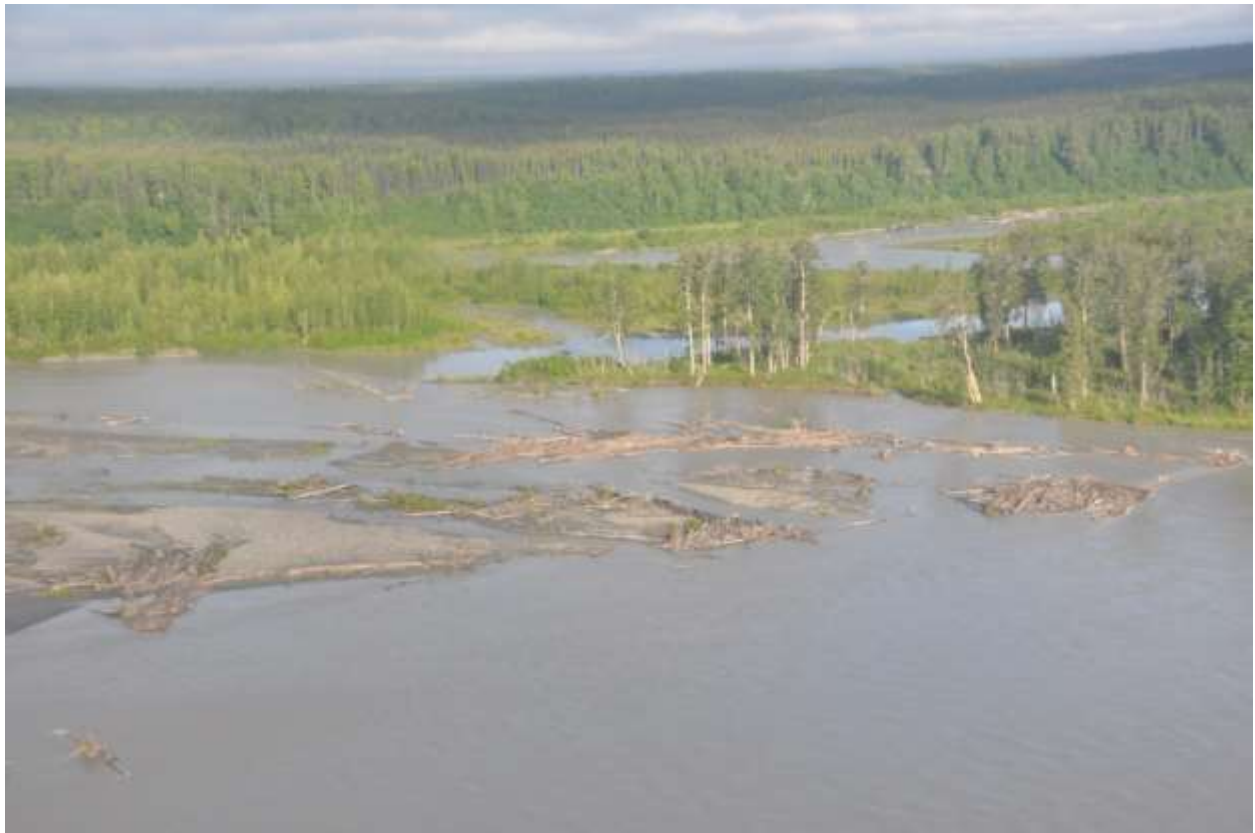
Photograph 33. June 30, 2012 Lower Susitna River between Talkeetna and Willow. Mid channel rafts of wood debris. Flow is from right to left.

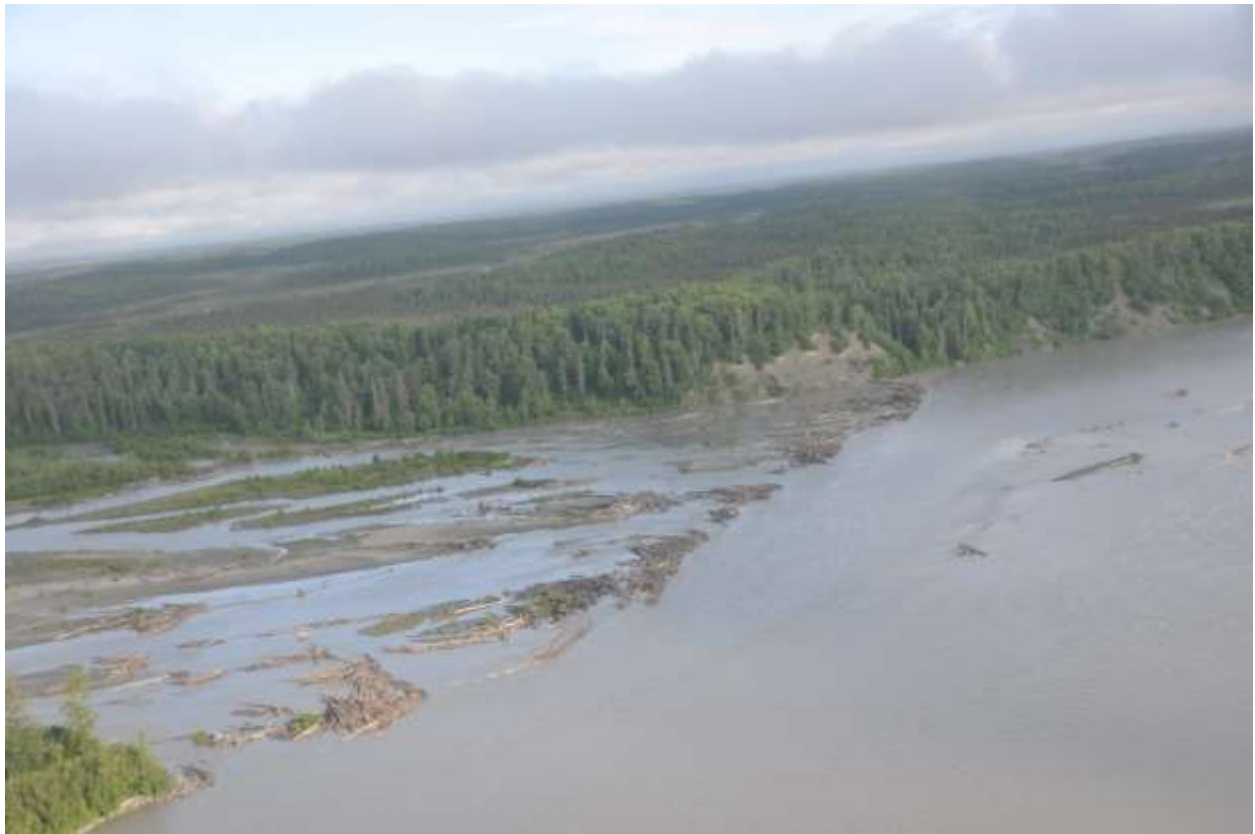
Photograph 34. June 30, 2012 Lower Susitna River between Talkeetna and Willow. Rafts of racked wood debris.

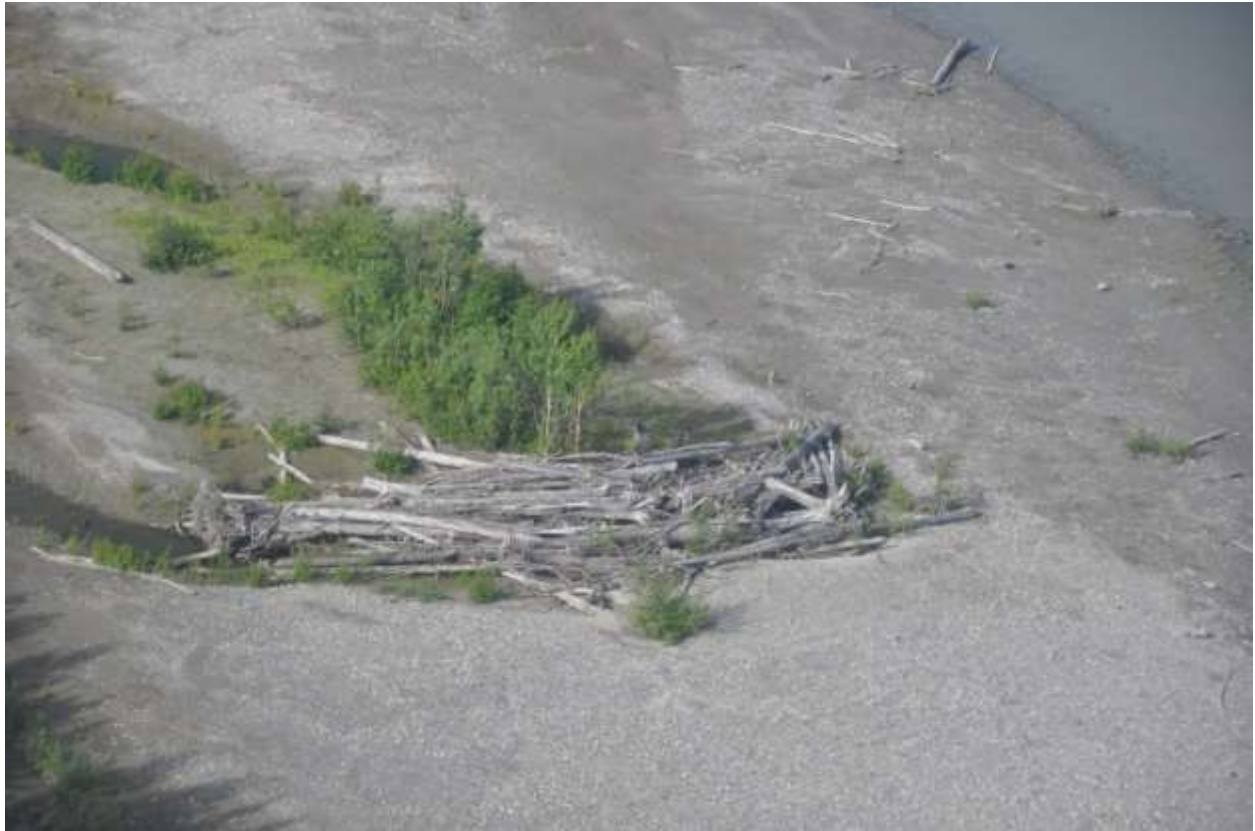
Photograph 35. June 30, 2012 Lower Susitna River between Talkeetna and Willow. Raked wood deposited at young balsam poplar/alder vegetation obstruction.

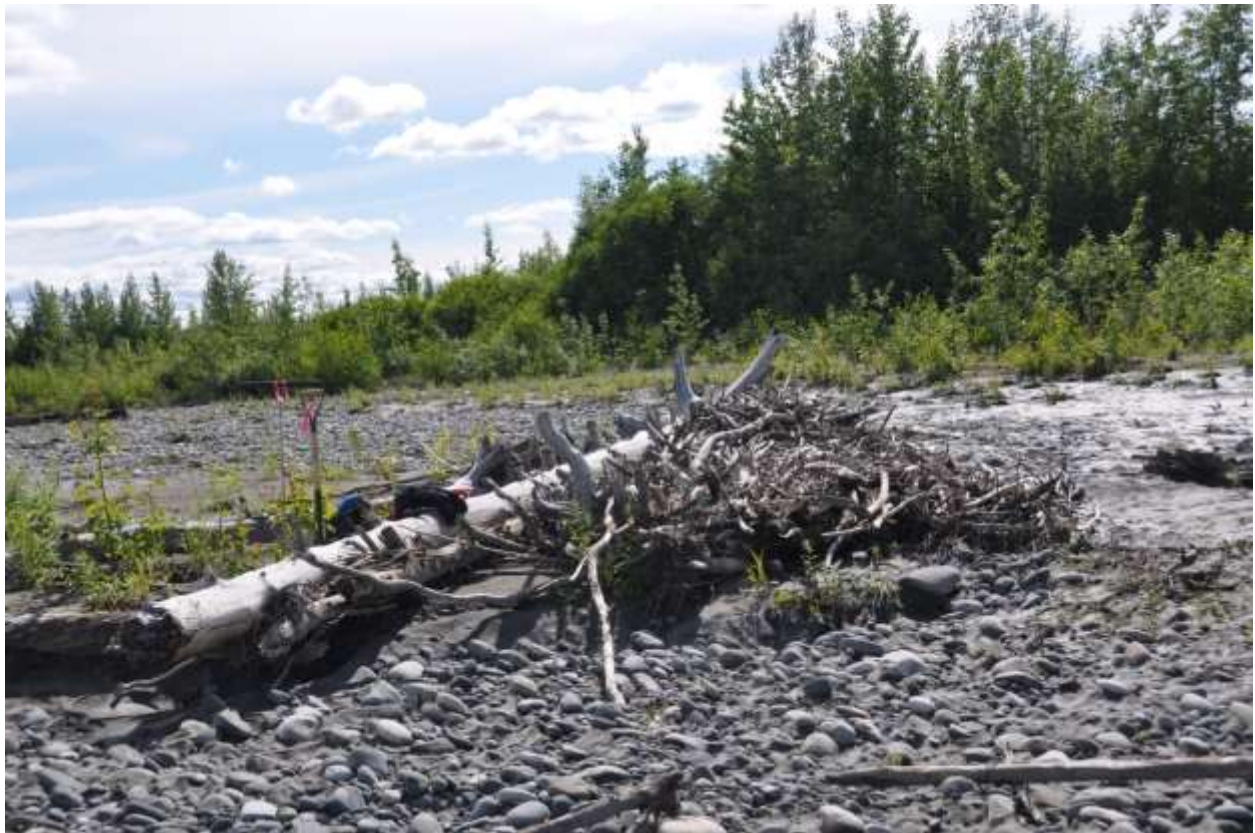
Photograph 36. June 30, 2012 Lower Susitna River between Talkeetna and Willow. Racked wood on mid channel gravel bar.

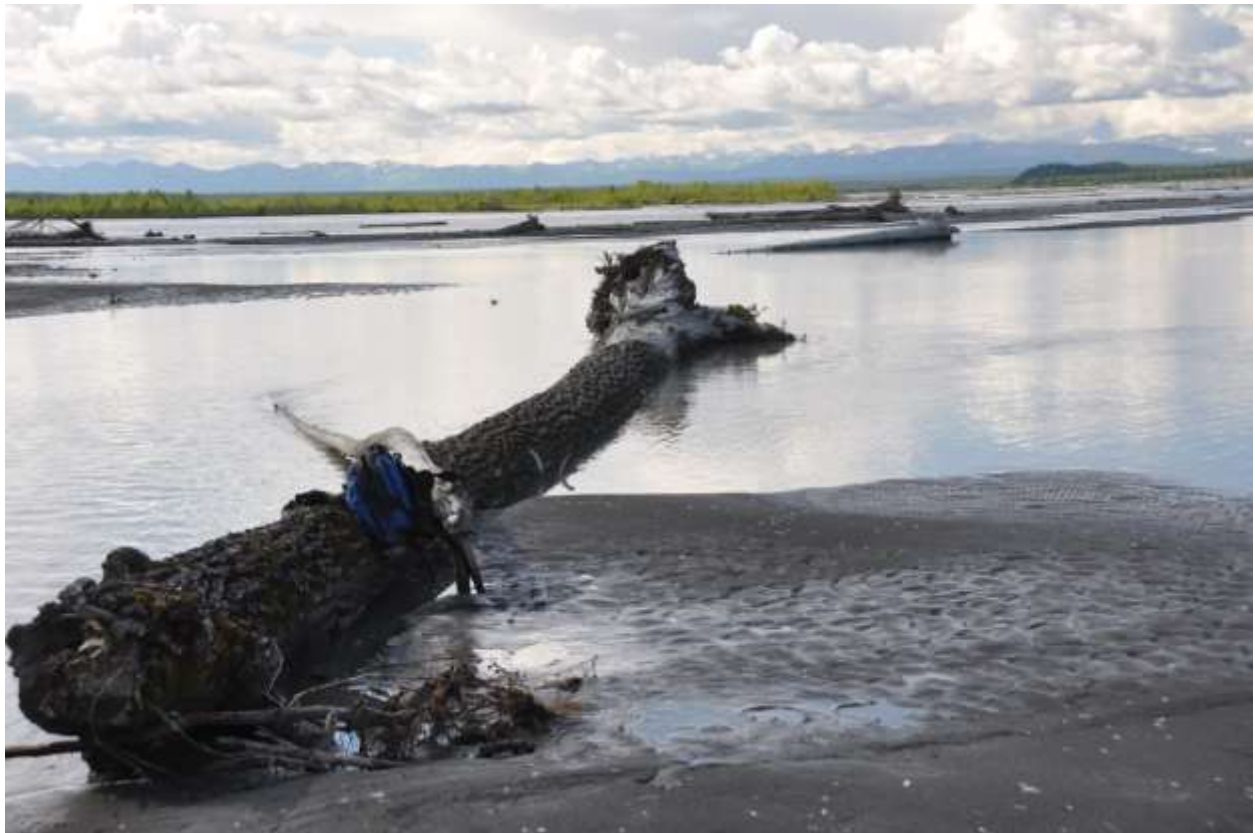
Photograph 37. June 30, 2012 Lower Susitna River at Talkeetna immediately below Three Rivers Confluence. Balsam poplar (85 cm diameter, DBH; 18 m length; Plot T19).
