# **Susitna-Watana Hydroelectric Project (FERC No. 14241)**

## **Riparian Vegetation Study Downstream of the Proposed Susitna-Watana Dam**

ABR, Inc.—Environmental Research & Services

February 2013

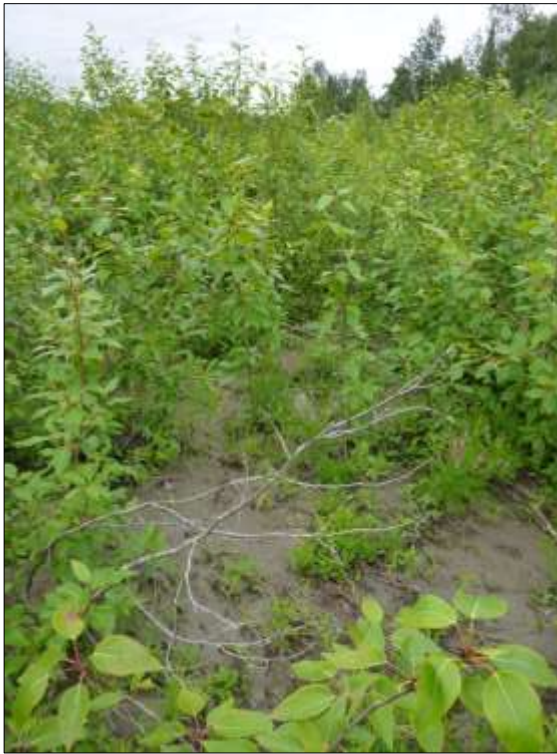
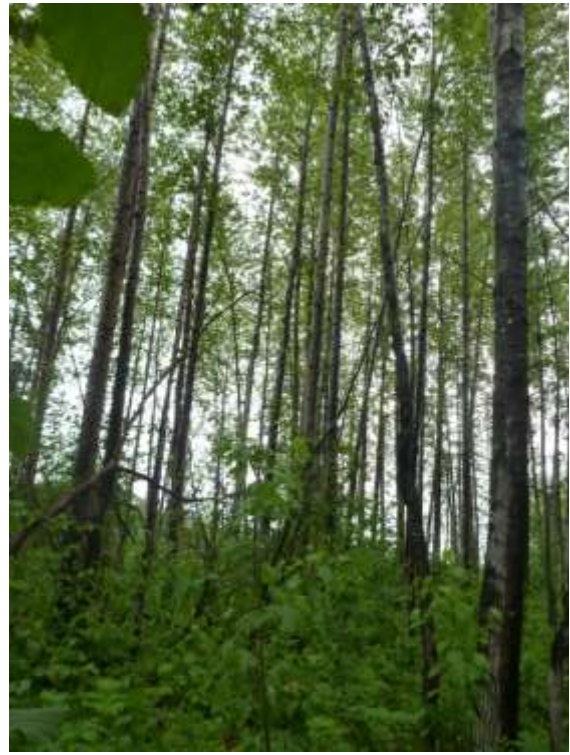
**Figure 2. Open Balsam Poplar Forest showing the sapling (left) and timber (right) successional stages, Riparian Vegetation Study area, Susitna River floodplain, Alaska, 2012.**

the field, and these would sometimes be classified within one Level IV vegetation class (e.g., Open Balsam Poplar Forest; see Figure 2). To differentiate the full range of early and mid-successional vegetation types on the Susitna River floodplain, it was necessary to create some new vegetation classes for this study. These new types were defined based on existing AVC Level IV vegetation types and, for the early successional types, followed the types described by Helm and Collins (1997).

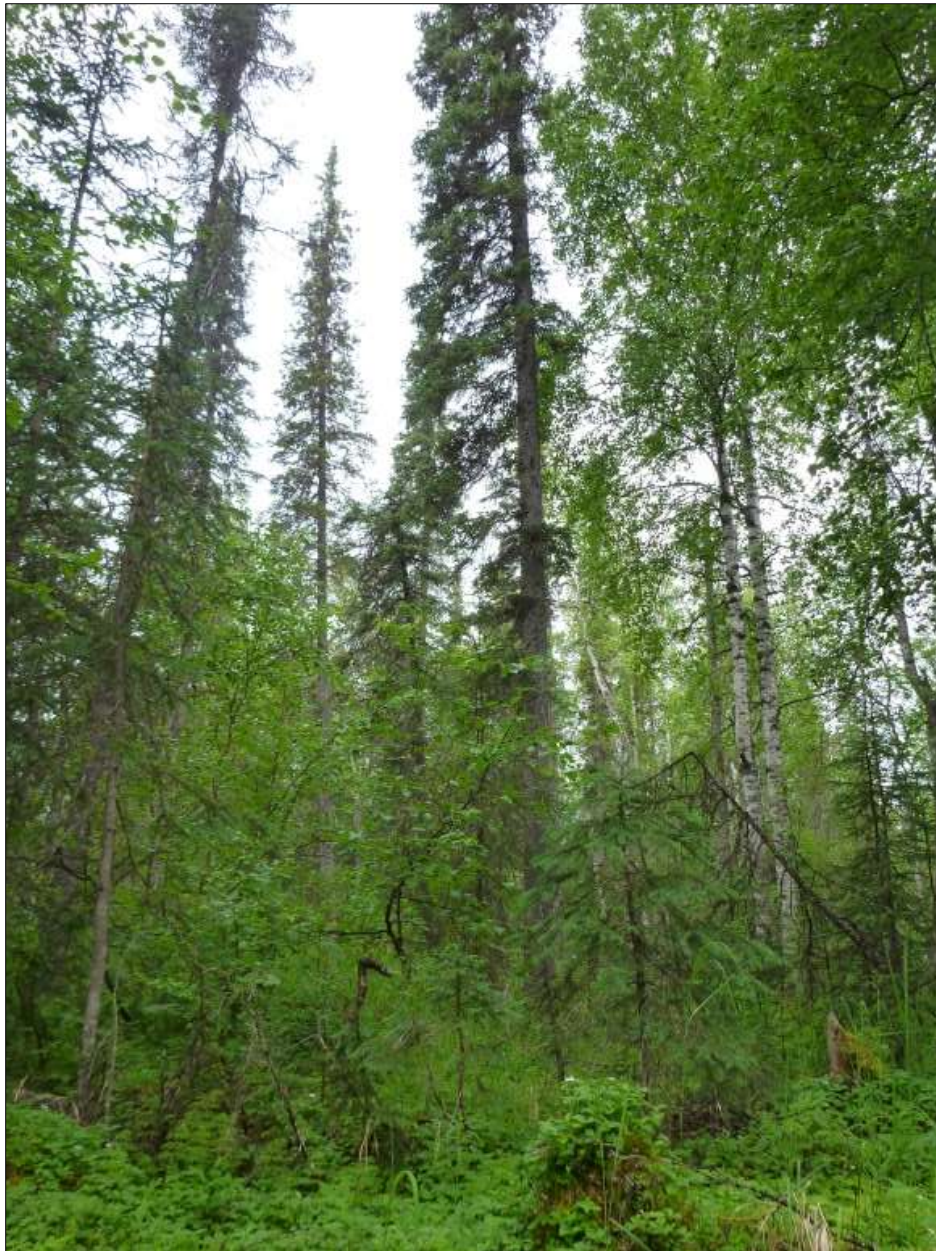
**Figure 3. Open Spruce–Paper Birch forest, Riparian Vegetation Study area, Susitna River floodplain, Alaska, 2012.**

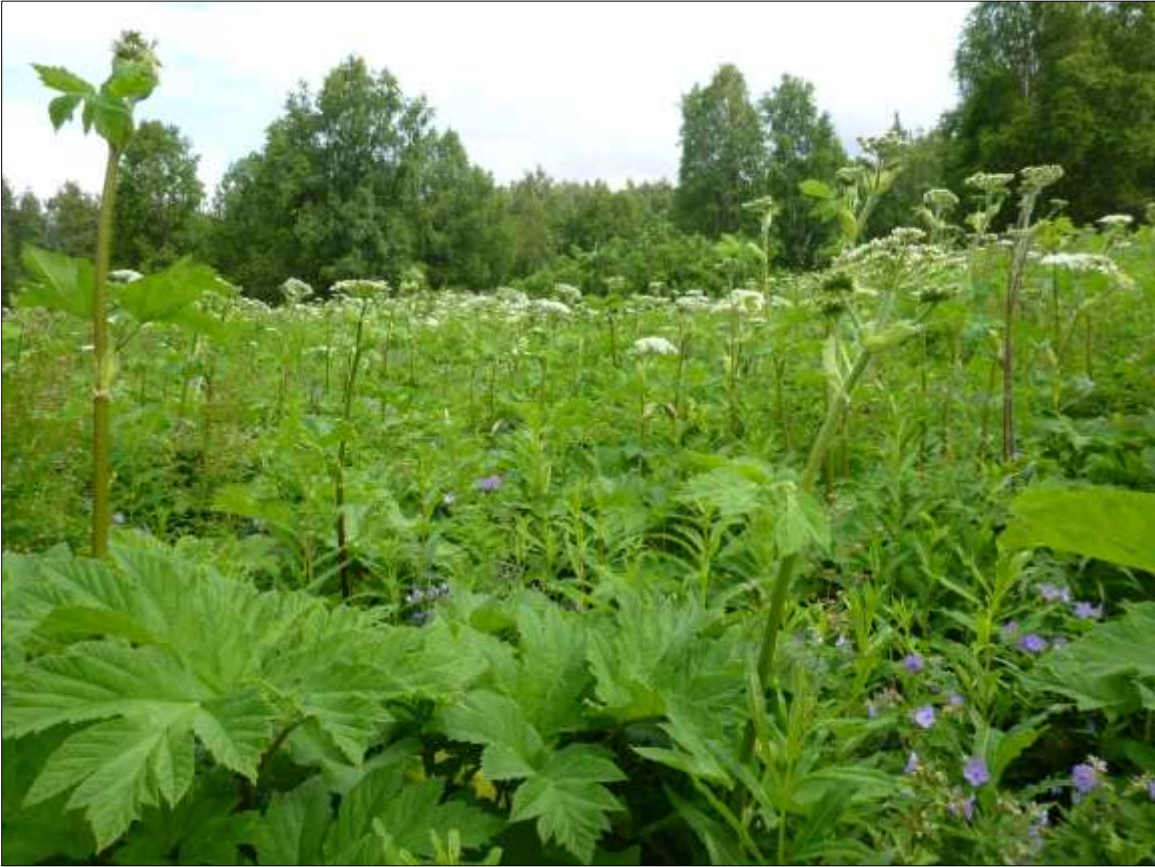
**Figure 4. Large Umbel Meadow, Riparian Vegetation Study area, Susitna River floodplain, Alaska, 2012. Vegetation in photo is approximately 1.5–2.0 meters (4.9–6.6 feet) tall.**

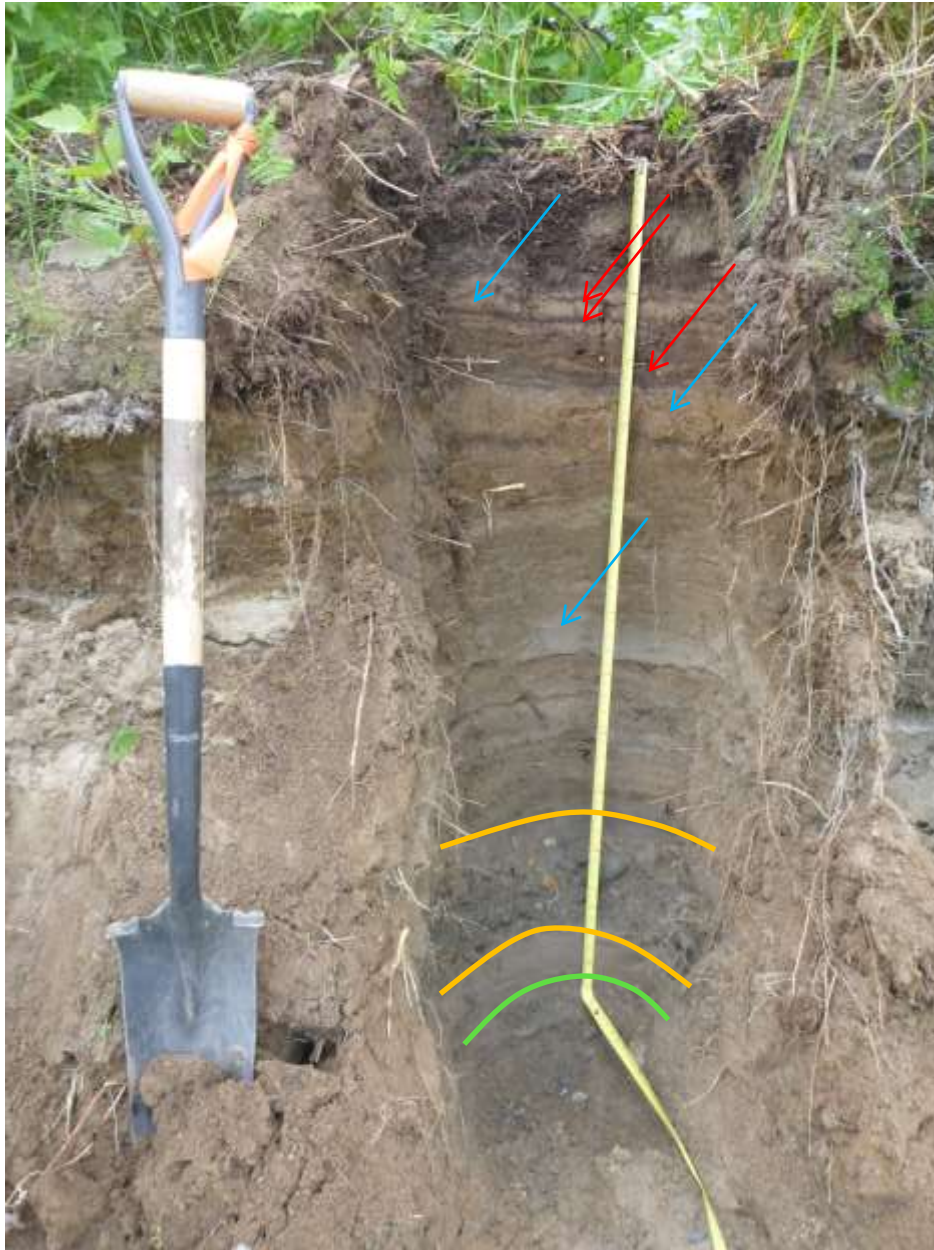
**Figure 5. Typical Cryofluvents at a river bank exposure, Riparian Vegetation Study area, Susitna River floodplain, Alaska, 2012.**

Dark horizontal lines (red arrows) indicate layers of organic material buried by periodic past sedimentation events. Orange and grayish layers (blue arrows) are riverine sands and silts. Cobbly/gravelly layer (between orange lines) indicates historic large, powerful flood event. The cobbly layer at the bottom of the pit represents the original cobble bar surface (below green line). Shovel in photo is approximately 1 meter (3.3 feet) tall.

A total of 15 soil subgroups (Soil Survey Staff 2010) were sampled during the 2012 field survey. The most common types were Typic Cryofluvents ( $n=19$  occurrences; Figure 5), Oxyaquic Cryofluvents ( $n=12$ ), Typic Cryorthents ( $n=5$ ), Aquic Cryofluvents ( $n=4$ ), and Oxyaquic Cryorthents ( $n=4$ ; Figure 6). Definitions of common soil subgroups found in the study area are provided in Table 3.

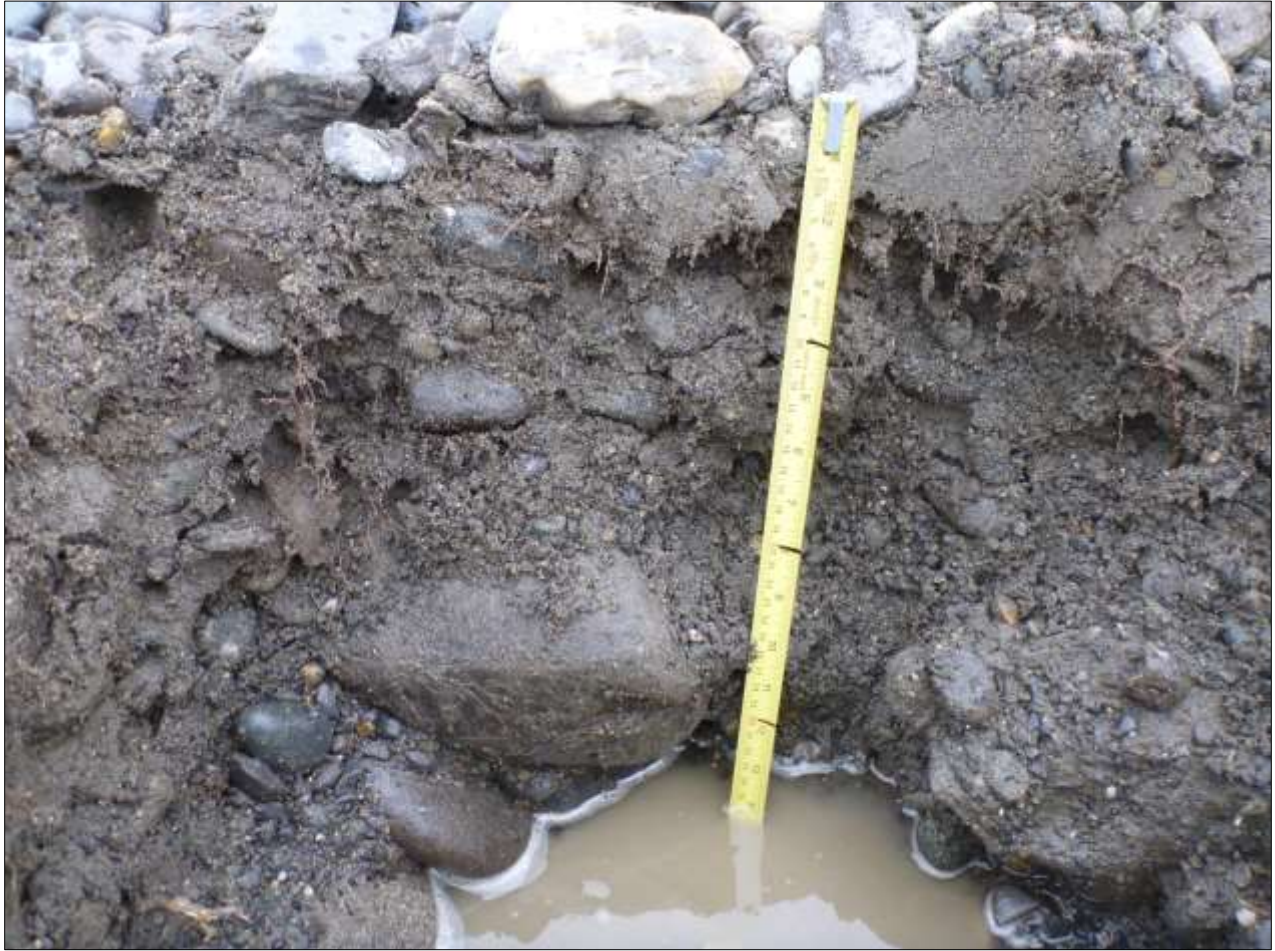
**Figure 6. Oxyaquic Cryorthents on an active cobble bar showing water table at 35 centimeter (14 inches) below soil surface, Riparian Vegetation Study area, Susitna River floodplain, Alaska, 2012.**

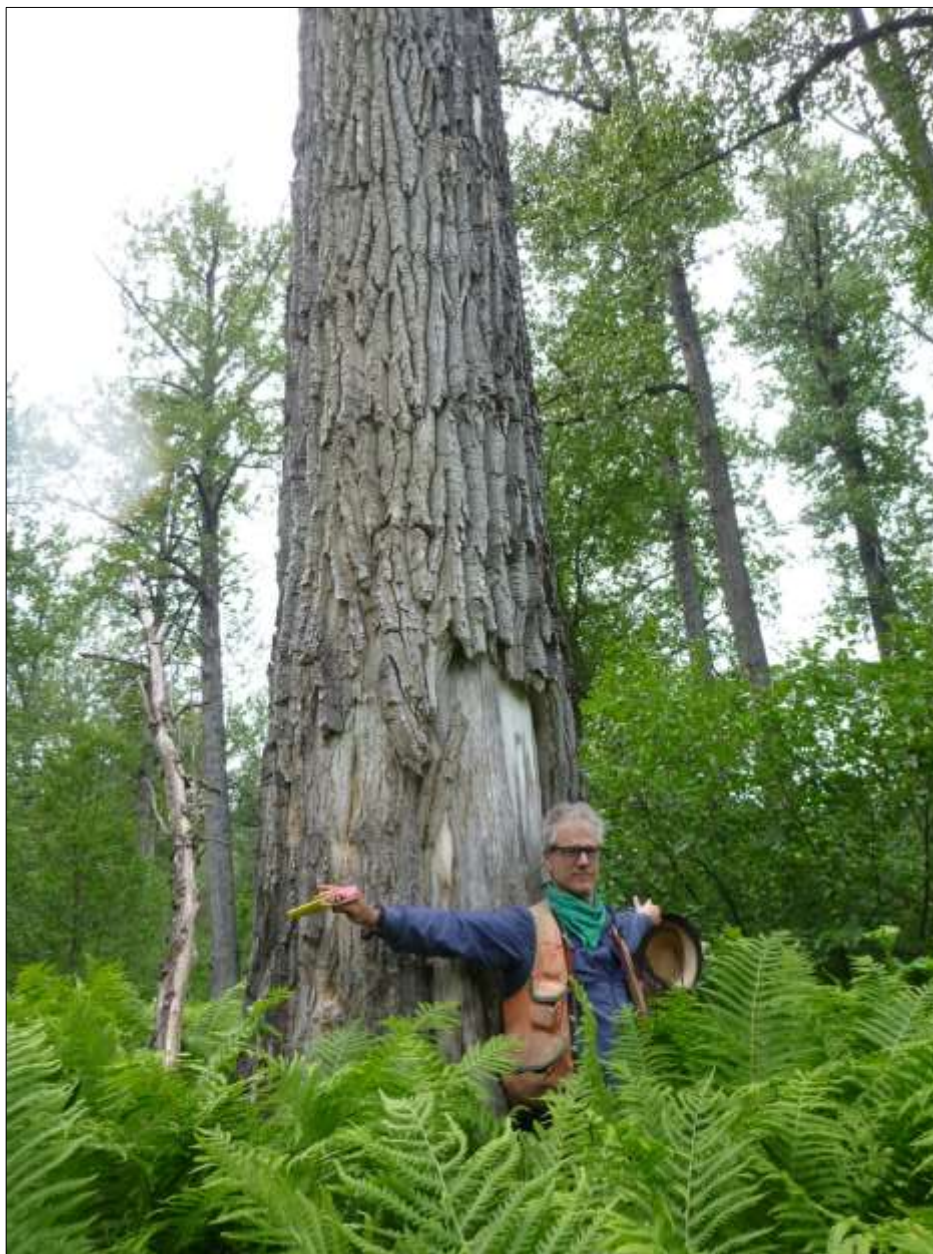
**Figure 7. Ice scar on balsam poplar, Riparian Vegetation Study area, Susitna River floodplain, Alaska. Scientist in photo is ~1.9 meter (6.2 feet) tall.**

Evidence of ice processes was common throughout the study area, including tree-bole scarring (up to 4–6 meter [13–20 feet] above ground level on the upstream side of trees; Figure 7), ice gouging and “bull-dozing” along banks and gravel bars (Figure 8), large displaced stones, and “mowing” of vegetation.

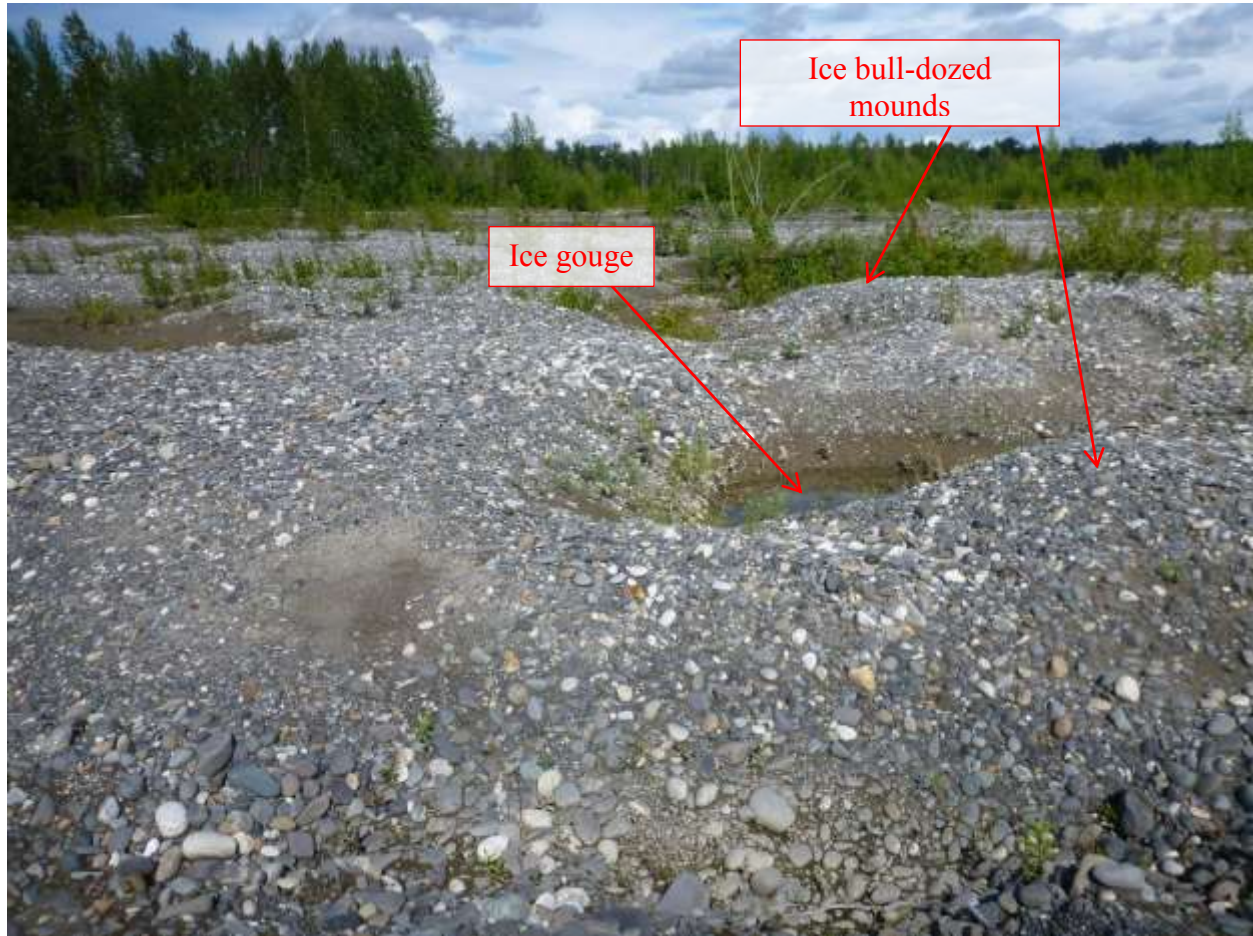
**Figure 8. Recent ice gouging and ice bull-dozing on a mid-river gravel bar, Riparian Vegetation Study area, Susitna River, Alaska, 2012.**

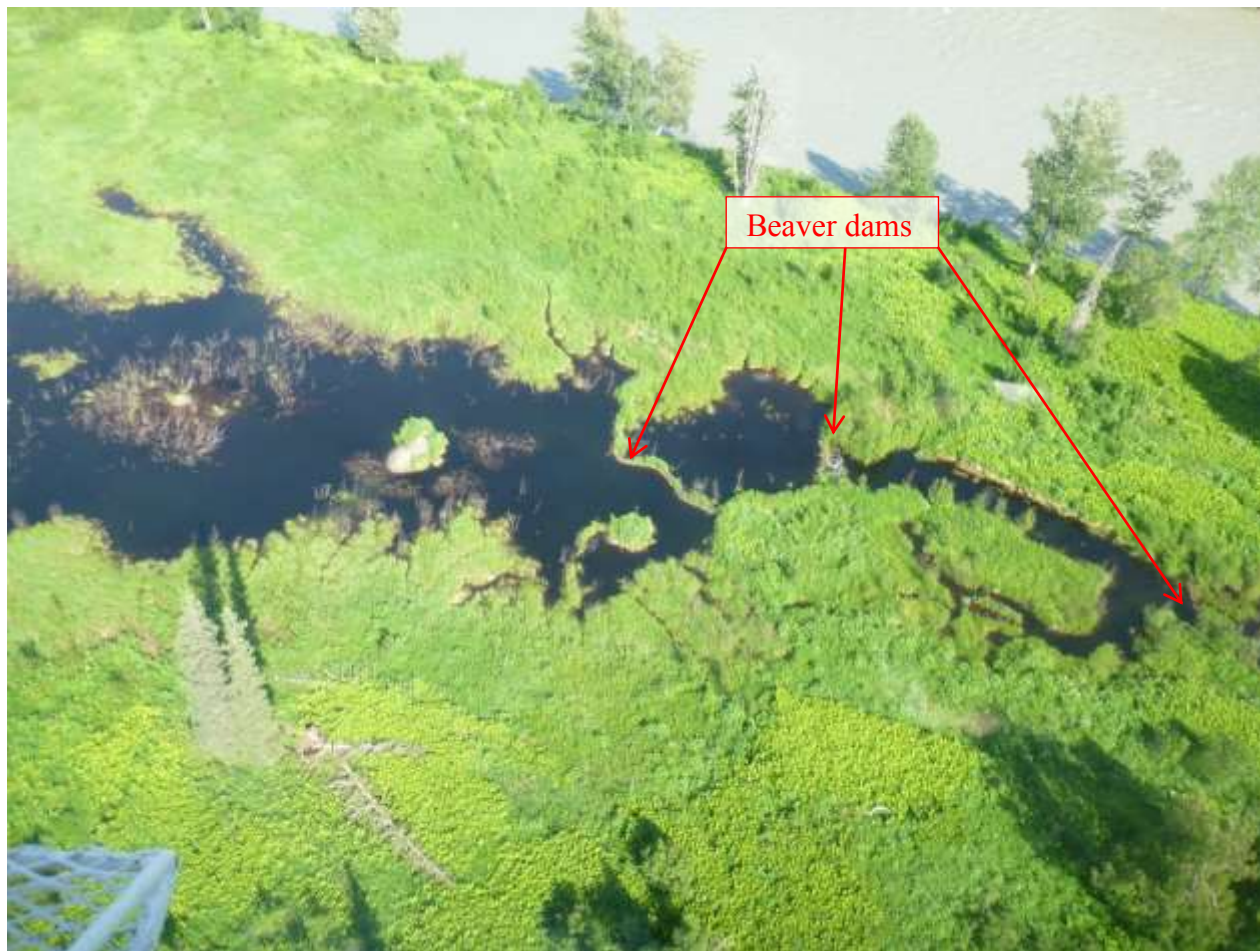
**Figure 9. Aerial view of beaver pond complex, Riparian Vegetation Study area, Susitna River floodplain, Alaska, 2012.**

Signs of beaver activity were observed throughout the study area, particularly in the Middle River and Lower River – Middle Susitna River segments where beavers often formed dams in inactive side channels and sloughs of the river (Figure 9). Observations of beaver activity included chewed and felled trees and shrubs, dams and lodges, and impoundments. Several older, large (10–30 meters [33–98 feet] across, and 1–2 meters [3.3–6.6 feet] high) vegetated beaver dams were also observed that showed evidence of recent maintenance by beavers (Figure 10).

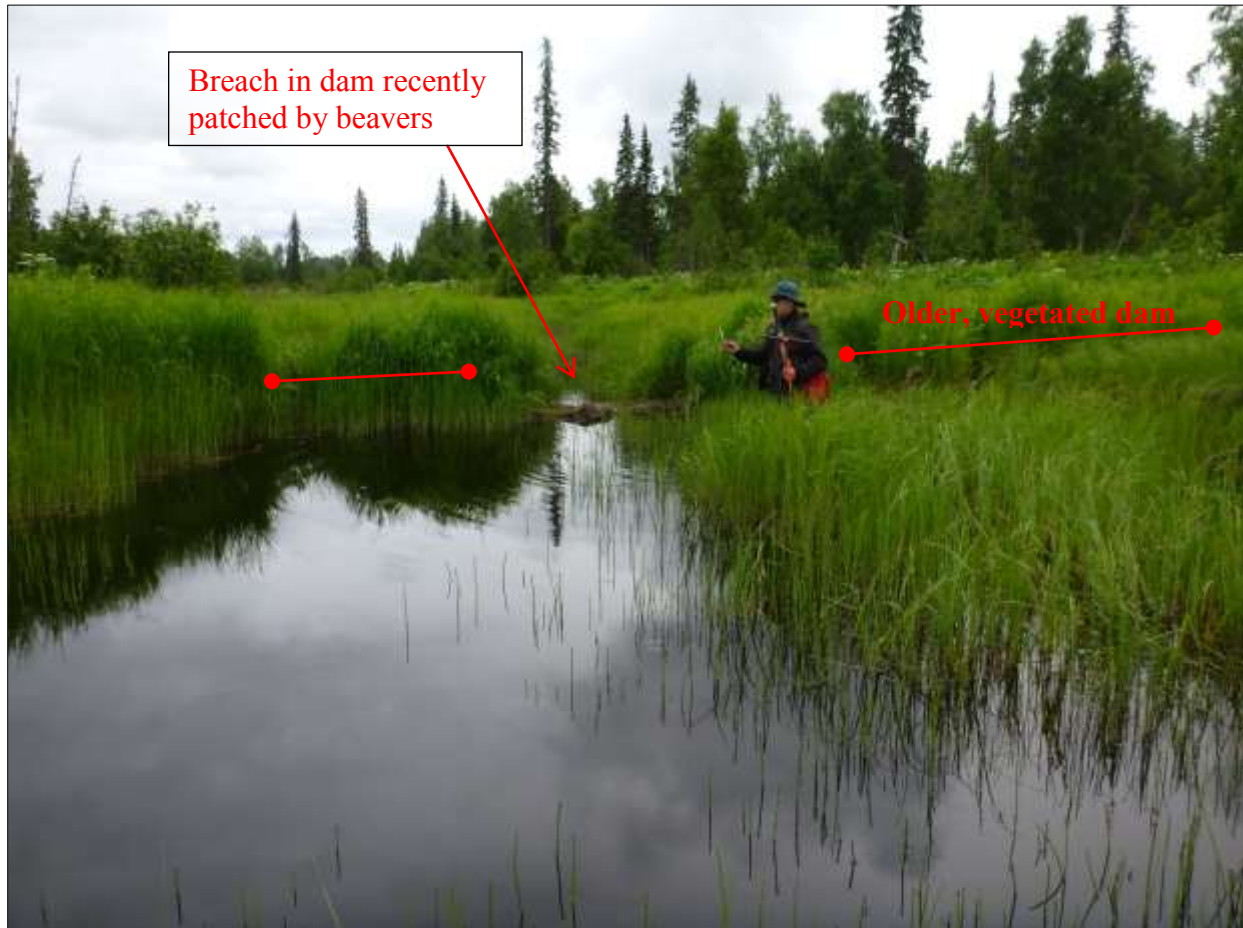
**Figure 10. Beaver impoundment showing older, vegetated dam with breach recently maintained by beavers, Riparian Vegetation Study area, Susitna River floodplain, Alaska, 2012.**
